TECHNICAL MEMORANDUM

To: Bill Slater and Fred Green **Date:** 20 Sept 2016
Cc: Patricia Randell, Erik Pit, Emilie Hamm, Chris Dixon,
Jason Berkers, and Paul LePage **Project #:** A399-1
From: Alan Martin and Justin Stockwell (Lorax Environmental Services Ltd.)
Subject: Mount Nansen – 2016 Water Quality Update – **FINAL**

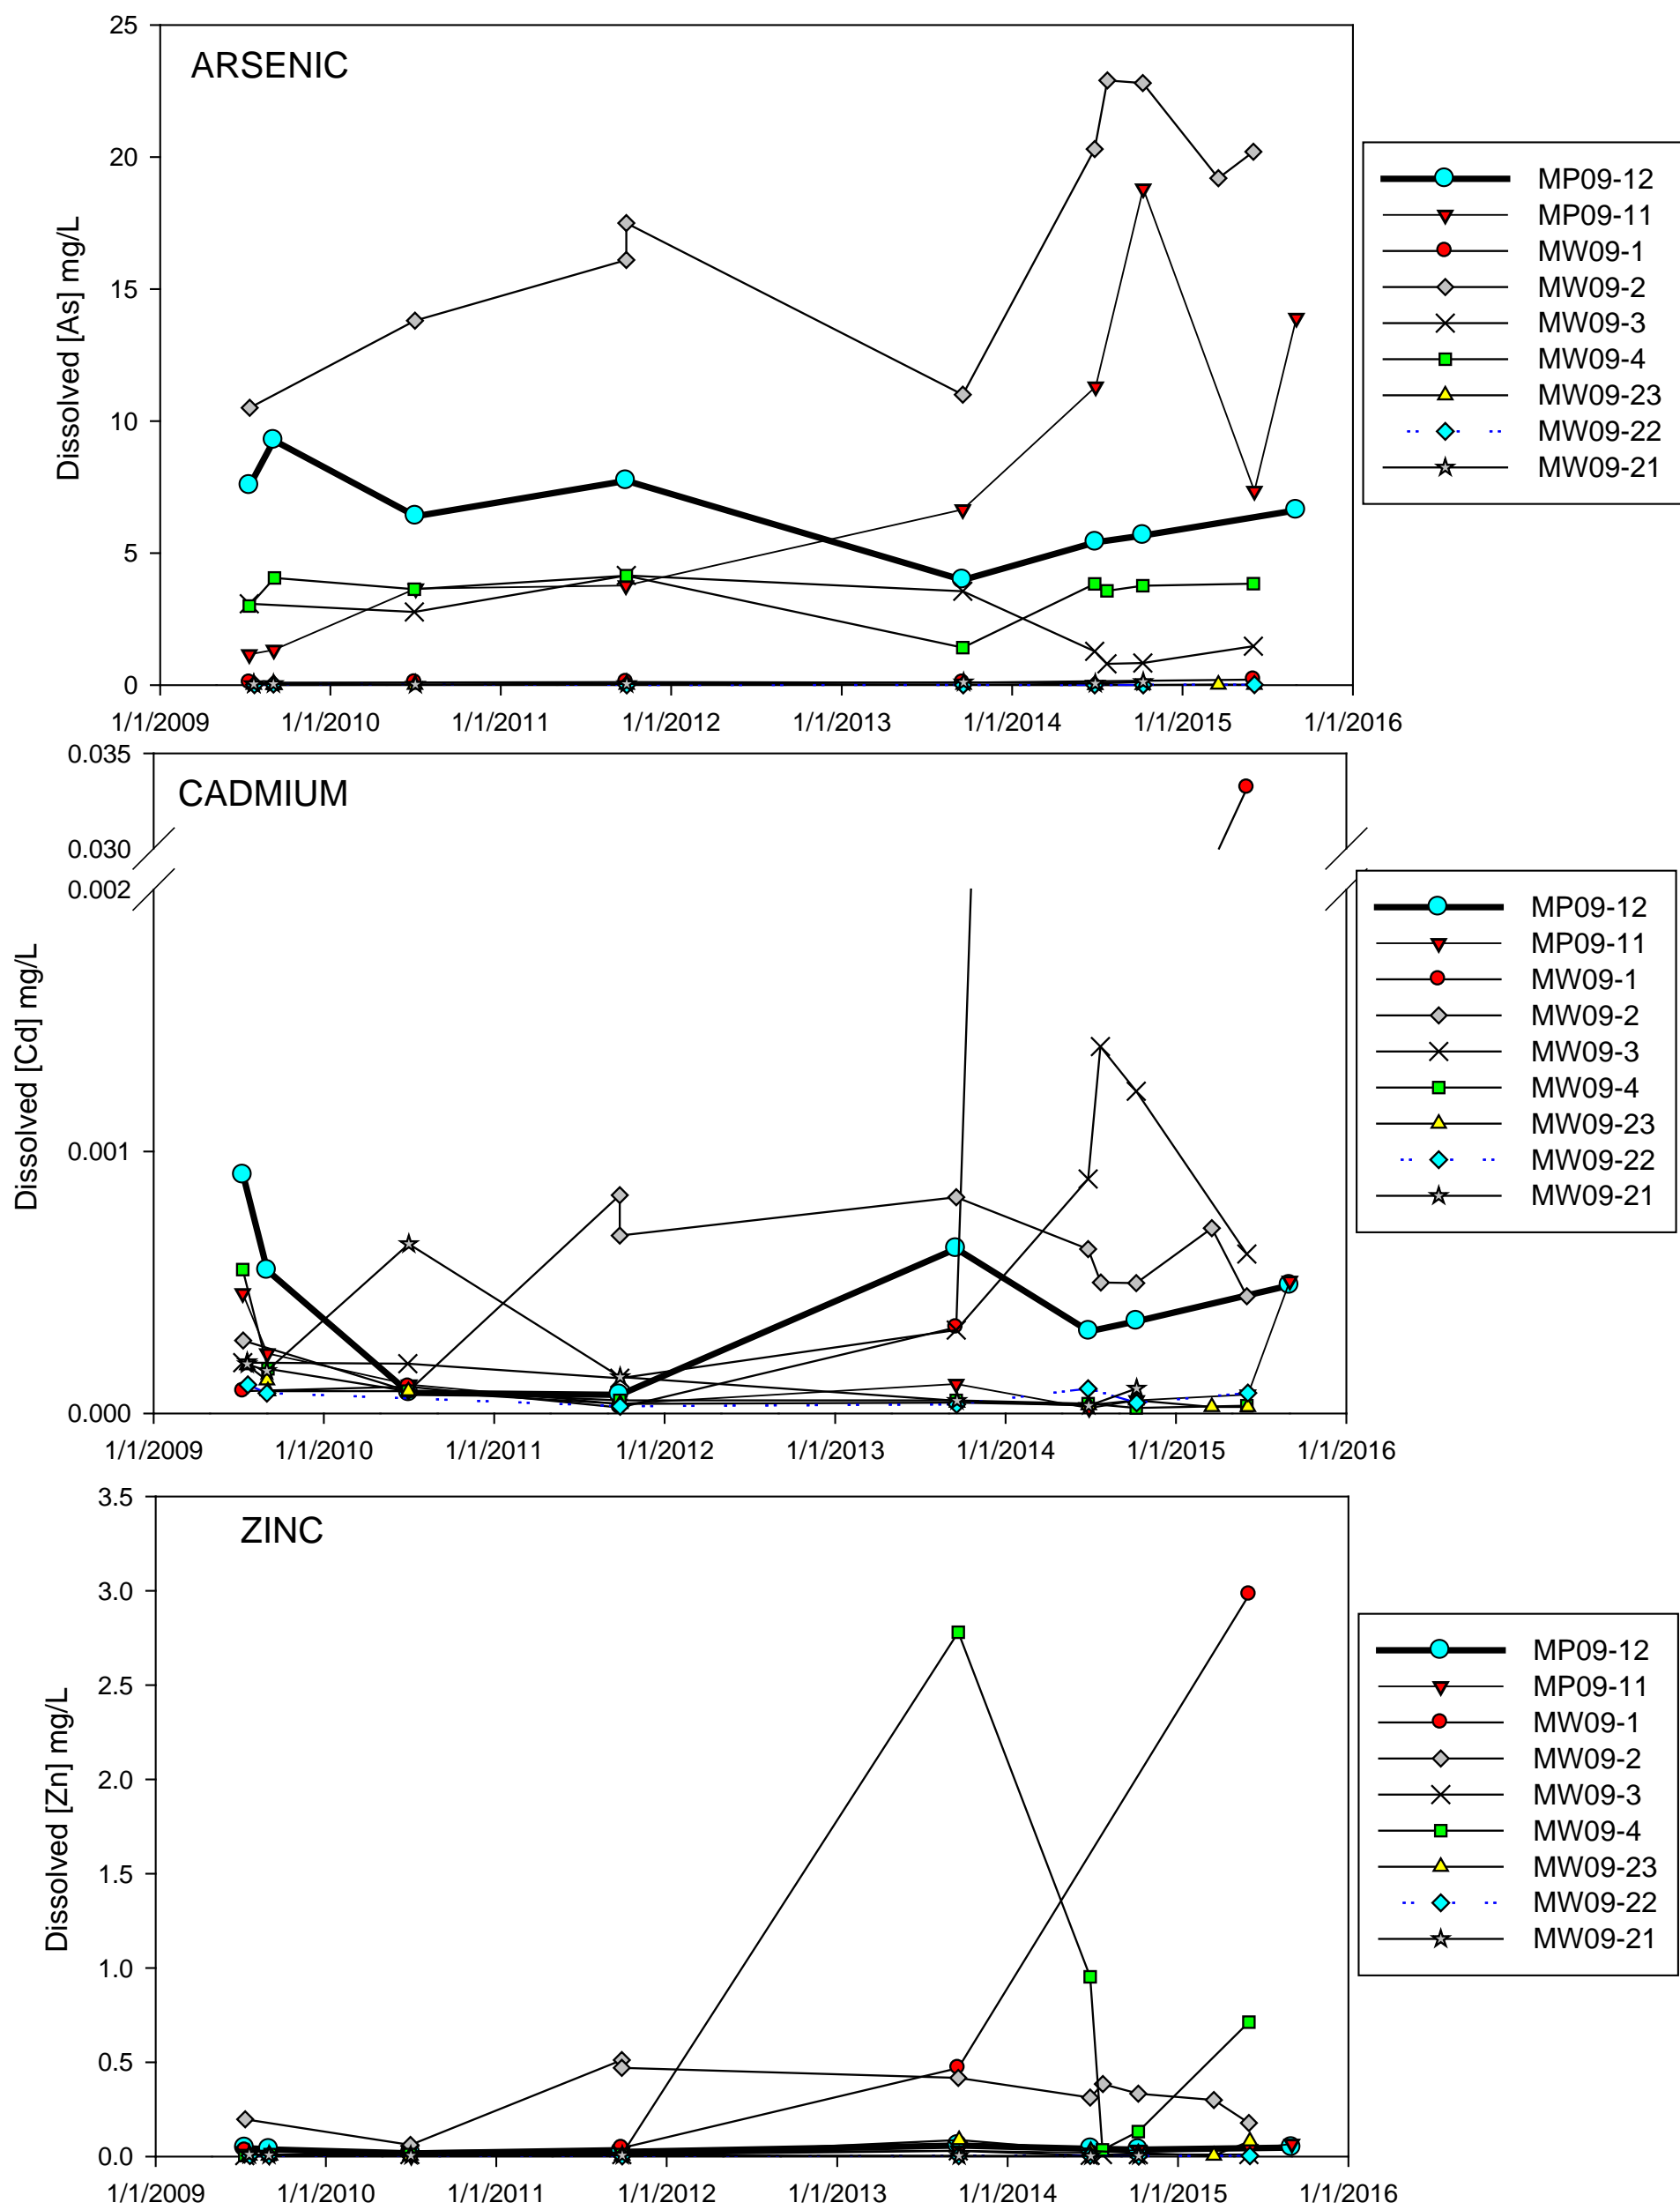
Figure 10: Time series profiles of dissolved As, Cd and Zn for Tailings Management Area groundwater wells. Note break in scale for Cd on Y-axis.

Water quality data for groundwater wells in the tailings facility are shown for major ions and pH (Figure 9), trace elements (Figure 10) and redox-related parameters (Figure 11). In general, major ions show seasonal and spatial variability. Data from piezometer MP09-12 are generally interpreted to be representative of background conditions and are shown in bold for comparison to other locations. With respect to major ions, SO₄ shows significant temporal variability with some evidence of increasing concentrations at MW09-1, MW09-2, and MW09-22. Data from MW09-1 should be viewed with caution, however, as the well head is reportedly cracked at surface (Hemmera, 2016) and likely has been contaminated by near-surface tailings and/or pond water. Possible SO₄ increases are evident at MW09-22, which shows a trend towards higher values in 2014 and 2015 (809 to 1990 mg/L) in comparison to values in 2009 and 2011 (70 to 156 mg/L).

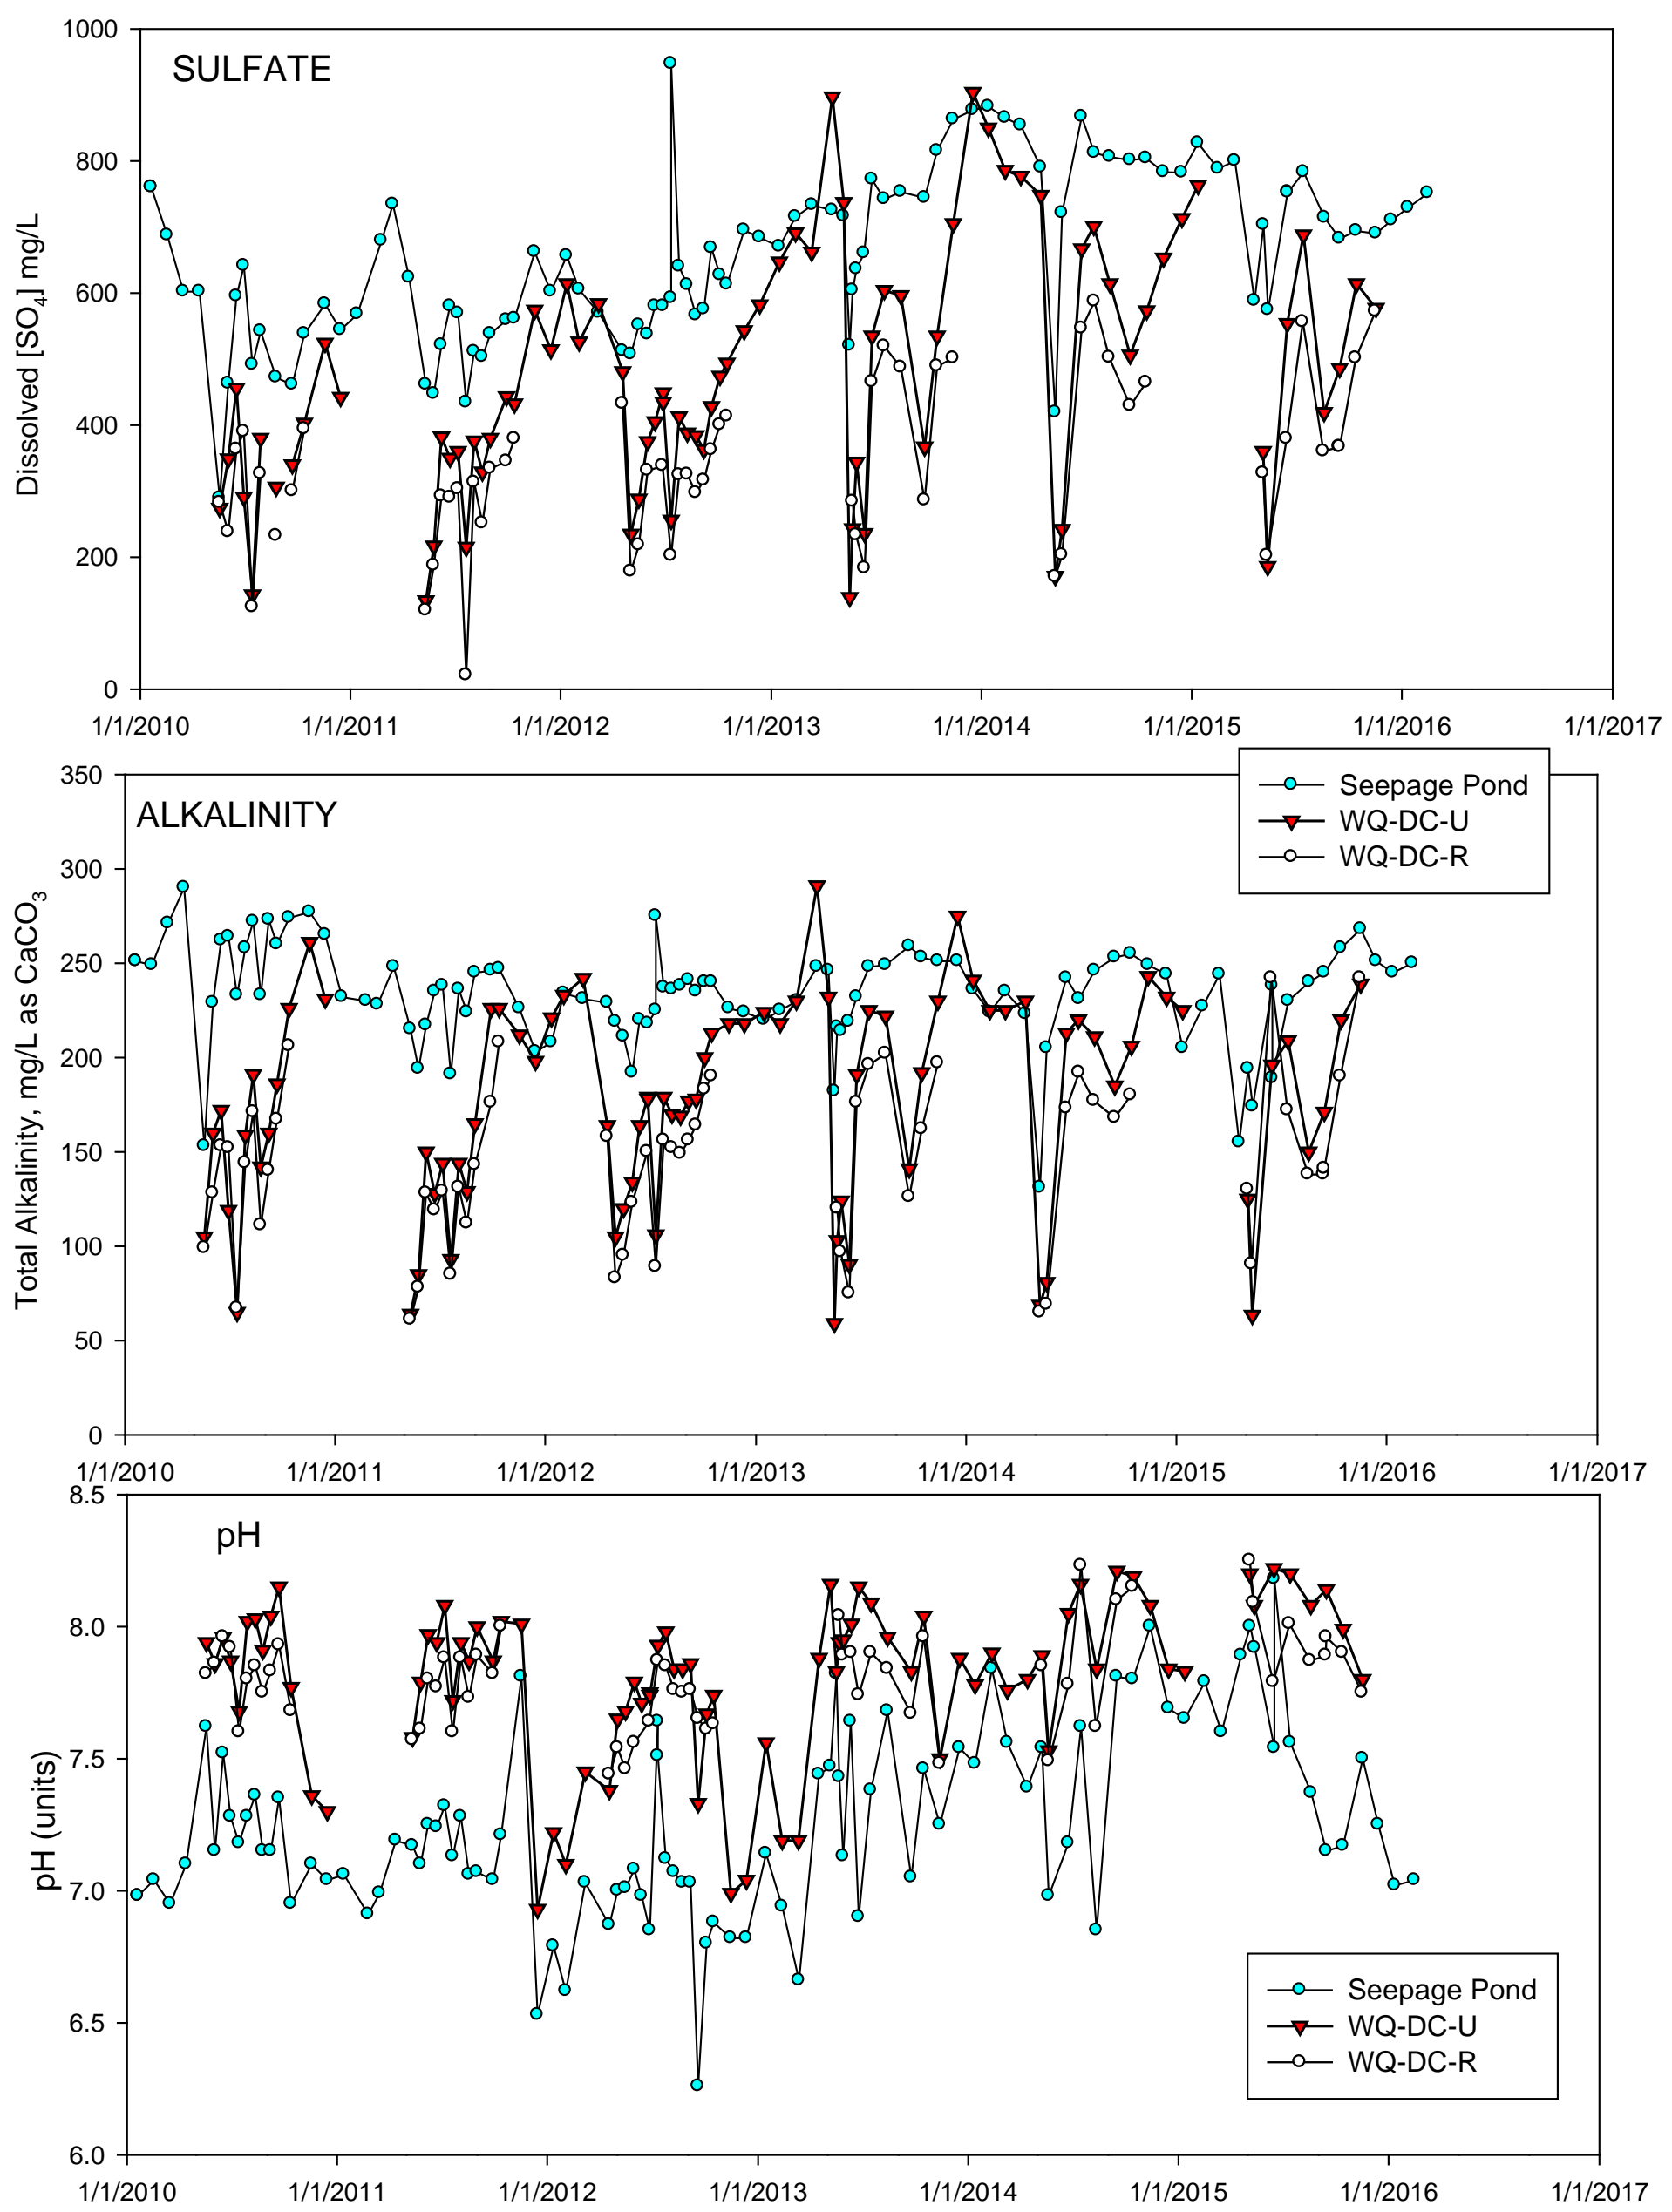
Figure 15: Time series profiles for SO4, alkalinity and pH for Seepage Pond and Lower Dome Creek (2010-2015 data).

As outlined in Section 2.2, several parameters show recent increases in concentration in the Seepage Pond (SO₄, Fe, Mn, Zn, Cd), while NO₃-N concentrations have been decreasing. The increase in SO₄ concentration observed between 2012 and 2014 is evident in lower Dome Creek at both DC-U and DC-R (Figure 15). With respect to redox-sensitive parameters, the dissolved Mn peak in the Seepage Pond in 2014 is congruent with peak values at DC-U (Figure 16). However, evidence for increasing trends in Mn concentrations over time is not apparent further downstream at DC-R. Comparison of Mn data between DC-U and DC-R suggest a slight effect of dilution downstream similar to SO₄. In contrast, the relative effect of dilution on Fe is markedly different as Fe concentrations show seasonal increase between DC-U and DC-R. Further, the progressive rise in dissolved Fe concentrations in the Seepage Pond since 2010 is not evident at
