**Mount Nansen Summary Data Report
Department of Indian Affairs & Northern Development
Whitehorse, Yukon**

Project No. 0201-00-14618

September 2002

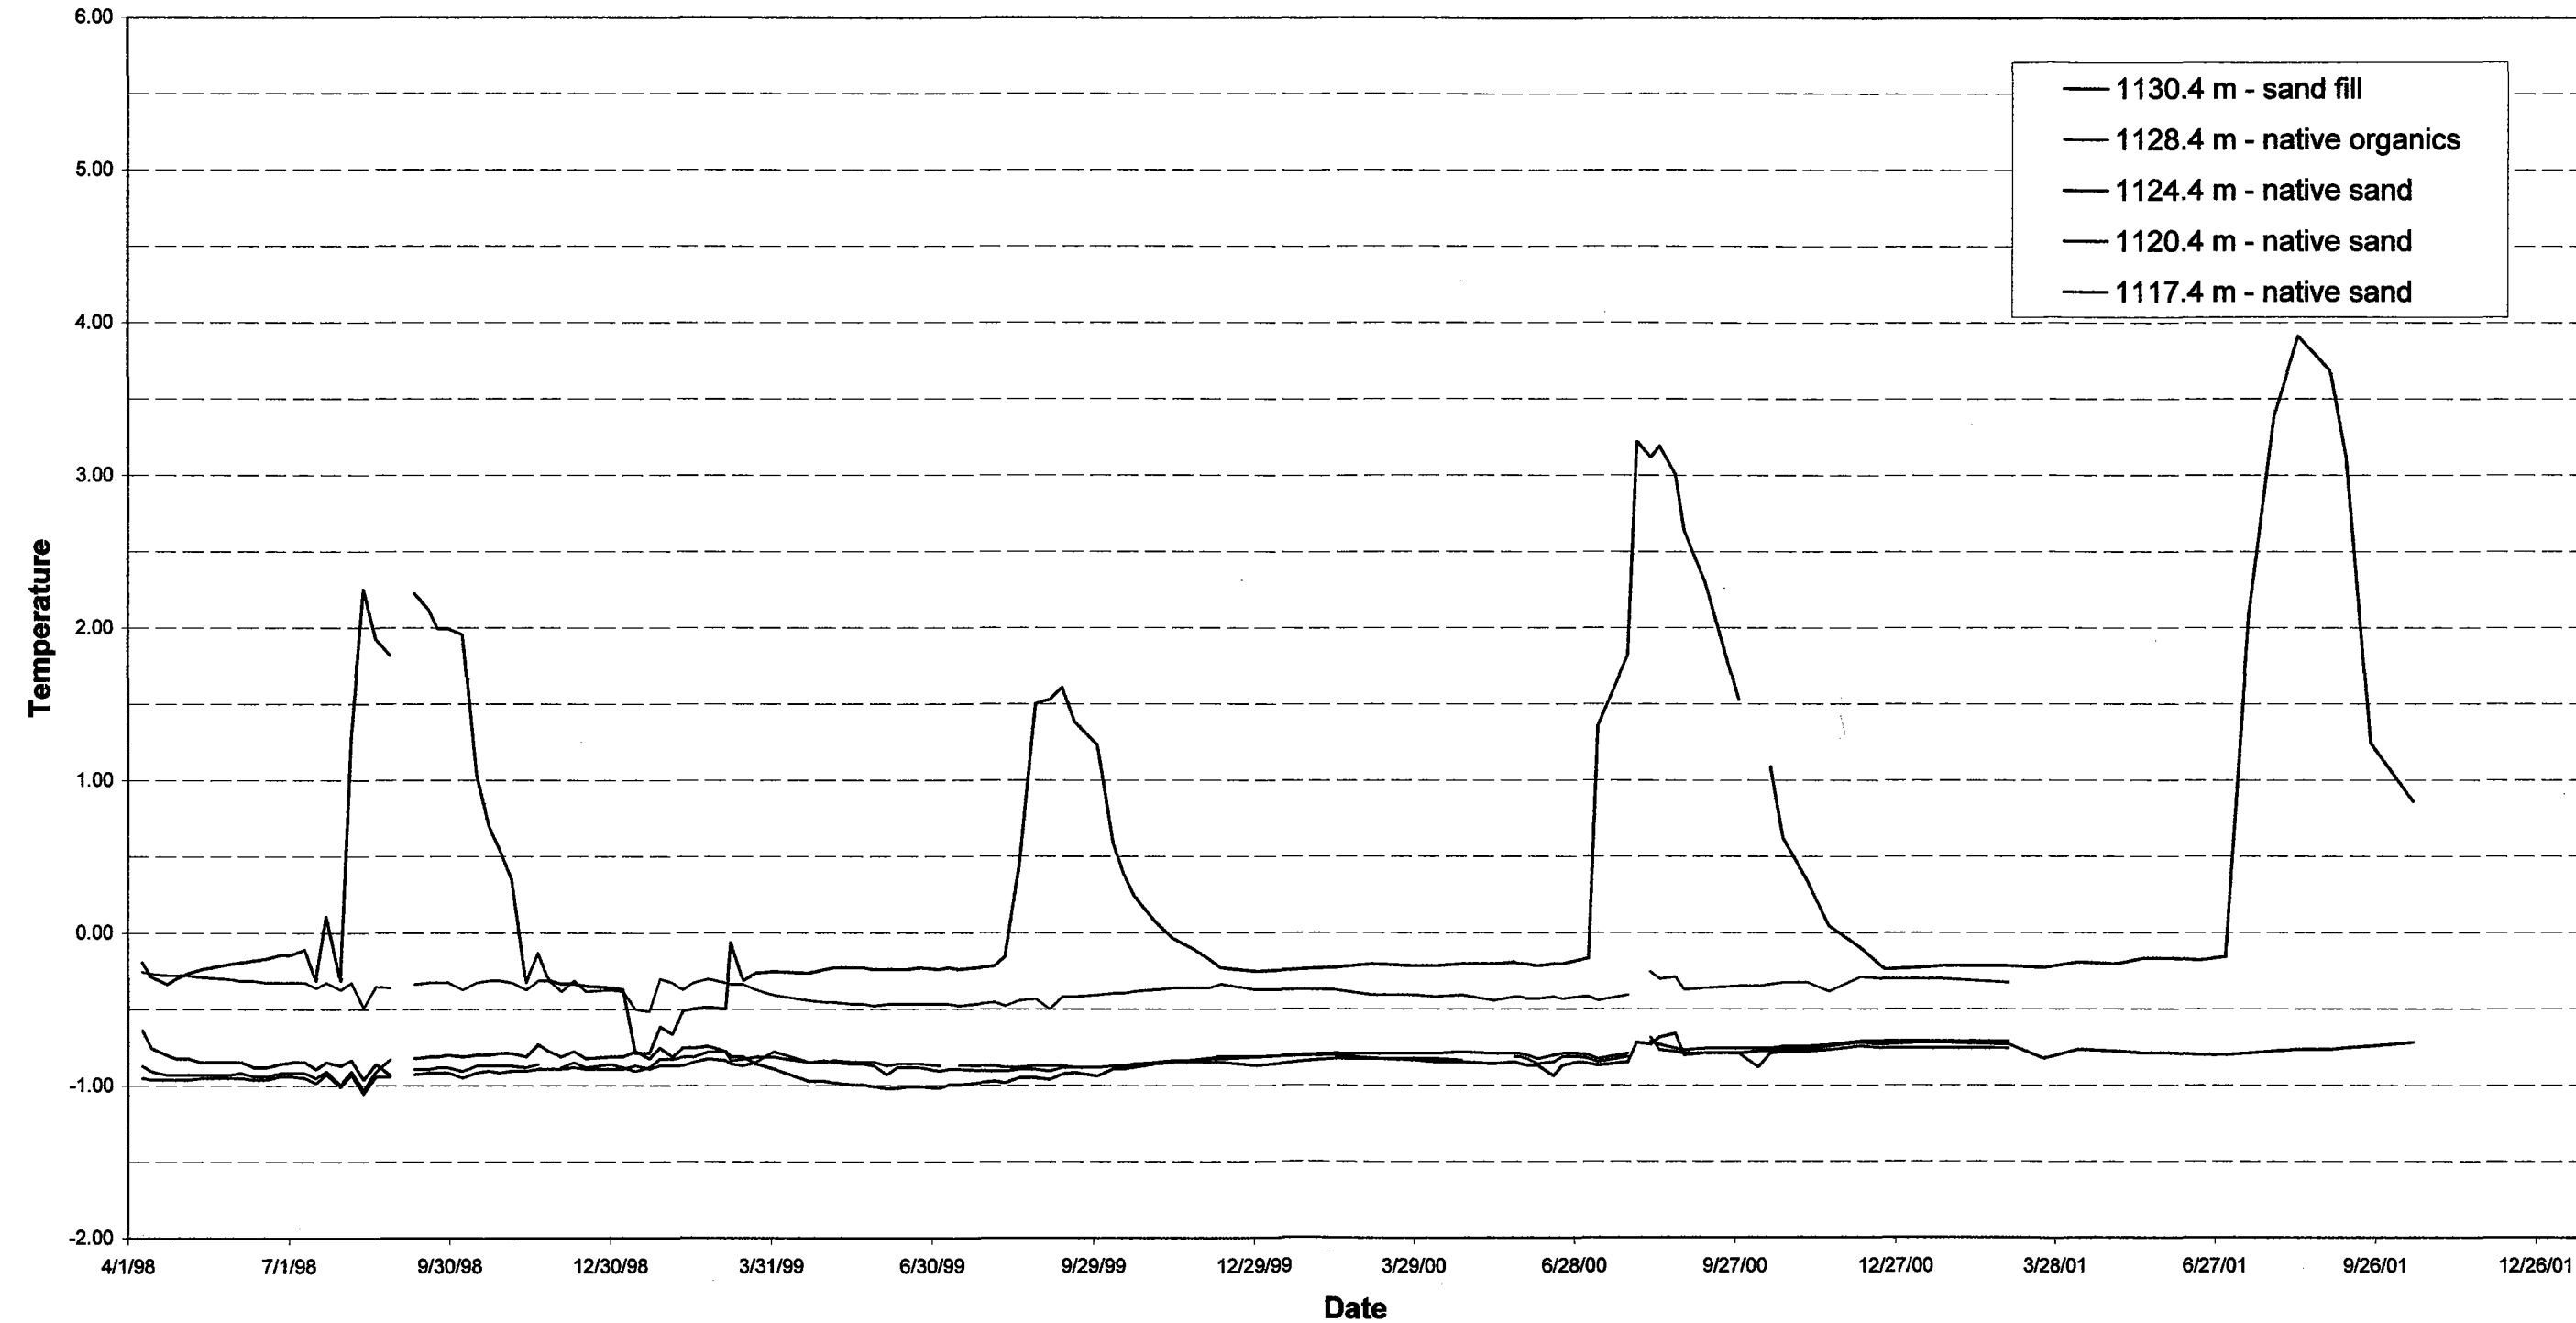
Ground Temperature Profiles
BH # 12861-07

NOTE: 1) BH Location: Downstream Toe of Dam
2) Ground surface: 1132.6 m.
3) Fill and native ground interface: 1129.3 m.
4) Thermistor Beads at 1139.3 and 1131.4 not shown.

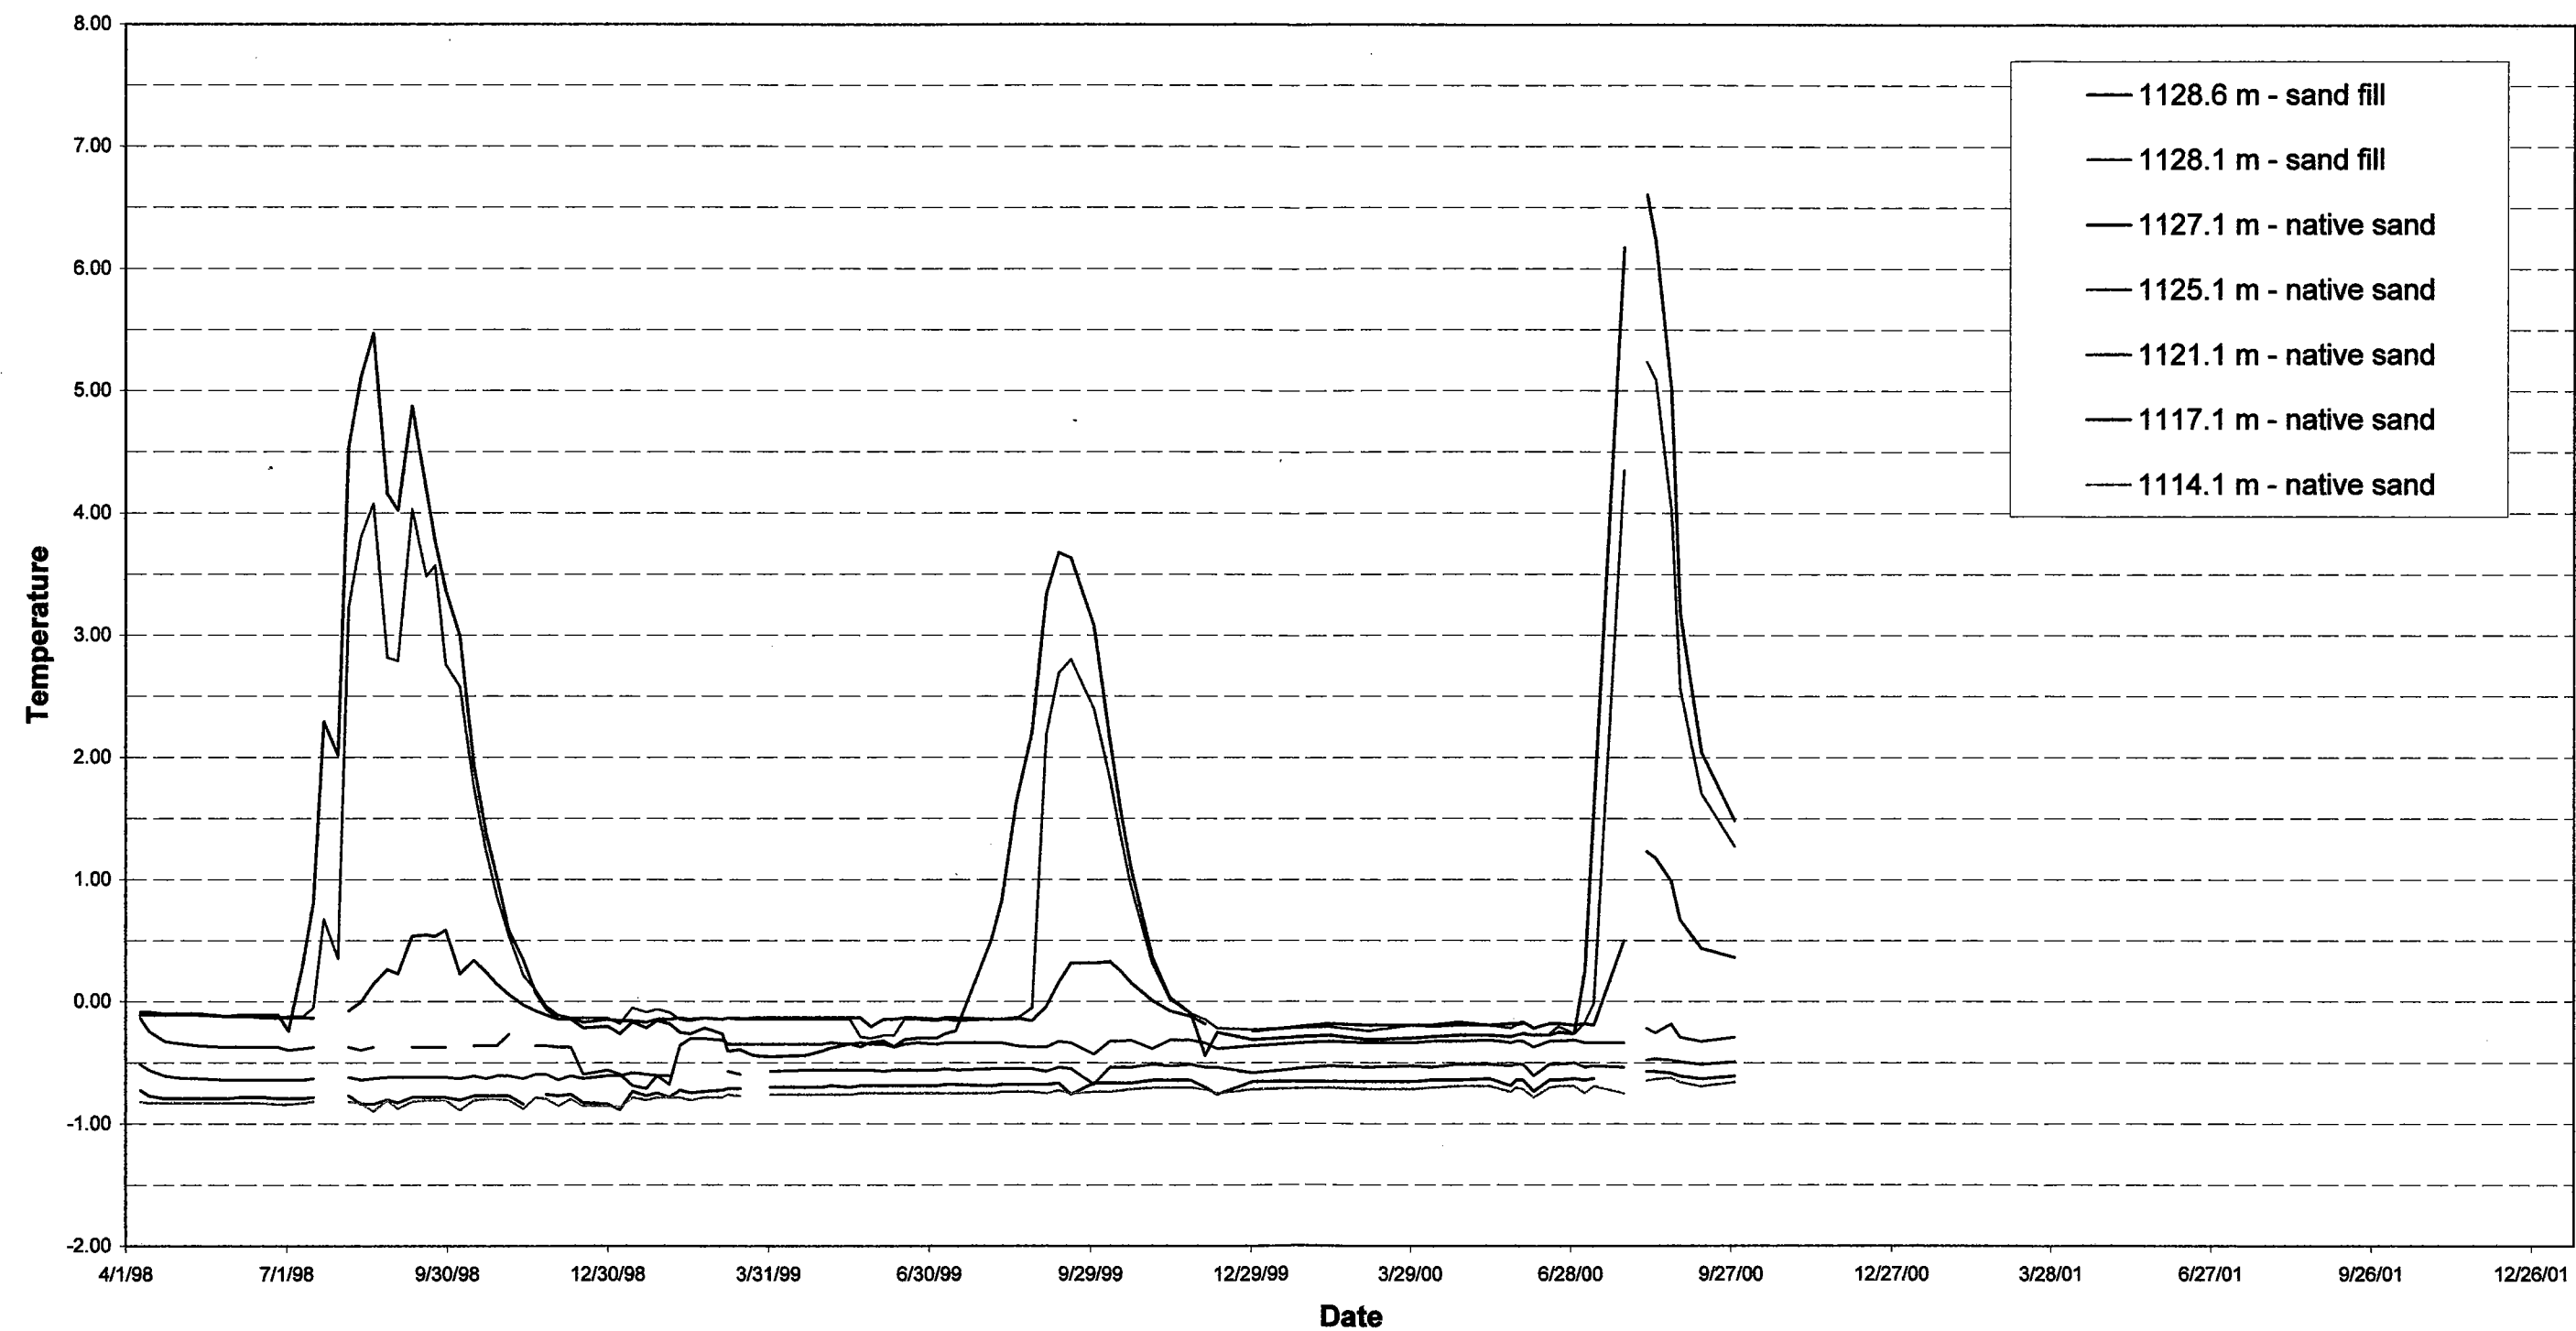
Figure A-7
Ground Temperature Profiles
BH # 12861-08

NOTE: 1) BH Location: Crest of Seepage Dam
2) Ground surface: 1130.7 m.
3) Fill and native ground interface: 1127.6 m.

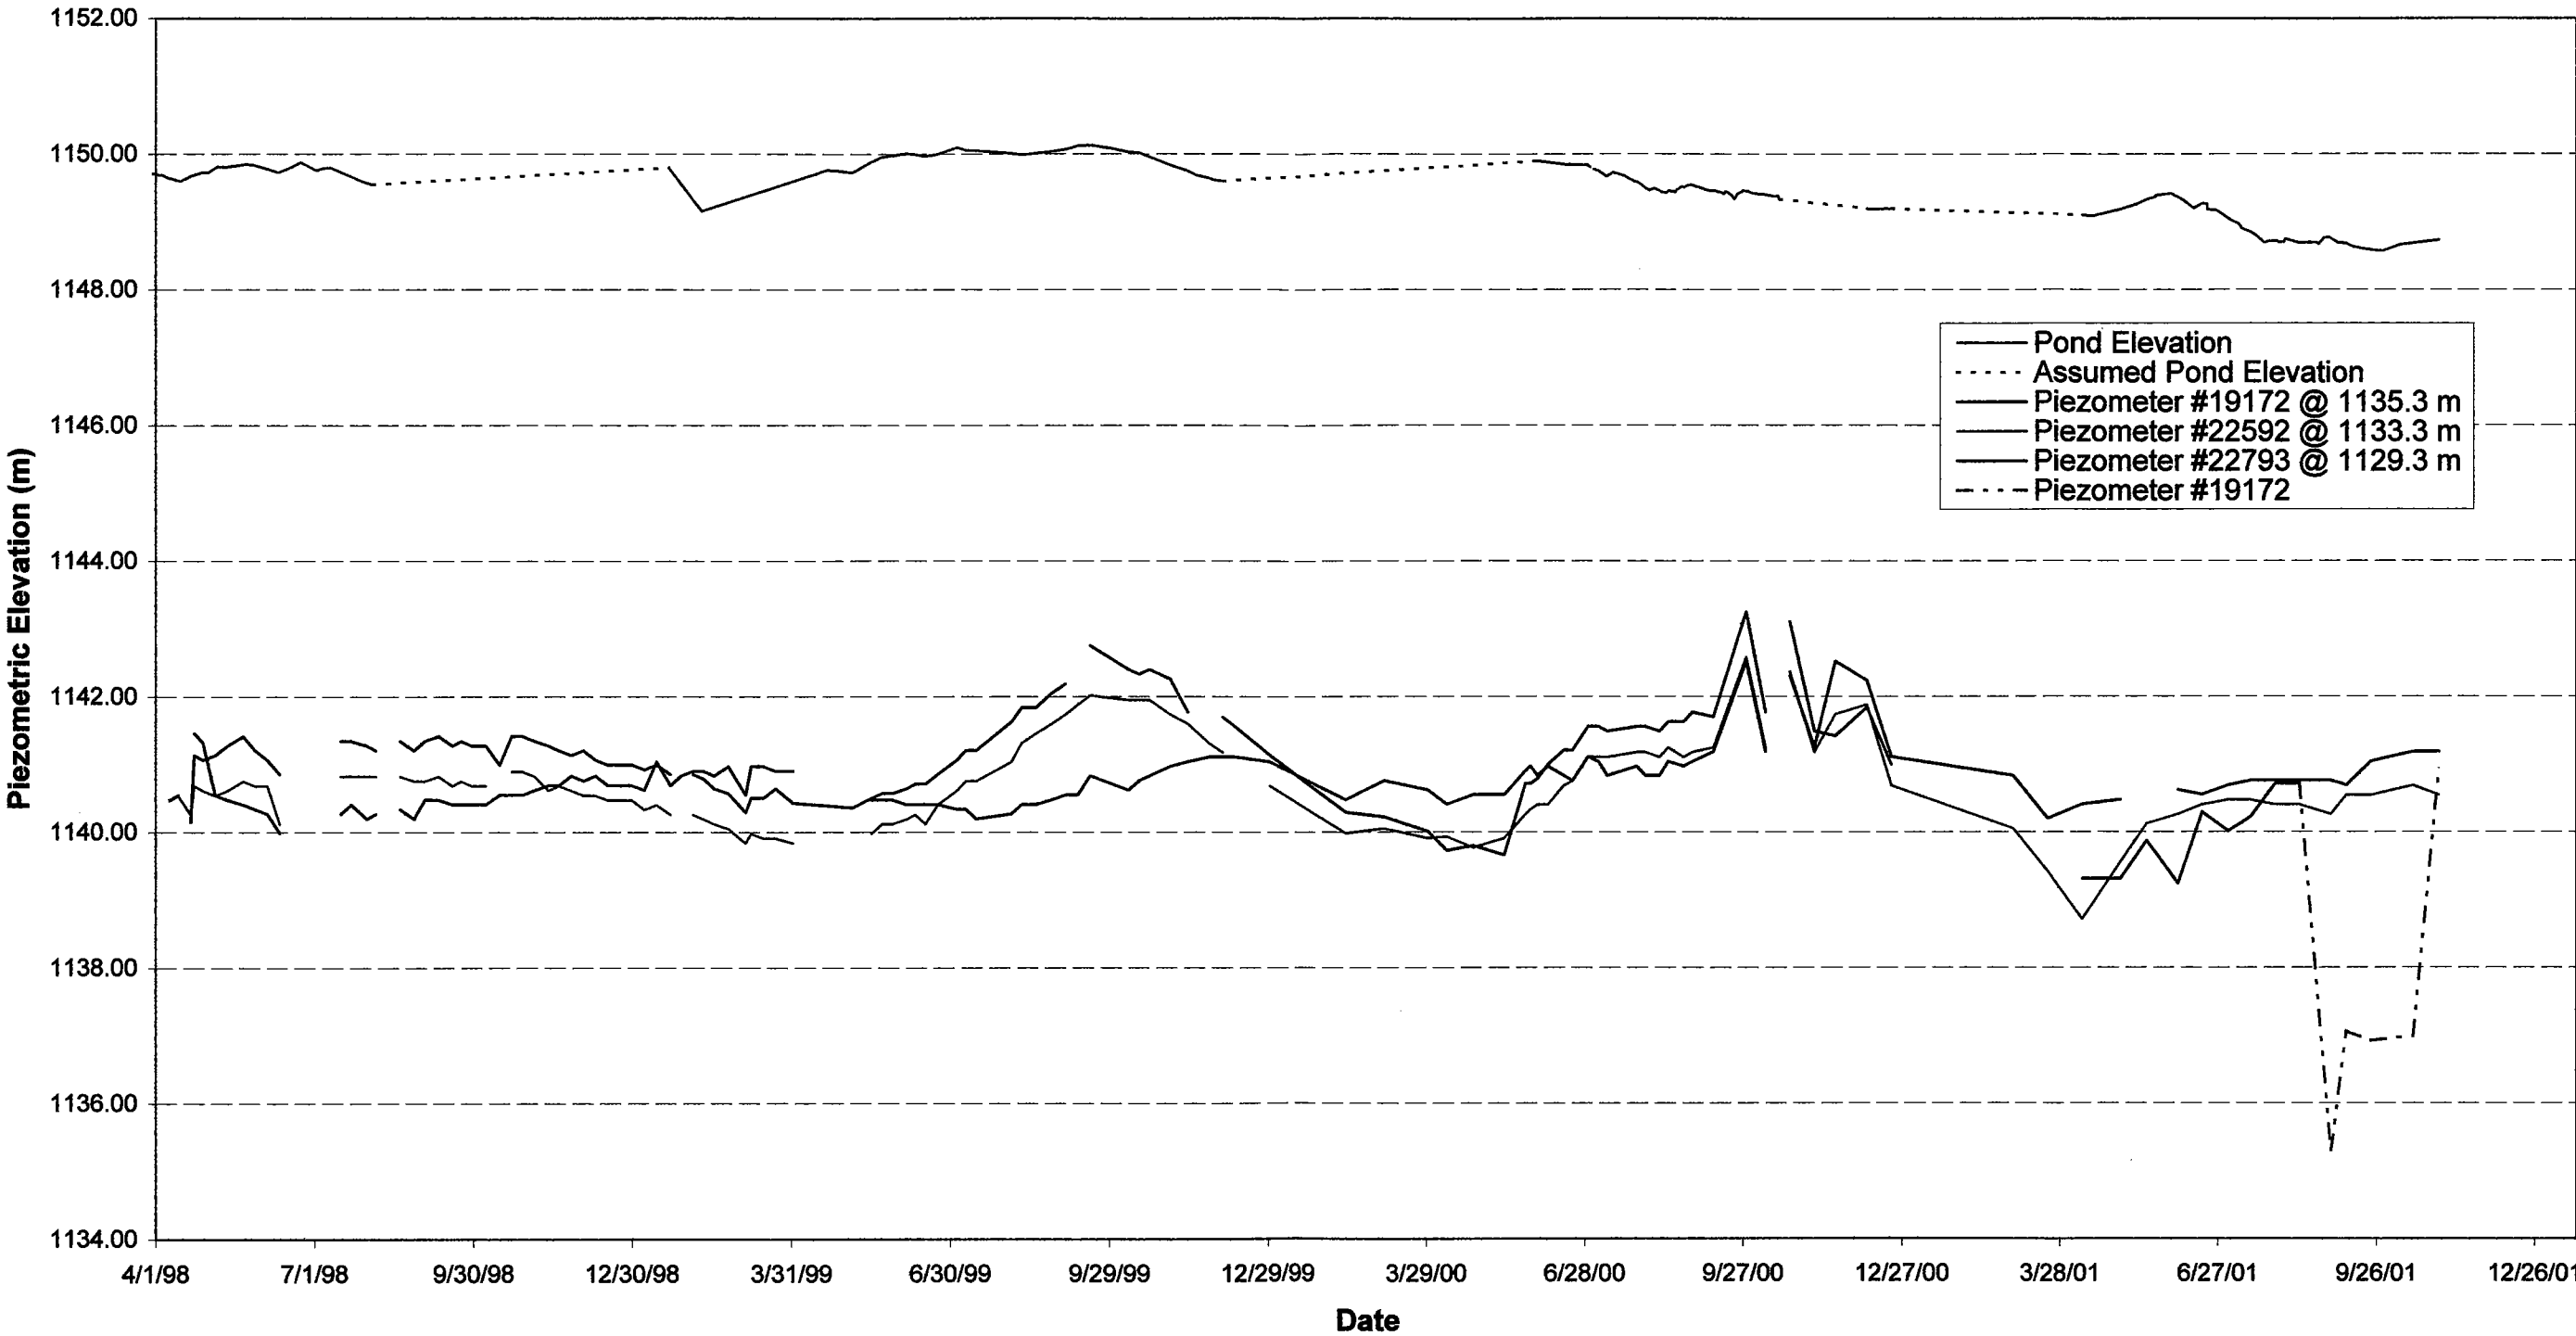
Piezometric Elevation Profiles
BH # 12861-02

NOTE: 1) BH Location: Crest of Dam
2) Ground surface: 1151.4 m.
3) Fill and native ground interface: unknown.
4) Temperatures of Piezometers are unknown.
5) Dashed line segments represent potentially erroneous readings.

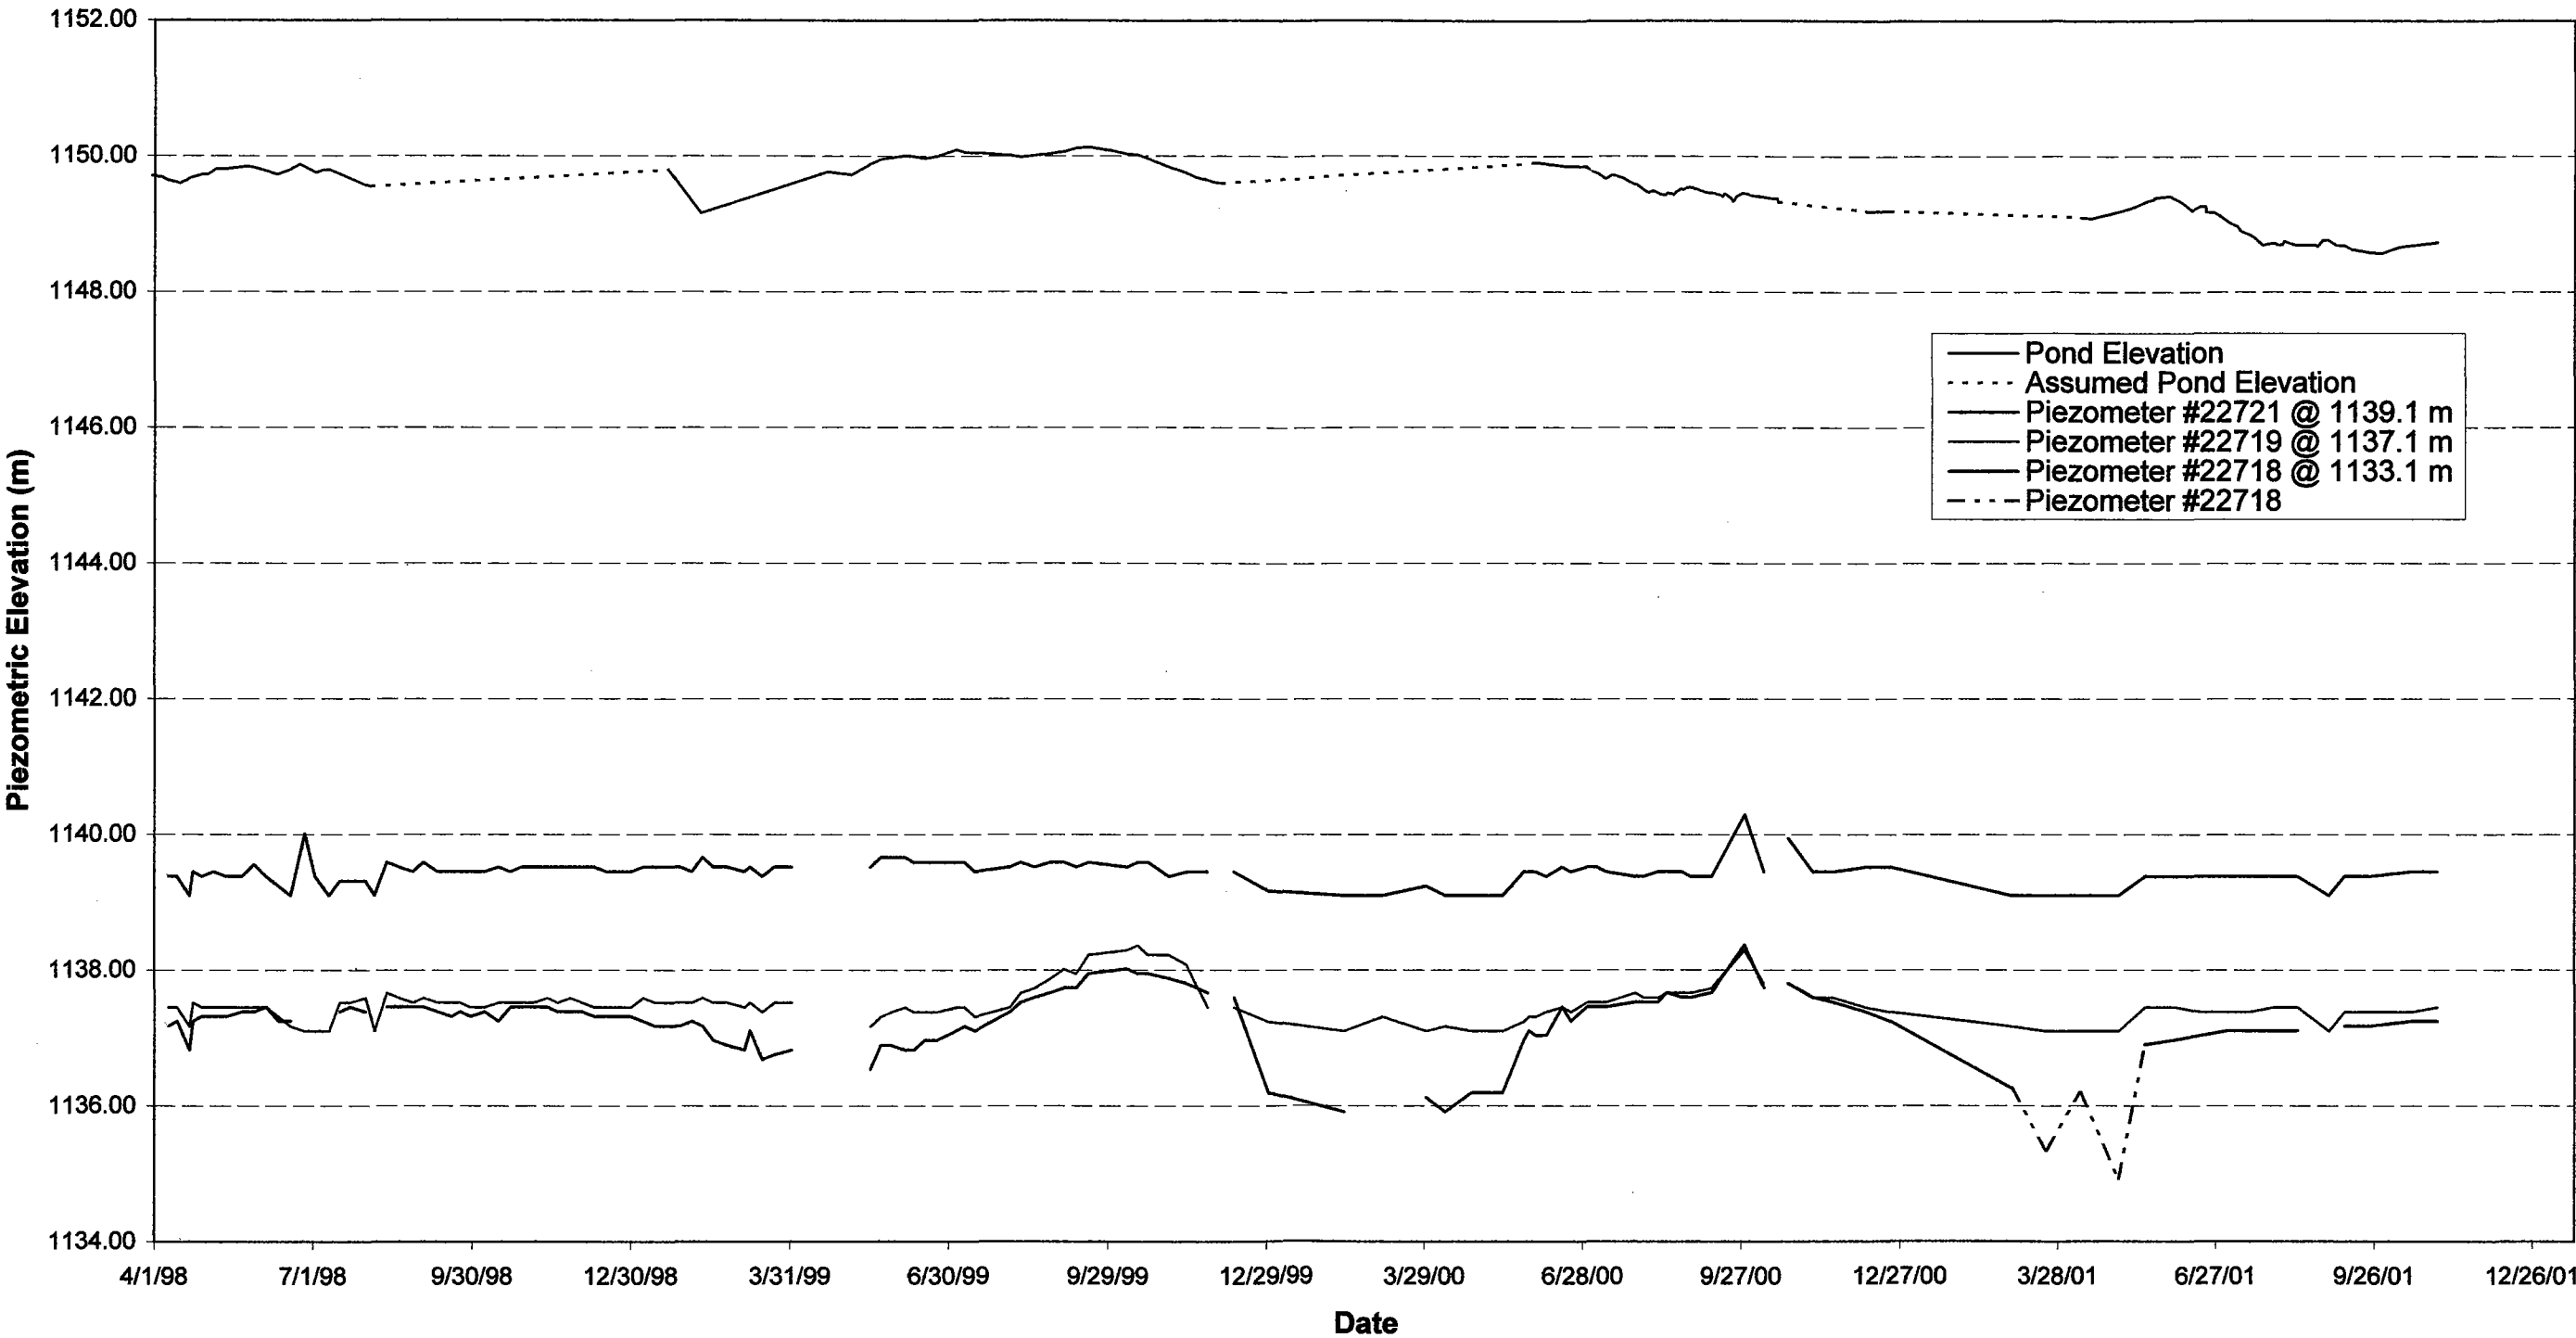
Piezometric Elevation Profiles
BH # 12861-05

NOTE: 1) BH Location: North Abuttment off of Toe Berm
2) Ground surface: 1143.3 m.
3) Fill and native ground interface: 1142.7 m.
4) Dashed line segments represent potentially erroneous readings.

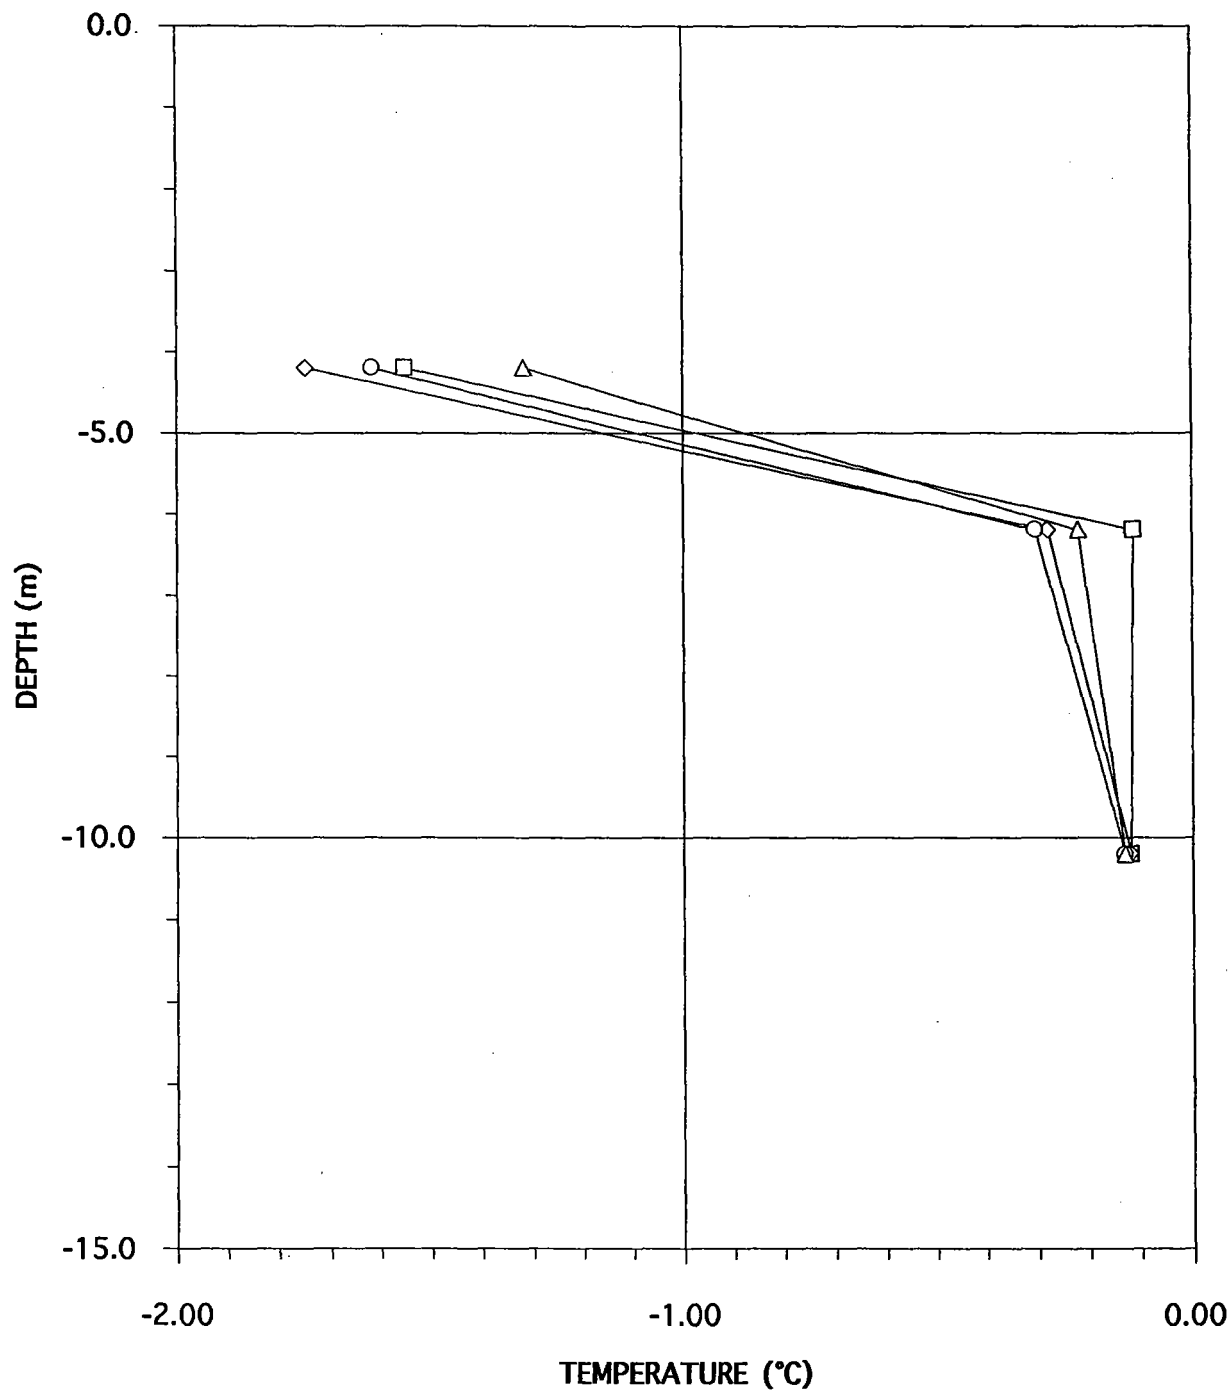
GROUND TEMPERATURE PROFILE
MT. NANSEN - TAILINGS DAM TOE BERM
BOREHOLE 12861-07 (el. 1143.3)

2.0					- frozen (permafrost), indicates some freeze back into fill											2.0						
3.0					ORGANICS - frozen (permafrost) black											3.0
