### **PROJECT MEMORANDUM**

<b>To:</b>	<b>Faro Mine Closure Planning Office</b>	<b>Fax No.:</b>	<b>Via e-mail</b>
<b>Attention:</b>	<b>John Brodie</b>	<b>CC:</b>	<b>Rock Drain Working Group</b>
<b>From:</b>	<b>Selina Tribe, Gerry Ferris</b>	<b>Date:</b>	<b>July 7, 2006</b>
<b>Subject:</b>	<b>Natural Hazard Terrain Assessment – NFRC and South Slope RCDC</b>		
<b>No. of Pages (including this page):</b>	<b>14 + Figures &amp; Appendices</b>	<b>Project No:</b>	<b>0257-031-01</b>

This memorandum provides a summary of the natural hazard terrain assessment performed for the North Fork Rose Creek (NFRC) basin and the natural slopes above the Rose Creek Diversion Canal (RCDC). In this study, only those natural hazards visible on airphotos within these two specific areas are addressed. There was no site reconnaissance carried out in conjunction with this phase of the assessment. This assessment of past performance (via historical airphotos) is thought to give an indication of the future performance within these two areas. This study does not provide a landslide hazard map for the basin (TBR 1996) nor address the various potential man made hazards within these basins (such as those from the c

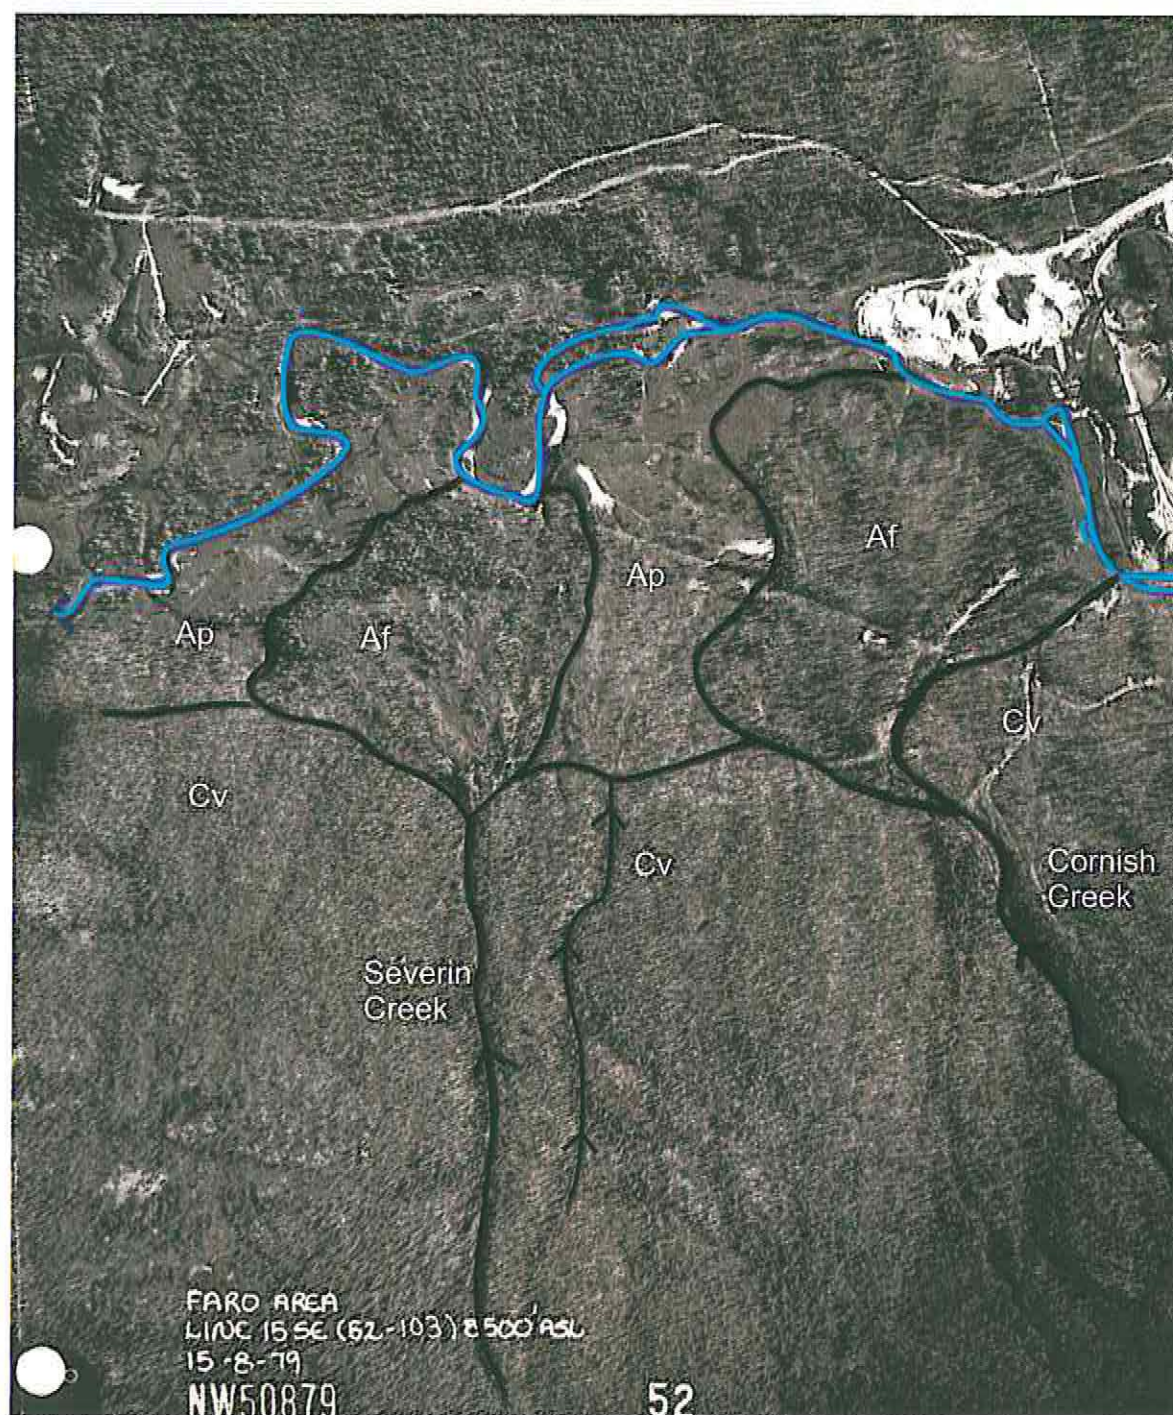
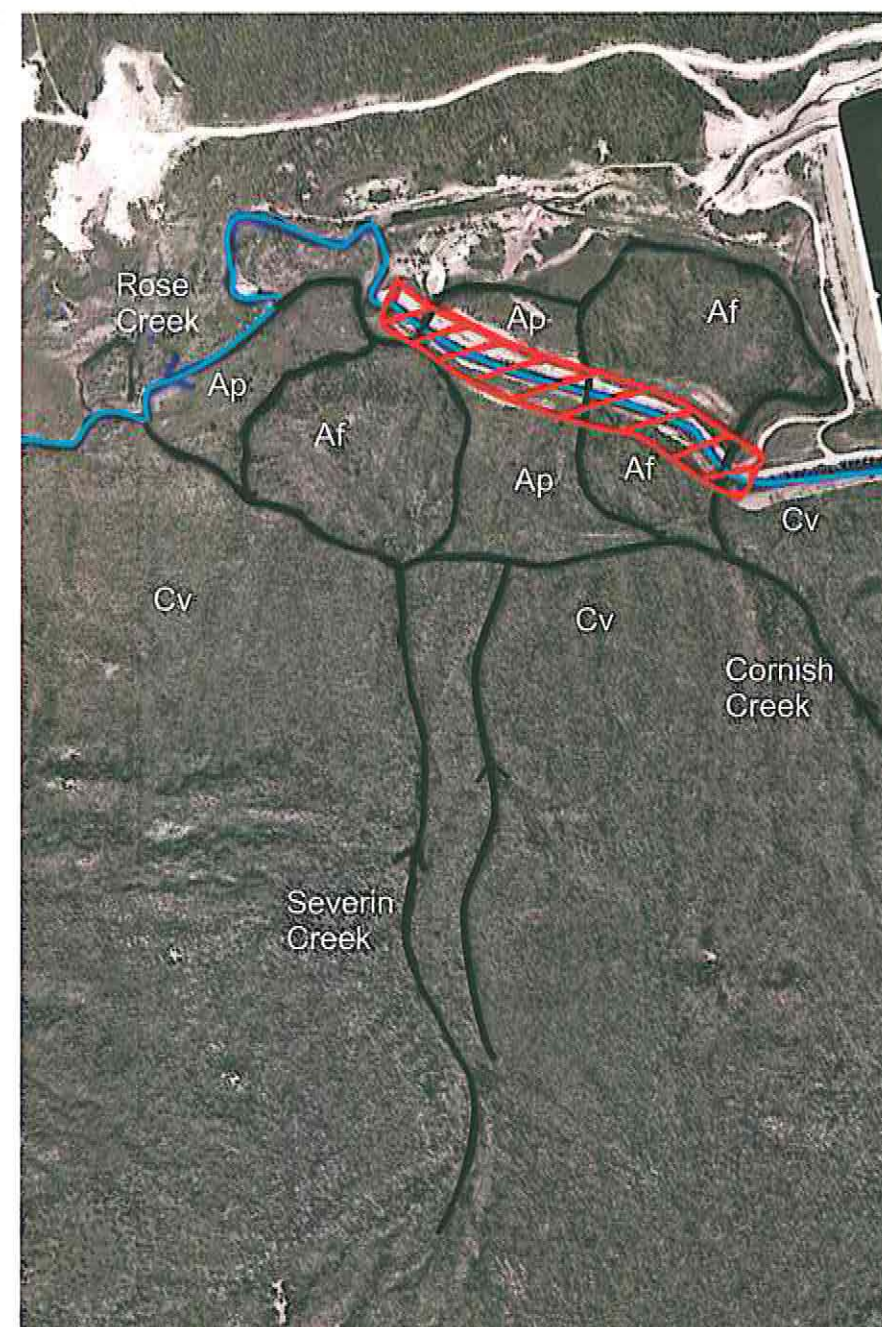
PROJECT	NATURAL HAZARD TERRAIN ASSESSMENT NFRS AND SOUTH SLOPE RCDC		
TITLE	TERRAIN ANALYSIS UPSLOPE OF RCDC		
PROJECT No.	FIGURE No.	REV.	
0257-031-01	7	0

The only natural hazard revealed in this natural hazard terrain assessment of the slope above the RCDC was the alluvial fans which have developed near the western limit of the study area. If conditions similar to those experienced in the past continue to be prevalent, similar scale of hazards would be expected.
