REPORT
ON
REQUIREMENTS FOR DEVELOPMENT OF
A REHABILITATION PLAN
CLINTON CREEK MINE
CASSIAR ASBESTOS CORPORATION
(1977)

Prepared for:
Yukon Territory Water Board

Prepared by:
R.M. Hardy & Associates Ltd.
Calgary, Alberta

December 30, 1977

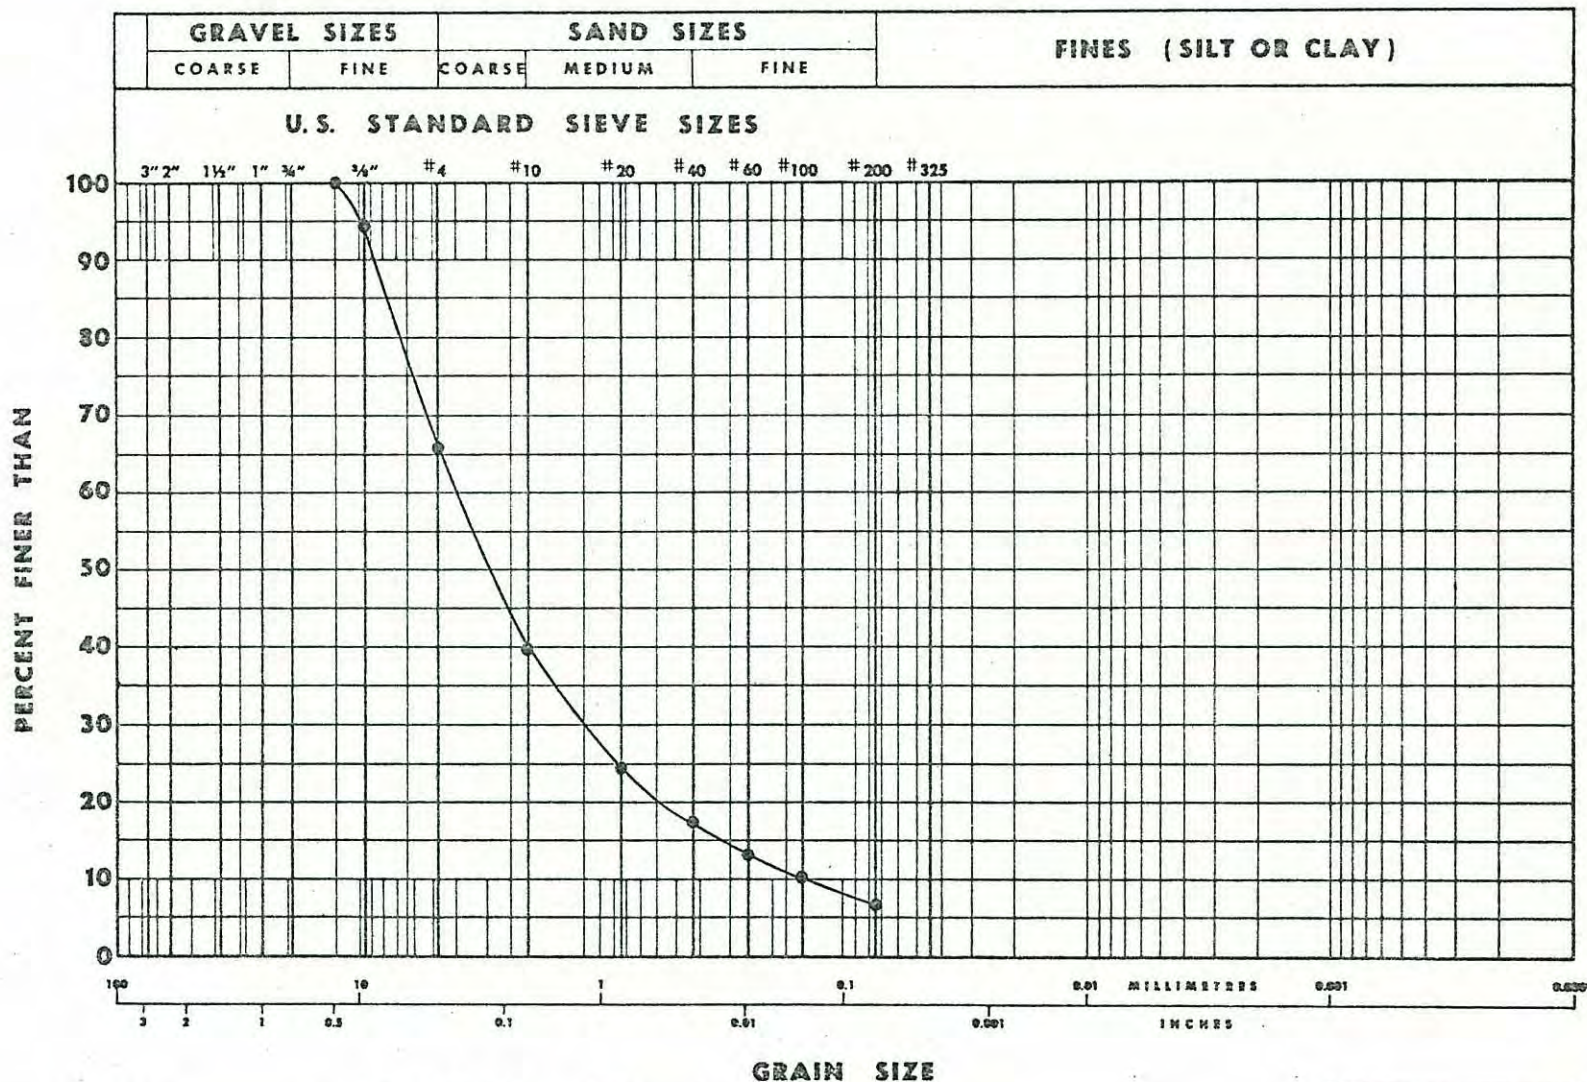
GRAIN SIZE CURVE

REMARKS: Gravel Size 34%
Sand Size 59%
Fines 7%
Moisture Content 9.0%

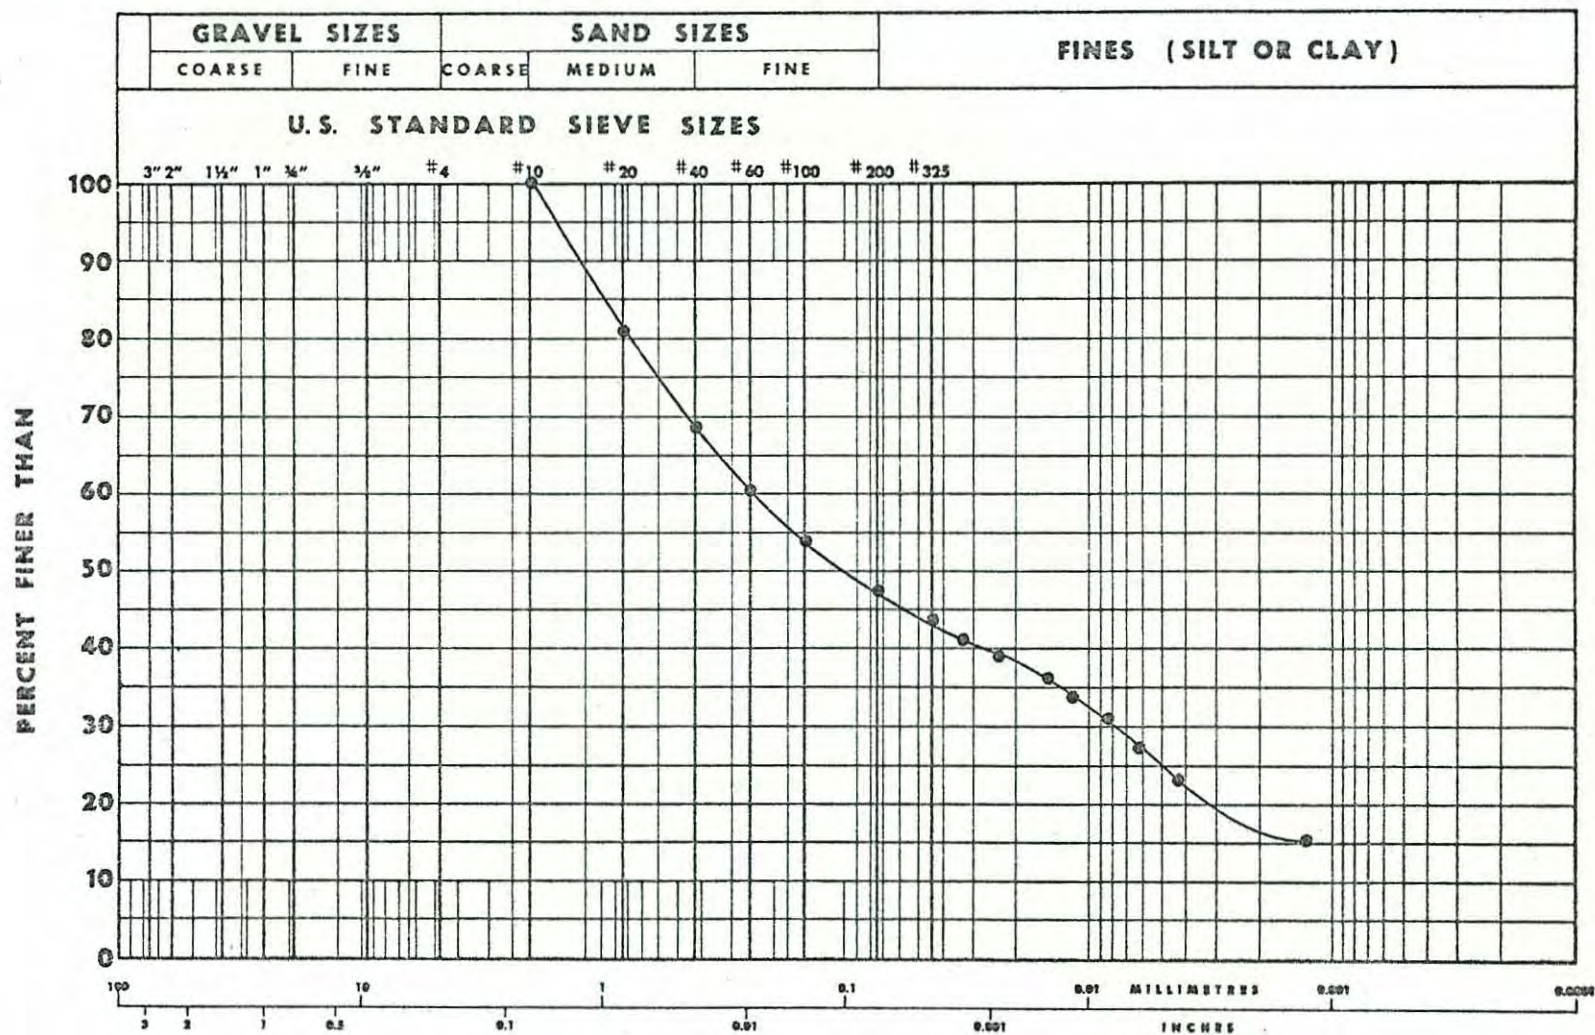
GRAIN SIZE CURVE

REMARKS: Liquid Limit 27.3 Sand size 52.5%
Plastic Limit 18.7 Silt size 31.5%
Index of Plasticity 8.6 Clay size 16%
Moisture Content 9.0%
