Golder Associates
CONSULTING GEOTECHNICAL ENGINEERS

REPORT TO
CASSIAR ASBESTOS CORPORATION LTD.
RE
MINE WASTE DUMP AND TAILING PILE
CLINTON CREEK OPERATIONS
CLINTON CREEK YUKON TERRITORY

July 1978

V77016

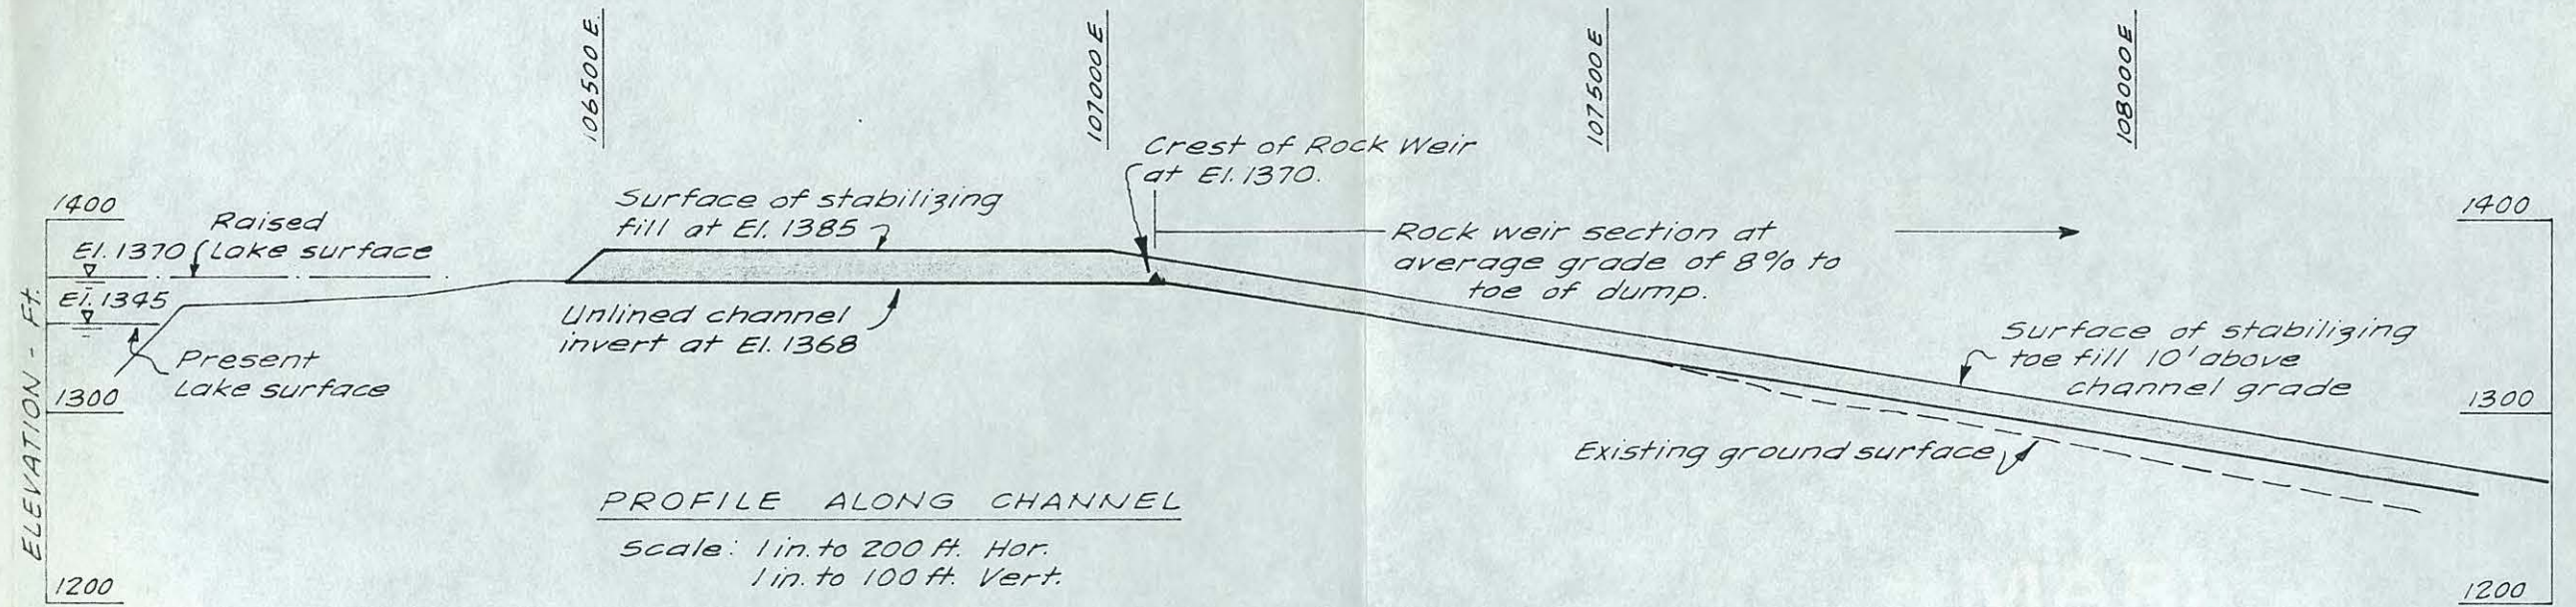
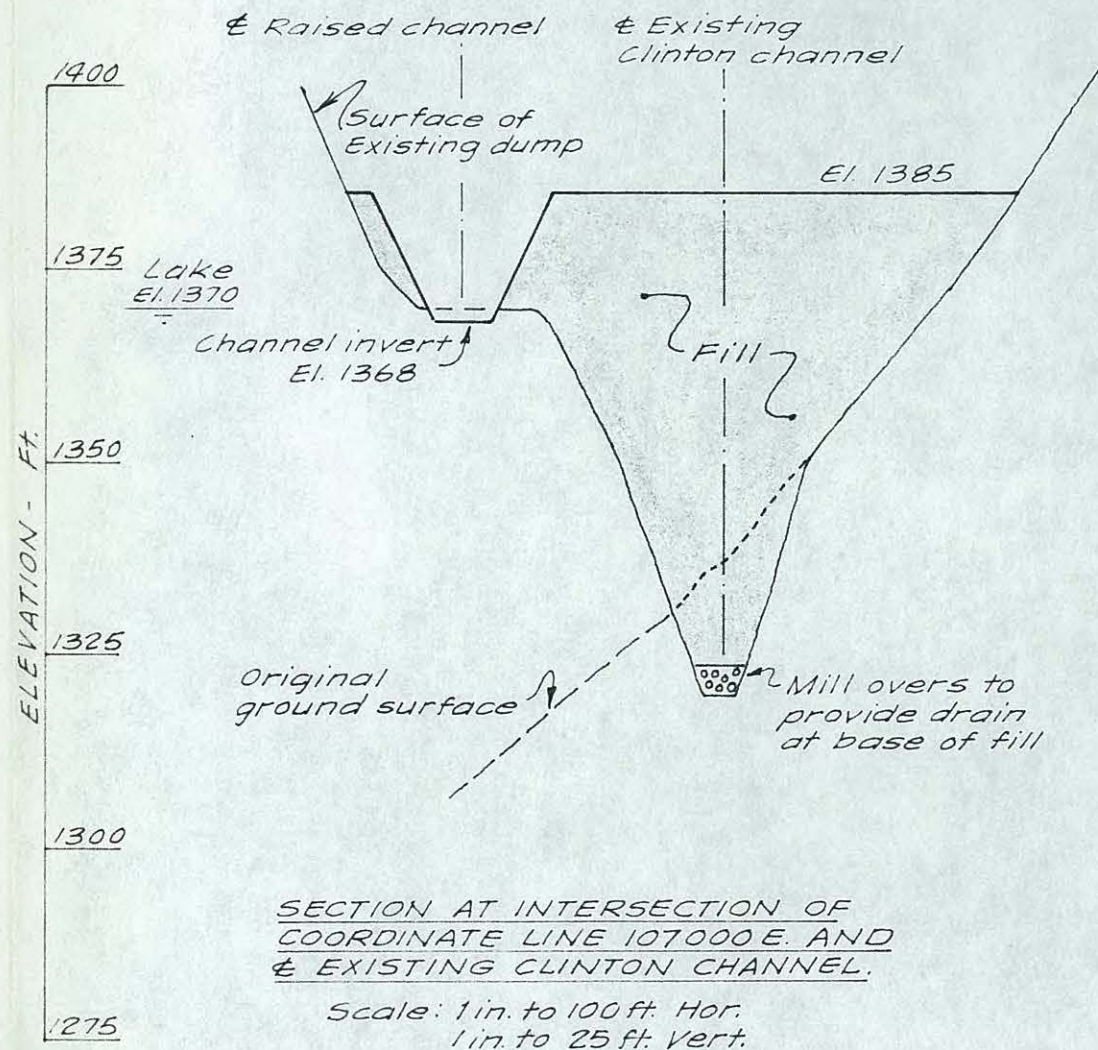
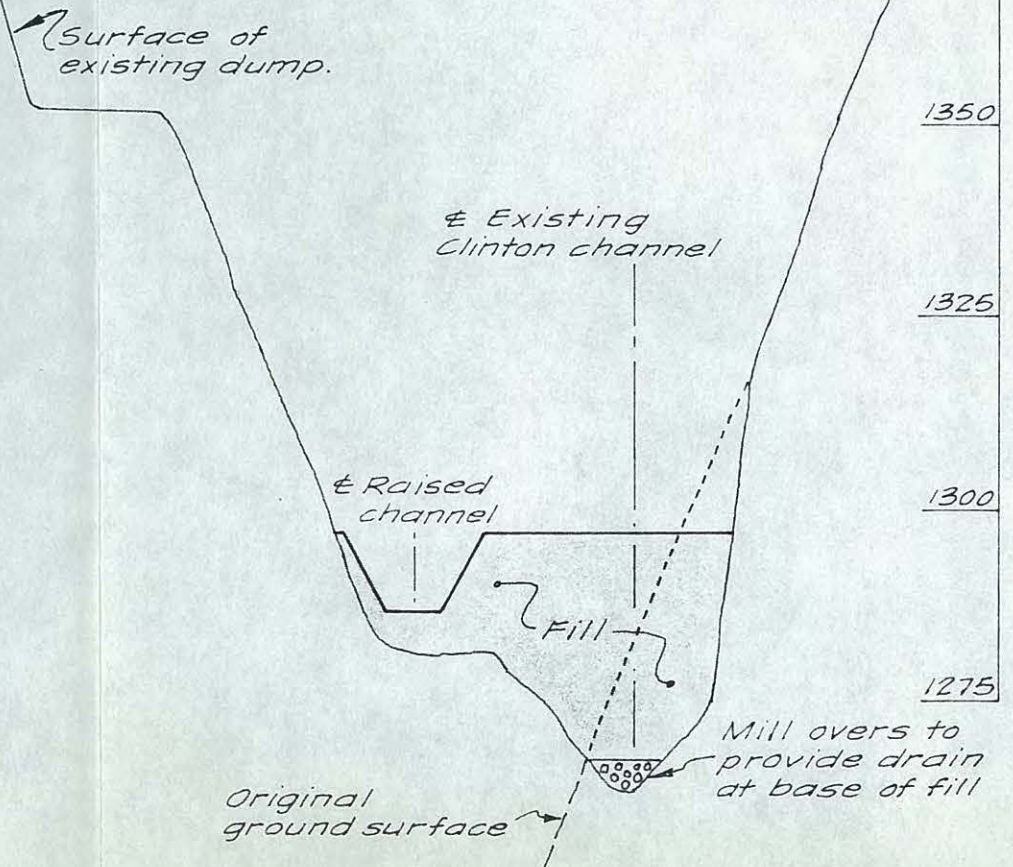
FIGURE 4

CLINTON DUMP STABILIZING TOE FILL AND RAISED CHANNEL

The fill that would be required to increase the factor of safety with respect to dump movement toward the channel to 1.25 is illustrated on Figure 4. Extending for a distance of approximately 540 ft. downstream from the existing culverts, fill would not be placed, with the result that the elevation 1370 contour would form the perimeter of a wide forebay extending to the upstream end of the new channel. A segment of the new channel would extend approximately level for a distance of 500 ft., to the upstream end of the rip-rap section. The rip-rap section would form a series of energy dissipating weirs at an average channel grade of 8 per cent. Each weir would provide for a 2 ft. net drop in head, and the weirs would be spaced at 25 ft. on center. Details of the rock weirs are illustrated on Figure 5.

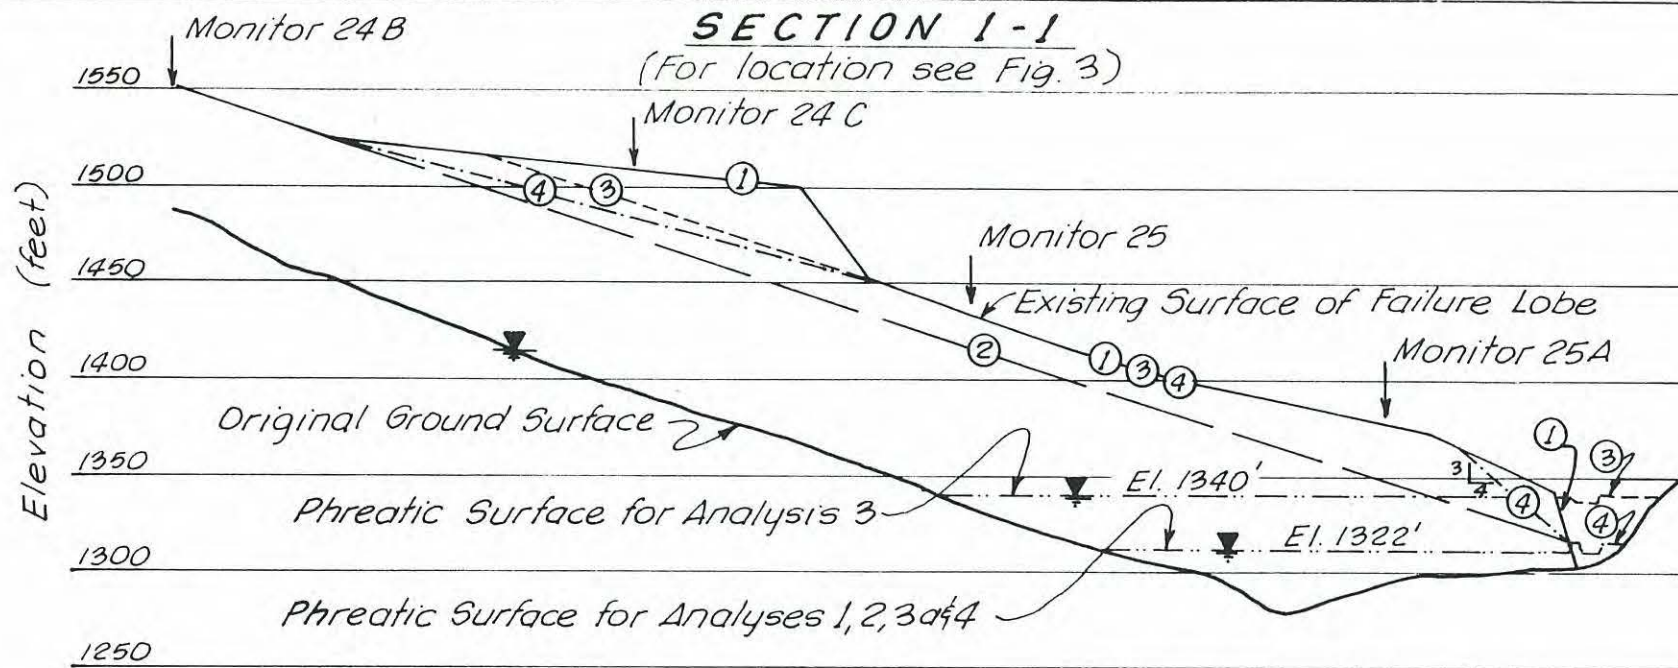
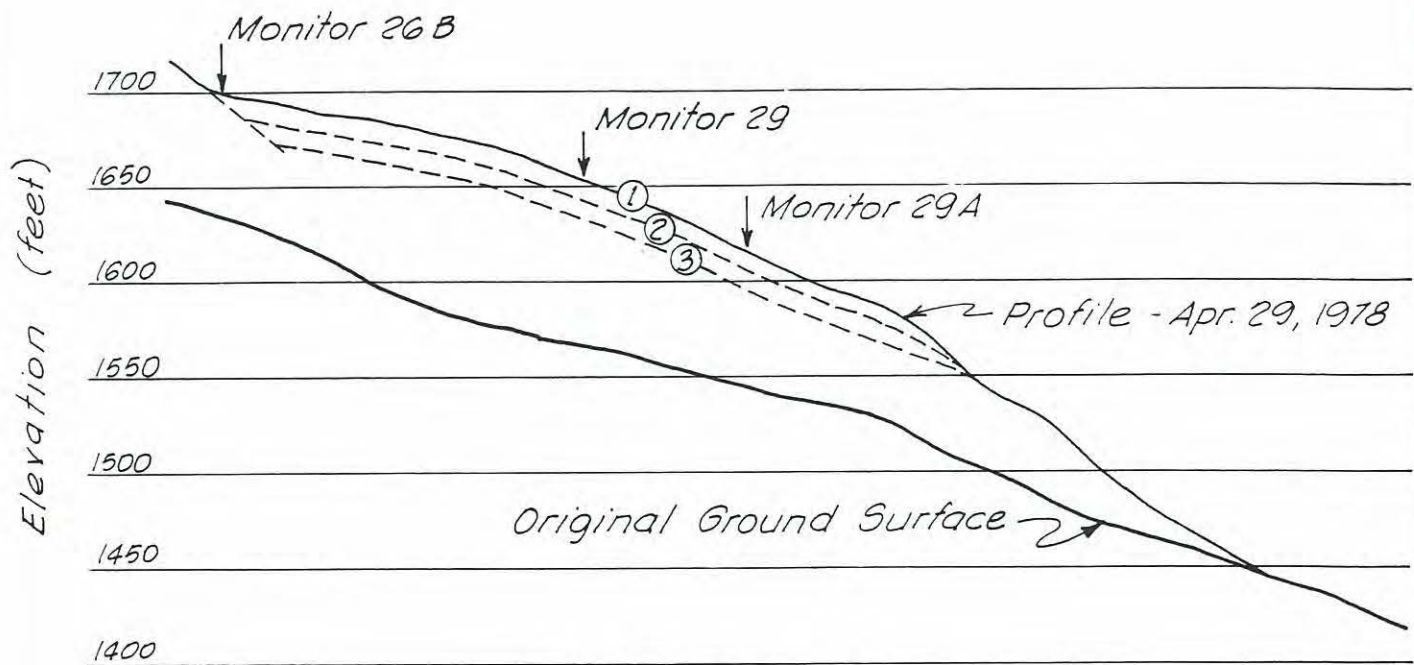
SECTION 2-2
(For location see Fig. 2)

A section through the 1974 failure lobe is shown on Figure 7. This section was analyzed using the indicated geometry, together with the strength parameters and unit weights determined for the tails and foundation soils at the site. It was assumed that in its present condition the failure lobe has a factor of safety against failure of 1.0. The analysis provided a pore pressure distribution along the tails/foundation interface for these conditions, i.e. for the condition of incipient failure. Various altered geometries for the surface of the failure lobe were then assessed, using the calculated pore water pressure, which was appropriately adjusted in each case for the effects of the new geometries. A tabulation of the factors of safety for several possible slope

Profile	Notes	Factor of Safety
1	Existing Slope	1.00
2	Slope trimmed to approximately 18° from Wolverine Channel	1.57
3	Wolverine Channel filled to elevation 1340'; phreatic surface in tails raised to elevation 1340'; upslope knob removed	1.04
3a)	Wolverine Channel filled to elevation 1340'; phreatic surface maintained at elevation 1322'; upslope knob removed	1.21
4	Wolverine Channel trimmed and armed against stream erosion; upslope knob removed	1.20

configurations, which would lead to improved stability of the failure lobe is given on Figure 7. The analyses lead to the conclusion that trimming of the "knob" upslope from the toe of the failure lobe, as shown on Figures 6 and 7, together with appropriate grading and lining of the Wolverine Creek channel at the toe of the lobe, will provide an adequate safety against further downslope movement of the failure lobe. The factor of safety against downslope movement attendant with this solution is 1.20. Details of the measures required to effect this solution are given in Section 5.7 and 5.8 of this report.

- a) The knob between coordinate lines 109200 E and 109500 E on section 113500 N should be trimmed according to the contours shown on Figure 6 and the profile denoted as (4) on Figure 7. Survey monitors should be established on the recontoured slope between approximately coordinates 109200 E and 109700 E on gridline 113500 N and checked periodically to assess any slope movements which may occur.
- b) The Wolverine Creek channel, where it bypasses the toe of the failure lobe, should be straightened and graded at 0.3 per cent from approximately elevation 1322 ft. at coordinate 113950 N - 109800 E to elevation 1320.2 ft. at

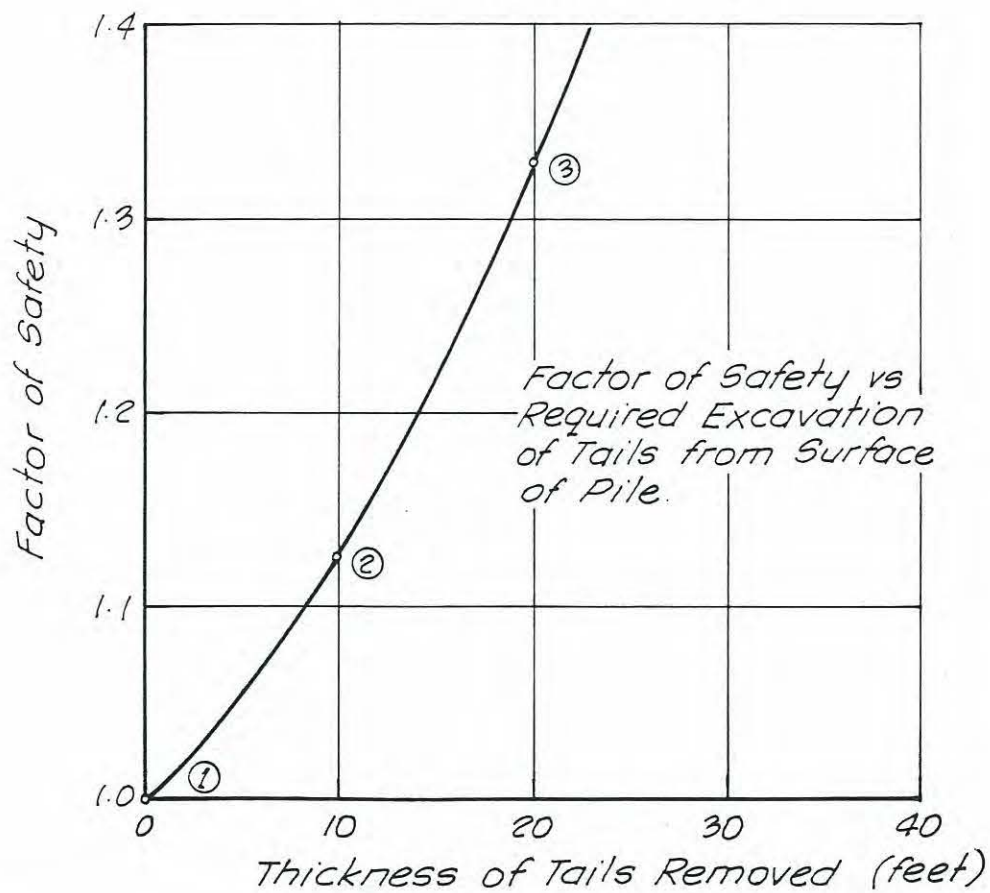
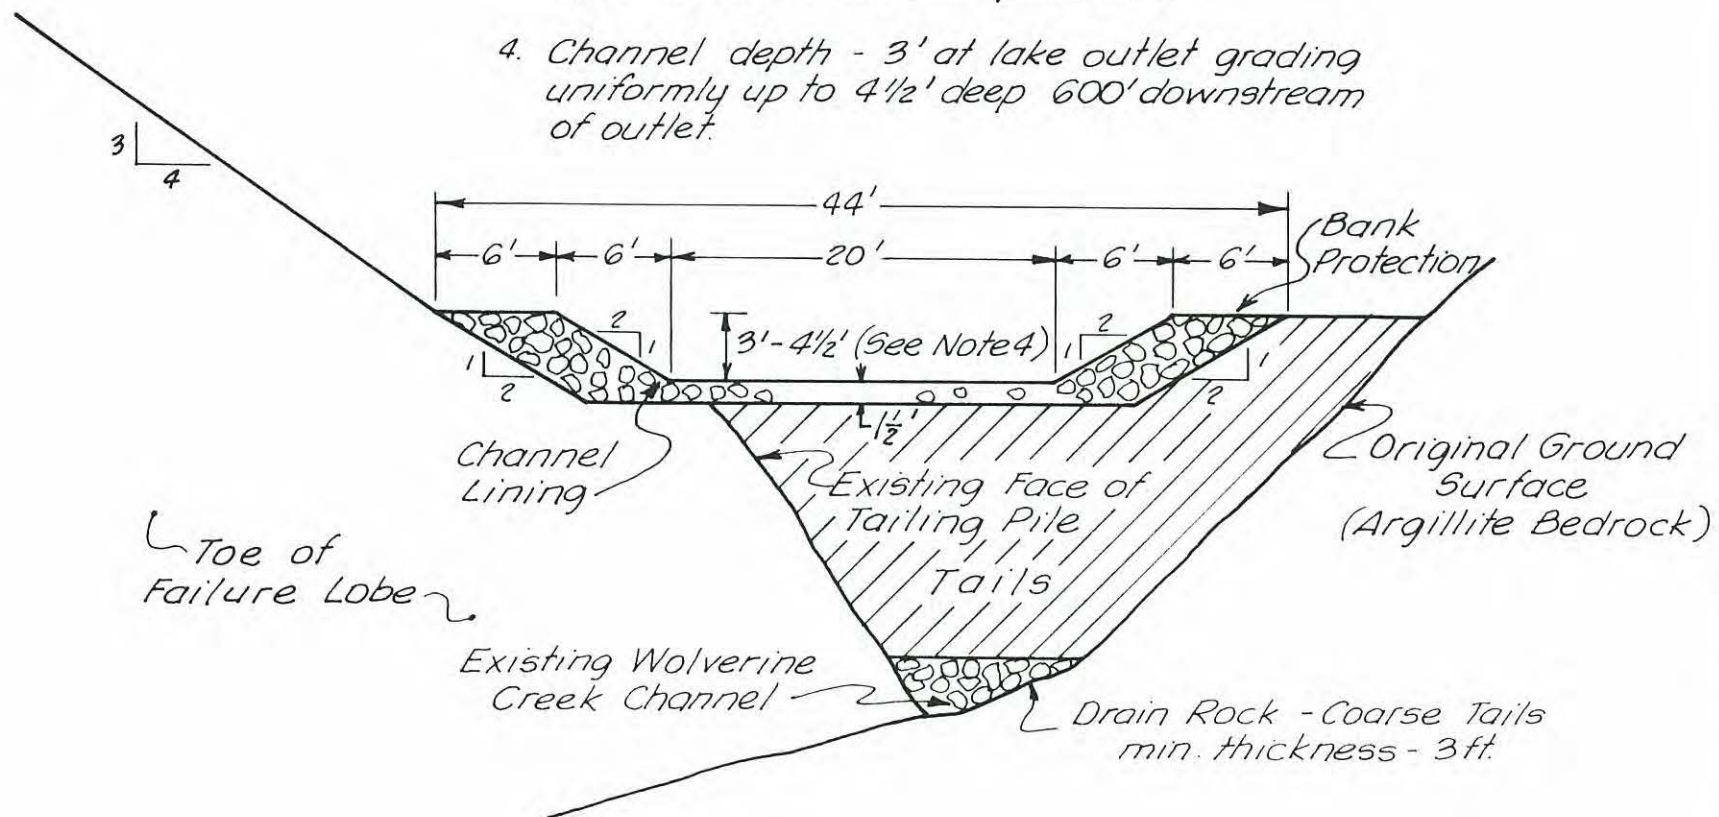
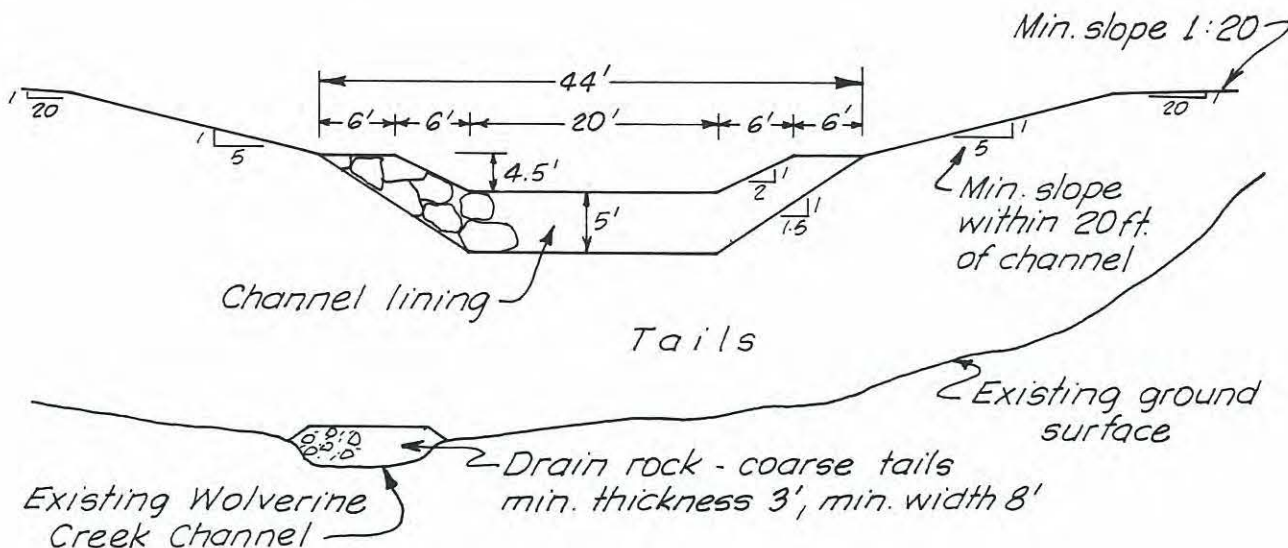
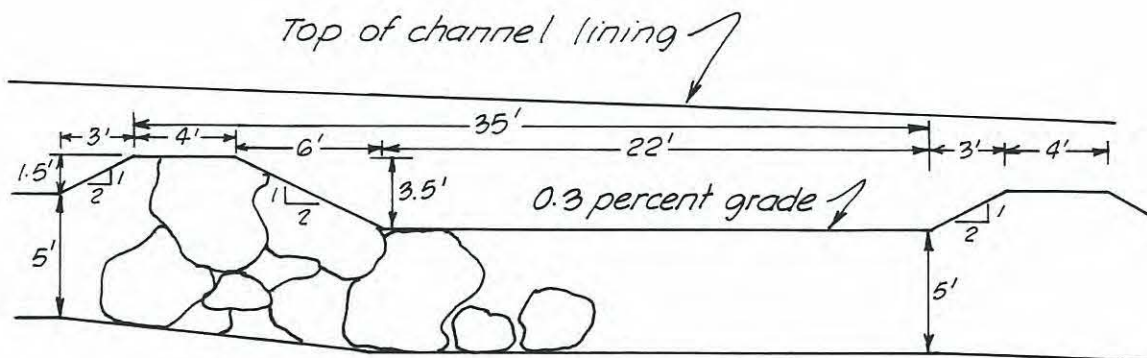
WOLVERINE CREEK CHANNEL DOWNSTREAM OF FAILURE LOBE

construction will be required. Materials needed to raise the ground surface to the required gradient above the drain rock can consist of tails taken from those areas of the tailing pile where excavation is required. Figure 10 shows a typical section through this portion of the channel, as well as a profile of the channel with details of the weir construction, channel gradients and material size requirements. The specifications for the channel were determined on the basis of the DIAND flood frequency analyses for Wolverine Creek.

Notes: 1. Channel outlet from lake at El. 1322'.

2. Channel gradient 0.3 percent.

3. Channel lining built with material consisting of 30 percent greater than 3 inch diameter particles.

4. Channel depth - 3' at lake outlet grading uniformly up to 4 1/2' deep 600' downstream of outlet.

Note: 1. Channel lining and wier materials must conform to:
20 percent greater than 48 inch diameter (~5500 lbs.)
50 percent greater than 40 inch diameter (~4300 lbs.)
80 percent greater than 30 inch diameter (~2700 lbs.)

Note: 1. Crests and downstream toes of weirs must be constructed of heavy rocks.

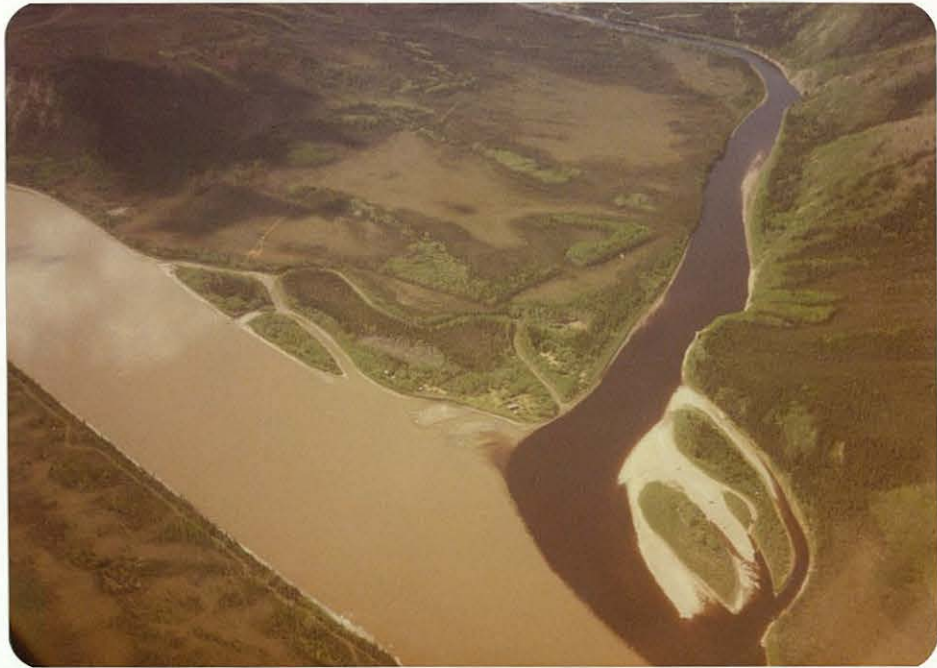
PHOTO 6

The junction of the Forty Mile river and the Yukon river. Clinton creek joins the Forty Mile just beyond the upper edge of the photo. Date of photo June 5th, 1978.

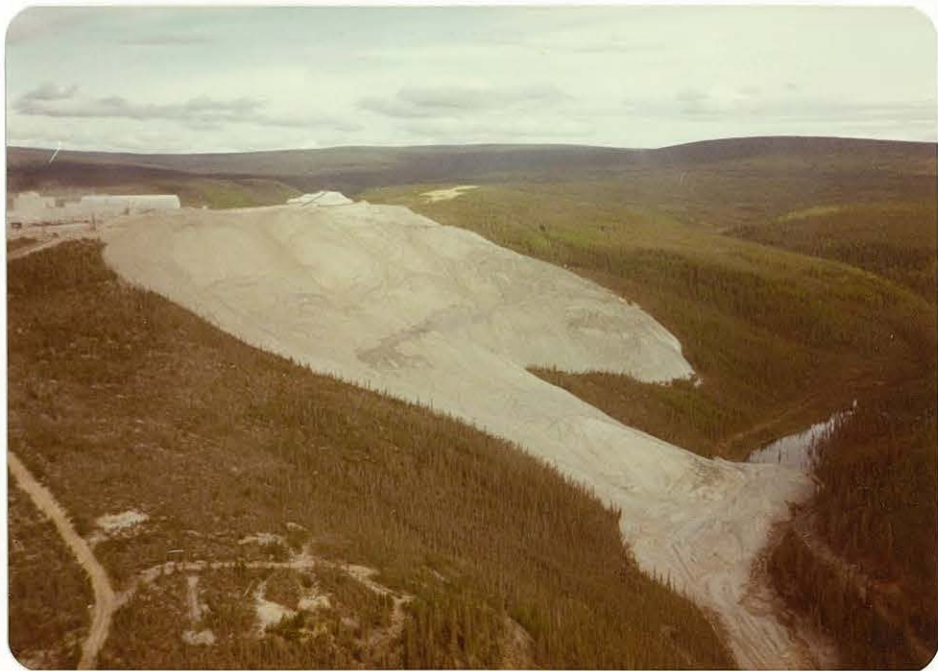
PHOTO 7

The separation of asbestos fibre at the Clinton Creek operation is a dry process. Tails are transported from the mill by belt conveyor and have been deposited in the form of a large pile located to the east and the northeast of the mill on the west slope of the Wolverine Creek valley. A photograph of the tailing pile is included as Photo 7 in Appendix A.

View of tailing pile-facing north

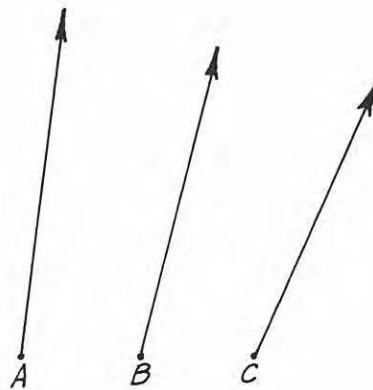
b)

PLAN SHOWING ABSOLUTE
HORIZONTAL MOVEMENT
VECTORS DURING TIME ΔT
RELATIVE TO x and y AXES.

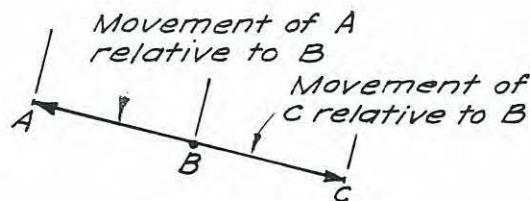
c)

Although the absolute movements of points A, B, and C are predominantly in the y-direction, the movements of the three points relative to one another are predominantly in the x-direction. Figure E-1 (c) shows the movement vectors of points A and C relative to point B. The movement of point A relative to point C is illustrated on Figure E-1(d). By the end of the time interval Δt , points A, B, and C have all moved further apart relative to one another, with the result that stretching has occurred between these points. This stretching could be expected to result in development of tension cracks on the ground surface. The alignment of these tension cracks could be expected to be approximately perpendicular to the relative movement vectors, that is approximately parallel to the azimuth of the vectors of absolute movement.

RELATIVE HORIZONTAL
MOVEMENTS AT THE END OF
TIME INTERVAL ΔT .

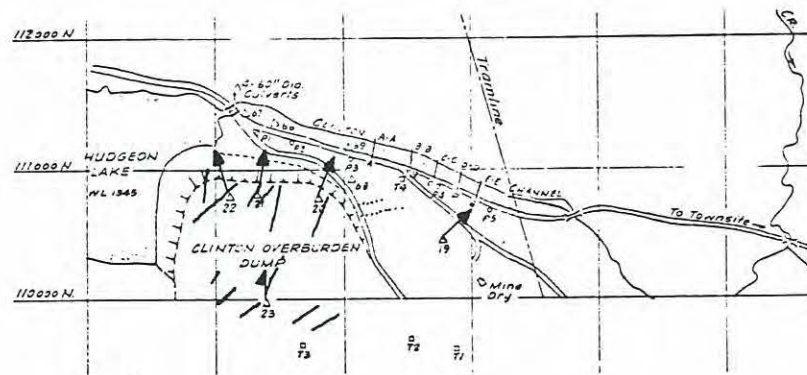
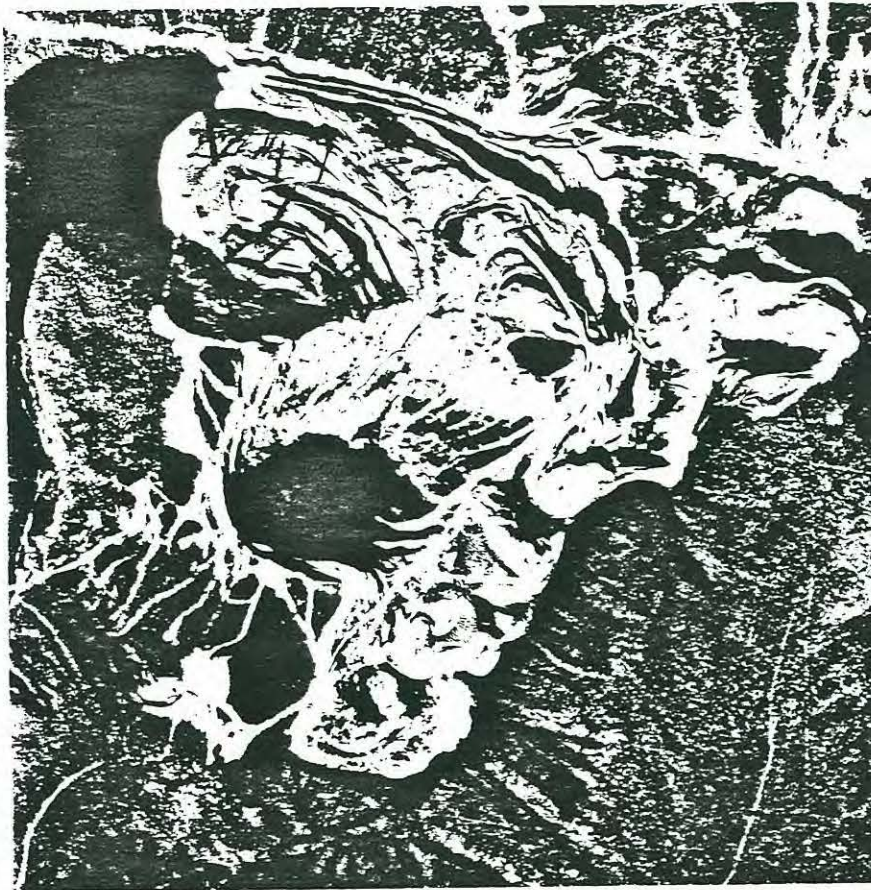
Figure E - 2

Figure E-2 shows a 1976 airphoto of the Clinton dump with some of the prominent tension cracks highlighted to facilitate reproduction. A sketch of the Clinton dump drawn to the same scale as the aerial photograph, and showing the crack patterns, together with the azimuth of the horizontal movement vectors that developed during late 1976 and early 1977 is also shown on the figure. The similarity between the azimuth of the horizontal movement vectors and the azimuth of the surface cracks is readily apparent.

CRACK PATTERNS AND VECTOR AZIMUTHS CLINTON DUMP

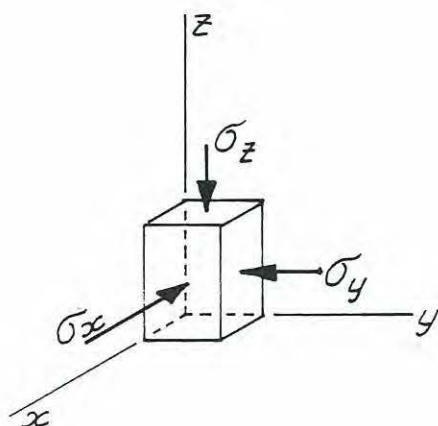
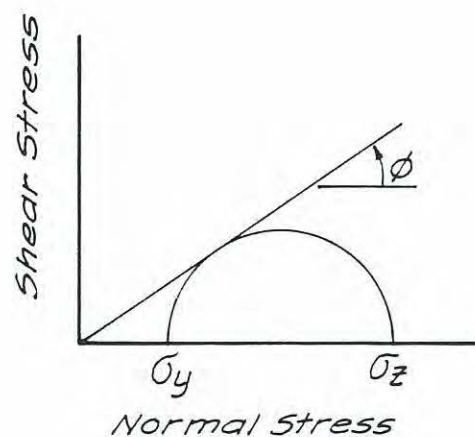
Figure E - 3

The presence of the cracks on the surface of the dump indicate that tension strains have occurred at depth below the surface with the result that the horizontal stresses have been reduced to the active state. Thus, the minor principal planes are vertical (or approximately 30), and their azimuths are approximately coincident with the azimuths of the tension cracks, and the minor principal stresses are equal to the active earth pressures. Since the major principal stress is equal to geostatic pressure, and the minor principal stress is equal to the active earth pressure, it follows that the intermediate principal stress must be equal to or greater than the active pressure, and must be equal to or less than geostatic pressure. The pattern of cracking indicates that the intermediate principal stresses are greater than the active pressures.

IMPLIED STRESSES CLINTON DUMP
