Anvil Range Mining Corporation (Interim Receivership) Rose Creek Tailings Facility

2001 Hydrogeological and Geochemical Investigation Faro Mine, Yukon

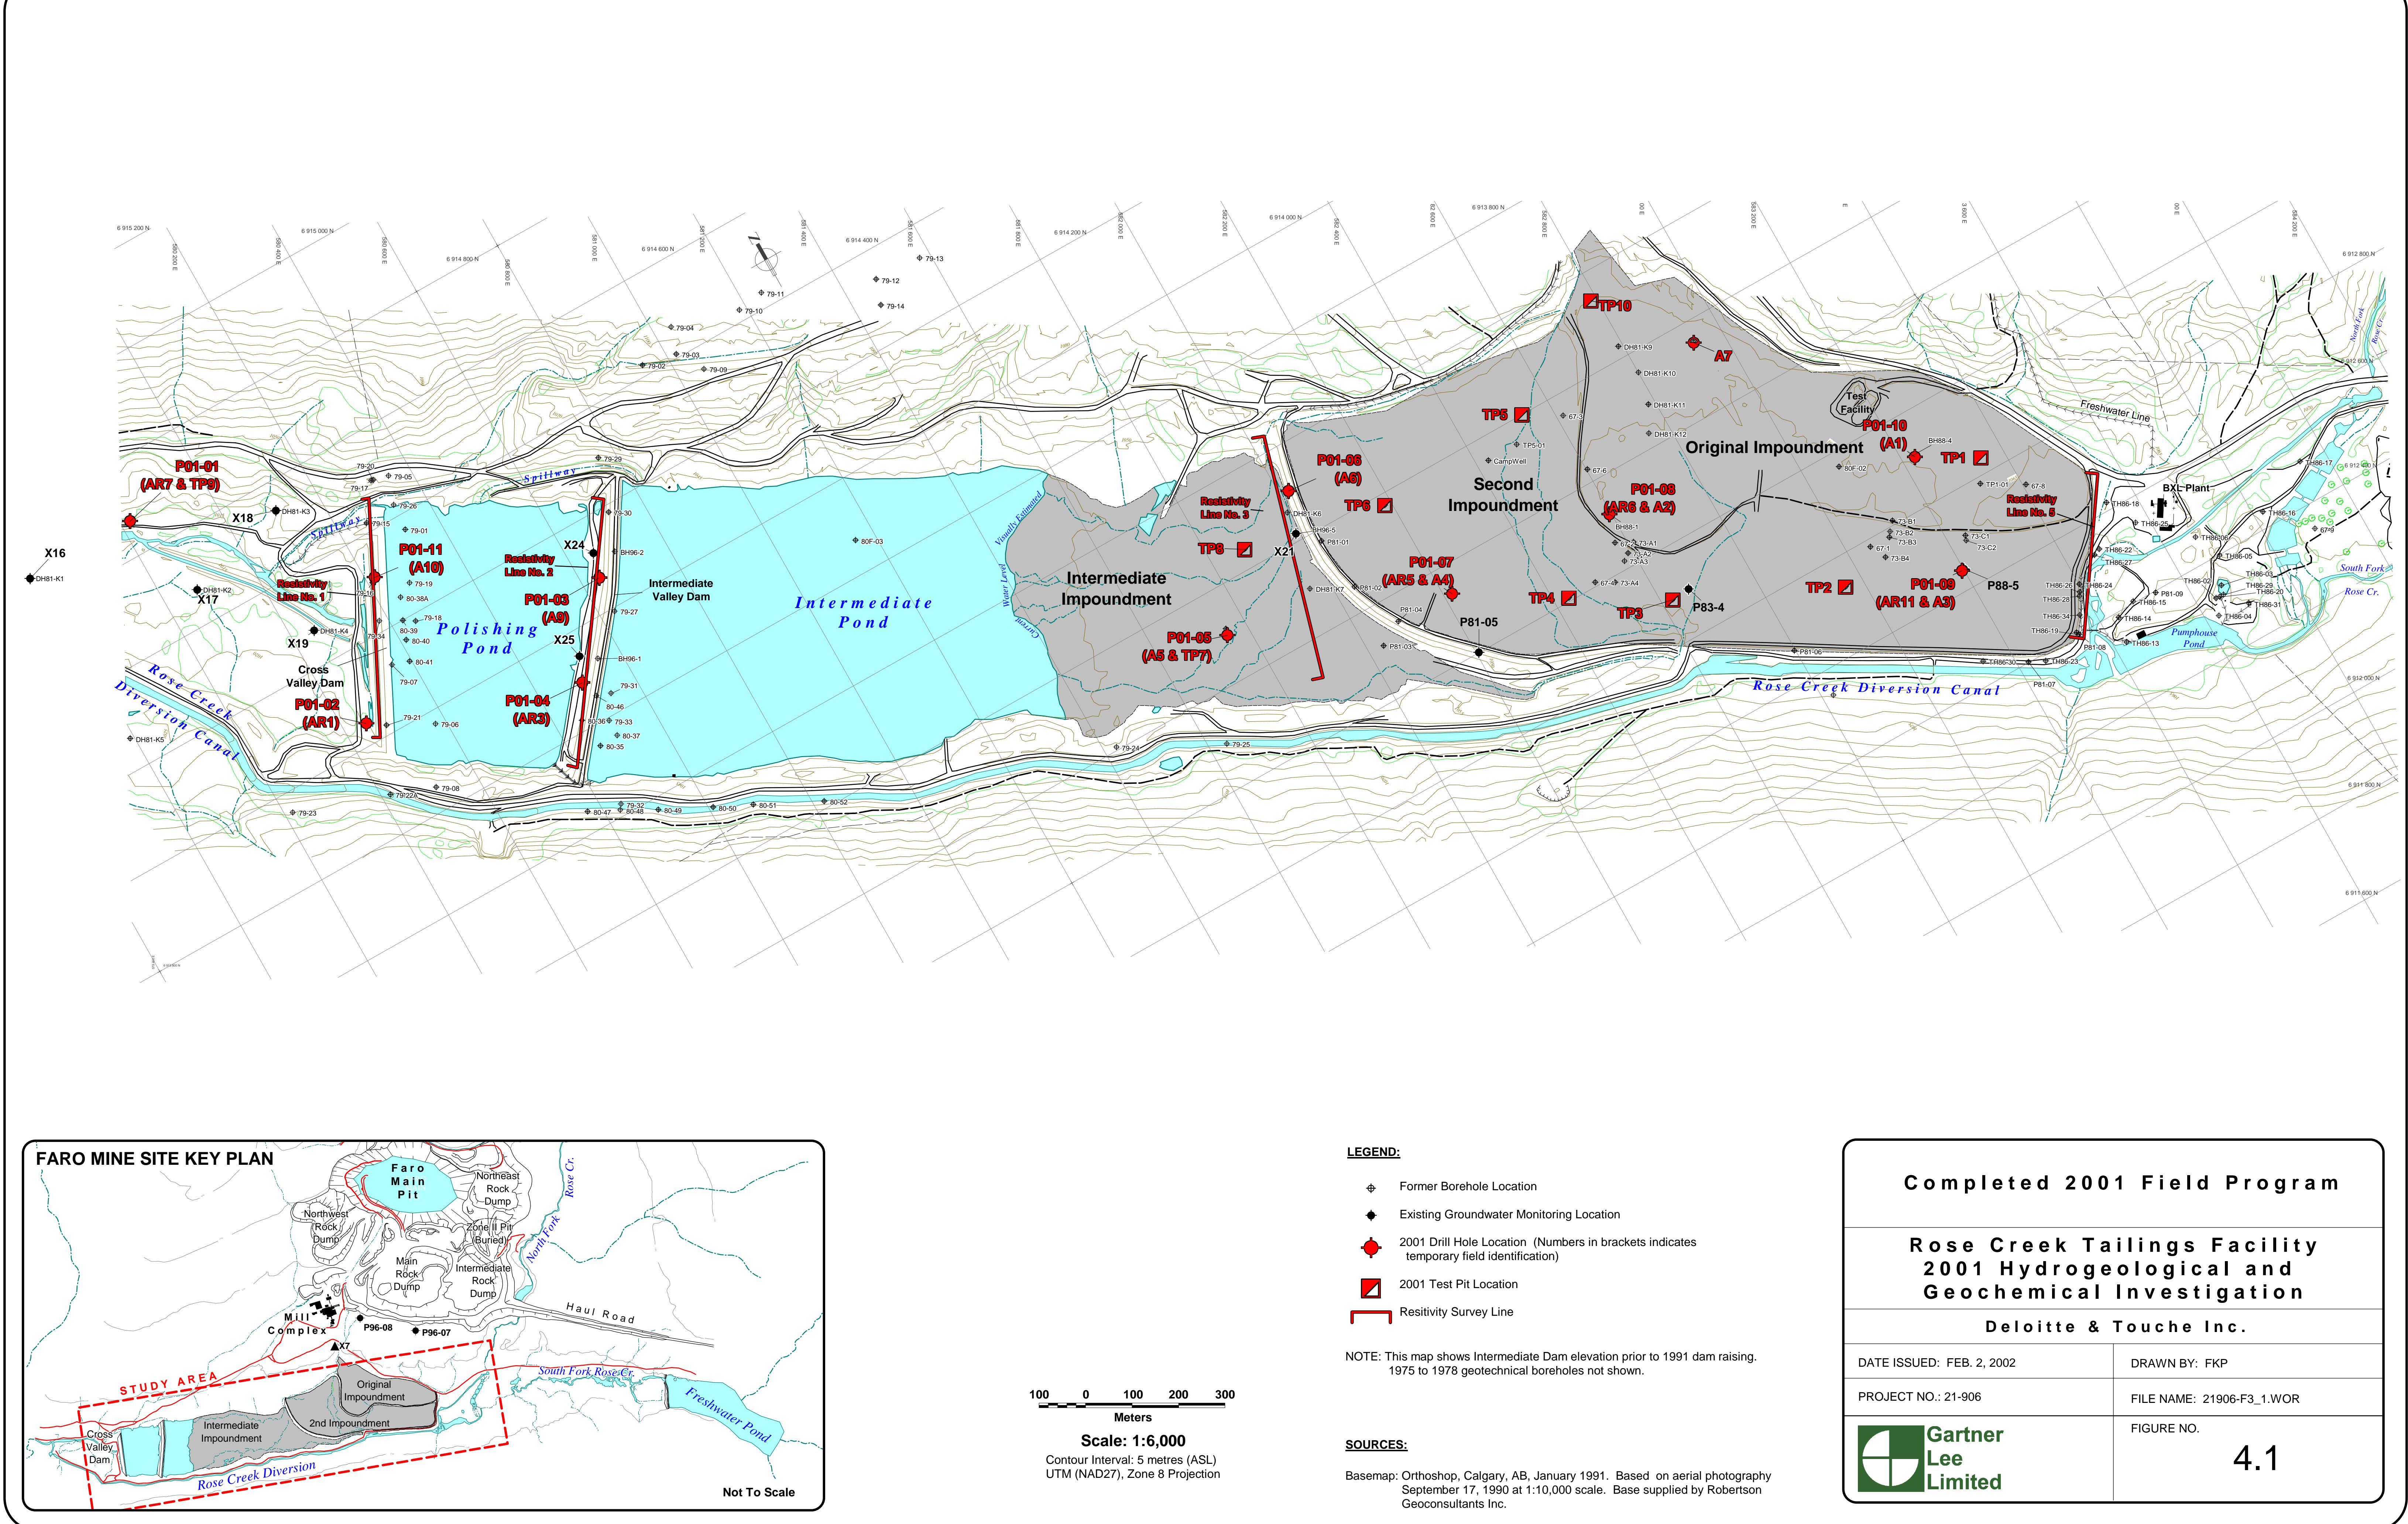
RESISTIVTY SURVEY

Four Lines Completed.

No preferential flowpaths identified.

Results corresponded to Stratigraphy and Groundwater Quality.

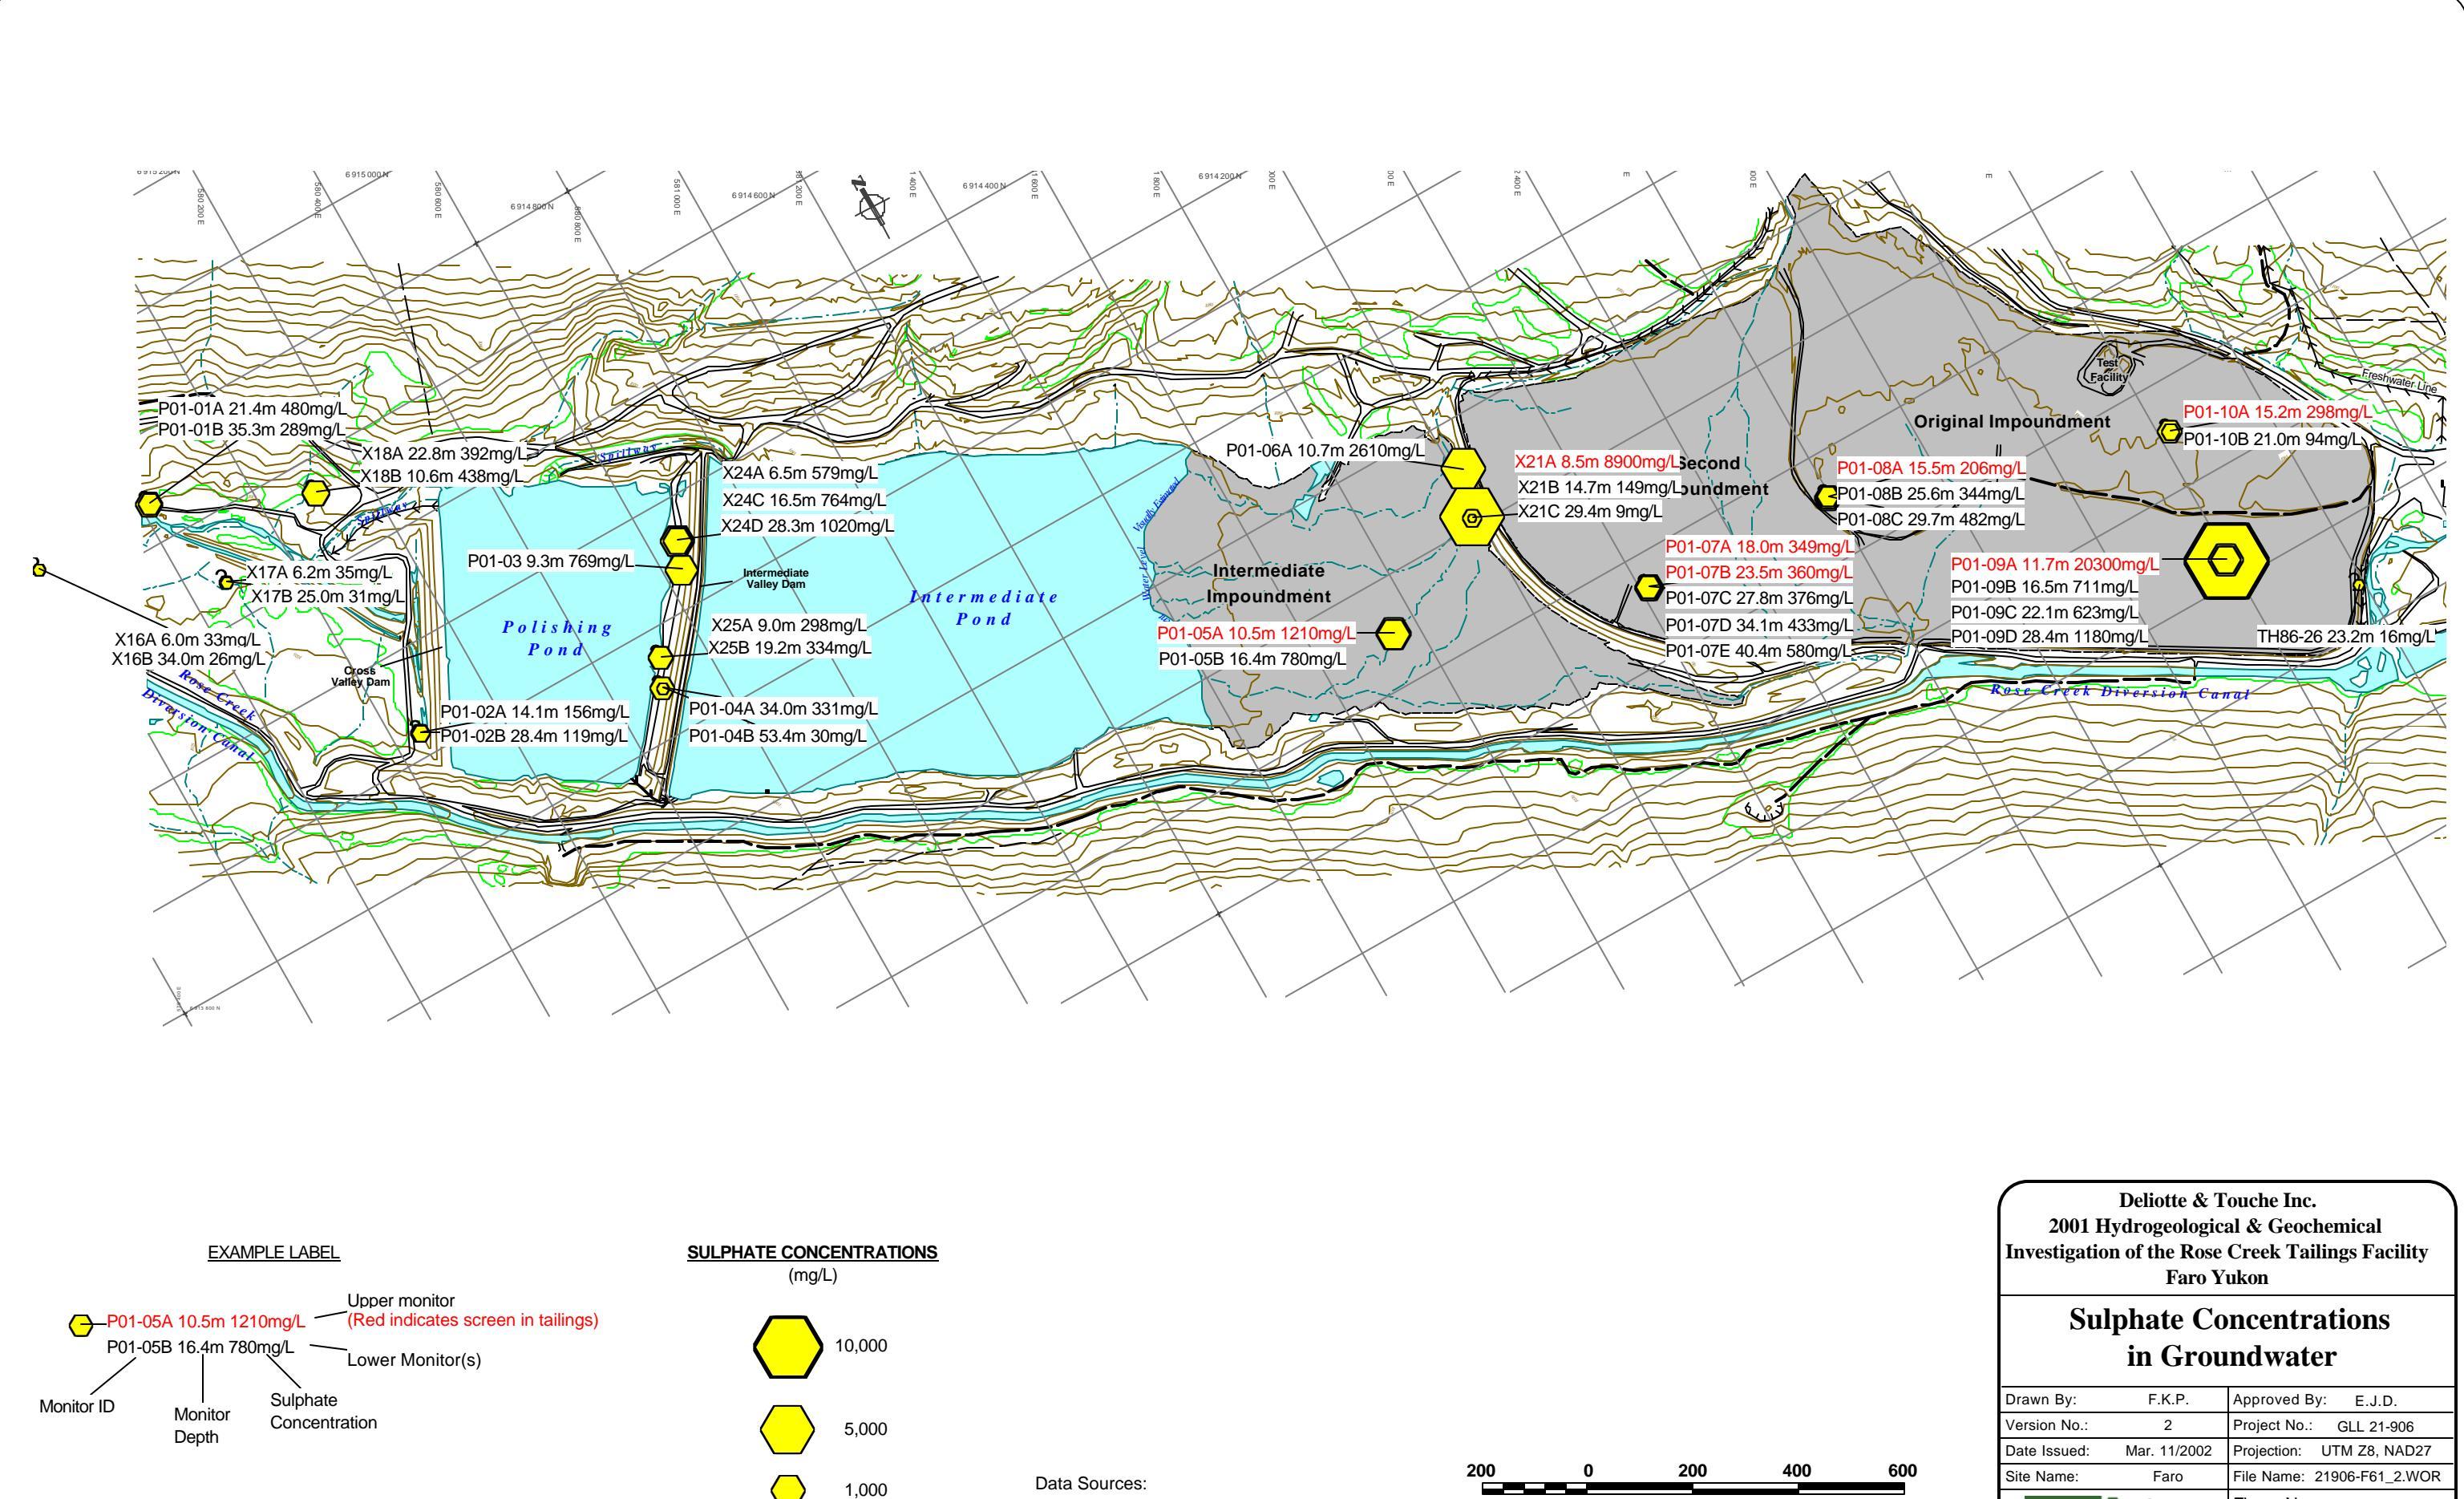
6.1

- 4. Tailings porewater migration appears to be restricted to the sand and gravel portion of the aquifer. The basal till unit that overlies bedrock does not appear to be impacted.
- Greater concentrations of sulphate are observed along the north side of the valley than in the valley centre. This has been observed consistently since 1996.
- 6. Oxidation products (represented by sulphate and zinc) are distributed throughout the aquifer beneath the tailings and concentrations in groundwater increase with depth in the aquifer at some locations.

- Groundwater chemistry based on samples collected Sept. 6-11, 2001

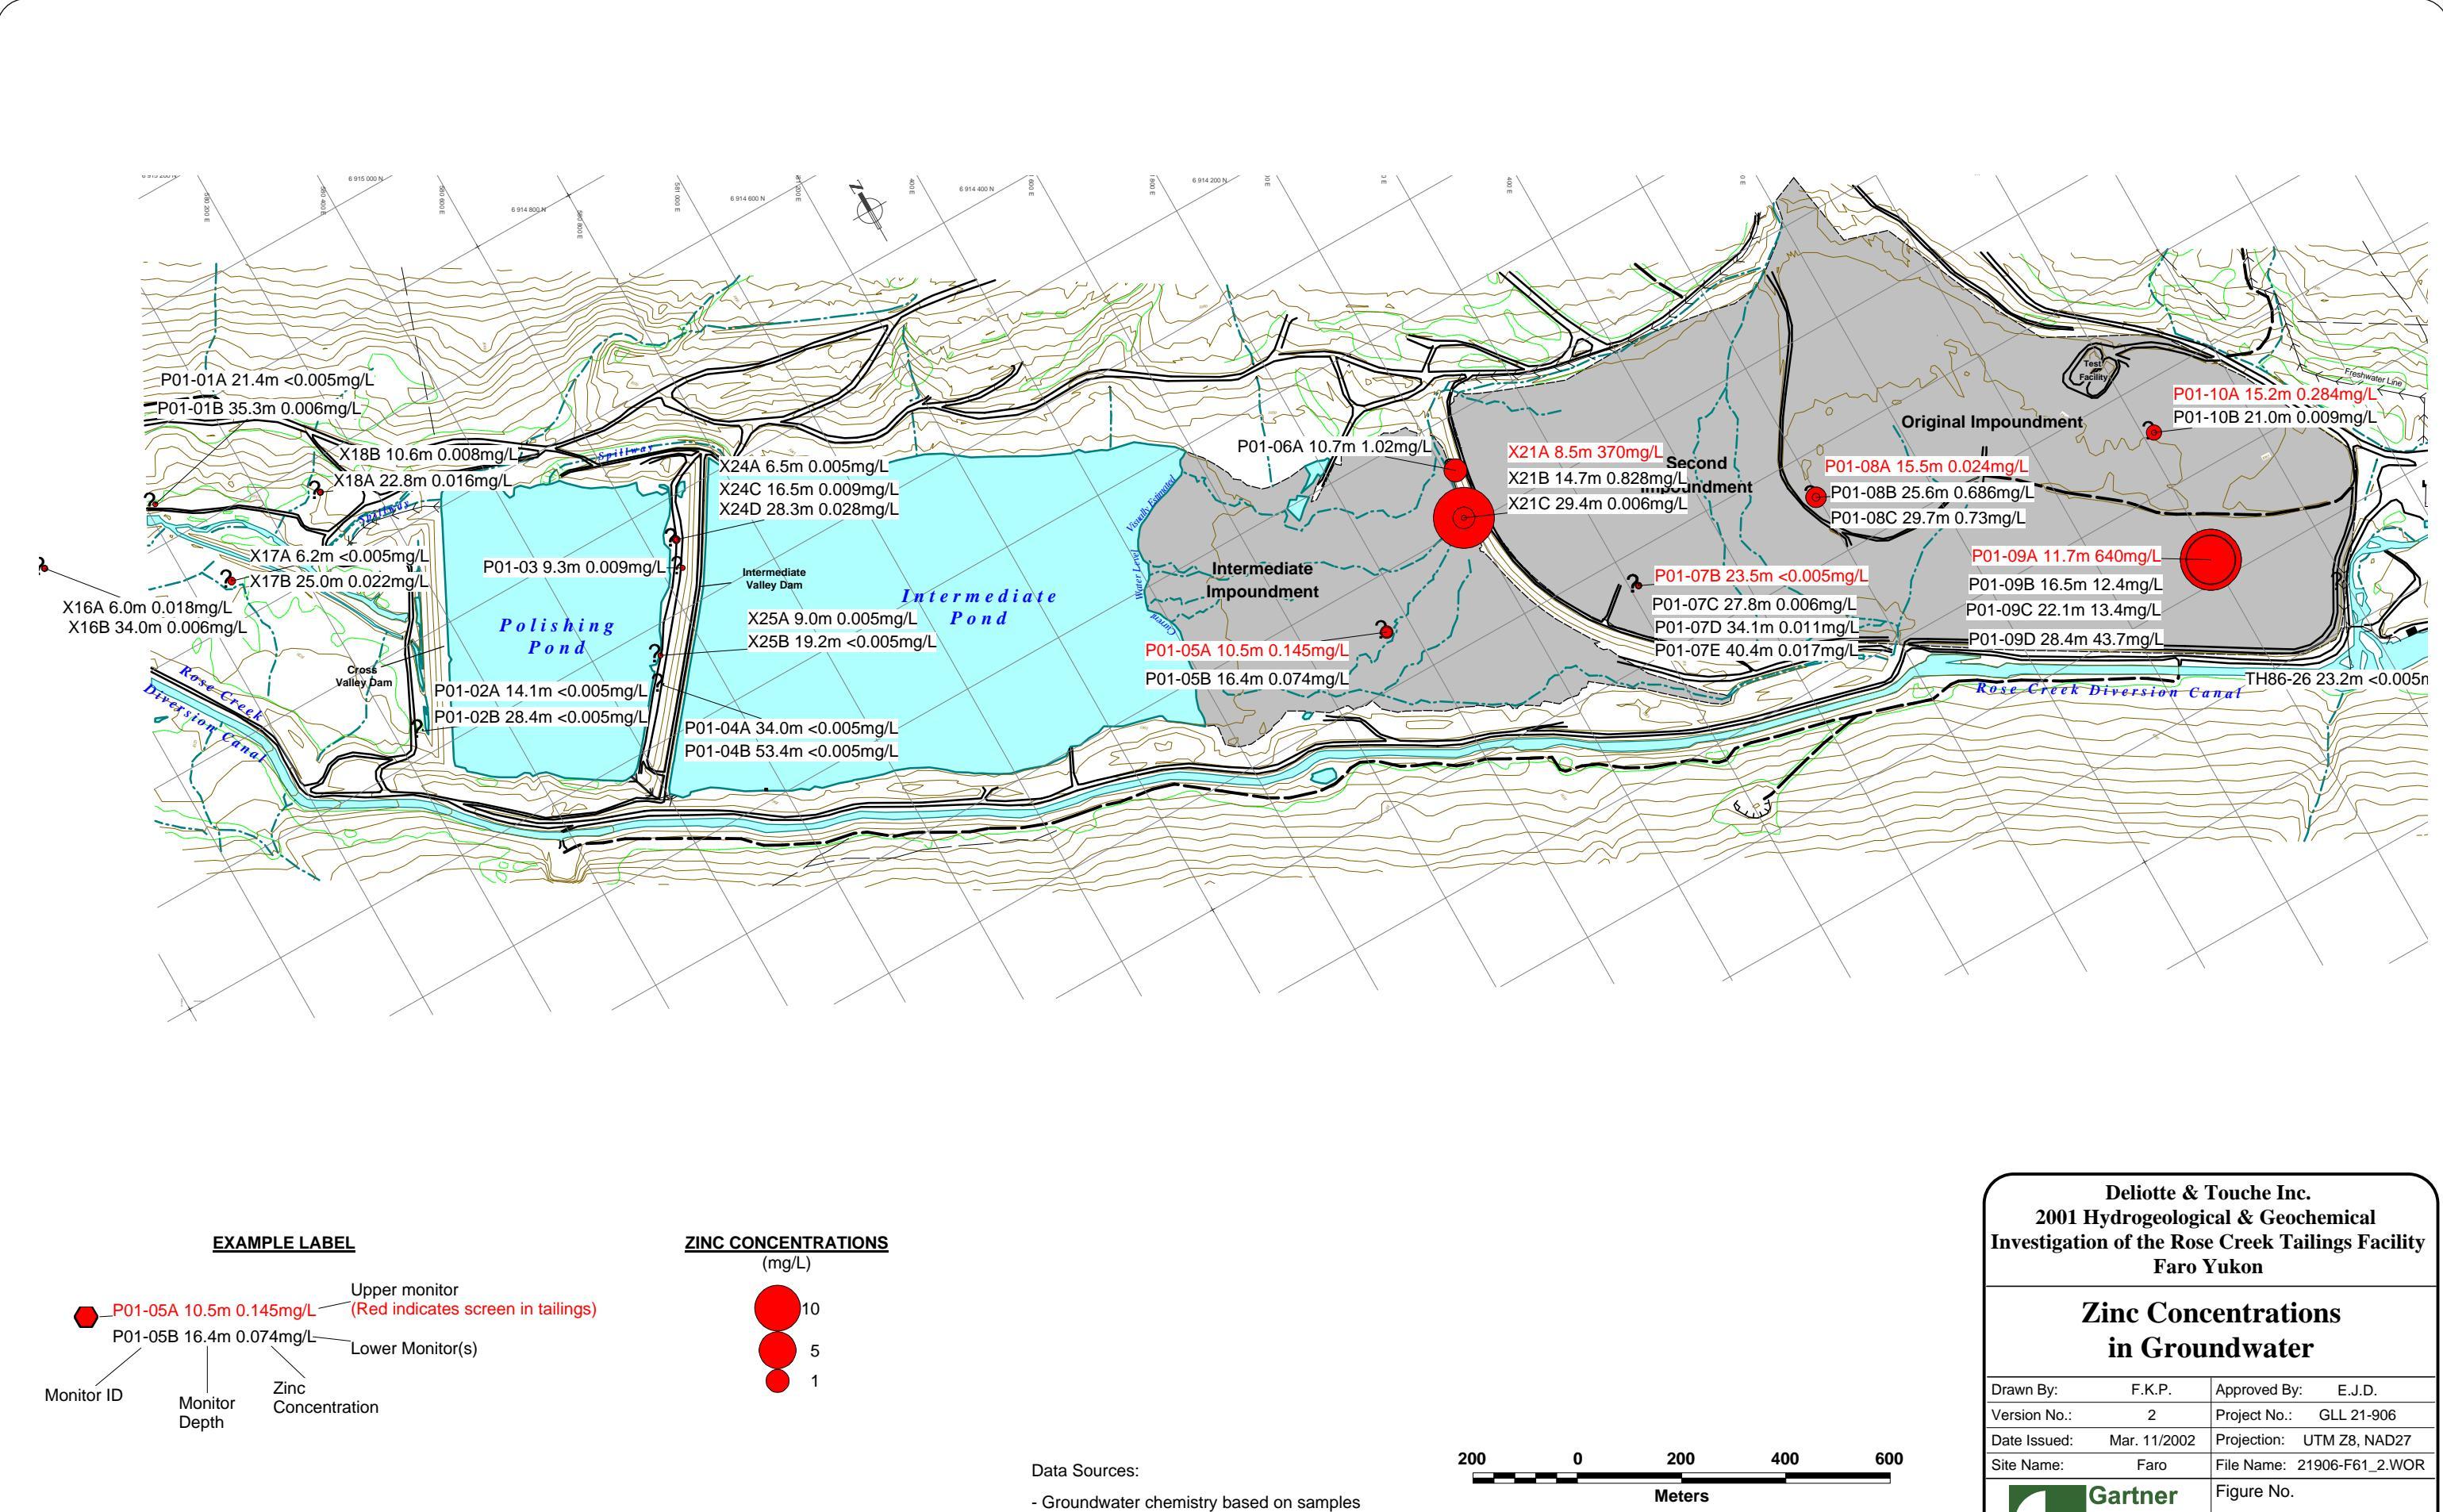
6.2

- Groundwater chemistry based on samples collected Sept. 6-11, 2001
