**Miles Canyon Bridge  
Level II Inspection Report  
Whitehorse, Yukon**

*Prepared by*  
**Dan Tingley Ph.D., P. Eng. (Yukon)**

**Final Report  
23 November 2015**

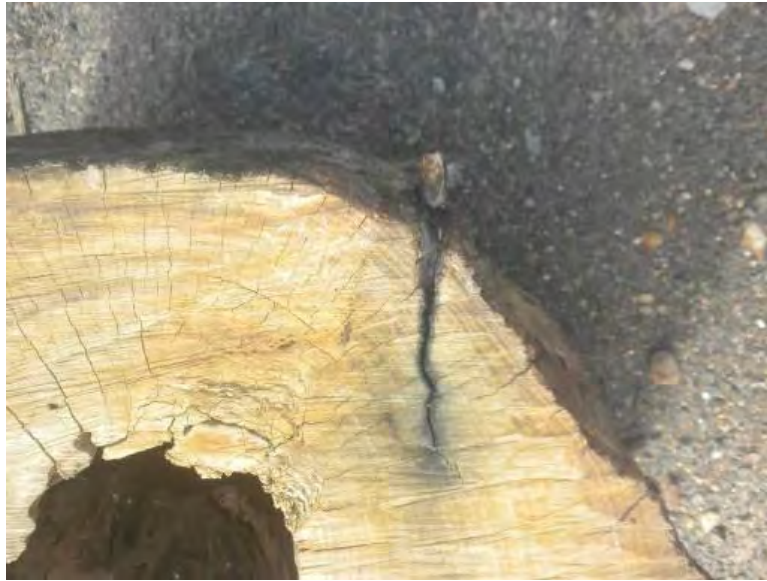
**Figure 2-1: Cavitated/piped timber pile section where the area at about 2 o'clock is decayed in the annulus and SG is significantly reduced. Also note in this area an old spike where there is ferric degradation (see Section 2 for explanation of ferric degradation) and decay propagated by moisture content (MC) in the wood at the fastener caused by condensation off the spike.**

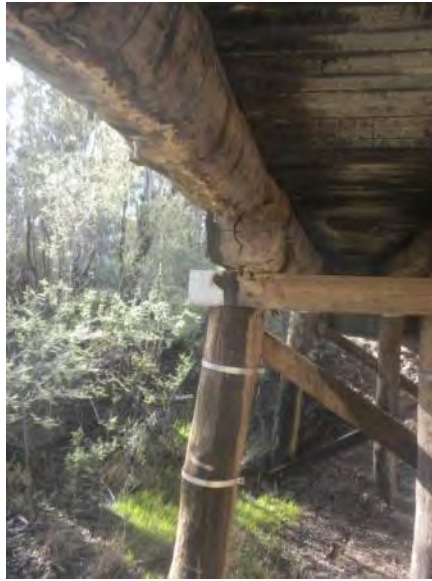
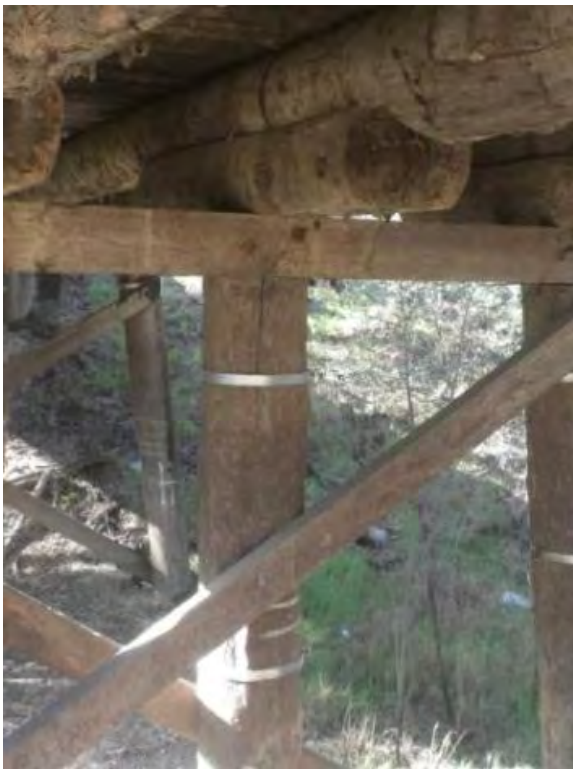
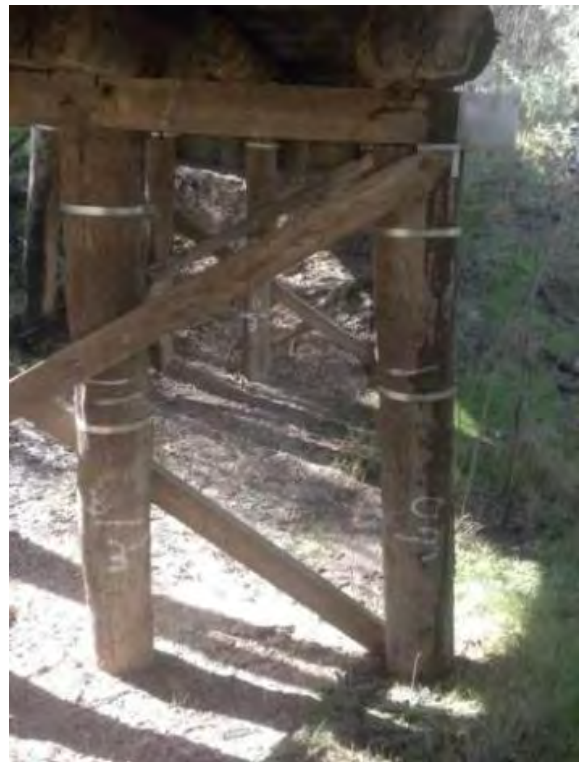
**Figure 2-2: Banded piles. See (a, b and c) above for band in Shackell's Folly bridge pile. If the wood expands due to the moisture, it will develop 1000 mpa in the band, well over its maximum stress capability. The thin gage banding intended to conform to the surface better still makes no contact and is loose! Totally ineffective for the intended purpose! Shackell's Folly Bridge is particularly interesting for the steel banding as the steel deck ballast tray is leaking and during the inspection there was ample water flowing onto the log piles causing them to swell, note the water on the cross head and log pile in (c) above. Further, this bridge has a steel ballast tray with vertical through connectors into the log girders similar to the vertical connectors into the cross bearers used in many timber bridges throughout Australia, which has led to decay in the centers of the cross bearers in many timber bridges.**

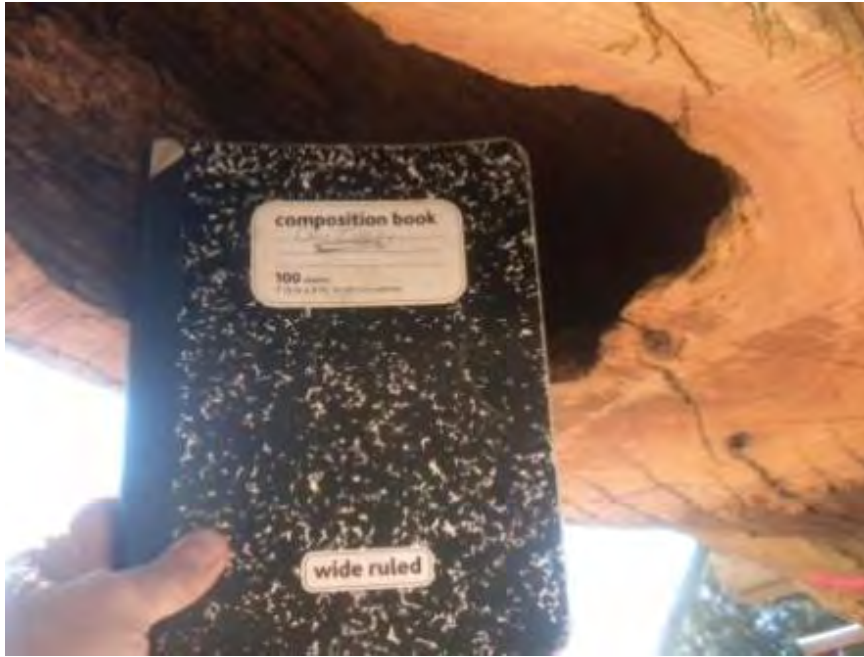
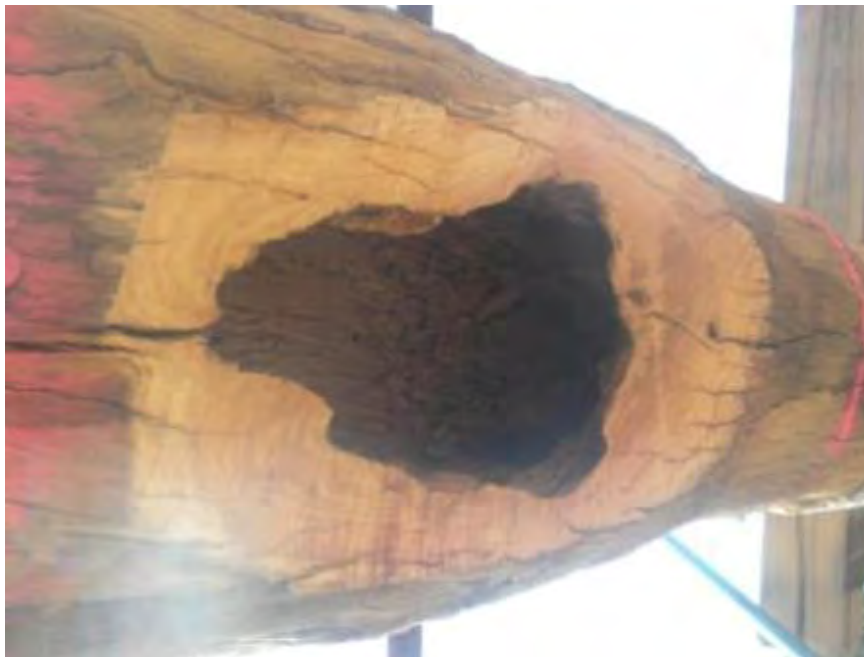
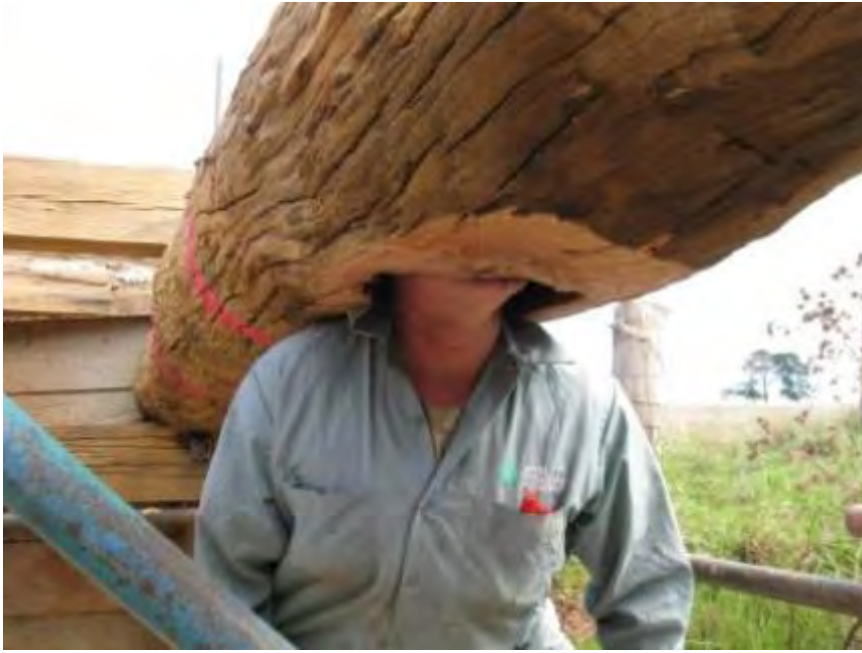
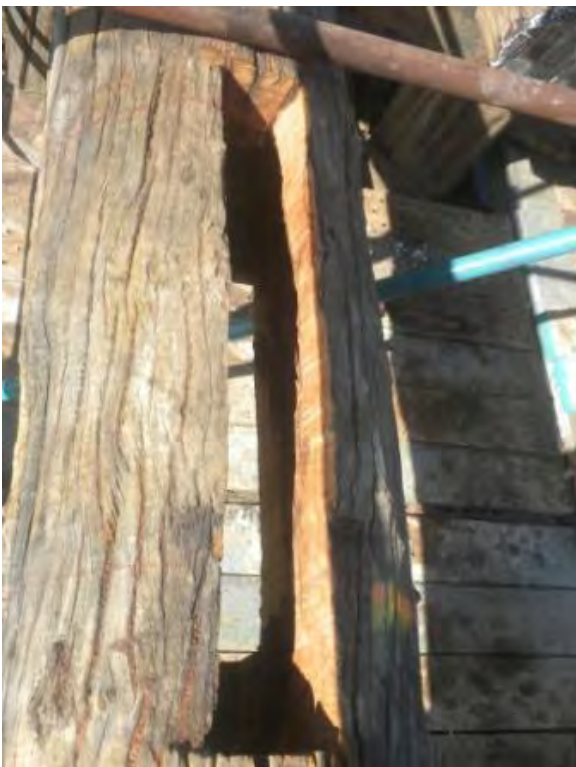
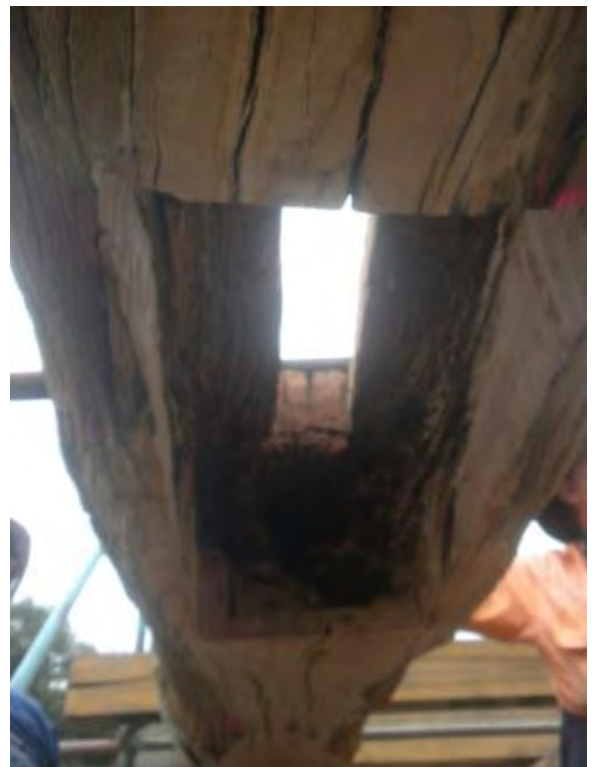
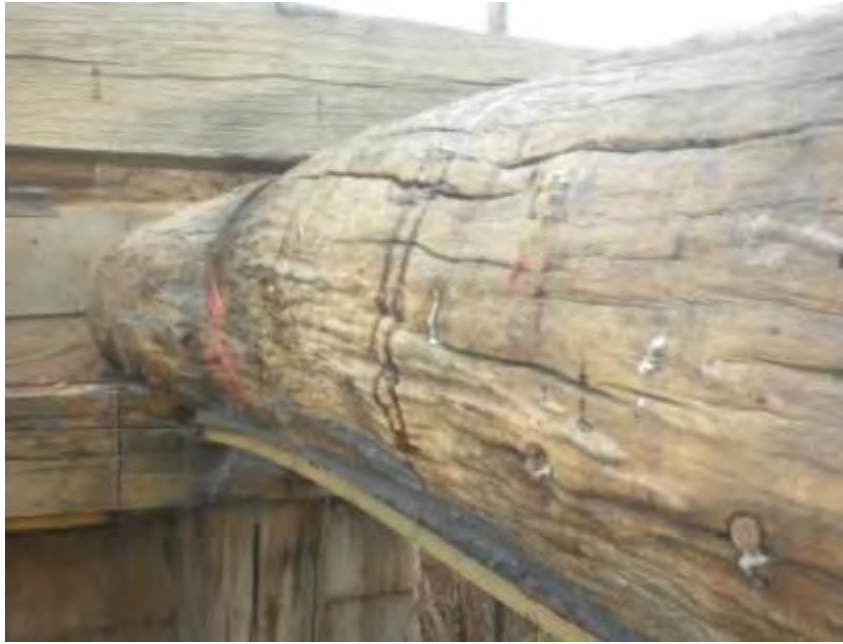
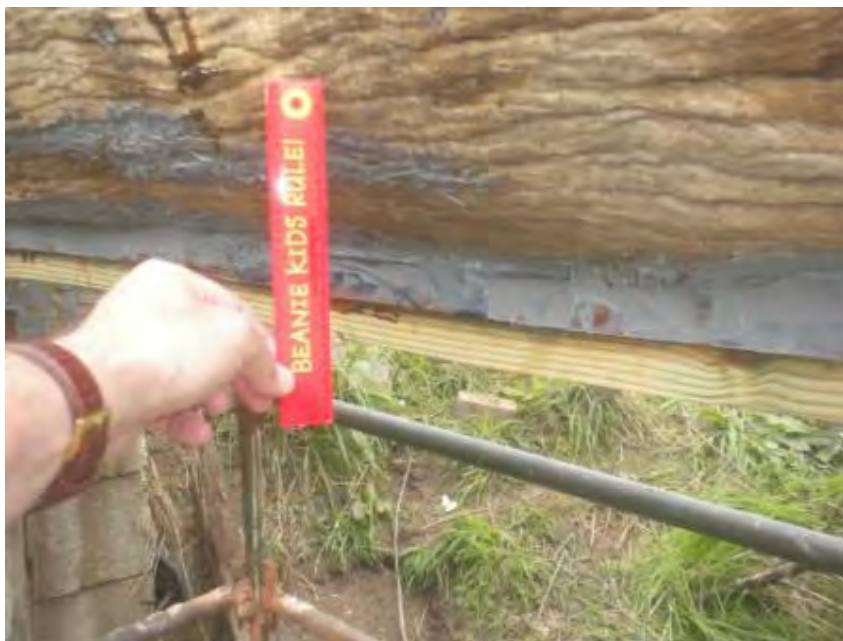
**Figure 2-3: Cavitated timber bridge girder (a, b and c) in place at Costello's Bridge in Mitchell Shire. In addition to the large cavity running 2/3 the length of the log, the annulus SG is significantly reduced. Decay propagated by constant elevated MC in the wood around the metal vertical through bolts was caused by condensation on the through bolt shank and shelf water following the bolt channel into the core of the log. This constant hydration source provided fertile ground for the decay fungal colony to grow. Such excessively decayed, cavitated, reduced SG annulus log girders can be retrofitted utilizing keyways and new treated hardwood keys (d and e) and interior injection with fire proof polymers that slowly polymerize as they work their way into all the open cavities in the log. In addition, high strength fiber retrofits (f and g) are applied and diffused to prevent further decay from occurring in the annulus wood. Note the oak bungs in the side of the log plugging the hole where the diffusers are placed in the log annulus (f and g)**

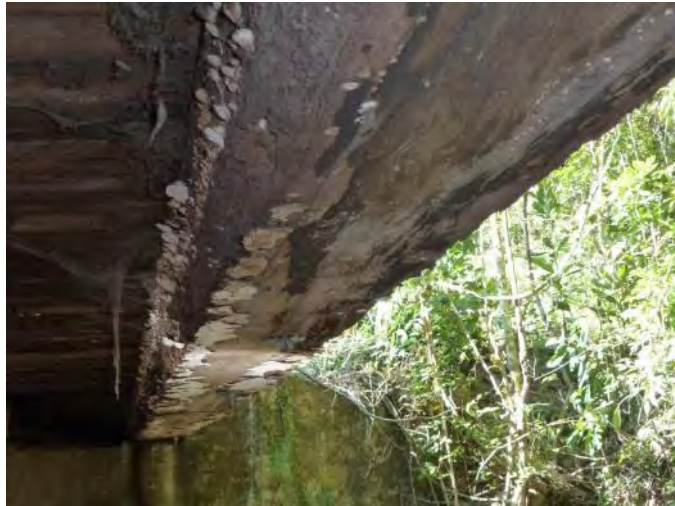
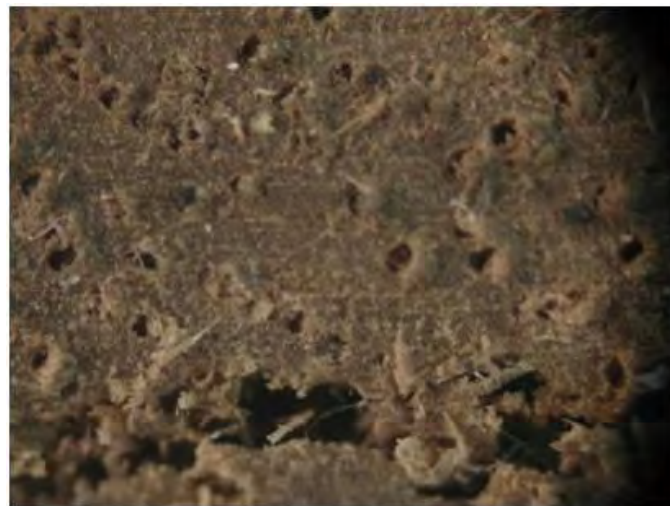
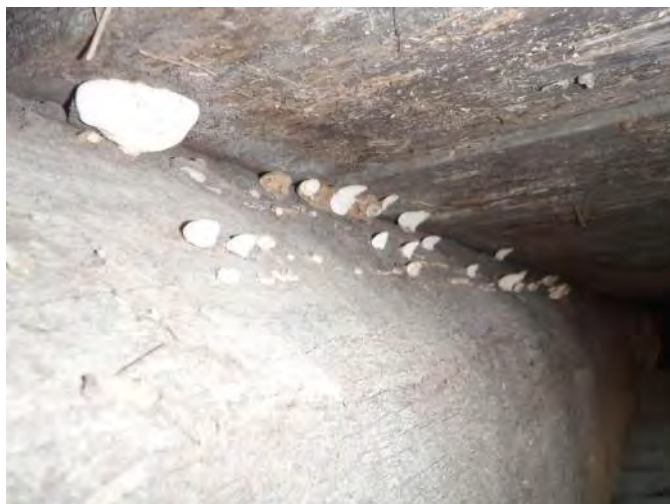
**Figure 2-4: Photograph of fruiting bodies (brown) on timber element in the tenth timber bridge found in the Kirrama range in CCRC (a). Note the shelf water from the leaking deck and outside the deck rain shadow, falling on the outer timber log girder. This coupled with the girder being on the south side of the bridge, the uphill side and closer to moisture all led to increased levels of moisture and elevated decay conditions. Proper drainage techniques for decks and protection for the elements are important. Proper steps should be taken to allow water to move quickly away from timber bridge structural elements. See photograph in (b). (particularly interesting hyphae at 9 o'clock on left side of photograph coming out of pore and into another adjacent pore) above, taken with a microscope, of a wood core taken from a timber bridge in Murrindindi Shire in Victoria, where fungal hyphae can be seen growing through the large pores in the core cross section. These hyphae tips secrete enzymes on the wood that break the cellular structure down as discussed earlier. When fruiting bodies are evident, hyphae are present in the wood at work breaking down the cellular structure and causing loss of structural capacity. Photograph in c) above shows a log girder in Hamilton's Road Bridge with a fruiting body due to similar conditions discussed above.**

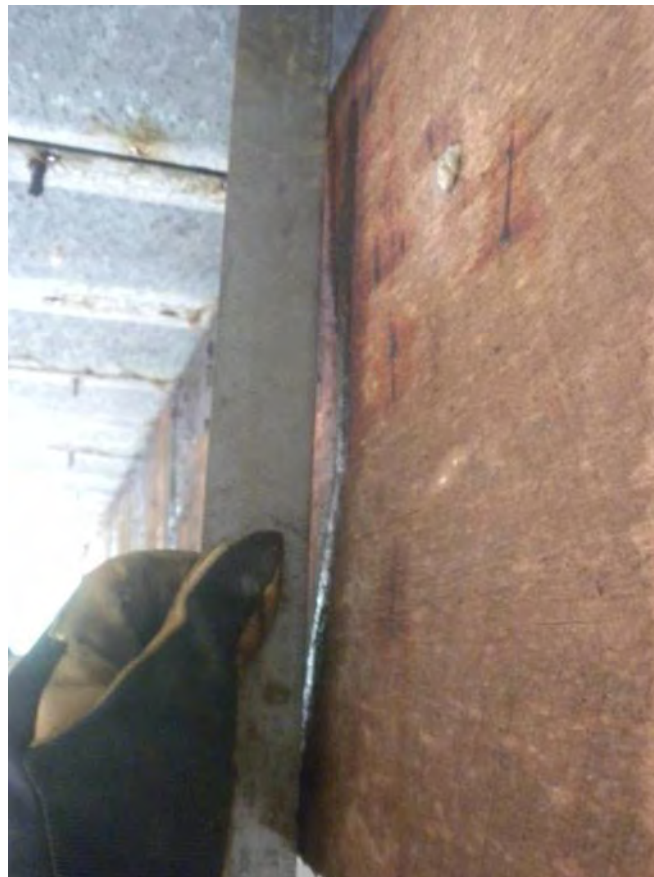
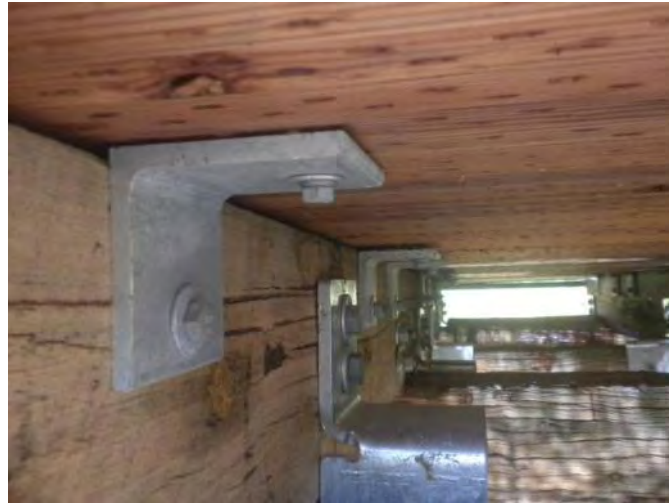
**Figure 2-5: Photograph of sunken face on a cross bearer in a timber bridge (a). This is strong evidence of decay from excessive water migration into the cross bearer vertically along deck spike traces. Even though hot petroleum jelly (see black stain beneath the square edge) was used, it is obvious how ineffective this method is in preventing decay caused by such improper timber construction practices. Proper deck clips fastened to the cross bearers with horizontal through bolts are required (b). Advanced decay of the type witnessed in the timber cross bearers causes significant loss of structural capacity.**

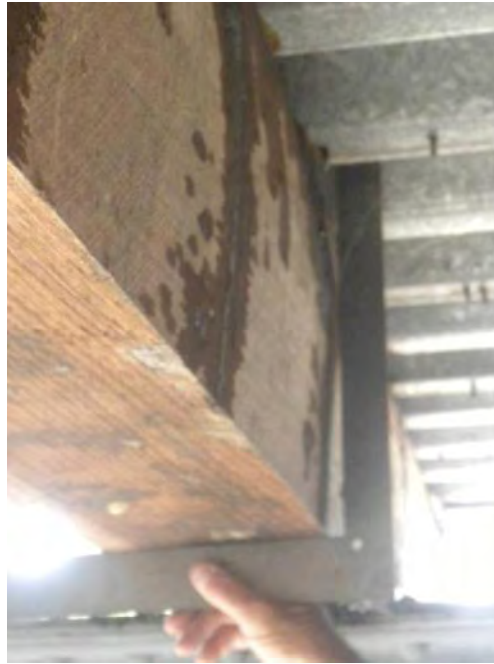
**Figure 2-6: A bulging face on a cross bearer in a timber bridge. This is strong evidence of decay from excessive water migration into the cross bearer along deck spike traces. Even though hot petroleum jelly (see black stain beneath the square edge) was used, it is obvious how ineffective this method is in preventing decay caused by such improper timber construction practices. Advanced decay of the type witnessed in the timber cross bearers causes significant loss of structural capacity. These cross bearers were only a few years in service but had their useful lifetime shortened by 80% or better because of poor connector installation practices.**

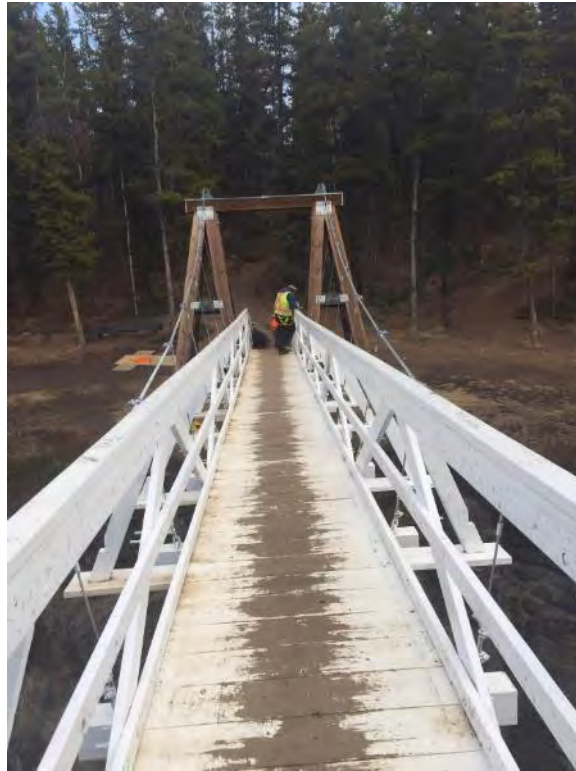
The deck is made up of nominal 2x10 timber planks. The planks are secured with vertical nails into the stringers below, and are coated with heavy, white paint. The deck planks are in fair condition; however, the paint has worn off along the center of the walking surface and many of the nails have worked loose over time. It is recommended that un-painted timbers be used for future deck replacements, and that the planks be secured using an alternative fastener system from below the deck; see Figure 3-2 below for an example.

**Figure 3-1: Deck from above, looking toward Abutment 2. Note the worn paint down the center of the walking surface.**

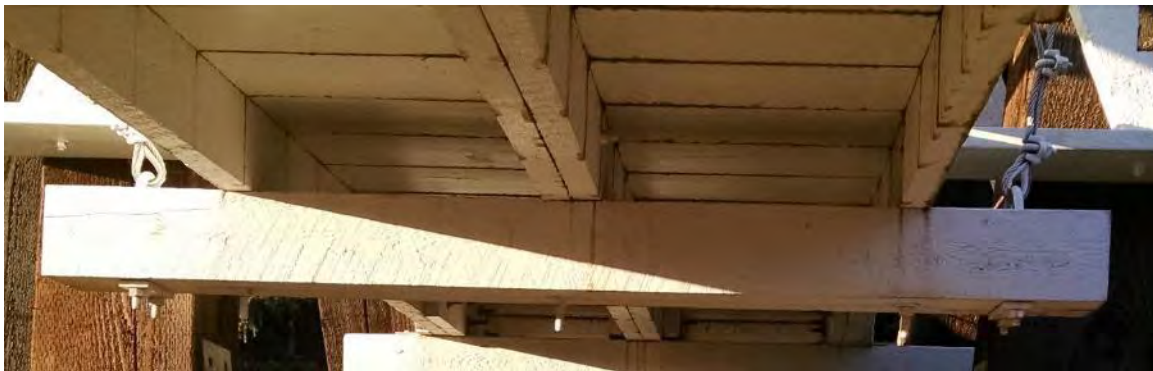
The stringers show some visible signs of decay, but the paint prevents a thorough visual inspection. The non-destructive testing revealed further internal decay, especially near the top surface. This is a common problem were the deck is secured with vertical nails; the nails allow moisture to enter the stringer and cause accelerated decay.

**Figure 3-3: Stringers passing over Crossbeam 1, seen from below. Note the vertical bolts through Stringers 1 (right) 3 and 4.**

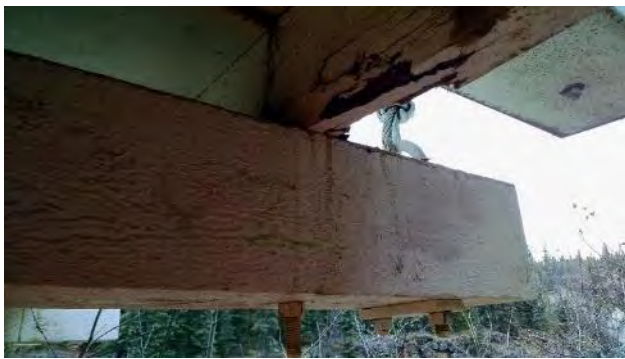
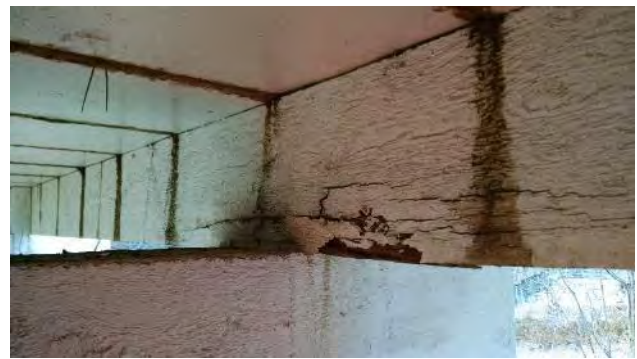
Stringer 1 in Span 22 was found to have significant decay in and partial failure near the support at Crossbeam 21. This area also shows excessive deflection under load, which has led to the failure of the railing cross brace connections in Span 22.

**Figure 3-5: Stringer 1 has failed over Crossbeam 21. This has caused excessive deflection in Span 22, and the railing cross braces have failed there.**

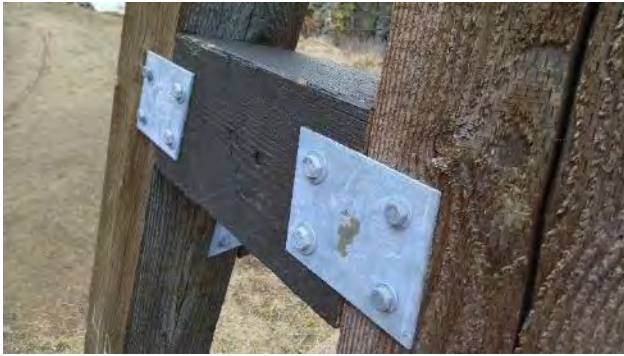
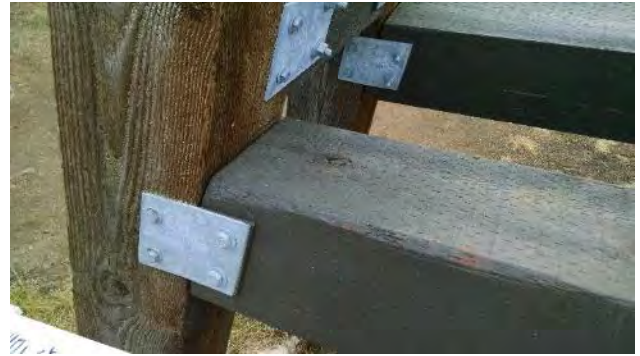
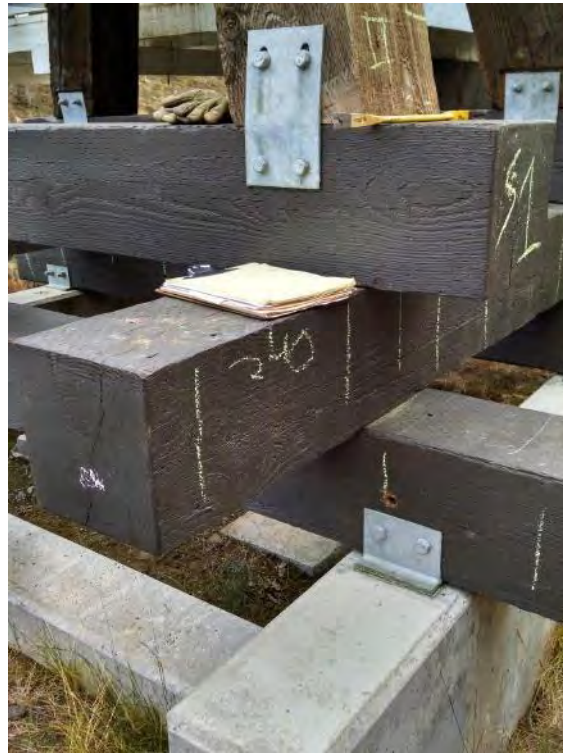
**Figure 3-9: The salvaged timbers are coated with heavy solids paint. This is not recommended for large timbers, as water will inevitably enter the timbers through, shrinkage cracks, fastener holes, peeling paint, etc; the paint then prevents the timber from breathing and keeps the moisture content elevated, accelerating the rate of decay. Also note that several of these members have holes and cutoff fasteners left from their previous use before the towers were rebuilt.**

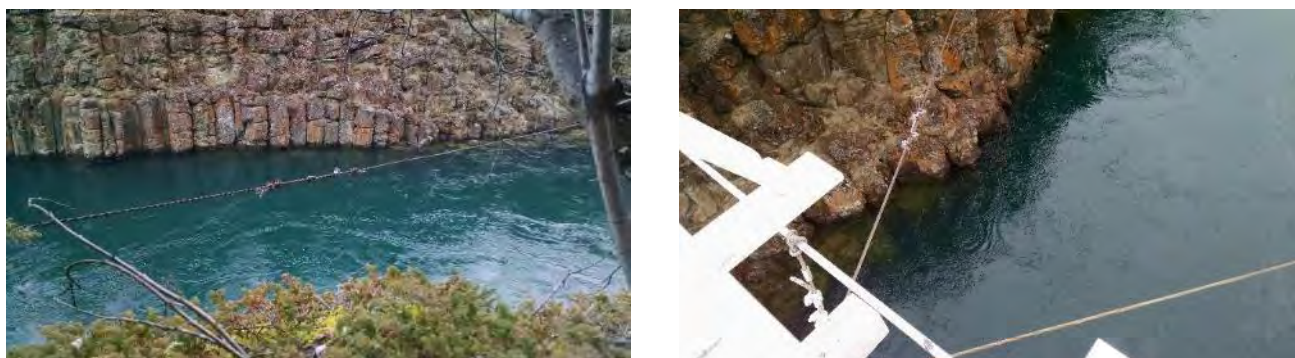
**Figure 3-14: The Side 1 cable (left) has a splice near End 1 and the Side 2 cable has a splice near mid-span on End 2. These splices appear to be repairs to previous damage and are in fair condition.**

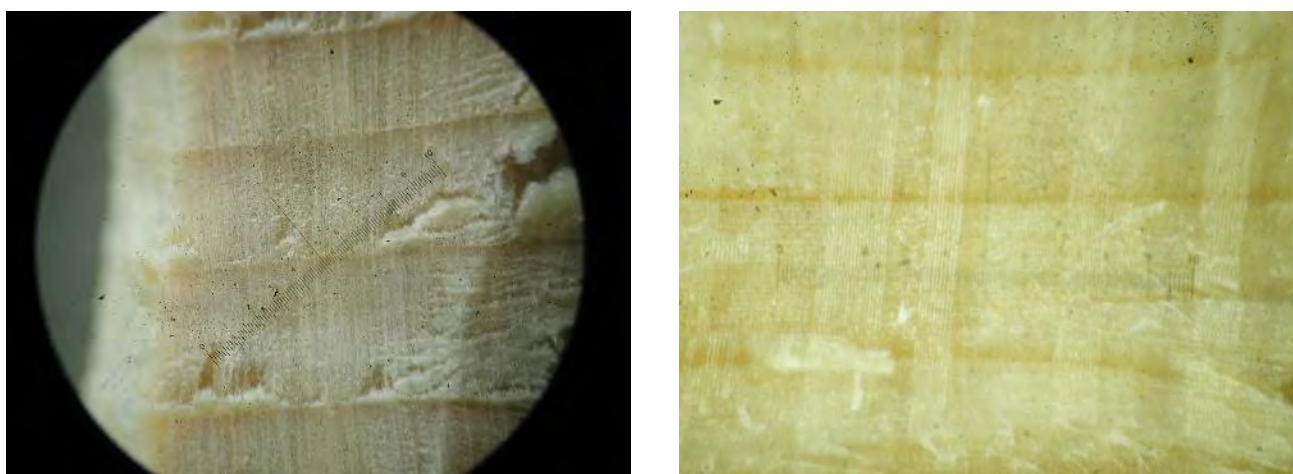
**Figure 3-17: Samples from Crossbeam 3, photographed under high magnification. Based on the grain patterns and cell structure, the species was identified as Spruce.**

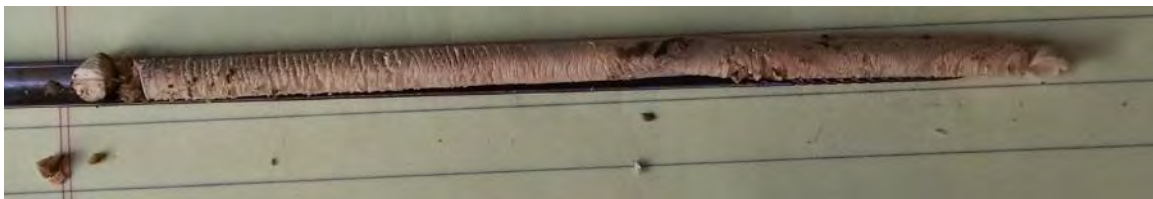
**Figure 3-20: Crossbeam 3, 8 inches from End 1. Vertical core, bottom at left.**  
This sample shows somewhat reduced specific gravity in the Top-Outside and Bottom-Inside sections. Note the knot in the Top-Inside section which may account for the higher specific gravity in that section

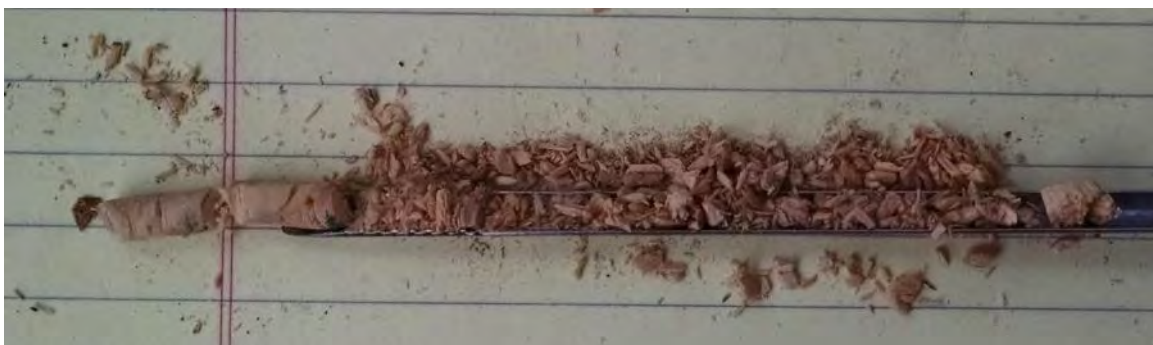
**Figure 3-22: Crossbeam 11, 56 inches from End 1. Vertical core, bottom at left. This core shows severe decay and crumbling in the top three quarters; specific gravity readings could only be made in the Bottom-Outside section. These findings support the SWT results which show high Red Zone readings throughout this end of the beam.**

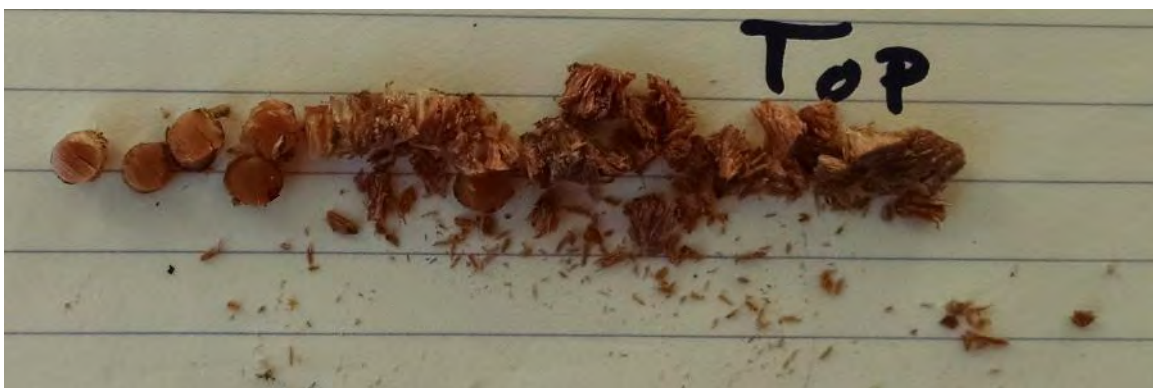
**Figure 3-26: Crossbeam 20, 64 inches from End 1, 1 inch from Side 2 of beam. Vertical core, bottom at left.**

**This sample crumbled into fine pieces and specific gravity calculations could not be made. Moisture content was very high throughout. The condition of this sample is consistent with the Red Zone SWT reading at the same location.**

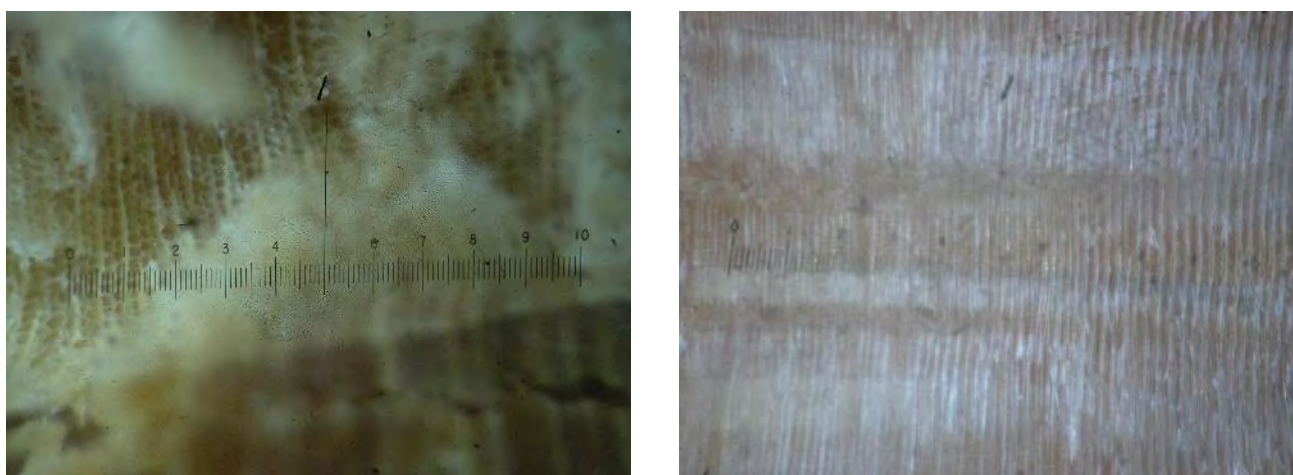
**Figure 3-32: The sample from Abutment 1 under high magnification. The species is Spruce.**

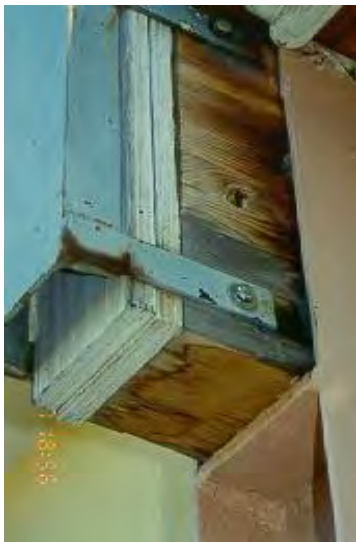
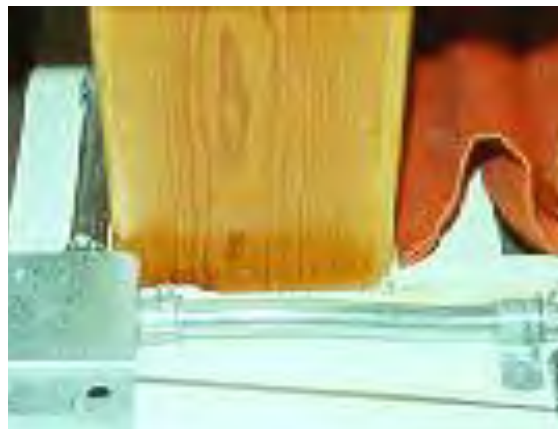
Figure , showing a poor connection detail on a bridge. The connection shown in Figure and Figure , has lag screws drilled into the top of the beam allowing water to be drawn into the wood (like a tube holding water); this can easily seen by the water seeping out between the laminations on the side of the beam.

**Figure 1. The left and right photos show the exterior and interior respectively of a bulging, or mushrooming, glulam. Note the discoloration near the bottom of the beam on the left, and the moisture entering the inside of the building on the right, both indicative of a good environment for biotic agents of deterioration.**

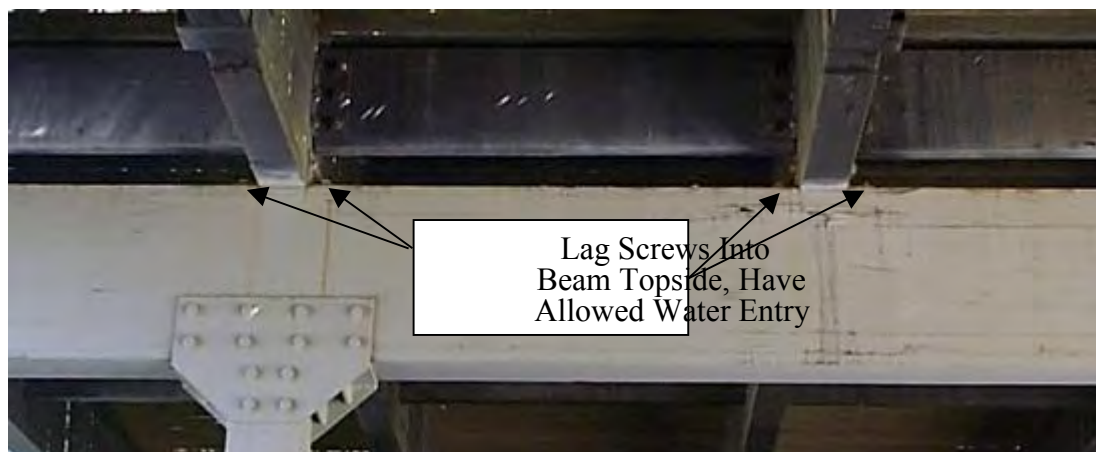
**Figure 2. A glulam beam supporting the glulam girders of a bridge shows evidence of water damage.**

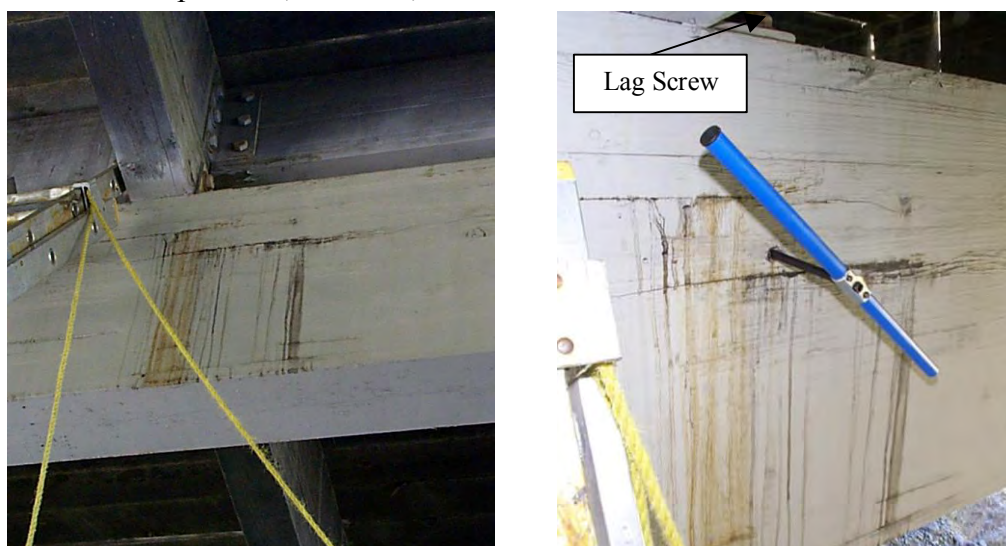
**Figure 3. The left and right photos show evidence of water inside the beam. The lag screws drilled into the topside of the beam have allowed water to enter and build up in the wood and then seep out the sides as shown. The right photo shows a core sample being taken to further define the extent of internal deterioration.**

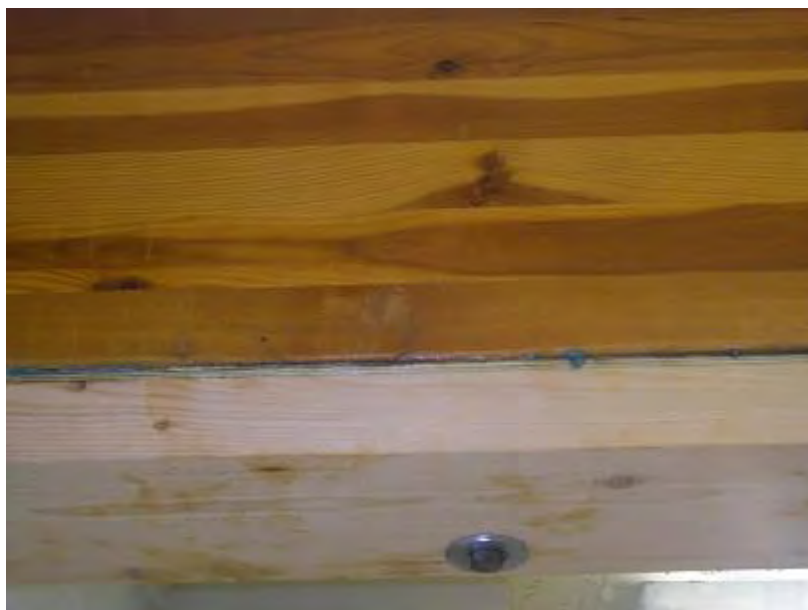
**Figure 6: Photograph of a FRP reinforced tension lamination attached to an existing glulam beam.**

lamination<sup>23</sup>. A photograph of a FRP reinforced tension lamination bonded to an existing glulam beam is shown in Figure 6 and Figure 7. Structural epoxy and lag screws are used to attach the reinforced tension lamination to the bottom side of the existing beam.

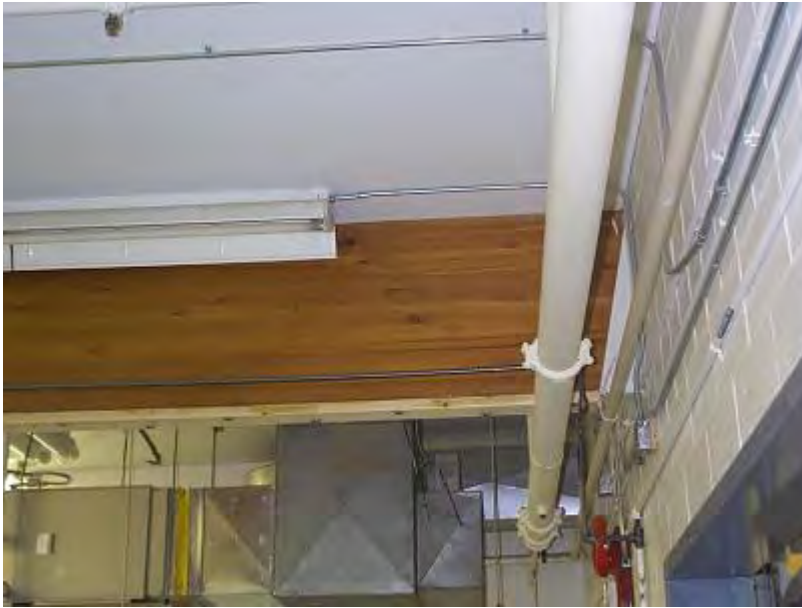
**Figure 7: Complicated FRP reinforced tension lamination installation.**

Since the purpose of the FRP reinforced tension lamination is to increase the bending stiffness and bending strength, it may not need to be extended under the support. Therefore, retrofit of the supports or bearing walls may not be required and mechanical units may be left in place. Figure 7 shows a photograph of a complicated FiRP® Reinforced tension lamination retrofit.

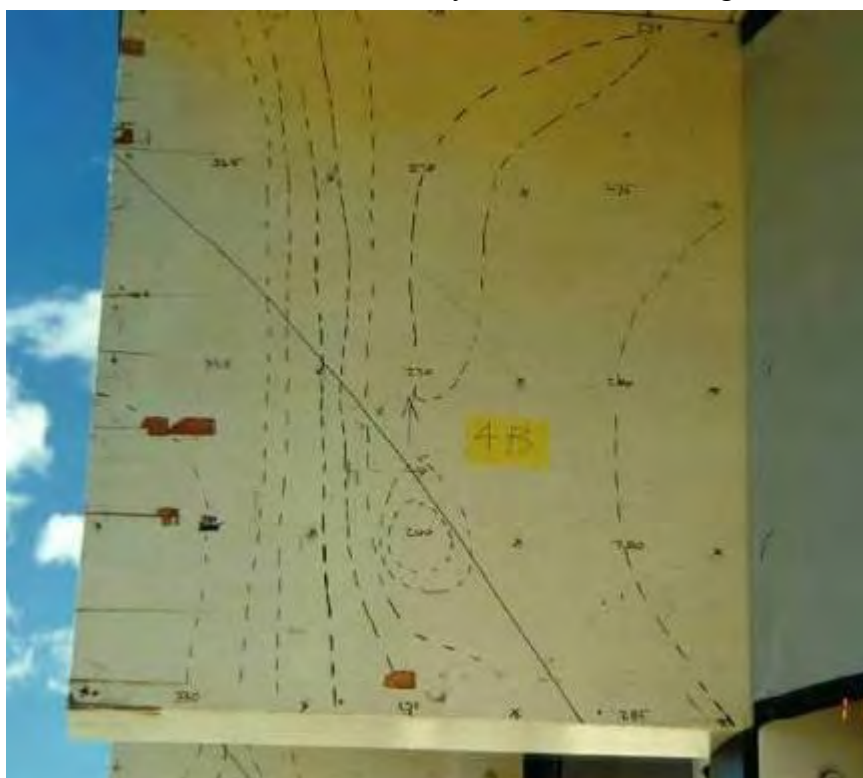
**Figure 11: Stress wave time contour map used to determine areas of decay.**

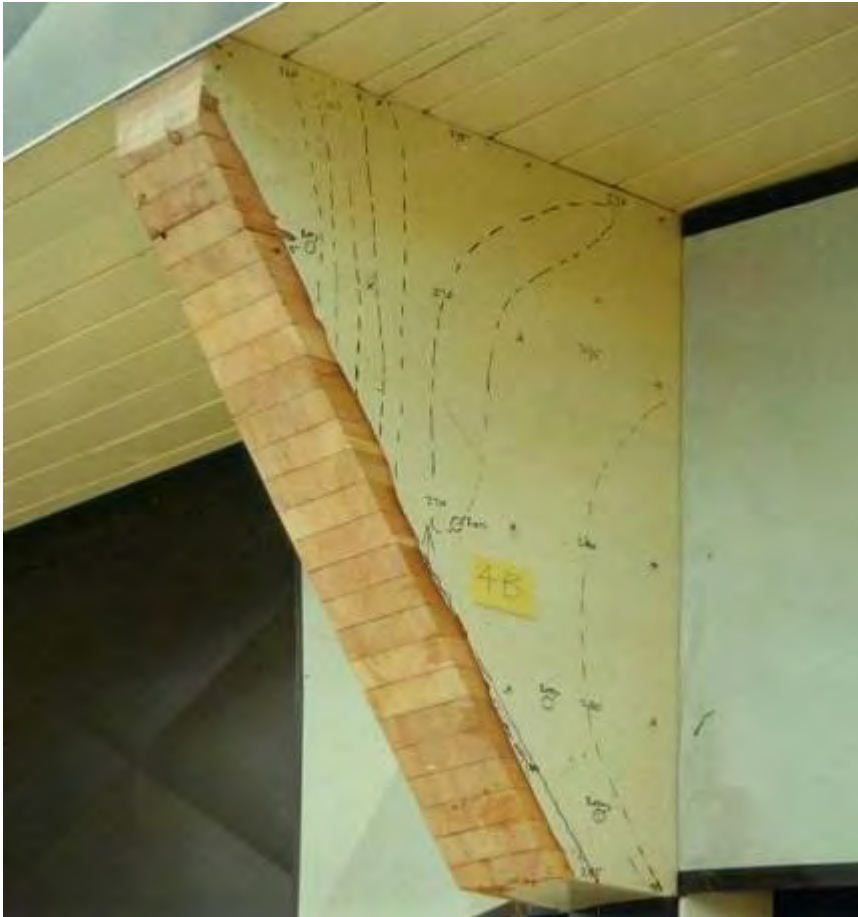
**Figure 12: Photograph of a slash-cut detail.**

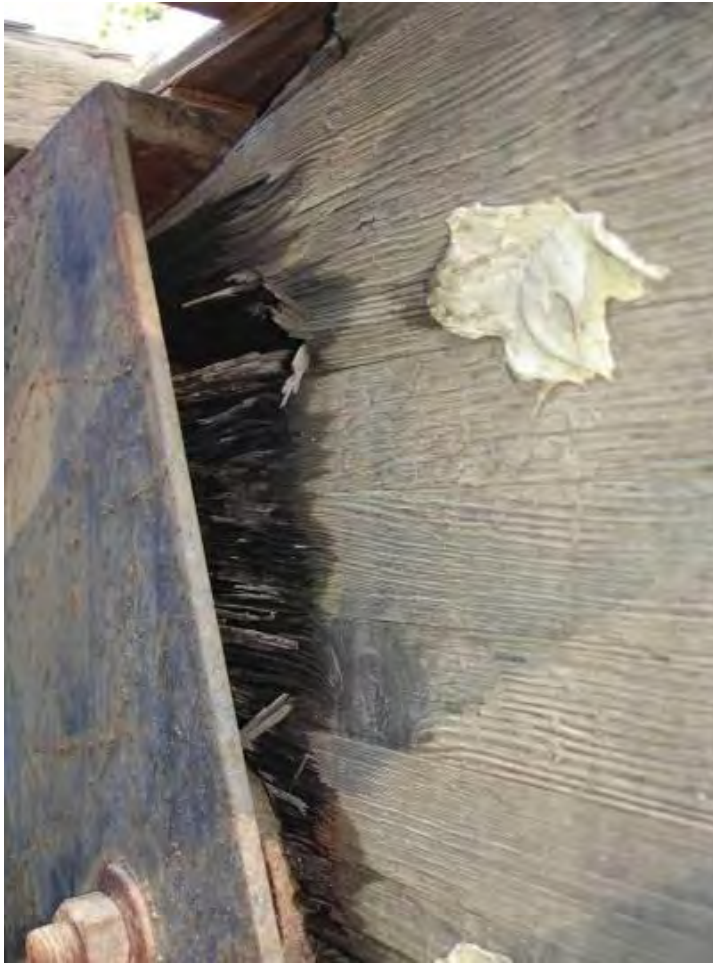
In very wet environments bacteria can colonize in untreated wood. Bacterial damage can include softening of the wood surface, increased permeability and even degradation of chemical preservatives so that the wood becomes more susceptible to less chemically tolerant organisms. Usually the process bacterial attack is very slow, but under extensive exposure for long periods damage can become significant. See the photograph in Figure 1 of a beam that completely degraded due to biotic agents. The first agent was fungi, the second was insect infestation, the third was wood peckers, and the fourth was rodents. These steps all occurred in 22 years in a treated glulam bridge girder where the end of the beam had been cut back in the field after pressure treating and were not properly field treated. The end in the cantilever connector was completely decayed and degraded and the beam was about to fall out of the connector when discovered in an inspection by the author.

Figure 1. Photographs of a glulam beam that completely degraded due to biotic agents over a short 22 year period.

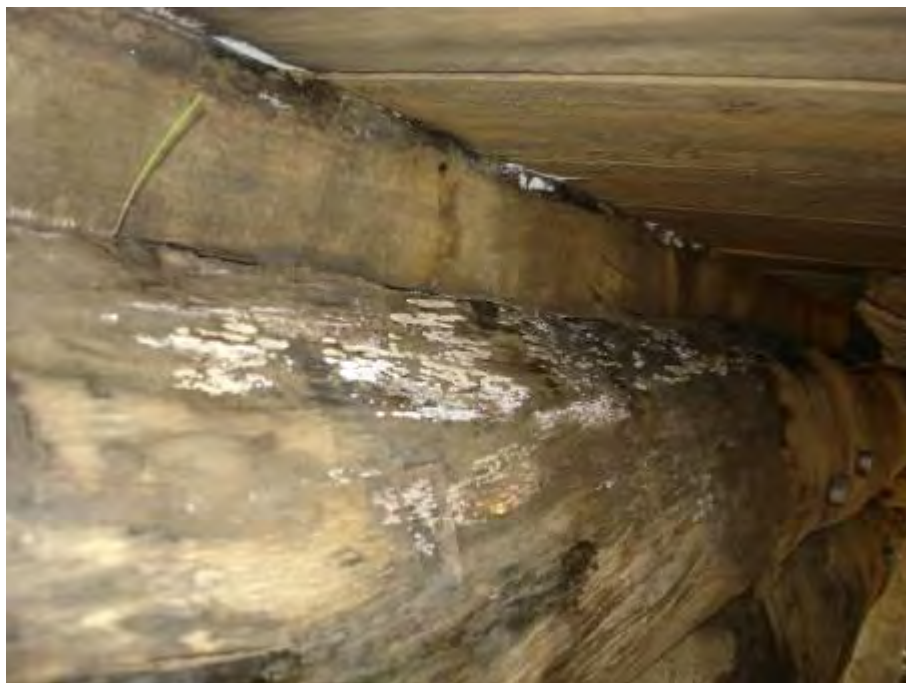
Figure 2. Photographs of a white rot on a round hardwood log girder in Victoria, Australia.

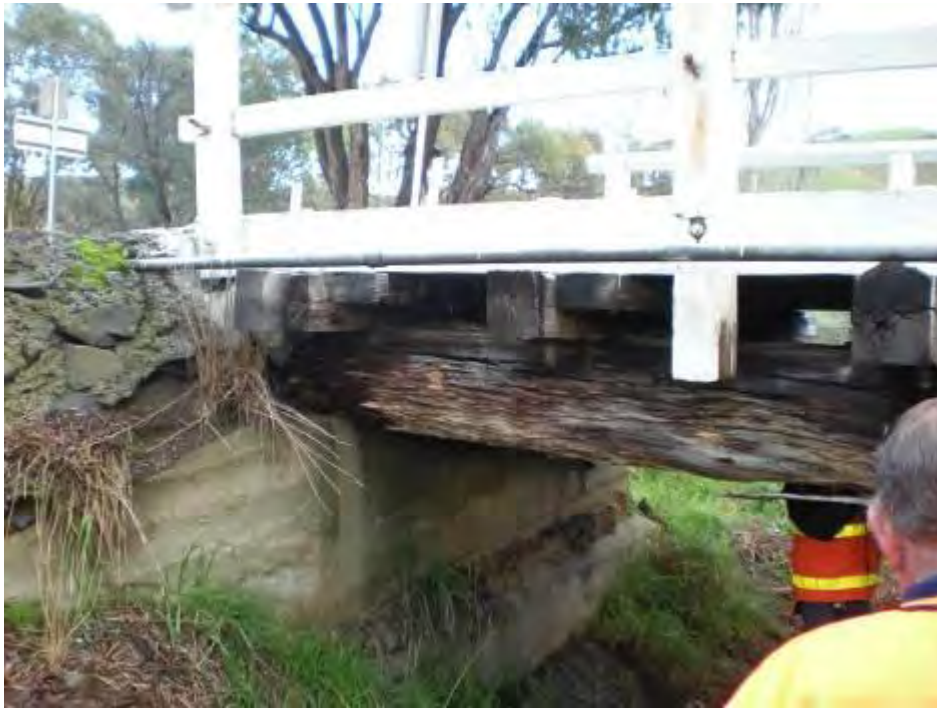
Figure 3. Bridge round log girder, showing advanced signs of decay with compression bulbing over the reaction point, Victoria, Australia.

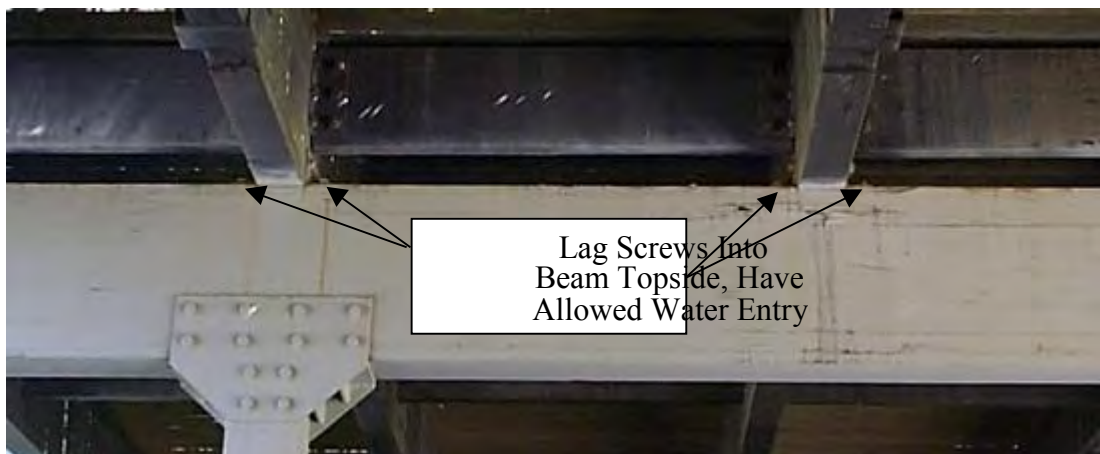
Figure 4. A glulam beam supporting the glulam girders of a bridge shows evidence of water damage in Whistler B.C., Canada.

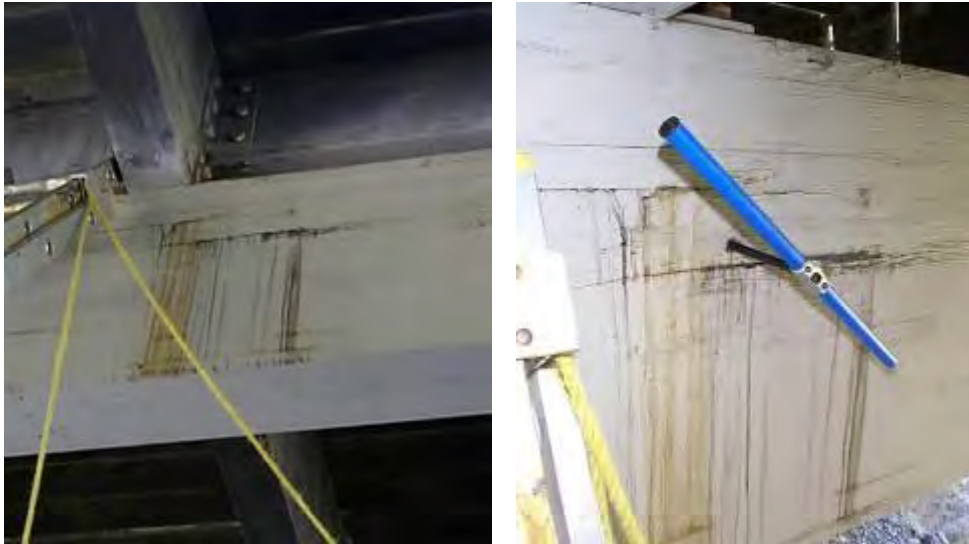
Figure , showing a poor connection detail on a bridge. The connections shown in Figure 4-5, contain lag screws drilled into the top of the beam allowing water to be drawn into the wood (like a tube holding water); this can easily seen by the water seeping out between the laminations on the side of the beam.

Figure 5. The lag screws drilled placed in the topside of the beam have allowed water to enter and build up in the wood and then seep out the sides as shown. The right photo shows a core sample being taken to further define the extent of internal deterioration.
