**Miles Canyon Bridge  
Level II Inspection Report  
Whitehorse, Yukon**

*Prepared by*  
**Dan Tingley Ph.D., P. Eng. (Yukon)**

**Final Report  
23 November 2015**

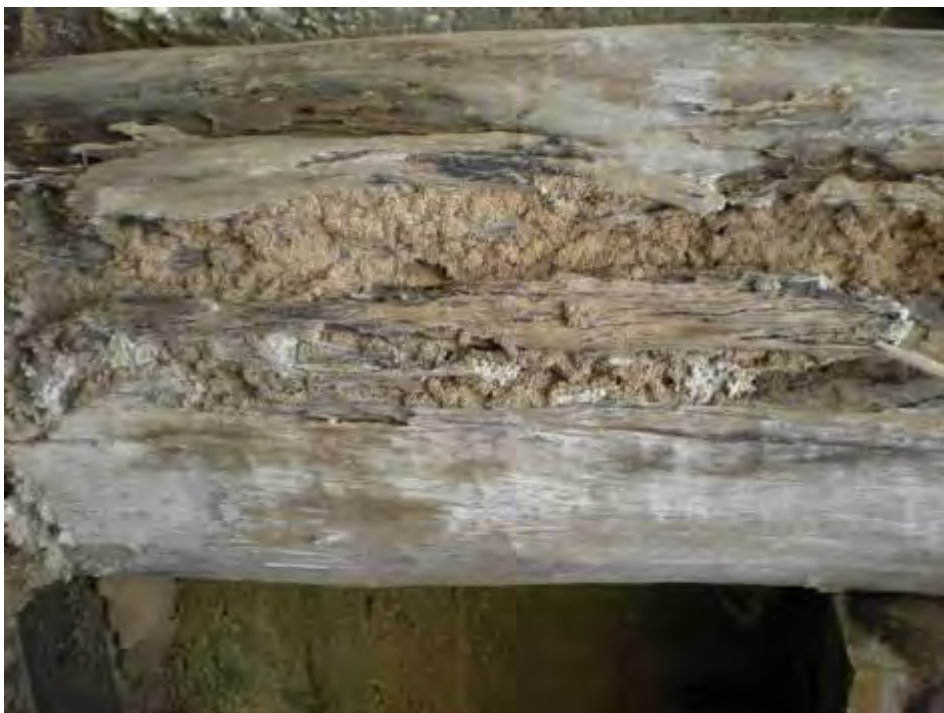
Figure 6. White Ant deterioration to a bridge timber in Victoria, Australia.

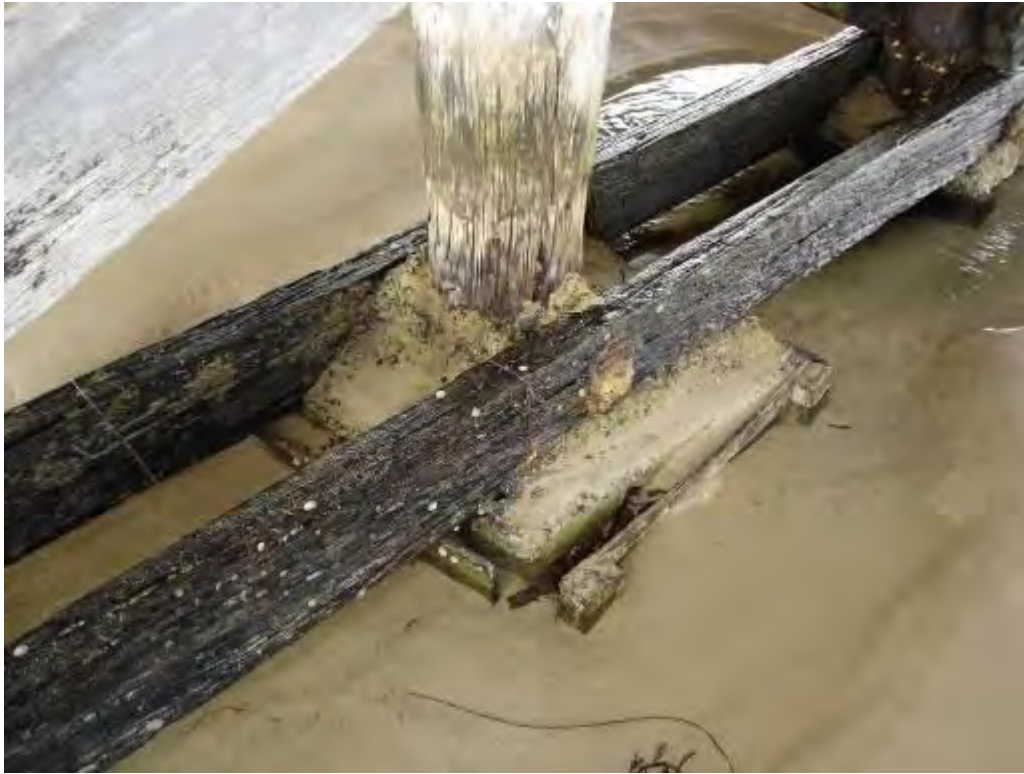
Figure 8. Marine borer damage to a pier and walers in the Barwon Heads bridge in Victoria, Australia.

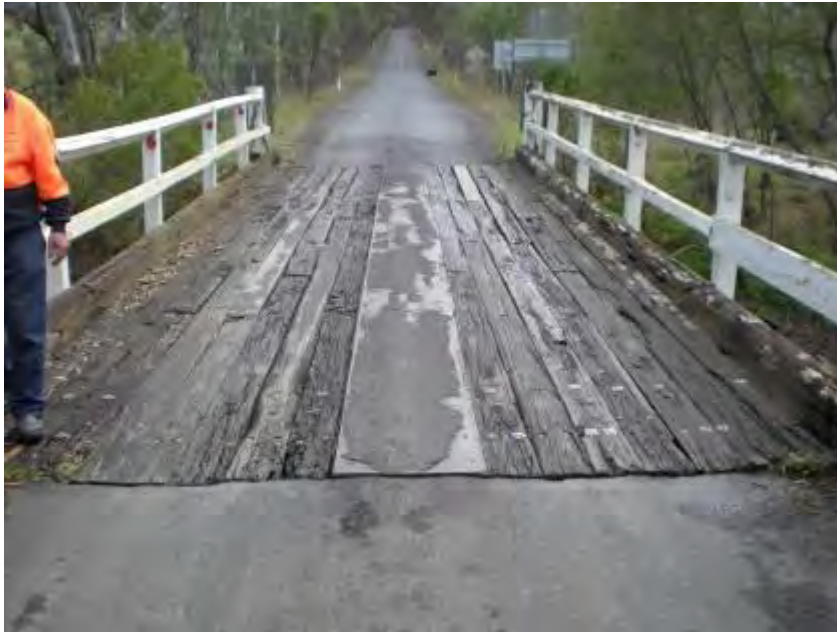
Physical agents can damage the wood material and degrade away preservative treatments. This allows increased susceptibility of attack by biotic agents. Abrasion, mechanical impact, by products of metallic corrosion, highly acidic or basic substances and ultraviolet light are examples of such physical agent damage. See Figure 9 below for examples of tire wear on a bridge deck that could have been significantly reduced by the use of running boards on sleepers to allow for proper moisture flow. The runners could have been replaced easily and thereby saved the deck timbers.

Figure 9. Deck timbers worn by traffic. Runners like the one shown in the center for cyclists would have allowed easier lower cost bridge deck maintenance.

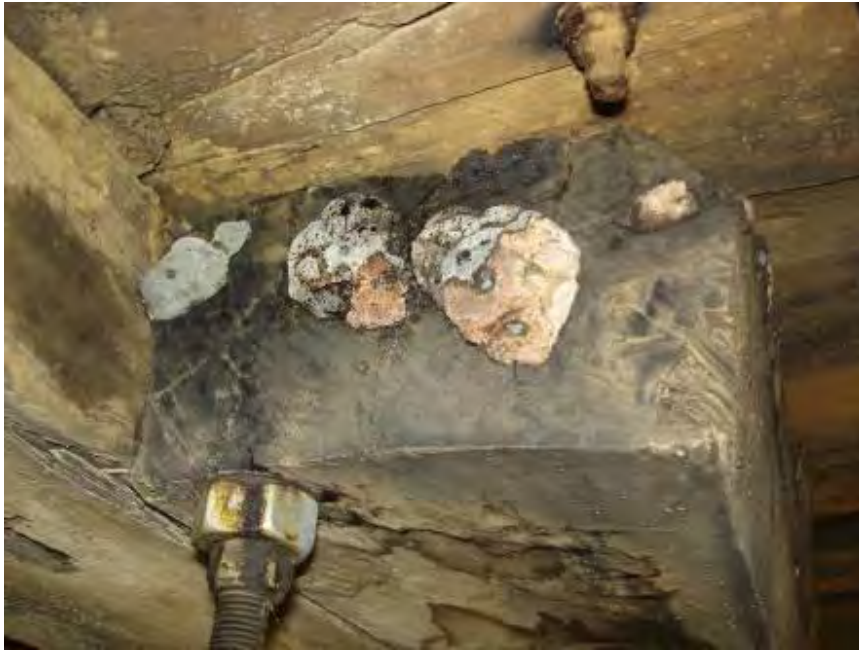
Figure 10. Rusty metal connectors, ferric damage in the wood and fruiting bodies from fungal decay.

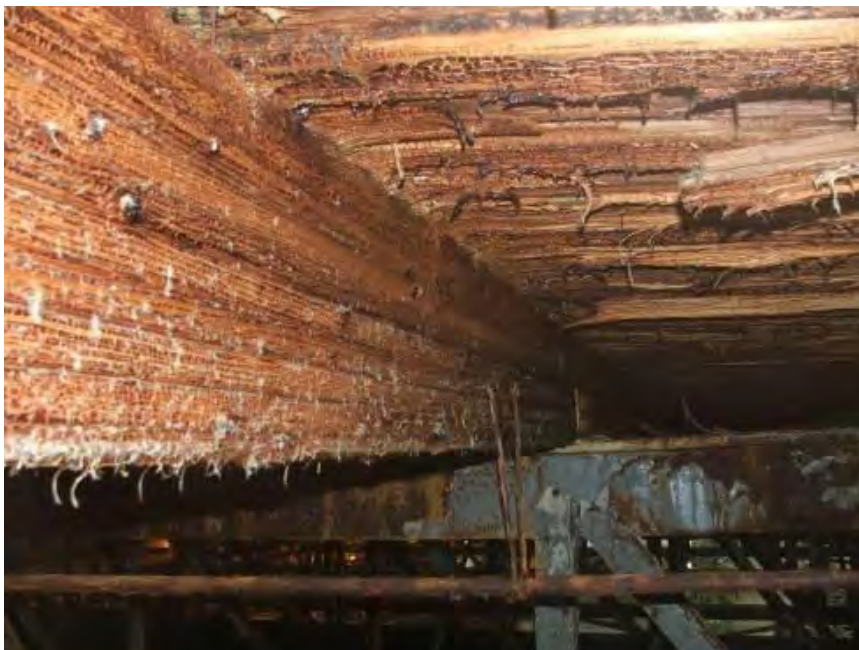
Figure 11. Strong base degradation of wood beams in a roof system of a paper manufacturing facility.

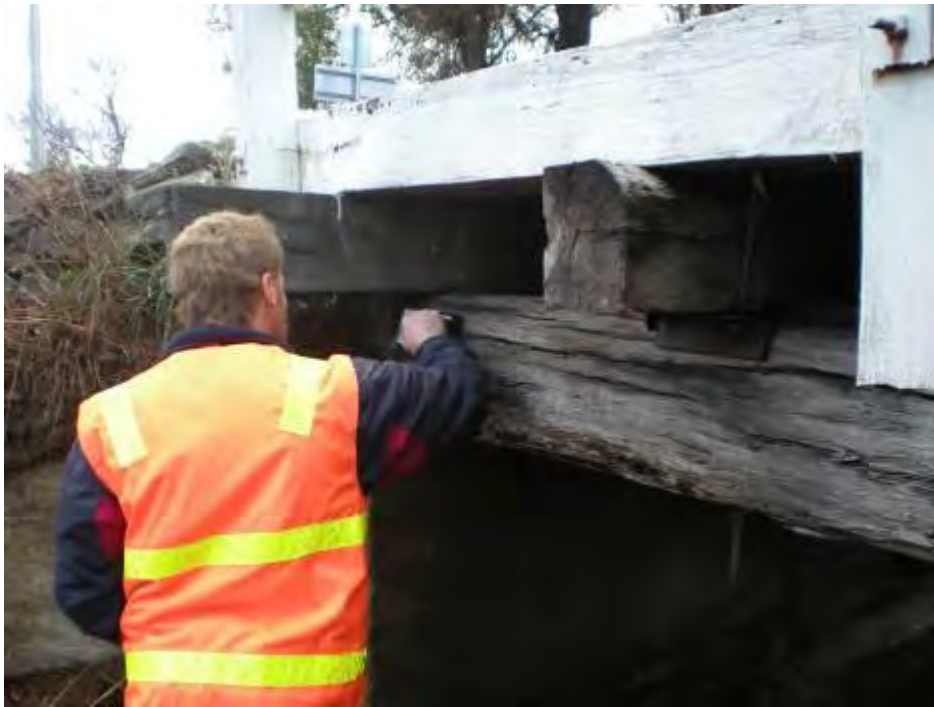
indicates conditions suitable for decay. See Figure 12 below for a bridge inspector in Victoria utilizing a moisture meter to assess a log girder that has very high moisture content.

Figure 12. Moisture content meter in use to determine moisture content in a log girder in Victoria, Australia.

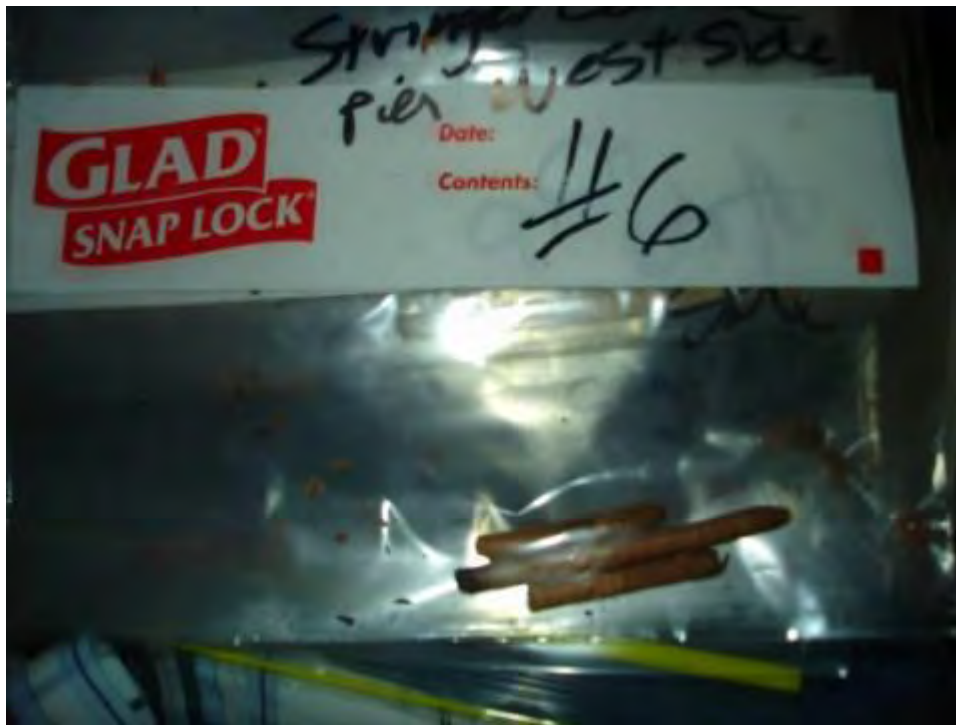
Figure 13. A core sample taken with an increment borer from Red Box round log girder in Victoria, Australia.

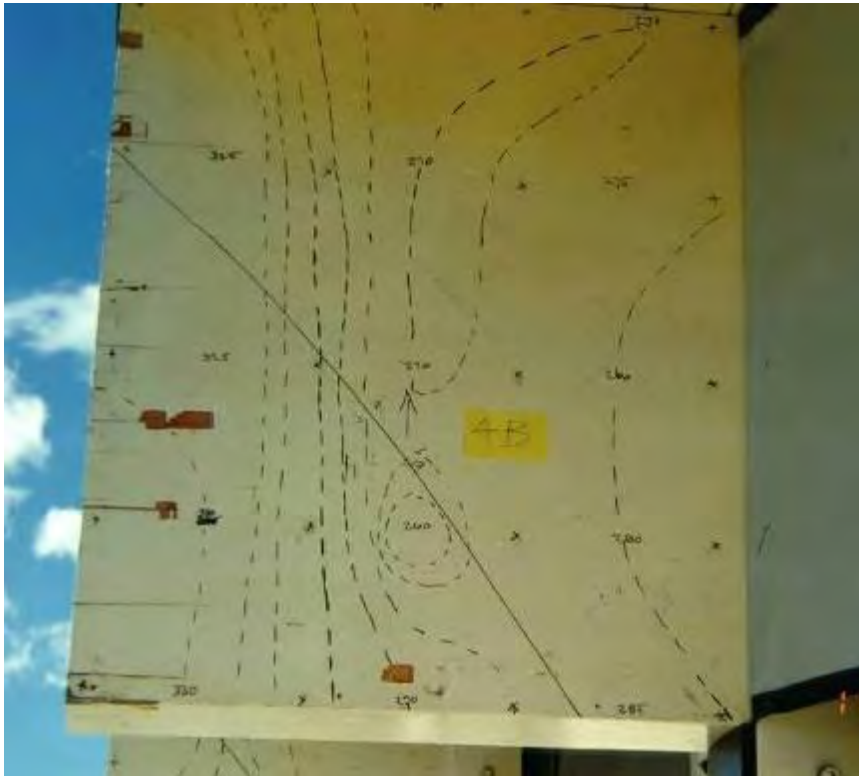
Figure 14 below shows a contour map drawn on the side of a beam, created with the stress wave timer. This figure shows that the very end of the beam has relatively high stress wave time values (greater than 300 microseconds per foot) indicating areas of low density due to fungal decay. The stress wave times tend to decrease toward the wall indicating higher density. The covered area next to the wall has the lowest stress wave times because this region is subjected to the least amount of moisture.

Water is easily absorbed and transported parallel to the grain in wood structure elements. This factor can often provide enough moisture for active fungal attack many feet from the source. An especially harmful situation occurs when an exposed beam end collects and absorbs water to areas in

Figure 14: Stress wave time contour map used to determine areas of decay.

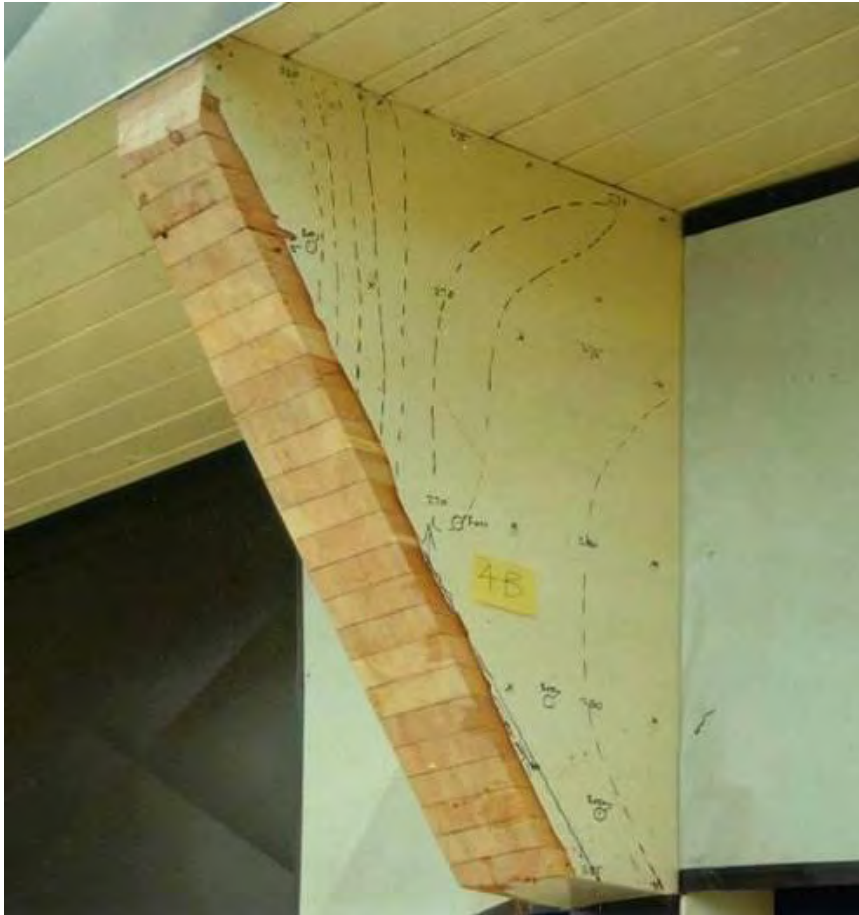
Figure 18: Photograph of a slash-cut detail coupled with end sealing with paraffin wax.

A combination of an amputation in a slash direction to limit further water exposure coupled with end-sealing with a high solids coating and paraffin wax, and preservative treatment is used to renovate the beam ends. See Figure 18 below. The design of the slash-cut meets two key parameters:

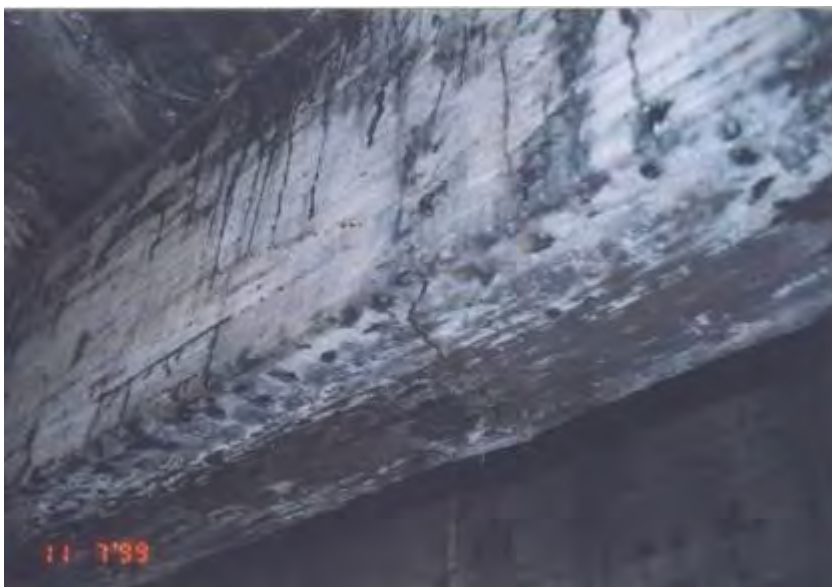
Figure 22. Cracked girder.

Girder (#6) had a large crack at mid-span at the bottom of the beam, possibly due to overload. Stress wave times through this cracked region were much slower, indicating the crack is significant through the beam width. Figure 22 shows a picture of this cracked girder.

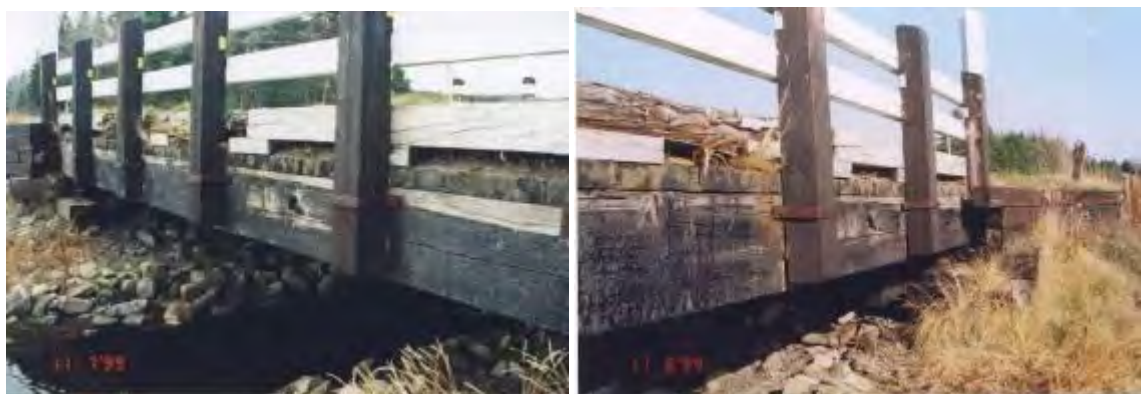
The girder dimensions are approximately, 250-mm wide, 490-mm deep (10 in. x 20 in.) and have a 9.02-m (30 ft.) clear span. The center to center spacing is not equal for all girders but is averaged to be 724-mm (28.5 in.). The north and south outer girders had visible water runoff from the deck onto the side of the beams. Accordingly these girders had the highest measured moisture content. After a core sample was taken from girder #1 (north outer girder), water began dripping out the hole, indicating the wood fibers were saturated with water (moisture content greater than 30%), Table 2 shows severe decay in this region. The other outer girder (#13) had a damage “hole” in the side of it, and this damaged area also had SWT’s indicating decay.

Figure 25. Soldiers Cove outer girder showing damage “hole” on side (top) and girder end shear crack (bottom)

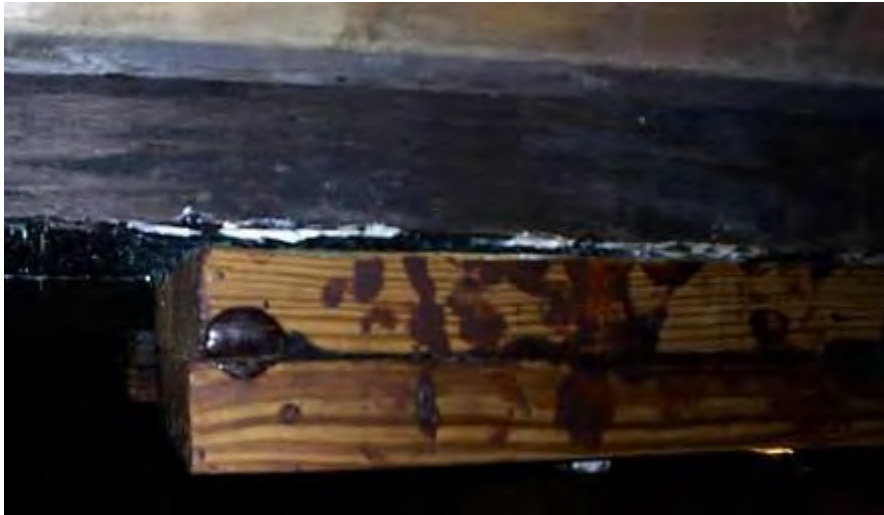
See Figure 35 for completed retrofit on a girder in the Quoddy Bay Bridge. For the most part the bond achieved between the bridge girder and the tension laminations was acceptable, but there was one tension lam that was bonded tightly on one side and had a gap on the other side, see Figure this had to be repaired. Considering the conditions under which the retrofit work was completed the work was well done.

Figure 36. Gap between tension lamination and existing girder on the Quoddy Bay Bridge.

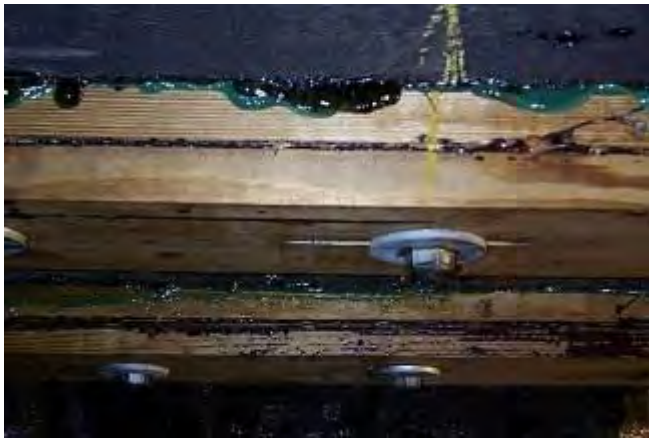
There was some concern about some of the epoxy bonds because of the creosote layer on the existing girders in both bridges. When they were tightened the lag screws the epoxy squeeze out would have a fine layer of creosote covering the surface, see Figure . This concern was addressed in future retrofit projects and the concern eliminated with a preparation strategy that specified that at least 1/8" of wood was removed from the bottom of a creosoted beam. See Figure 39 for photographs of a properly prepared creosoted beam tension surface. See Figure 40 for an improperly planned surface on the bottom of a bridge girder. The beams for Quoddy Bay Bridge were installed in one day.

Figure 38. Creosote covered epoxy squeeze out.

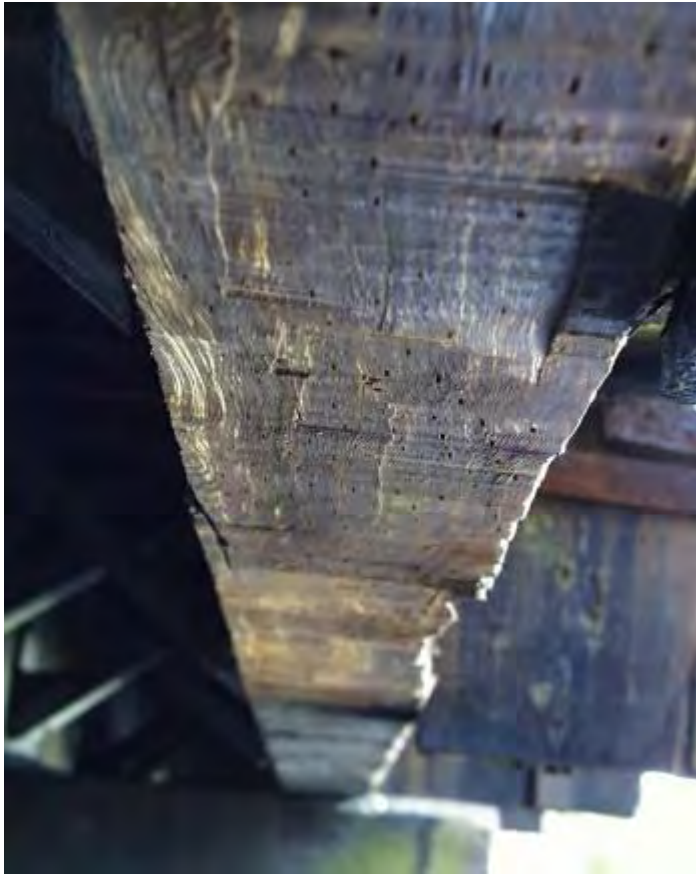
Figure 40. Properly prepared surface on creosoted bridge girder in terms of depth of planning. However note the improper uneven surface and planner gouge that had to be smoothed out for completion of retrofit installation.

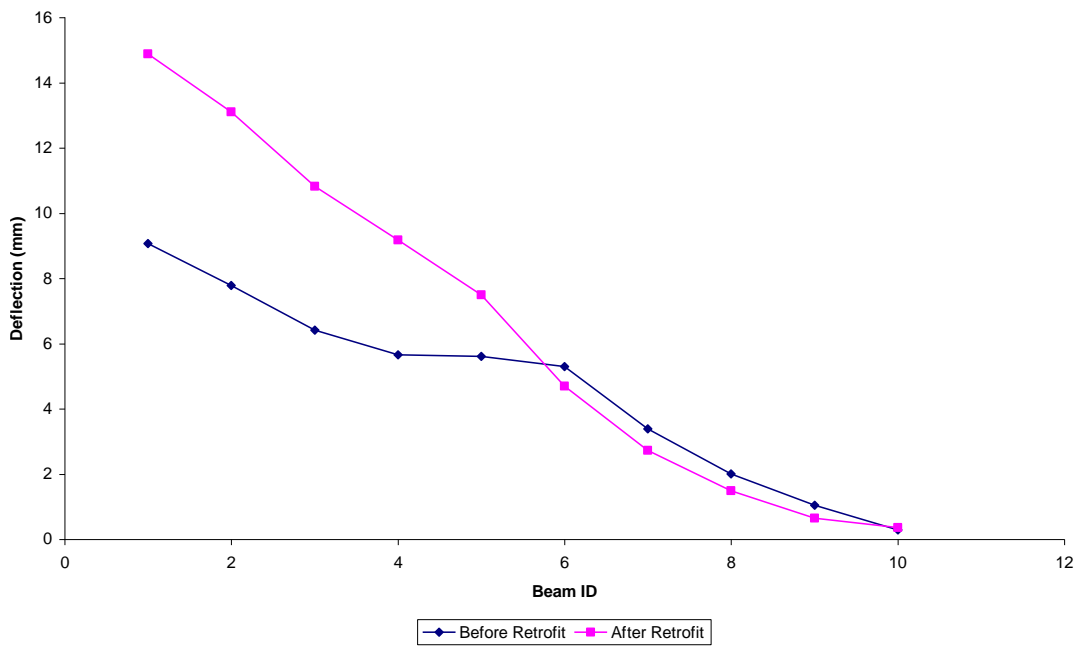
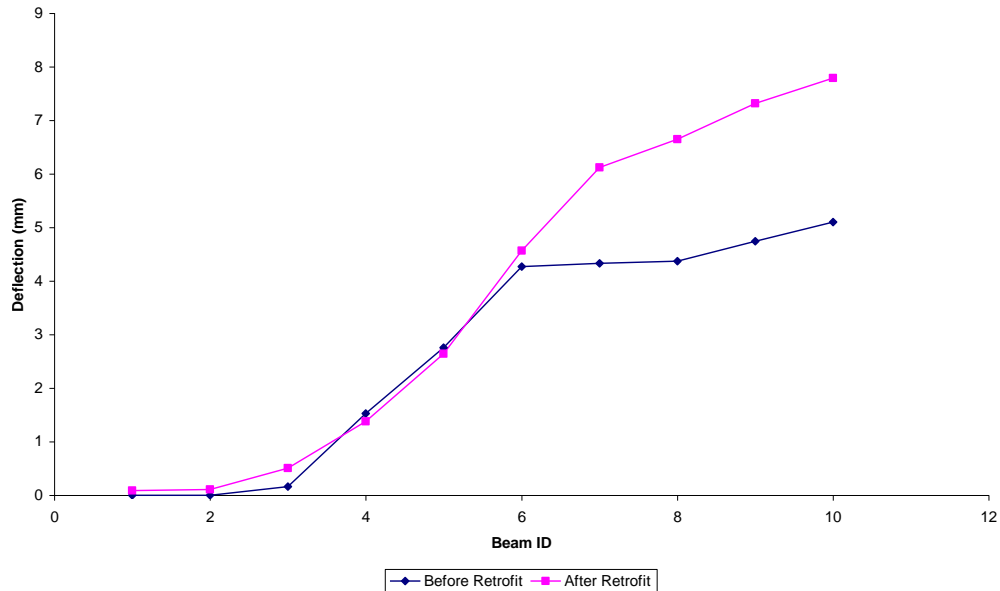
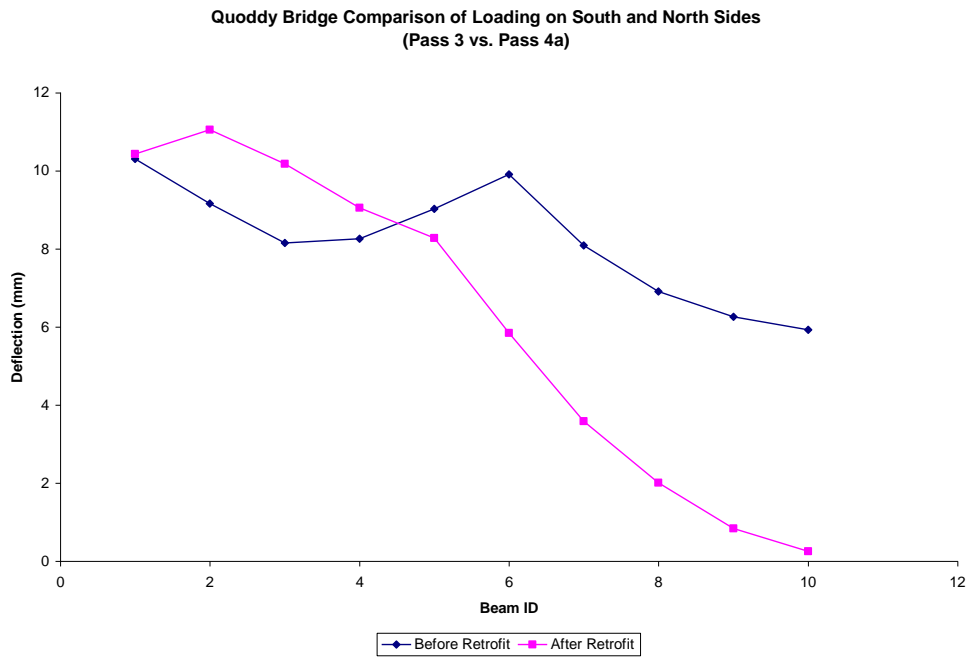
Figures 41 and 42 below, show the results for load deflection testing before and after for Quoddy Bay and Hay Cove respectively. The results showed that stiffness was dramatically improved for the bridges. The testing (See Figures 43-44) involved the use of extensometers and **NSTPW** gravel trucks of known weights. These trucks were positioned at specified locations and deflection data recorded. Then these vehicles are driven across the bridge at various known speed and deflection measurements recorded. The trucks that were used had two back axles and on front axle had provided a 36T axle load.

Figure 41. Deflection data comparison between, before retrofit, and after retrofit for Quoddy Bay bridge. South side a). north side b.) and merged data c.)

Please note that there were some data errors in the test results shown for the Quoddy Bay bridge. The deflection for the pre-retrofit case on the south side appeared to be reversed. The data logger out feed identification was improperly labeled it appeared. However, this couldn't be confirmed

with the **NSTPW** engineering department. Clearly, the data is spurious and incorrect for the south side girders as the deflection would be less after the installation of the retrofit. See Figure 44 for photographs of load testing process.

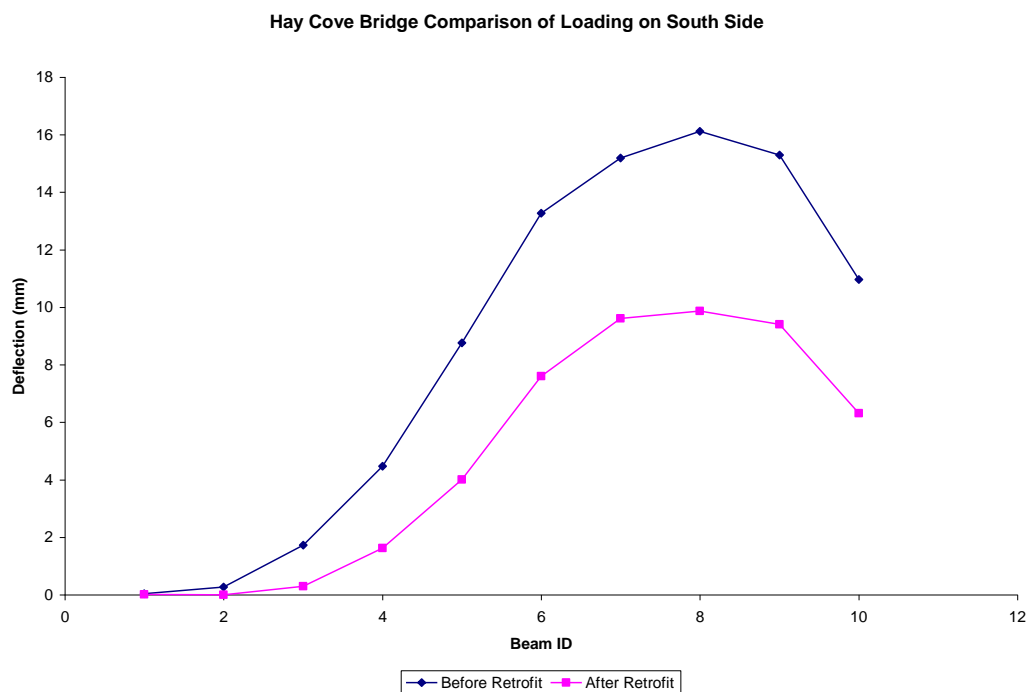
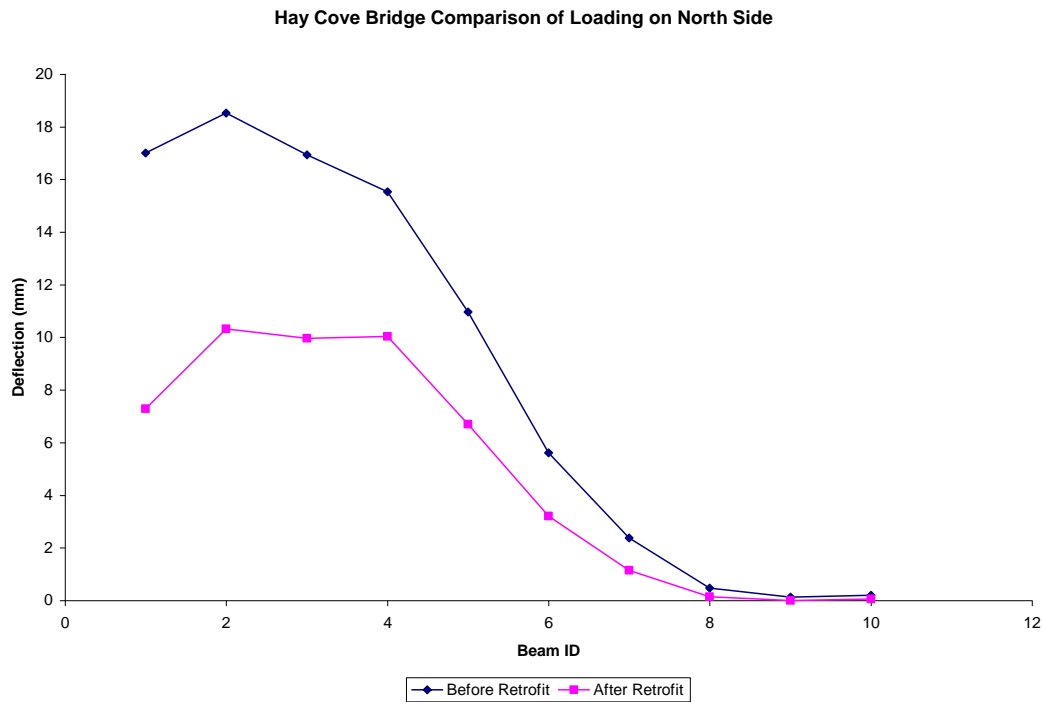
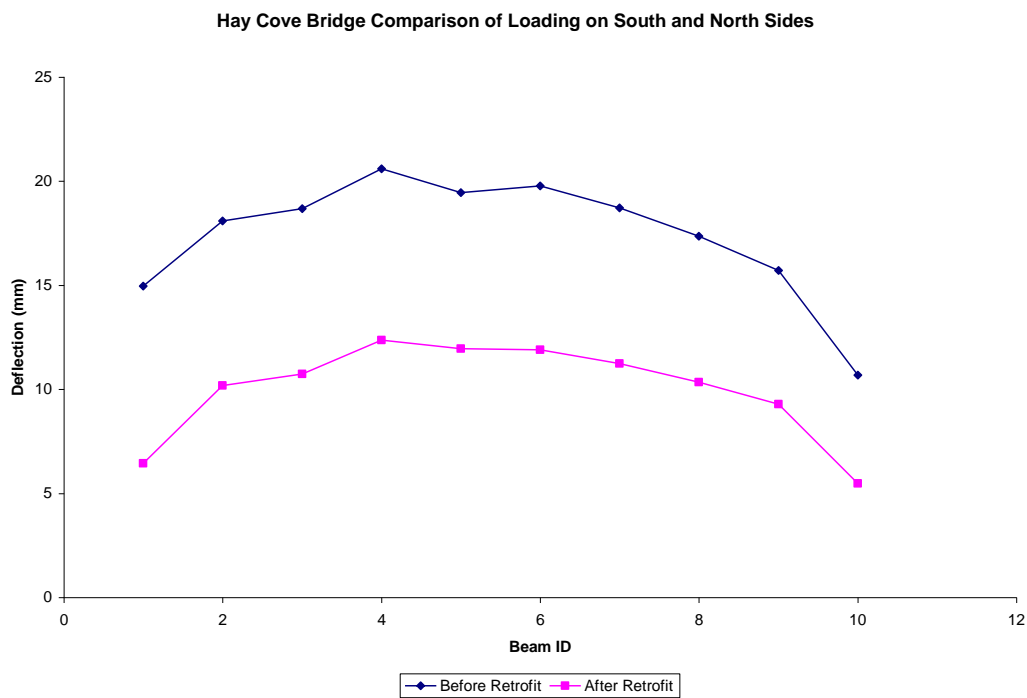
Figure 42. Deflection data comparison between before retrofit and after retrofit for Hay Cove Bridge. South side a), north side b) and merged data c).

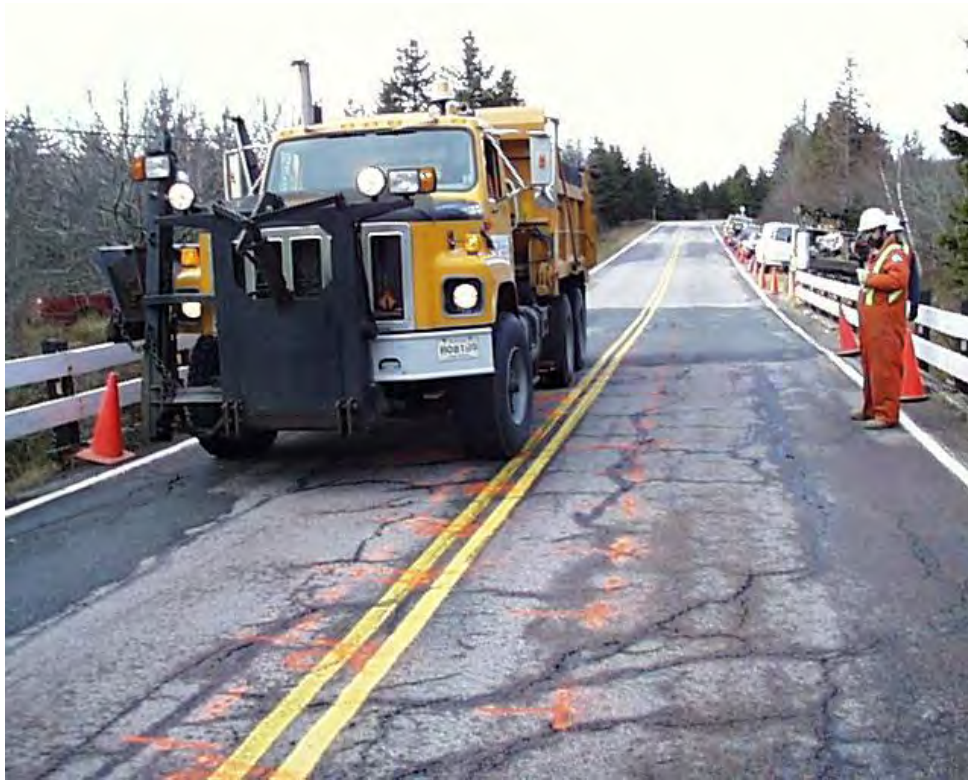
Figure 43. Gravel truck utilized to create known weight (36 ton per axle) positioned at specified locations. Also note excessive cracking in roads over the bridge deck from overloading prior to retrofitting.

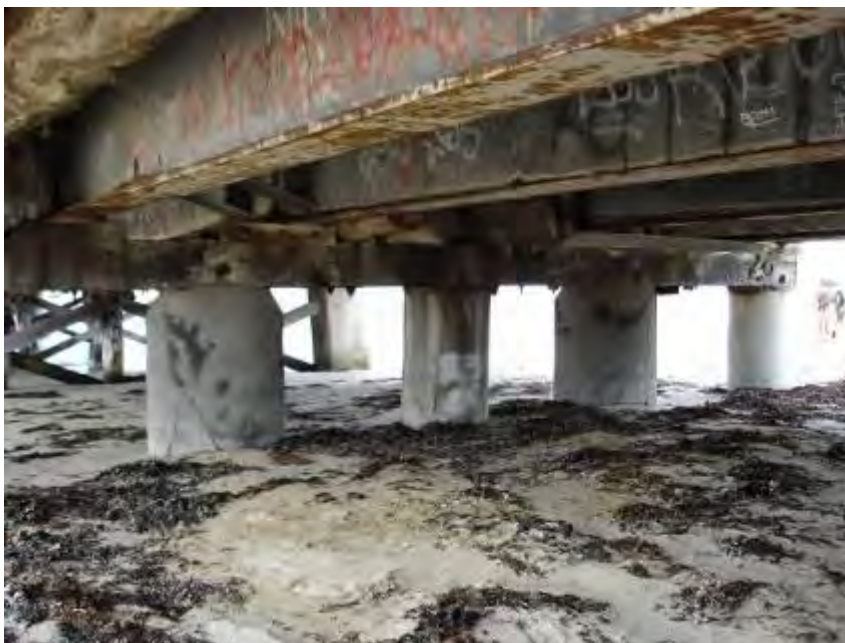
The Barwon Head bridge has gradually deteriorated over time. In response to this deterioration various rehabilitation techniques and strengthening strategies have been utilized. See Figure 8 which contains a photograph of steel I-beams that have been installed along side of the log longitudinal log girders. These I-beams have also deteriorated in certain places.

Figure 8 Photograph of Steel I-Beams Utilized to Strengthen the Barwon Heads Bridge.

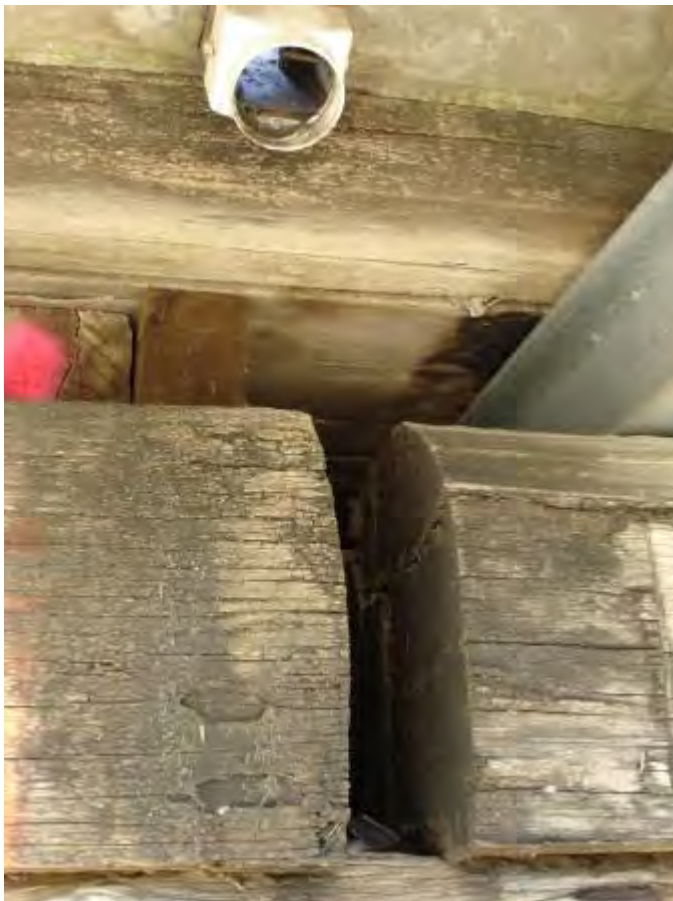
The deterioration is found in a broad cross section of the structural elements. The causes of this deterioration have been basically due to environmental factors. In some cases the deterioration could have been prevented and in other cases it would have at been reduced by the utilization of better construction and design techniques. See Figure 9 which contains a photograph of a downspout for a drain that is dumping on a structural member and subsequent accelerated decay and degradation. Note in Figure 8 the steel I-beams have been placed at a very critical shear location in the pile cap transverse girder support beam; a distance 2.5 to 3 “d” from the reaction where “d” is the depth of the beam. The applied shear stress reaches a maximum at the neutral axis at this point in the beam. The placement of the sister I-beam girders at this location has increased the loss of strength in the pile caps due to the decay and degradation of the bridge.

Figure 9. Photograph of Improperly Placed Downspout Causing Accelerated Decay in Structural Members below.

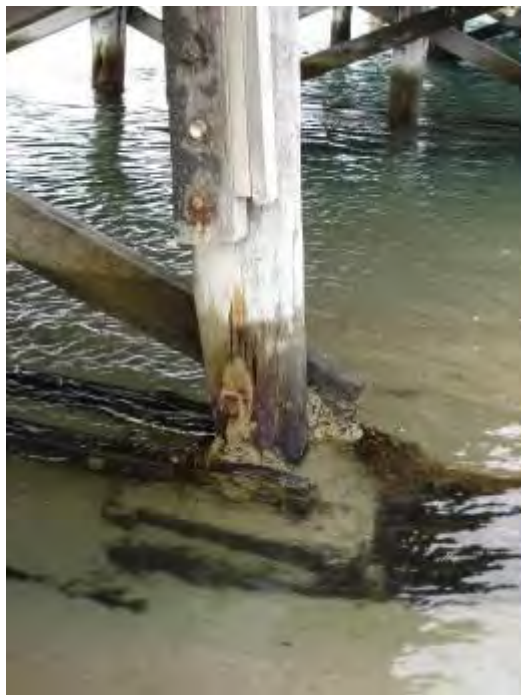
The piers have been investigated with the above techniques along with pulse echo analysis techniques (PET) in the case of the Smiths Bridge. This investigation is limited to the areas below and above the pier concrete jackets where they are present. See Figure 12 for photograph on a typical timber pile with a concrete jacket wrap and the subsequent condition many such piers are found in at old bridges such as the Barwon Heads Bridge.

**Figure 12. Photograph of typical timber pile pier with a concrete jacket wrap. Splash zone degradation from borers, decay, weathering and water has occurred in the pier above the jacket (and likely inside the jacket) to a point where the removal of the jacket, fiber wrap and epoxy/chopped-fiber injection under the fiber wrap is required. Also extensive fumigant preservation will be required.**

To analyze the wood pier under the concrete jacket x-ray technology is utilized. In most cases however, removal of the concrete jacket is necessary and the preferred solution. Subsequently the restoration of the pier in place utilizing a light weight high strength pre-cured or cured on site high-

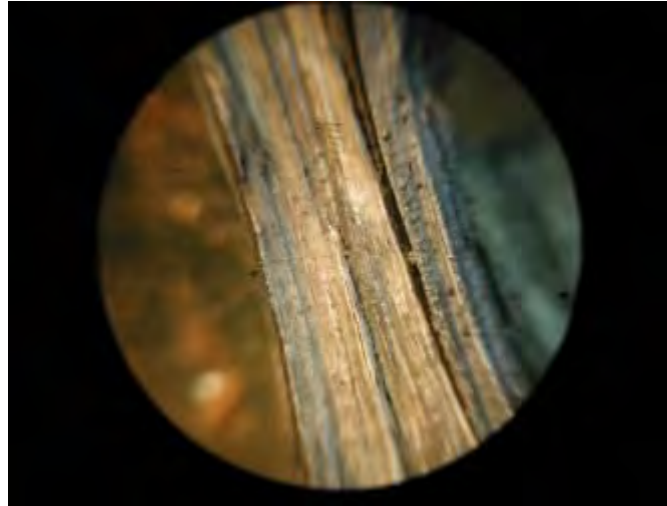
**Figure G-1. Surface high magnification (HM) shot of surface showing coating.**

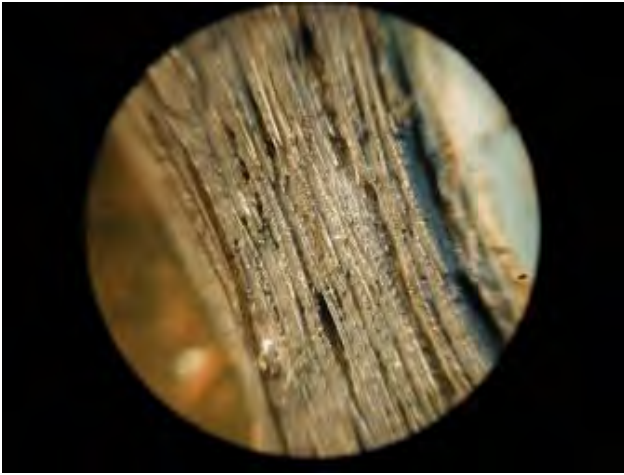
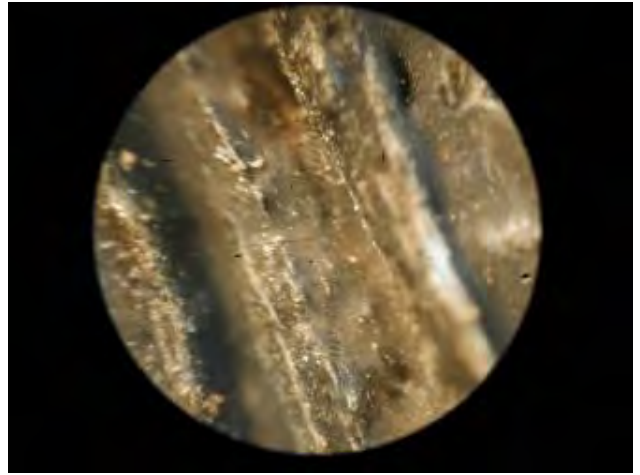
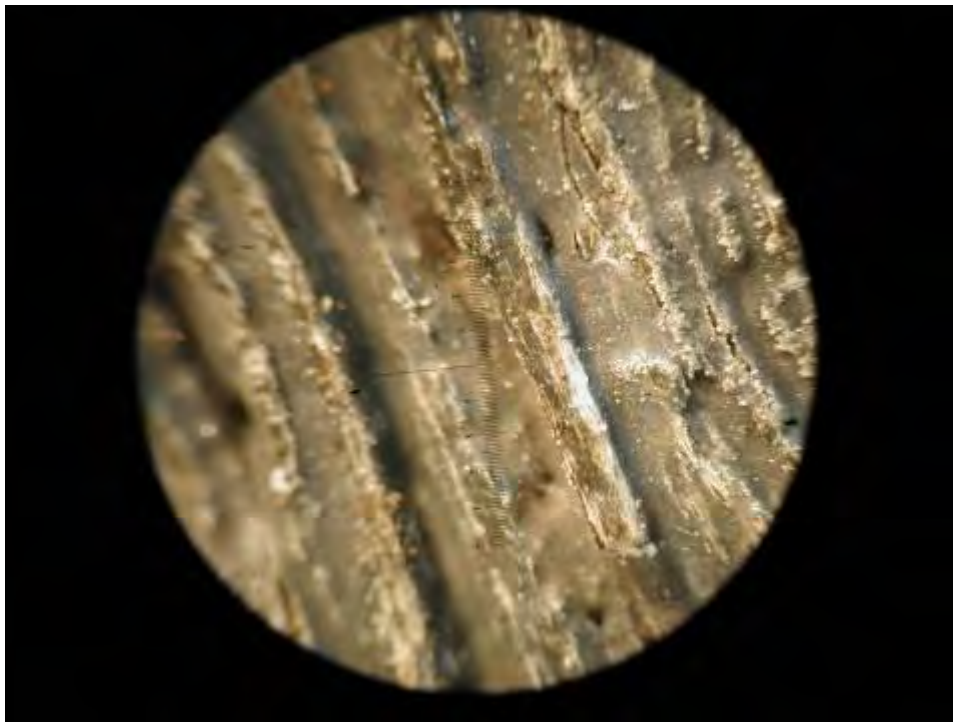
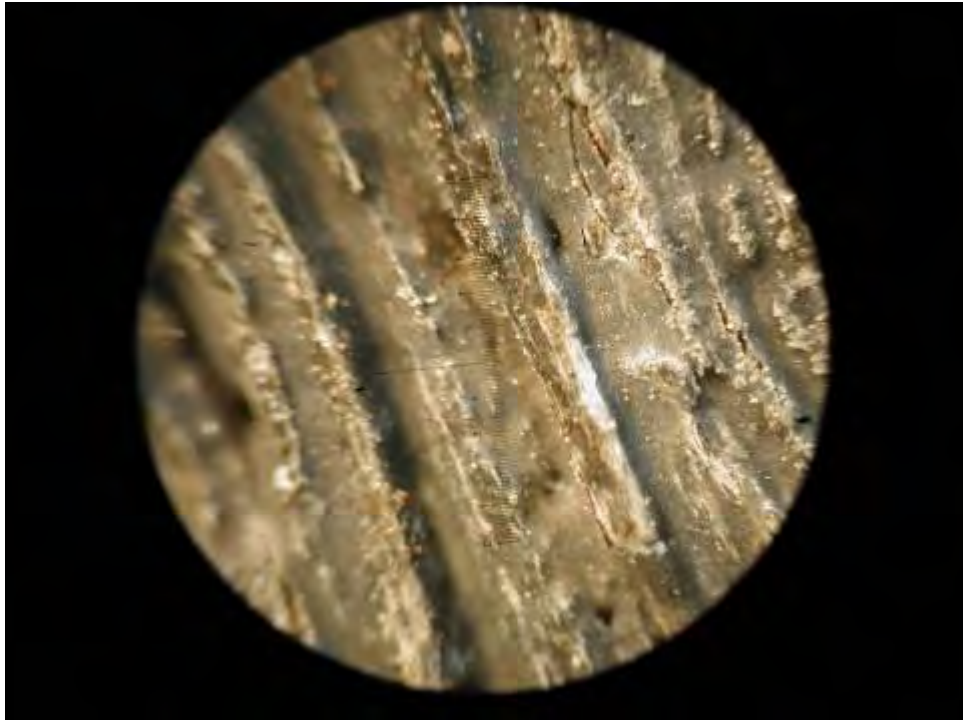
**Figure G-2. Surface high magnification (HM) shot of surface showing coating. In these shots note the cracking of the surface that occurs on a brittle coating when the wood shrinks and expands with moisture content change. This allows the moisture in and subsequently does not allow the surface to breath allowing decay.**

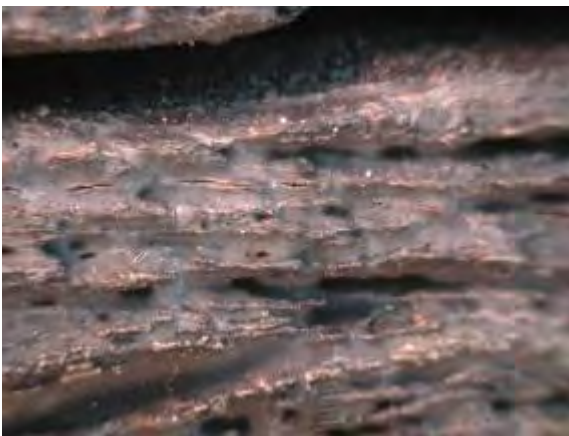
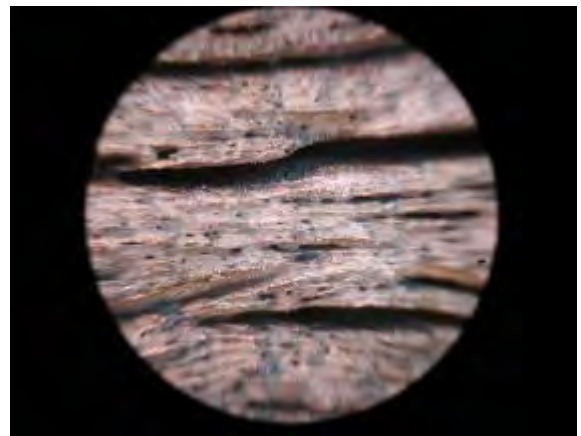
**Figure G-3. Surface high magnification (HM) photograph of surface, showing coating. In these photographs note the cracking of the coating on the ridges of deeply fissured surface that occurs on a brittle coating when the wood shrinks and expands with moisture content change.**

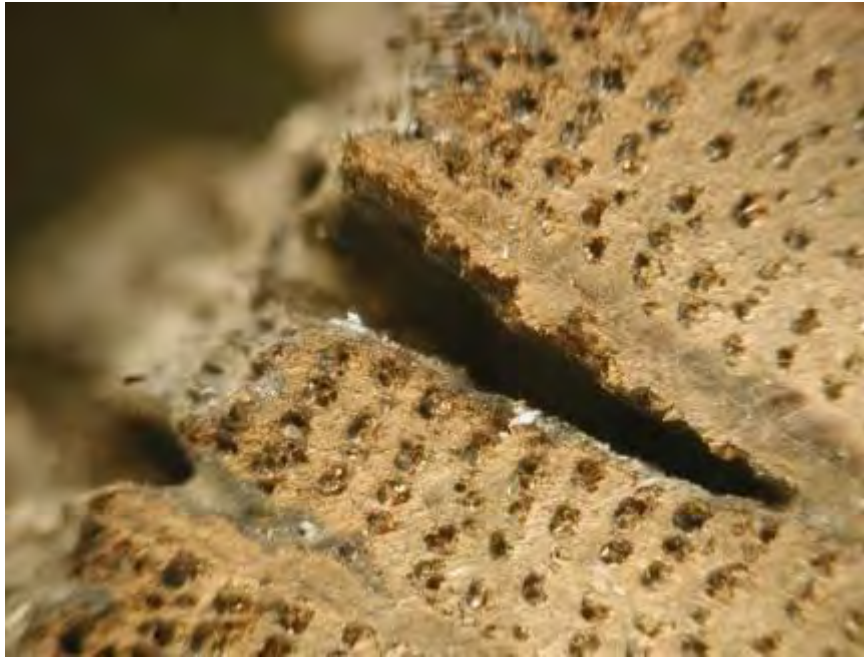
**Figure G-4. Transverse HM photograph showing surface coating extending down into the fissures. In these photographs note how the expansion and contraction of the wood at the fissured points will cause the cracking of the coating. These are the logical entrance points for decay and other degradation causing organisms e.g. moss, insects etc.**

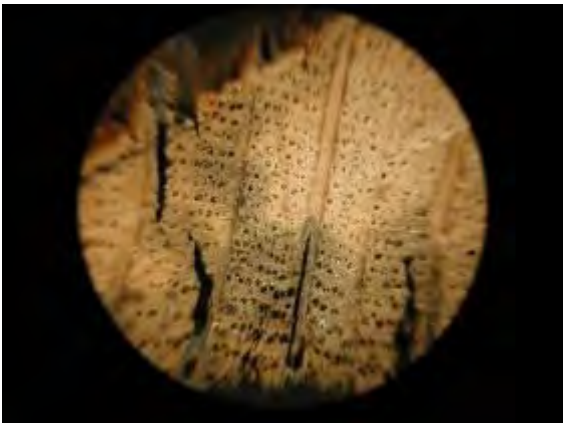
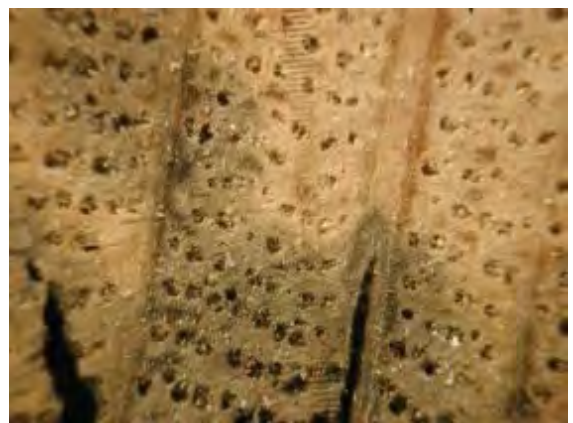
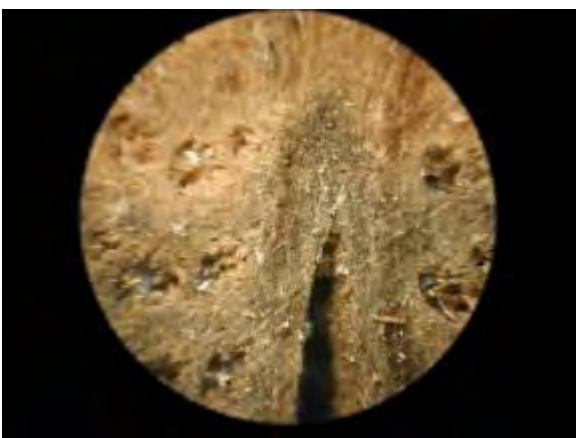
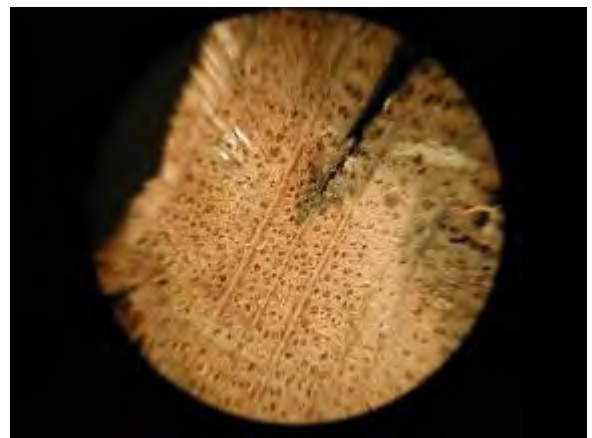
**Figure G-5. Transverse HM photographs showing surface coating carrier (petroleum based likely) movement into the wood laterally through late wood pores without tyloses and depth wise through rays without tyloses.**

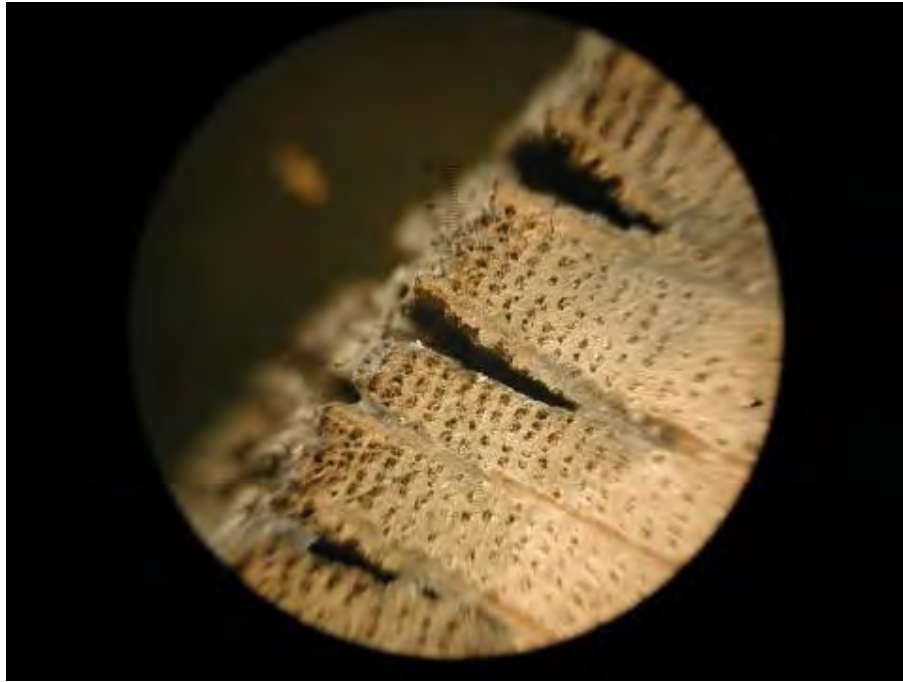
**Figure G-6. Transverse HM photographs, showing surface coating and surface cracks/fissures focused in the rays which are often the point where surface cleavage takes place as they are planes of weakness across a tangential face.**
