**Miles Canyon Bridge  
Level II Inspection Report  
Whitehorse, Yukon**

*Prepared by*  
**Dan Tingley Ph.D., P. Eng. (Yukon)**

**Final Report  
23 November 2015**

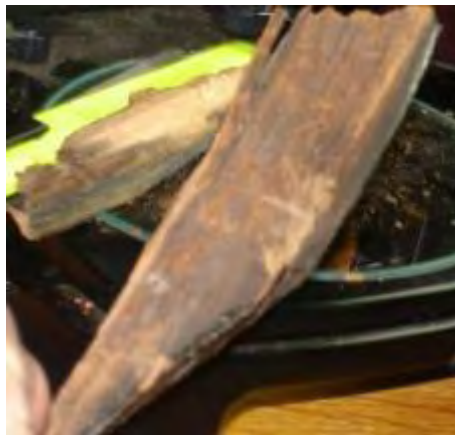
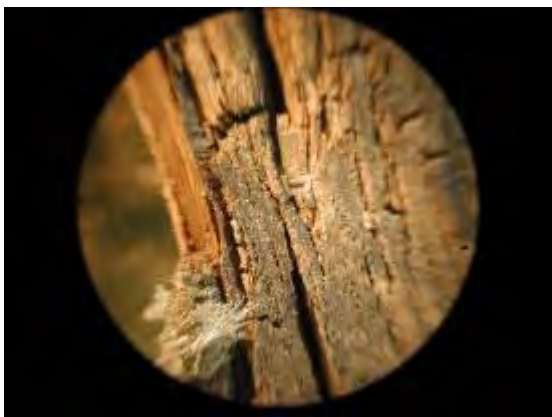
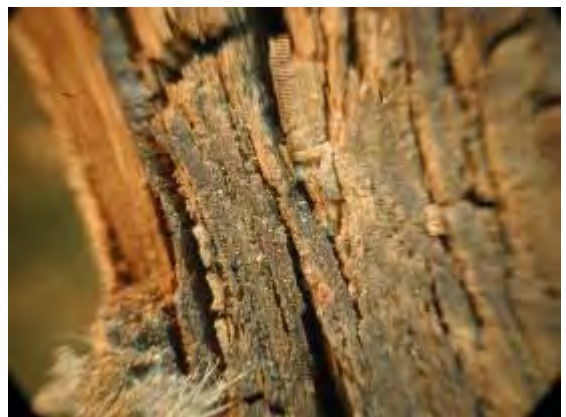
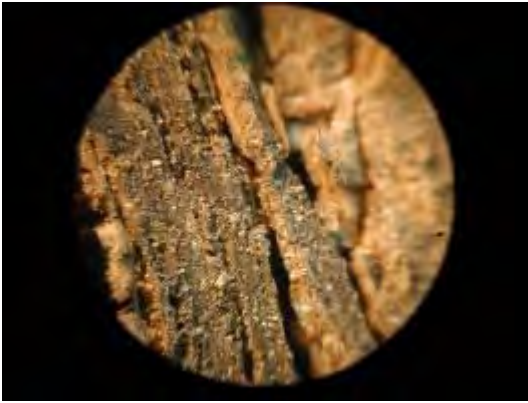
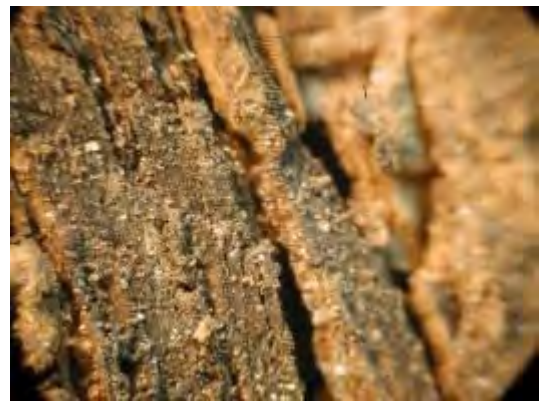
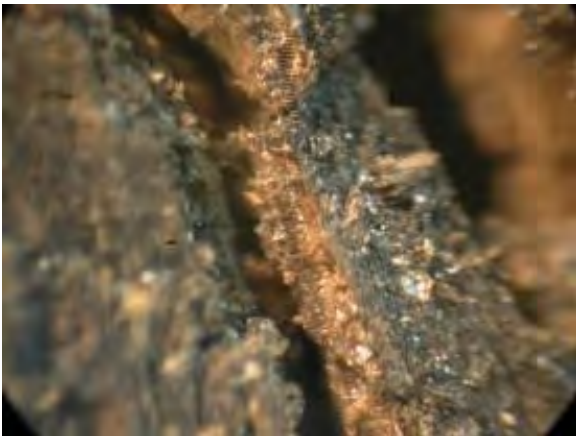
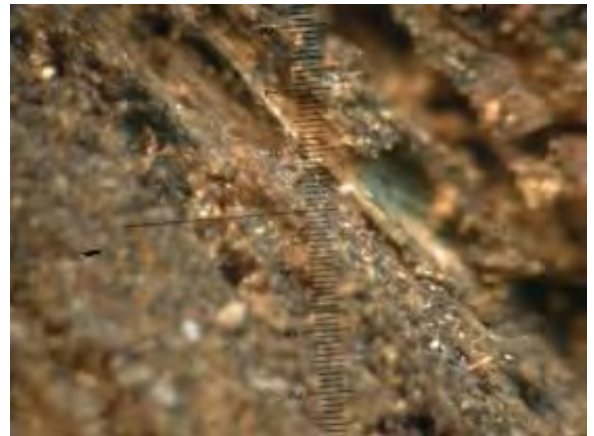
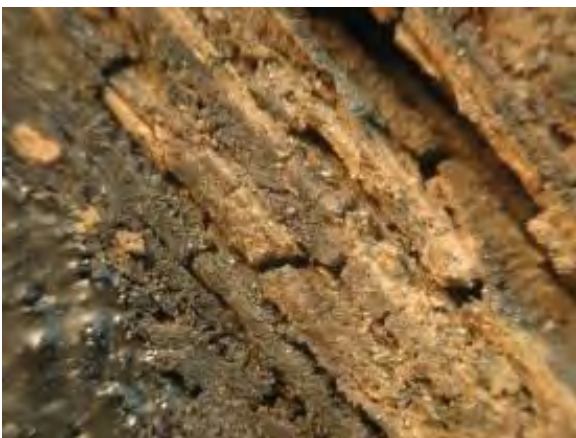
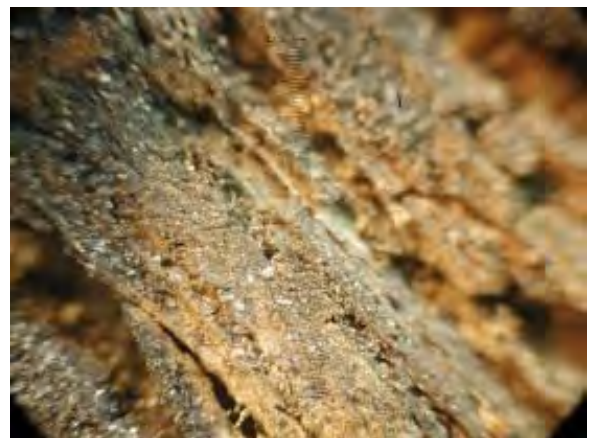
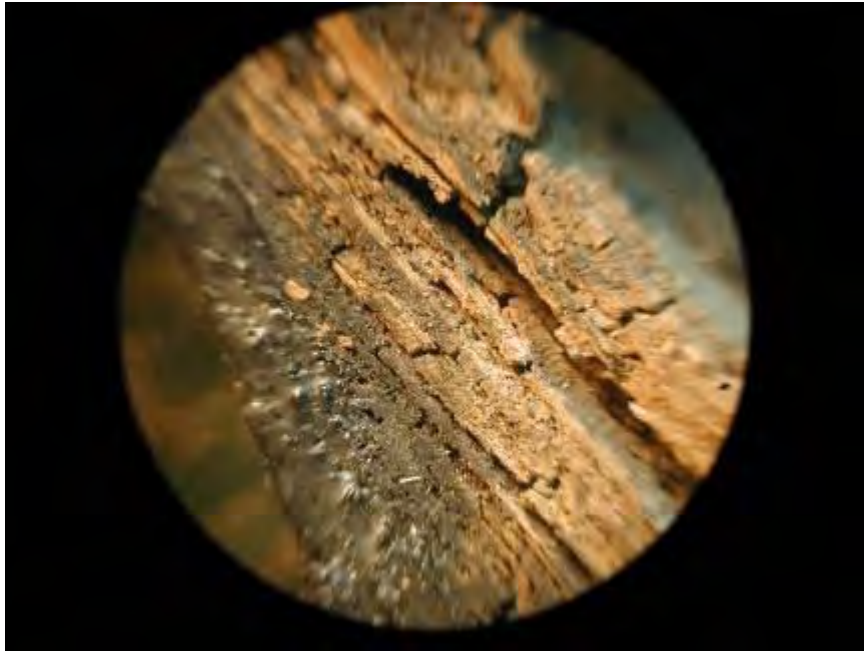
**Figure G-7. Photographs showing the interior face of the recovered piece of white oak façade (a.). No coatings on this face. An abundance of decay is evident from periods of high MC. Tangential face shows low magnification (LM) left side and HM on the right side. Note the fruiting bodies in photograph (b.). Note the dramatically reduced SG of the wood in photographs in (c.). The fungal activity has moved further in from the surface and a severely reduced SG decayed zone is left behind. Photographs in (d.) show fungal spores (white). The wood in photograph (d.) is completely decayed and no integrity in the structure is intact. When this happens to zones around fasteners the wood falls out of position due to its own dead weight. Photograph (e.) shows the coating on the surface and non-coated inner surface where the piece narrows decay has moved from behind to completely decay the congruent faces.**

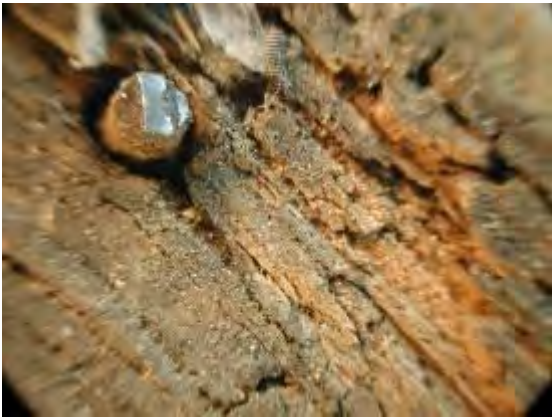
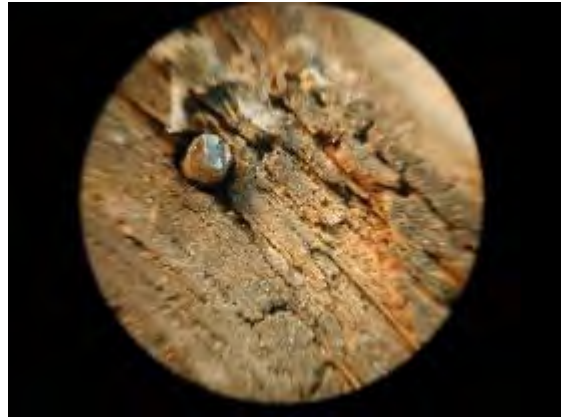
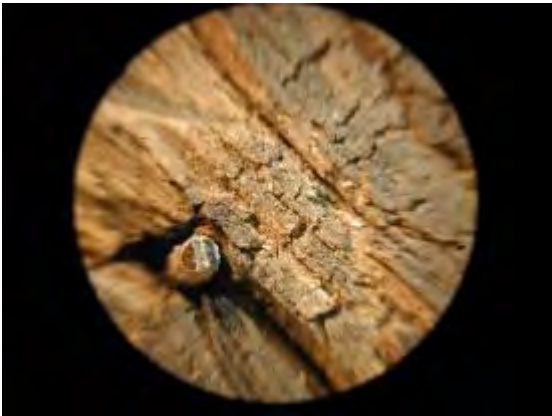
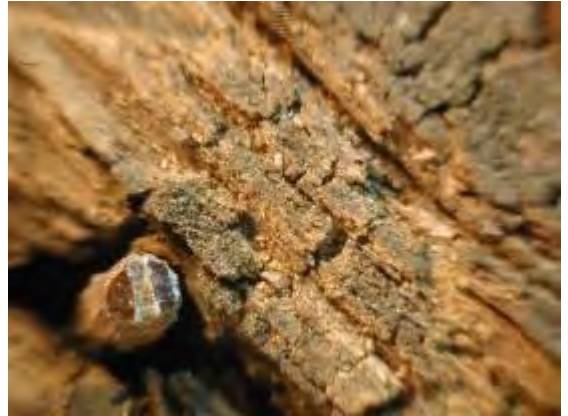
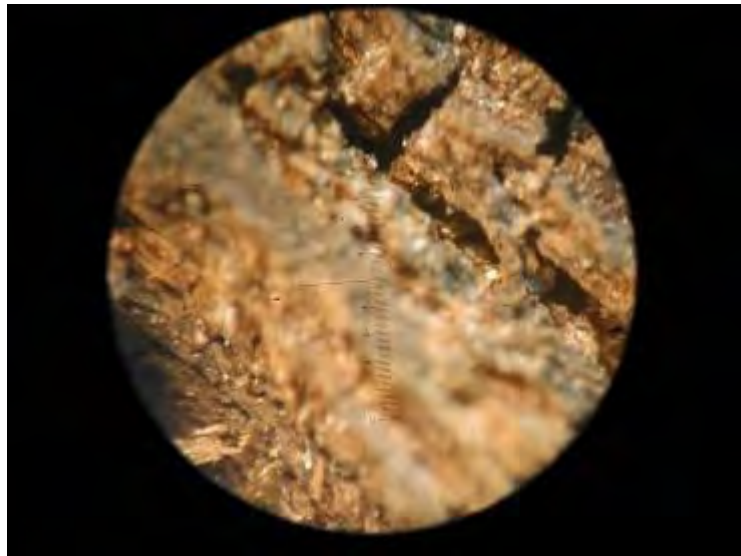
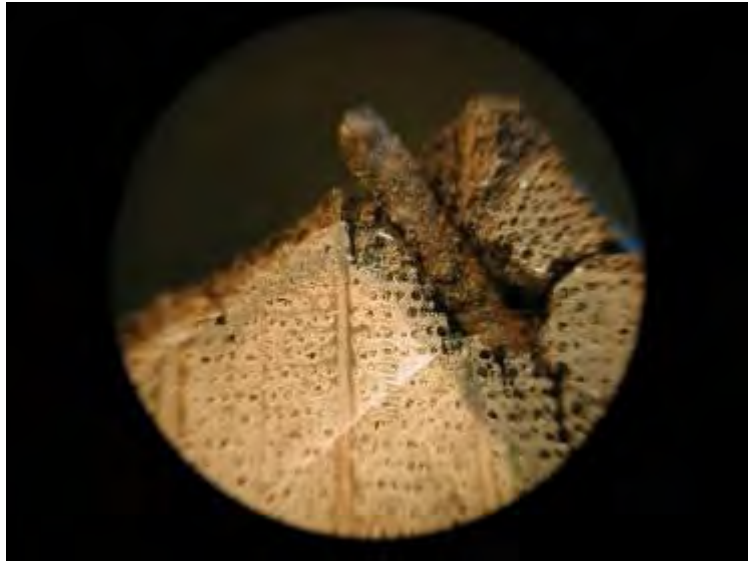
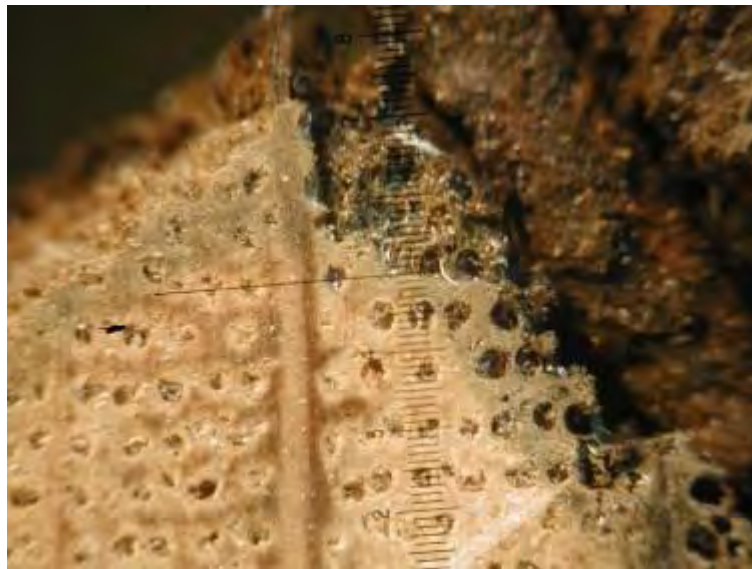
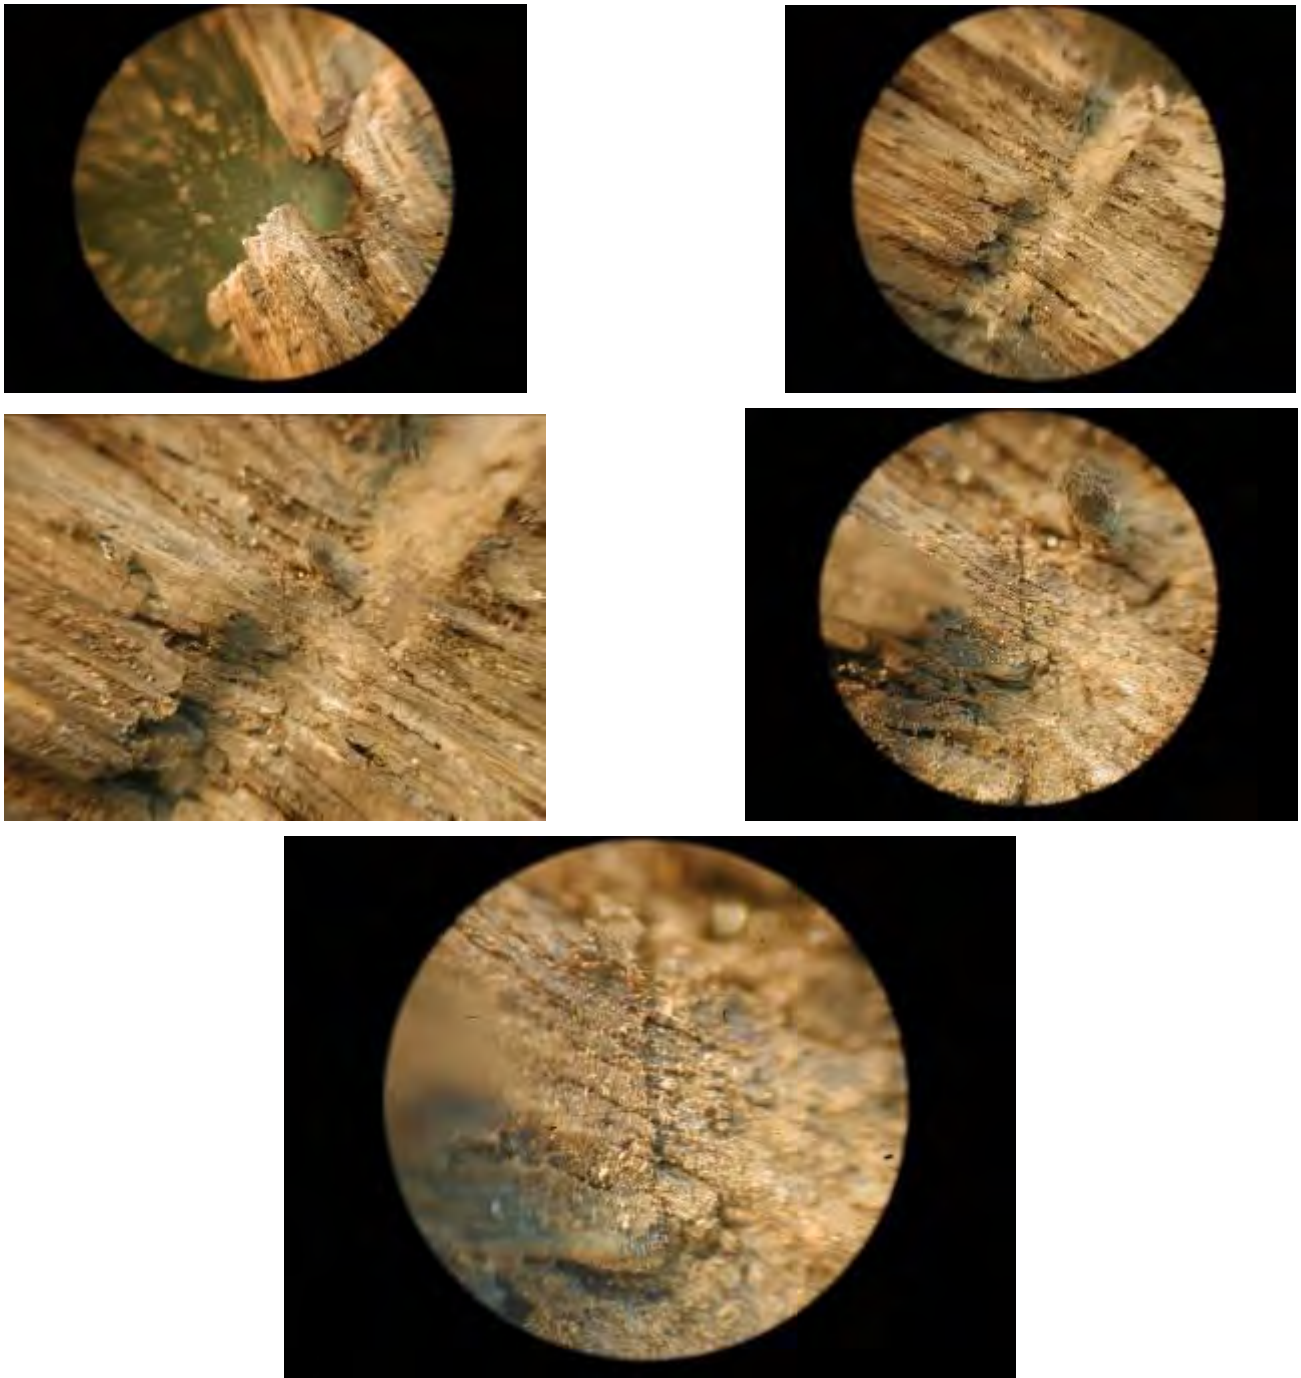
**Figure G-8. Interior face of the recovered piece of white oak at a fastener location (nail) (a.). This nail depends on cleavage resistance in the wood to maintain holding force. This cleavage resistance is one of the first strength characteristics that is reduced in a decaying piece of wood (a.). In addition old nails had an iron oxide impact on the wood in cleavage around nails. The iron oxide reduces woods resilience and embrittles the cell wall and lignin that holds the cells together (b.). The hemicellulose surface of the cell wall loses its flexibility and the wood deformation zone around the nail hardens and the nail loses its fastening capability. When this happens to zones around fasteners the wood falls out of position due to its own dead weight.**

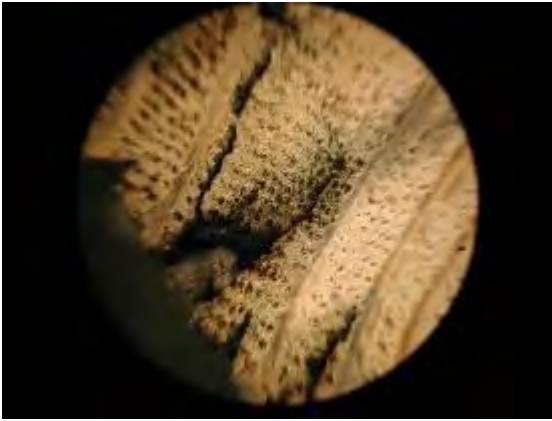
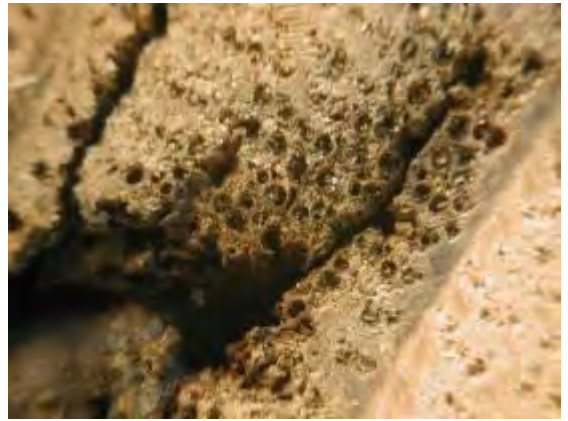
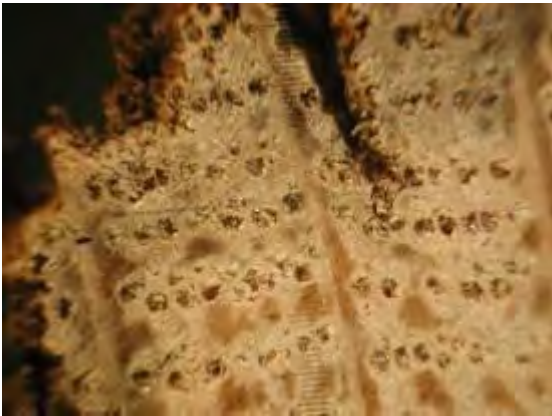
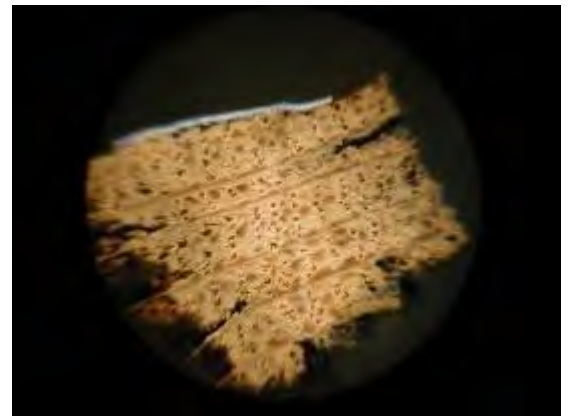
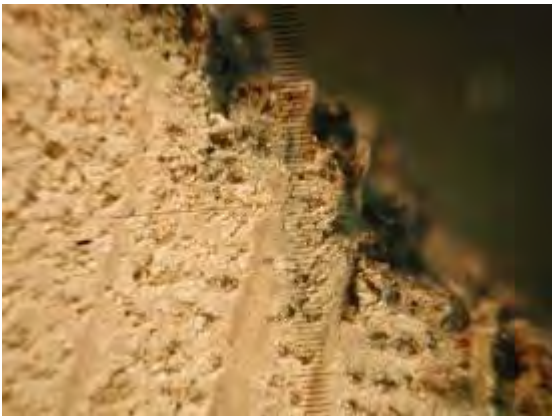
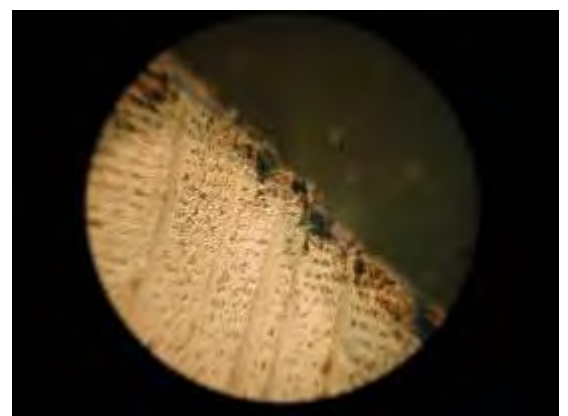
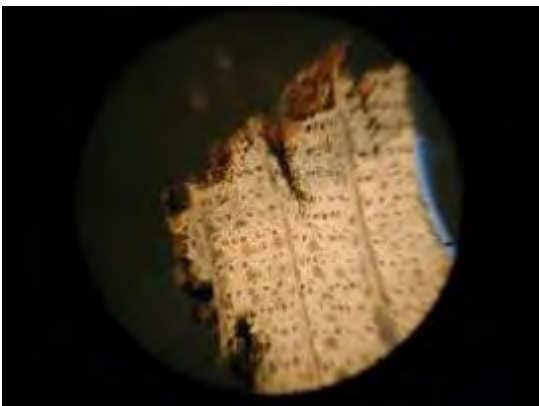
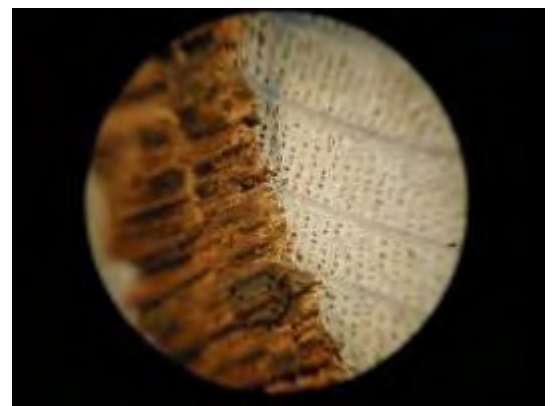
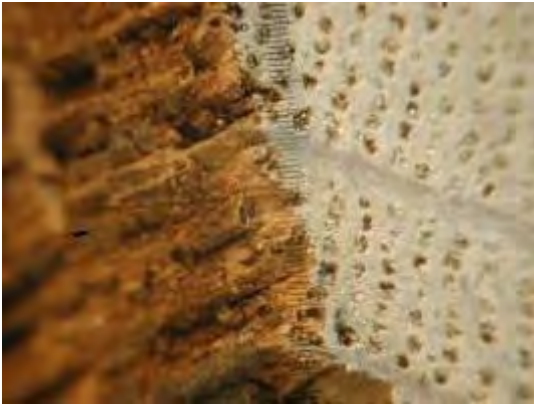
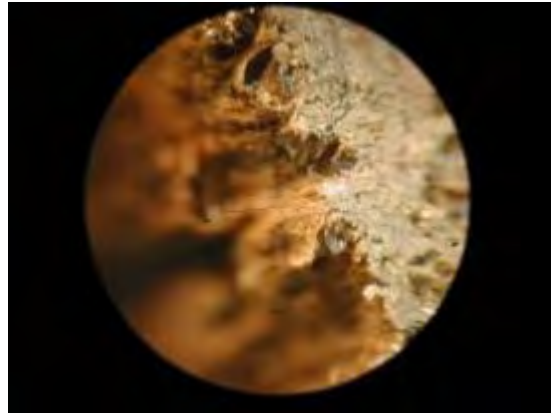
**Figure G-9. Collection of HM and LM shots of interest.**

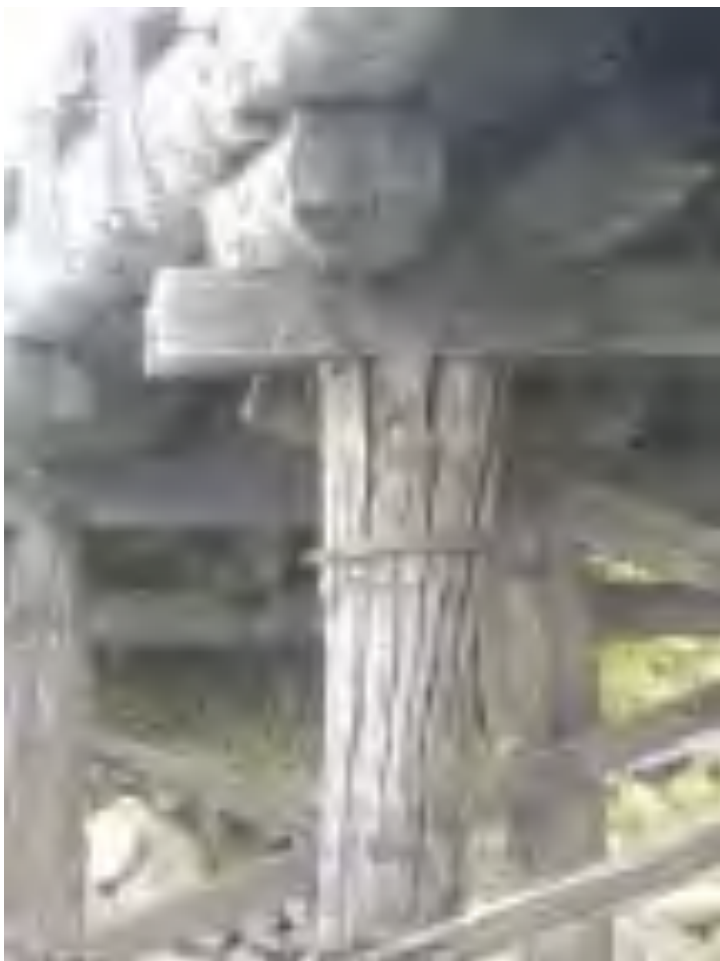
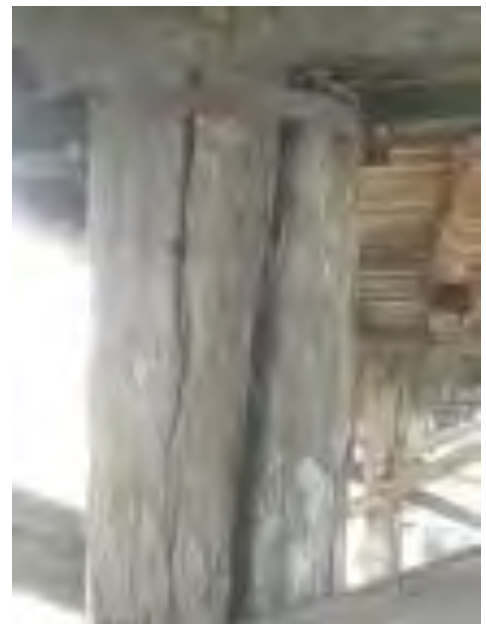
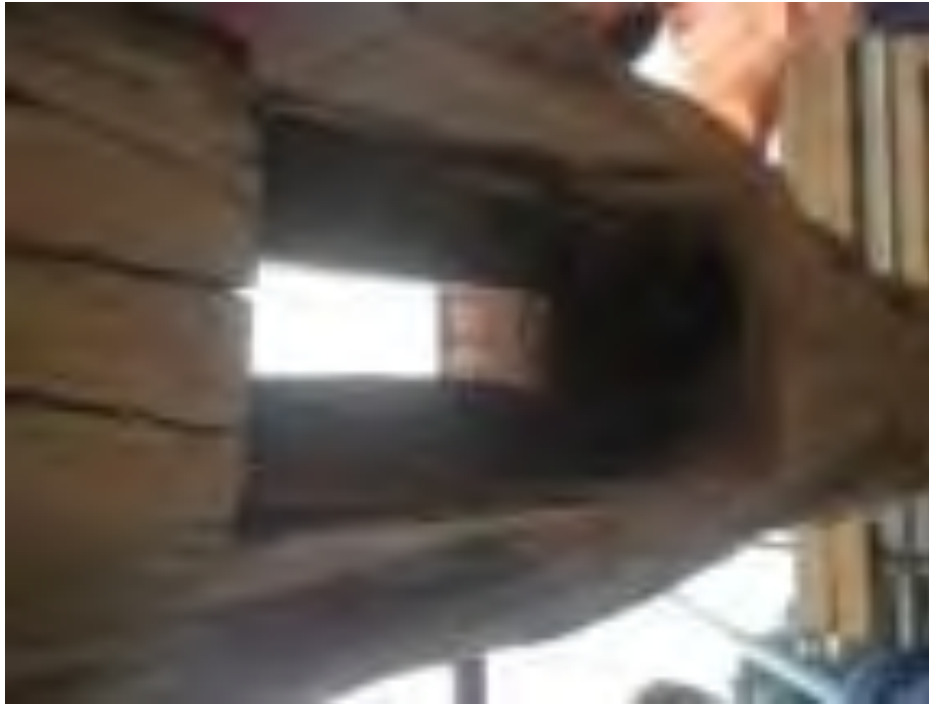
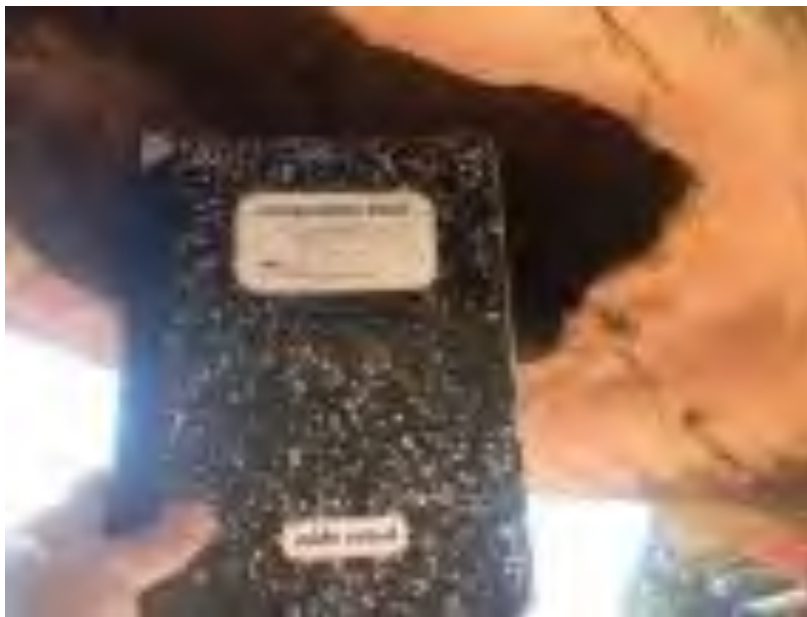
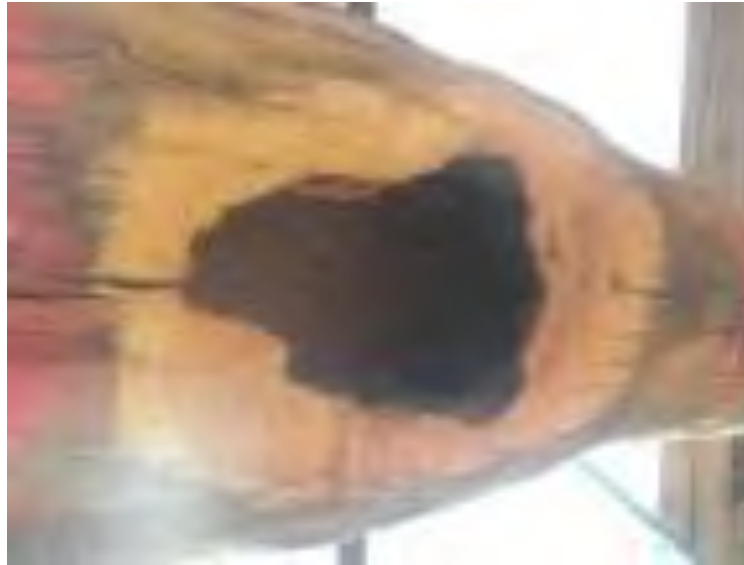
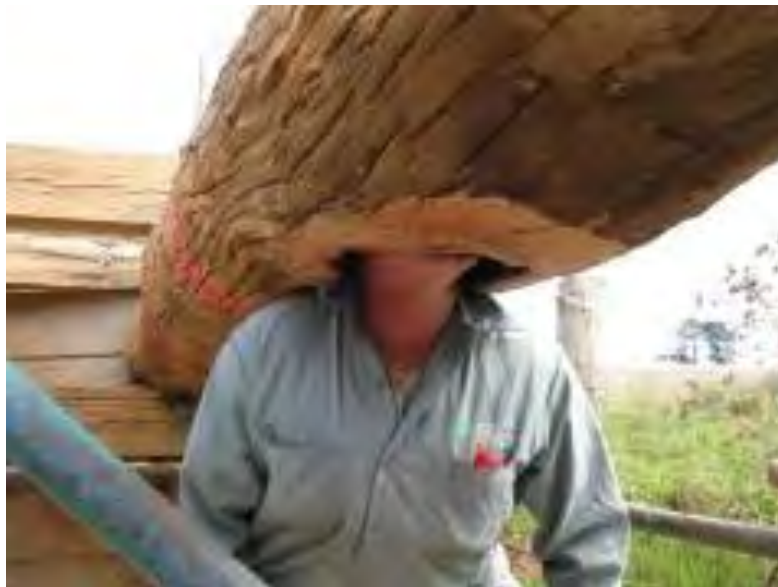
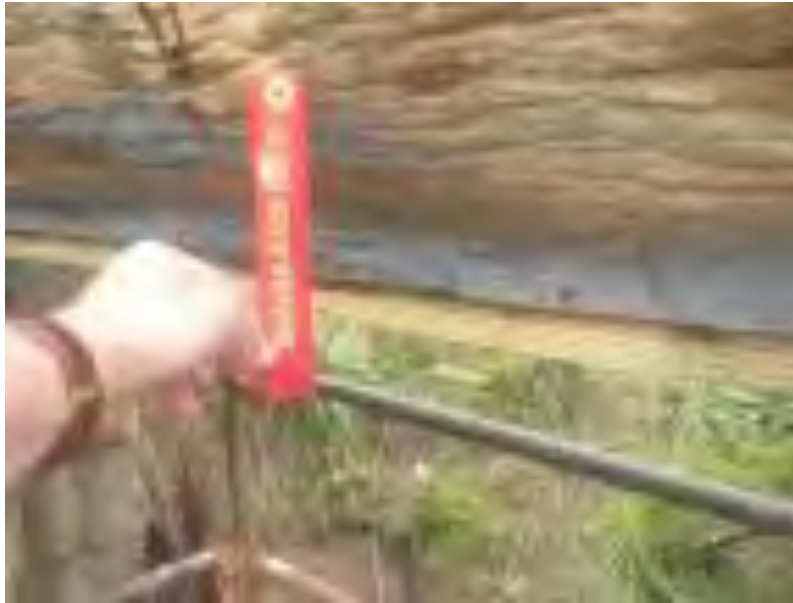
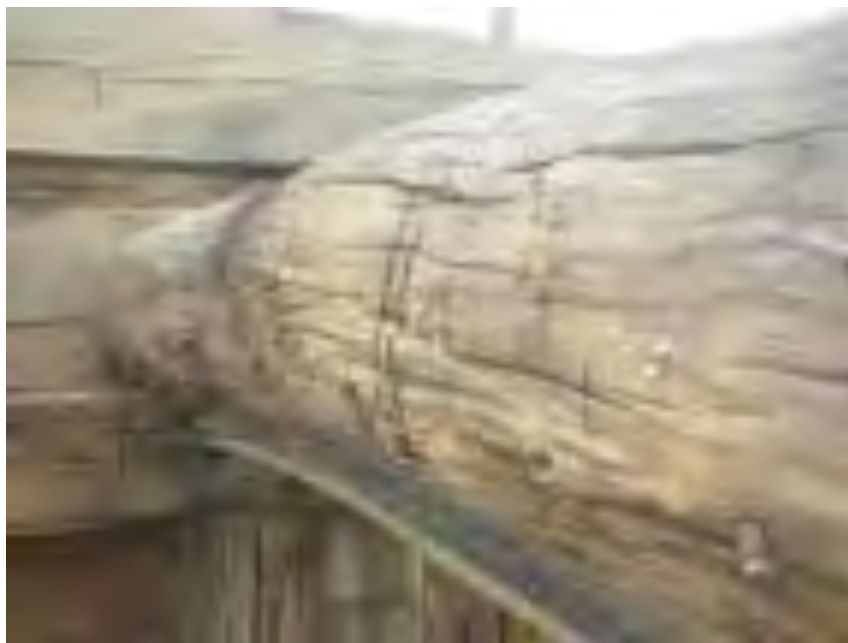
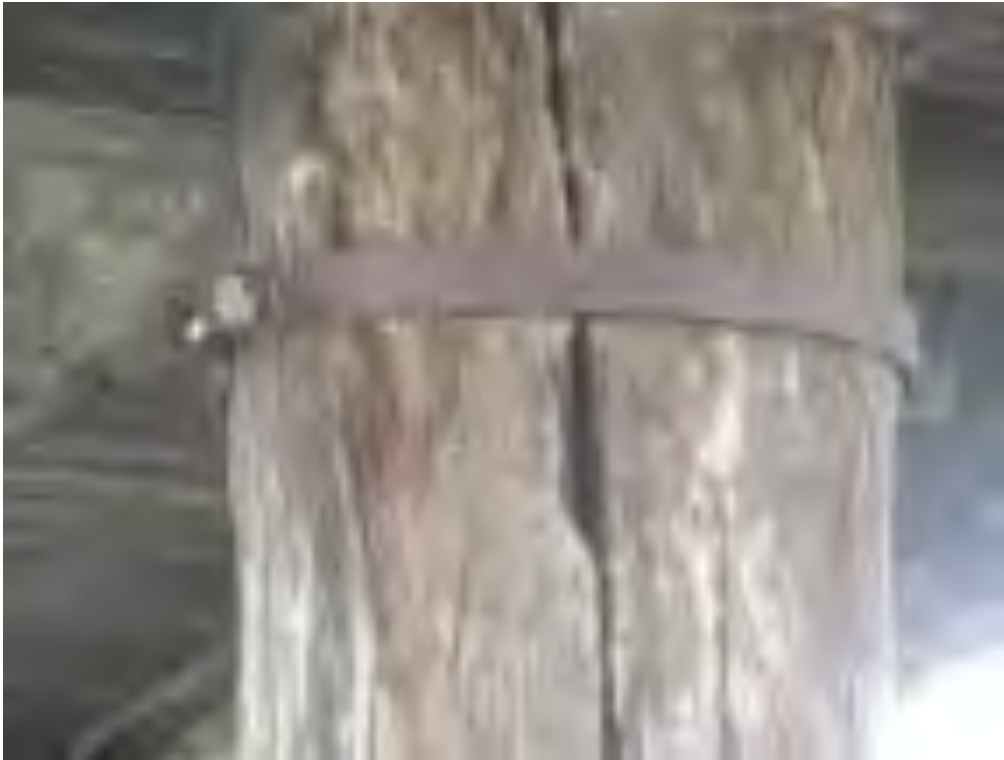
I have attached some photos of other bridges in your area where Level II and III reports had been prepared by local engineers using traditional techniques and methods employed by Vic Roads and other agencies. As you can see when the Stress Wave Timer and other similar non destructive testing equipment was used they revealed that a different situation than was determined by the local engineer. These conditions were revealed for certain when more in-depth mechanical methods were employed to expose the core of the structural elements.

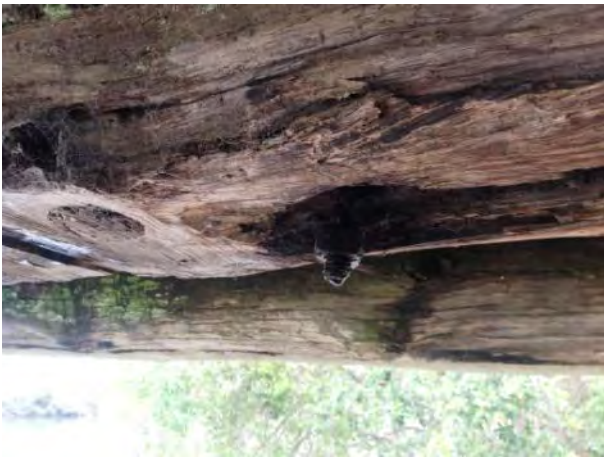
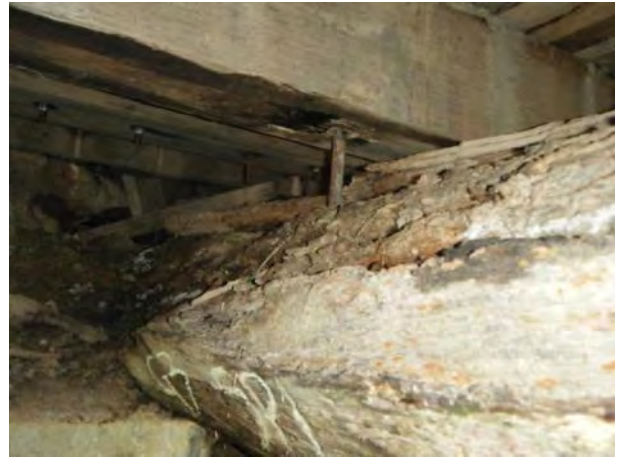
1. Change vertical through bolting to horizontal bolting or verticals that do not pass through the upper surface. Vertical through bolts allow moisture to penetrate the elements below, where it becomes trapped, causing decay.

**Decay caused by vertical through bolts and spiking**

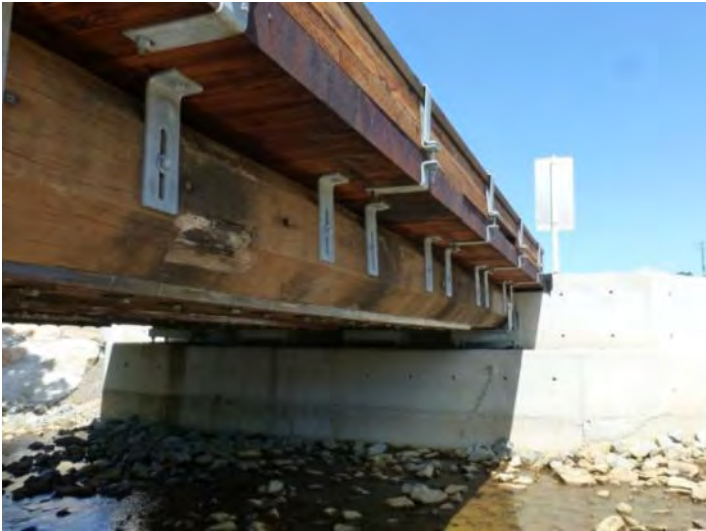
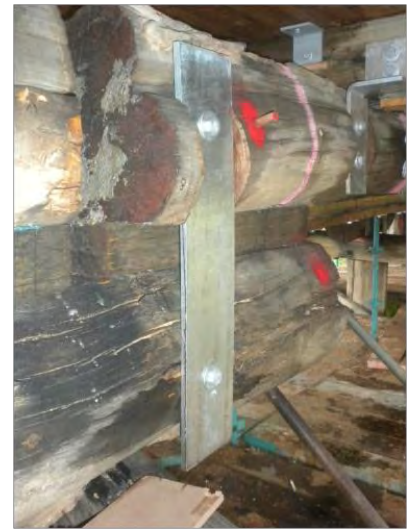
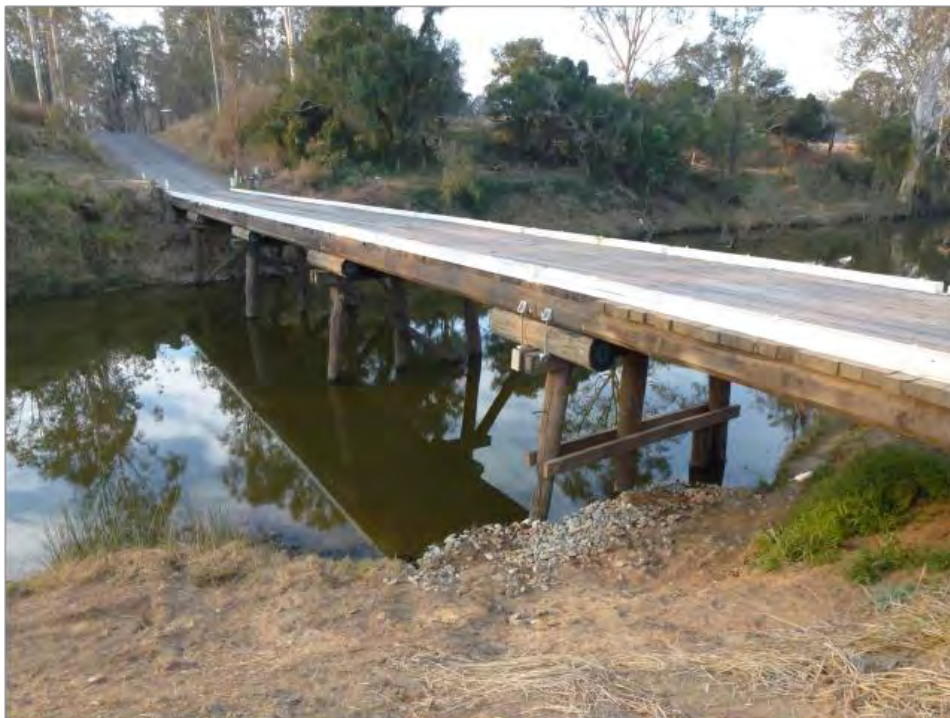
**The alternative horizontal fastening systems shown above do not allow moisture to seep down from above and become trapped in the lower members.**

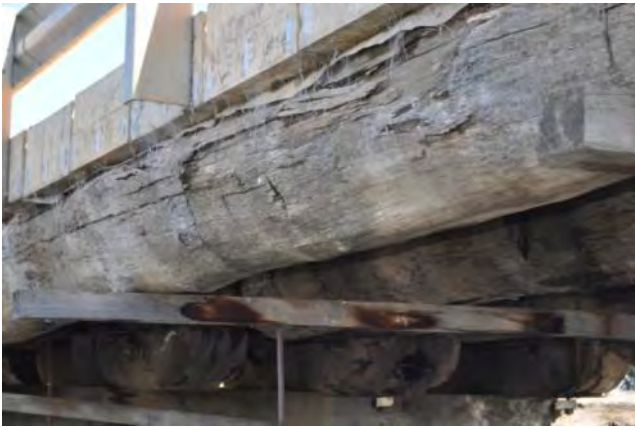
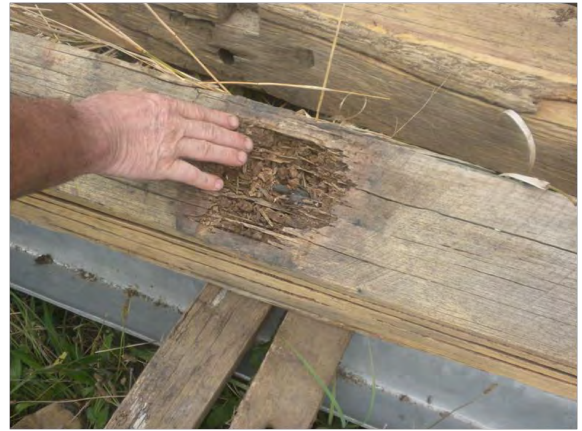
2. Stop the use of malthoid barrier between the deck and girders. Moisture follows the fastener shank down to where it becomes trapped between the malthoid barrier and the element below, decaying the lower element.

**The use of bent metal or waterproof paper coverings has trapped moisture in these elements, causing decay.**

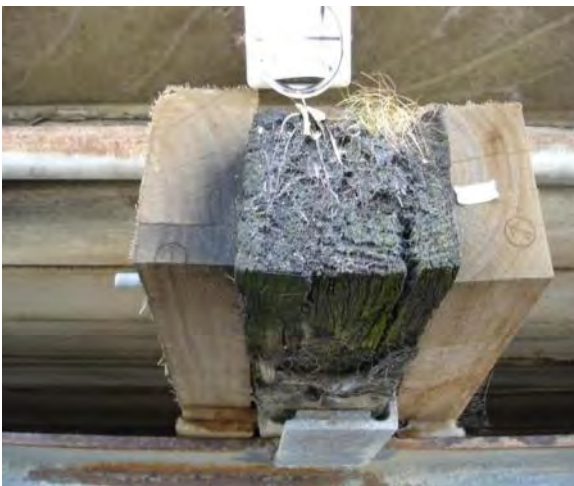
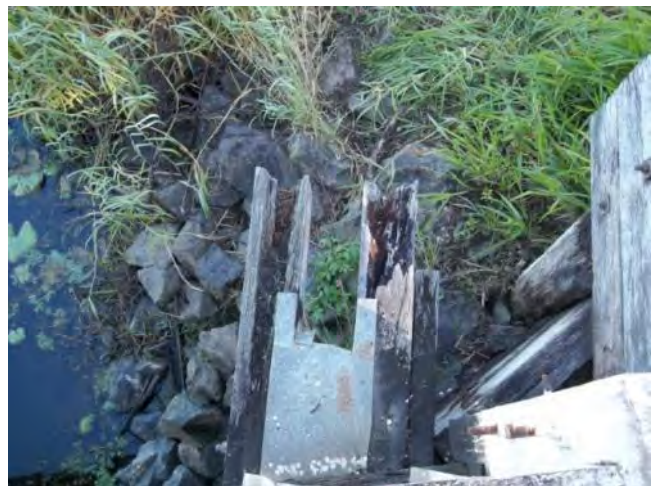
**Deck drainage must be directed out and completely away from the timber elements below to avoid deterioration such as shown above.**

3. Insure positive drainage that does not fall directly onto structural elements below.

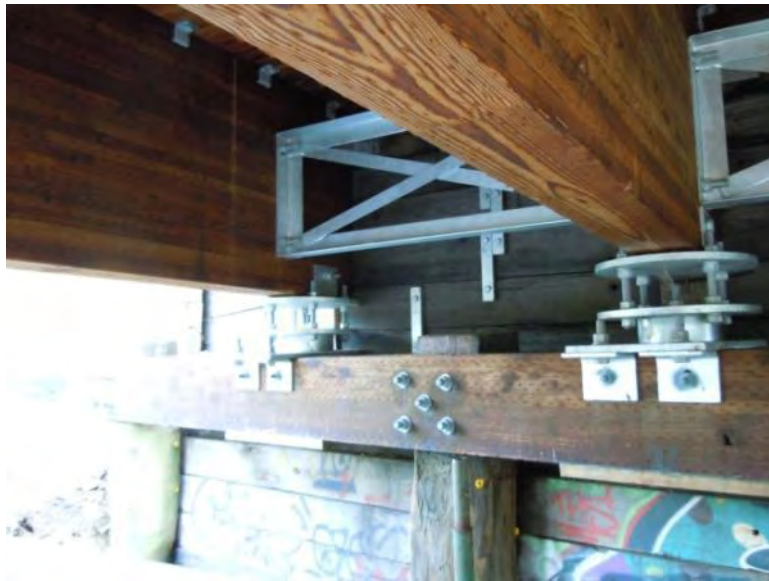
**Slotted holes have been provided in the steel parts above to allow for the expansion and contraction of the timber members. S-clips attaching the deck have been inserted into slots in the girders to allow for movement of the deck panels.**

4. Accommodate dimensional change in timber elements due to changes in moisture content. Provide oval holes in side plates and other similar measures to allow for expansion and contraction of the timber.

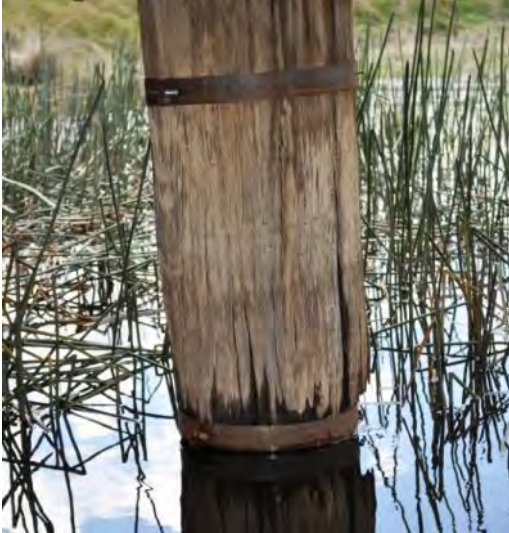
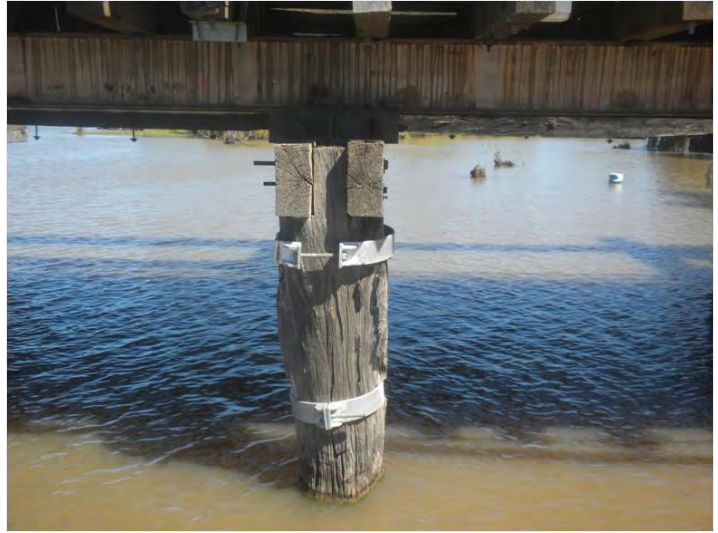
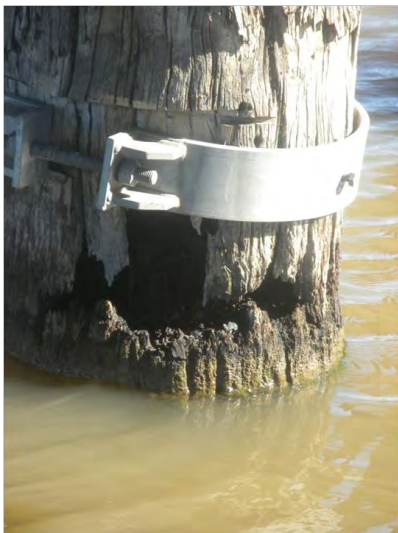
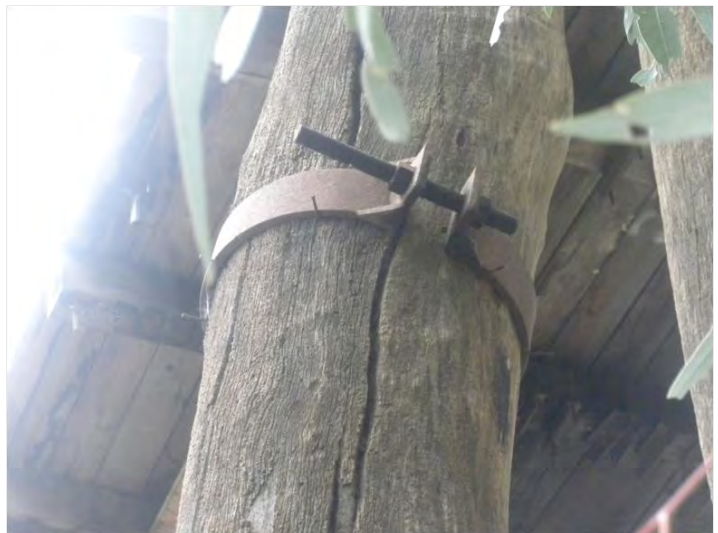
5. Stop the use of banding. Steel banding is no longer a recommended practice for stabilization of timber piles that are degraded by decay, splits, cracking, or have broomed/feathered tops. It does not prevent buckling inward; and the pile is driven tip down so the taper is down and the bands slip down the pile becoming ineffective.

**Steel bands on the piles above have not strengthened the pile or stopped deterioration.**

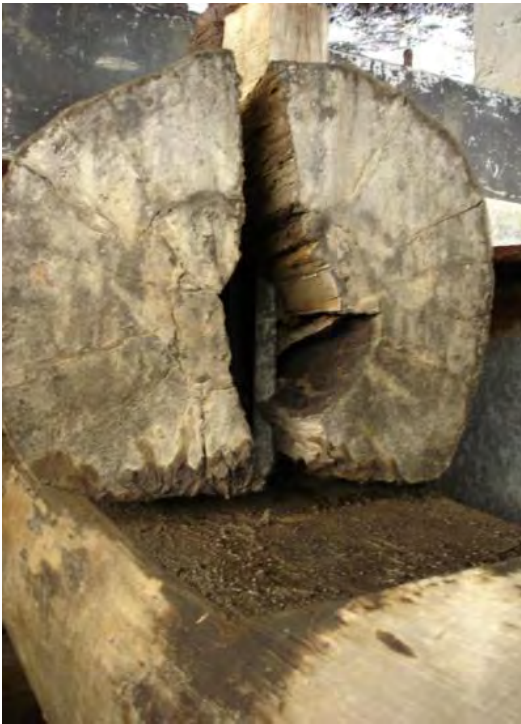
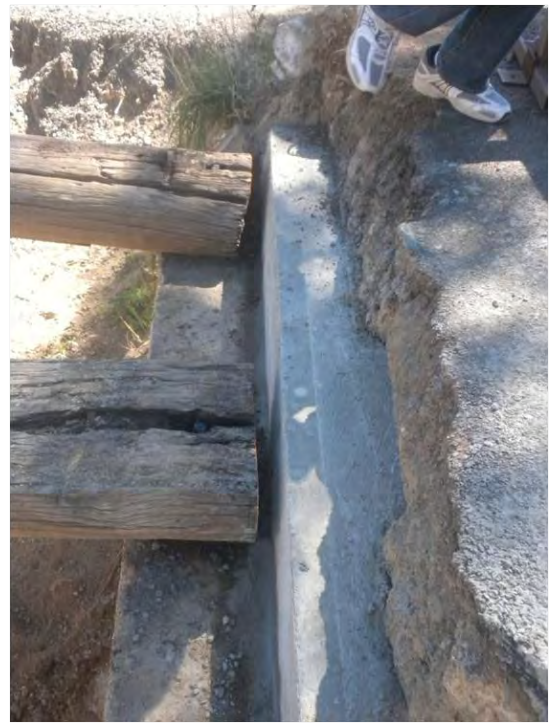
**These splits were caused by the near end drift pinning. Substitute horizontal connectors to locate elements without damaging them.**

6. Stop the use of near end drift pinning.

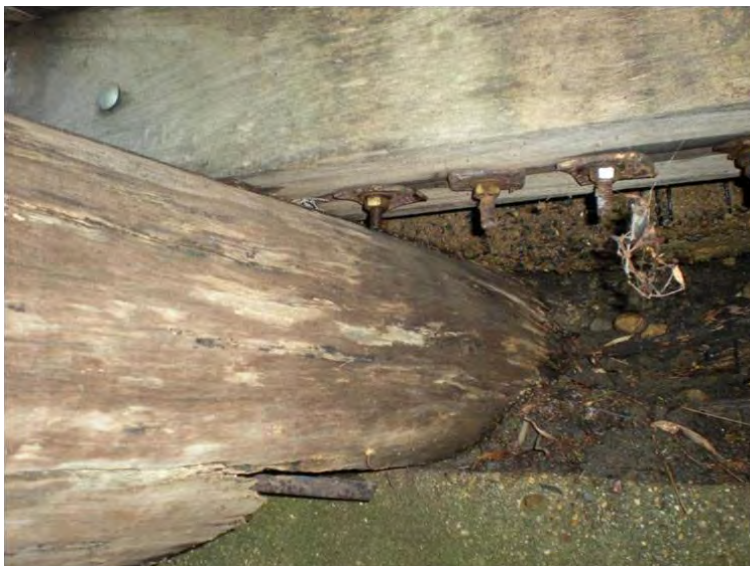
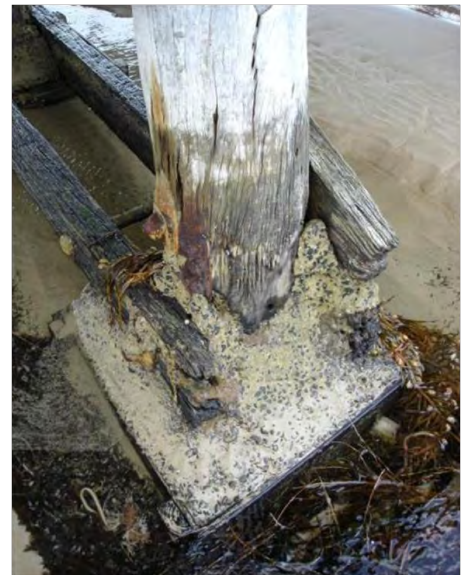
**The end of the girder on the left is buried in damp debris and cannot dry out. To prevent deterioration, the girder end should be open and free to breathe. The concrete encasing the pile and wales on the right is meant to strengthen the pile, but is instead holding moisture against the timber, accelerating the rate of decay.**

7. Provide proper clearance for timber elements to breathe and dry out.

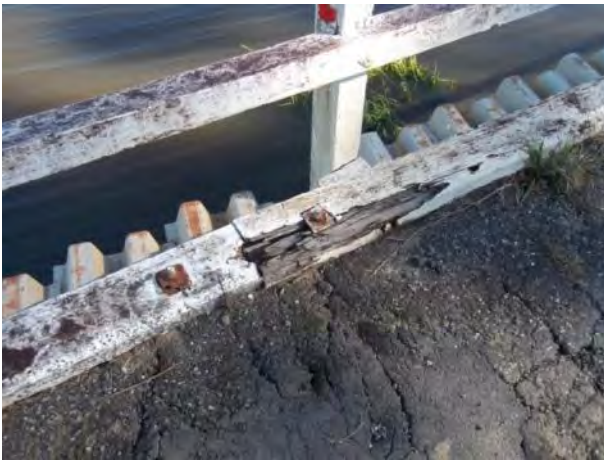
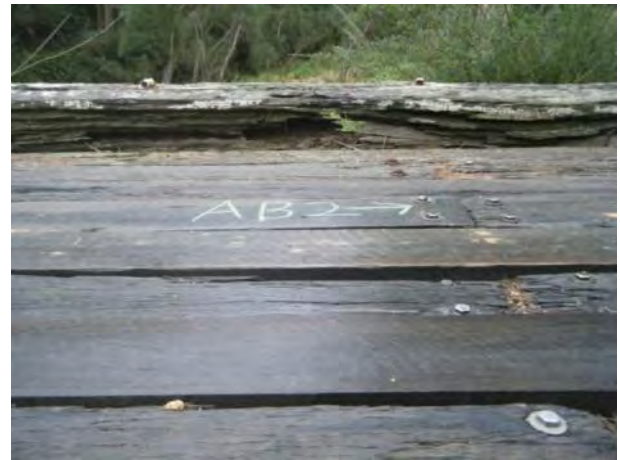
**Heavy solids paint has been applied to these kerbs and rail. Vertical through bolting and impact damage have then given moisture a way to infiltrate under the paint where it cannot evaporate, accelerating the rate of decay.**

8. Stop the use of heavy percentage solid coatings (over 29% solids). Moisture can penetrate the coatings at vertical holes or damaged surfaces and become trapped against the timber, promoting decay. Use stains (less than 29% solids) that allow the wood to breathe.

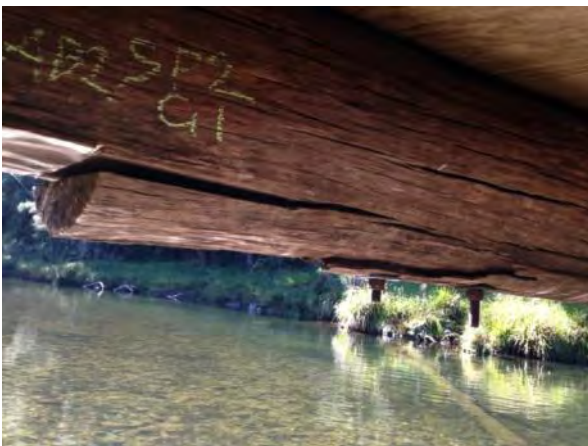
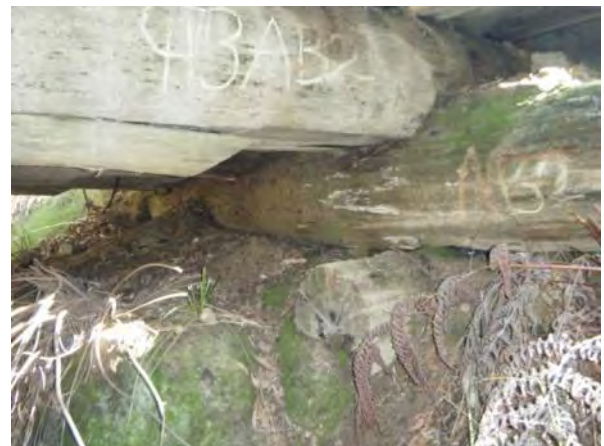
**Reentrant corner cracking at the snipe or notch in these girders could have been eliminated if a longer (6:1) slope was cut. These girders could be stitched or injected to stabilize the cracking after a longer slope cut is machined. Such cuts should be CN and sealed. The girders should be diffused to prevent decay.**

9. Stop the use of heavy notching which promotes reentrant corner cracking. Use a 6:1 slope cut instead.
