**Miles Canyon Bridge  
Level II Inspection Report  
Whitehorse, Yukon**

*Prepared by*  
**Dan Tingley Ph.D., P. Eng. (Yukon)**

**Final Report  
23 November 2015**

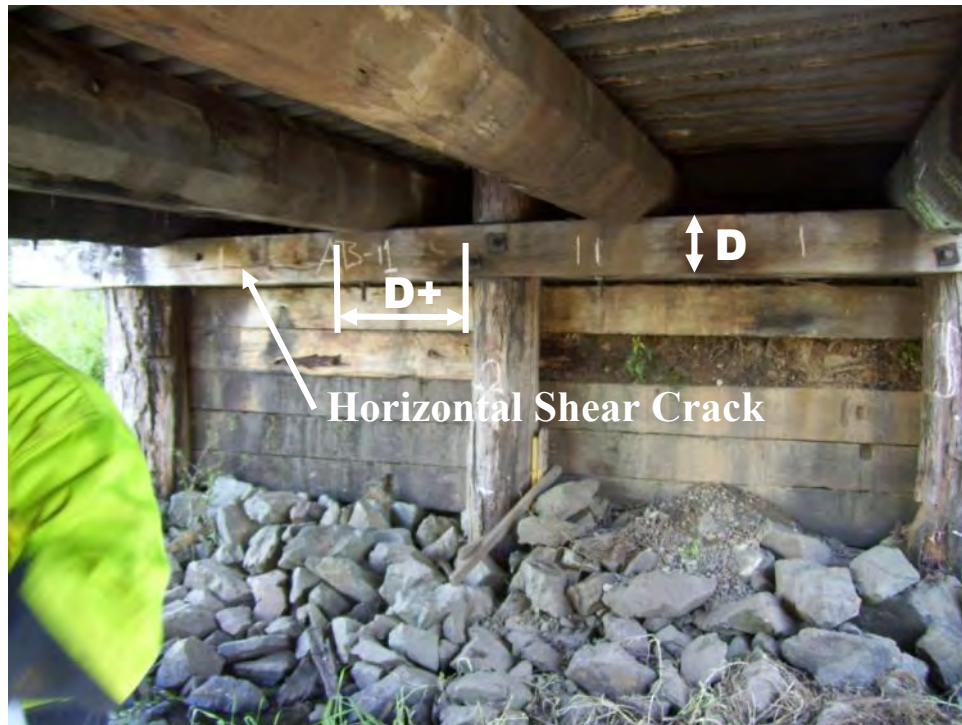
**Girders should be located no more than  $D$  (the depth of the crosshead) away from the piles to prevent shear failures. These girders are too far from the piles, and a horizontal shear crack is visible in the crosshead.**

10. Use properly sized timbers in pile bents and place loads within  $D$  of the pile to prevent micro-checking (horizontal shear cracking) in undersized cross heads.
