SOIL TEMPERATURE AND STABILITY EVALUATION  
FIFTH AVENUE REPLACEMENT SEWER SYSTEM  
DAWSON CITY, YUKON

0201-10471

SEPTEMBER, 1991

EBA Engineering Consultants Ltd.  
14535 - 118 Avenue  
Edmonton, Alberta  
T5L 2M7

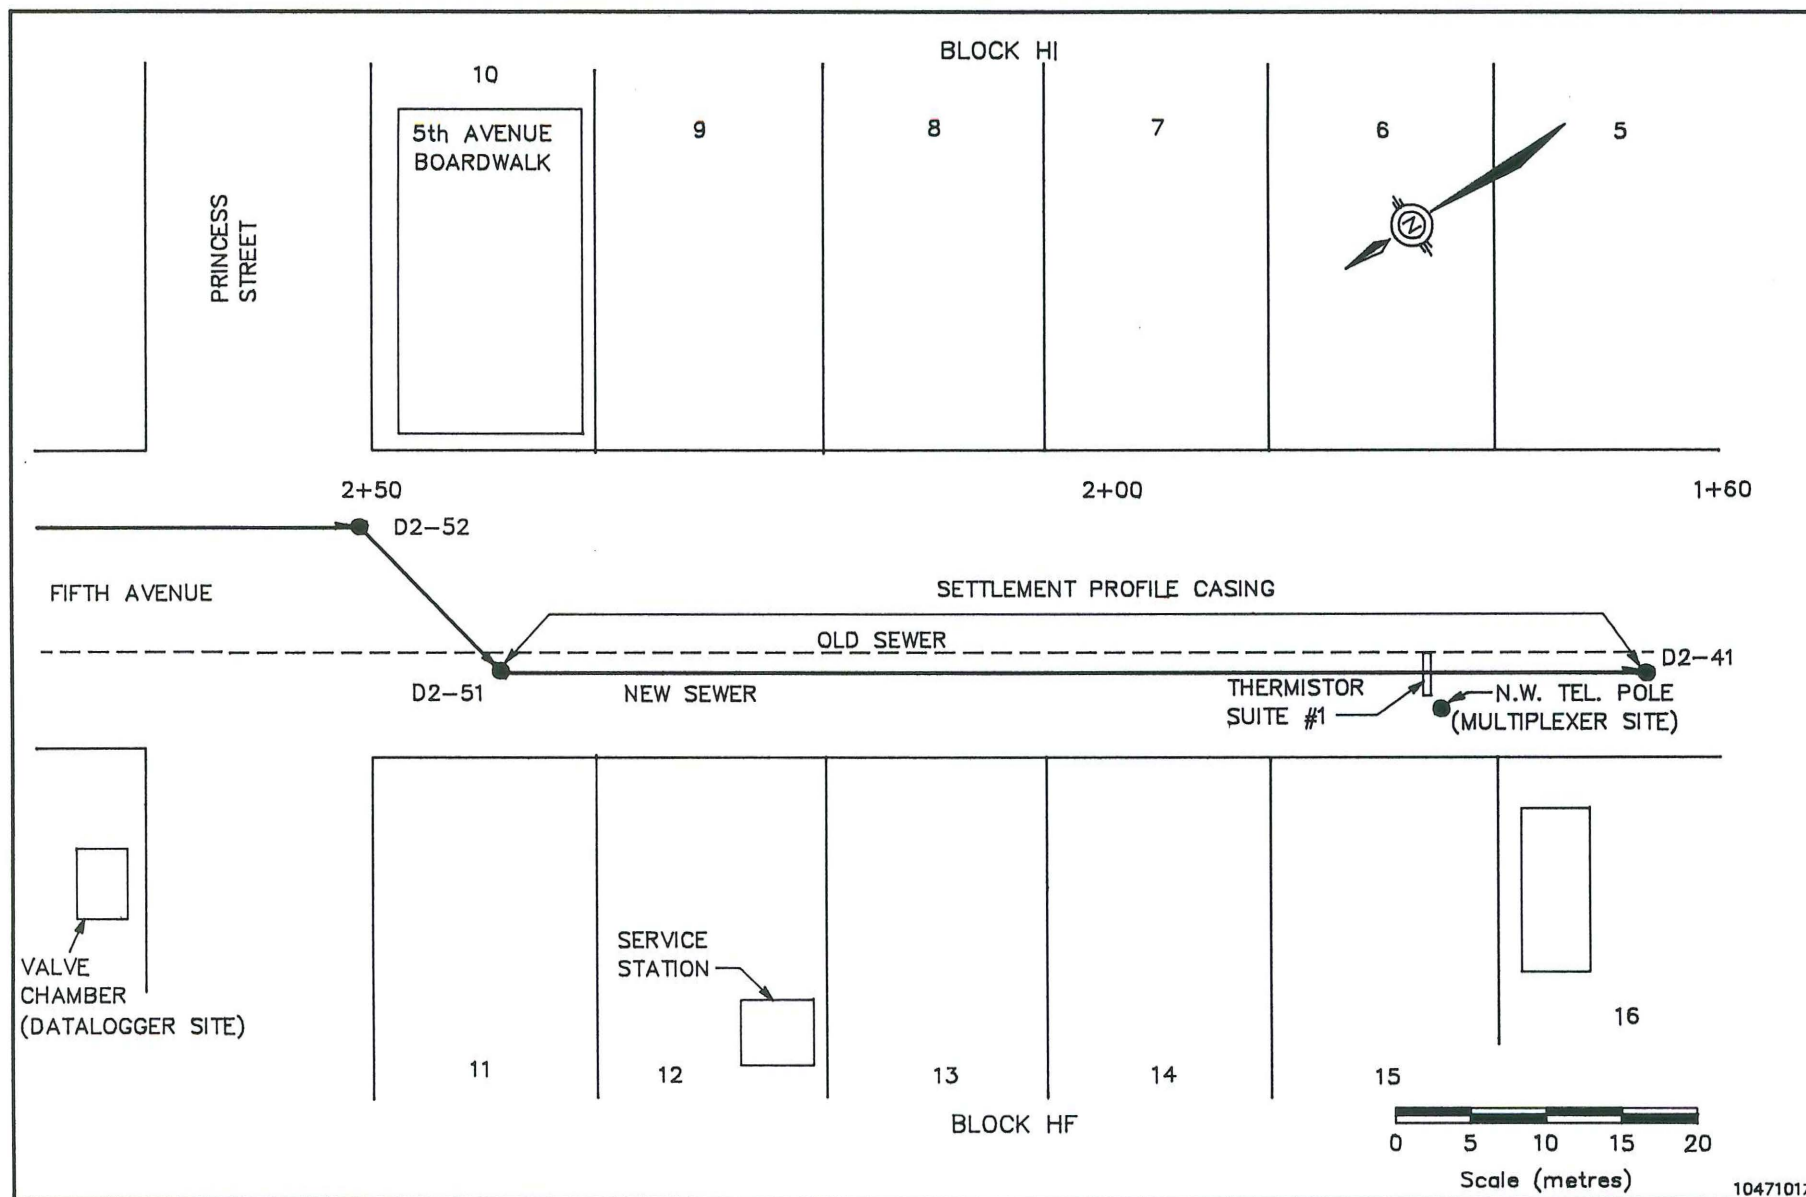
**FIGURE 2 LOCATION PLAN**  
**THERMISTOR SUITE #1 AND SETTLEMENT PROFILE CASING**  
**FIFTH AVENUE AT BLOCK HF**

The modified pipe system would still be susceptible to longitudinal distortion caused by differential settlement or heave that could ultimately affect gravity drainage performance of the system if not properly addressed by the thermal design characteristics of the trench. The instrumentation program included suites of thermistor cables at two locations and a horizontal inclinometer casing strapped to the top of a segment of the new sewer line. Details of the instrumentation equipment, installation procedures and monitoring locations are described in the installation report (EBA, 1987). Figure 1 presents a general location plan for the Fifth Avenue instrument locations. Figures 2 and 3 present further location plan information on larger scale drawings.

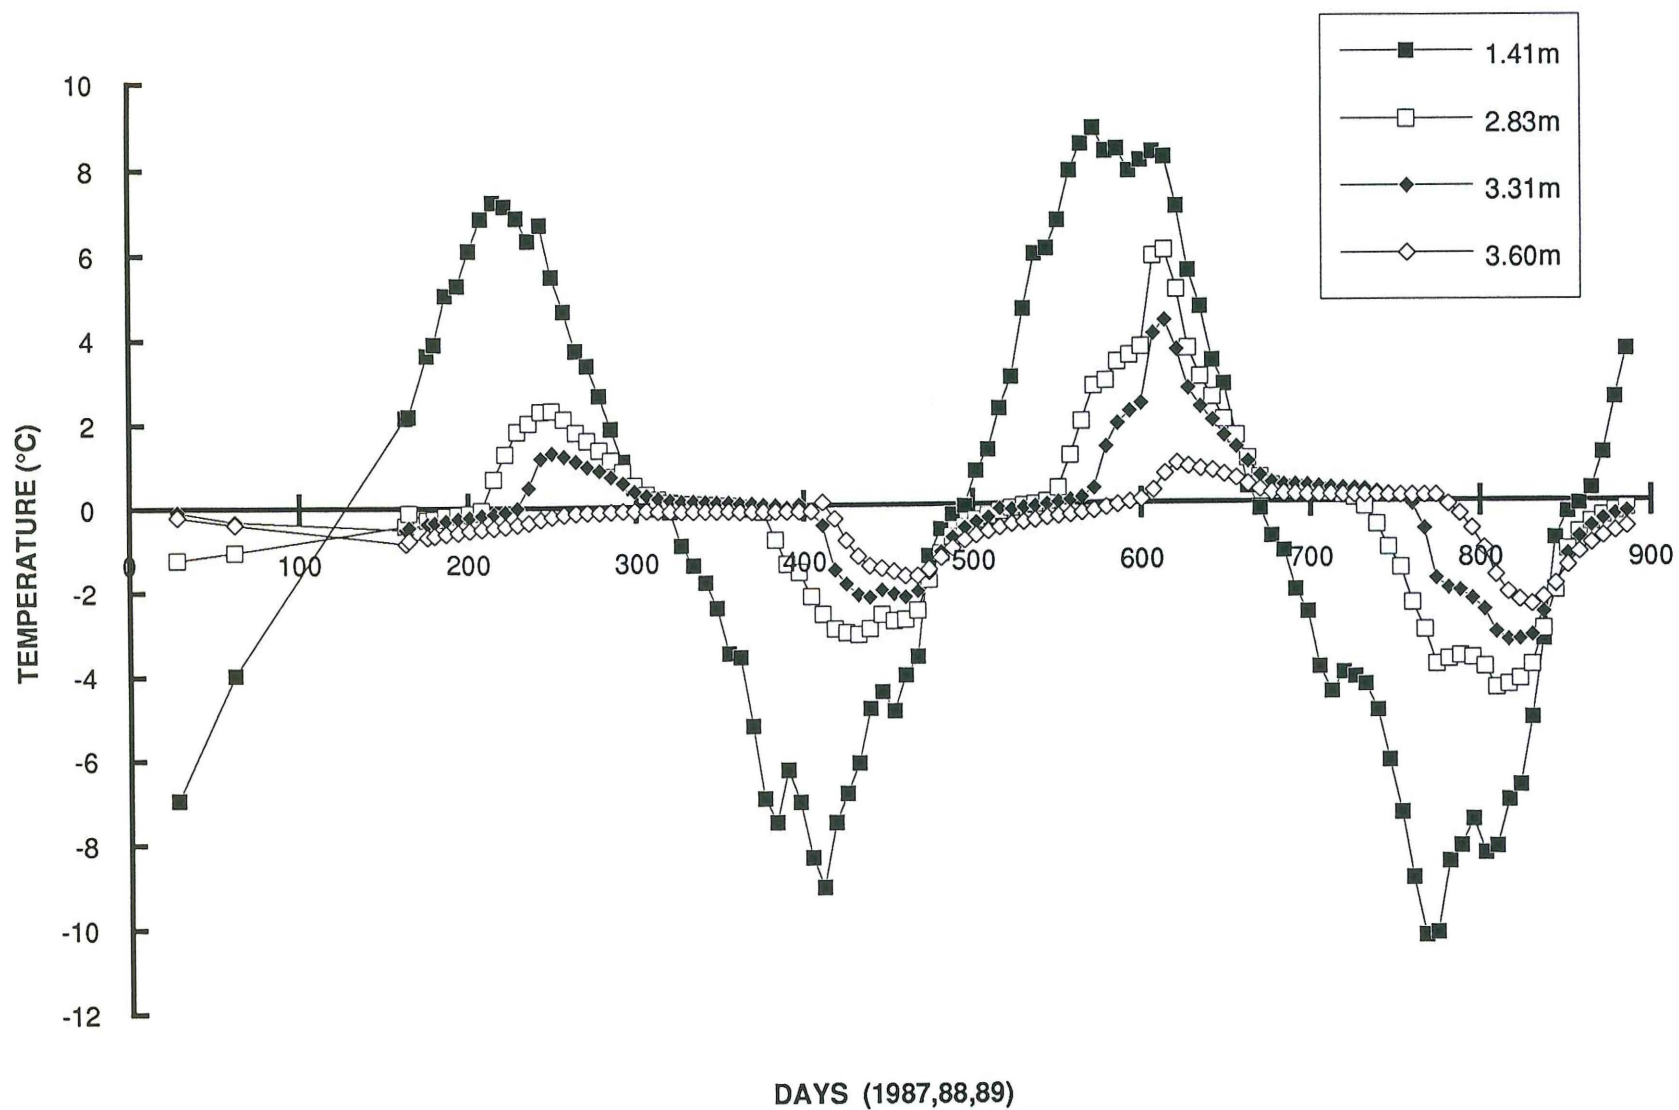
FIGURE 6 TEMPERATURE HISTORY  
SUITE #1, CABLE 651

Ground temperature information was collected from both suites of thermistor cables by an automatic data logger. The data was recorded hourly, but stored as daily maximums and minimums on cassette tapes. The raw data has been downloaded and converted into spreadsheet format, from which representative weekly mean temperatures have been computed. These temperatures are plotted against time for selected thermistor positions on a vertical orientation through the trench at each suite location in Figures 6 and 7. These plots illustrate the transient annual temperature cycle experience within the trench backfill and show how the amplitudes of the cycle diminish with depth.

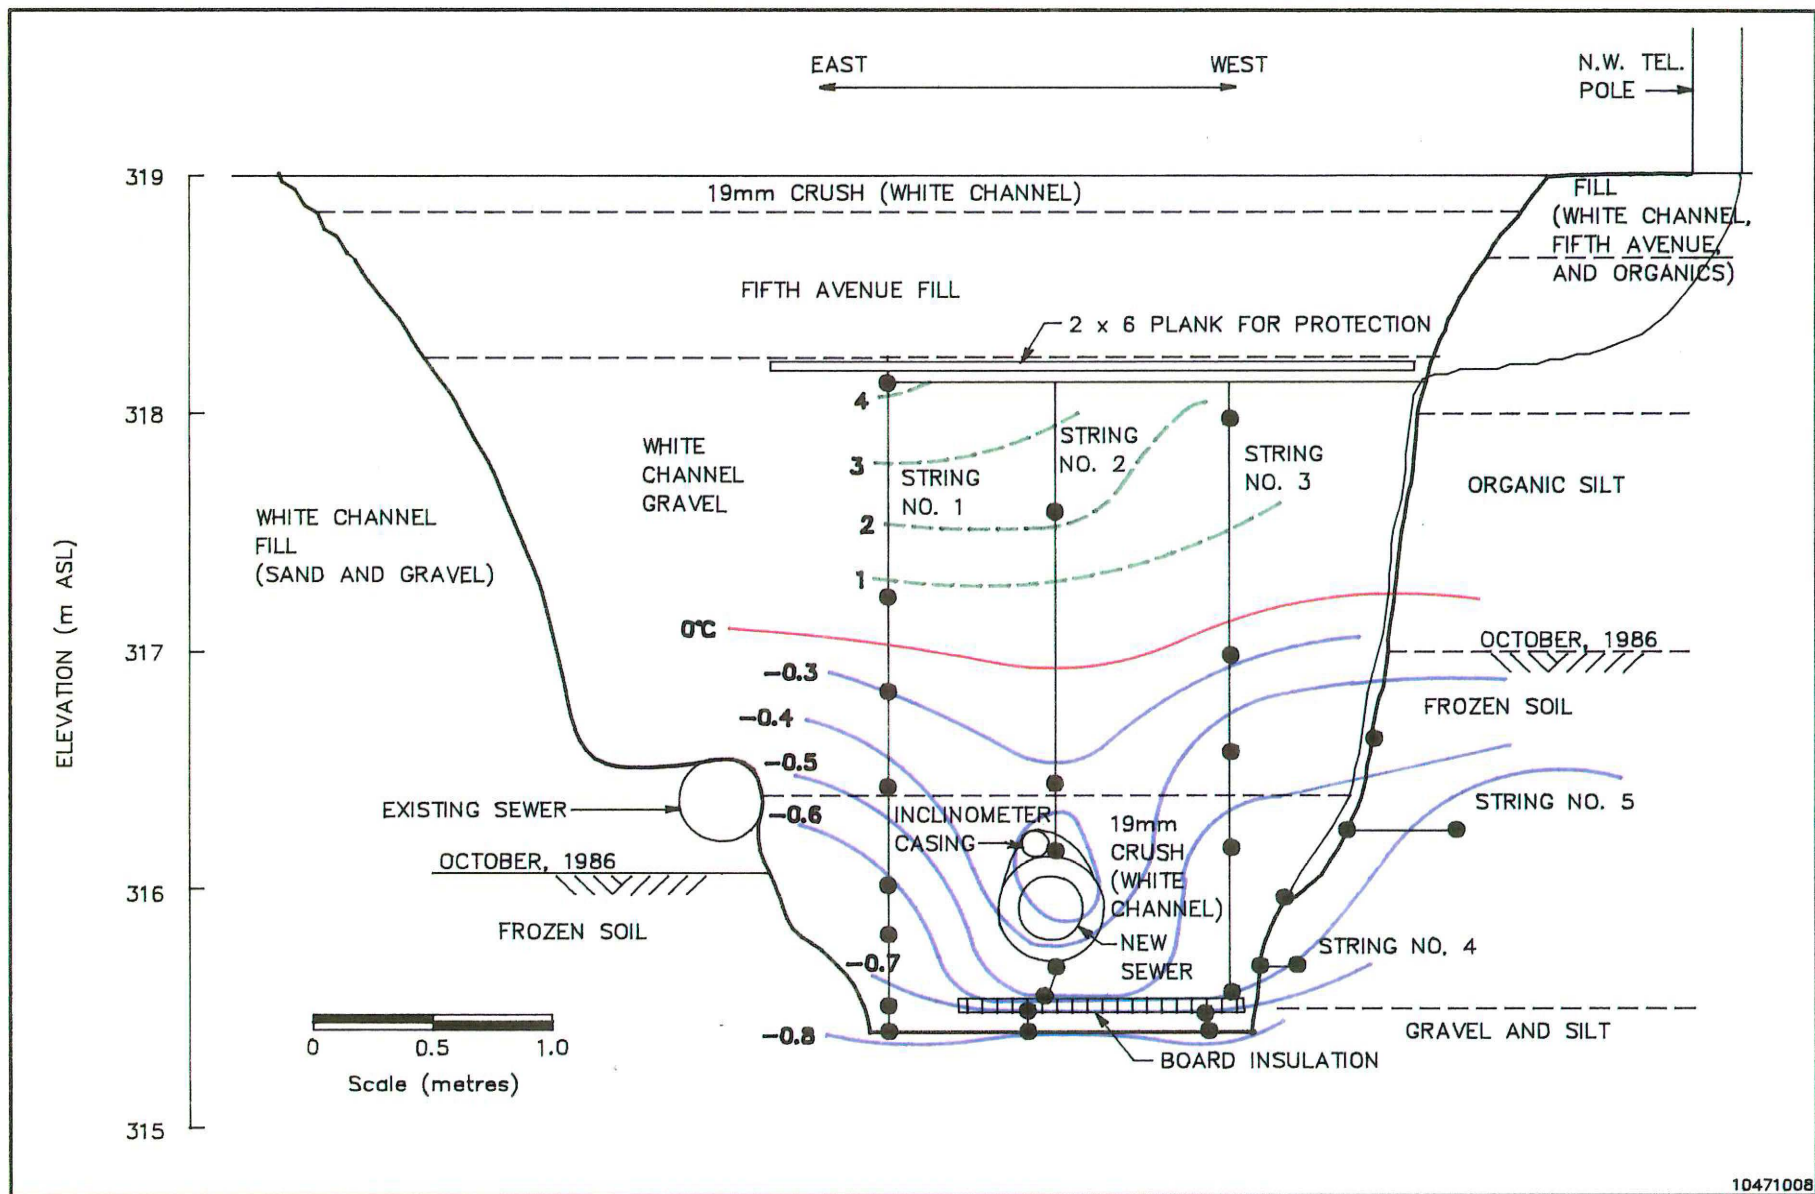
FIGURE 8 THERMISTOR SUITE #1  
TEMPERATURE ISOTHERMS  
JUNE 13, 1987

The temperature data has also been used to produce temperature contour maps through the instrumented cross section at various times, including dates corresponding to inclinometer readings and periods of peak seasonal freezing and thawing. These contours are presented in Figures 8 through 14 for Suite 1 and Figures 15 through 21 for Suite 2.

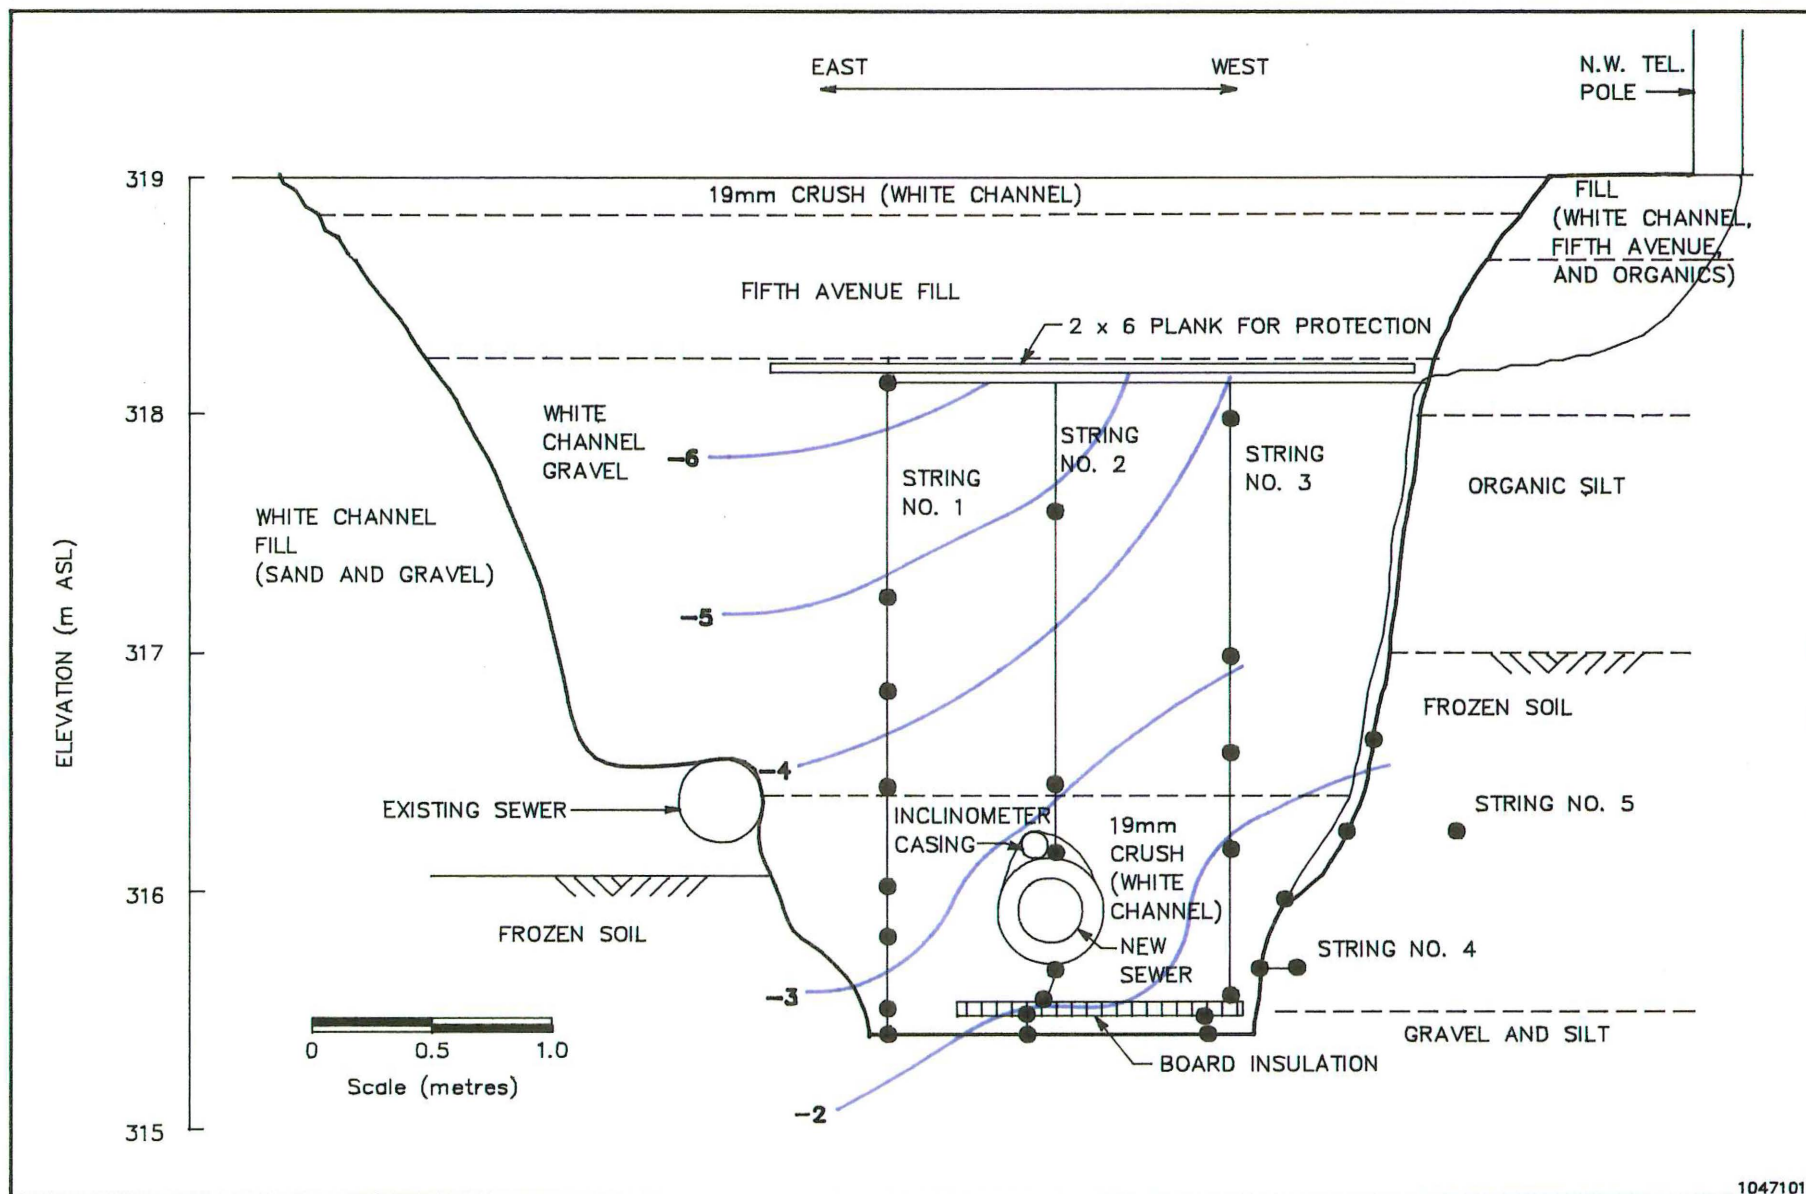
FIGURE 11 THERMISTOR SUITE #1  
TEMPERATURE ISOTHERMS  
MARCH 28, 1988 (PEAK FREEZE)

The contour plots show that during peak thaw in September of 1987 (Figures 9 and 16), the maximum thaw depth is maintained within the rigid board insulation at the Suite 2 location and fairly well maintained within the trench backfill at the trench bottom (except near the east wall) at the Suite 1 location. The slightly poorer performance at the Suite 1 location may be partly due to both the wider trench dimension and the lack of insulation extension across the full width of the trench floor. Both trench locations are shown to have frozen back entirely by the time of peak freeze in March of 1988 (Figures 11 and 18).
