2008 Reconnaissance-level landform grading field investigation at the Faro Minesite

SRK Project #: 1CY001.015 Task 004 // BGC Project Number: 0533-002

Final report May 26, 2009

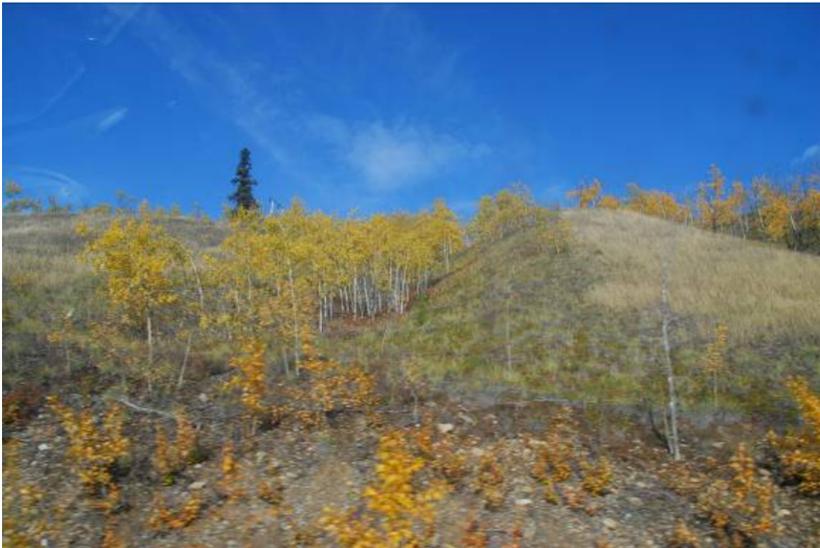
<p>Slopes near Carmacks</p> <p>UTM Zone 8 NAD 83 0446877, 6884262 Elev. 576m 62.086N 136.017W NTS 115I01</p> <p>North side of Highway 4 (Robert Campbell Highway), close to the Yukon River. Approx 13km east of Carmacks, 140km west of Faro Minesite</p>	<p>Slope length 80-100m Swale crest to swale crest: 20 to 25 m Swale cross slope: 10 to 15 degrees Swale longitudinal slope: 25 to 27 degrees Swale depth (crest to thalweg): 2.1 to 2.3m Stable dozer cut like slopes, 20m wide, 25 degrees, 2m deep, 15 degree side slopes, base width about 10m South facing Thick, organic rich soils in swales, dense vegetation. Very thin soil cover on ridges.</p>

<p>If this technique is used, each site should be visited by a multidisciplinary team for a half day visit.</p>

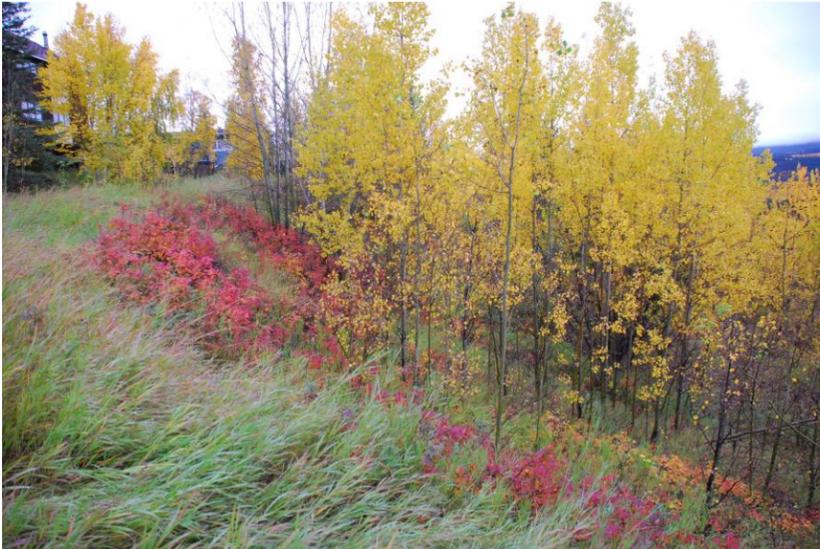
<p>This slope provides a useful analogue to for dozer-sized downslope furrows for Faro waste rock dumps. It provides insight into geometry, soils, vegetation communities and tailored planting, convex toe slopes, and mounds on the slopes. Useful natural analogue for large downslope corrugated slopes.</p>
<p>Gullies below Faro townsite (Gully behind townhouse over Pelly River)</p>	<p>28 degree valley wall, trembling aspen forest, glaciofluvial vegetated circular scarp</p>

<p>If this technique is used, the site should be visited by a multidisciplinary team for a half day visit.</p>

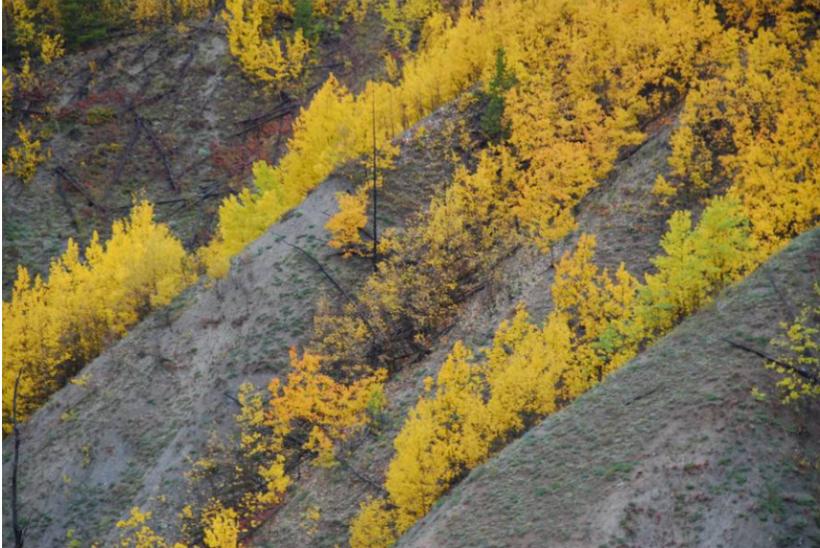
Location	Observation	Photo	Landform design implication
<p>Fingers natural area Tourist stop near Faro – 710 GPS</p>	<p>Till over bedrock, not a great tour site, gullies undercut, lookout.</p>

<p>Interesting soils and vegetation patterns, but may not be applicable to mine reclamation.</p>
<p>Headlands of Rose Creek (adjacent to Rose Creek Diversion)</p>	<p>Some creeks are underlain by organic wetland material. Fen like wetland in uplands for Rose Creek has just a few inches of peat developed over the many years. No erosion.</p>

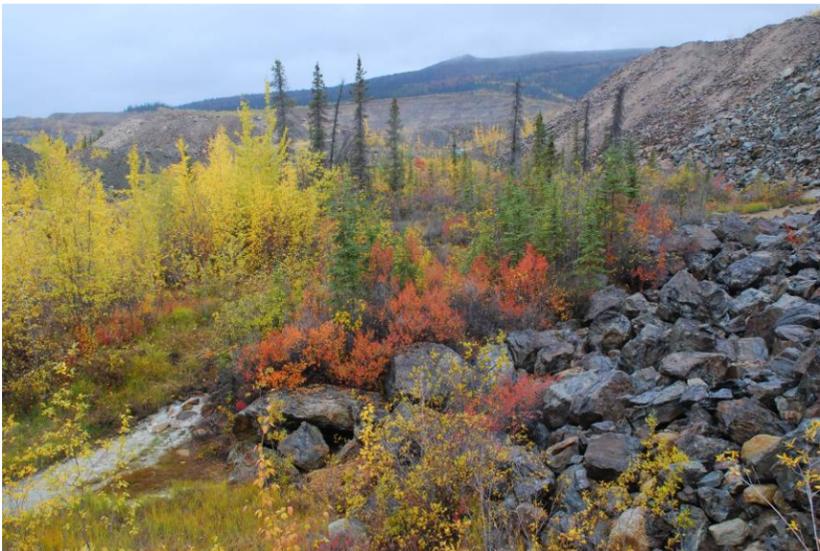
<p>Almost all creeks are naturally armoured with boulders or are underlain by bedrock. Plan to armour all channels. Give consideration to building floodplain and tree islands as in these natural creeks.</p>
<p>Natural area at base of two dump swales just southwest of Faro pit GPS 706</p>	<p>There are some areas of natural veg in the mine area – try to preserve these as seed sources</p>

<p>Attempt to preserve natural areas within the mine footprint, starting with mapping them. Use coarse boulders to trap sediments coming from the dump slopes.</p>

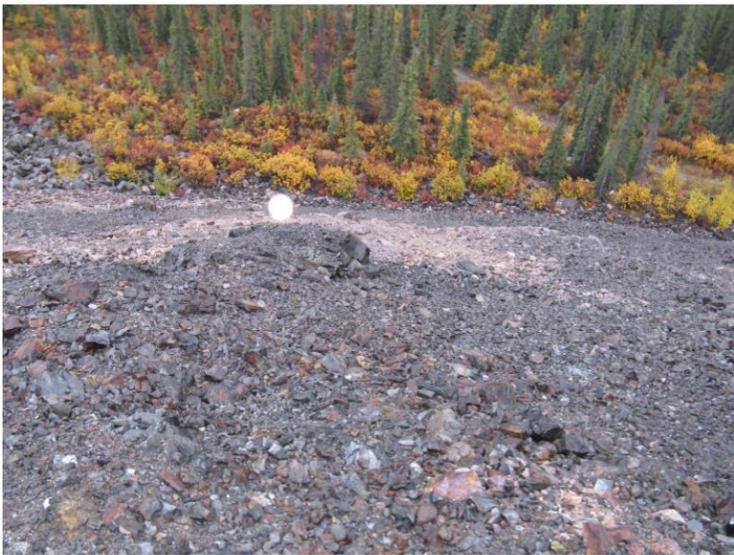
2529

ID	Easting m	Northing m	Elev (ft)	Material	% fines	Gully?	Slope aspect	Slope length (m)	Slope angle α (deg)	Slope angle α (%)	Slope angle α (xH:1V)	Max clast diameter (m)	Min clast diameter (m)	% Veg cover	Gully length, m	Gully depth, m	Gully width, m	Photo #	Comments
1	585307	6914015	3982	Phyllite	0	No	S	83	37	75	1.3	0.4	0,1	0

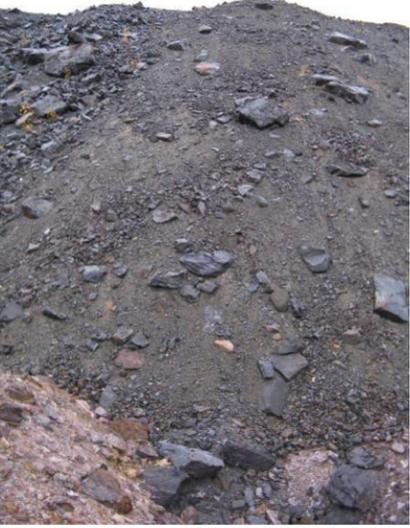
ID	Easting m	Northing m	Elev (ft)	Material	% fines	Gully?	Slope aspect	Slope length (m)	Slope angle α (deg)	Slope angle α (%)	Slope angle α (xH:1V)	Max clast diameter (m)	Min clast diameter (m)	% Veg cover	Gully length, m	Gully depth, m	Gully width, m	Photo #	Comments
2	50 m end of 1			Phyllite/ Gneiss	50	No	S	33	36	73	1.4	1.5	0.1	1

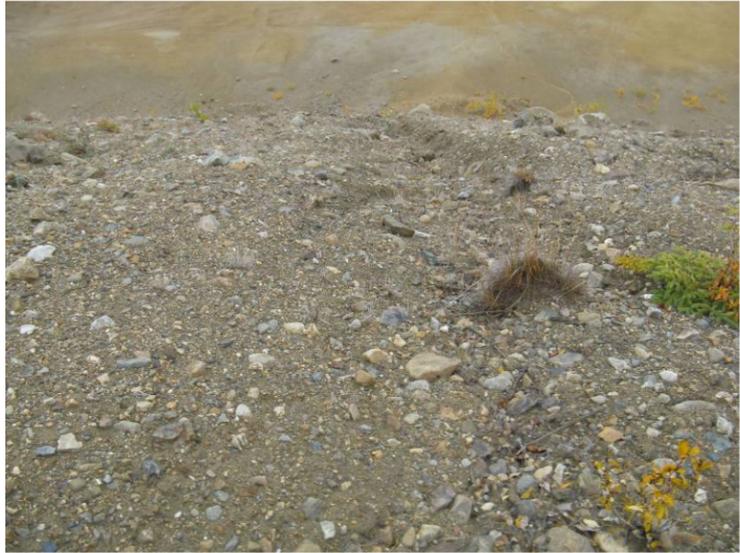
ID	Easting m	Northing m	Elev (ft)	Material	% fines	Gully?	Slope aspect	Slope length (m)	Slope angle α (deg)	Slope angle α (%)	Slope angle α (xH:1V)	Max clast diameter (m)	Min clast diameter (m)	% Veg cover	Gully length, m	Gully depth, m	Gully width, m	Photo #	Comments
8	585544	6914622		sandy gravel igneous intrusive rocks, some glaciofluvial	20	Yes	SE	42	34	67	1.5	0.6	0.05-0.1	1	5	0.4	1.5

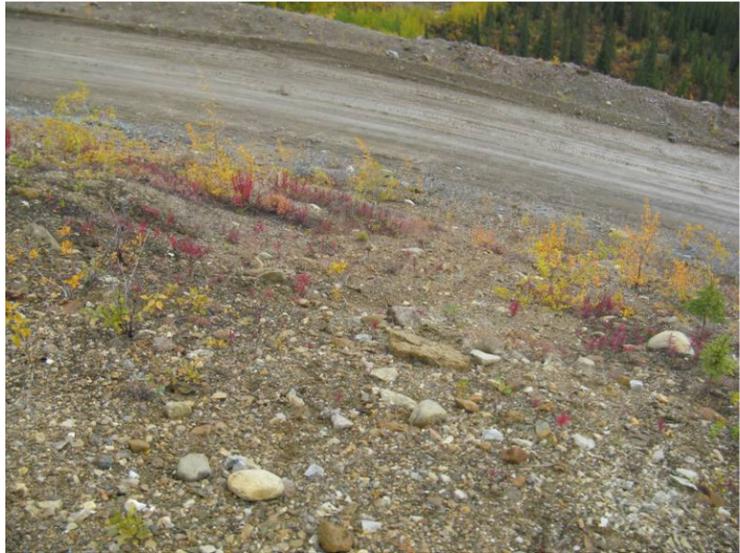
2544

2543	
9	585624	6914711	4185	Sandy gravels	10	Yes	S	20	32	62	1.6	0.4	0.1	30	6	0.3	7

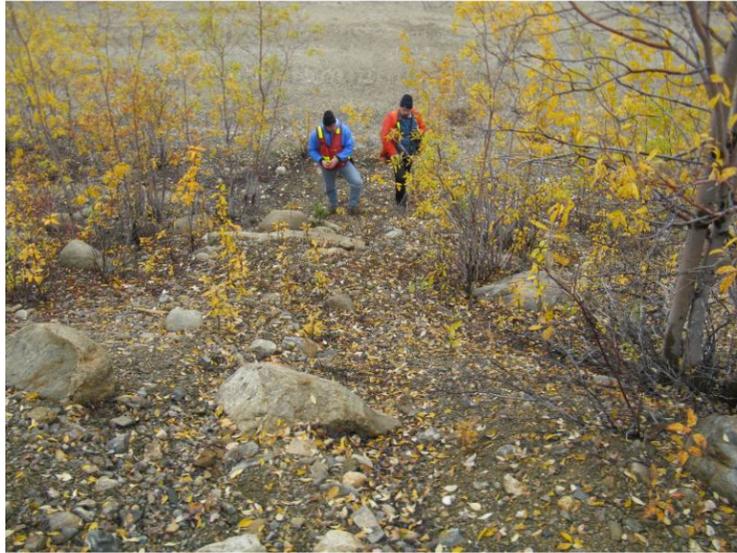
ID	Easting m	Northing m	Elev (ft)	Material	% fines	Gully?	Slope aspect	Slope length (m)	Slope angle α (deg)	Slope angle α (%)	Slope angle α (xH:1V)	Max clast diameter (m)	Min clast diameter (m)	% Veg cover	Gully length, m	Gully depth, m	Gully width, m	Photo #	Comments
10	585396	6914881	4232	Silty, sandy gravels, glaciofluvial	10	No		15	27	51	2.0	1	0.1	50

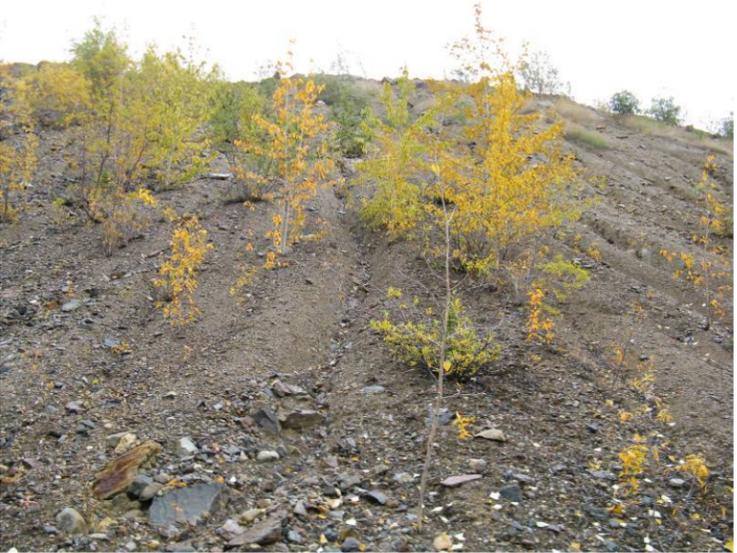
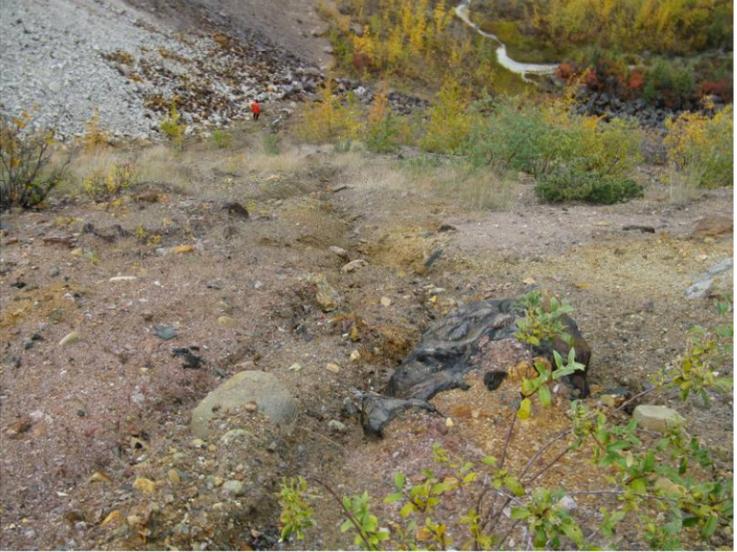
ID	Easting m	Northing m	Elev (ft)	Material	% fines	Gully?	Slope aspect	Slope length (m)	Slope angle α (deg)	Slope angle α (%)	Slope angle α (xH:1V)	Max clast diameter (m)	Min clast diameter (m)	% Veg cover	Gully length, m	Gully depth, m	Gully width, m	Photo #	Comments
12	585156	6914221	3925	silty sandy gravel trace clay	60	Yes	NE	62	36	73	1.4			10	6	0.4	1

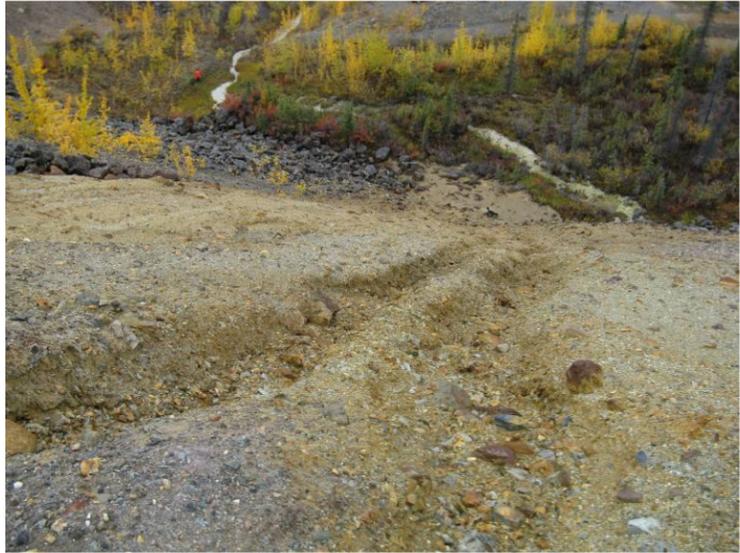
ID	Easting m	Northing m	Elev (ft)	Material	% fines	Gully?	Slope aspect	Slope length (m)	Slope angle α (deg)	Slope angle α (%)	Slope angle α (xH:1V)	Max clast diameter (m)	Min clast diameter (m)	% Veg cover	Gully length, m	Gully depth, m	Gully width, m	Photo #	Comments
13	585180	6914298	4026	unknown, slightly cohesive	90	Yes		75	35	70	1.4			0		0.3	0.4

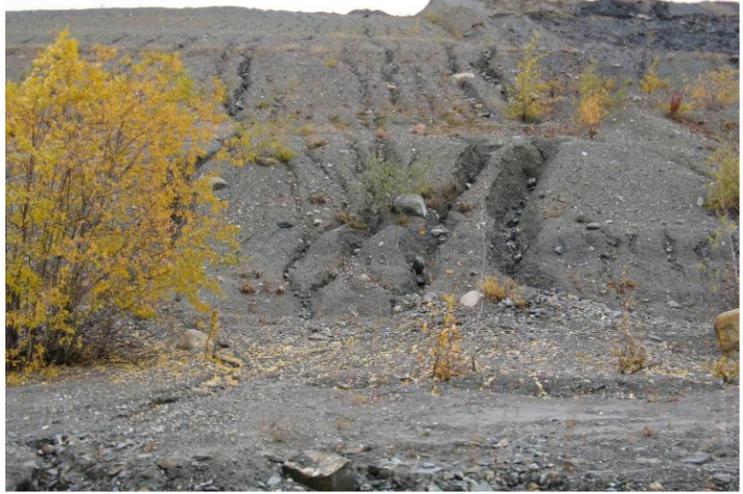
ID	Easting m	Northing m	Elev (ft)	Material	% fines	Gully?	Slope aspect	Slope length (m)	Slope angle α (deg)	Slope angle α (%)	Slope angle α (xH:1V)	Max clast diameter (m)	Min clast diameter (m)	% Veg cover	Gully length, m	Gully depth, m	Gully width, m	Photo #	Comments
20	593683	6902448	3684		50	Yes	S	105	23	42	2.4	1	0.1	2	6	1.2	4

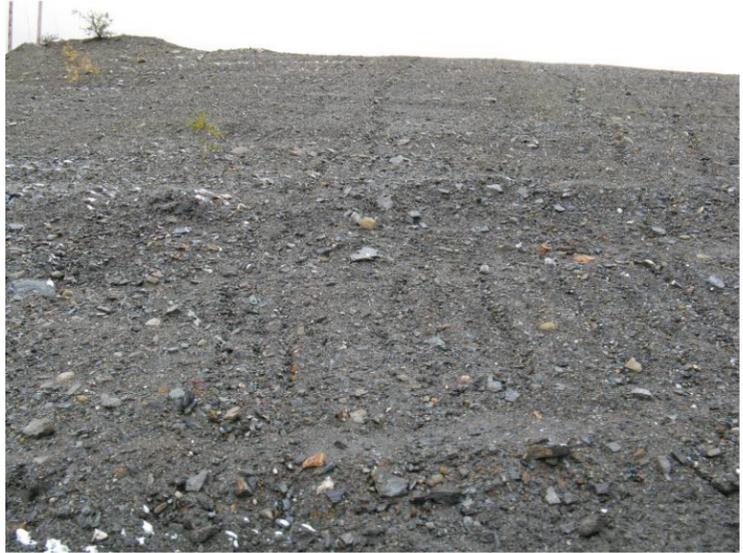
ID	Easting m	Northing m	Elev (ft)	Material	% fines	Gully?	Slope aspect	Slope length (m)	Slope angle α (deg)	Slope angle α (%)	Slope angle α (xH:1V)	Max clast diameter (m)	Min clast diameter (m)	% Veg cover	Gully length, m	Gully depth, m	Gully width, m	Photo #	Comments
22	592597	6904321	4022		50	No	N	26	20	36	2.7	0.3	0.05	0

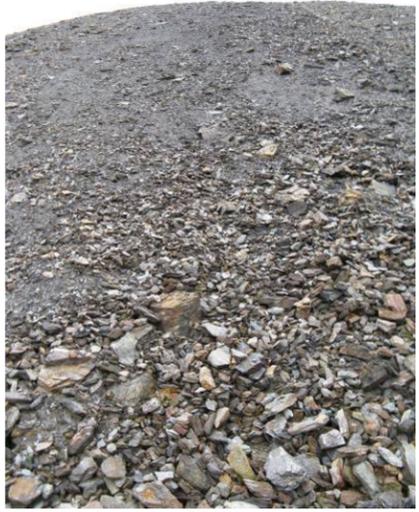
<p>2591</p>

ID	Easting m	Northing m	Elev (ft)	Material	% fines	Gully?	Slope aspect	Slope length (m)	Slope angle α (deg)	Slope angle α (%)	Slope angle α (xH:1V)	Max clast diameter (m)	Min clast diameter (m)	% Veg cover	Gully length, m	Gully depth, m	Gully width, m	Photo #	Comments
24	583849	6913699	3899	veneer of Phyllite cover, yellow-fine grained clasts, silty sand, matrix cohesive	30	Yes	S	100	35	70	1.4	1.2	0.1	0	10	0.4	3
