**APPENDIX I  
SITE VISIT INSPECTION MEMO  
(JULY)**

**MEMORANDUM**

Mr. Gerry Ferris, P.Eng., of BGC Engineering Inc. (BGC), undertook a visual inspection of selected facilities at Faro Mine between June 30 and July 3, 2009. At the end of this inspection much of the items contained in this memo were discussed with Mr. Roy Morrell and Mr. Jon Bronson. This memo summarizes the conditions observed, along with recommendations for maintenance or monitoring:

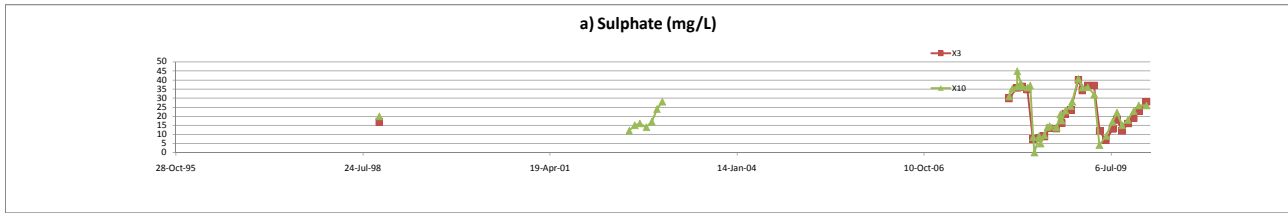
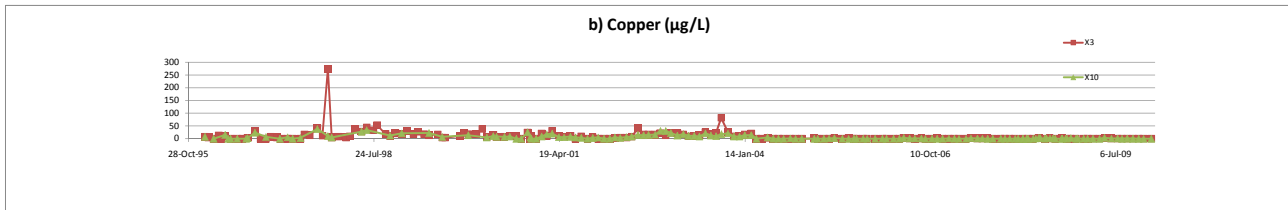
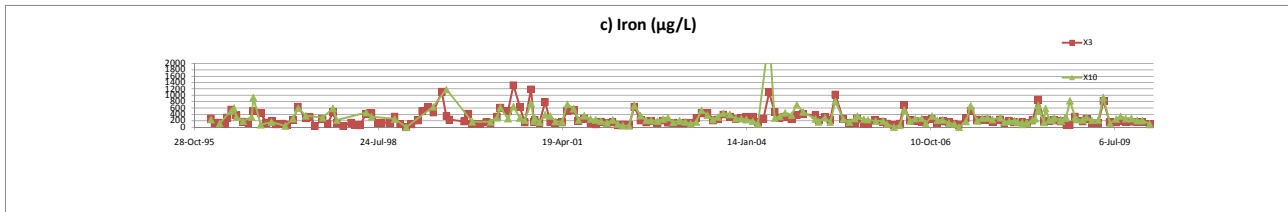
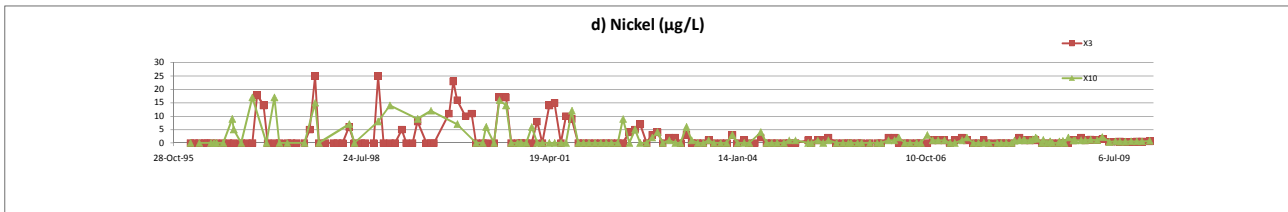
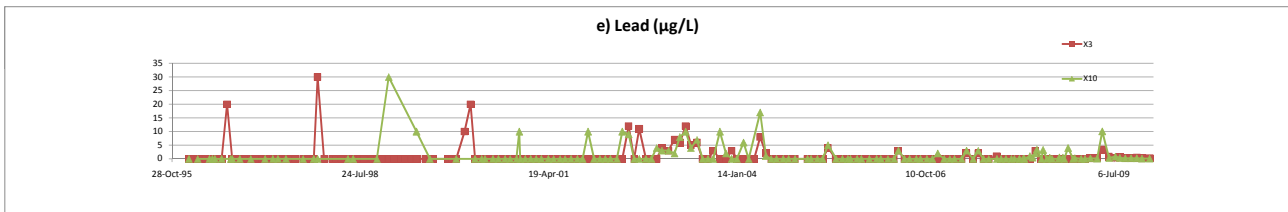
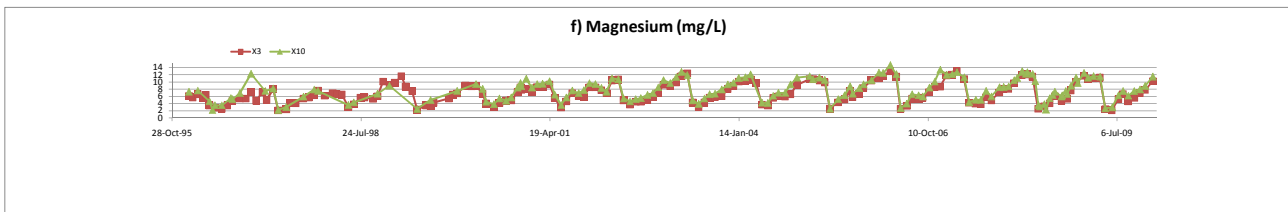
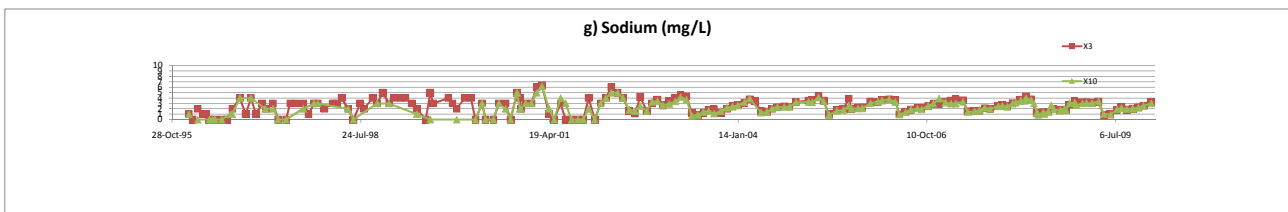
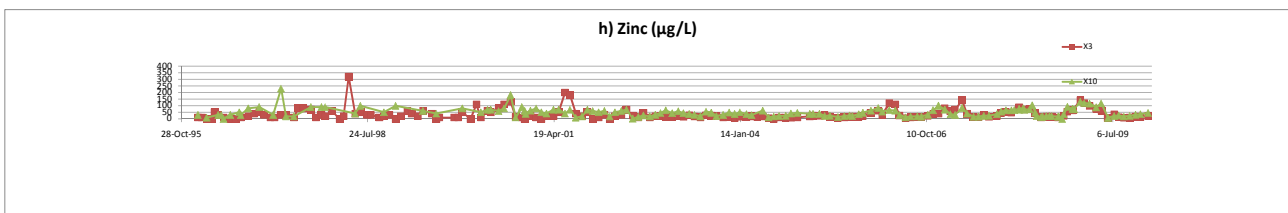
Figure 1a - h: Comparison of X3 and X10 for Select Water Quality Parameters

Figure 1 shows that for all the parameters selected (iron, sulphate, copper, nickel, lead, magnesium, sodium, zinc), with the possible exception of magnesium, iron and zinc, the concentrations of X3 and X10 are comparable. Statistical analysis would be required to determine whether or not the differences are significant between for magnesium, iron and zinc. In addition, the results for all parameters, including zinc show generally that trends at X3 parallel trends at

As in the preliminary review, Figure 1 shows that for all the parameters reviewed (with the possible exception of magnesium, iron and zinc), the concentrations of X3 and X10 are comparable. Statistical analysis would be required to determine whether or not the differences are significant for magnesium, iron and zinc. In addition, the results for all parameters, including zinc show generally that trends at X3 parallel trends at X10, indicating that no increasing trend in concentrations at X10 with respect to X3 is observable.

While detailed statistical analysis of the iron, magnesium and zinc may show that there is some loading to the RCDC within the reach from X3 to X10. A visual review of the graphs on Figure 1 indicates that the concentrations for each of the reviewed parameters are not increasing with respect to historic rates.

It is recommended that water quality at X3 and X10 be compared again after January monitoring events (the first working week of January), to include results after the staining was observed. From the comparison assessment further recommendations will be made.

Therefore, it is recommended that efforts be made to determine the extent and verify the source of the seepage, as part of closure planning. This is especially recommended given the groundwater capture rates put forth in the closure planning process to meet long term water quality targets. DES has taken the preliminary step of adding a sampling location (immediately downstream of the observed stain area) to the monthly water quality monitoring program, however no other monitoring sites have been added, and no other investigations are planned. The water quality monitoring at this additional location is undertaken to start a historic record at this site, with the assumption that further studies will be forthcoming, whether that be through DES or another agency / consultant / contractor, as part of closure planning.

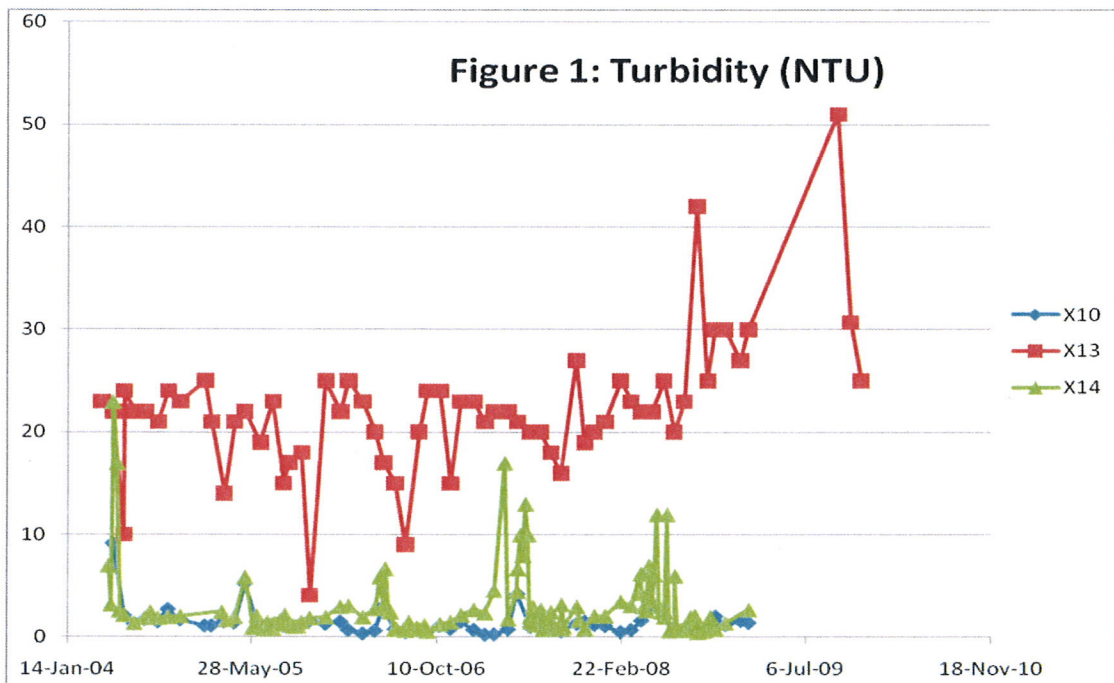
Turbidity at X13 has been shown to be consistently higher than the effluent quality standard for samples collect in 2009. While the October 2009 result (October 4, 2009: 51 NTU) did not reach the certified lab in time to be analysed within the recommended holding time, and the result may therefore be questionable, the November 2009 sample was assessed within the recommended holding time. A review of historic turbidity at X13 was therefore undertaken. The results of the review, including turbidity at X10 and X14, located in Rose Creek, upstream and downstream, respectively, of the confluence of X13 (combined Cross Valley Dam seepage) flows with Rose Creek, are shown in Figure 1.

The review of historic trends shows that turbidity at X13 has generally exceeded the effluent quality standard of 15 NTU, as specified in Appendix B of the Care and Maintenance Contract, since the beginning of the available historic record (April 2004).

December 2009 turbidity results are within the range of historically observed results at X13, indicating the potential of an anomalous sample/reading in October.

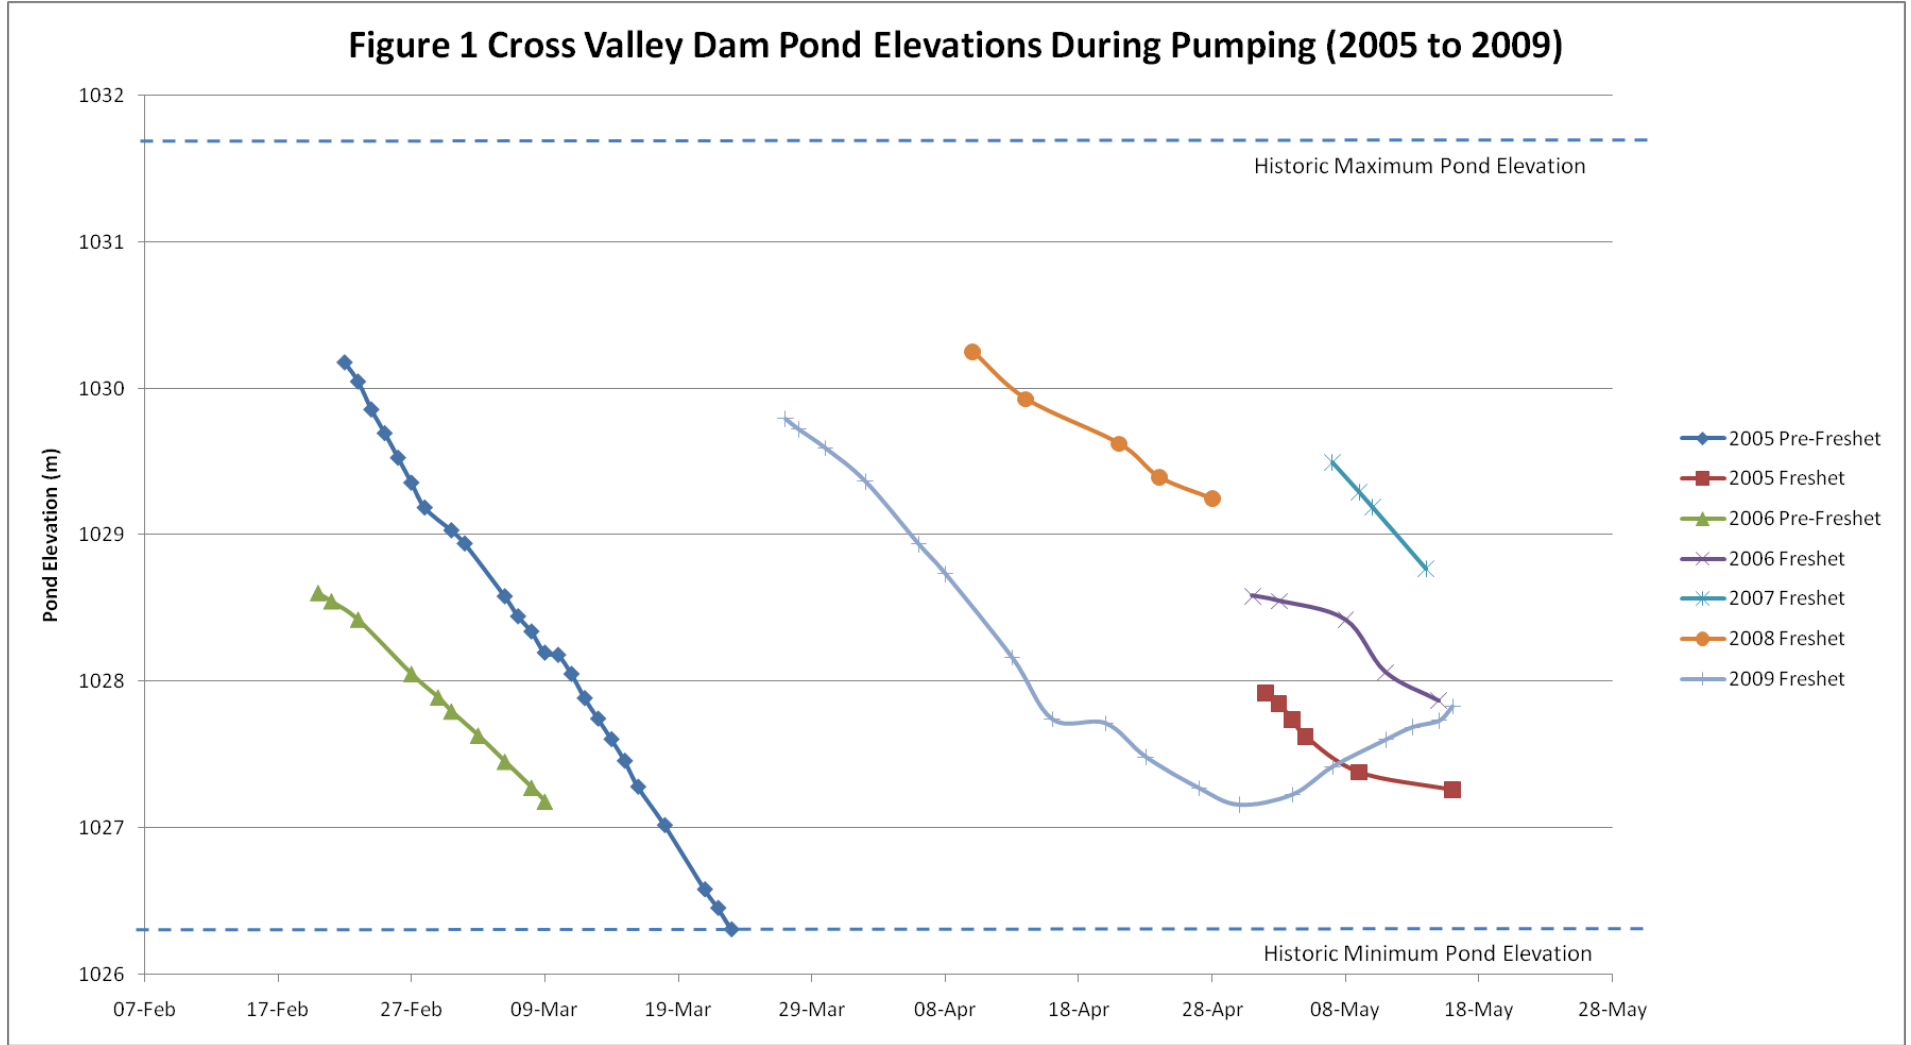
**Figure 1 Cross Valley Dam Pond Elevations During Pumping (2005 to 2009)**

The Cross Valley Dam pond elevation has fluctuated between a maximum of 1031.7 m and a minimum of 1026.3 m between 1999 and 2008. The maximum daily drawdown rate recorded is 191 mm/day, the maximum average drawdown is 133 mm/day. Figure 1 shows all of the major drawdown events recorded since 1999 during the freshet period.

Drawdown began in March for both the Intermediate and Cross Valley ponds. Figure 1 and 2 outline the pond elevations during drawdown for 2009 and historic records. Average drawdown rates for 2009 were 39 and 5 mm/day for the Cross Valley and Intermediate ponds, respectively. The 2009 drawdown rates were below rates measured in previous years and were lower than to recommendations provided by BGC (as outlined in sections 2.1.3 and 2.2.3). Monitoring was conducted as per Section 2.3.

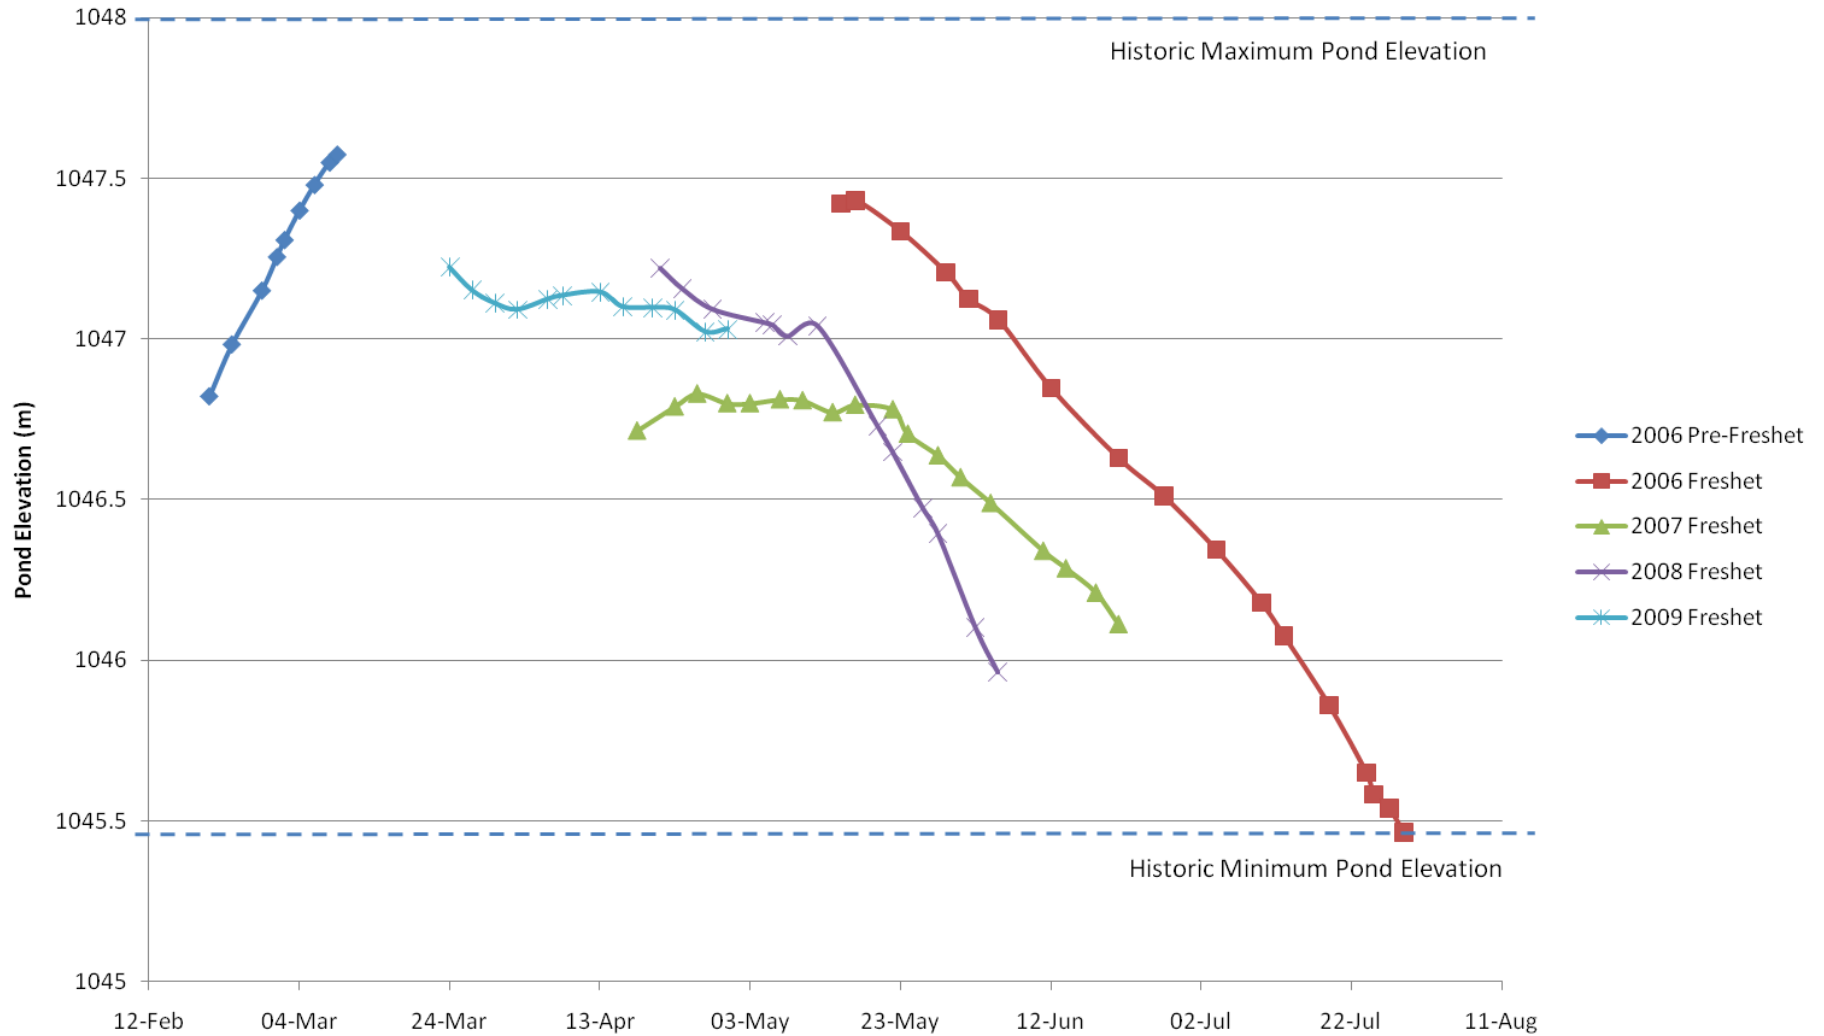
### Figure 2 Intermediate Dam Pond Elevations During Pumping (2006 to 2009)

The Intermediate Dam pond elevation has fluctuated between a maximum of 1048.0 m and a minimum of 1045.5 m between 1999 and 2008. The maximum daily drawdown rate recorded is 67 mm/day with the maximum average drawdown rate of 44 mm/day. Figure 2 shows all of the major drawdown events recorded since 1999 during the spring freshet period.
