REPORT ON

2009 Faro Pit Slope Movement Monitoring

Submitted to:
Denison Environmental Services
Faro Care and Maintenance Project
P.O. Box 280
Faro, YT
Y0B 1K0

Report Number: 09-1426-0019/2000

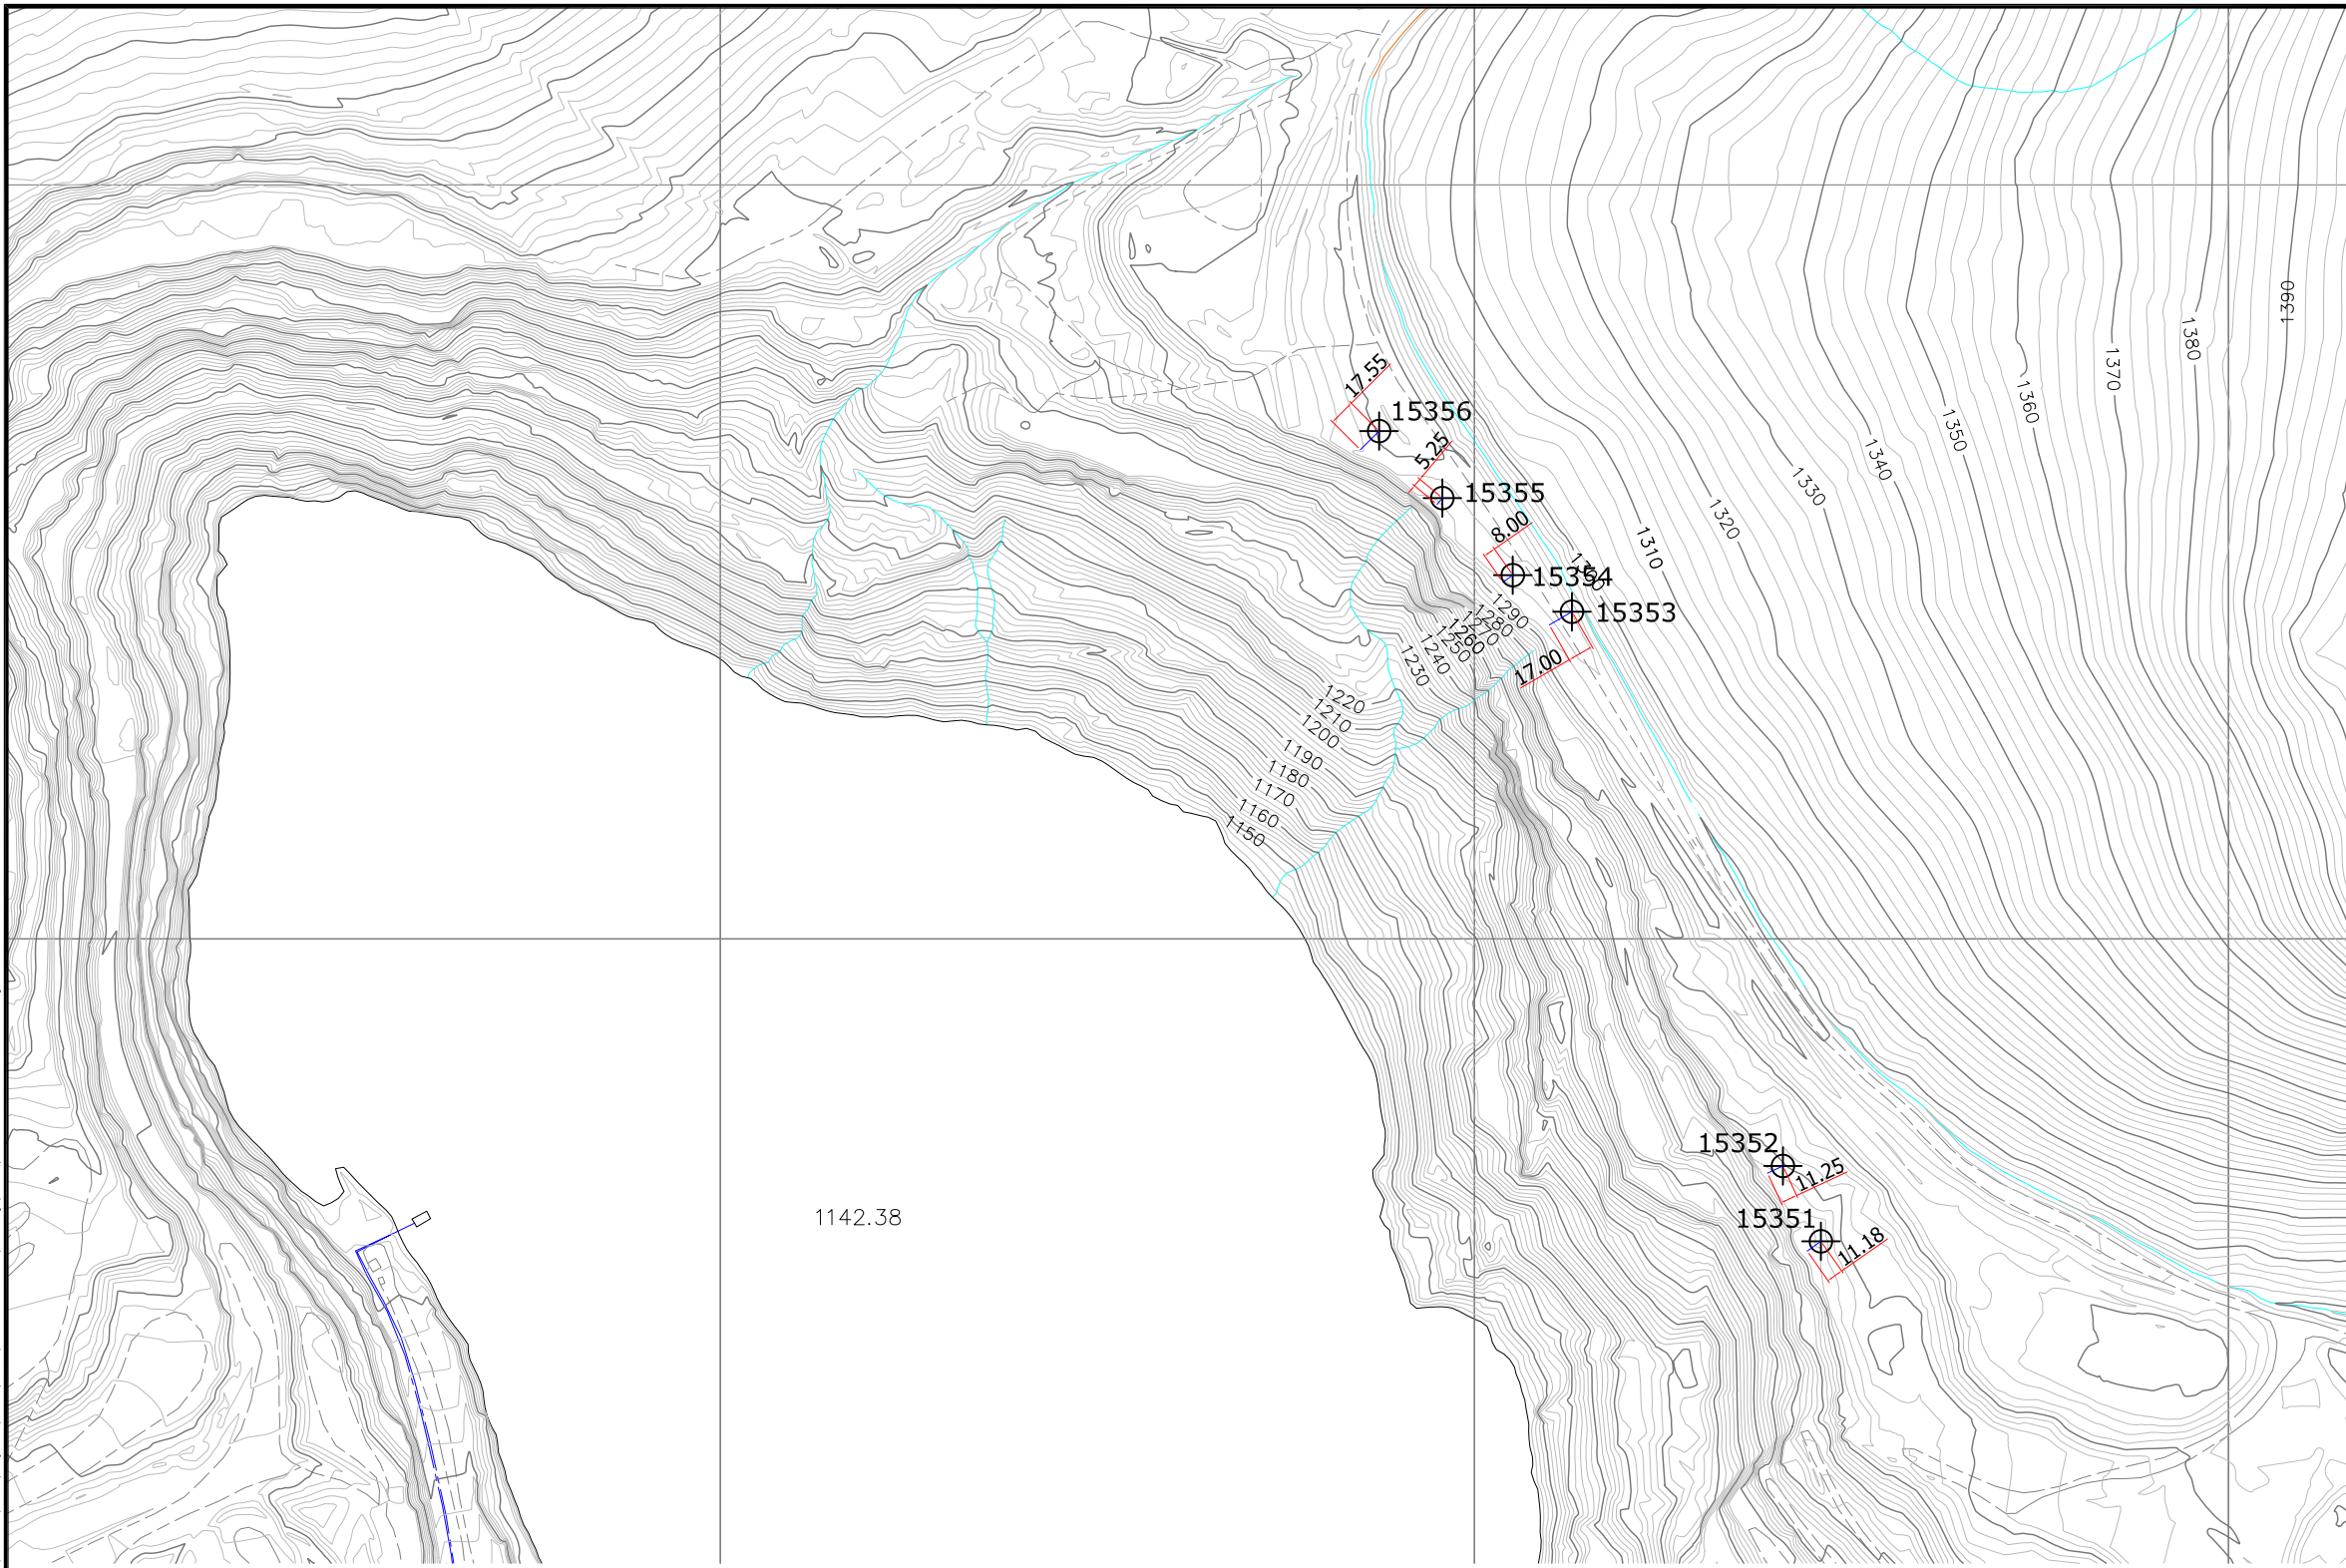
LEGEND:
 13912 SLOPE MOVEMENT OBSERVATIONS - LOCATION OF REFERENCE BARS AND MEASURED DISTANCES (AUGUST 2009)

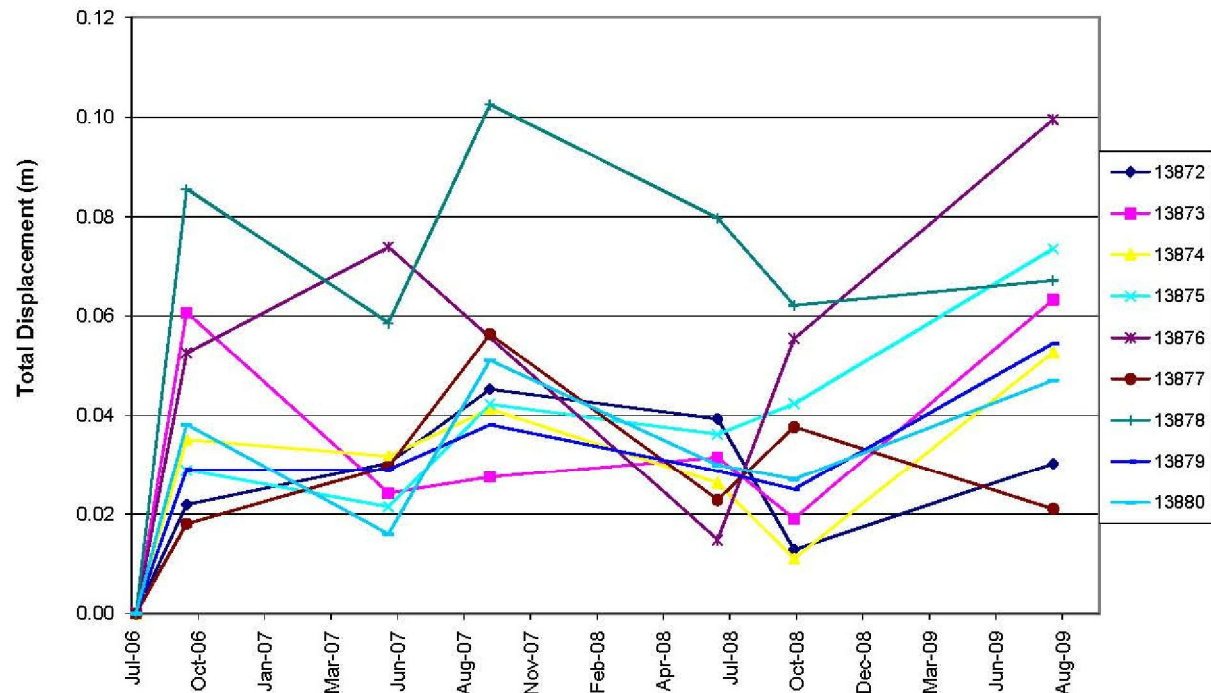
Cumulative Displacement Plot

Point #	$\Delta_N(m)$	$\Delta_E(m)$	$\Delta_Z(m)$	$\Delta_{NxE}(m)$	Point #	Total Displacement (m)	Trend (deg)	Plunge (deg)
13872	0.0148	-0.0141	-0.0222	0.0204	13872	0.0302	316	-47
13873	0.0187	-0.0045	-0.0603	0.0192	13873	0.0633	346	-72
13874	0.0067	-0.0155	-0.0499	0.0169	13874	0.0527	293	-71
13875	0.0030	-0.0285	-0.0677	0.0287	13875	0.0735	264	-67
13876	-0.0016	-0.0001	-0.0995	0.0016	13876	0.0995	184	-89
13877	0.0192	-0.0036	-0.0077	0.0195	13877	0.0210	349	-22
13878	0.0292	-0.0137	0.0589	0.0323	13878	0.0672	335	61
13879	0.0181	-0.0071	-0.0509	0.0194	13879	0.0545	339	-69
13880	0.0254	-0.0026	-0.0395	0.0255	13880	0.0470	354	-57
