December 20, 2013

ISSUED FOR USE
EBA FILE: WI4103179-01

Subject: 2013 Annual Geotechnical Inspection of Earth Structures
Mount Nansen Site, YT.

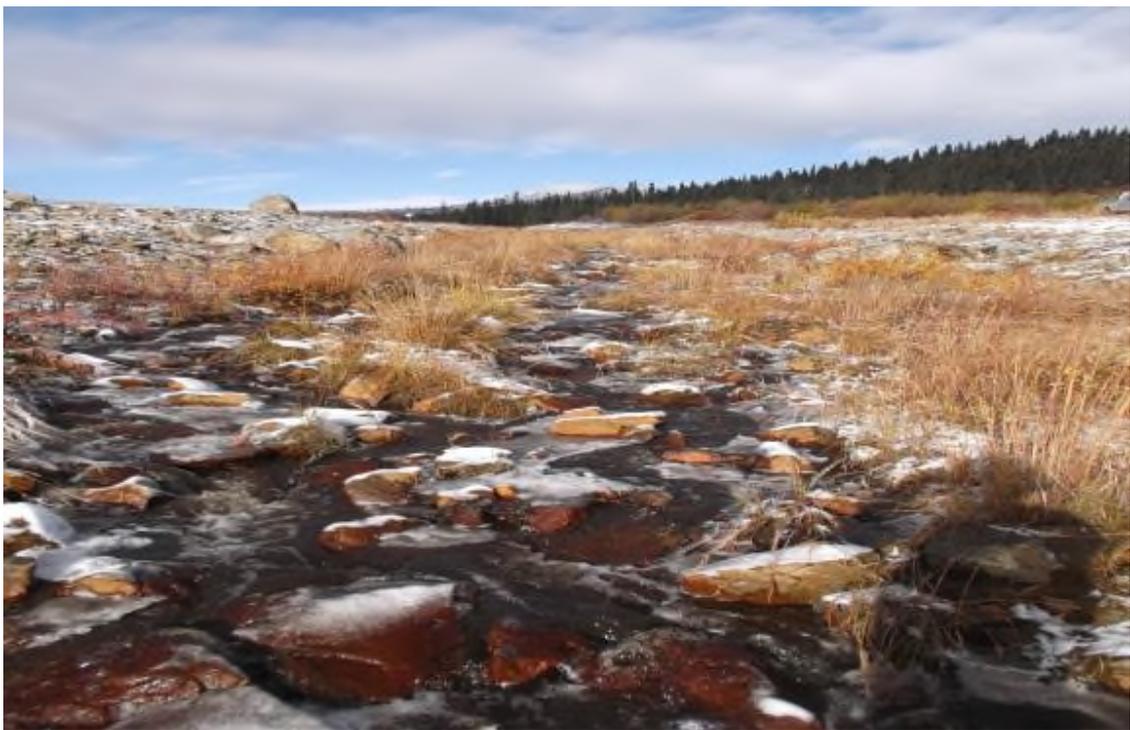
Repairs to the spillway at the Mount Nansen site

On September 26, 2013, the site operator at the Mount Nansen site (Denison Environmental Services) began the repair of the erosion scar in the spillway, following the recommendations in the EBA Geotechnical inspection report from June 2013. Jeff Moore, a representative from the Assessment and Abandoned Mines Branch (AAM) was onsite during the repairs to ensure the repairs were completed according to the recommendations put forth by EBA.

The rip rap material used to armour the bank of the spillway was sourced from 2 piles of material from the south side of the spillway. These piles were sampled by EBA in June during the geotechnical inspection and analyzed for acid rock potential. Three samples were collected and analyzed, with one sample potentially acid generating (PAG). On September 13, an EBA representative arrived on-site and began to sort and mark the rock from these piles that could be used for rip rap in the repairs of the spillway. These rocks were marked with orange paint, and with the assistance of the site operations staff, were placed in a separate pile where they could be used for the spillway repairs.
