June 15, 2012

Yukon Government
Faro Mine Remediation Project
Suite 2C-4114-4th Ave
PO Box 2703 (K-149)
Whitehorse, Yukon Territory
Y1A 2C6

Faro Mine Complex
2011 Annual Geotechnical Review

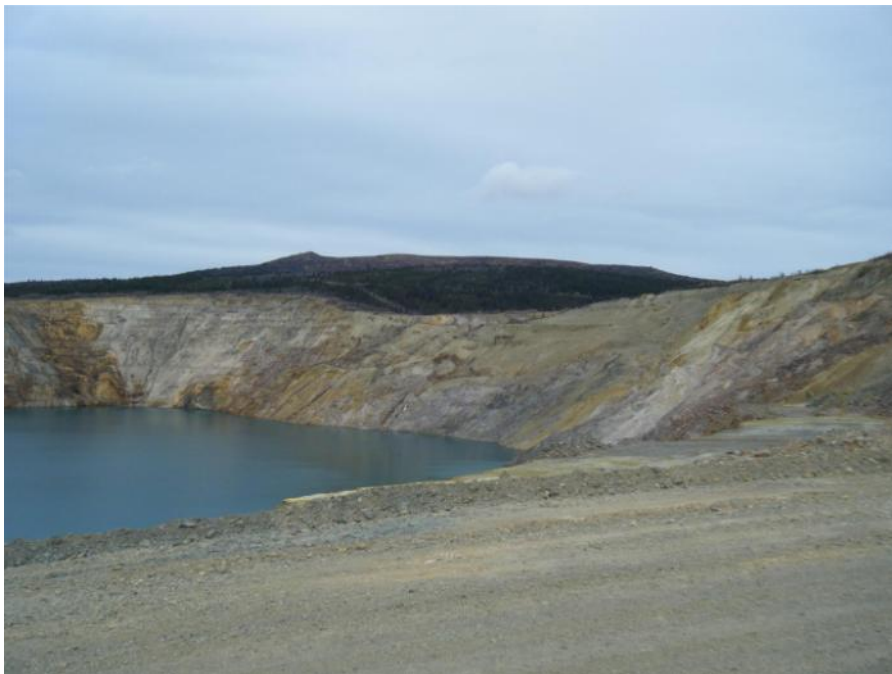
Photo 2 East wall of Faro Pit as seen from south (September 21, 2011)

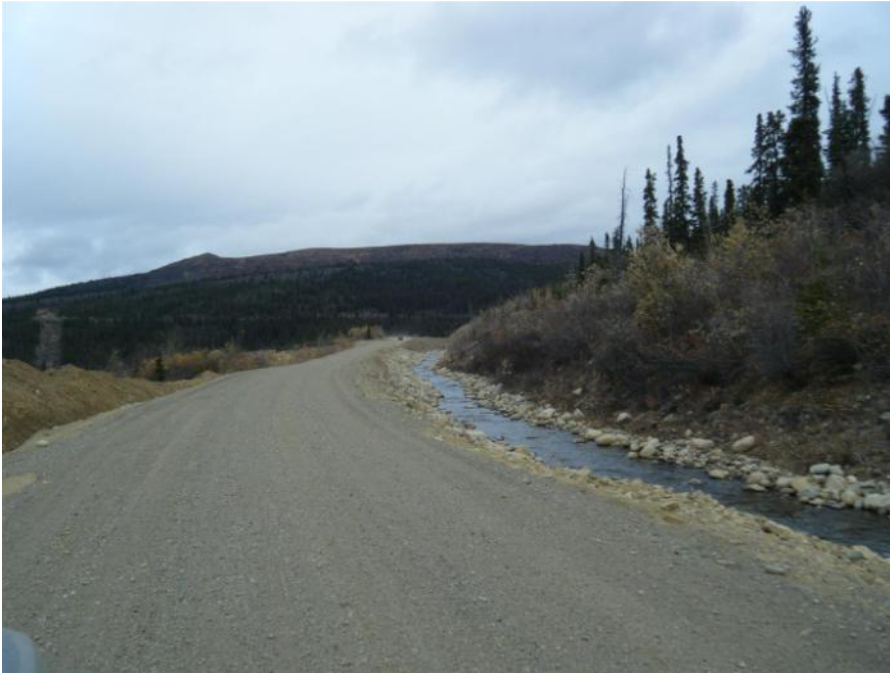
Photo 3 Faro Creek Diversion Ditch above Faro Pit, looking upstream
(September 20, 2011)

- Continue visual monitoring of diversion channel and any seepage from the channel to the Faro Pit wall with photos taken at strategic locations.
- Cover exposed geotextile and tarp in the diversion channel with rock armour. Replace damaged geotextile and tarp prior to rock armour placement.

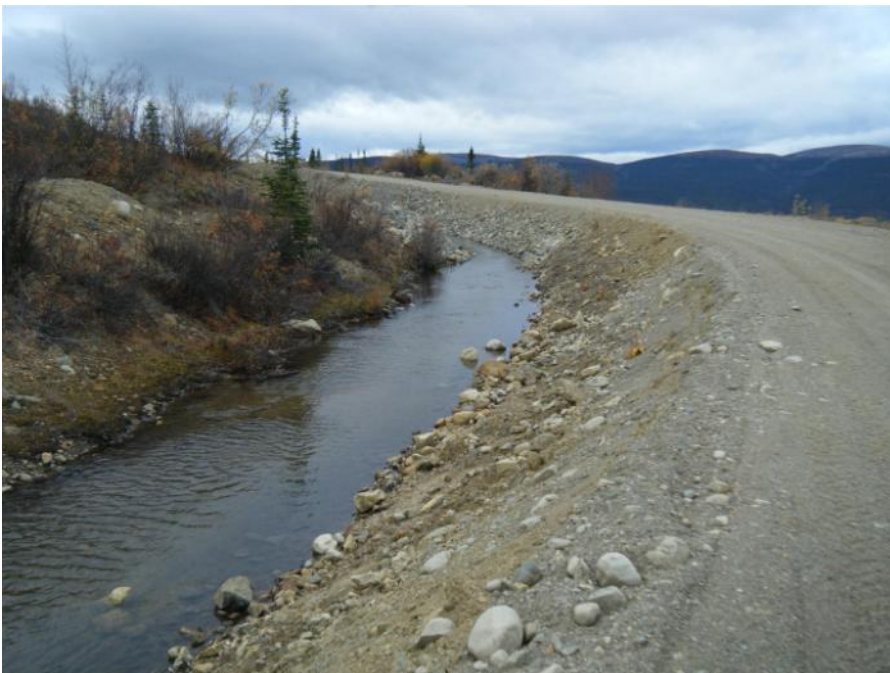
Photo 4 Faro Creek Diversion Ditch above Faro Pit, looking downstream
(September 20, 2011)

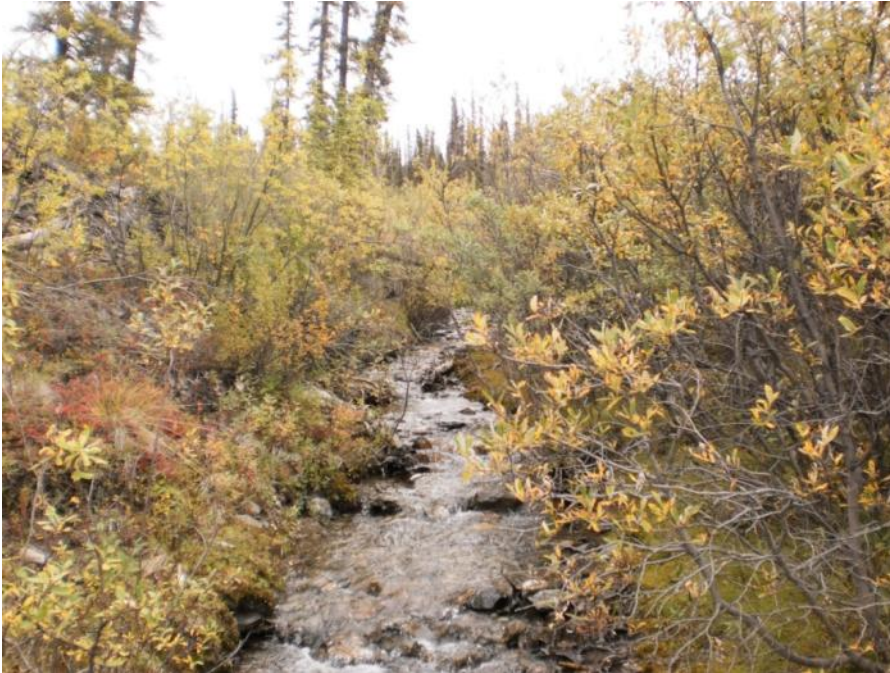
Photo 5 Interceptor ditch near beginning reach – looking upstream
(August 23, 2011)

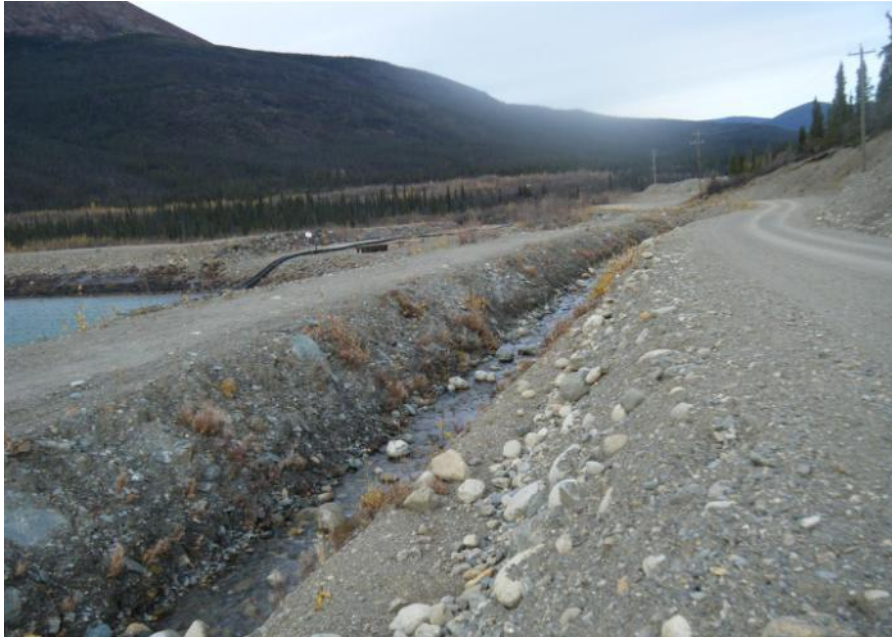
Photo 7 Lower reach of North Valley Wall Interceptor Ditch adjacent to Cross Valley Pond (September 20, 2011)

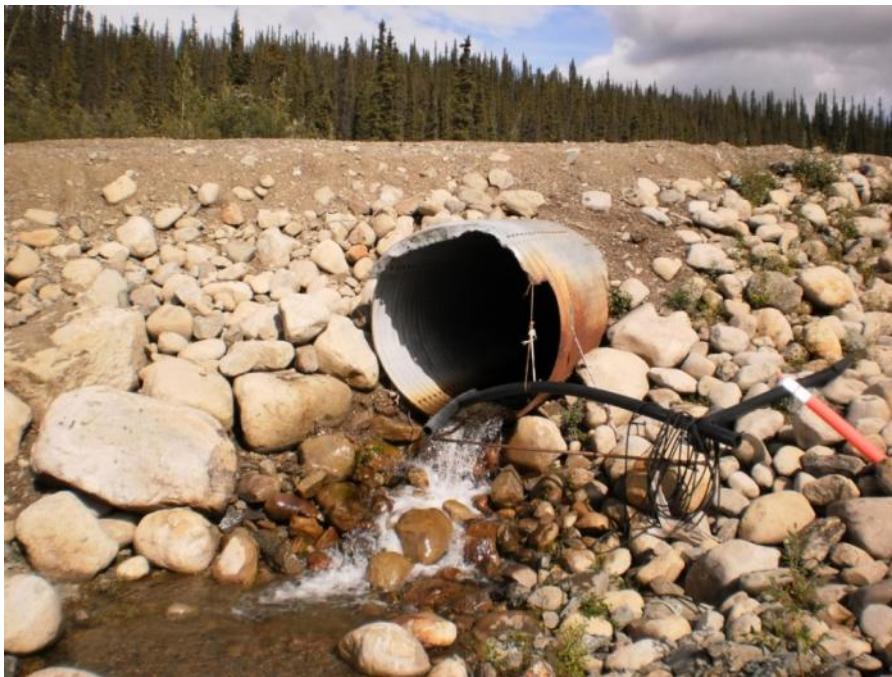
Photo 8 Culvert discharge from Interceptor Ditch adjacent to Cross Valley Pond (August 23, 2011)

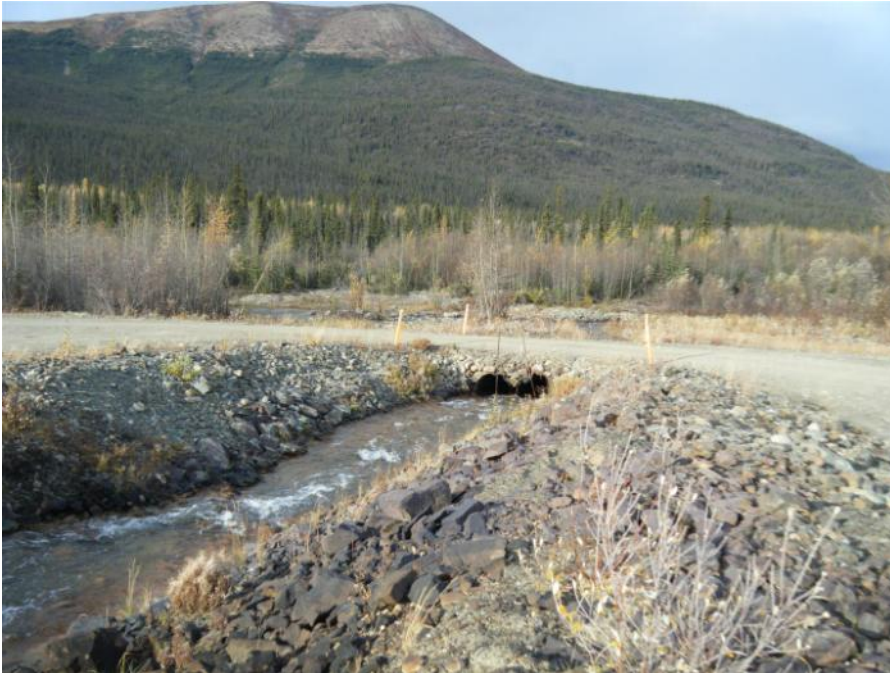
Photo 9 Interceptor Ditch culverts across access road below Cross Valley Dam (September 20, 2011)

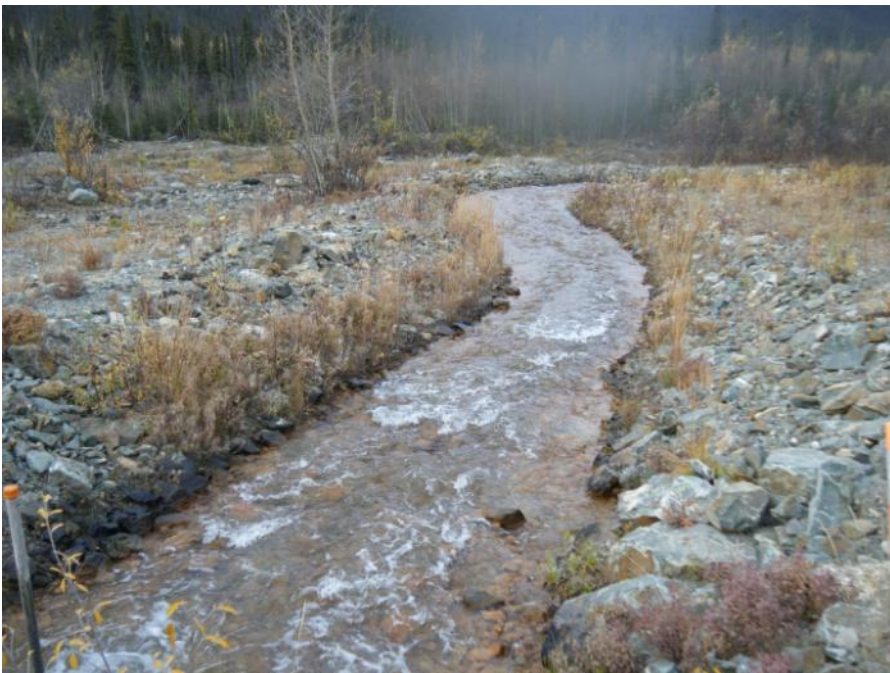
Photo 10 Interceptor Ditch below Cross Valley Dam, looking downstream (September 20, 2011)

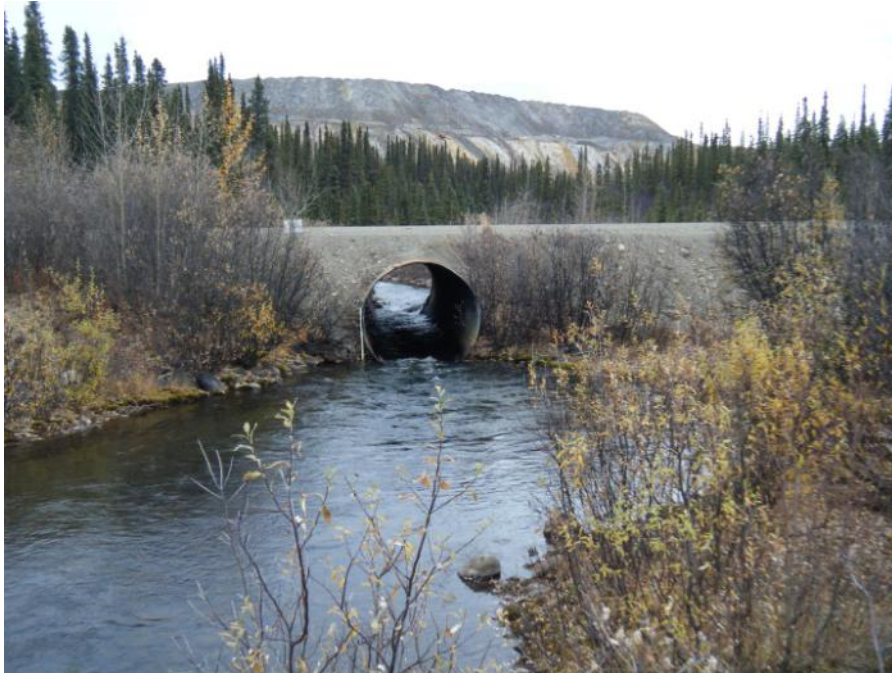
Photo 11 Rose Creek North Fork culvert under main road (September 21, 2011)

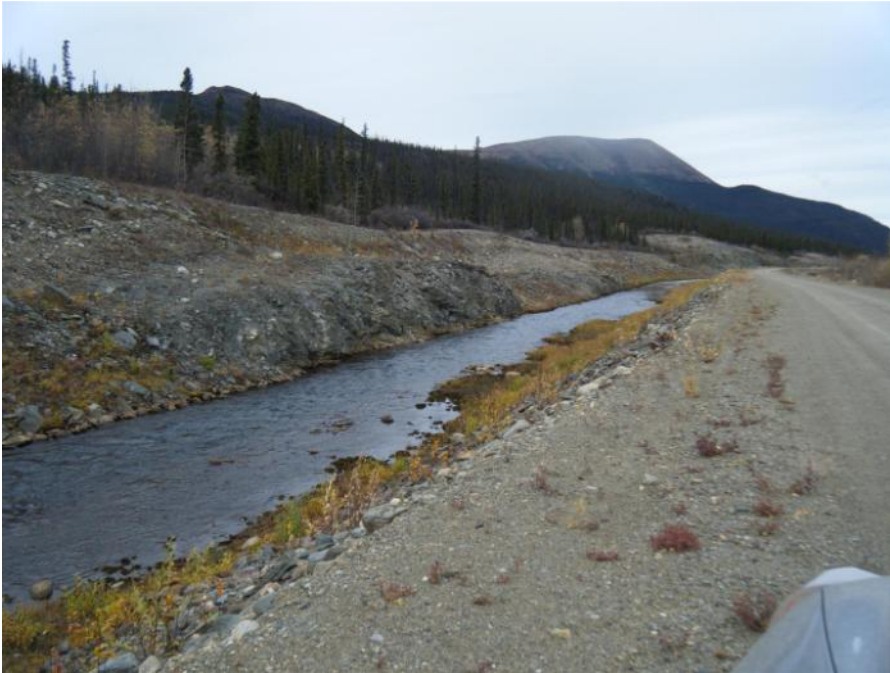
Photo 13 **Rose Creek Diversion Channel downstream of Fuse Plug
(September 21, 2011)**

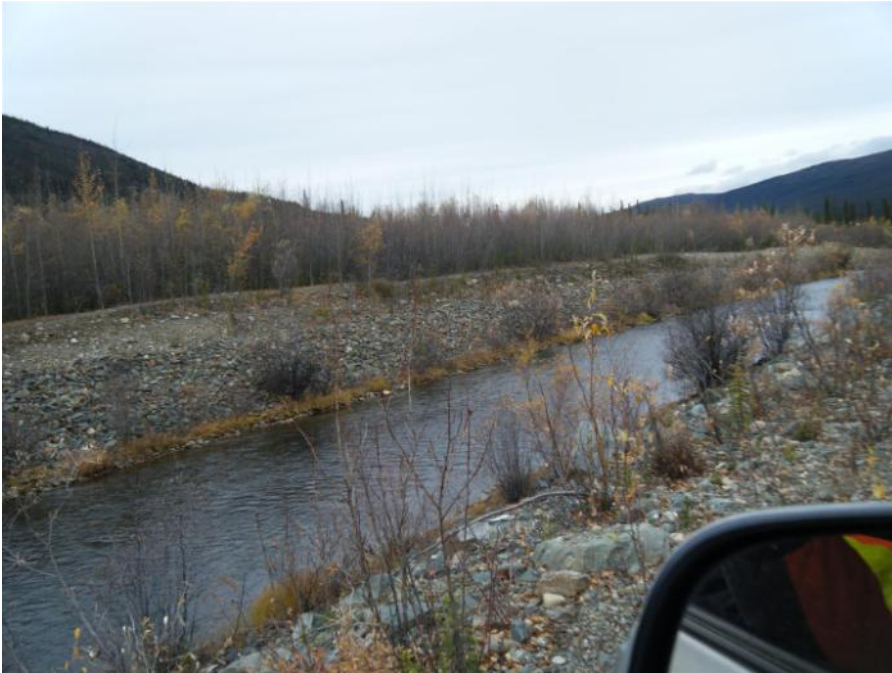
Photo 15 Rose Creek Diversion Channel (September 21, 2011)

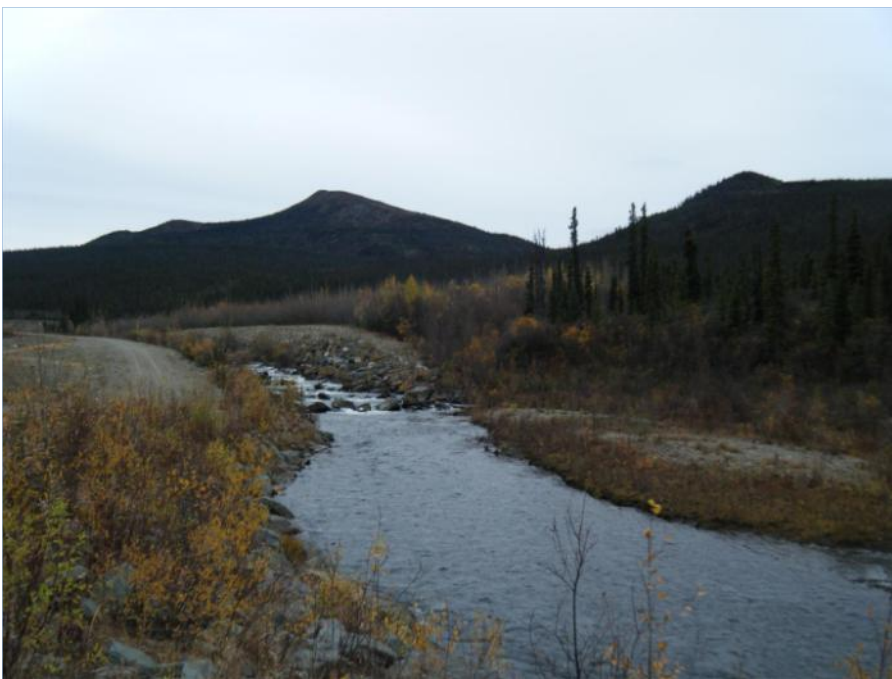
**Photo 16 Downstream end of Rose Creek Diversion Channel
(September 21, 2011)**

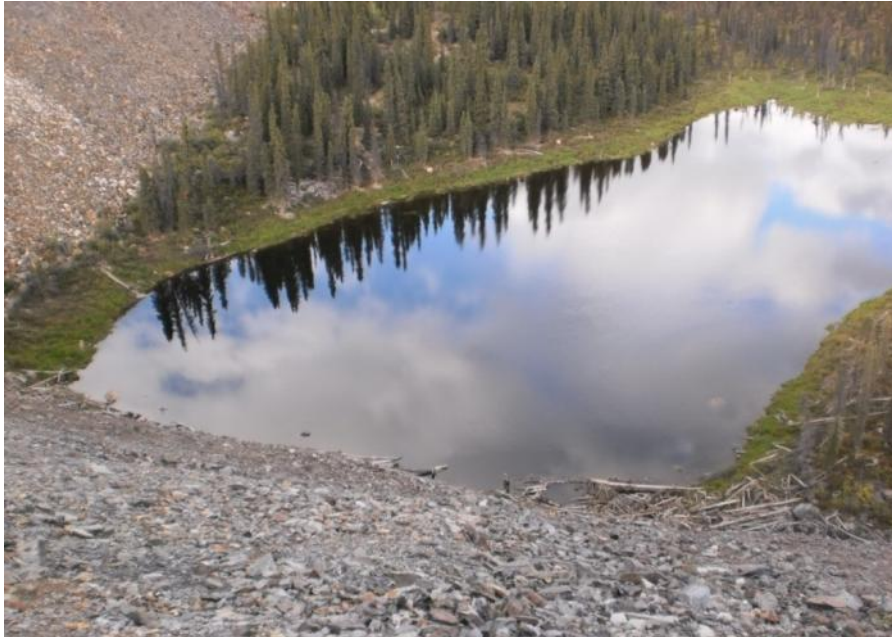
Photo 17 Wood debris on upstream slope of Access Road between Faro and Vangorda Plateau (August 23, 2011)

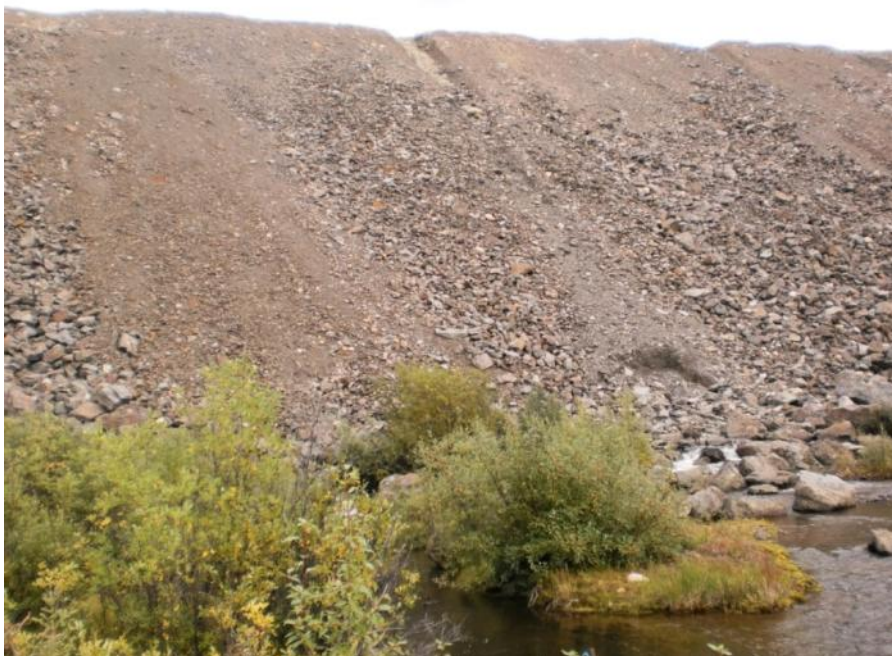
Photo 18 Downstream slope of Access Road between Faro and Vangorda Plateau (August 23, 2011)

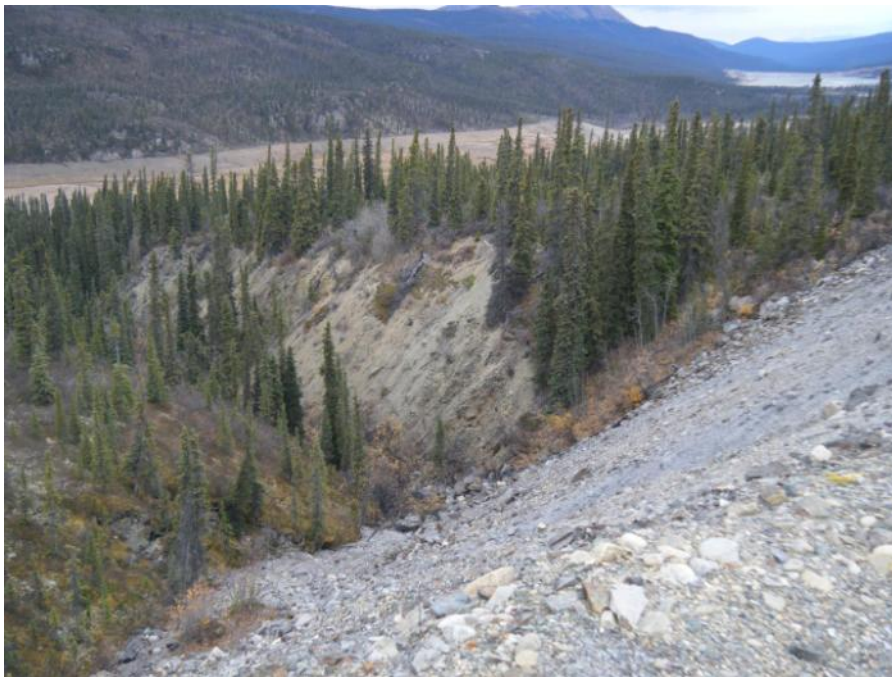
Photo 20 K8 Creek downstream outlet (September 20, 2011)

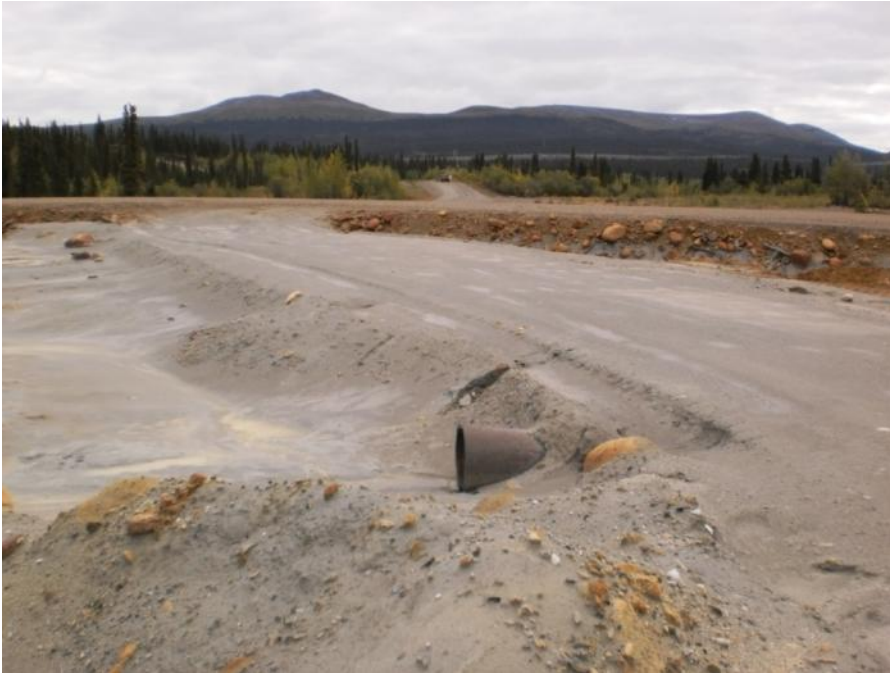
Photo 21 Junction of Original Tailings Dam (foreground) and Secondary Tailings Dam (background, August 23, 2011)

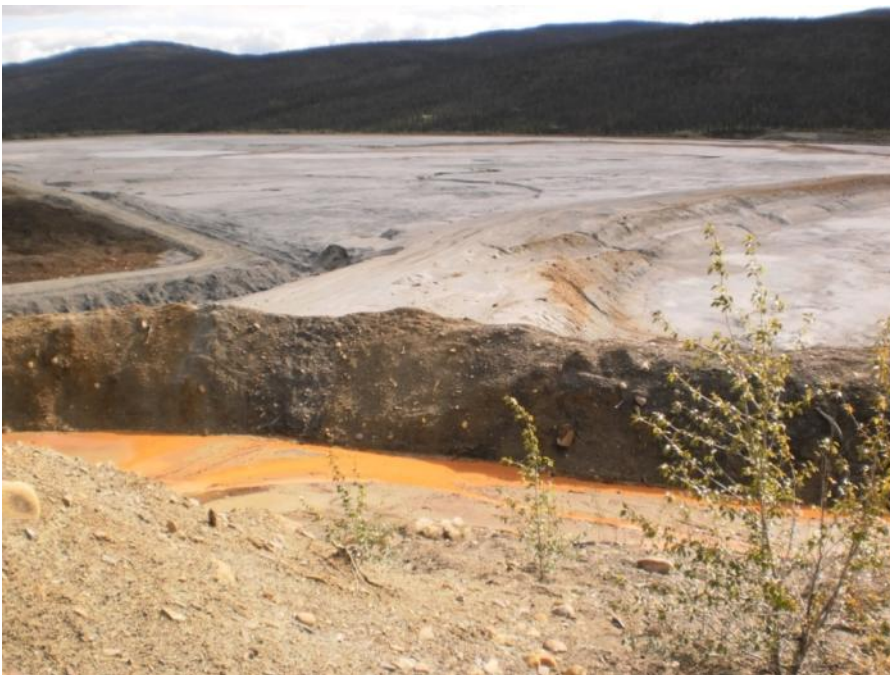
Photo 22 North end of Original Tailings Dam - a ditch in the foreground separating the dam with north abutment (August 23, 2011)

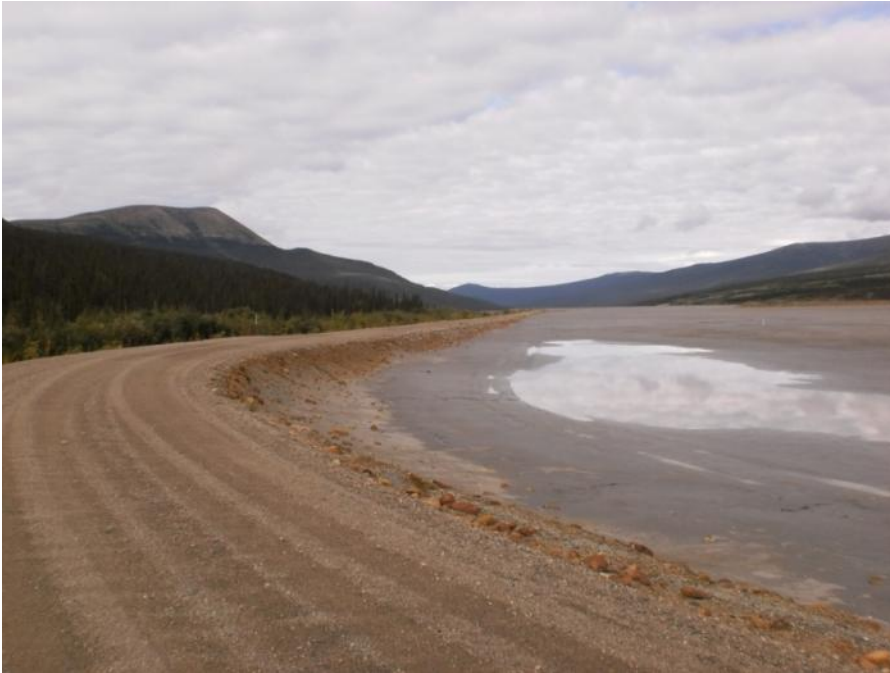
Photo 23 Southeast corner of Secondary Dam – looking northwest (August 23, 2011)

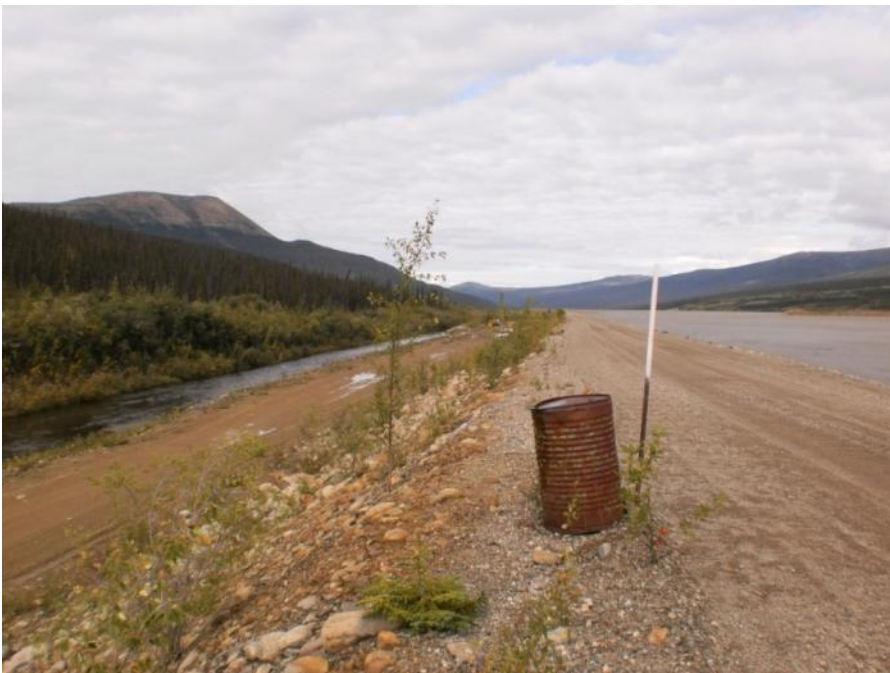
Photo 24 Secondary Tailings Dam - Rose Creek Diversion Channel on left and tailings beach on right (August 23, 2011)

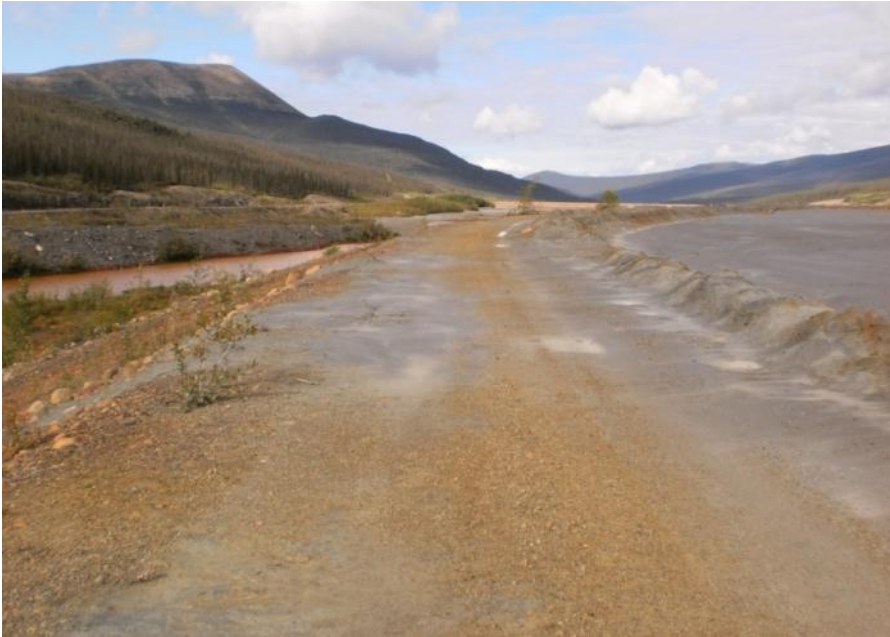
- The crest, upstream and downstream slopes appeared to be stable.
- No evidence of seepage along the downstream slope.
- Lower road conditions were satisfactory.
- A row of tailings piles was located on the upstream shoulder of the crest along the southwest portion of the dam. Tailings deposits covering the dam crest in the area were eroded by runoff from this row of tailings piles (see Photo 25).
- Cracks that were observed previously along the downstream road in the vicinity of the upstream end of the Rose Creek Diversion Channel were not seen, possibly due to road grading work.

Photo 25 Dam crest near the vicinity where the diversion channel and tailings dam alignment begin to diverge – note tailings pile along upstream crest shoulder (August 23, 2011)

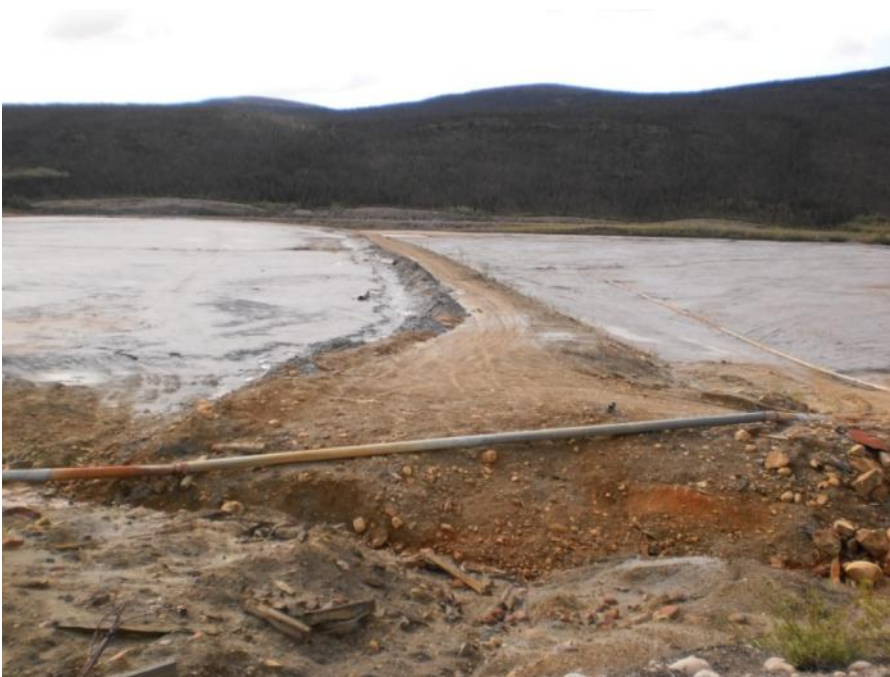
Photo 26 North end of Secondary Dam - a ditch in the foreground separating the dam with north abutment (August 23, 2011)

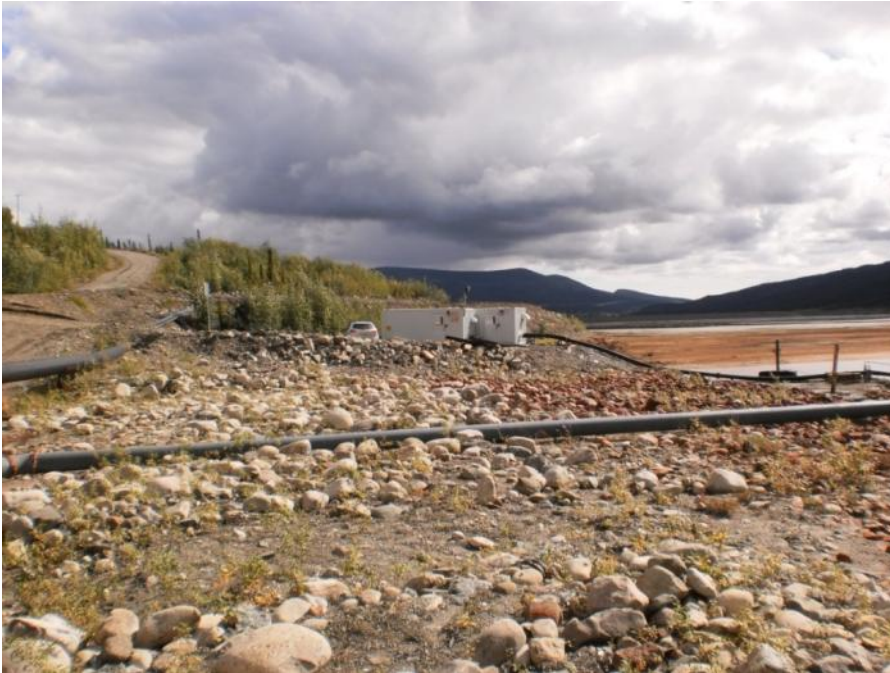
Photo 27 Upstream spillway approach channel at northeast abutment of Intermediate Dam (August 23, 2011)

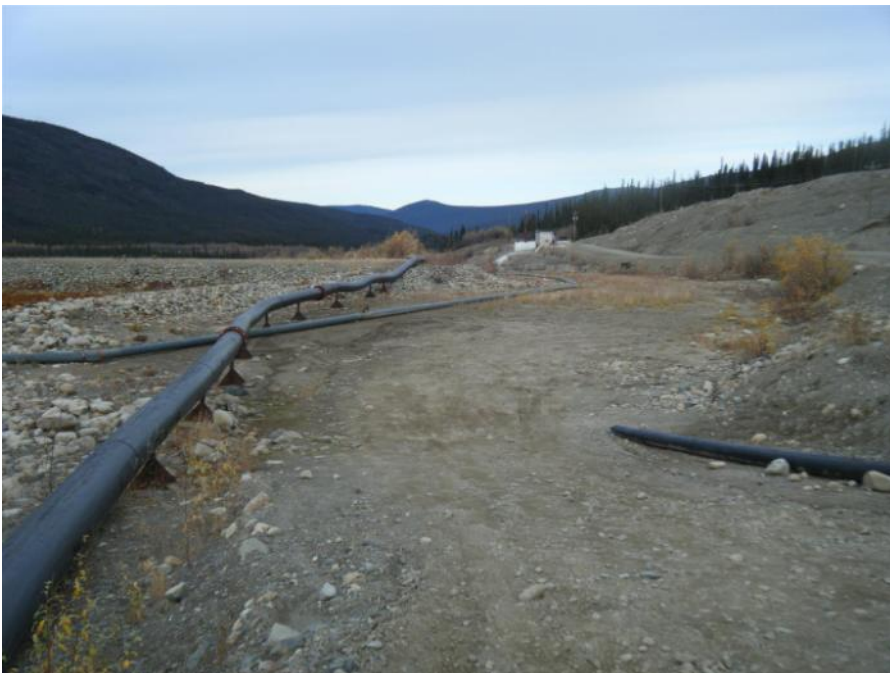
Photo 28 Intermediate Dam spillway channel - looking downstream (September 21, 2011)

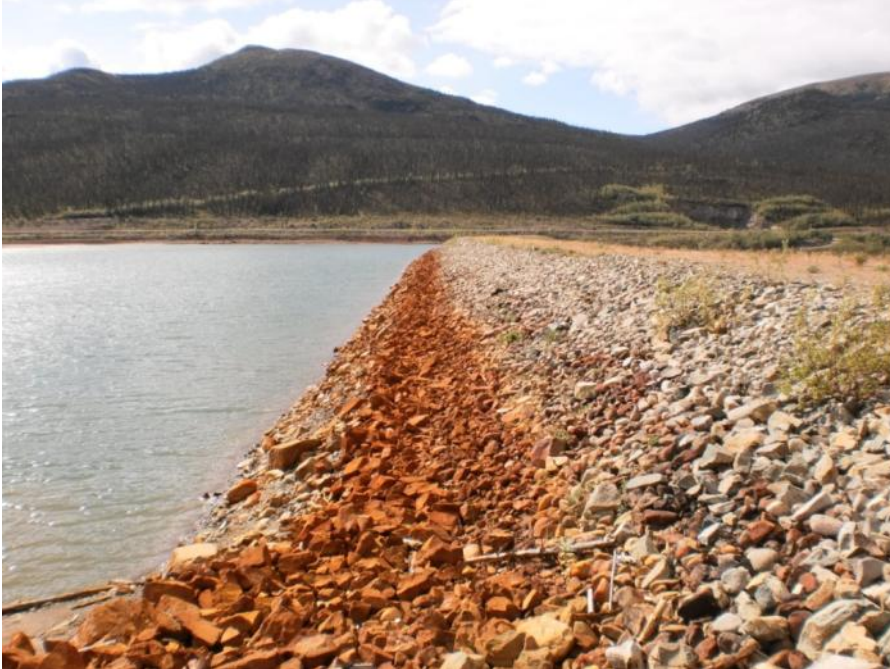
- Near south abutment, minor upstream slope fill adjustment was noted (see Photo 33).
- Wave erosions of upstream slope were closely inspected at different elevations (see Photos 29 to 31).

Photo 29 Upstream slope of Intermediate Dam - looking southwest
(August 23, 2011)

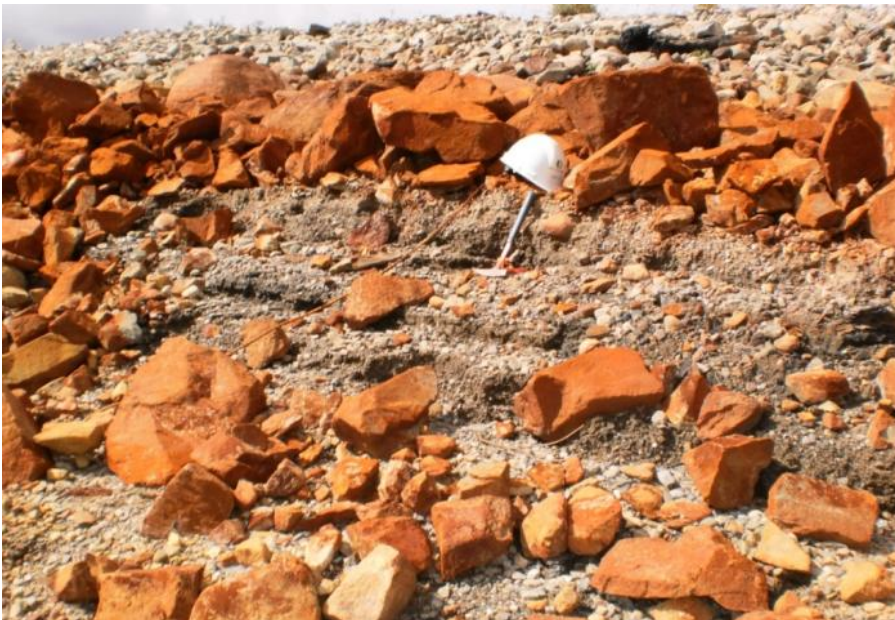
Photo 30 Wave erosion zone on upstream slope marked by hard hat and hammer
(August 23, 2011)

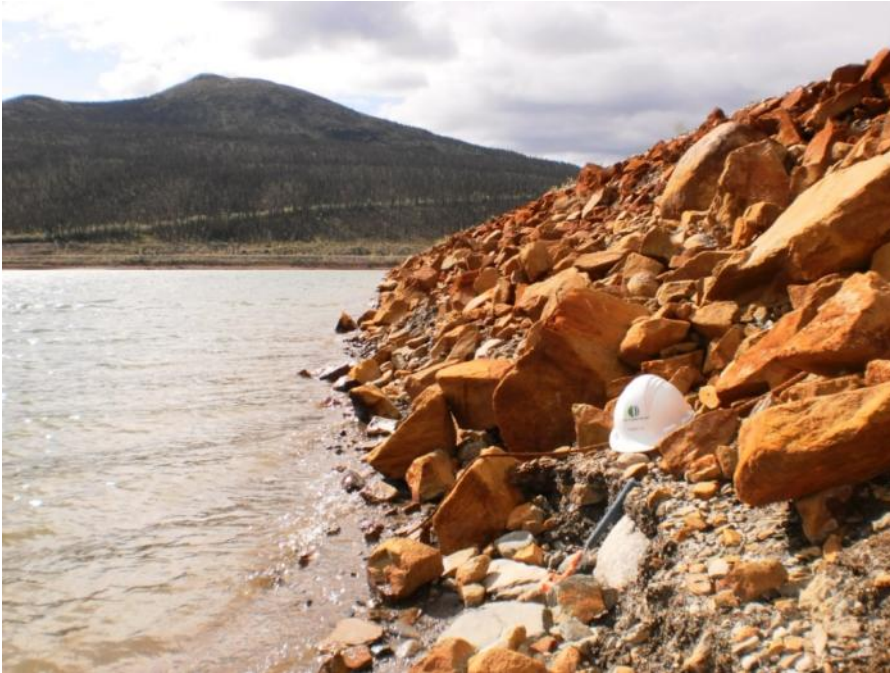
Photo 31 Wave erosion zone on upstream slope near pond level marked by hard hat and hammer (August 23, 2011)

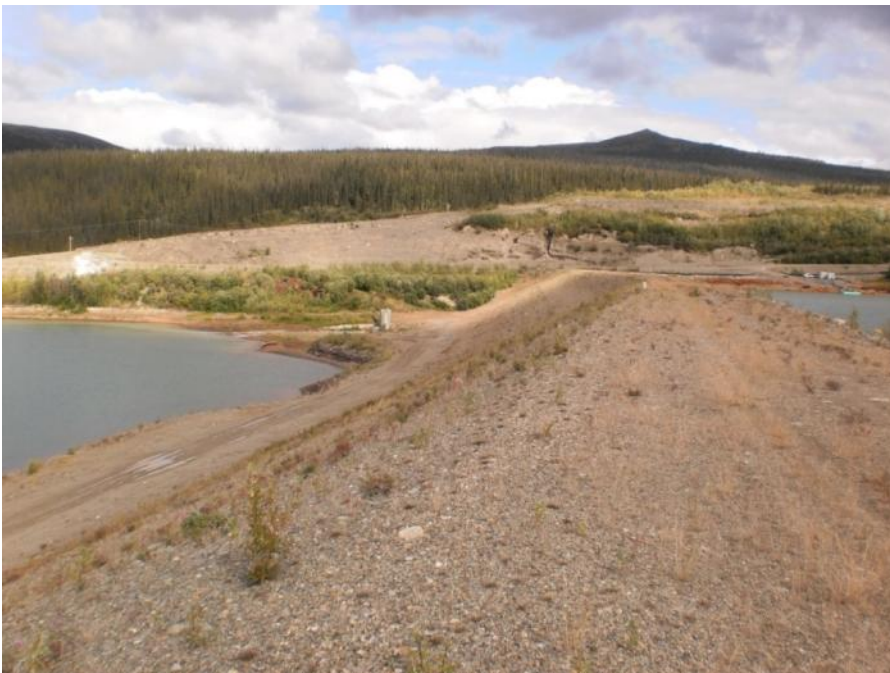
Photo 32 Northeast portion of dam crest and upstream slope (August 23, 2011)

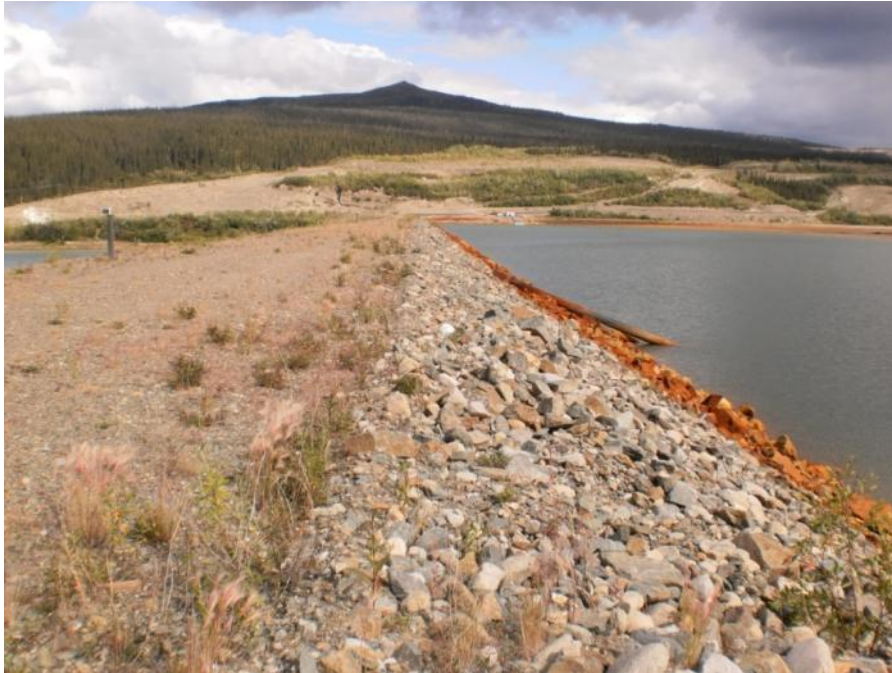
Photo 33 Southwest portion of dam crest and upstream slope (August 23, 2011)

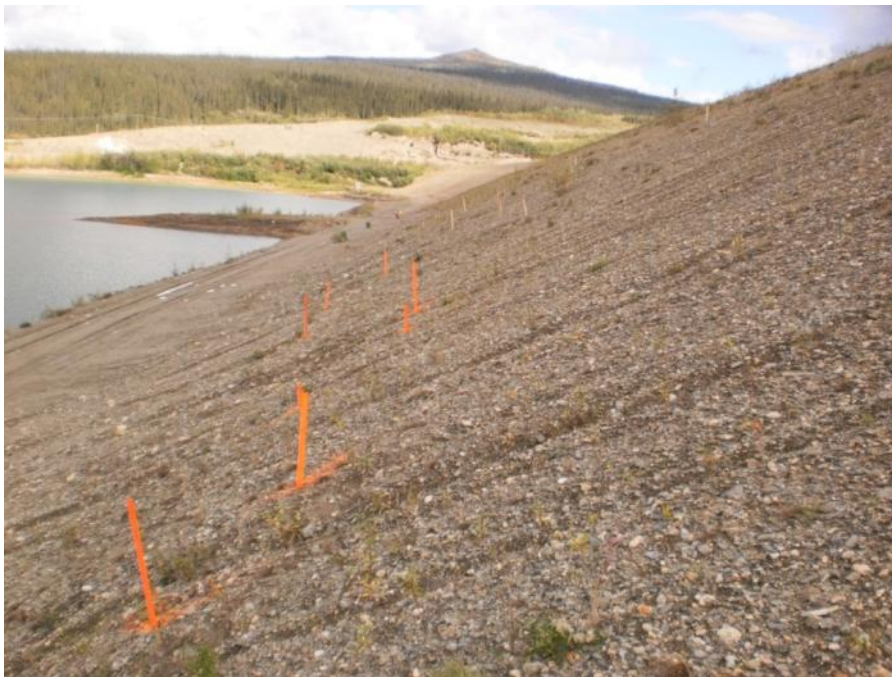
- Downstream slope is experiencing extensive rill erosion (see Photos 34 and 38), with longitudinal cracks and minor slope slumps developing (see Photo 35), and eroded materials are depositing on the downstream berm, which had been graded for berm maintenance, thus was not very apparent.

- DES placed wooden stakes on the downstream slope in the southwest portion to assist ongoing monitoring (see Photos 34 and 35).
- Significant shoulder erosion of the downstream berm was also observed at numerous locations, which require repair (see Photo 36).

Photo 34 Rill erosion along downstream slope (August 23, 2011)

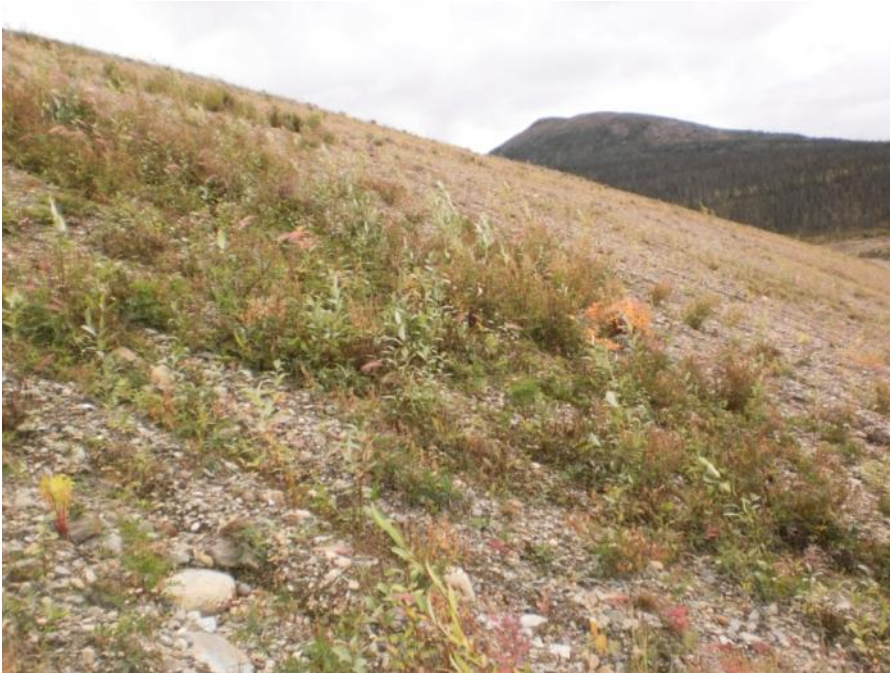
Photo 37 Less rill erosion over vegetated portion of downstream slope (August 23, 2011)

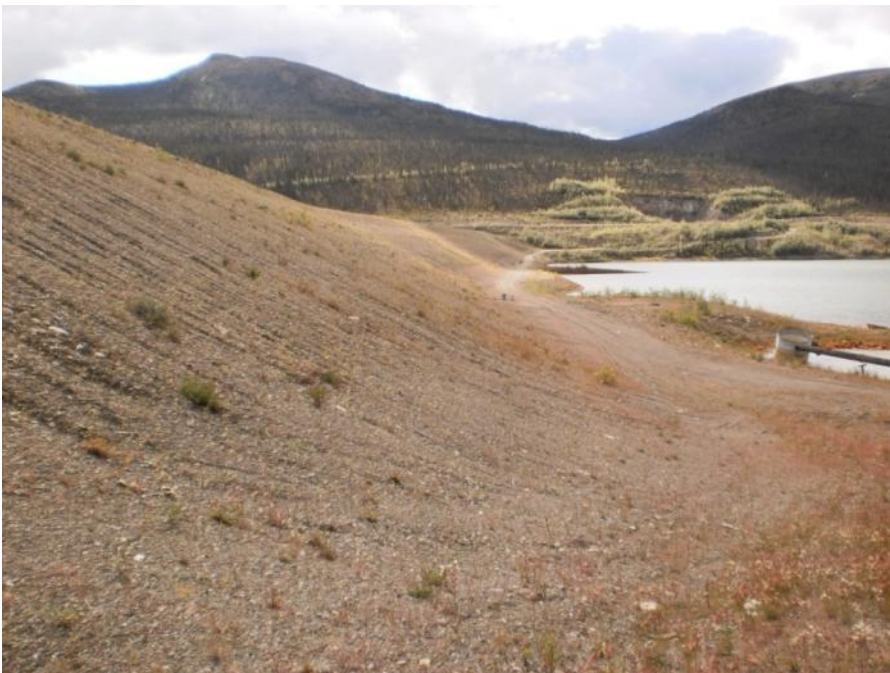
Photo 38 Northeast portion of downstream dam slope (August 23, 2011)

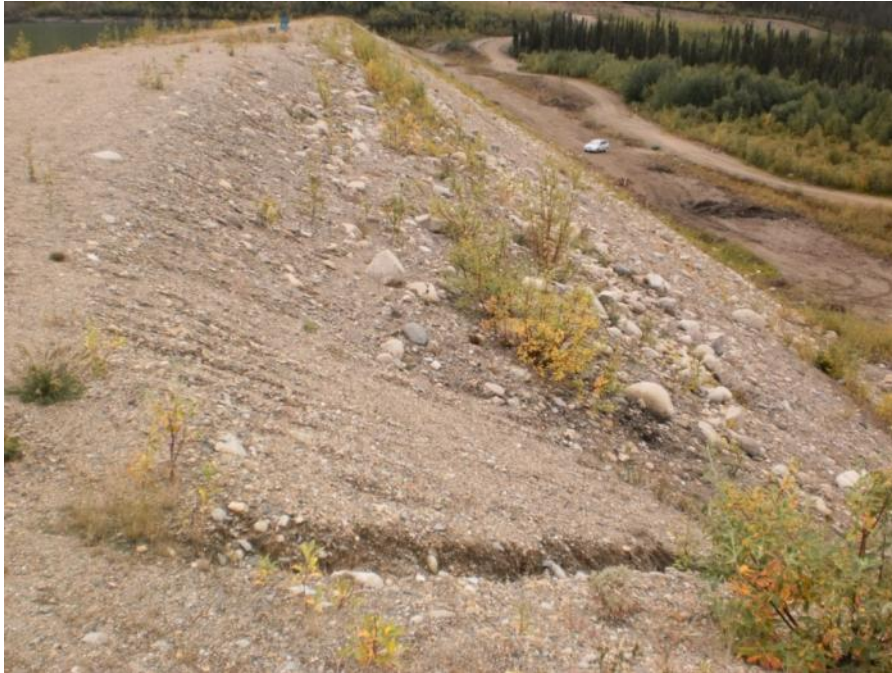
Photo 39 Crest and downstream slope of northeast portion of dam - note rill and gully erosion on slope (August 23, 2011)

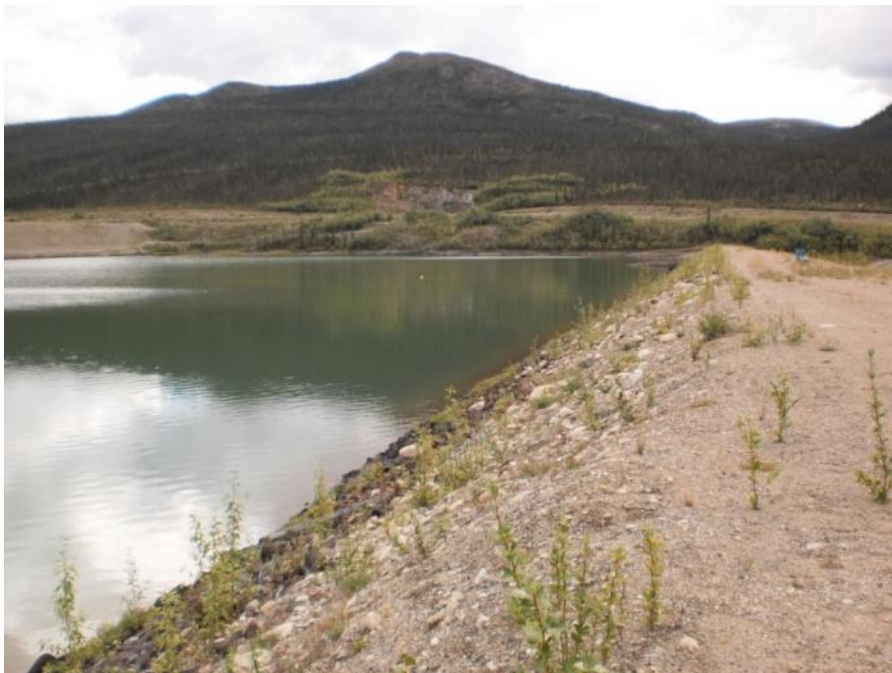
Photo 40 Crest and upstream slope of northeast portion of dam (August 23, 2011)

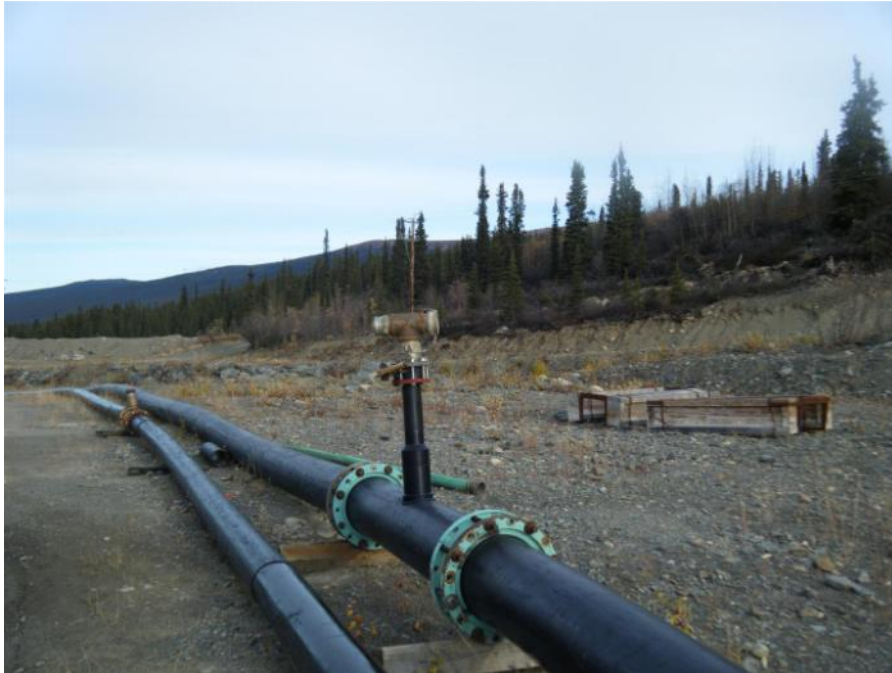
Photo 41 Cross Valley Pond siphon pipeline on spillway channel (September 21, 2011)

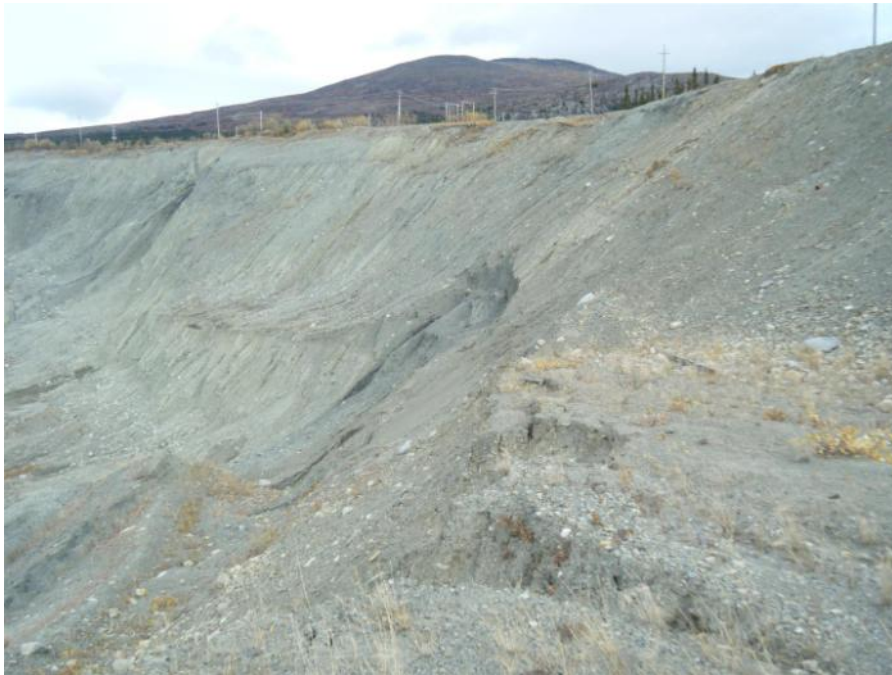
- There appears to be a new slump on the southeast wall of the pit (see Photo 46).

Photo 46 Grum Pit east wall - note new slump in foreground (September 20, 2011)

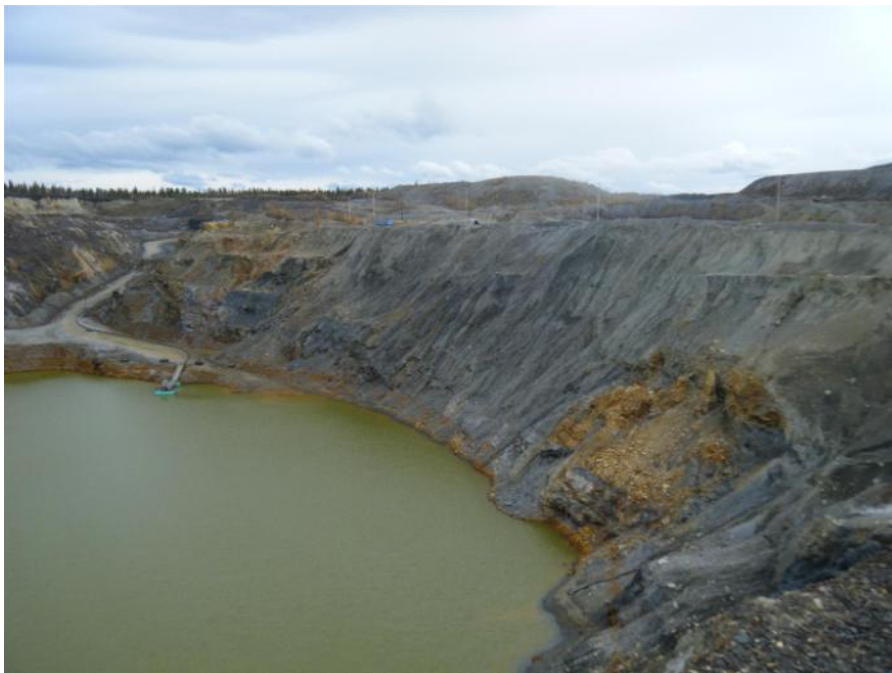
We understand that, currently, there is a pump barge that pumps water to the water treatment plant (see Photo 48).

Photo 48 Vangorda Pit as seen from northwest wall toward southeast
(September 20, 2011)
