June 15, 2012

Yukon Government
Faro Mine Remediation Project
Suite 2C-4114-4th Ave
PO Box 2703 (K-149)
Whitehorse, Yukon Territory
Y1A 2C6

Faro Mine Complex
2011 Annual Geotechnical Review

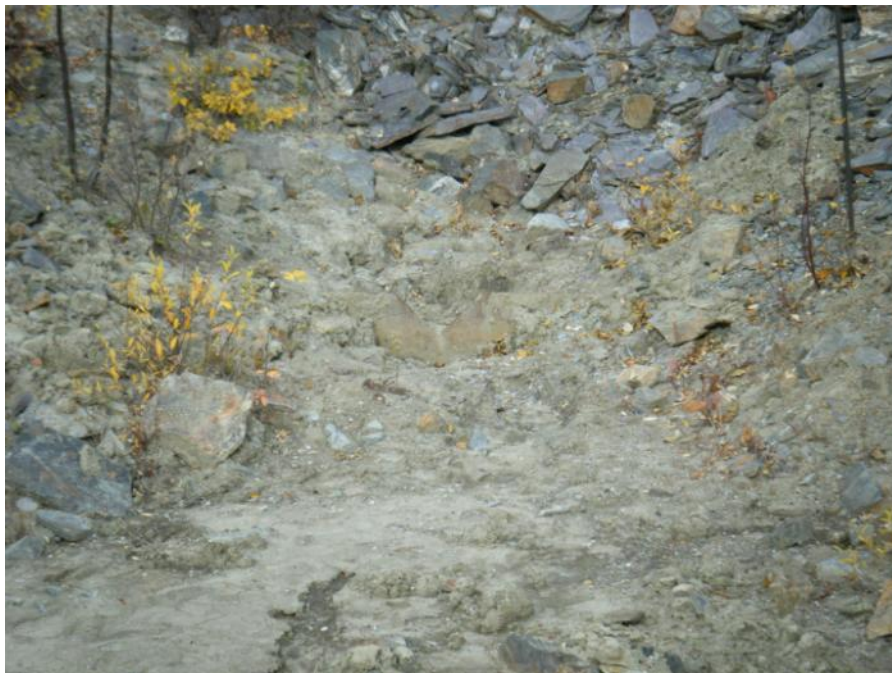
- Drain No. 1 – The drain was dry (see Photos 54 and 56), and does not have a weir. DES reported that the drain is usually dry.
- Drain No. 2 – The drain was dry. DES reported that the drain is usually dry.

Photo 54 Vangorda Waste Dump Drain No. 1 - no weir at this drain (September 20, 2011)

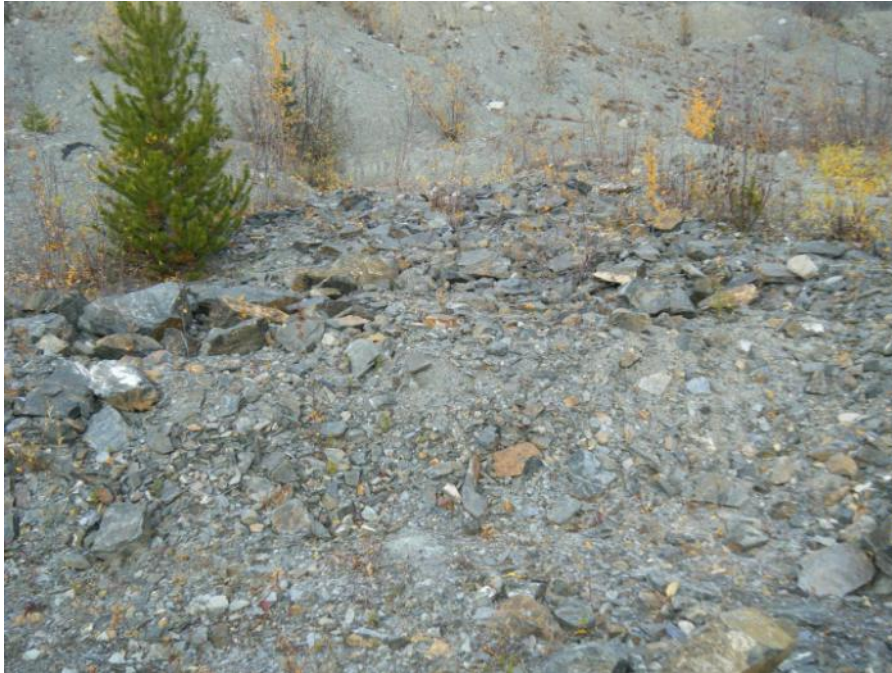
Photo 55 Vangorda Waste Dump Drain No. 1 - no weir at this drain
(September 20, 2011)

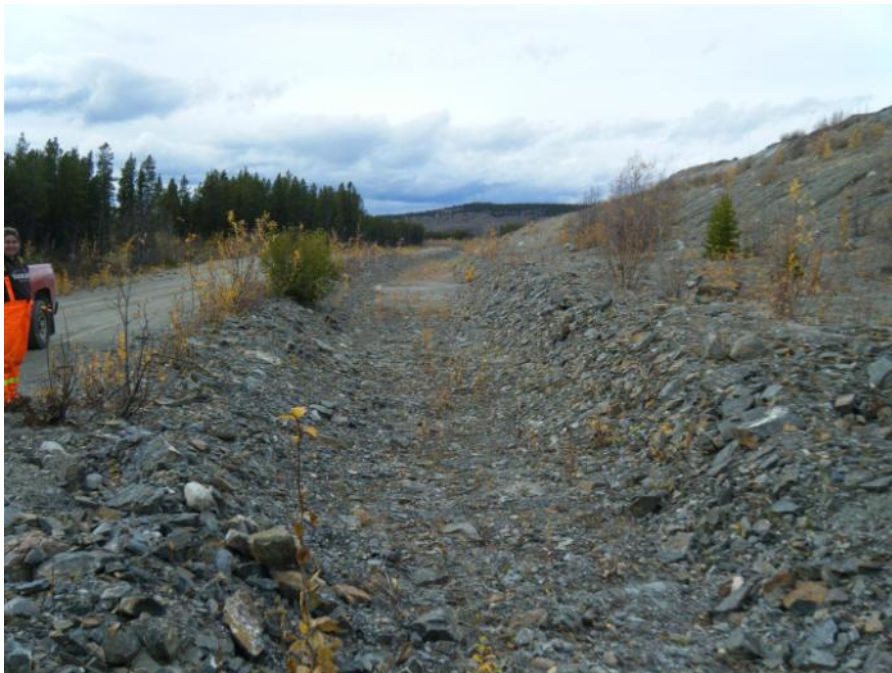
Photo 56 Vangorda Waste Dump Seepage Collection Ditch - looking downstream
from Drain No. 1. (September 20, 2011)

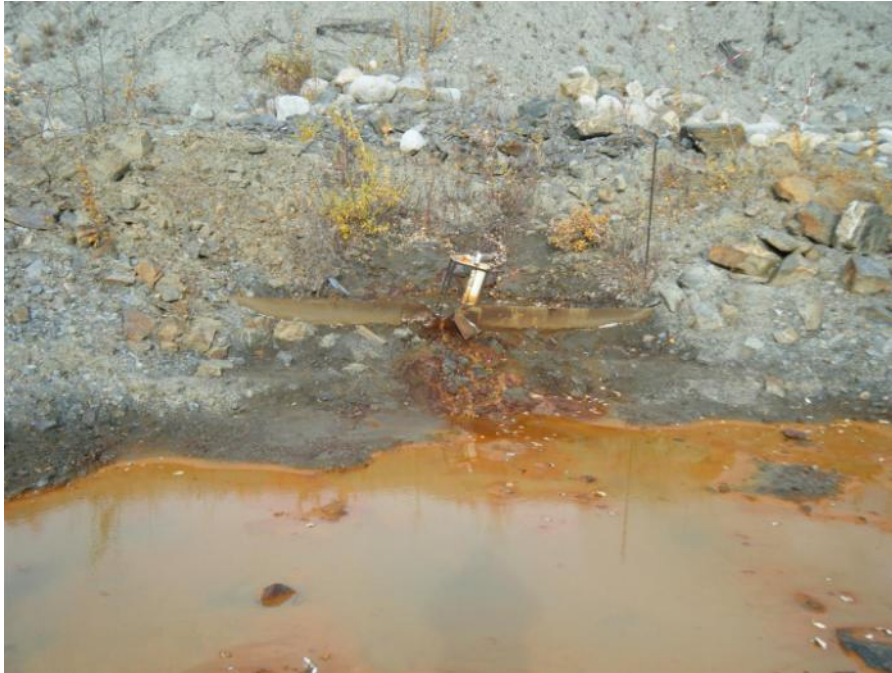
- Drain No. 3 – The staff gauge was tilted, and the weir plate was found to be delaminated (see Photos 57 and 58). DES reported that the flow is usually measured with a bottle and a watch.

Photo 57 Vangorda Waste Dump Drain No. 3 weir (September 20, 2011)

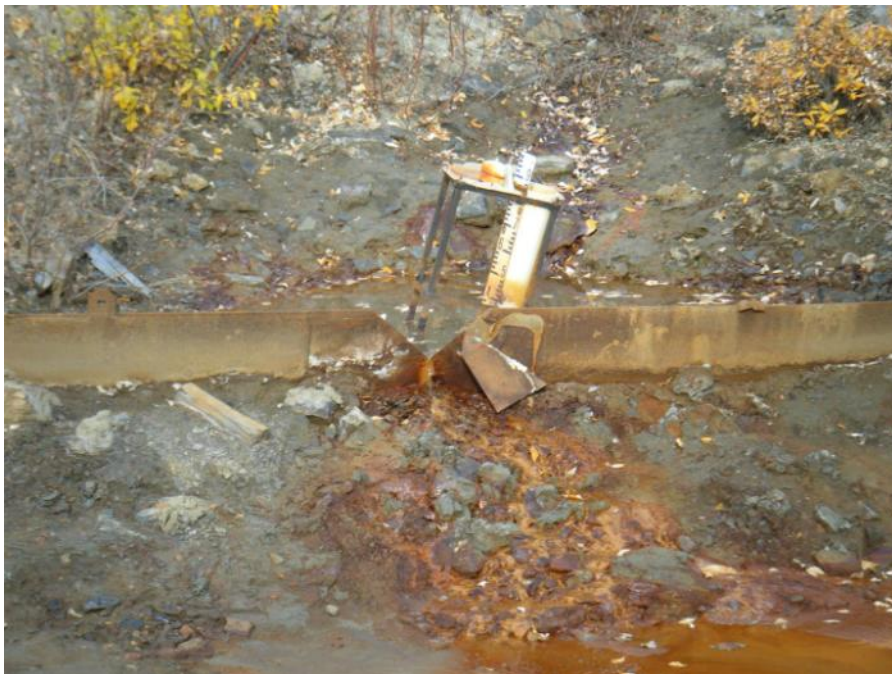
Photo 58 Vangorda Waste Dump Drain No. 3 weir - note delaminated weir plate and crooked staff gauge (September 20, 2011)

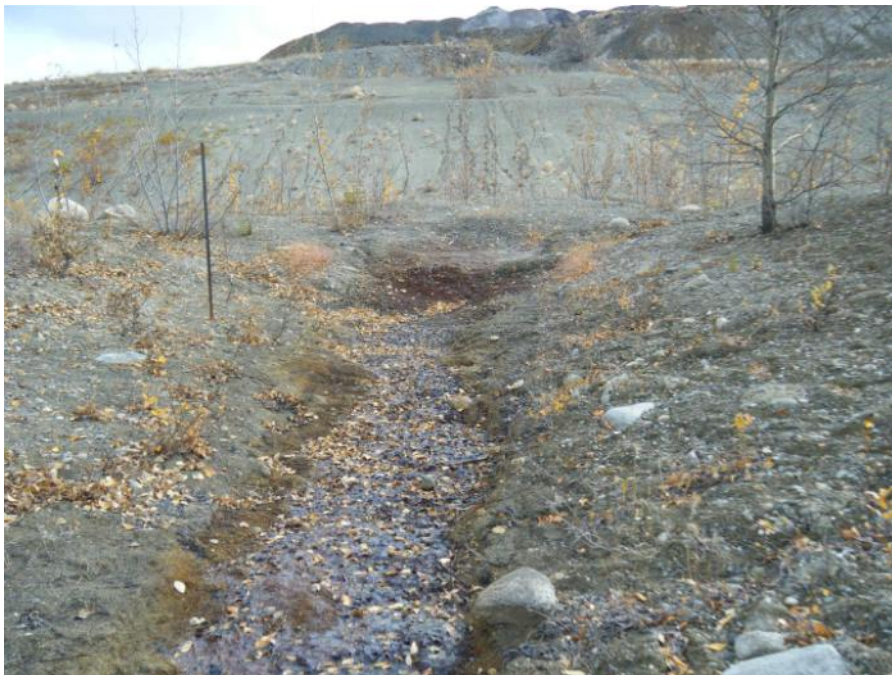
- Drain No. 4 – The drain does not have a weir (see Photo 62). DES reported that usually only a small trickle flows through the drain, and the flow is estimated by eye.

Photo 62 Vangorda Waste Dump Drain No. 4 - no weir at this drain (September 20, 2011)

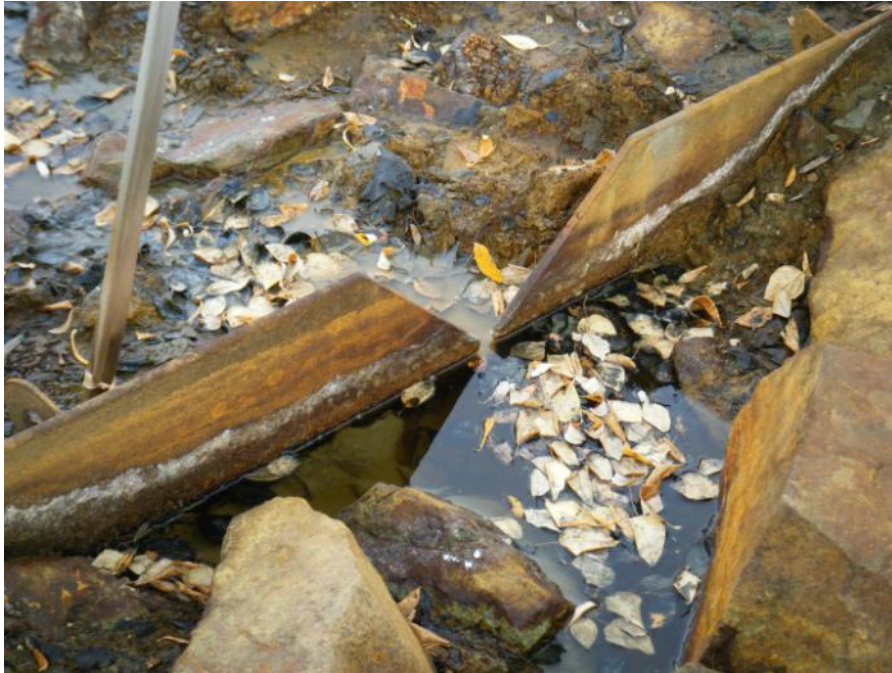
- Drain No. 5 – The weir plate was found to be split into two pieces (see Photo 63). There are boulders in the pool upstream of the weir and the channel invert downstream of the weir appeared to be too high to provide the flow condition required for proper flow measurement.

Photo 63 Vangorda Waste Dump Drain No. 5. Weir – weir plate split into two pieces at the V-notch (September 20, 2011)

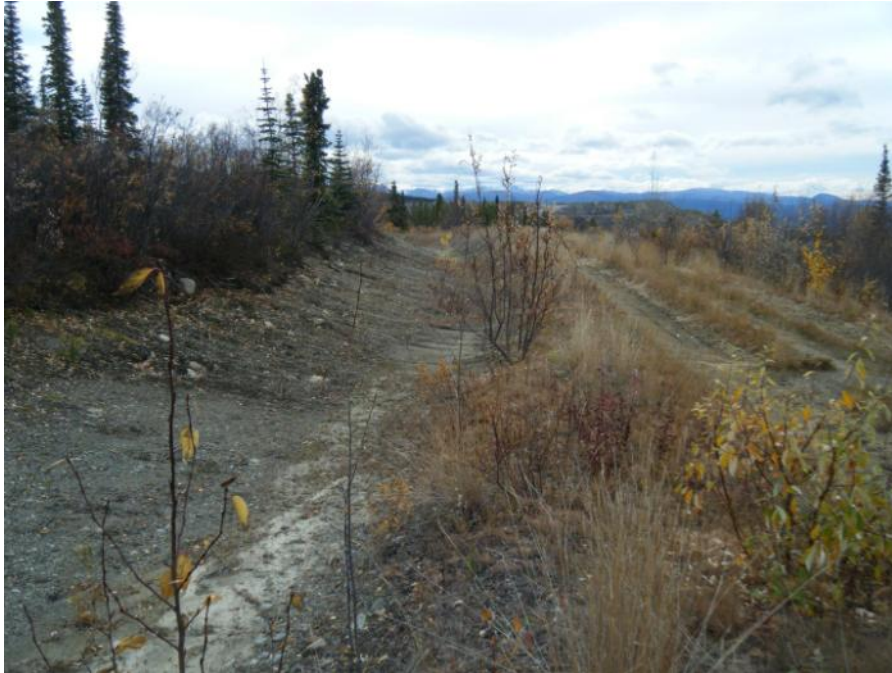
- Flow condition similar to that on May 24-25, 2011.
- Evidence of ditch cleaning (i.e., re-excavation of ditch channel) was noted along the upstream reach, where the ditch appeared to be shallow (see Photo 71).
- Minor ditch side-slope slumps along most of the ditch (see Photo 73).

Photo 71 North-East Interceptor Ditch near its upstream end. Excavator bucket marks indicate recent cleaning of the ditch (September 20, 2011)

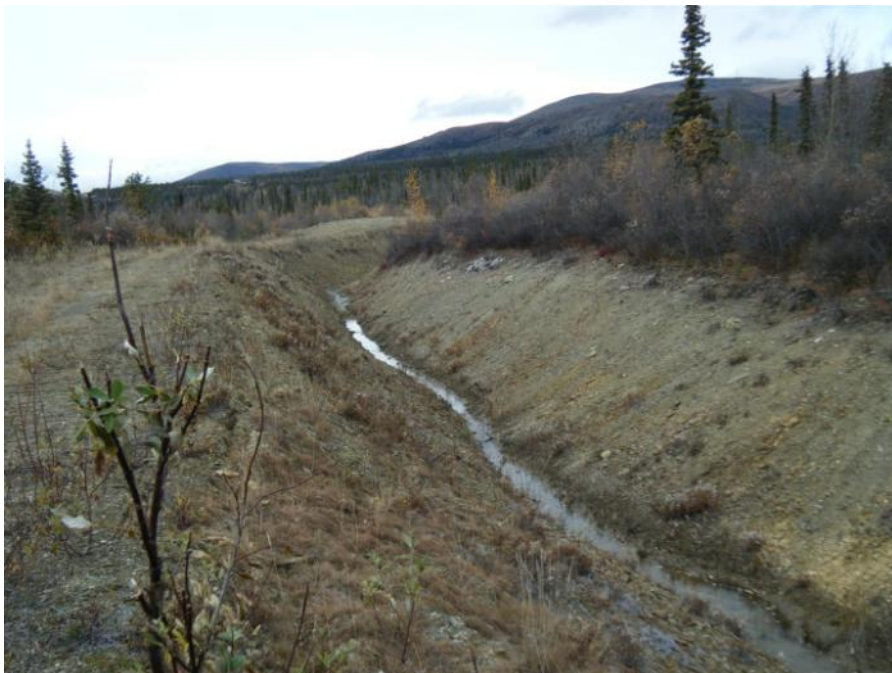
Photo 72 North-East Interceptor Ditch (September 20, 2011)

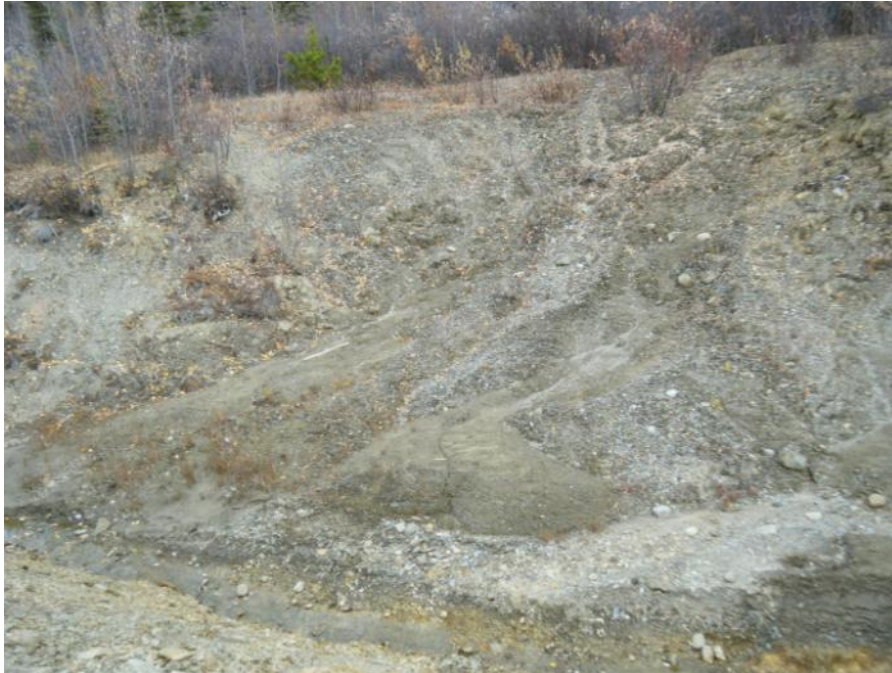
Photo 73 North-East Interceptor Ditch - note slumped side slope (September 20, 2011)

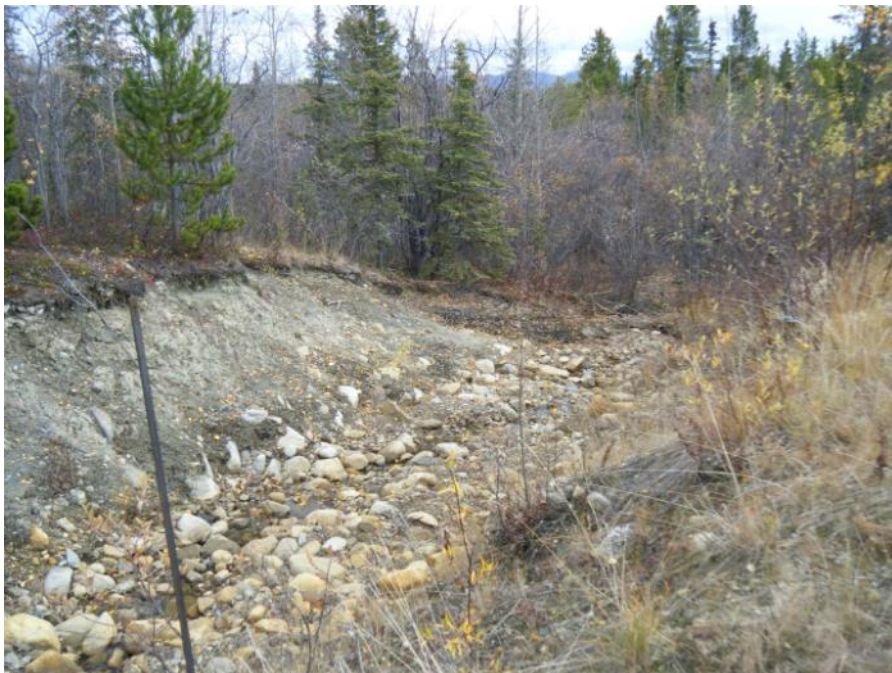
Photo 74 North-East Interceptor Ditch at its downstream end (September 20, 2011)

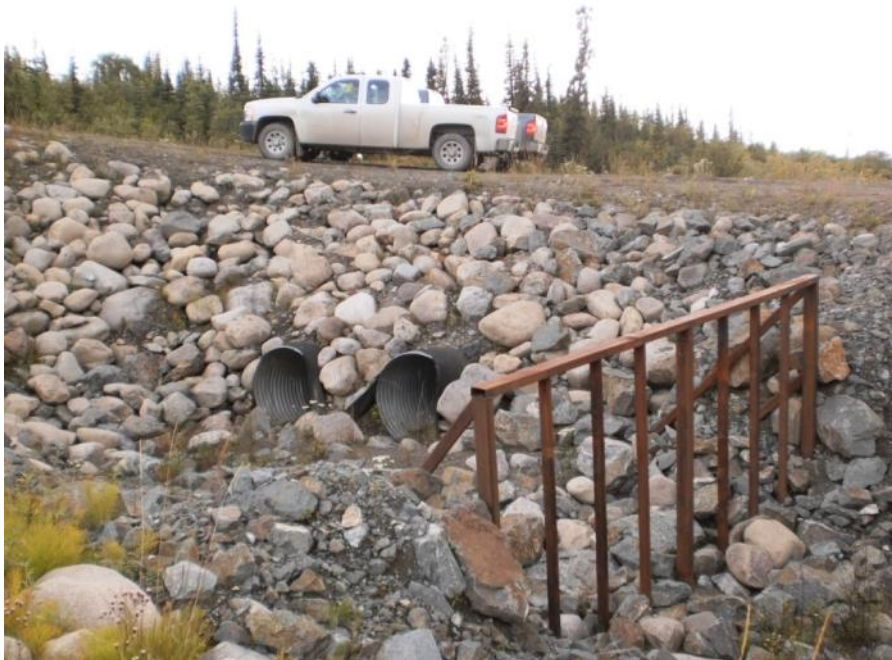
- Trashracks for the main culvert and emergency spillway culverts at the headworks were clear (see Photos 76 and 77). There was some build-up of sediment against the main culvert trashrack (see Photo 77).

Photo 76 Vangorda Flume emergency spillway intake culverts (August 23, 2011)

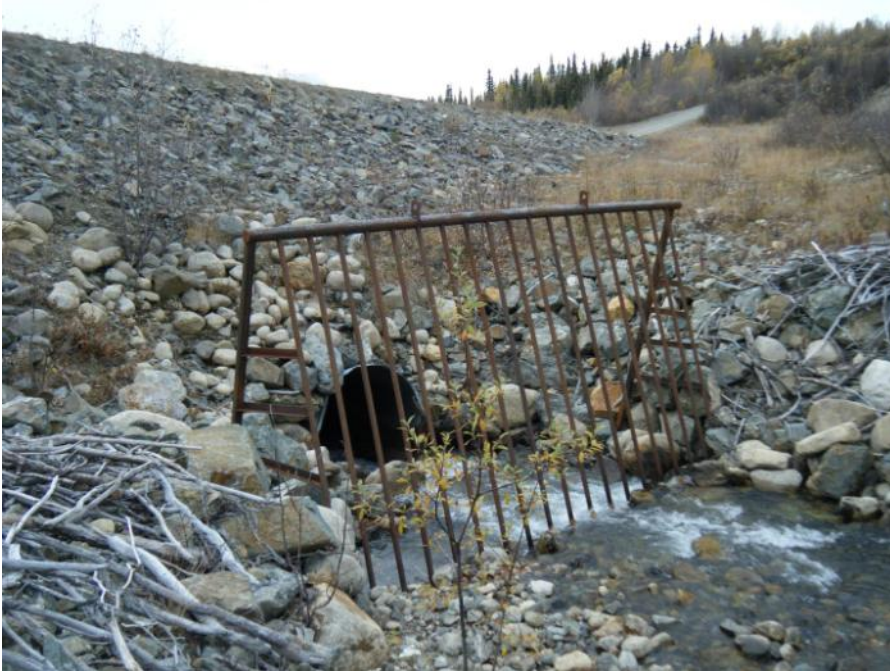
Photo 77 Vangorda Flume intake culvert (September 20, 2011)

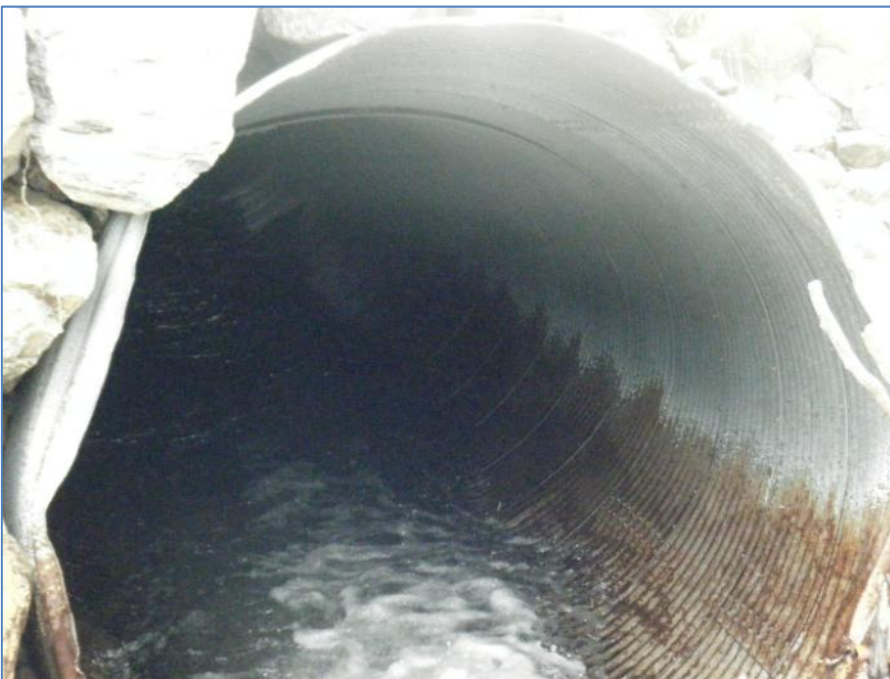
- Pipe plates at the first and last joints in the main culvert appear to be separated (see Photos 78, 80).
- When viewed from upstream end, the crown of the main culvert appeared to have slightly deformed downwards. When viewed from downstream end, the main culvert appeared to have a vertical bend near the upstream end.

Photo 78 Upstream end of Vangorda Flume intake culvert - first pipe joint appears to be separated (September 20, 2011)

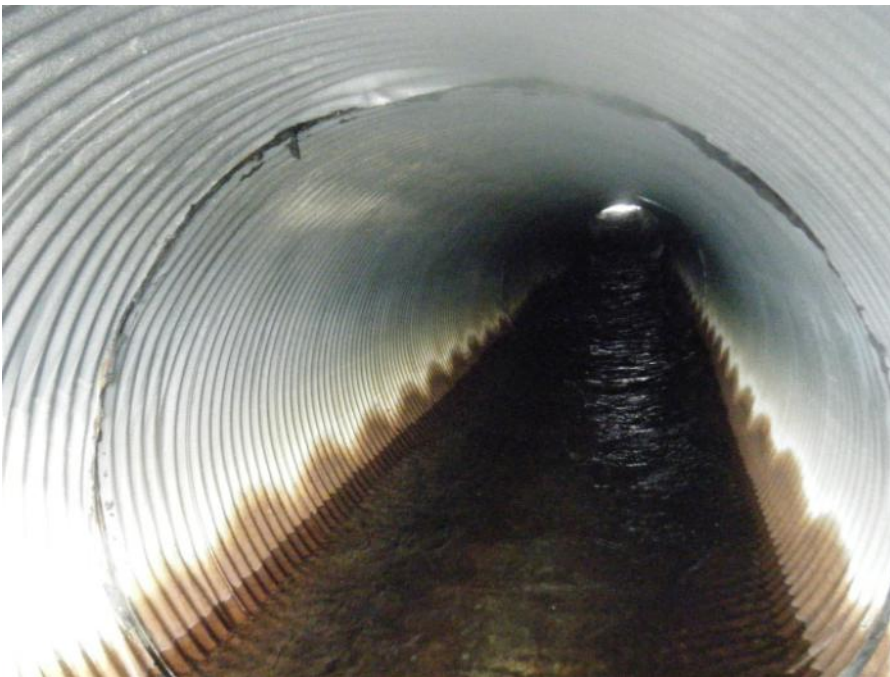
Photo 80 Vangorda Flume intake culvert as seen from downstream end - first pipe joint appears to be separated (September 20, 2011)

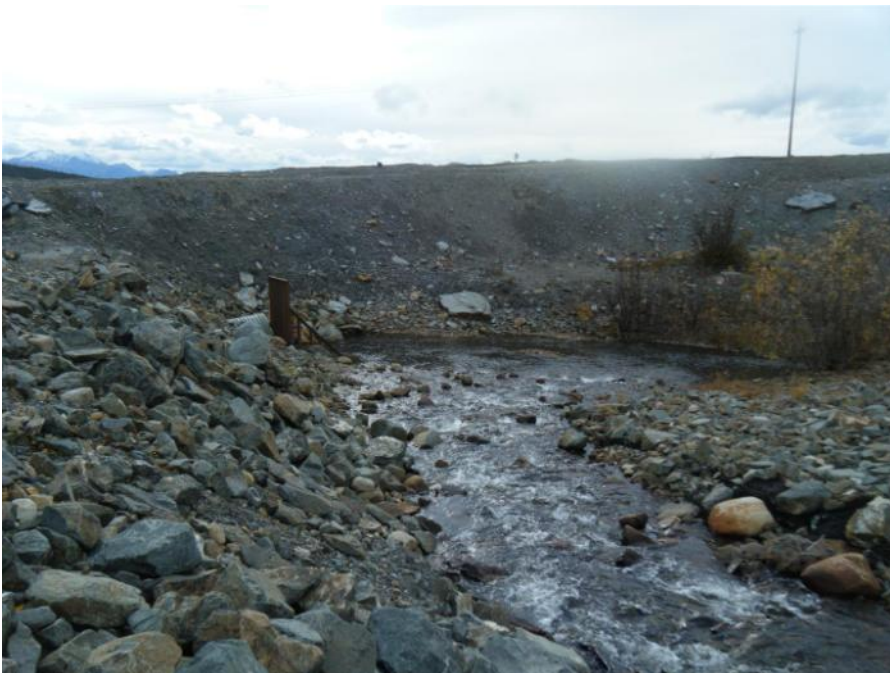
- There was a small amount of debris against trashrack at the inlet of the culvert to the drop box (see Photo 84).
- Pipe plates at the first joint in the culvert to the drop box appear to be separated (see Photo 85).

Photo 84 Vangorda Flume Plunge Pool and culvert to Vangorda Creek Diversion drop box (September 20, 2011)

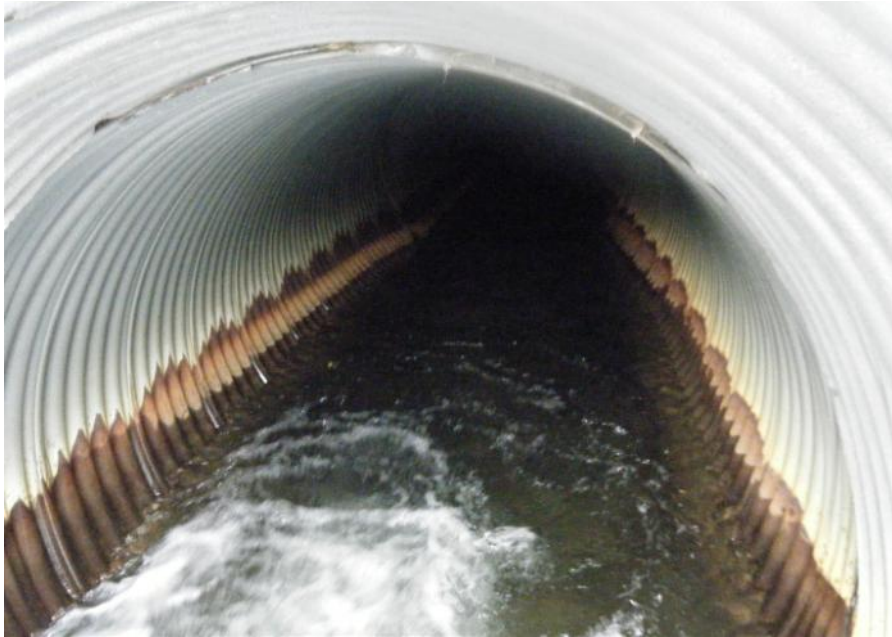
Photo 85 Upstream end of culvert to Vangorda Creek Diversion drop box - first pipe joint appears to be separated. (September 20, 2011)

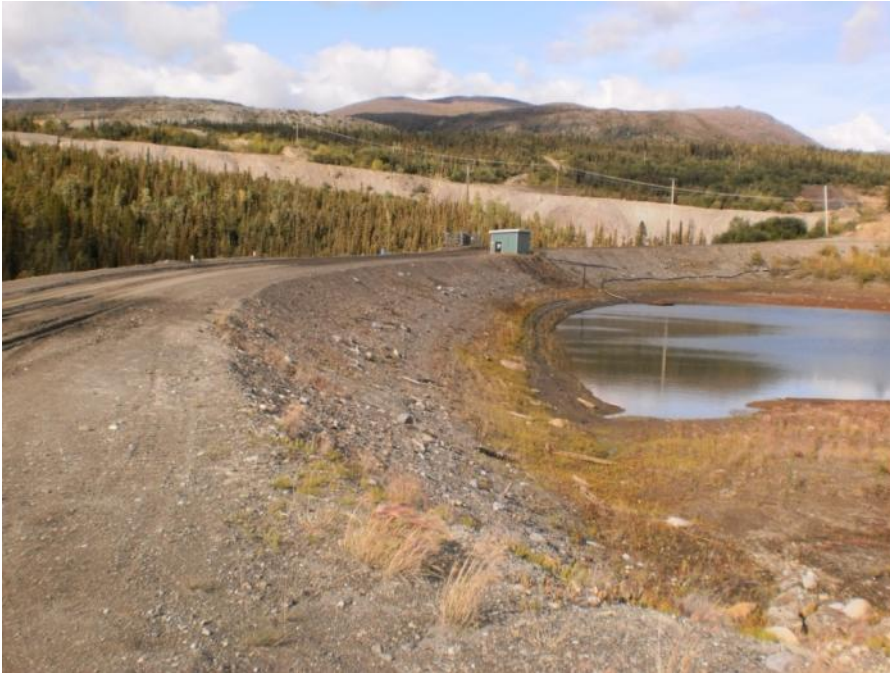
- Stable dam crest and slopes (see Photos 87, 89 to 91 and 94) with rill erosions developed on both the downstream and upstream crest shoulders and slopes (see Photos 92 and 93).
- Culvert spillway was in good condition (see Photos 88 and 89).
- Pond level was drawn down prior to the removal of submersible pump in preparation for the winter (see Photo 93).

Photo 87 Dam crest/upstream slope and pond (August 23, 2011)

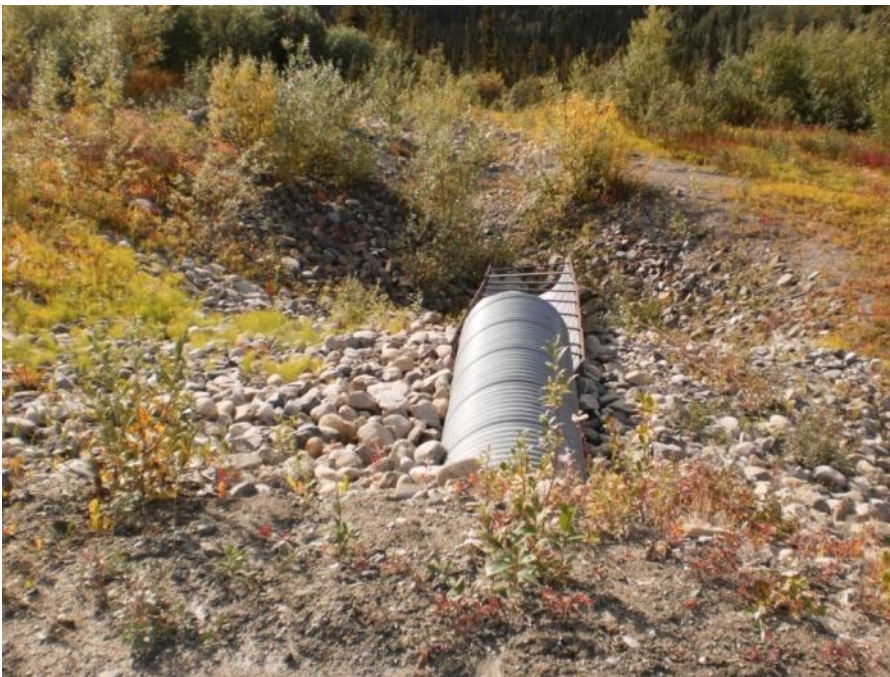
Photo 88 Culvert emergency spillway at left (south) abutment (August 23, 2011)

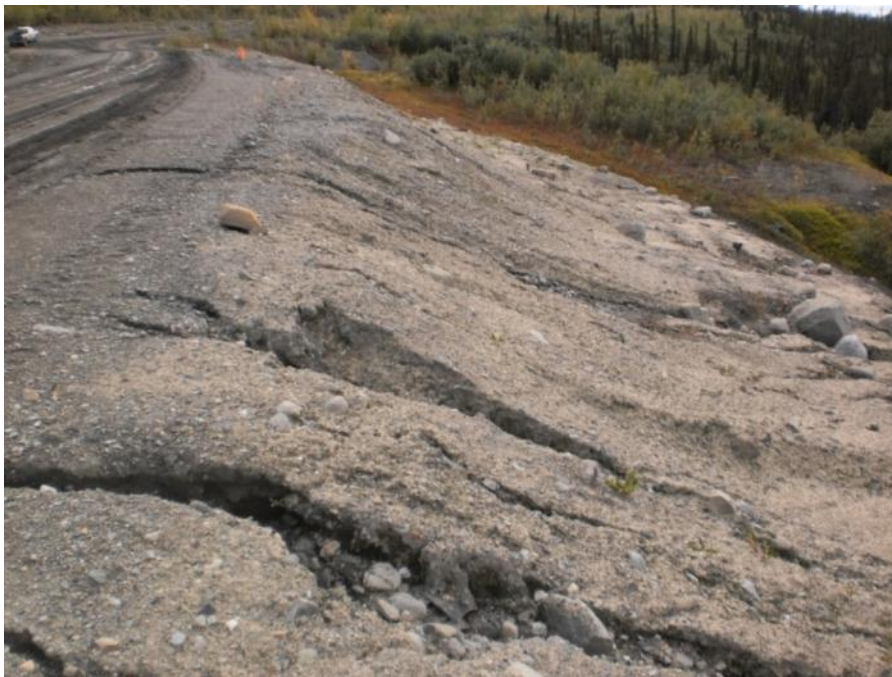
Photo 92 Gully erosions on downstream slope

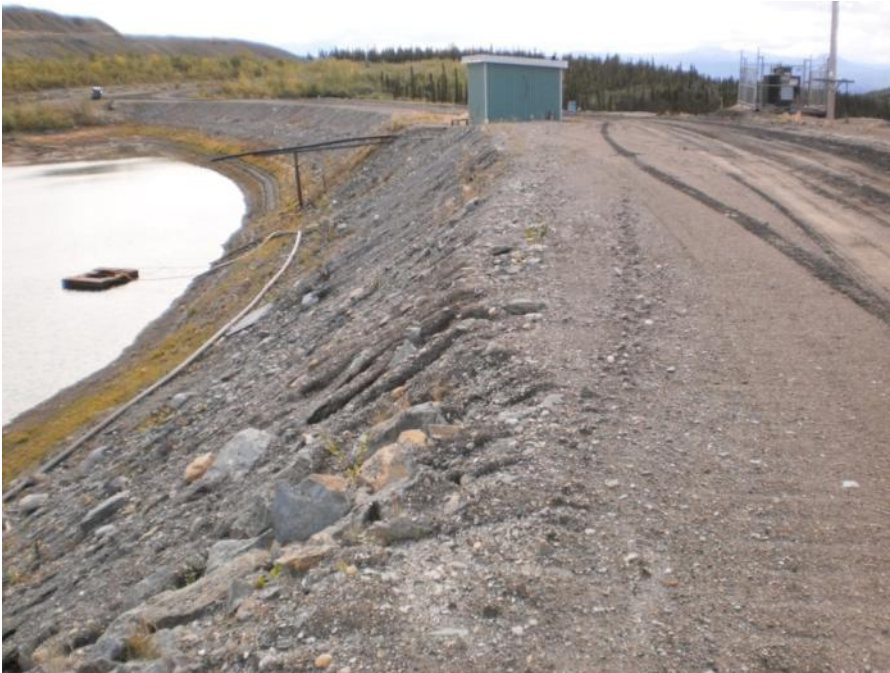
Photo 93 Dam crest and upstream slope - rill erosions in the foreground (August 23, 2011)

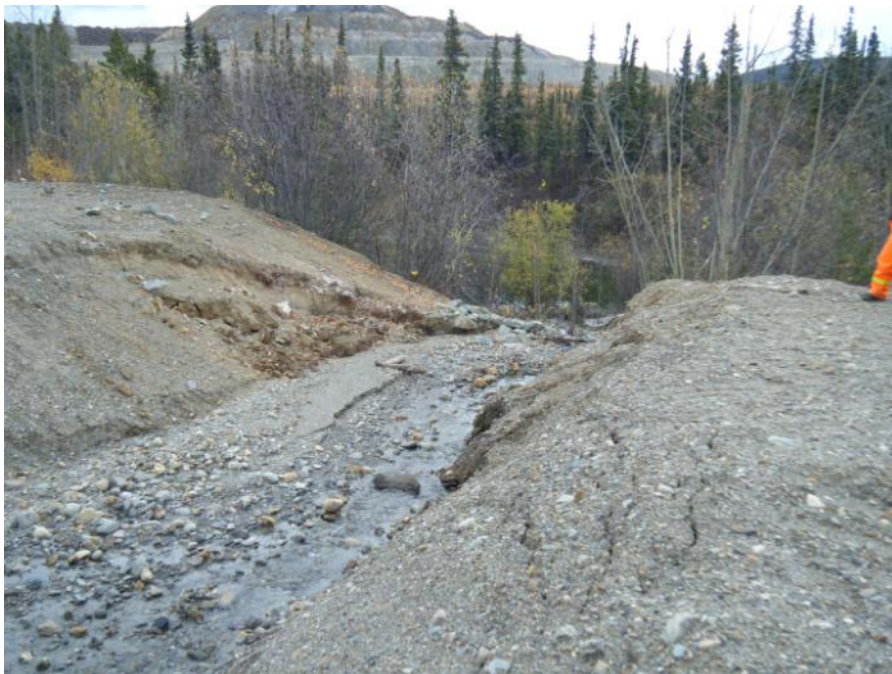
Photo 108 V-15 Diversion Ditch at its downstream end near Moose Pond (September 20, 2011)

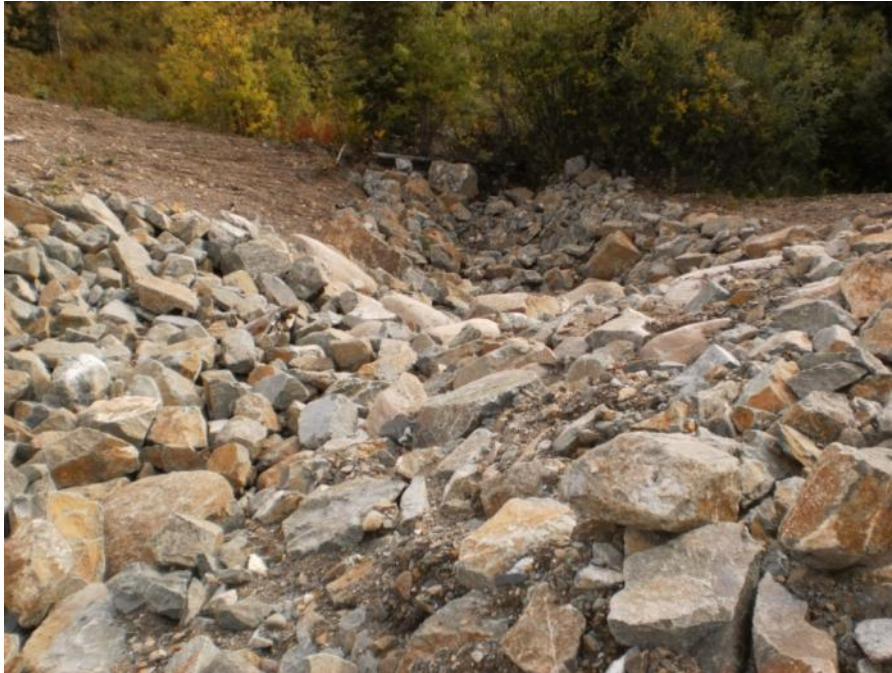
- Excess water from runoff over newly constructed Grum Dump cover was allowed to enter into the Moose Pond in the spring of 2011.
- Significant erosion and slumping of the sides of the V-15 seep ditch was observed at the location where the ditch entered into a steep reach before entering the Moose Pond (see Photos 108).
- Sedimentation caused by excess inflow sealed off the Moose Pond bottom (see Photo 110), and raised the pond level and caused excess seepage through a retaining esker (see Photos 112), and slumping of esker downstream slope (see Photos 113 to 115).
- Cessation of inflow to Moose Pond resulted in drop of pond level to the current level, which is probably higher than previous pond levels.
- Exfiltration from Moose Pond has probably changed from the pond bottom to the bank slope at higher elevations.

Photo 109 Downstream portion of V-15 Ditch discharge channel

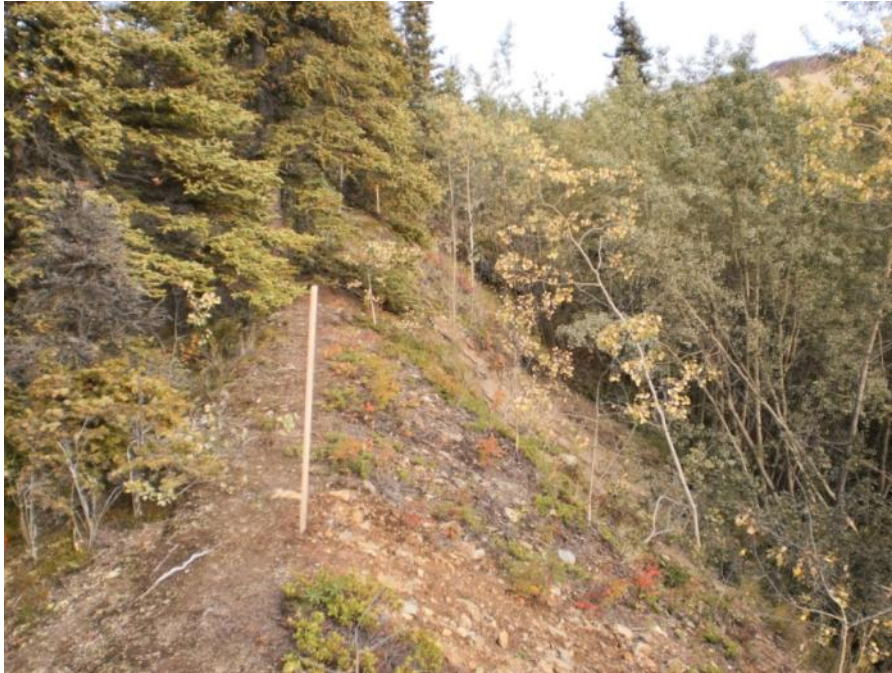
Photo 112 Ridge top of downstream esker (August 23, 2011)

- Monitor the slope stability and integrity of the esker ridge along the discharge face of its downstream slope (see Photos 112 to 115).
- Review potential remedial works that may be required to restore the stability and integrity of the esker ridge.
- Evaluate the long-term impact of the 2011 excess runoff incident on the normal exfiltration operation of the Moose Pond before the incident. In other words, can the Moose Pond serve its filtration function under the changed condition in the future without detrimental effects, or more costly measure needs to be implemented to restore its original condition.

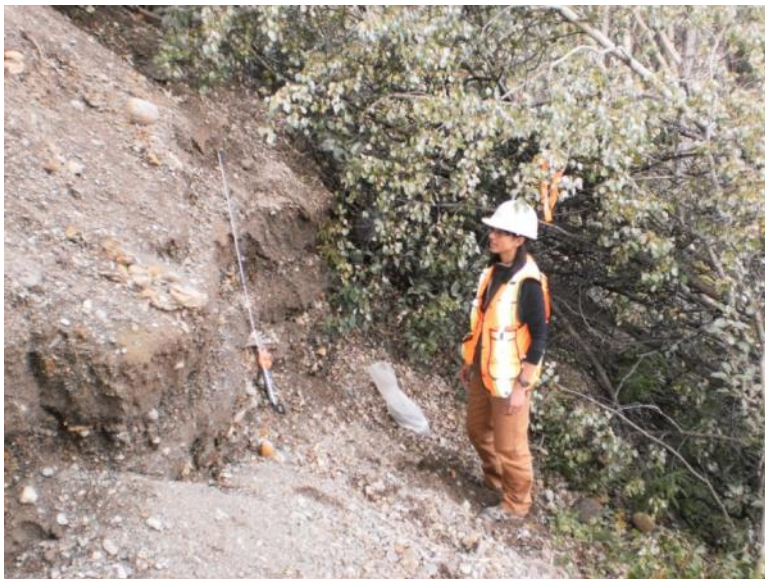
Photo 113 Downstream bank slope of esker

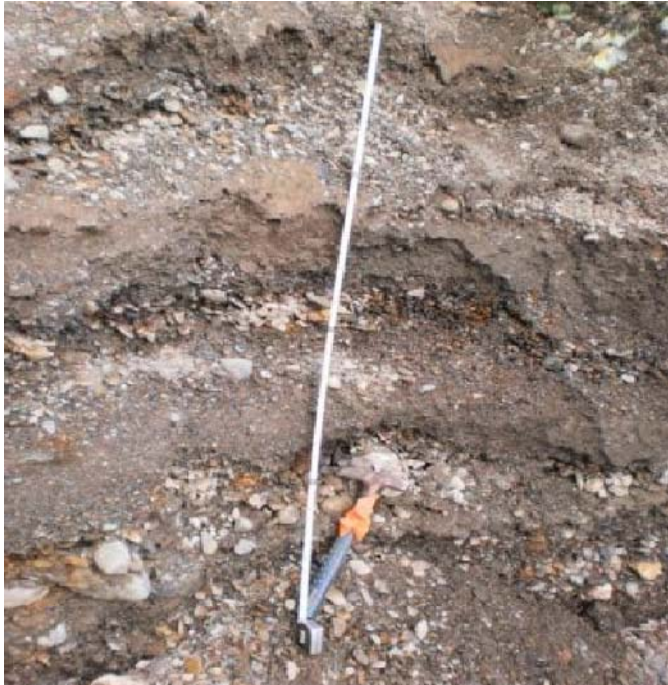
Photo 114 Close-up of esker slope showing alternating layers of coarse gravels and silty sands (August 23, 2011)

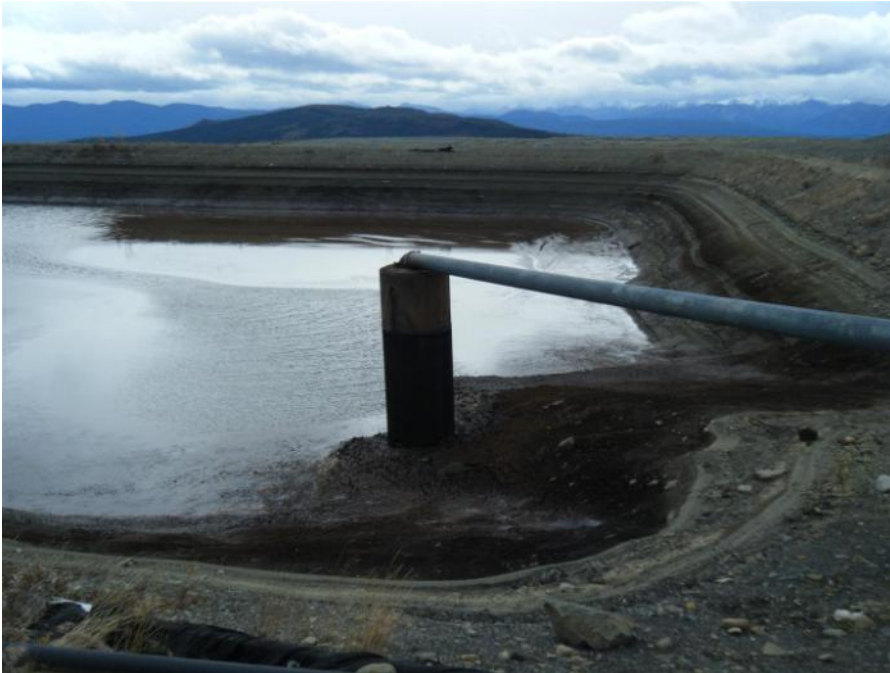
Photo 116 Grum Sludge Pond (September 20, 2011)

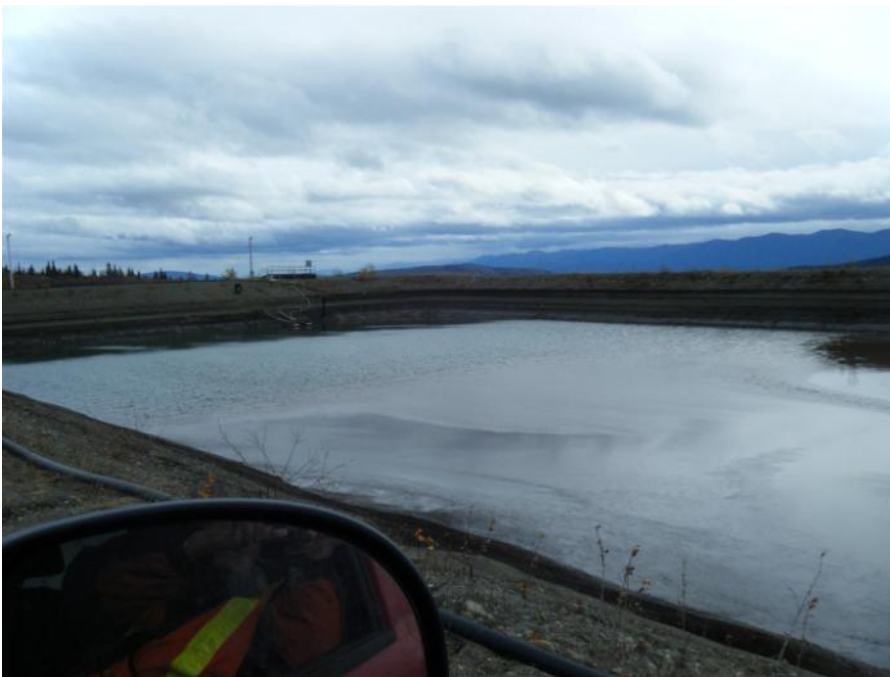
Photo 117 Grum Sludge Pond (September 20, 2011)

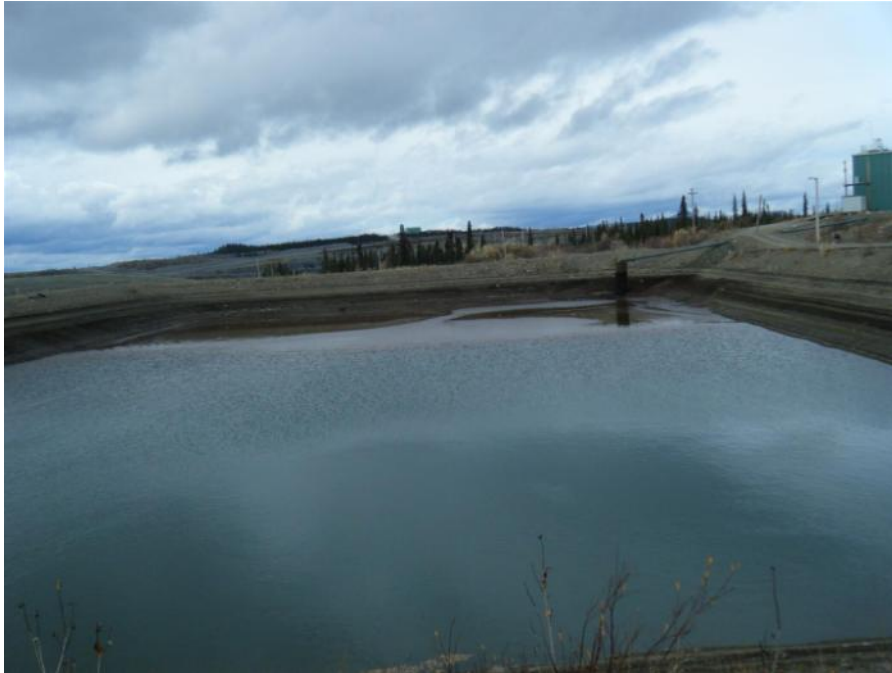
Photo 118 Grum Sludge Pond (September 20, 2011)

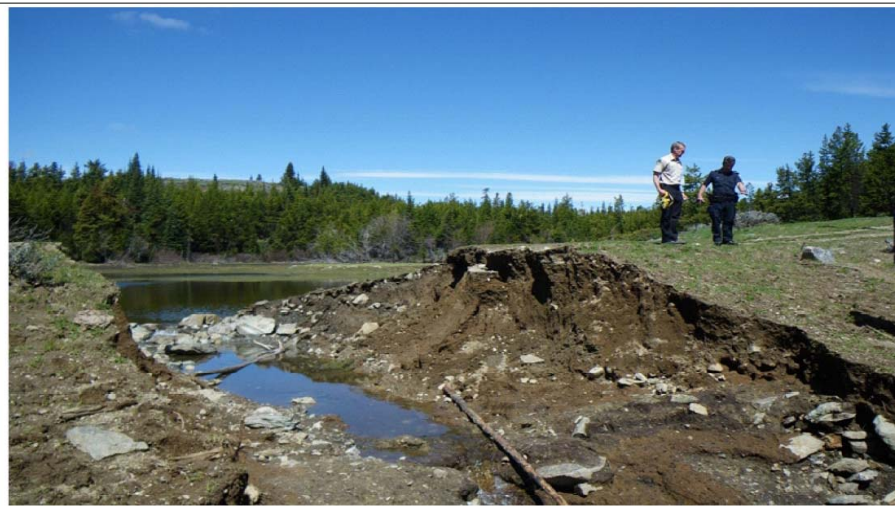
Figure 5 – Testalinden Dam Failure (near Oliver) June 13, 2010

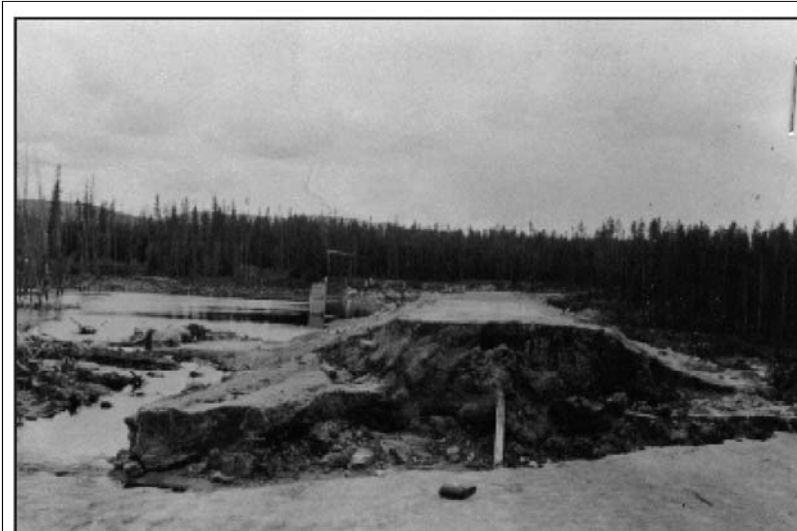
Figure 6 – Ellis Creek Dam Failure (near Penticton) 1941

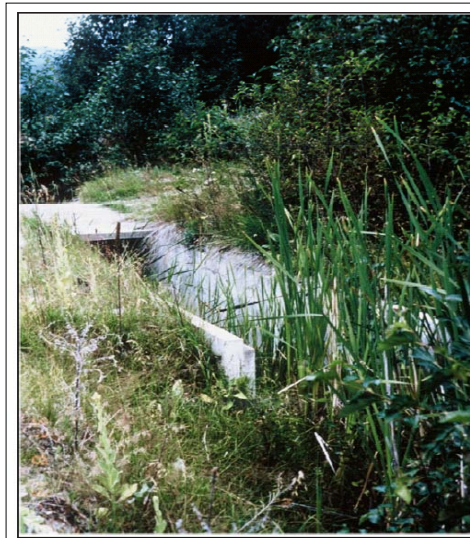
Figure 13 – Obstructed spillway channel

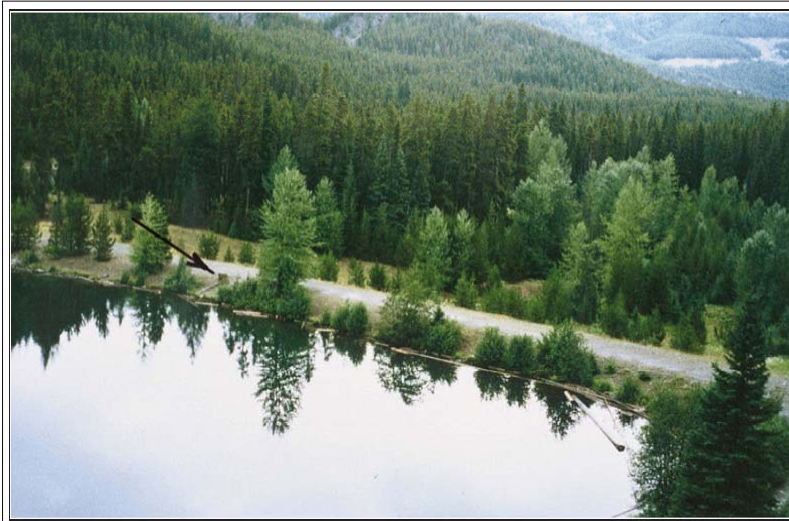
Figure 17 – Excess growth, broken log boom

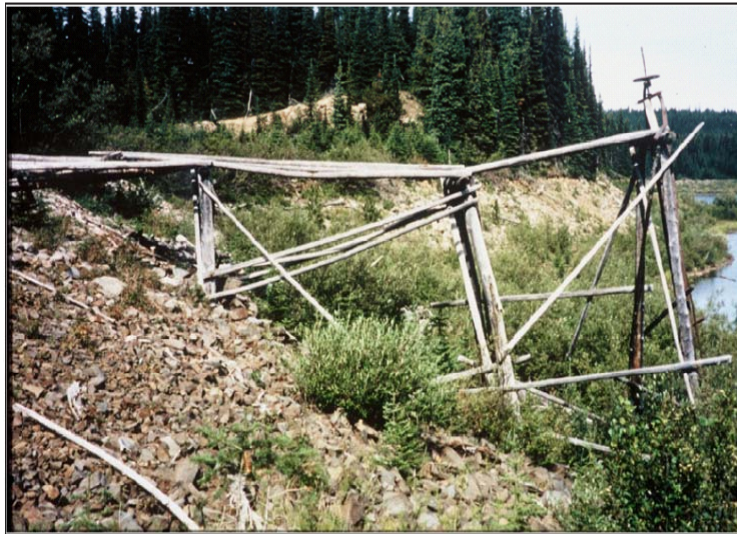
Figure 19 – Intake Control Access Structure Failure

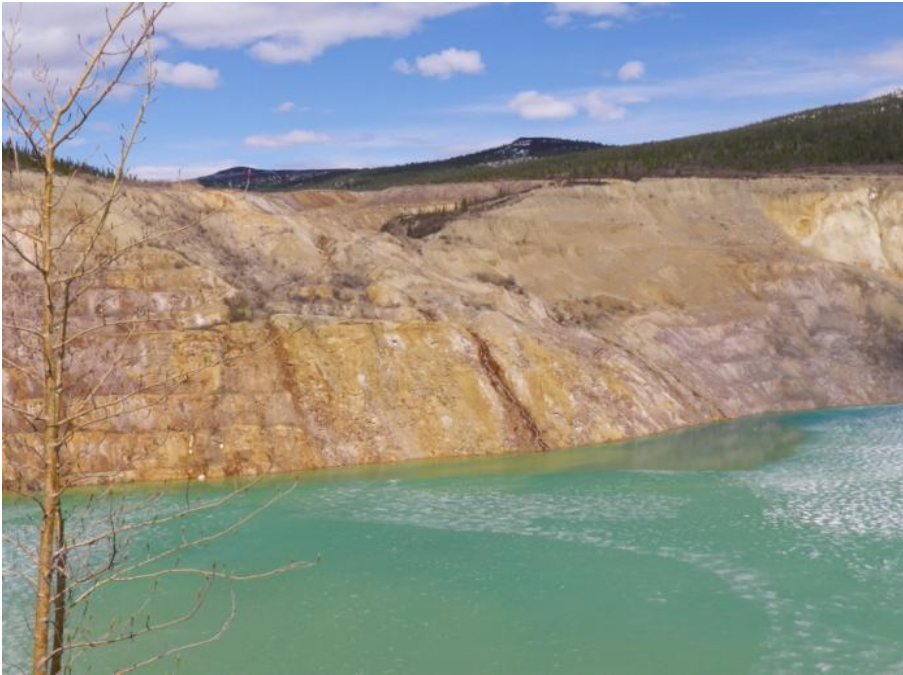
Photo 1 East wall of Faro Pit – northern segment as seen from “eye-in-the-sky”
(May 30, 2012)

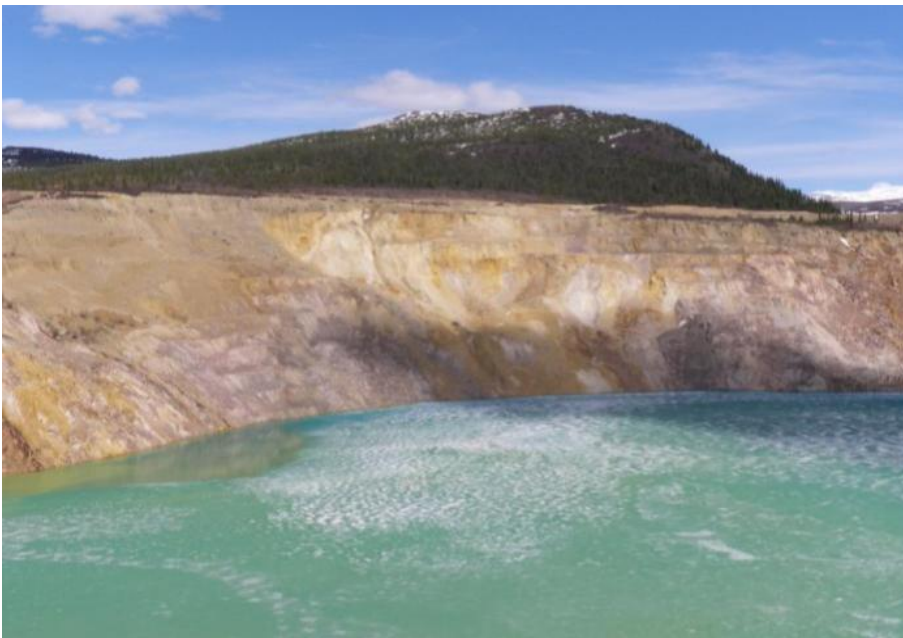
Photo 2 East wall of Faro Pit - southern segment as seen from “eye-in-the-sky”
(May 30, 2012)

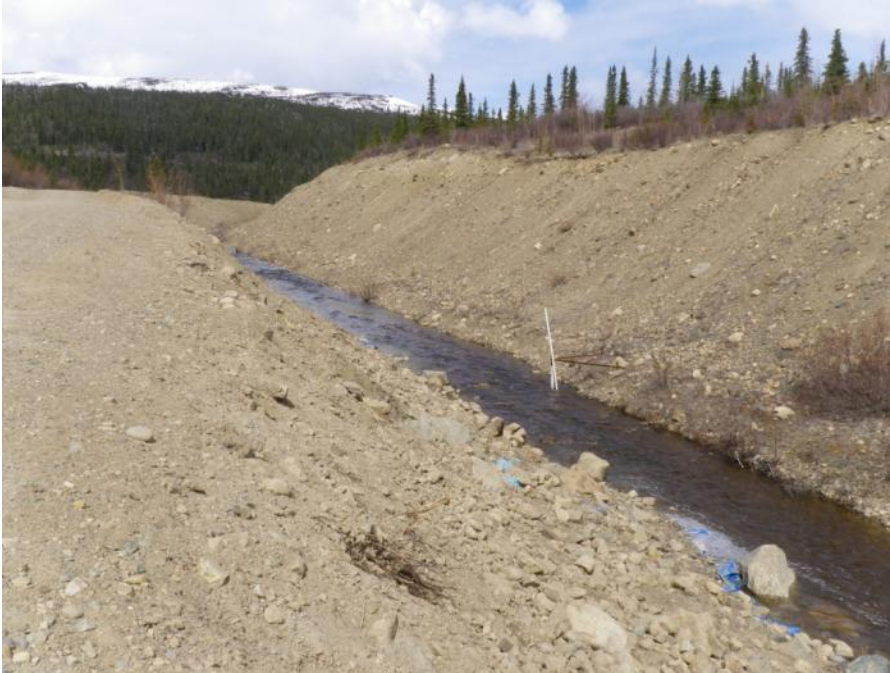
Photo 3 Faro Creek Diversion Channel above Faro Pit - looking upstream
(May 29, 2012)
