June 15, 2012

Yukon Government
Faro Mine Remediation Project
Suite 2C-4114-4th Ave
PO Box 2703 (K-149)
Whitehorse, Yukon Territory
Y1A 2C6

Faro Mine Complex
2011 Annual Geotechnical Review

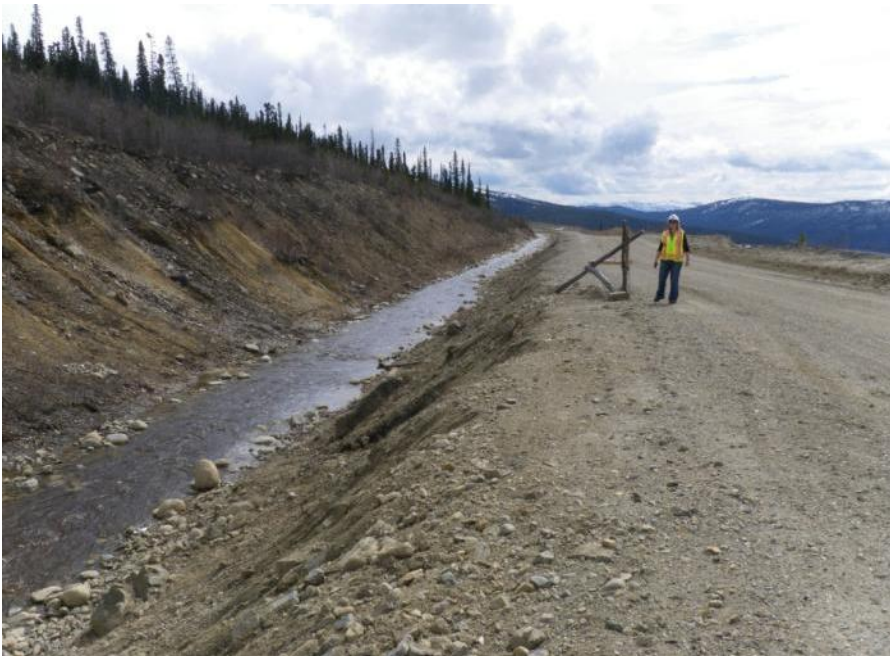
Photo 4 Diversion Channel above Faro Pit - looking downstream
(May 29, 2012)

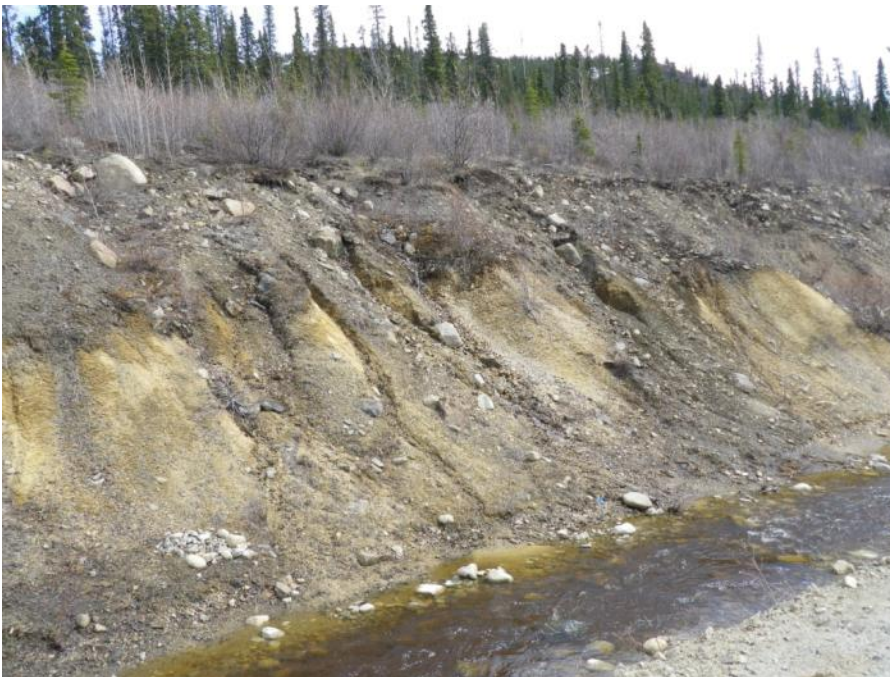
Photo 6 Slope erosions and slumps on channel bank slope (May 29, 2012).

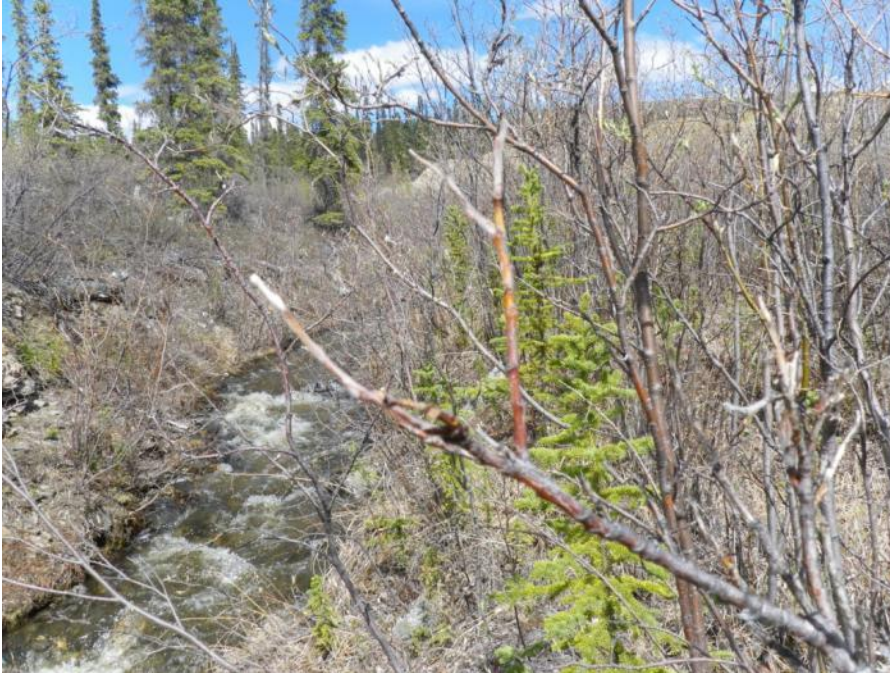
Photo 7 North Valley Wall Interceptor Ditch along upper reach - looking upstream (May 30, 2012)

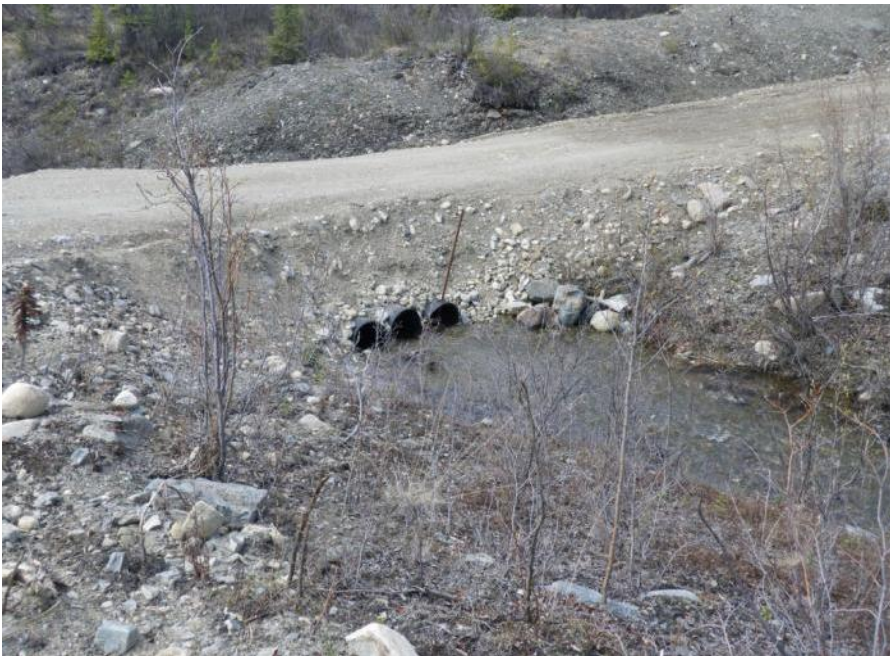
Photo 8 Channel upstream of Potable Water Well access road culverts - note sediment deposits at channel bottom (May 30, 2012)

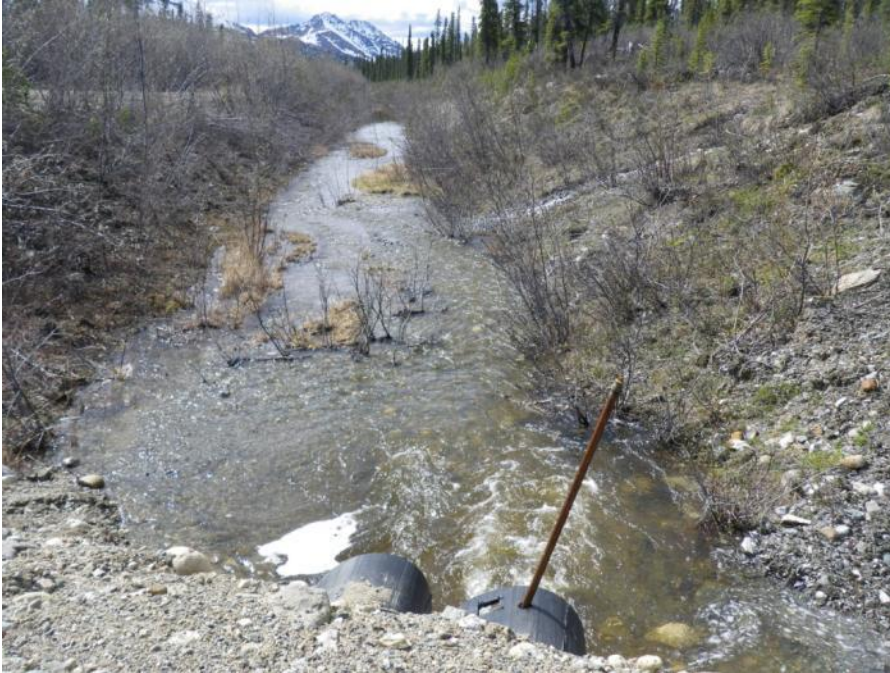
Photo 9 Channel downstream of Potable Water Well access road culverts - note sediment deposits at channel bottom (May 30, 2012)

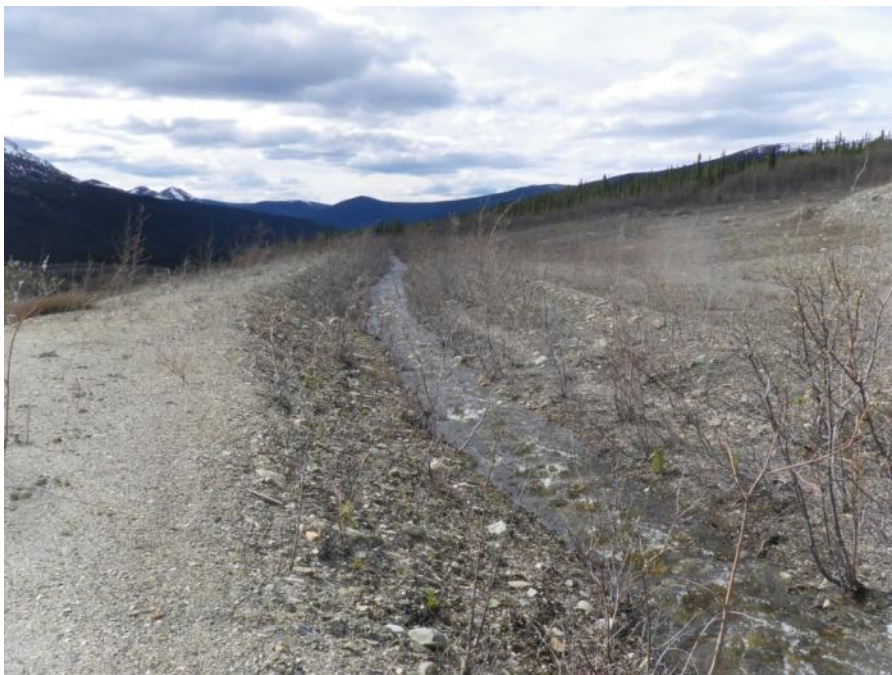
Photo 12 Middle reach of Interceptor Ditch (May 30, 2012)

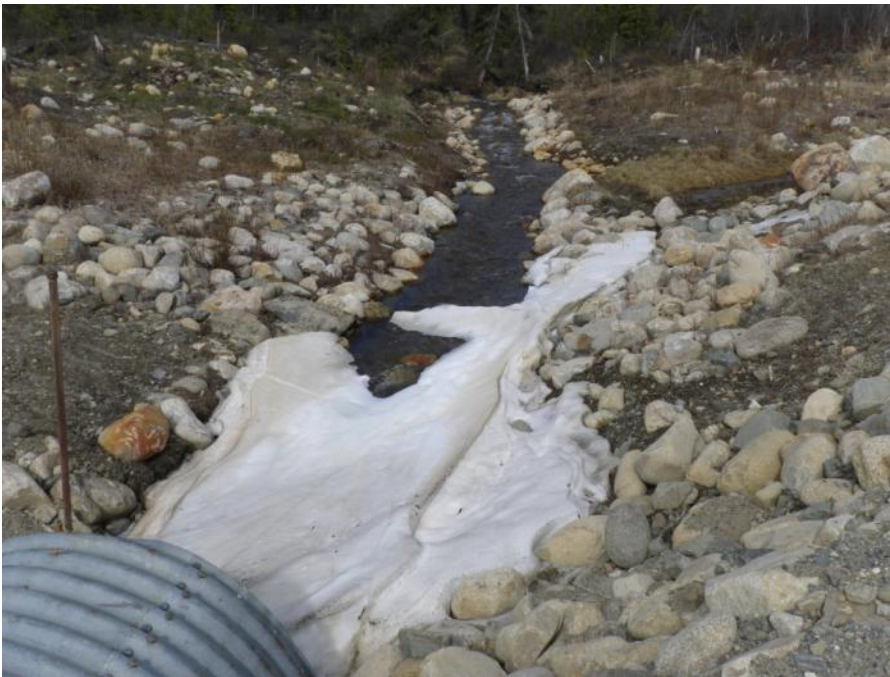
Photo 14 Entrance to culvert leading to lower reach of Interceptor Ditch (May 30, 2012).

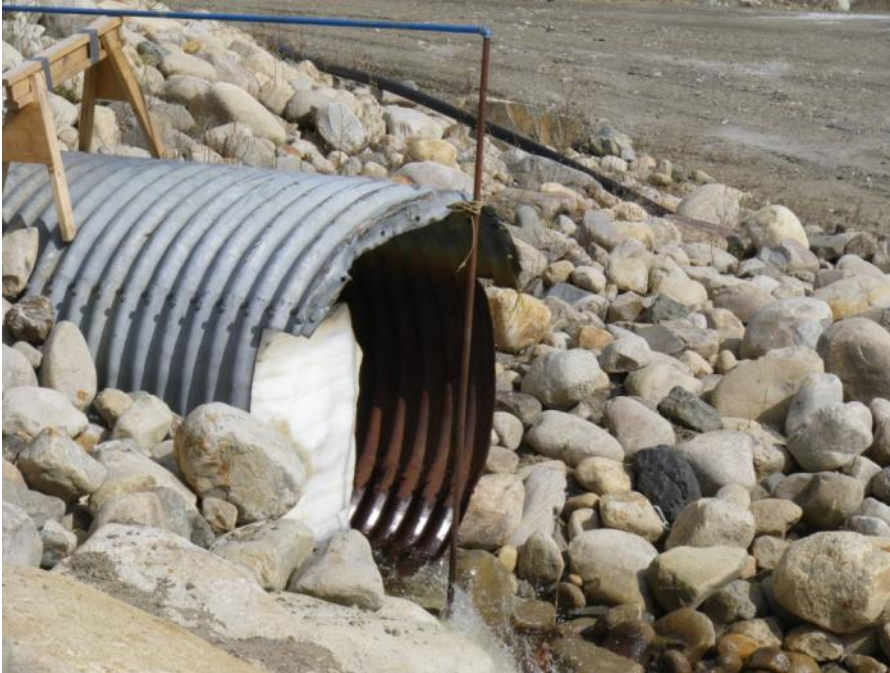
Photo 15 Discharge end of culvert leading to lower reach of Interceptor Ditch - note snow remaining inside culvert (May 30, 2012)

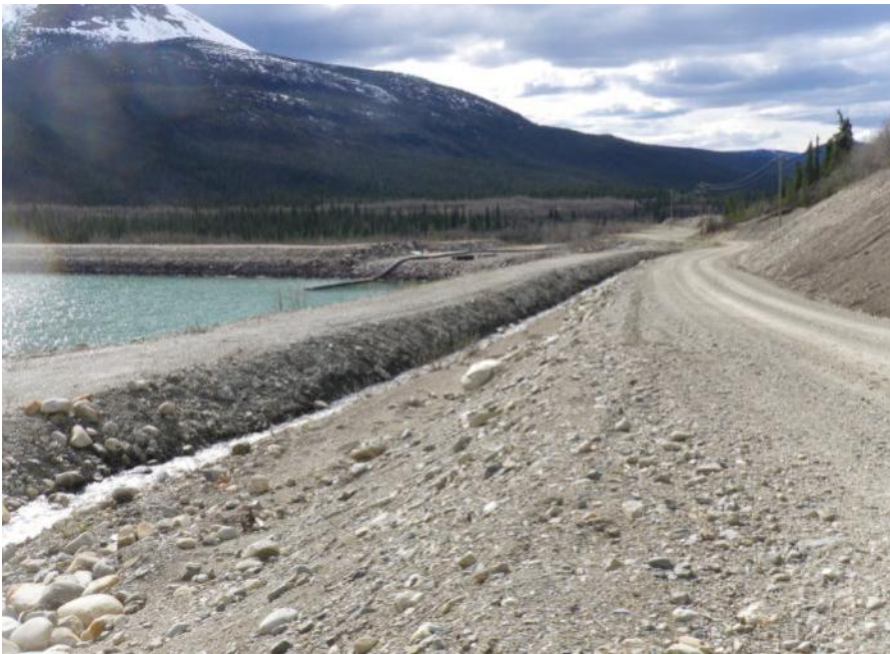
Photo 16 Interceptor Ditch lower reach adjacent to Cross Valley Pond (May 30, 2012)

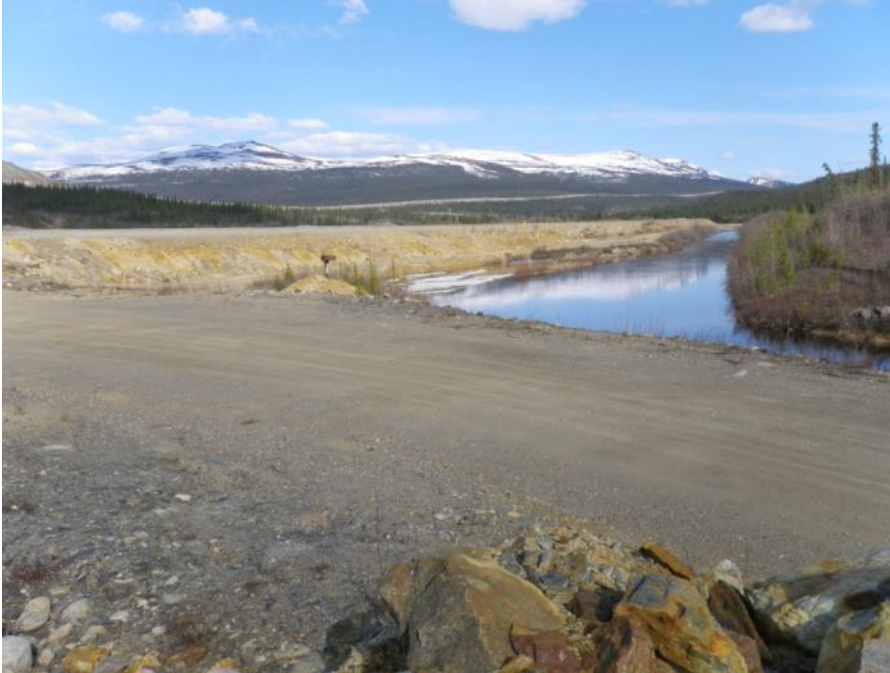
Photo 17 **Rose Creek Diversion Channel upstream of fuse plug (May 29, 2012)**

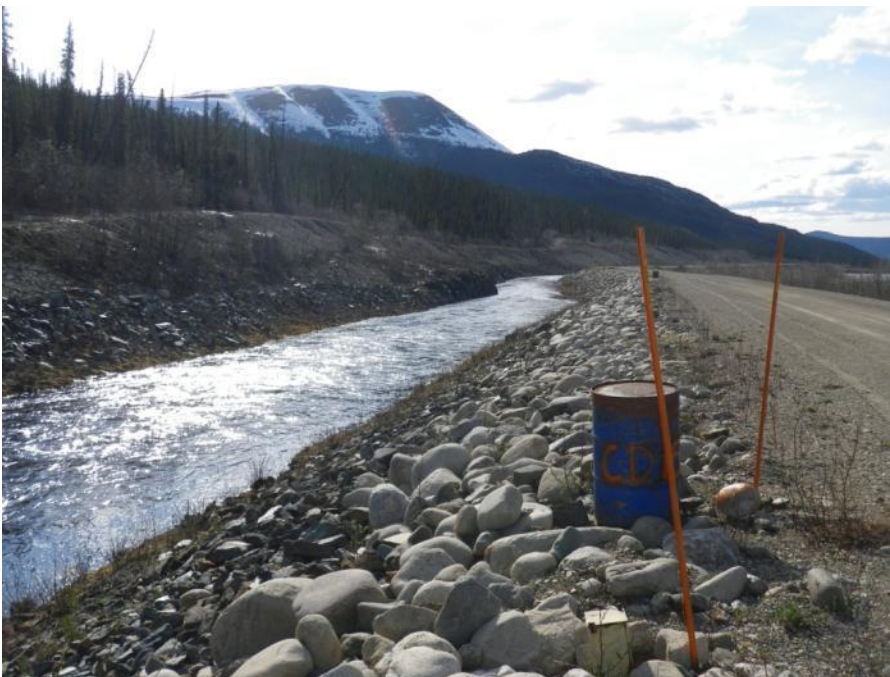
Photo 18 **Channel downstream of fuse plug (May 29, 2012)**

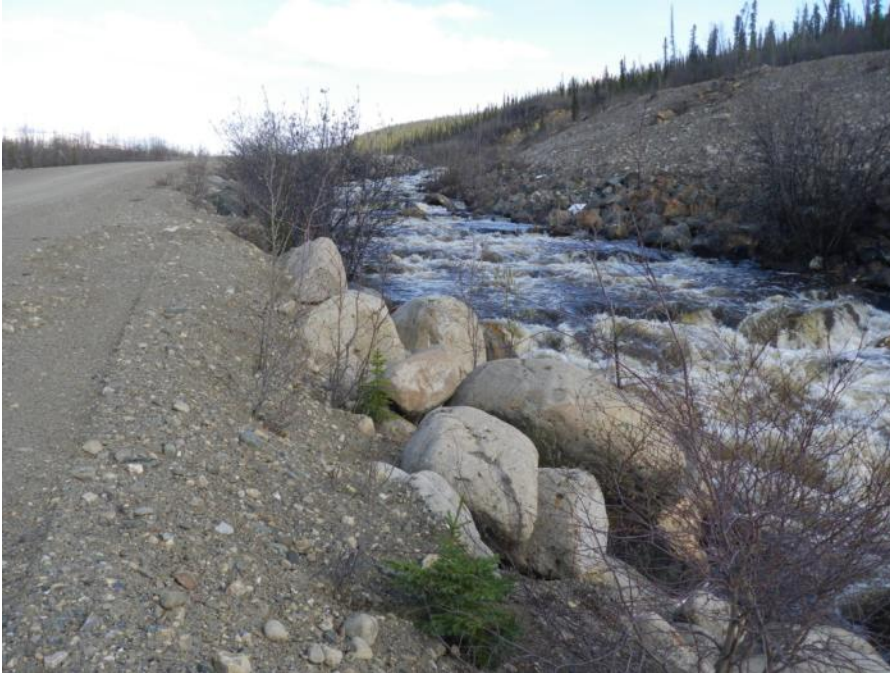
Photo 19 **Diversion Channel adjacent to Cross Valley Dam looking upstream
(May 29, 2012)**

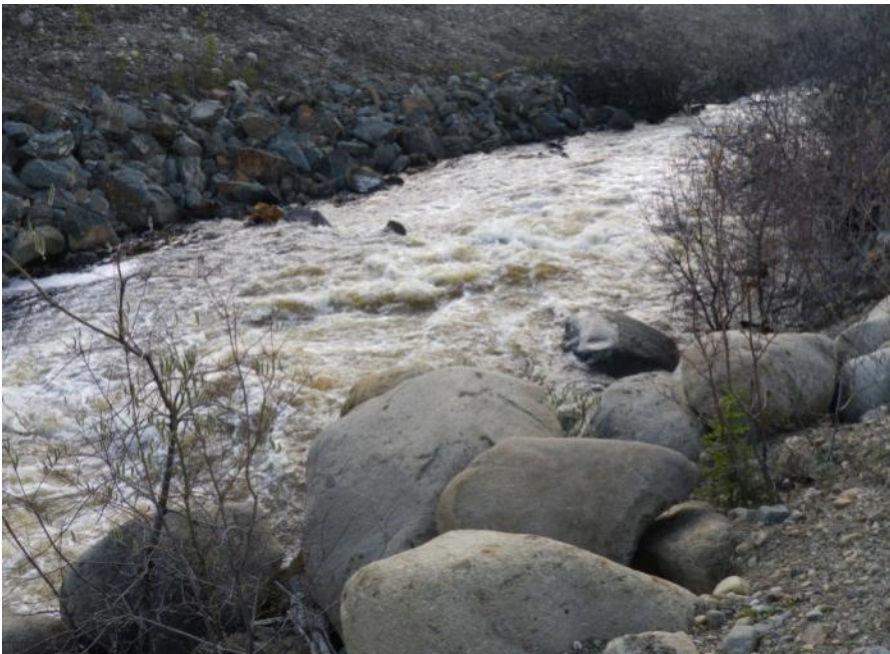
Photo 20 **Diversion Channel adjacent to Cross Valley Dam looking downstream
(May 29, 2012)**

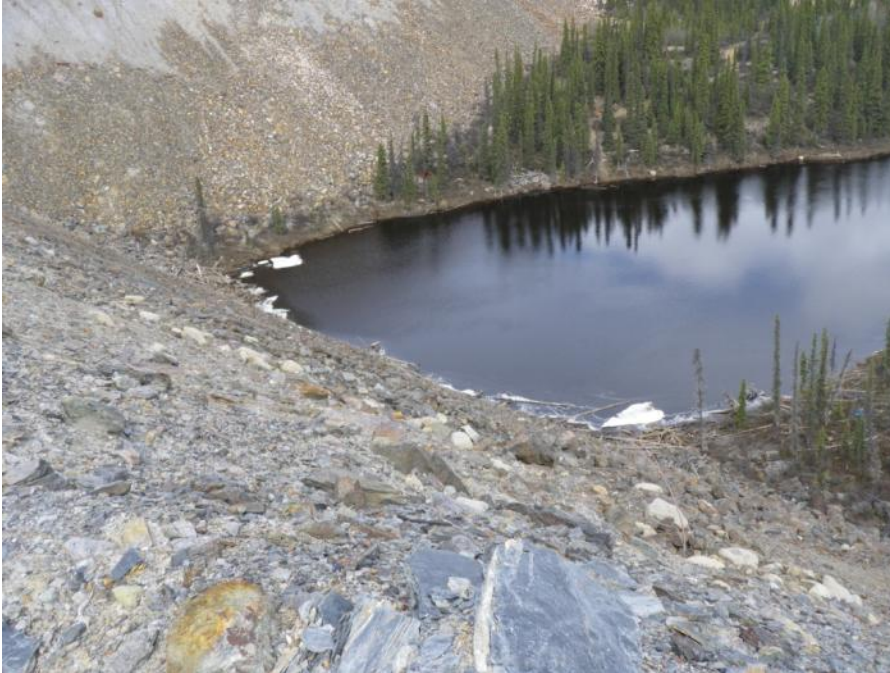
Photo 21 Wood debris on upstream slope of access road between Faro and Vangorda Plateau at North Fork Rock Drain (May 29, 2012)

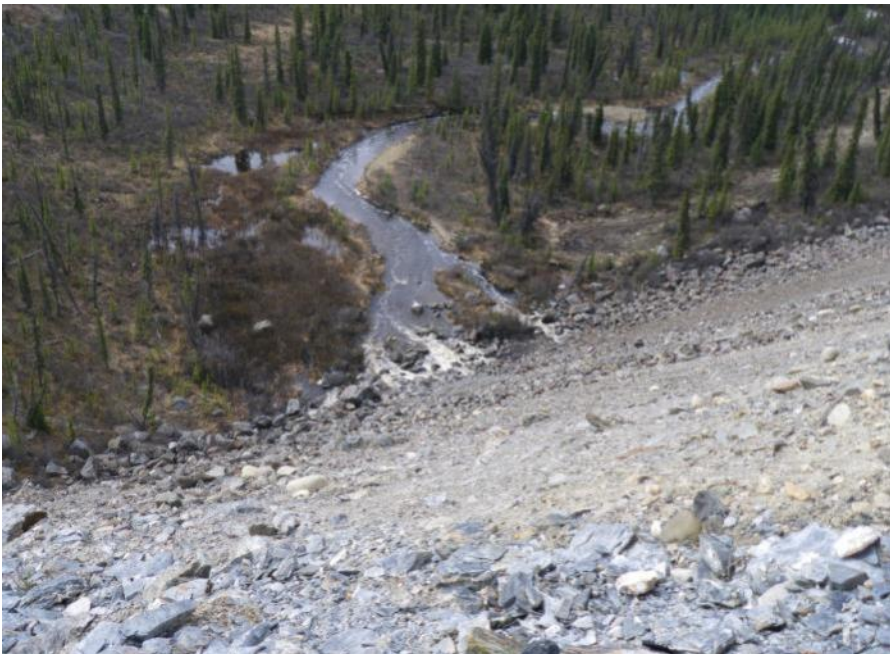
Photo 22 Downstream slope of access road at North Fork Rock Drain (May 29, 2012)

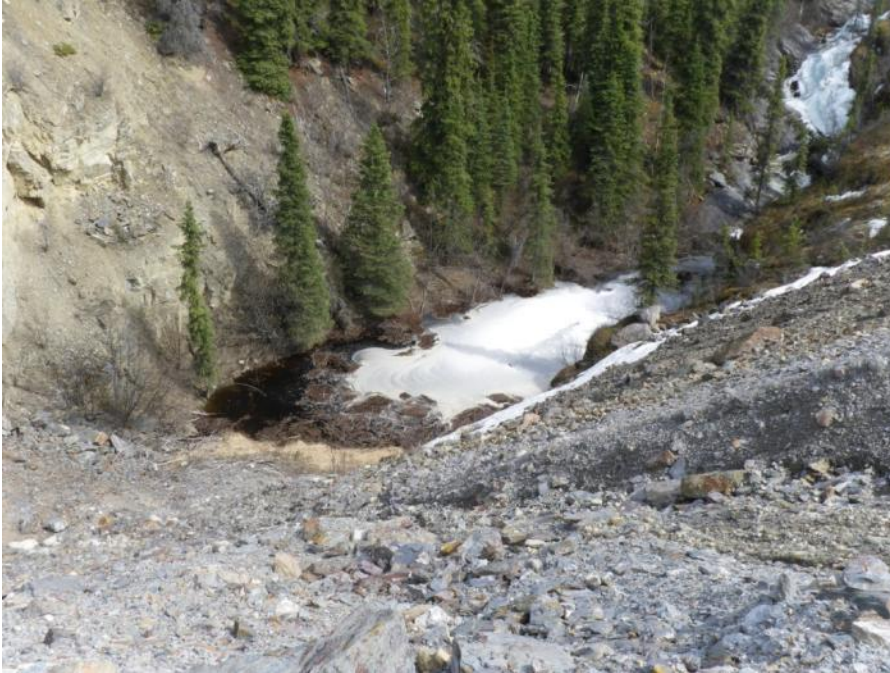
Photo 23 K8 Creek Rock Drain upstream pool (May 29, 2012)

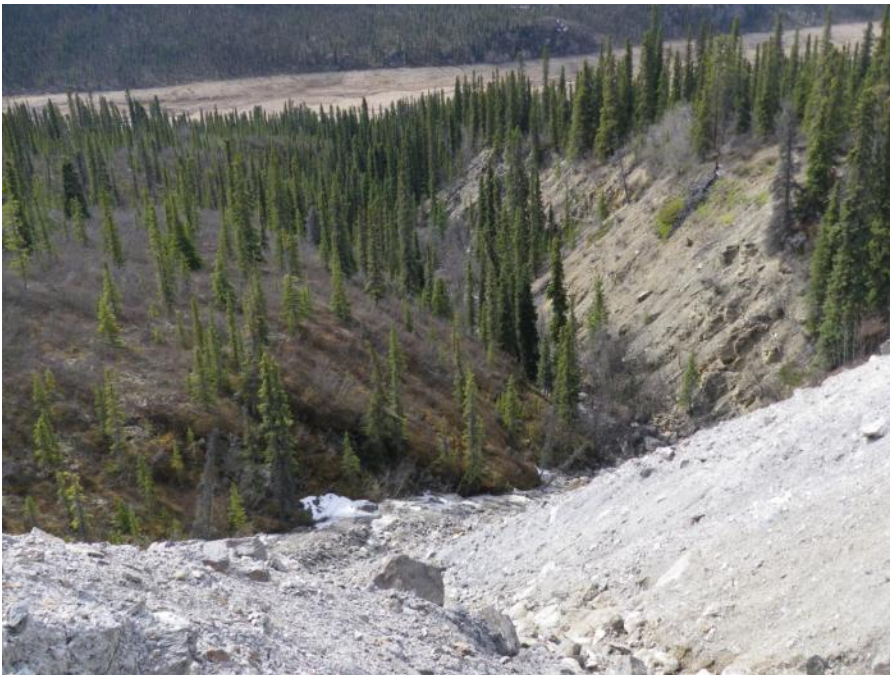
Photo 24 K8 Creek Rock Drain downstream outlet (May 29, 2012)

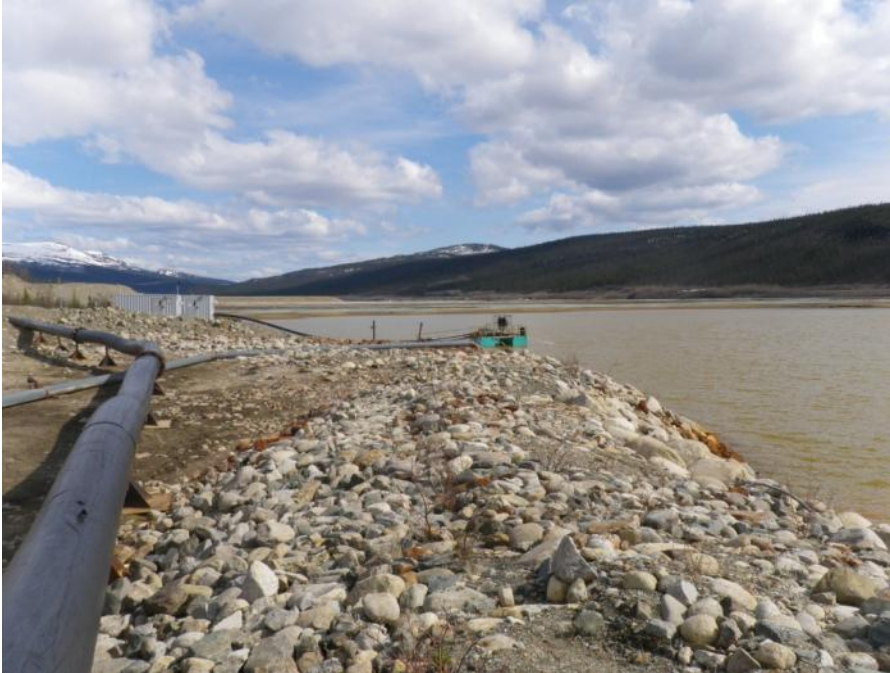
Photo 29 Intermediate Dam spillway at right abutment of dam looking upstream (May 29, 2012)

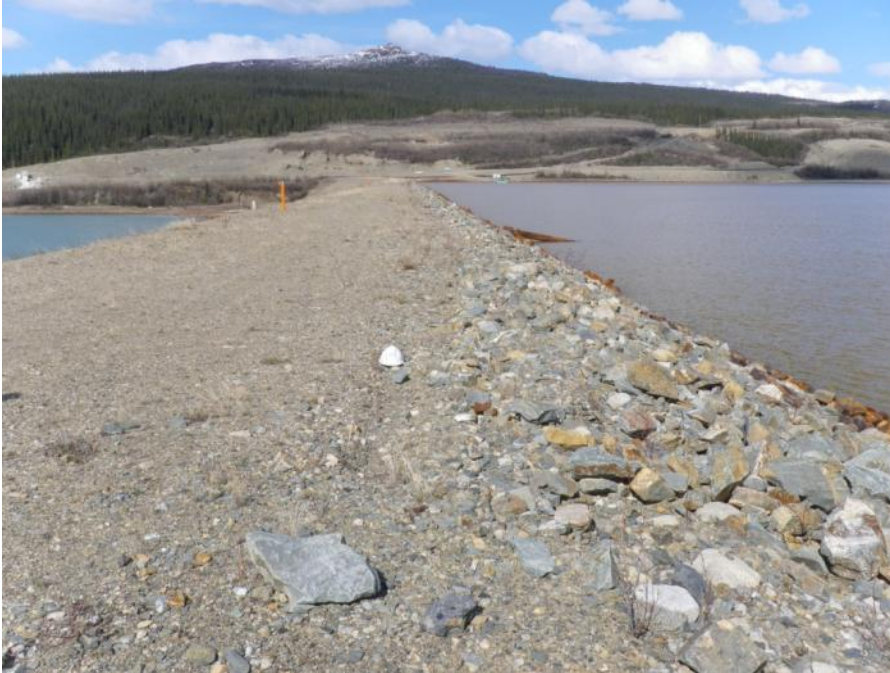
Photo 31 Dam crest and upstream slope - note damfill adjustment in area of hard hat along upstream crest shoulder (May 29, 2012)

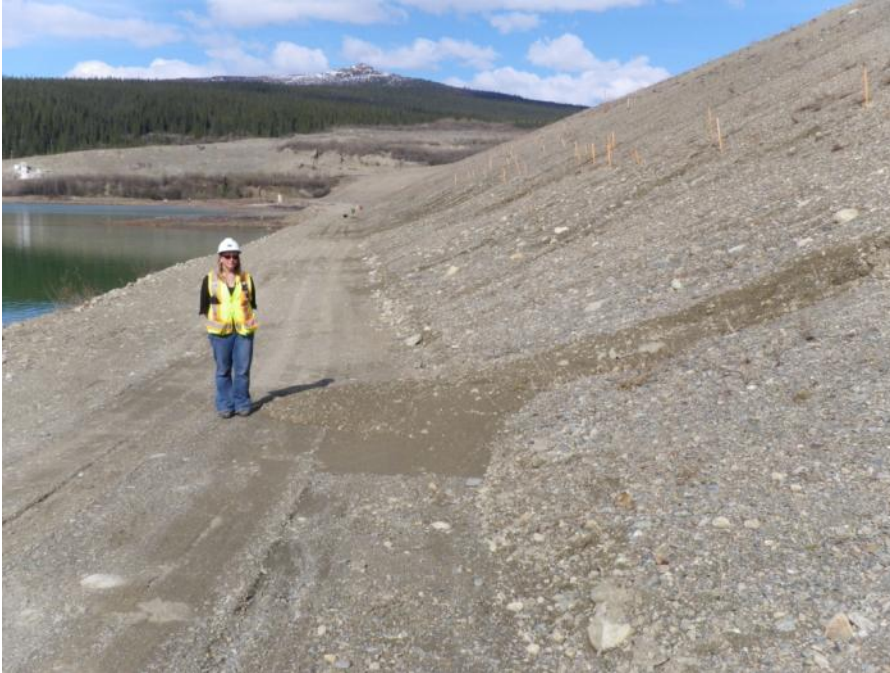
Photo 33 Rill erosions along downstream slope - note stakes used to assist ongoing monitoring by DES and deposits of eroded damfill on downstream berm surface (May 29, 2012)

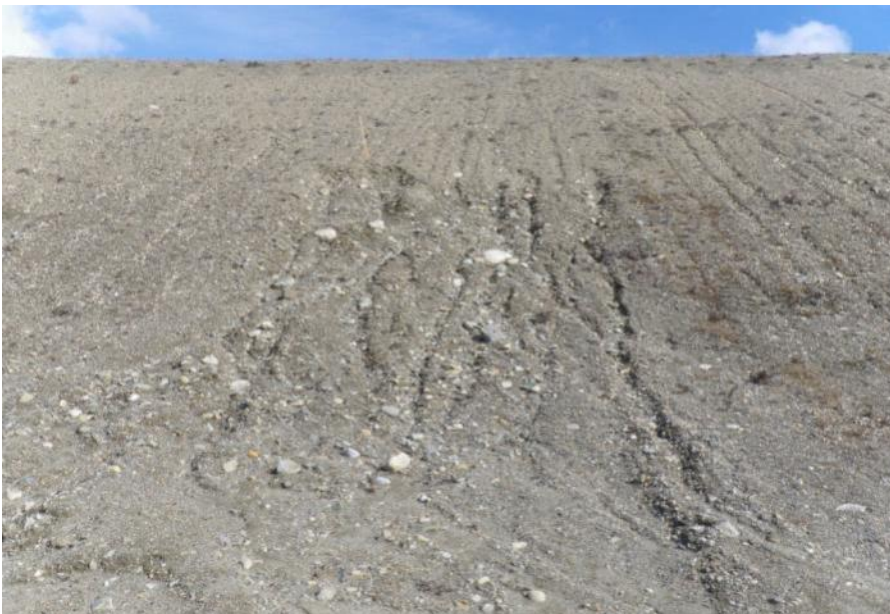
Photo 34 Rill erosions along downstream dam slope (May 29, 2012).

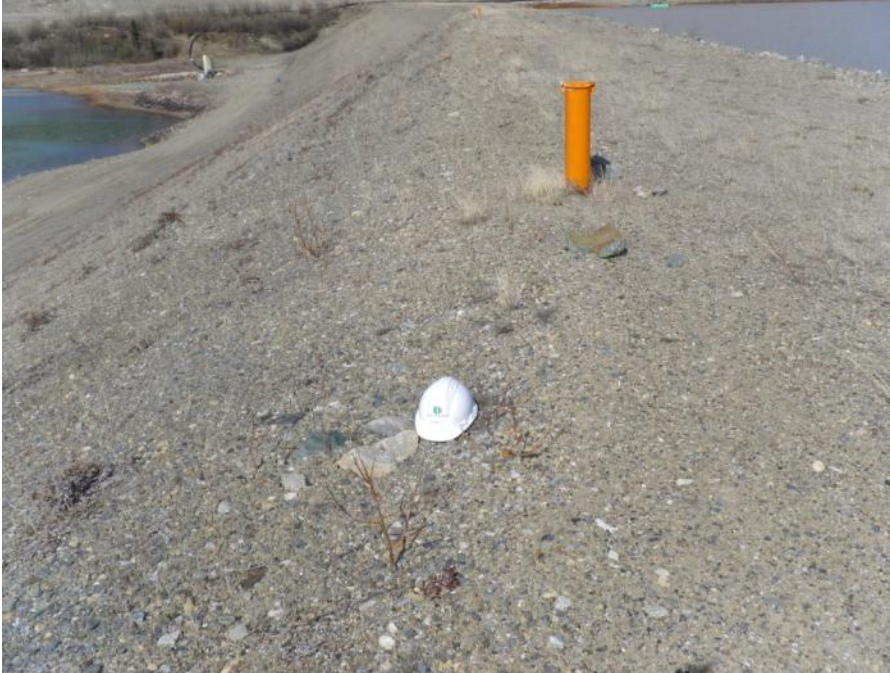
Photo 35 Sign of damfill adjustment near area of hard hat along crest shoulder (May 29, 2012)

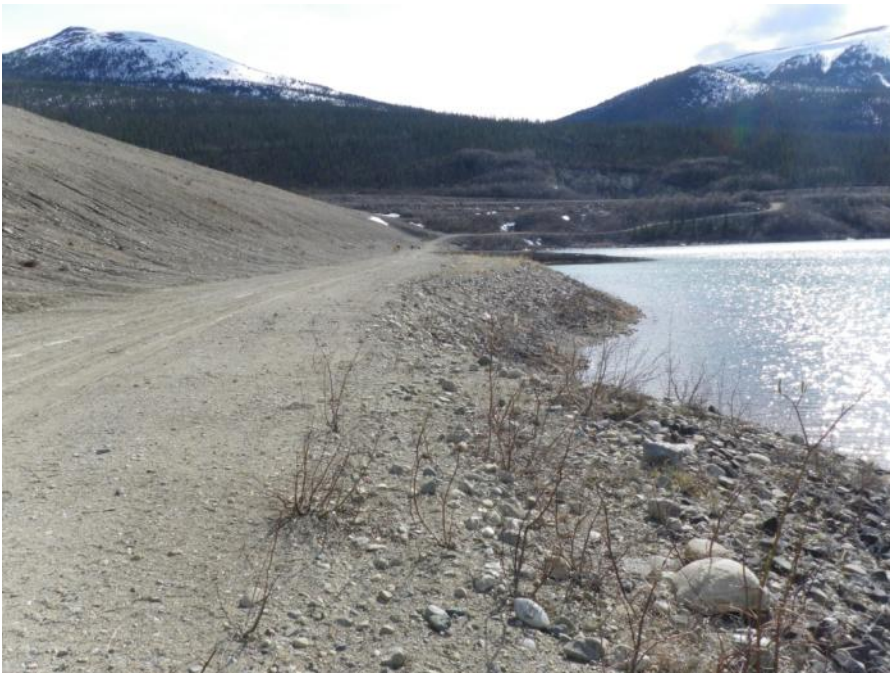
Photo 36 Downstream slope of downstream berm (May 29, 2012)

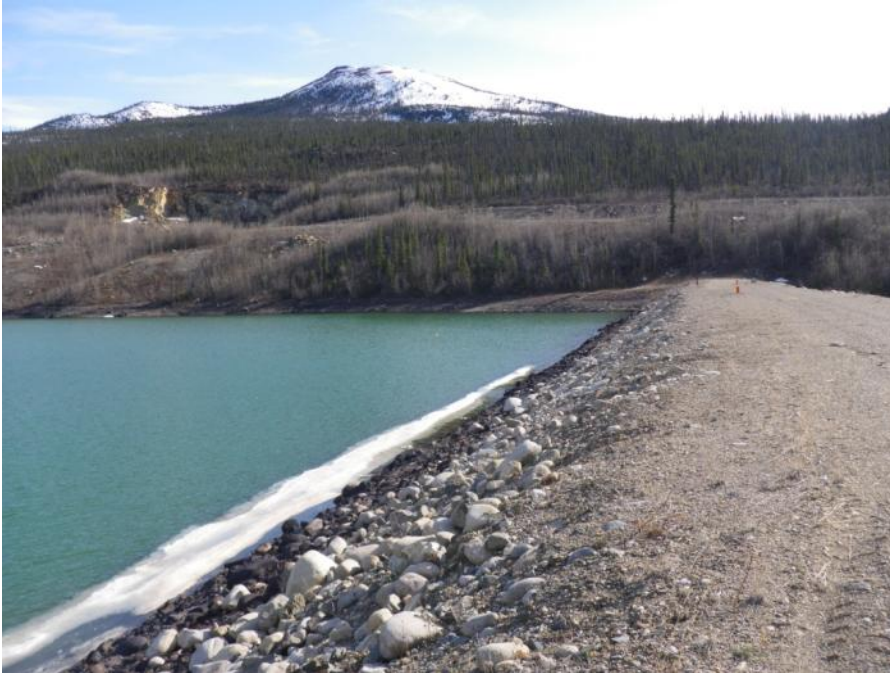
Photo 37 Cross Valley Dam crest and upstream slope (May 29, 2012)

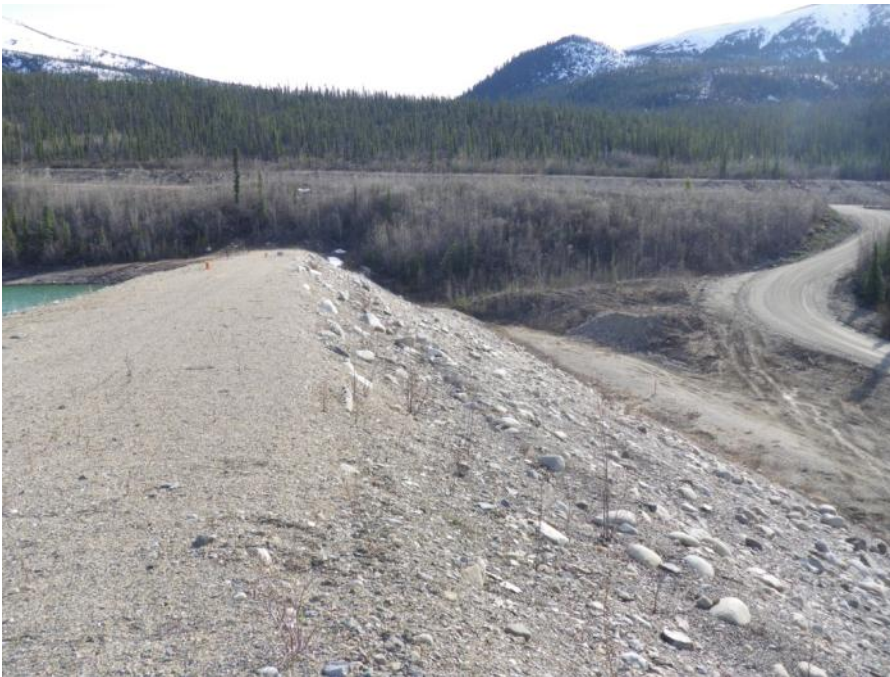
Photo 38 Dam crest and downstream slope (May 29, 2012)

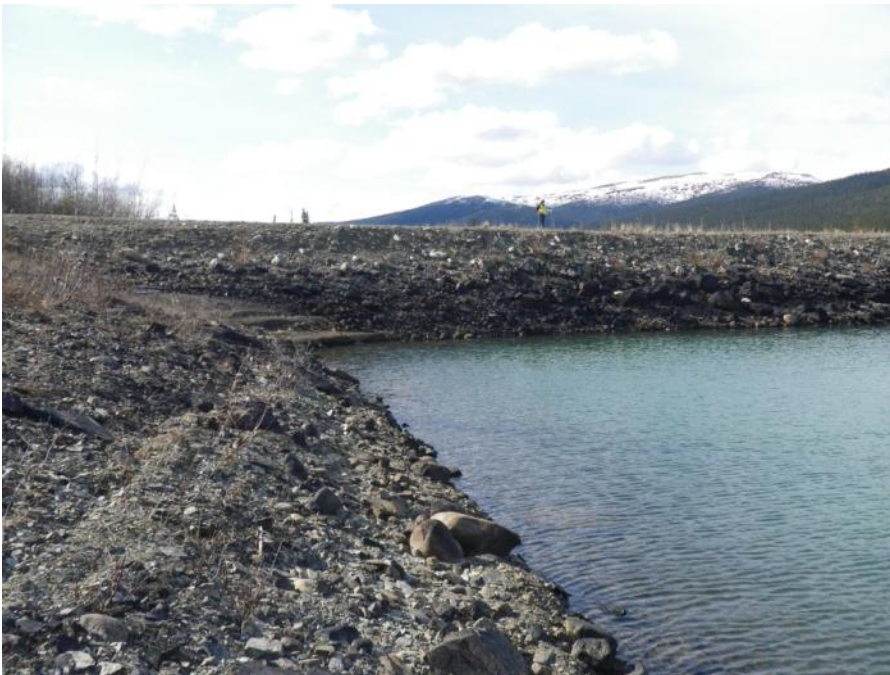
Photo 40 Canal Dyke slope upstream of Cross Valley Dam (May 29, 2012)

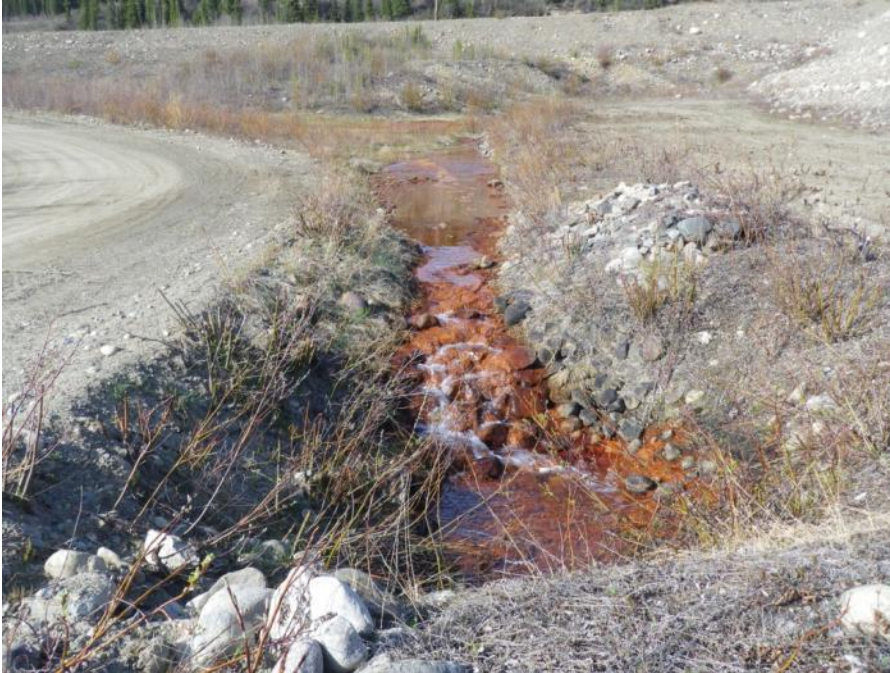
Photo 41 Downstream seepage along northeast segment of dam (May 29, 2012)

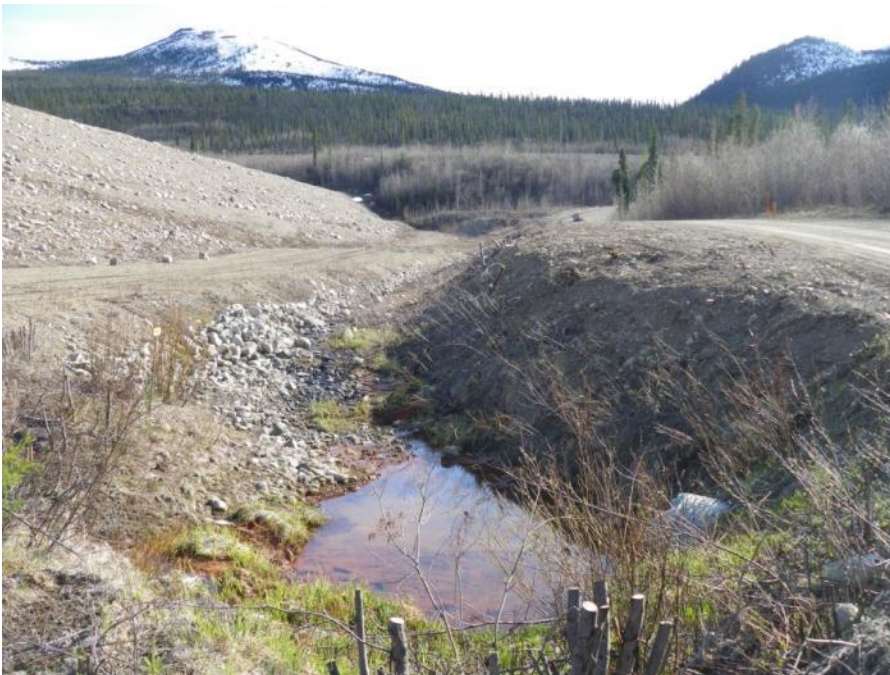
Photo 42 Downstream seepage along middle segment of dam (May 29, 2012)

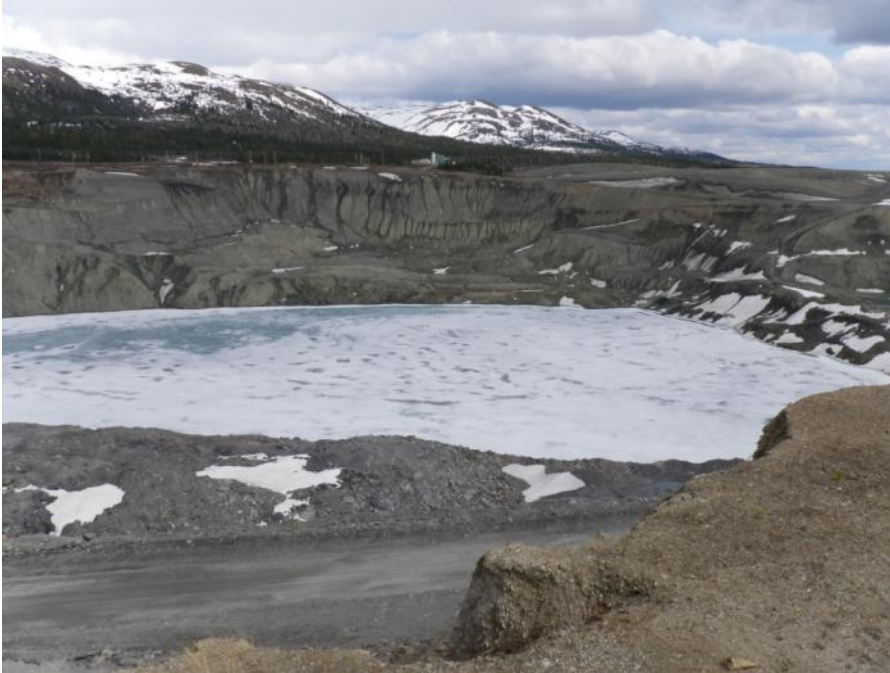
Photo 43 Grum Pit south segment of east wall as seen from northwest wall
(May 29, 2012)

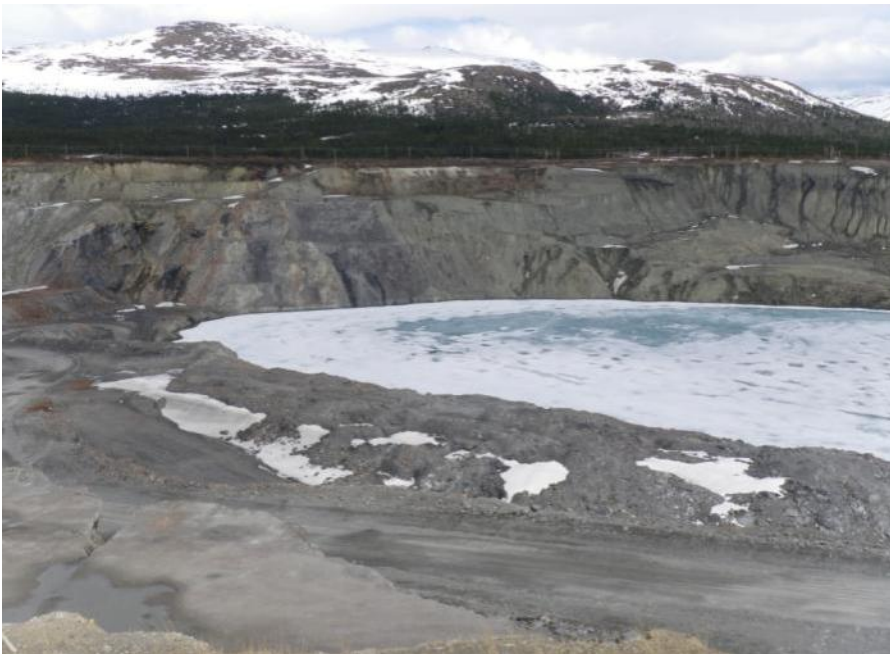
Photo 44 Grum Pit north segment of east wall as seen from northwest wall
(May 29, 2012)

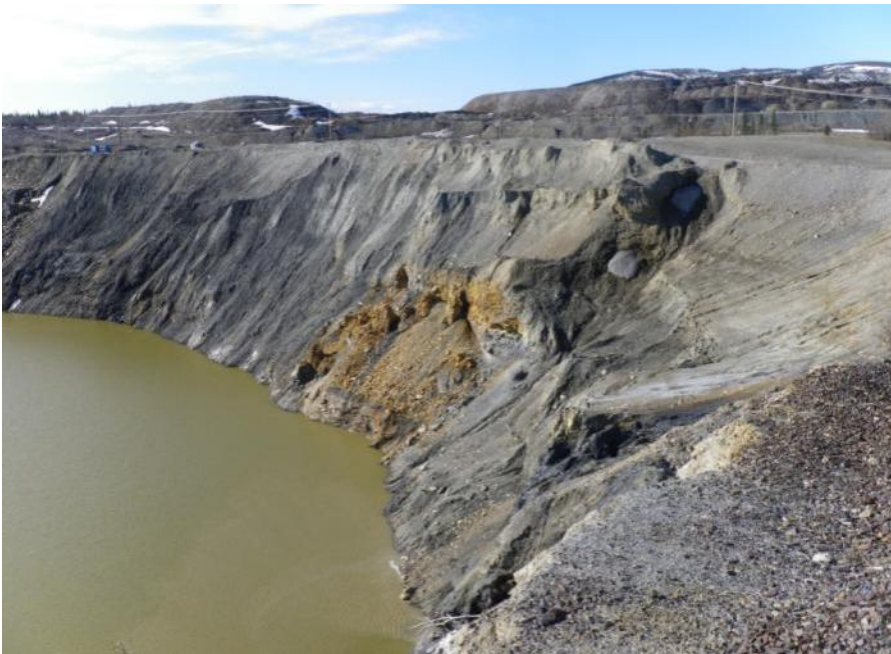
Photo 46 Vangorda Pit southwest wall as seen from northwest wall
(May 30, 2012)

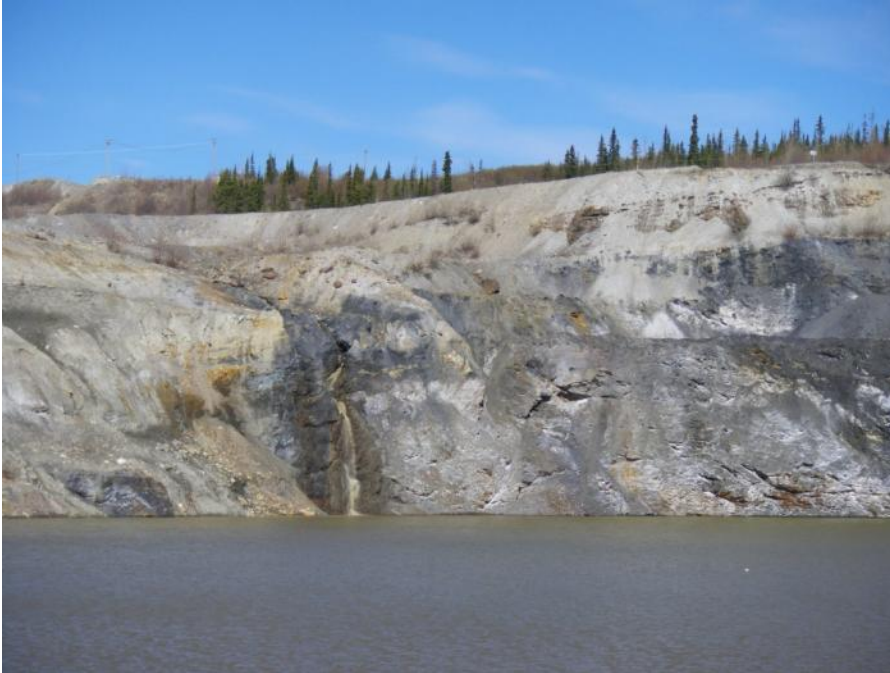
Photo 47 Vangorda Pit northwest wall lower segment - note Vangorda Flume behind the wall (May 30, 2012).

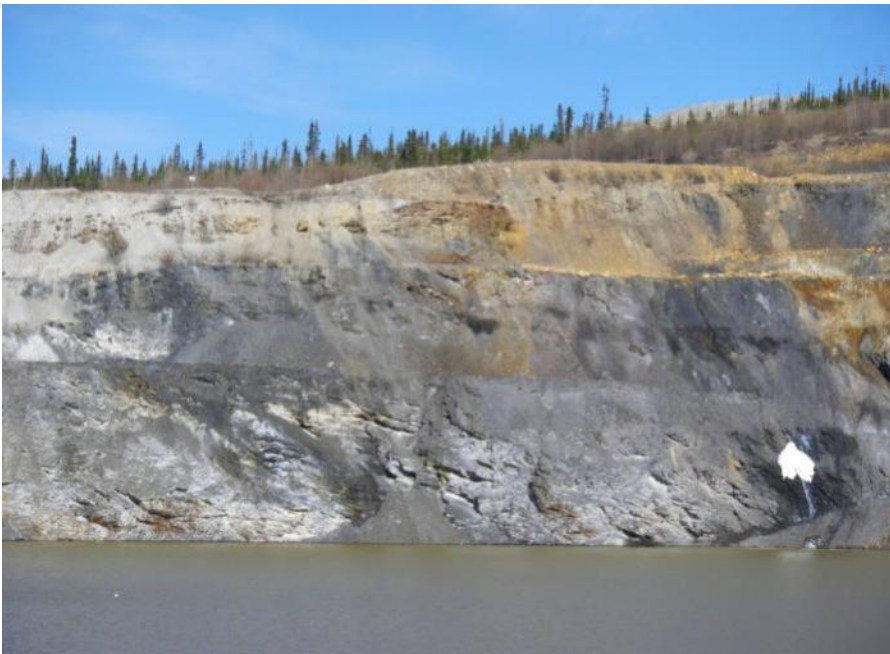
Photo 48 Vangorda Pit northwest wall upper segment - note Vangorda Flume behind the wall (May 30, 2012)

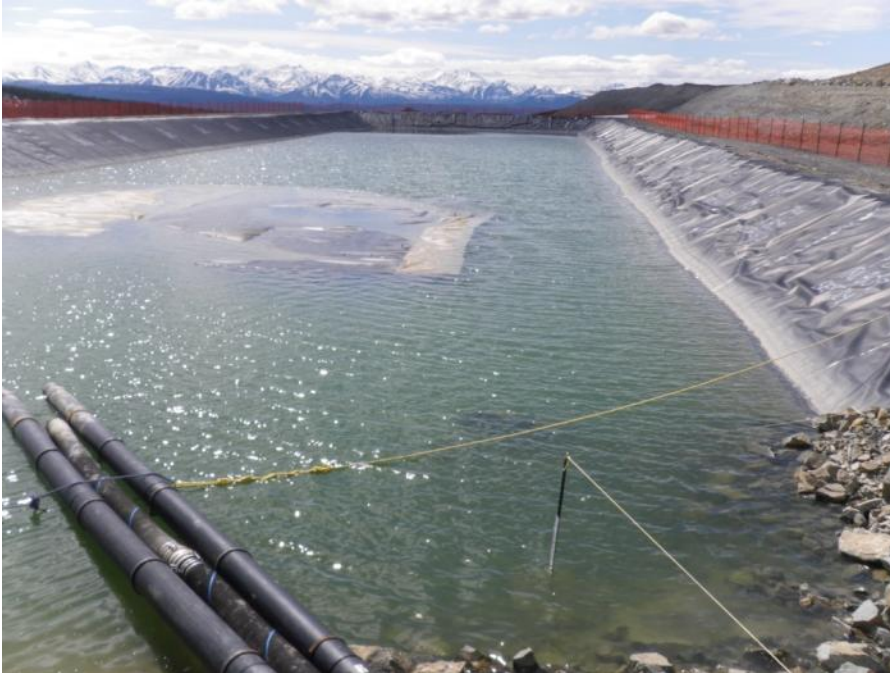
Photo 49 Grum Dump surface water storage pond (May 30, 2012)

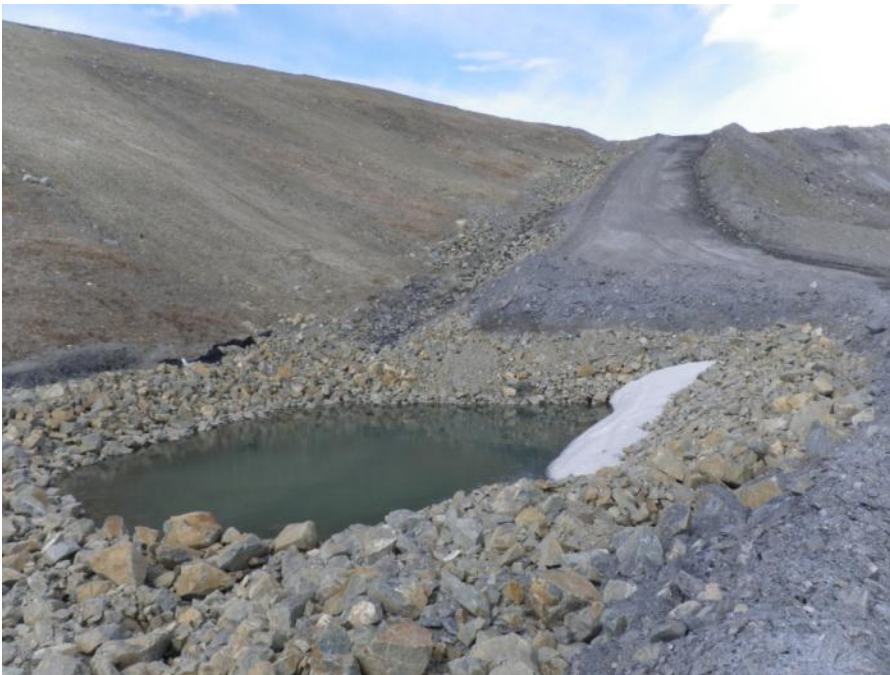
Photo 50 Grum Dump side slope, water retention pond on bench and access ramp (May 30, 2012).

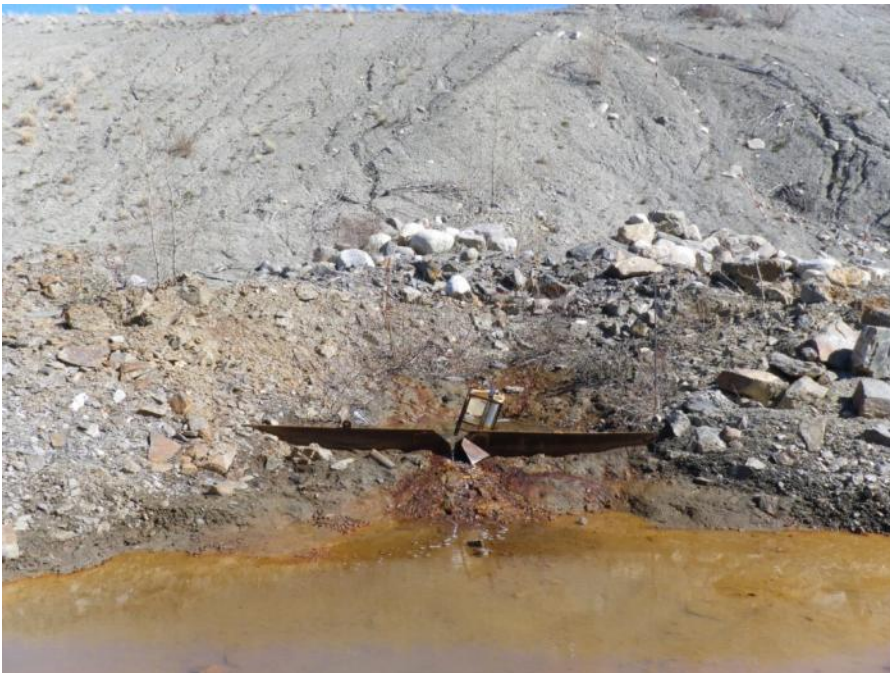
Photo 52 Vangorda Waste Rock Dump drain no. 3 (May 30, 2012)

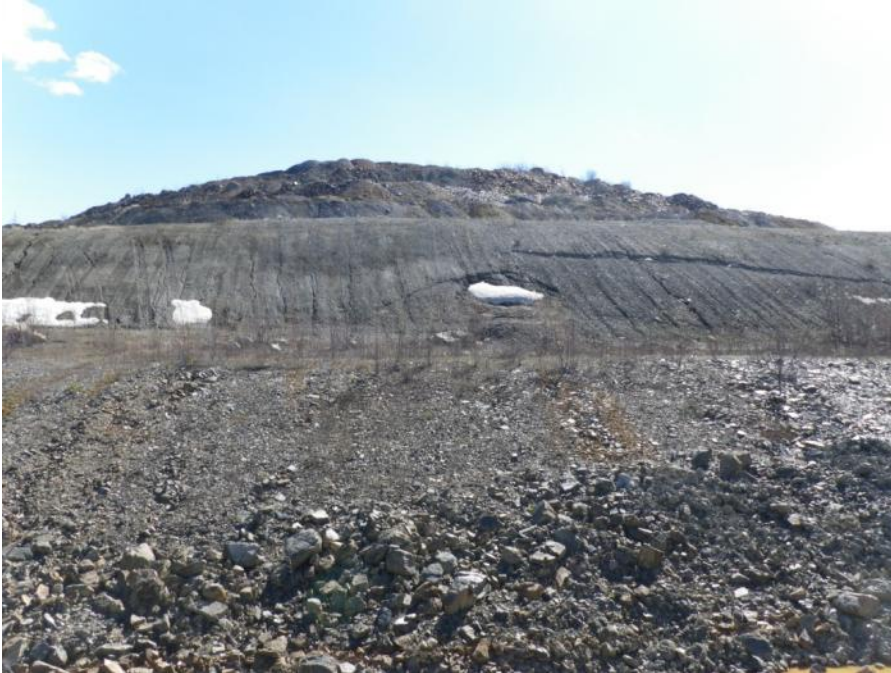
Photo 53 Dump face with previously marked slope slump (May 30, 2012)
