June 15, 2012

Yukon Government
Faro Mine Remediation Project
Suite 2C-4114-4th Ave
PO Box 2703 (K-149)
Whitehorse, Yukon Territory
Y1A 2C6

Faro Mine Complex
2011 Annual Geotechnical Review

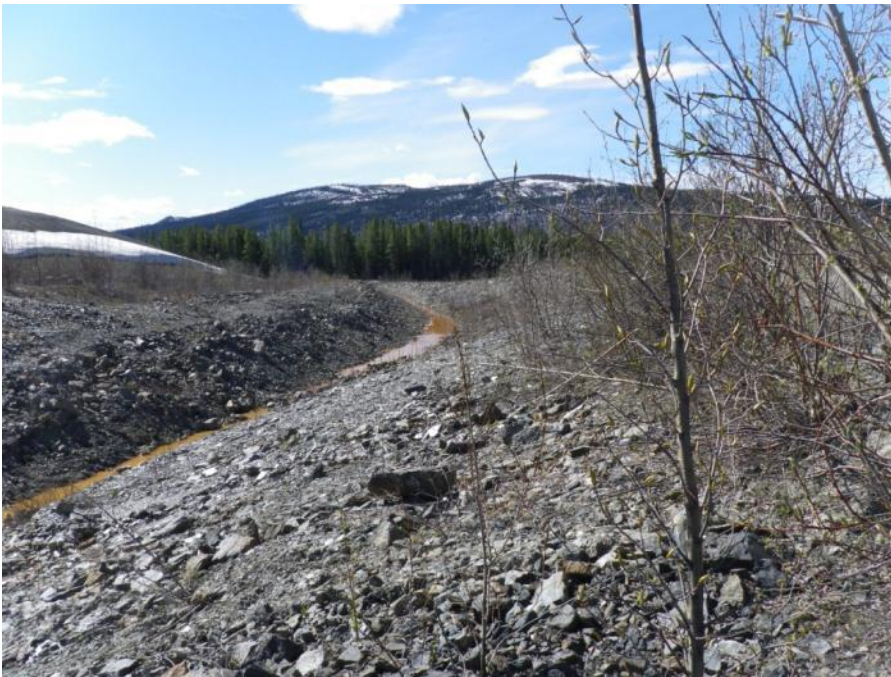
Photo 54 Seepage collection ditch between drain nos. 3 and 4. (May 30, 2012)

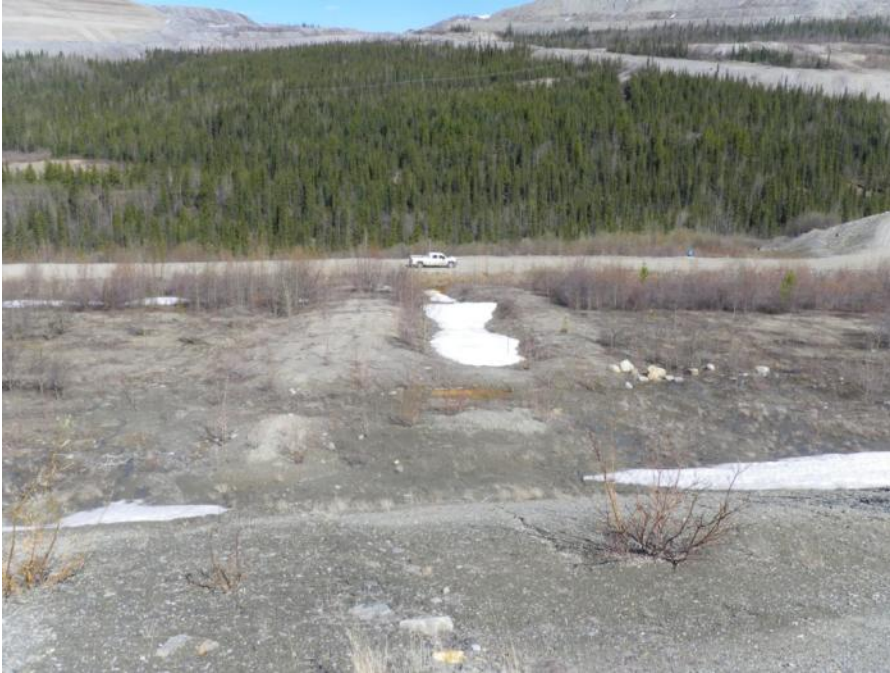
Photo 55 Dump slope and seepage collection ditch at drain no. 4 (May 30, 2012)

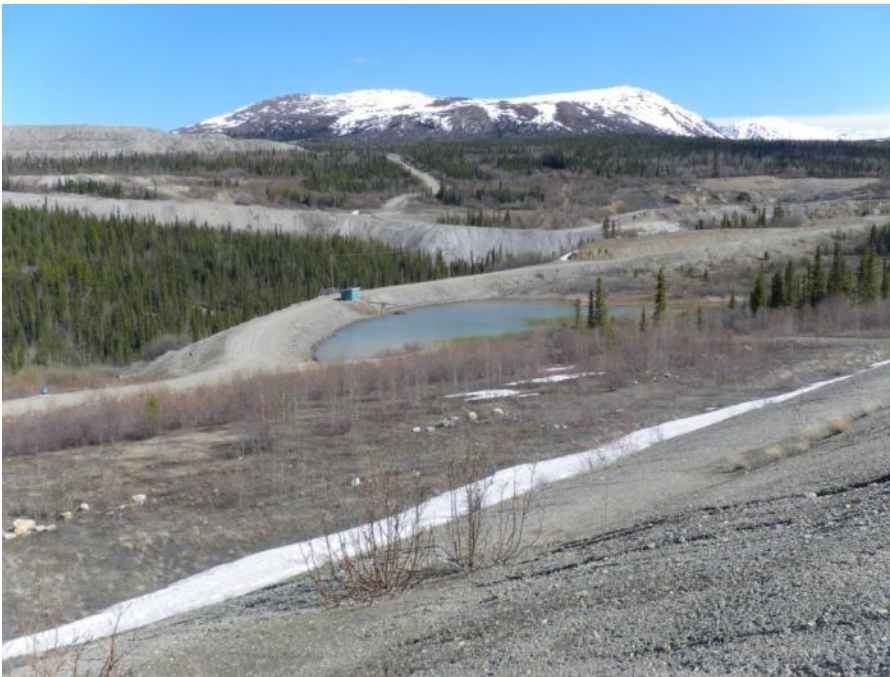
Photo 56 Toe of dump slope in area above Little Creek Dam (May 30, 2012)

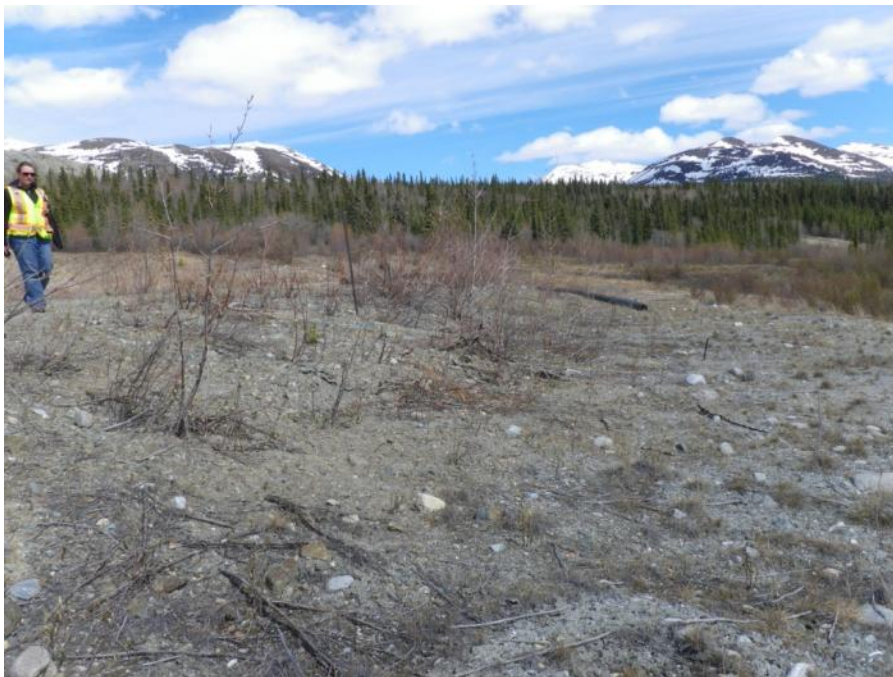
Photo 58 Grum Pit brim monitoring north pin array (May 30, 2012)

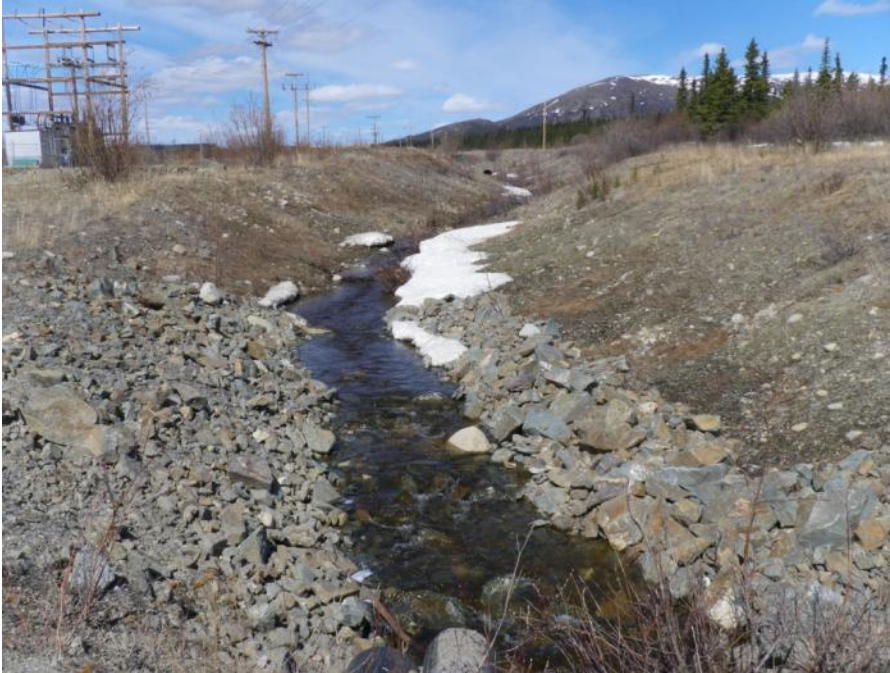
Photo 59 Grum Pit Interceptor Ditch in vicinity of power substation(May 30, 2012)

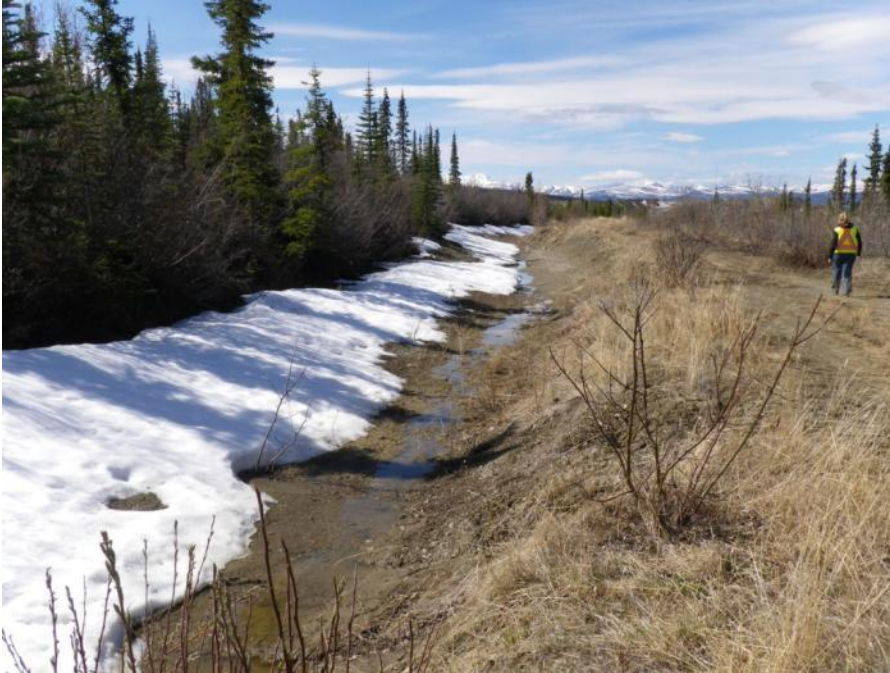
Photo 63 Vangorda North-East Interceptor Ditch upper reach (May 30, 2012)

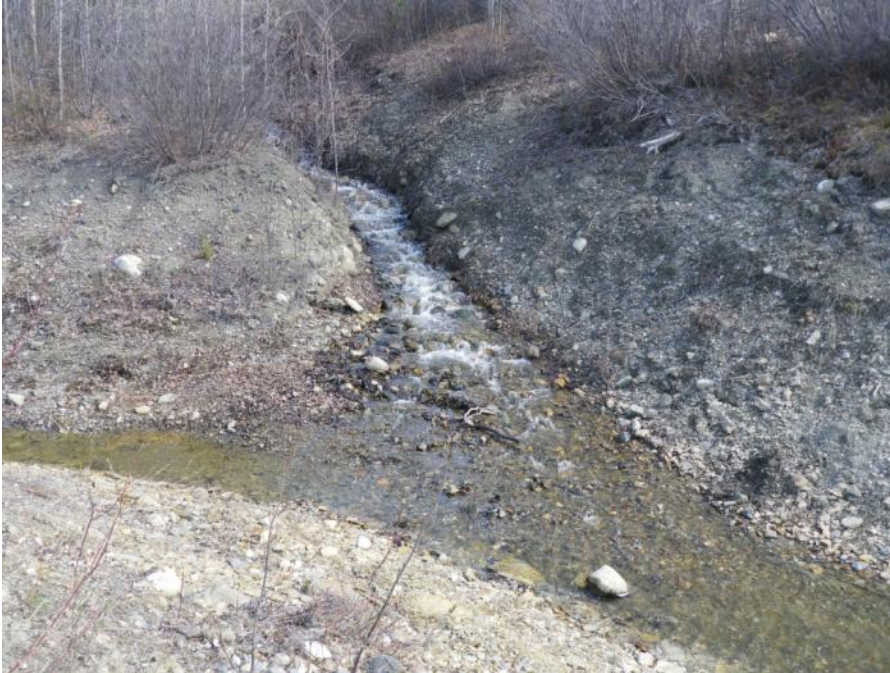
Photo 65 Increase of ditch flow downstream of confluence of a tributary stream
(May 30, 2012)

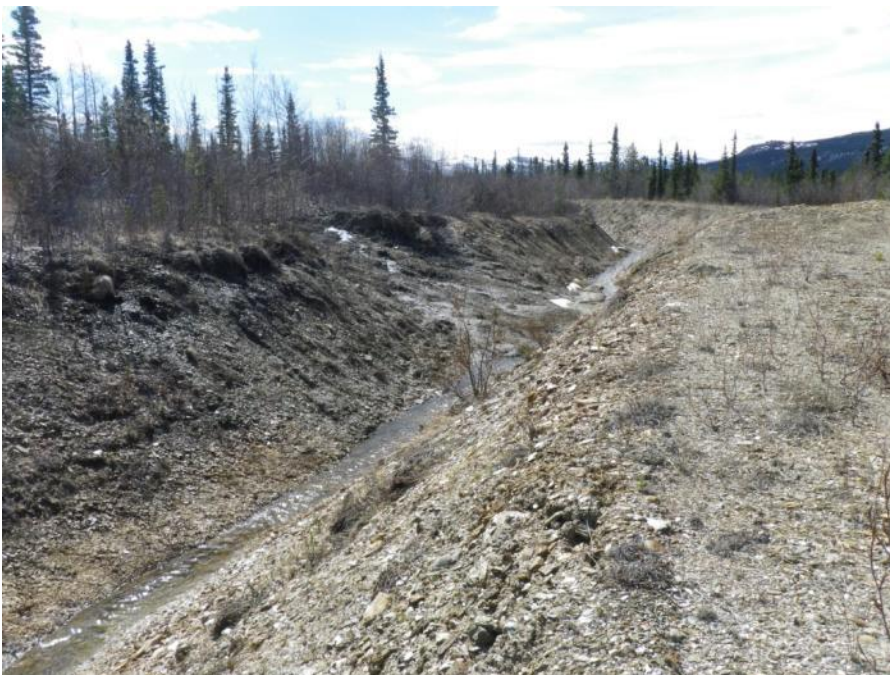
Photo 66 Ditch bank slope slump (May 30, 2012)

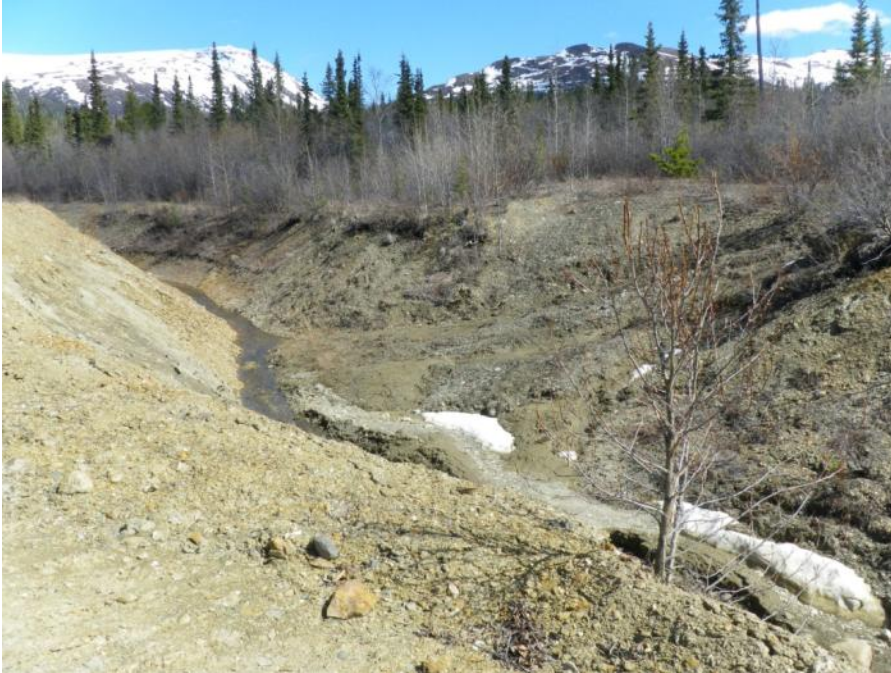
Photo 67 Ditch bank slope slump (May 30, 2012)

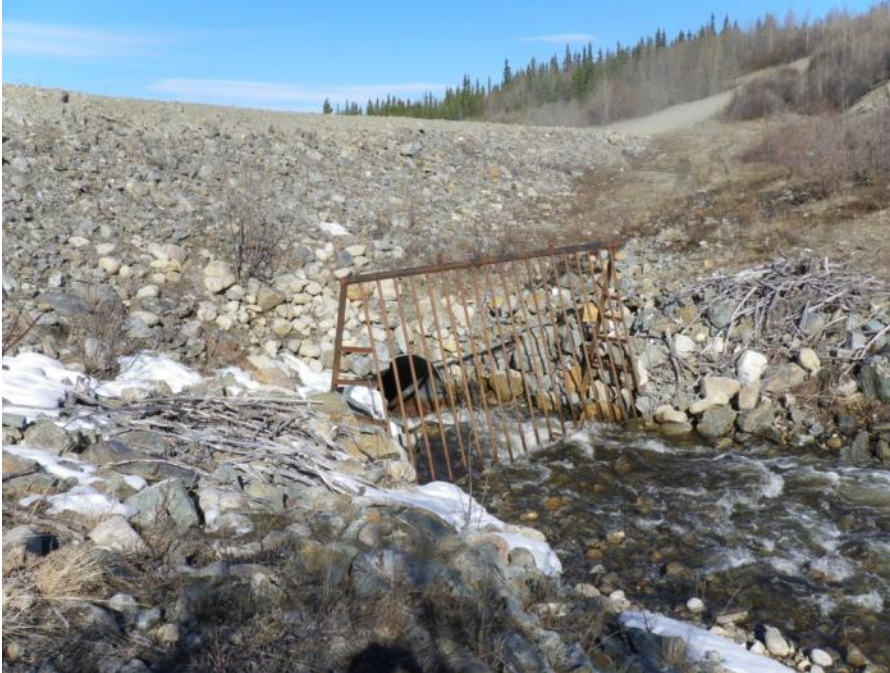
Photo 69 Vangorda Flume Diversion culvert inlet - note runoff entering into creek near culvert entrance (May 30, 2012)

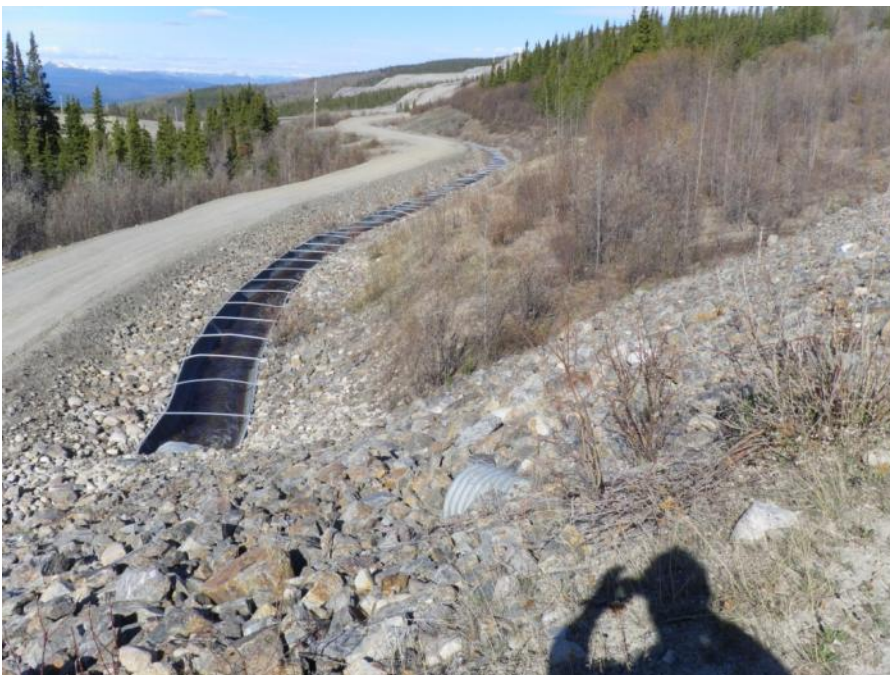
Photo 70 Culvert flow into Vangorda Flume Diversion (May 30, 2012)

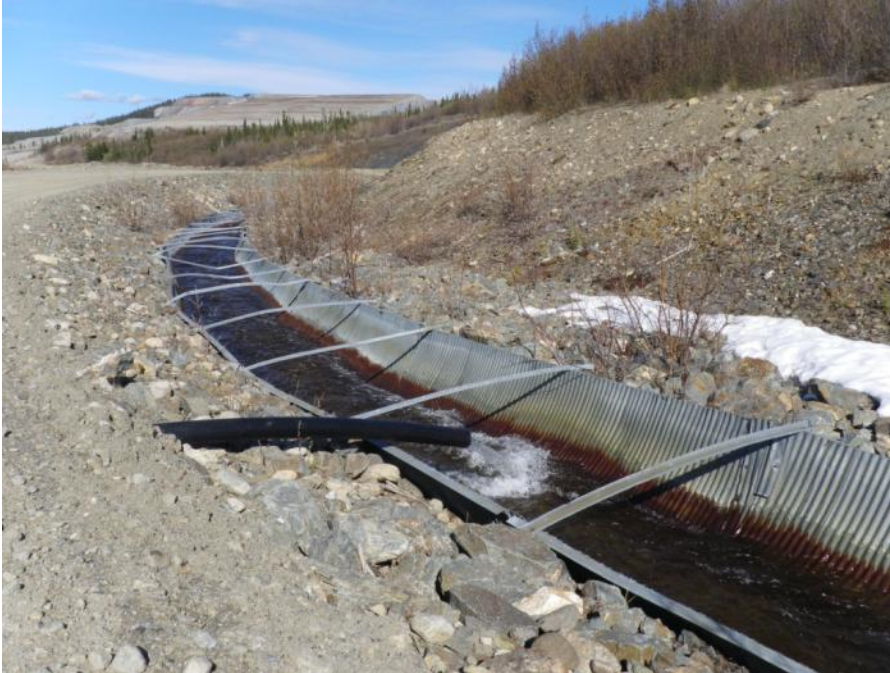
Photo 71 Inflow to Flume Diversion by pumping from intercepted runoff collected below access road (May 30, 2012)

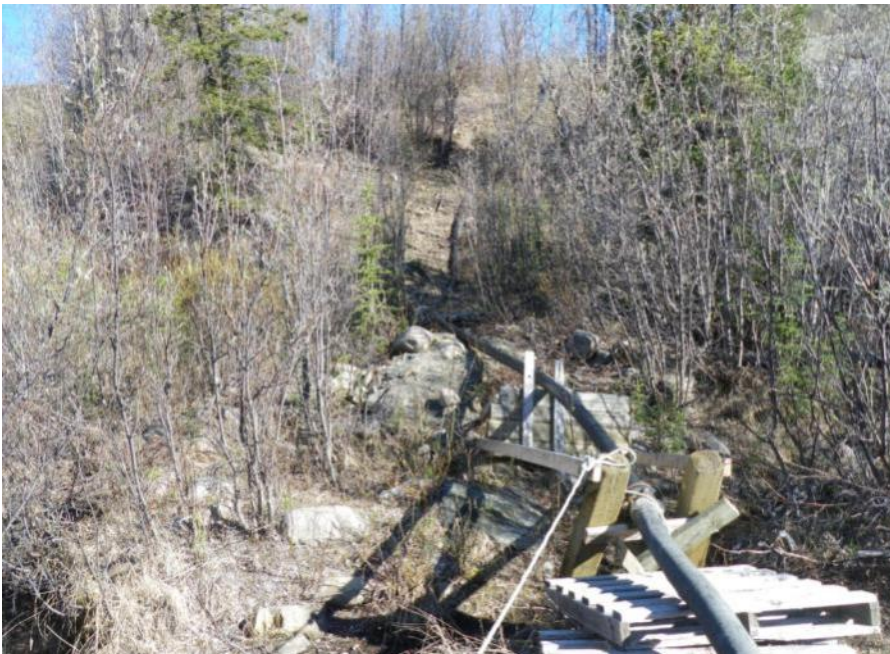
Photo 72 Pipeline below access road to convey collected surface runoff as seen on Photo 73 (May 30, 2012)

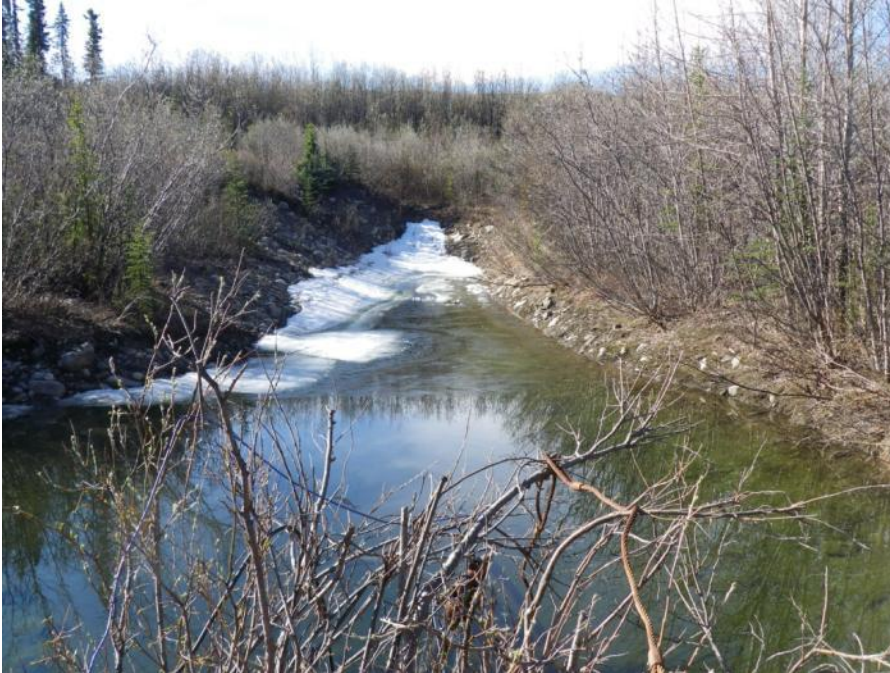
Photo 73 Excavated trench to collect surface runoff for pumping into Flume Diversion as seen in Photo 72 (May 30, 2012)

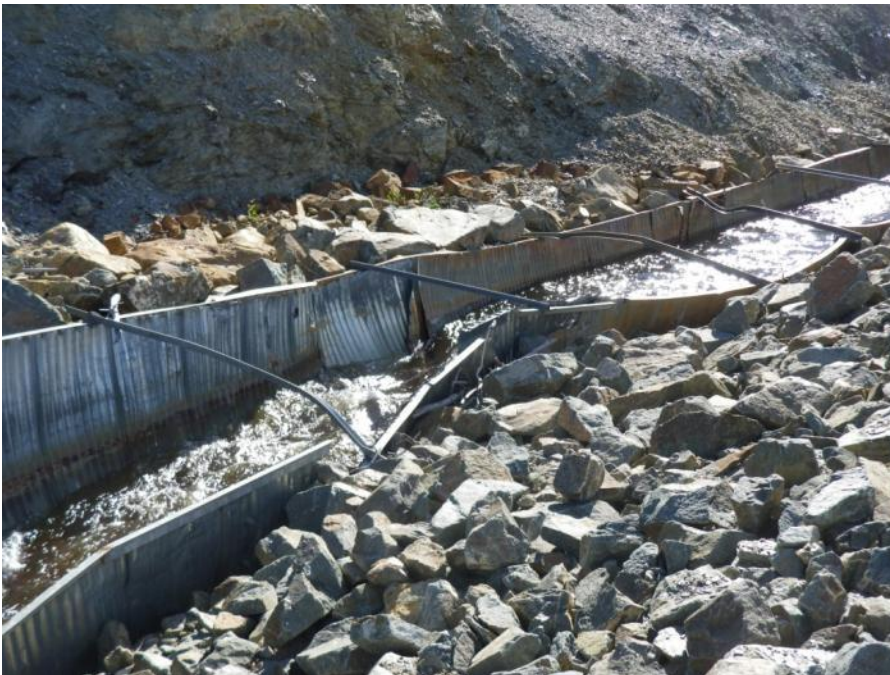
Photo 74 Battered section along lower reach of Vangorda Flume (May 30, 2012)

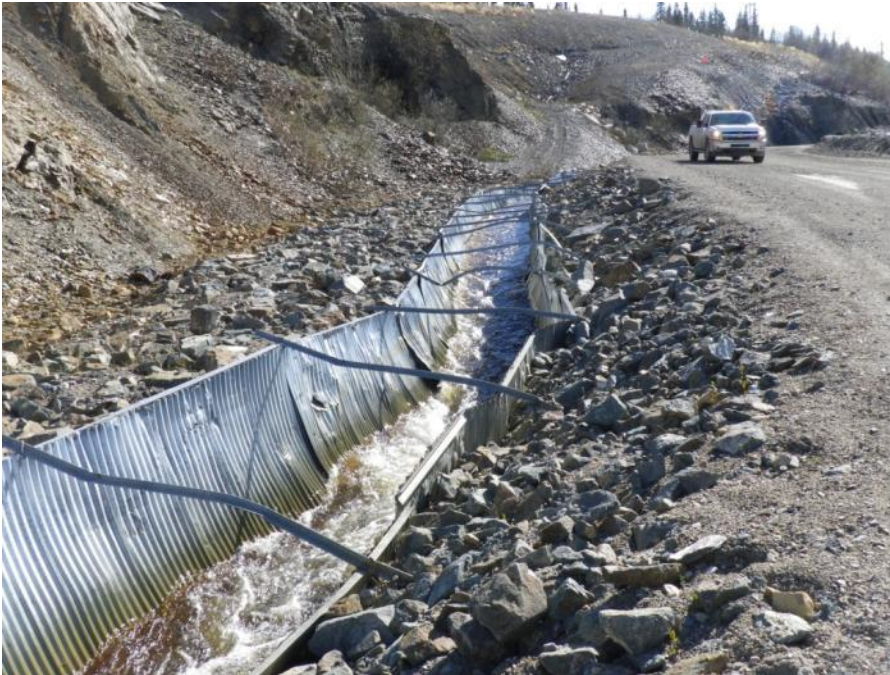
Photo 75 Battered section along lower reach of Vangorda Flume (May 30, 2012)

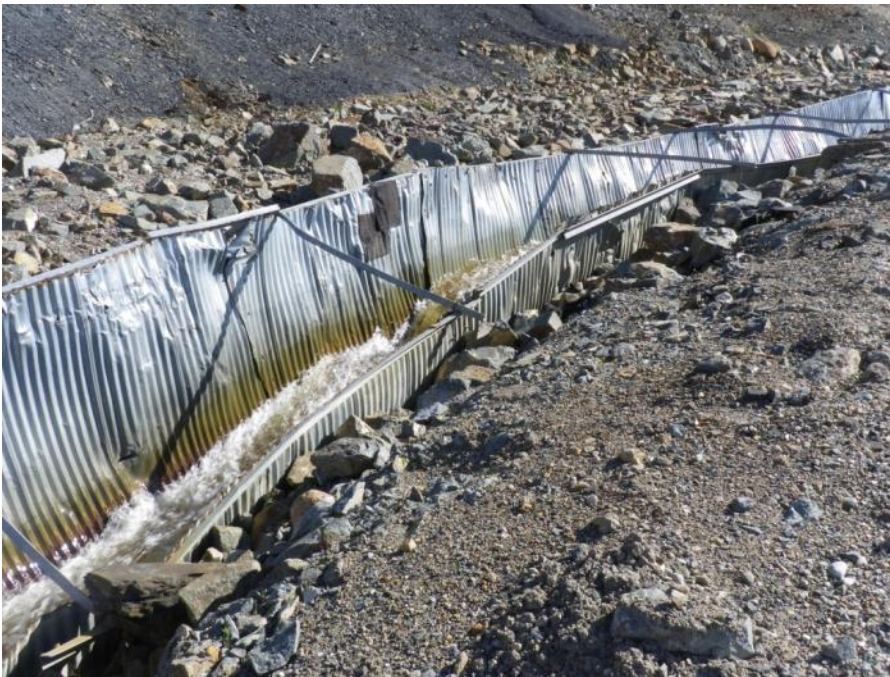
Photo 76 Battered section along lower reach of Vangorda Flume (May 30, 2012)

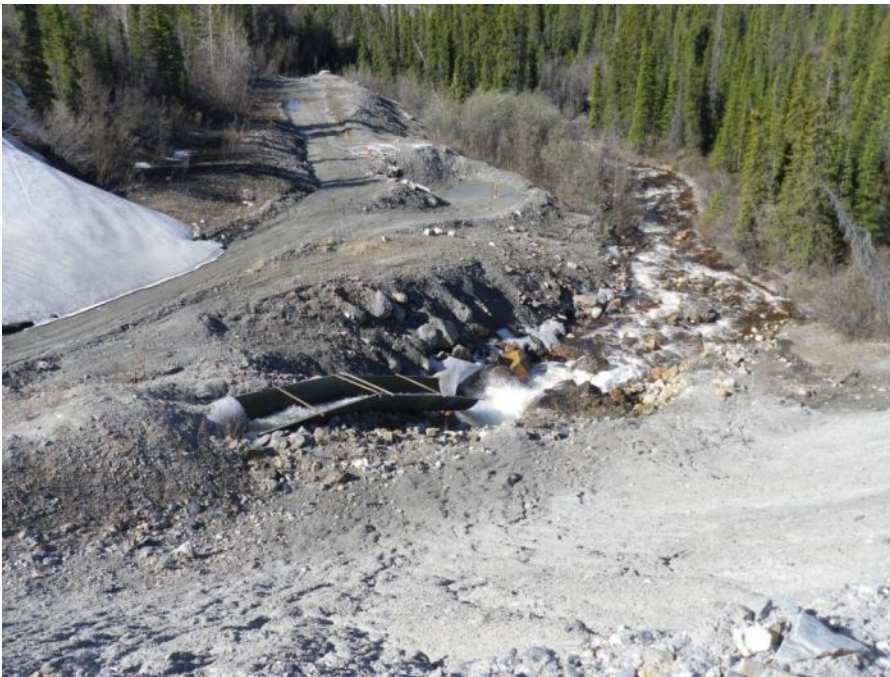
Photo 80 Discharge of Vangorda Flume flow via culvert leading from drop box as seen on Photo 79 (May 30, 2012)

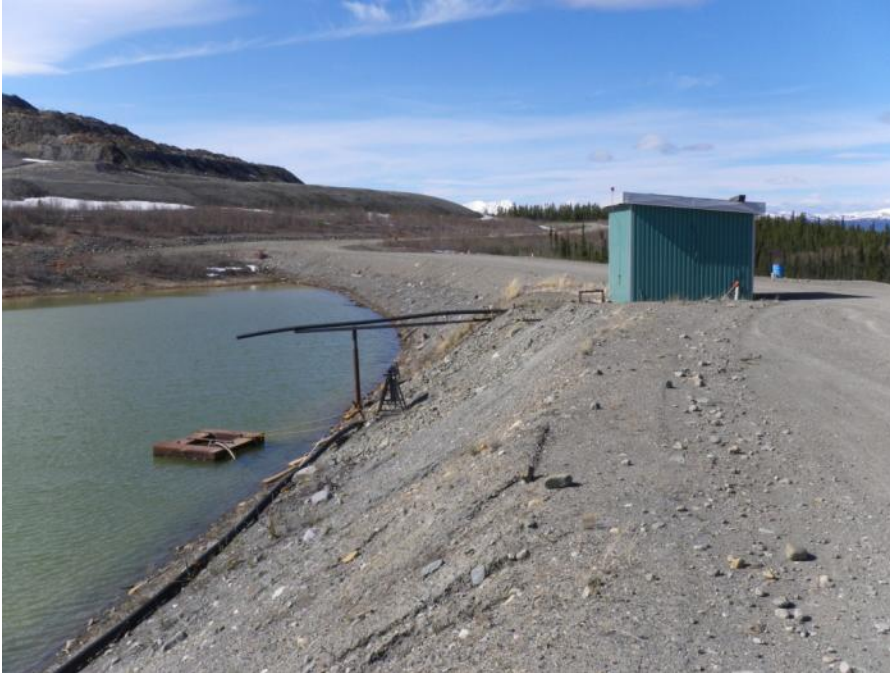
Photo 81 Little Creek Dam crest, upstream slope and Vangorda Dump seepage collection pond (May 30, 2012)

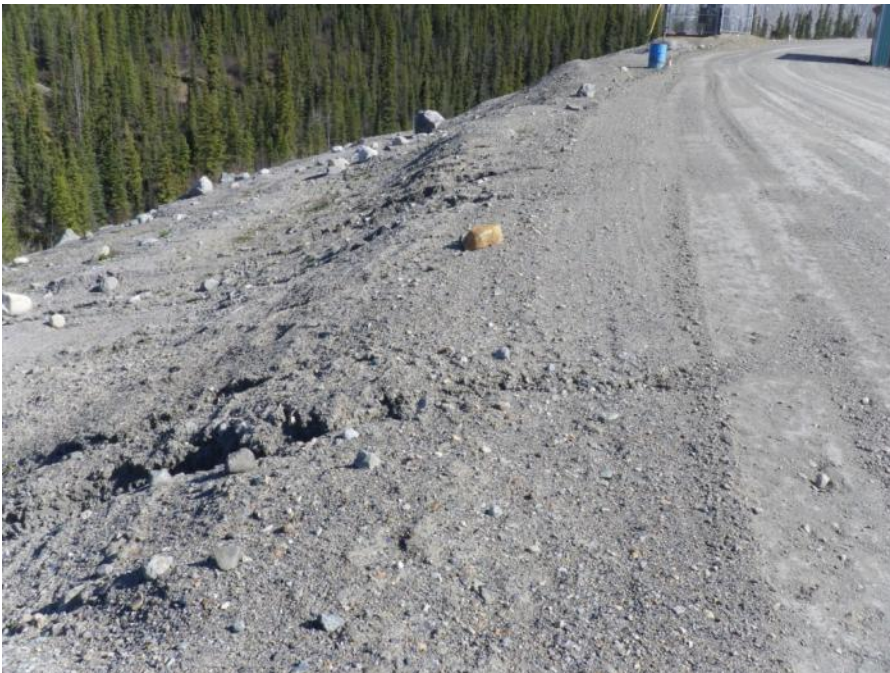
Photo 82 Dam crest and downstream slope (May 30, 2012)

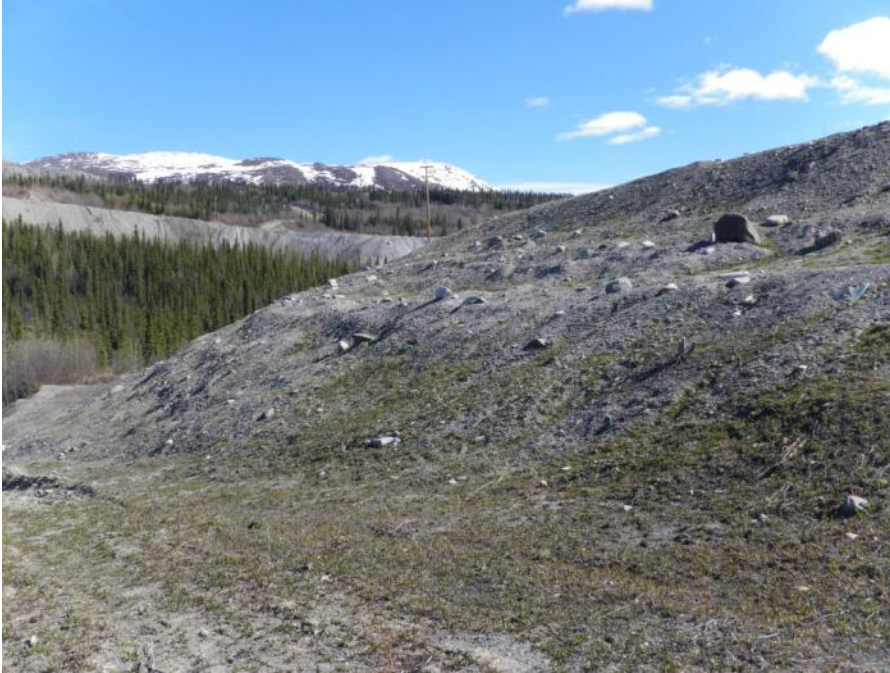
Photo 83 Downstream dam and berm slope (May 30, 2012)

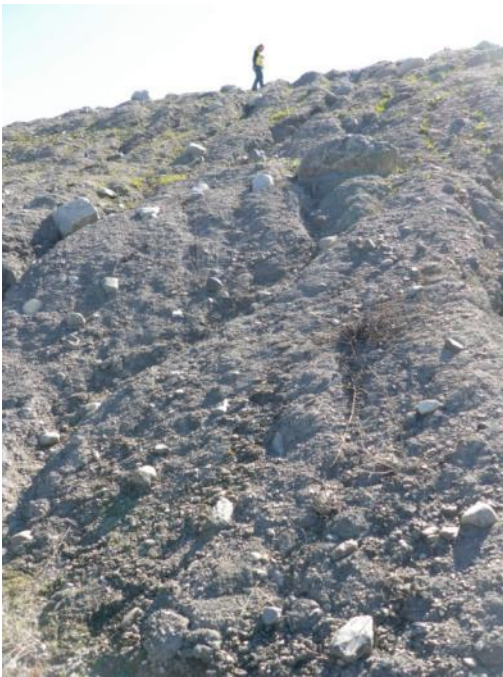
Photo 84 Downstream slope rill erosions (May 30, 2012)

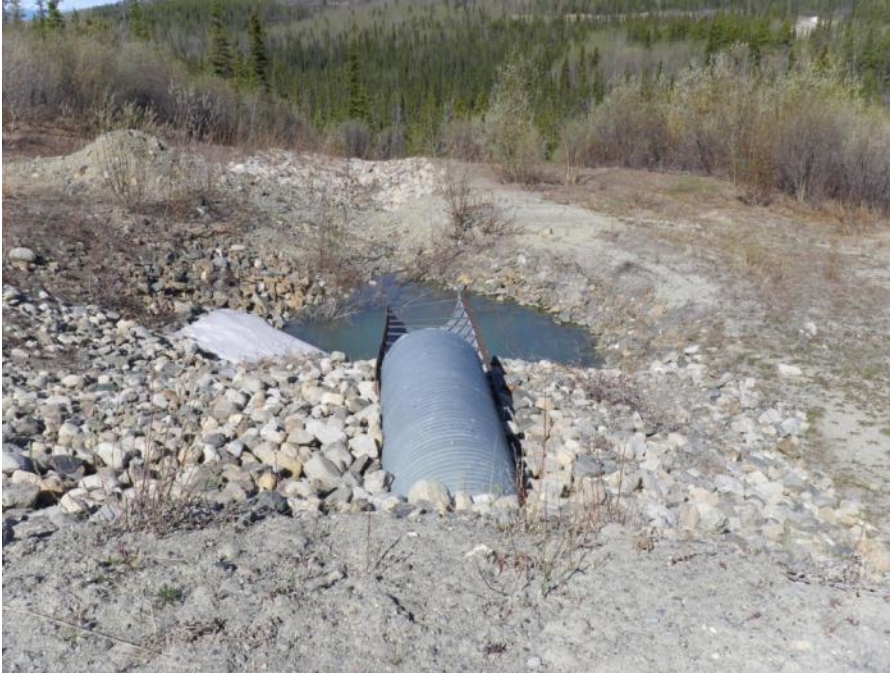
Photo 85 Culvert spillway outlet (May 30, 2012)

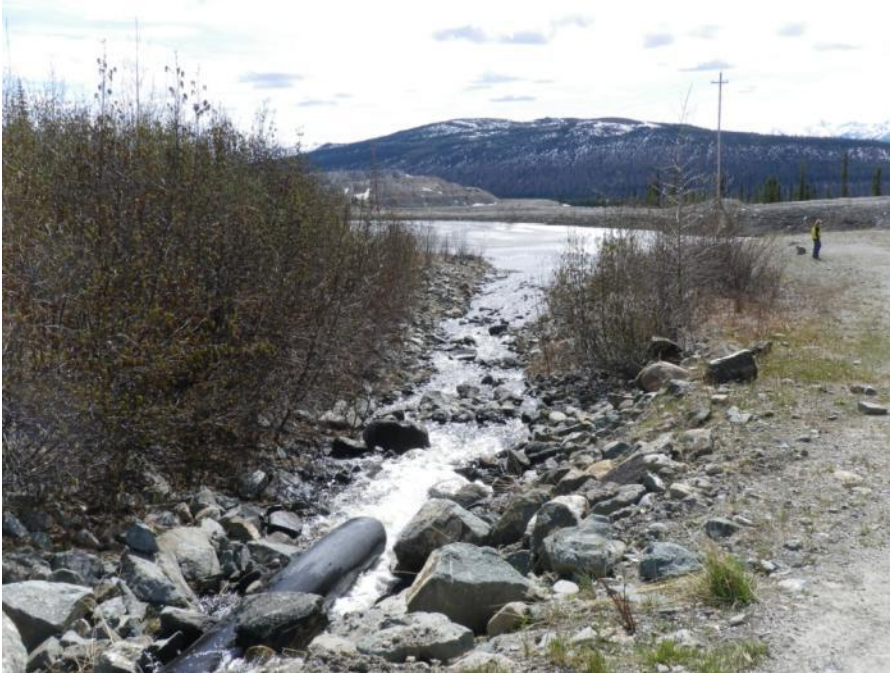
Photo 87 Flow entering Upper Sheep Pad Sediment Pond (May 30, 2012)

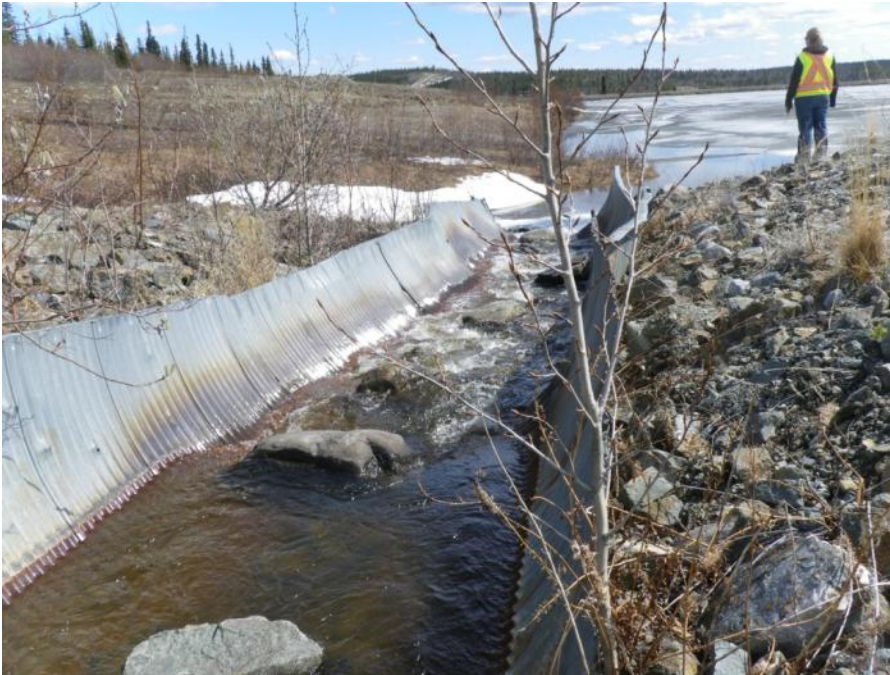
Photo 89 Flume flow from Upper to Lower Sheep Pad Pond (May 30, 2012)

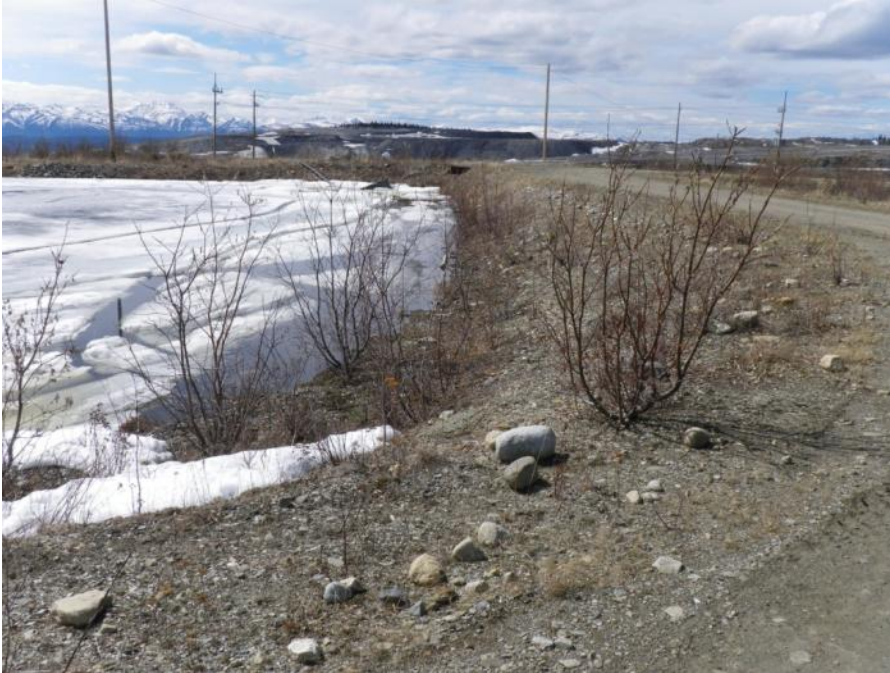
Photo 91 Grum Settling Pond (May 30, 2012)

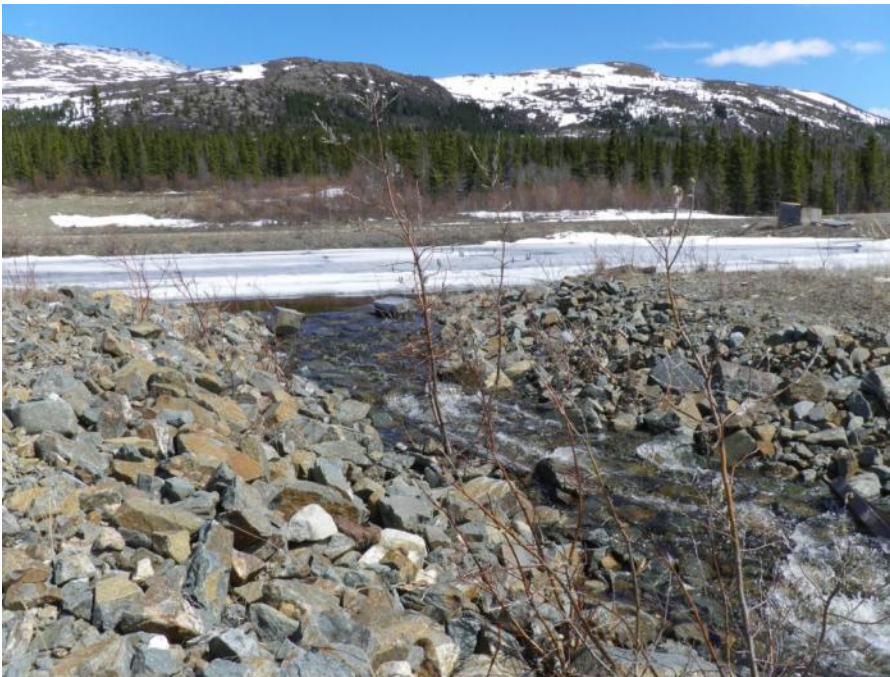
Photo 92 Grum Settling Pond and flow through spillway channel (May 30, 2012)

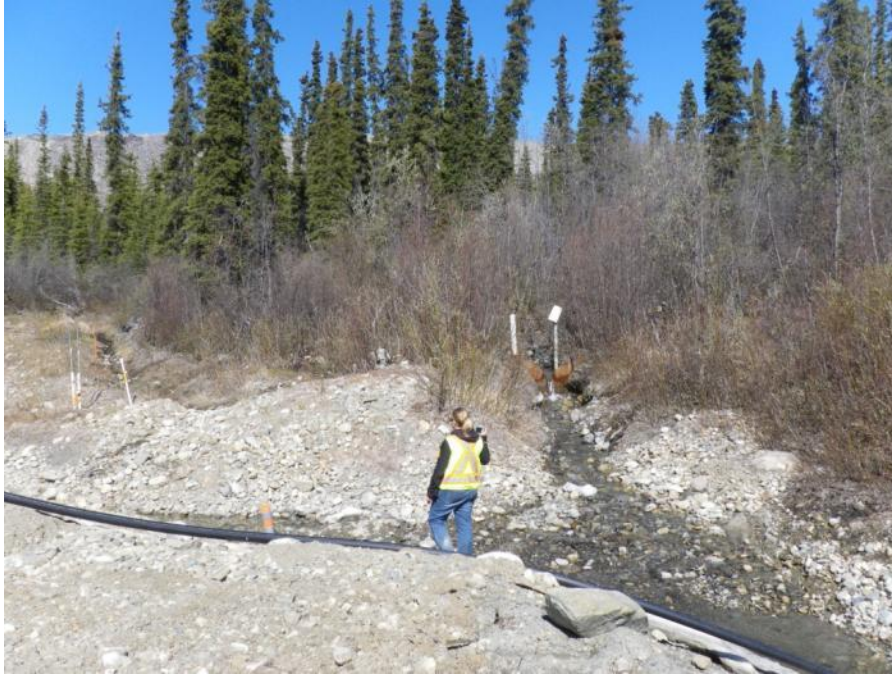
Photo 93 V-15 Diversion Ditch and weir flow (May 30, 2012)

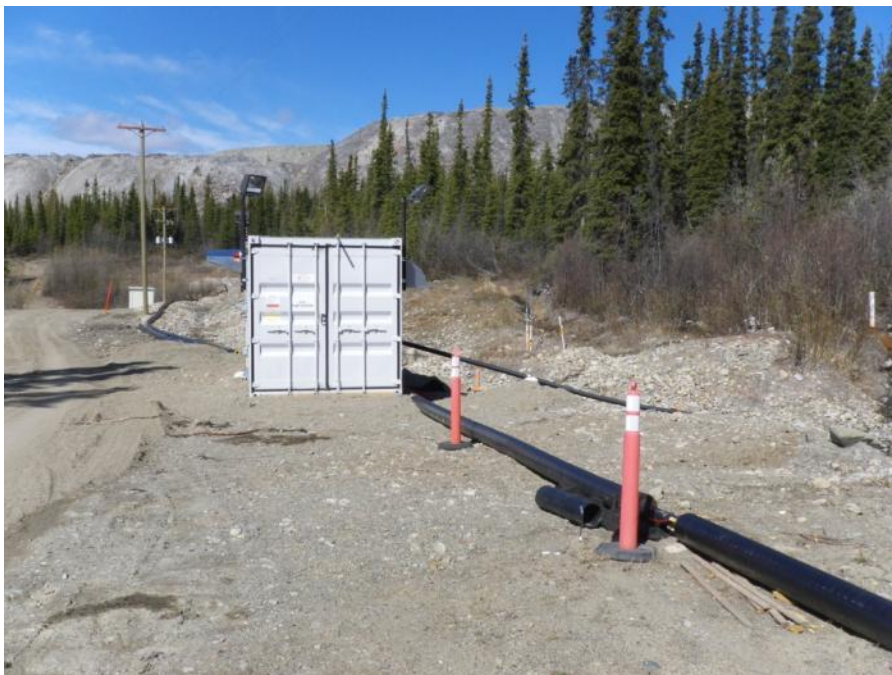
Photo 94 V-15 Enclosed Sump Pump for pumping excess water during spring freshet into Vangorda Pit (May 30, 2012)

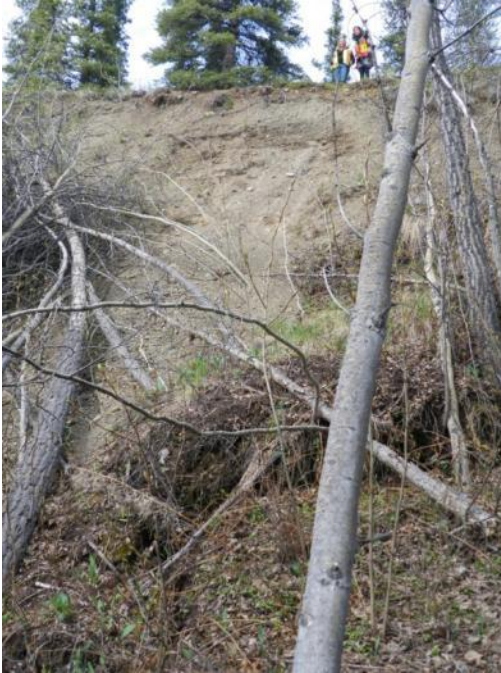
Photo 97 Downstream slope of esker - note seepage daylighting from slope (May 29, 2012)

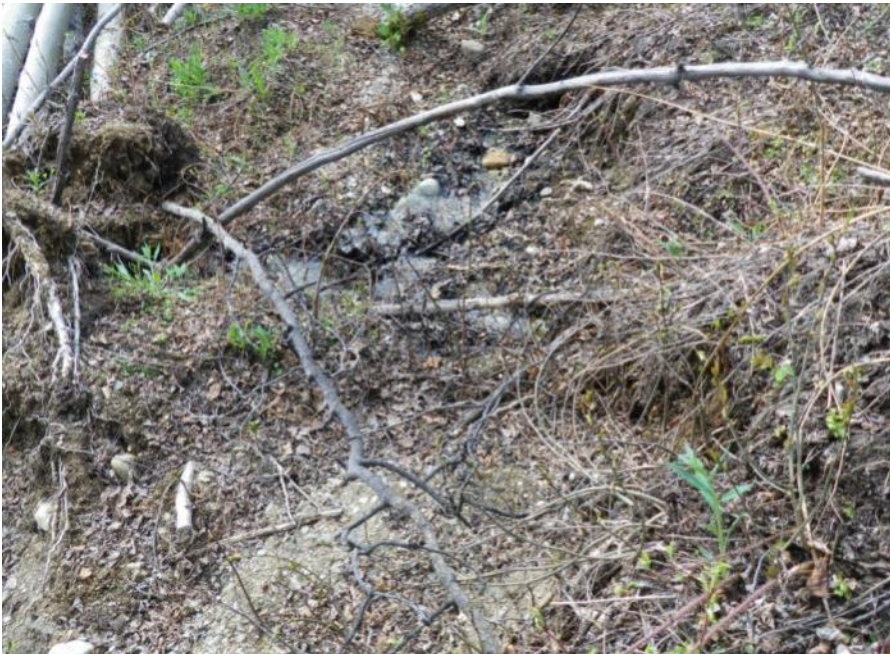
Photo 98 Seepage rate increased further down slope from the upslope daylighting location (May 29, 2012)

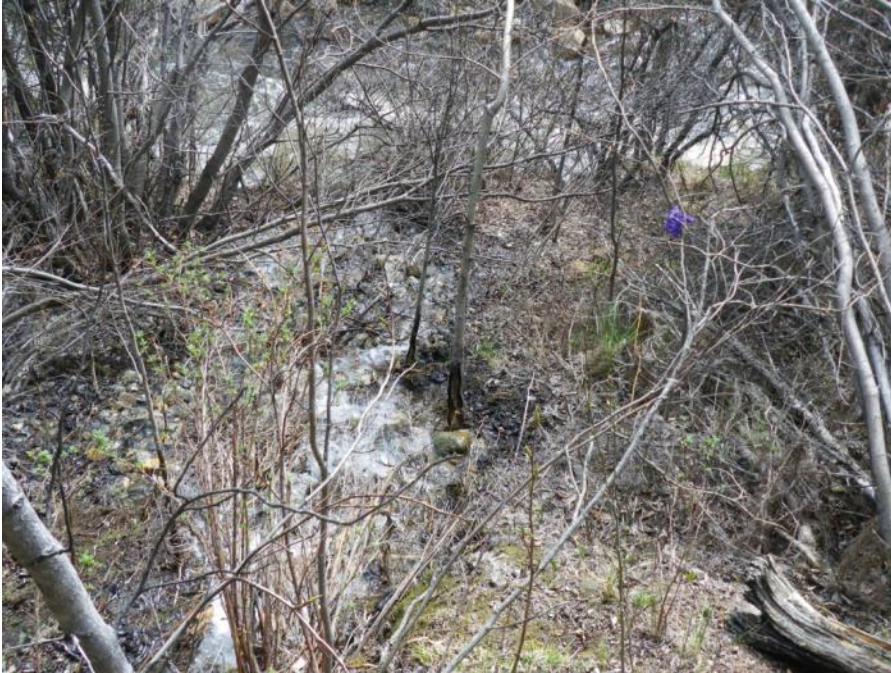
Photo 99 Seepage rate increased about ten-fold near entrance to Vangorda Creek (May 29, 2012)

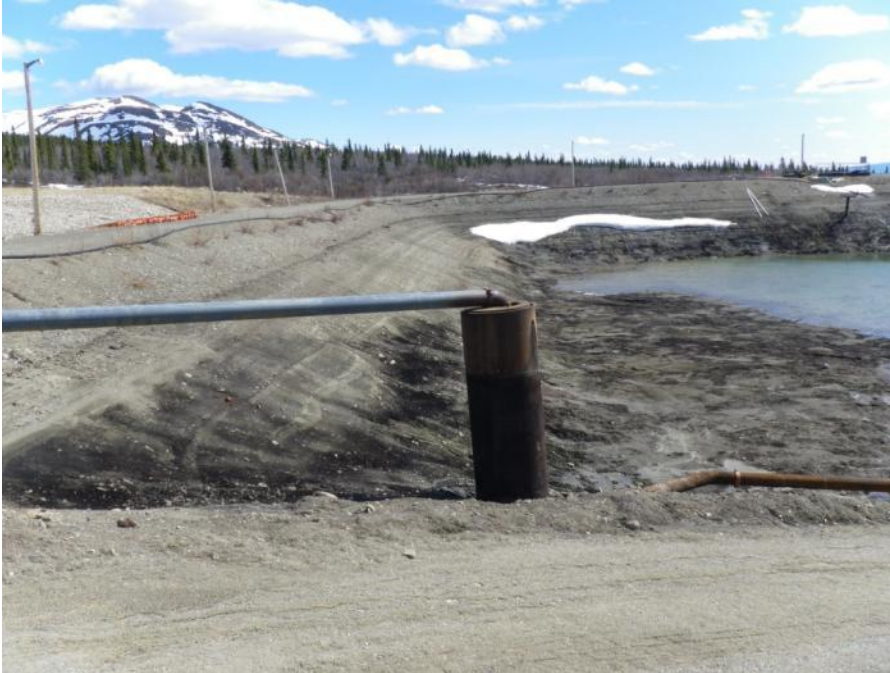
Photo 101 Sludge Pond and sludge inflow pipe - note freshly removed sludge surface (May 30, 2012)

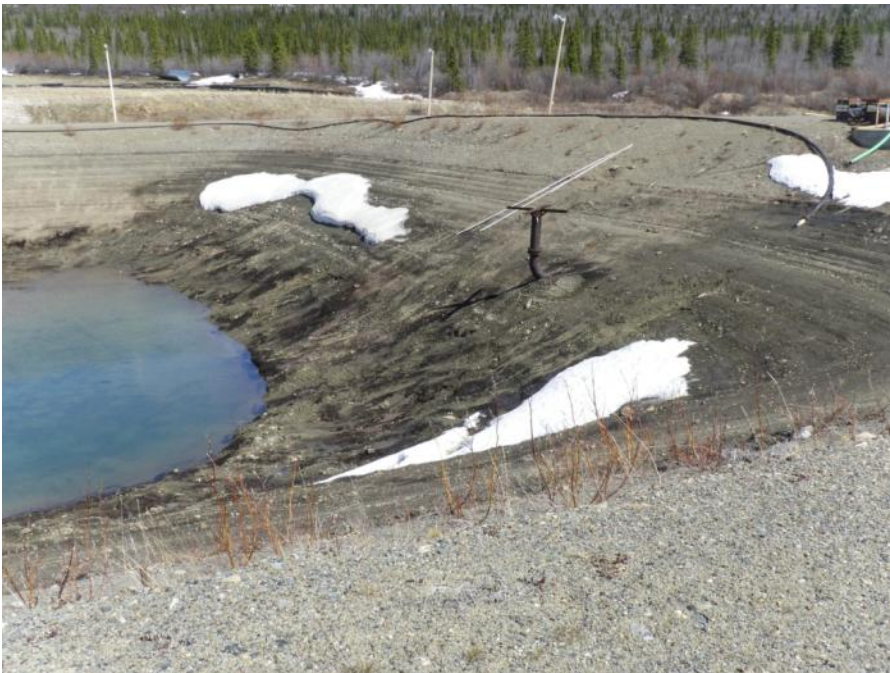
Photo 102 Sludge Pond (May 30, 2012)
