Re: EBA Engineering Report “Assessment of Rail Car and Small Mixing Tank - Mount Nansen Site - Yukon” (November 2012)

ASSESSMENT OF RAIL CAR AND SMALL MIXING TANK MOUNT NANSEN SITE YUKON

NOVEMBER 2012
ISSUED FOR USE
EBA FILE: W23101576

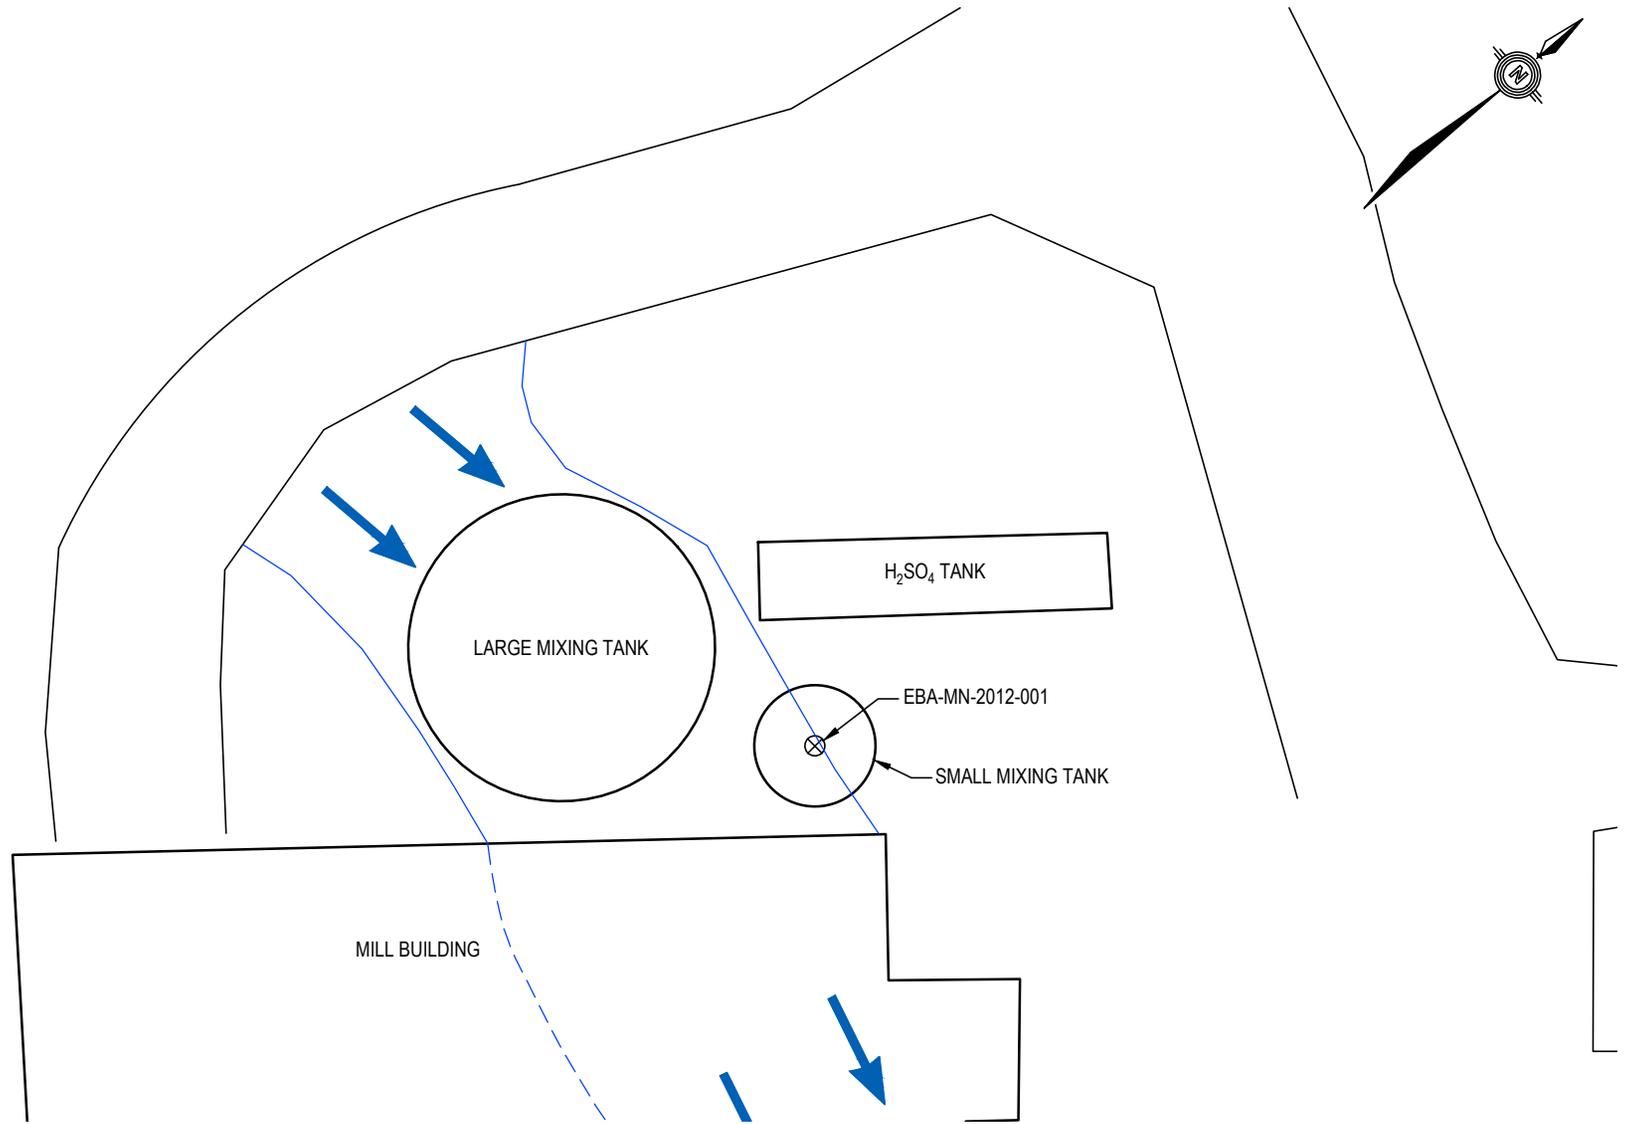
PROJECT NO. W23101576	DWN CB	CKD SGD	REV 0	Figure 2
OFFICE EBA-WHSE	DATE July 25, 2012

- ⊗ - APPROXIMATE LOCATION OF SAMPLE POINT
- ➔ - DIRECTION OF WATER INGRESS INTO LOWER MILL LEVEL
