CLINTON CREEK ASBESTOS MINE

REPORT  
ON  
1988 SITE INSPECTION

Prepared for:  
NORTHERN AFFAIRS PROGRAM  
Whitehorse, Y.T.

November 1988  
G052

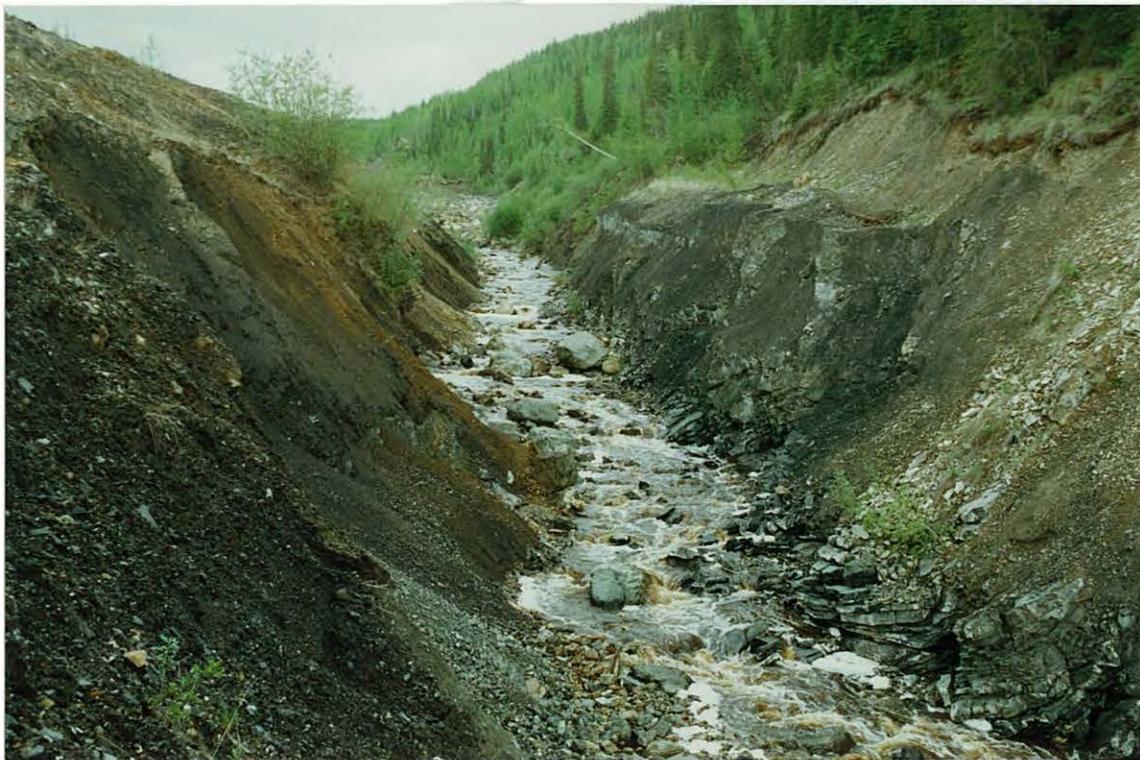
Relatively significant changes have taken place in the channel downstream from point A. The north bank is eroding, exposing thinly to medium-bedded, jointed shale and calcareous sandstone (Photo 8). While these strata will slow the erosion process, they are not competent enough to retard it entirely.

Photo 8: The same segment of the channel in June 1988. Note eroding banks and bedrock exposures in the channel bottom.
