**Project No: 60160515**

**Regarding: Former Clinton Creek Asbestos Mine - Site Inspection on 23 August, 2010**

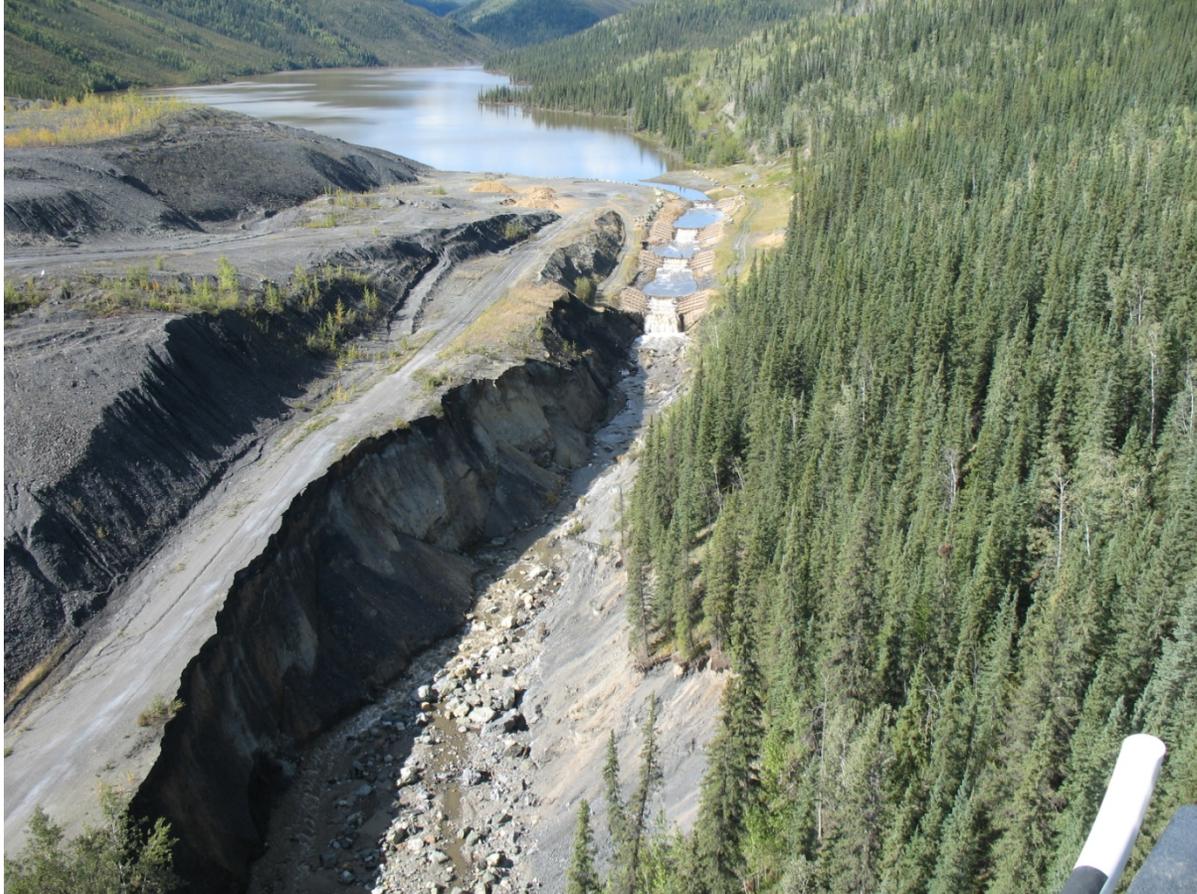
As a result of the reported events at the Clinton Creek access road, Brett Hartshorne of Yukon EMR Assessment and Abandoned Mines conducted a site reconnaissance by helicopter on Thursday 19 August, 2010. During the inspection it was noticed that the channel downstream of the structure had eroded significantly and Drop Structure #4 (the drop structure farthest downstream) was severely undercut. The step drop portion of the structure appeared to be reasonably intact while the downstream apron had bent down and was hanging at a steep angle. The sacrificial apron downstream of the structure apron was gone.
