Former Clinton Creek Asbestos Mine 2010 Site Inspection

AECOM

60160515 (402.3.1)

March, 2011

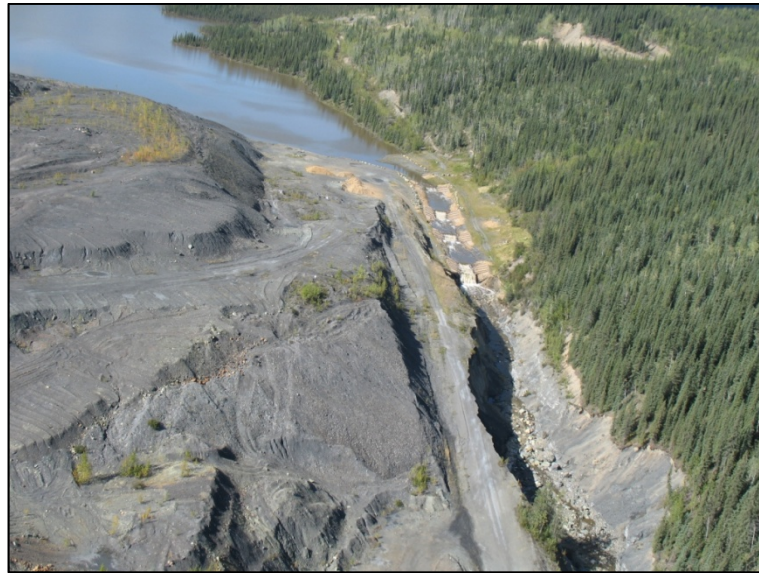
Figure 41 Clinton Creek Channel on August 23, 2010

At the time of the July 2010 site inspection, the mine site was wet from recent rain but flows in the creeks were not considered to be unusually high. The effects of the precipitation that fell after this inspection included some landslides in the Clinton Creek valley upstream and downstream of the mine site and high flows in the Clinton Creek channel and possibly the Wolverine Creek channel. These high flows caused significant damage to Drop Structure #4 and erosion of the creek channel and waste rock downstream of the drop structures. The creek profiles were re-surveyed in September 2010 to capture the effects of this event and are provided in the 2010 Long Term Performance Monitoring report for the site (AECOM 2011a). Directly downstream of DS#4 the creek bottom is about 5 m deeper than it was before this event. Figures 41 to 43 provide some insight into the erosion that took place on Clinton Creek in August 2010.

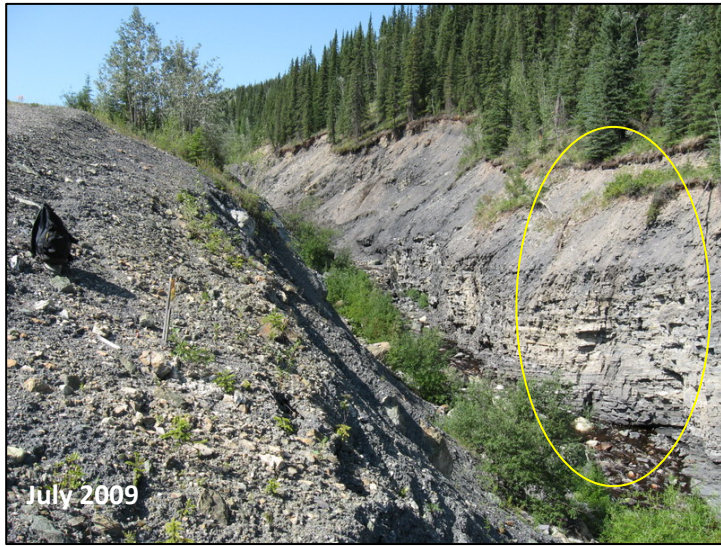
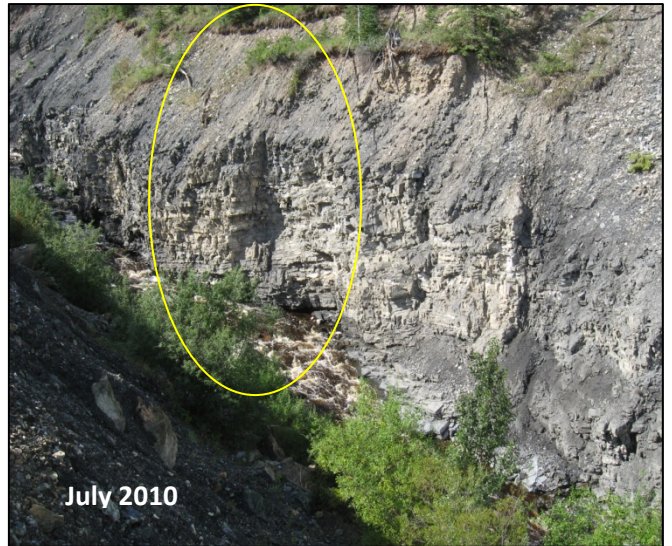
Figure 08 Station 0+470 at WP 342 in 2009 and 2010, U/S view

Farther upstream, at approximately Station 0+560, the physical features and vegetation along the LHS and RHS of the channel, as well as the channel bottom do not appear to have significantly changed from 2009 as seen on Figures 05, 06 and 07 taken from WP 341. A similar set of photos were taken at WP 342, located at approximately Station 0+470 in an upstream direction (Figure 08), cross-channel (Figure 09) and downstream (Figure 10); No significant changes in the condition of the channel over the one year period from July 2009 to July 2010 were noted.

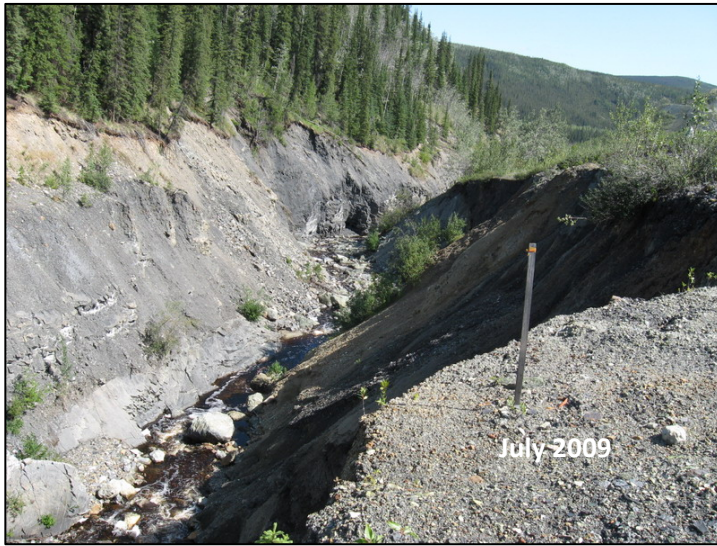
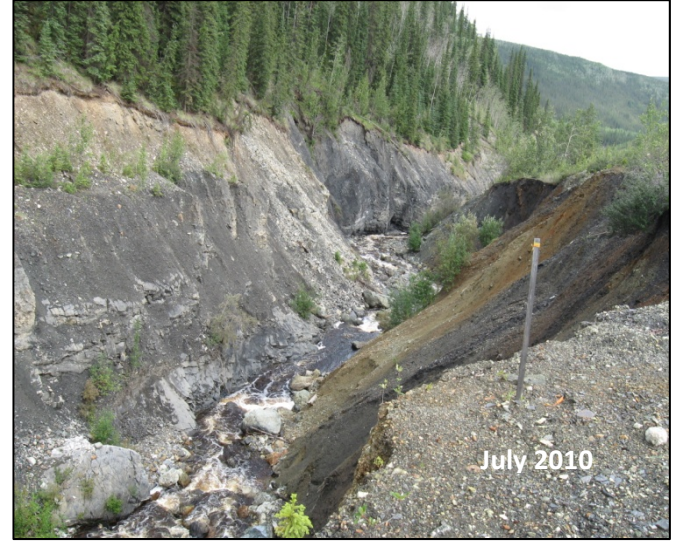
Figure 13 Clinton Creek Channel at WP 345 in 2009 and 2010, D/S view

The final vantage point to observe the channel is located near Station 0+290 m (WP 345) which provides a good view of the waste rock and bedrock contact located about 50 m downstream of the drop structures. Figure 13 illustrates these features and also signs of recent slide activity of the waste rock, likely initiated by erosion along the toe of the waste rock.

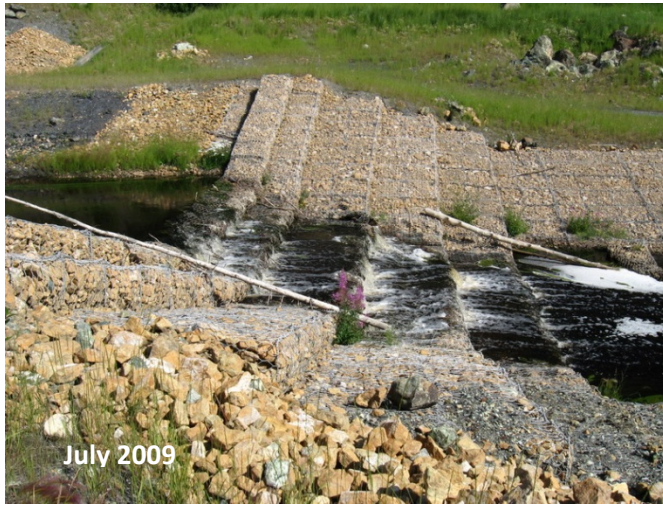
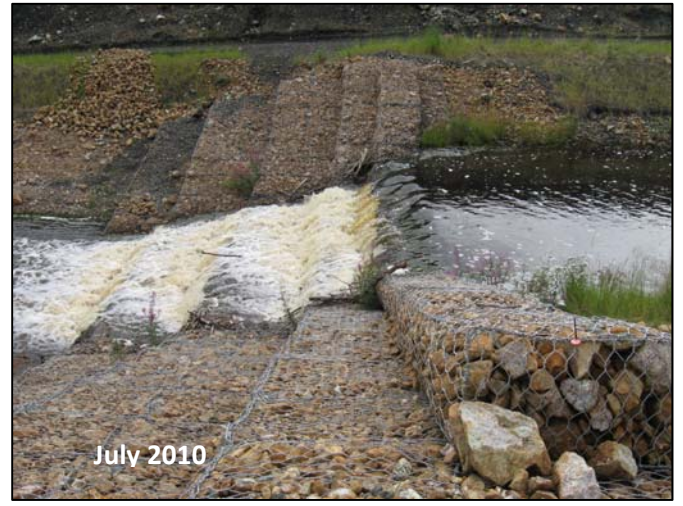
Figure 20 DS #3 in 2009 and 2010, cross channel views

Drop Structure #3 consists of a drawdown weir with 5 tiers that provide a 2 m drop in channel grade and an end sill on the bottom tier. Figure 19 illustrates the overall condition of the structure in 2009 and 2010. Cross-channel views of the structure are shown on Figure 20. The damage to Drop Structure #3 observed in 2009 included deformation of baskets, some small holes in the tops or downstream sides of individual baskets and the end sill was badly deformed but intact.

The repairs completed in 2009 held up well during the 2010 spring freshet and the structure appears to be in very good condition. The water flow over the weir was slightly uneven suggesting that RHS of the upper most tier may have settled a small amount relative to the LHS. The channel slopes between DS #3 and DS#4 (Figure 21) are in good condition with no signs of erosion other than high water marks.

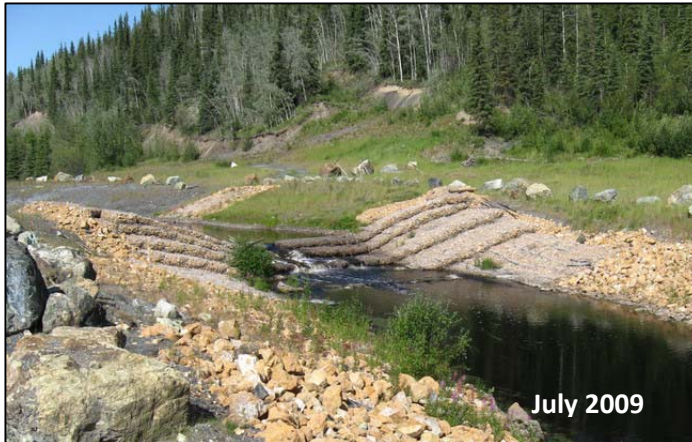
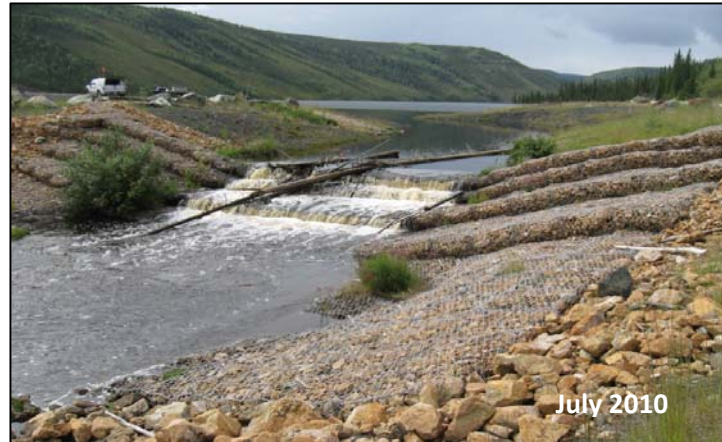
Figure 24 DS #1 in 2009 and 2010 view U/S

Drop Structure #1 consists of a drawdown weir with 4 tiers that provide a 1.5 m drop in channel grade and an end sill on the bottom tier. An upstream view of the structure in 2009 and 2010 is illustrated on Figure 24. Cross-channel view of the structure from 2007 and from 2009 and 2010 are shown on Figures 25 and 25a, respectively. The

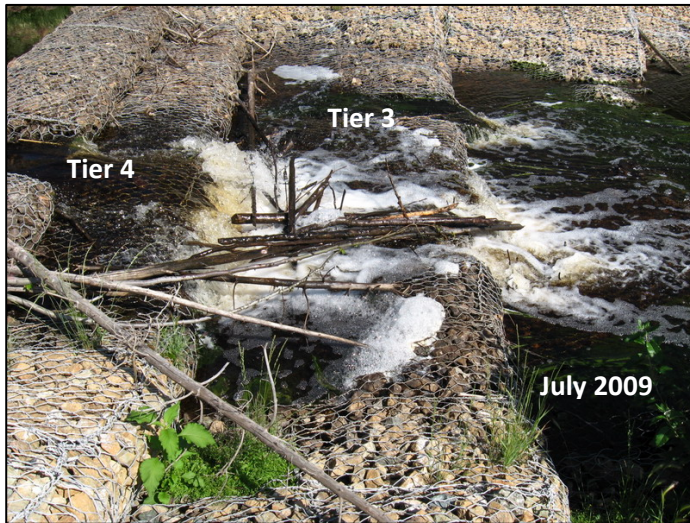
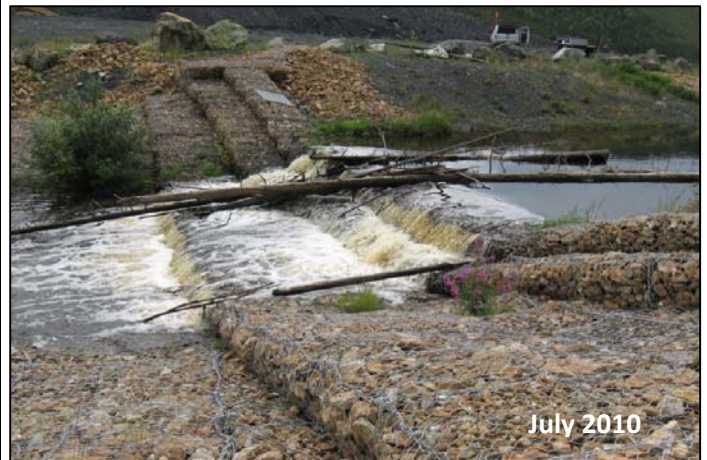
Figure 25a DS #1 2009 and 2010 cross-channel views to north and south, respectively

damage observed in 2009 included the drawdown weir leaning downstream, loss of gabion fill from several of the baskets in the end sill and Tiers 2, 3 and 4 (Figure 25a) and deformation of the end sill. The 0.5m wide opening in the drawdown weir was completed in 2007 to allow the elevation in Hudgeon Lake to drop during low flow periods and prior to freeze-up. This drop structure has undergone some settlement since construction in the fall of 2002.

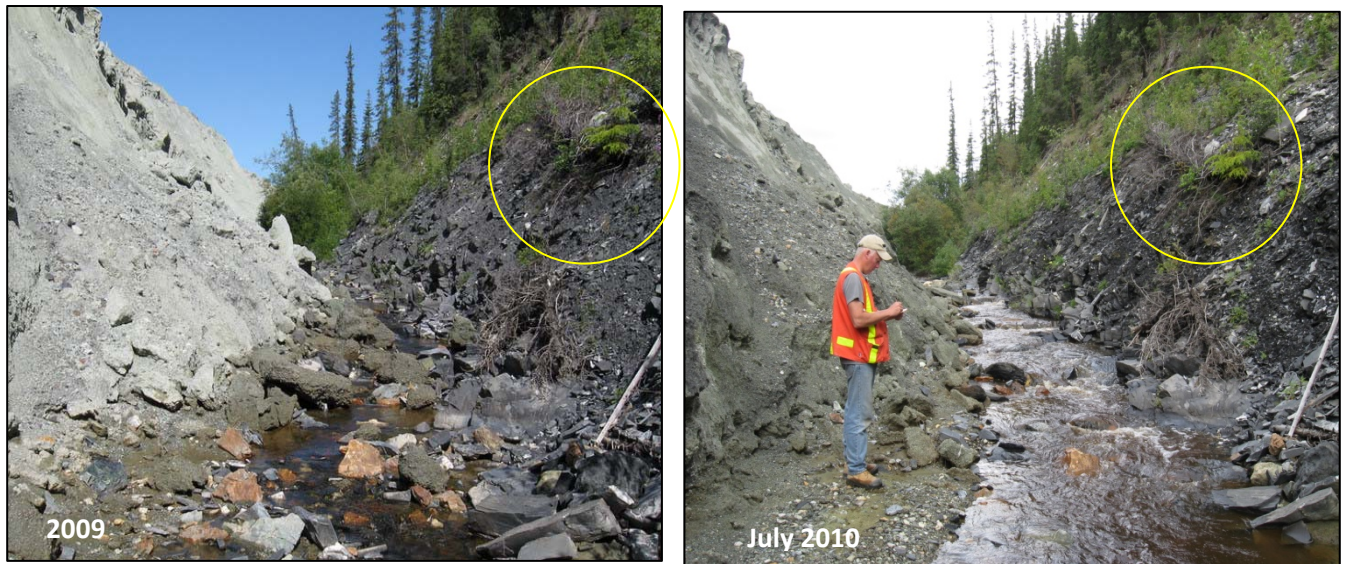
Figure 29 View U/S Along Wolverine Creek Across S Lobe at WP 337 in 2009 and 2010

The creek channel alignment across the tailings can be seen Drawing 1. A view of the creek channel near the downstream limit of the South Lobe (i.e. WP 337) is shown on Figure 29. It does not appear that there has been any significant change in the channel bottom or valley slope side of the channel. Not unexpectedly, there are noticeable differences in the tailings side of the channel due to the on-going sloughing and erosion of the over steepened tailings. At the upstream end of the channel across the South Lobe (WP 338), Figure 30 illustrates that there have been no significant changes in the creek channel at this location since 2009. The leading edge of the tailings lobe which forms the RHS of the channel consists of freshly exposed tailings with numerous slumps confirming that there is ongoing erosion of the tailings and deposition of this material downstream.

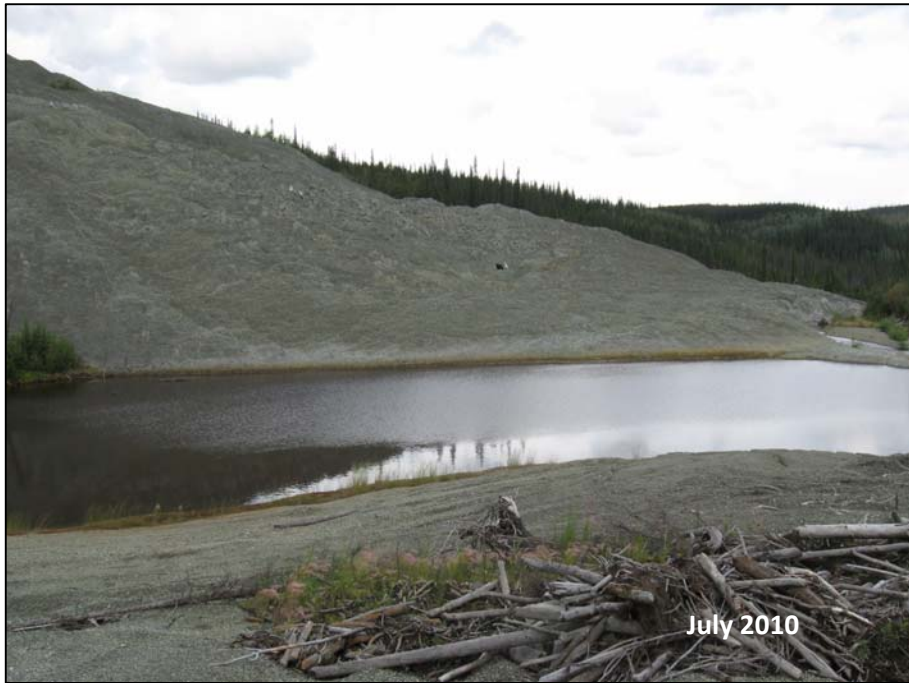
Figure 31 View of North Lobe, Lower Slope Area and creek channel,
view north from South Lobe in 2010

Figure 31 illustrates the general location of the channel across the North Lobe as viewed from the South Lobe. The leading edge of this tailings lobe forms the RHS of the channel and consists of freshly exposed tailings with numerous slumps confirming that there is ongoing erosion of the tailings and deposition of this material downstream.

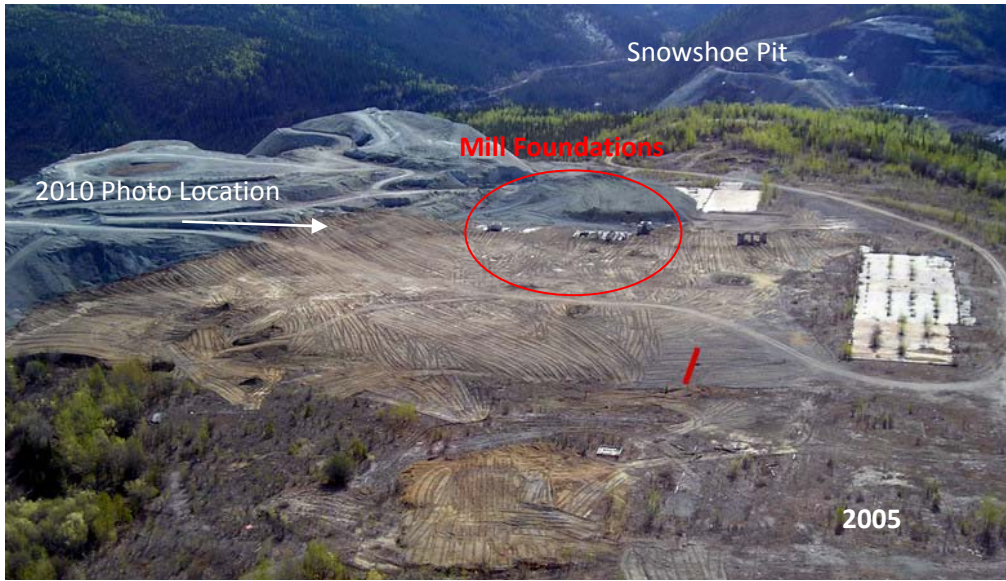
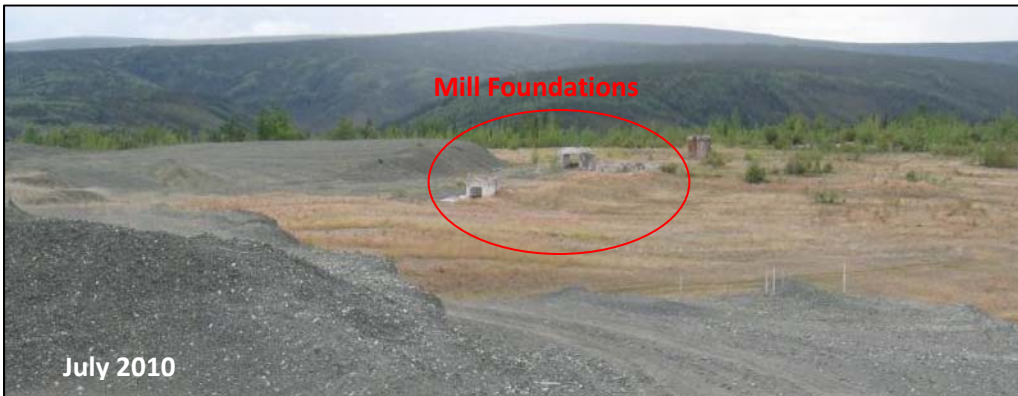
Figure 32 Former Mill Area in 2005 (facing SW) & 2010 (facing NW from WP 71)

Some vegetation (e.g. foxtail barley) has established on the Mill Site since the demolition and re-grading work completed in 2004. An aerial view of the Mill Site from 2005 and a view from WP #71 on the tailings pile in 2010 is shown on Figure 32.

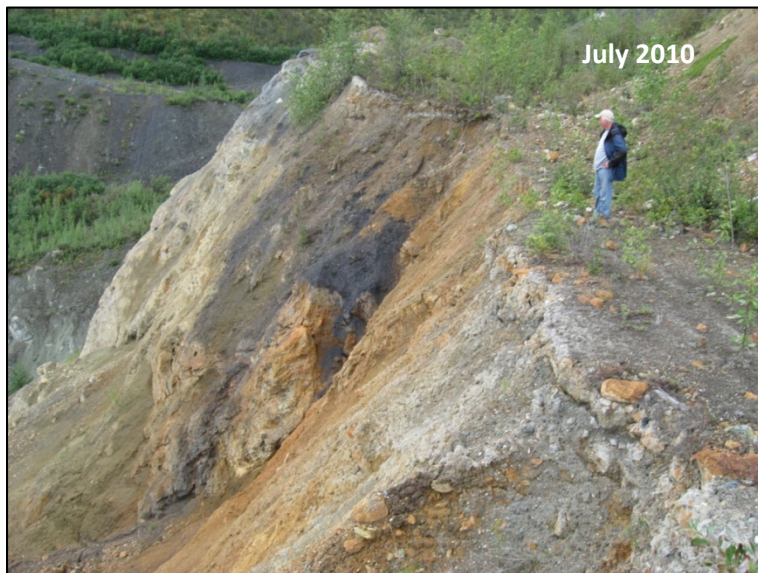
Figure 39 View of Creek Pit from WP 90 in July 2010, view South East

Figure 38, taken from WP 89, illustrates the general condition of this open pit in 2010. Note the level of water in the pond and the flow from the Porcupine Waste Rock Dump, which is located directly upstream of the pit. Some sloughing of the west wall of the Creek Pit was observed in 2010 as shown on Figure 39 taken from Waypoint 90. Photos should be taken from this Waypoint in future inspections.
