2007 Geotechnical Closure Studies, Keno Hill, YT

Project Reference Number
SRK 1CE012.000

March 2008

Elsa Reclamation and Development Company Ltd.

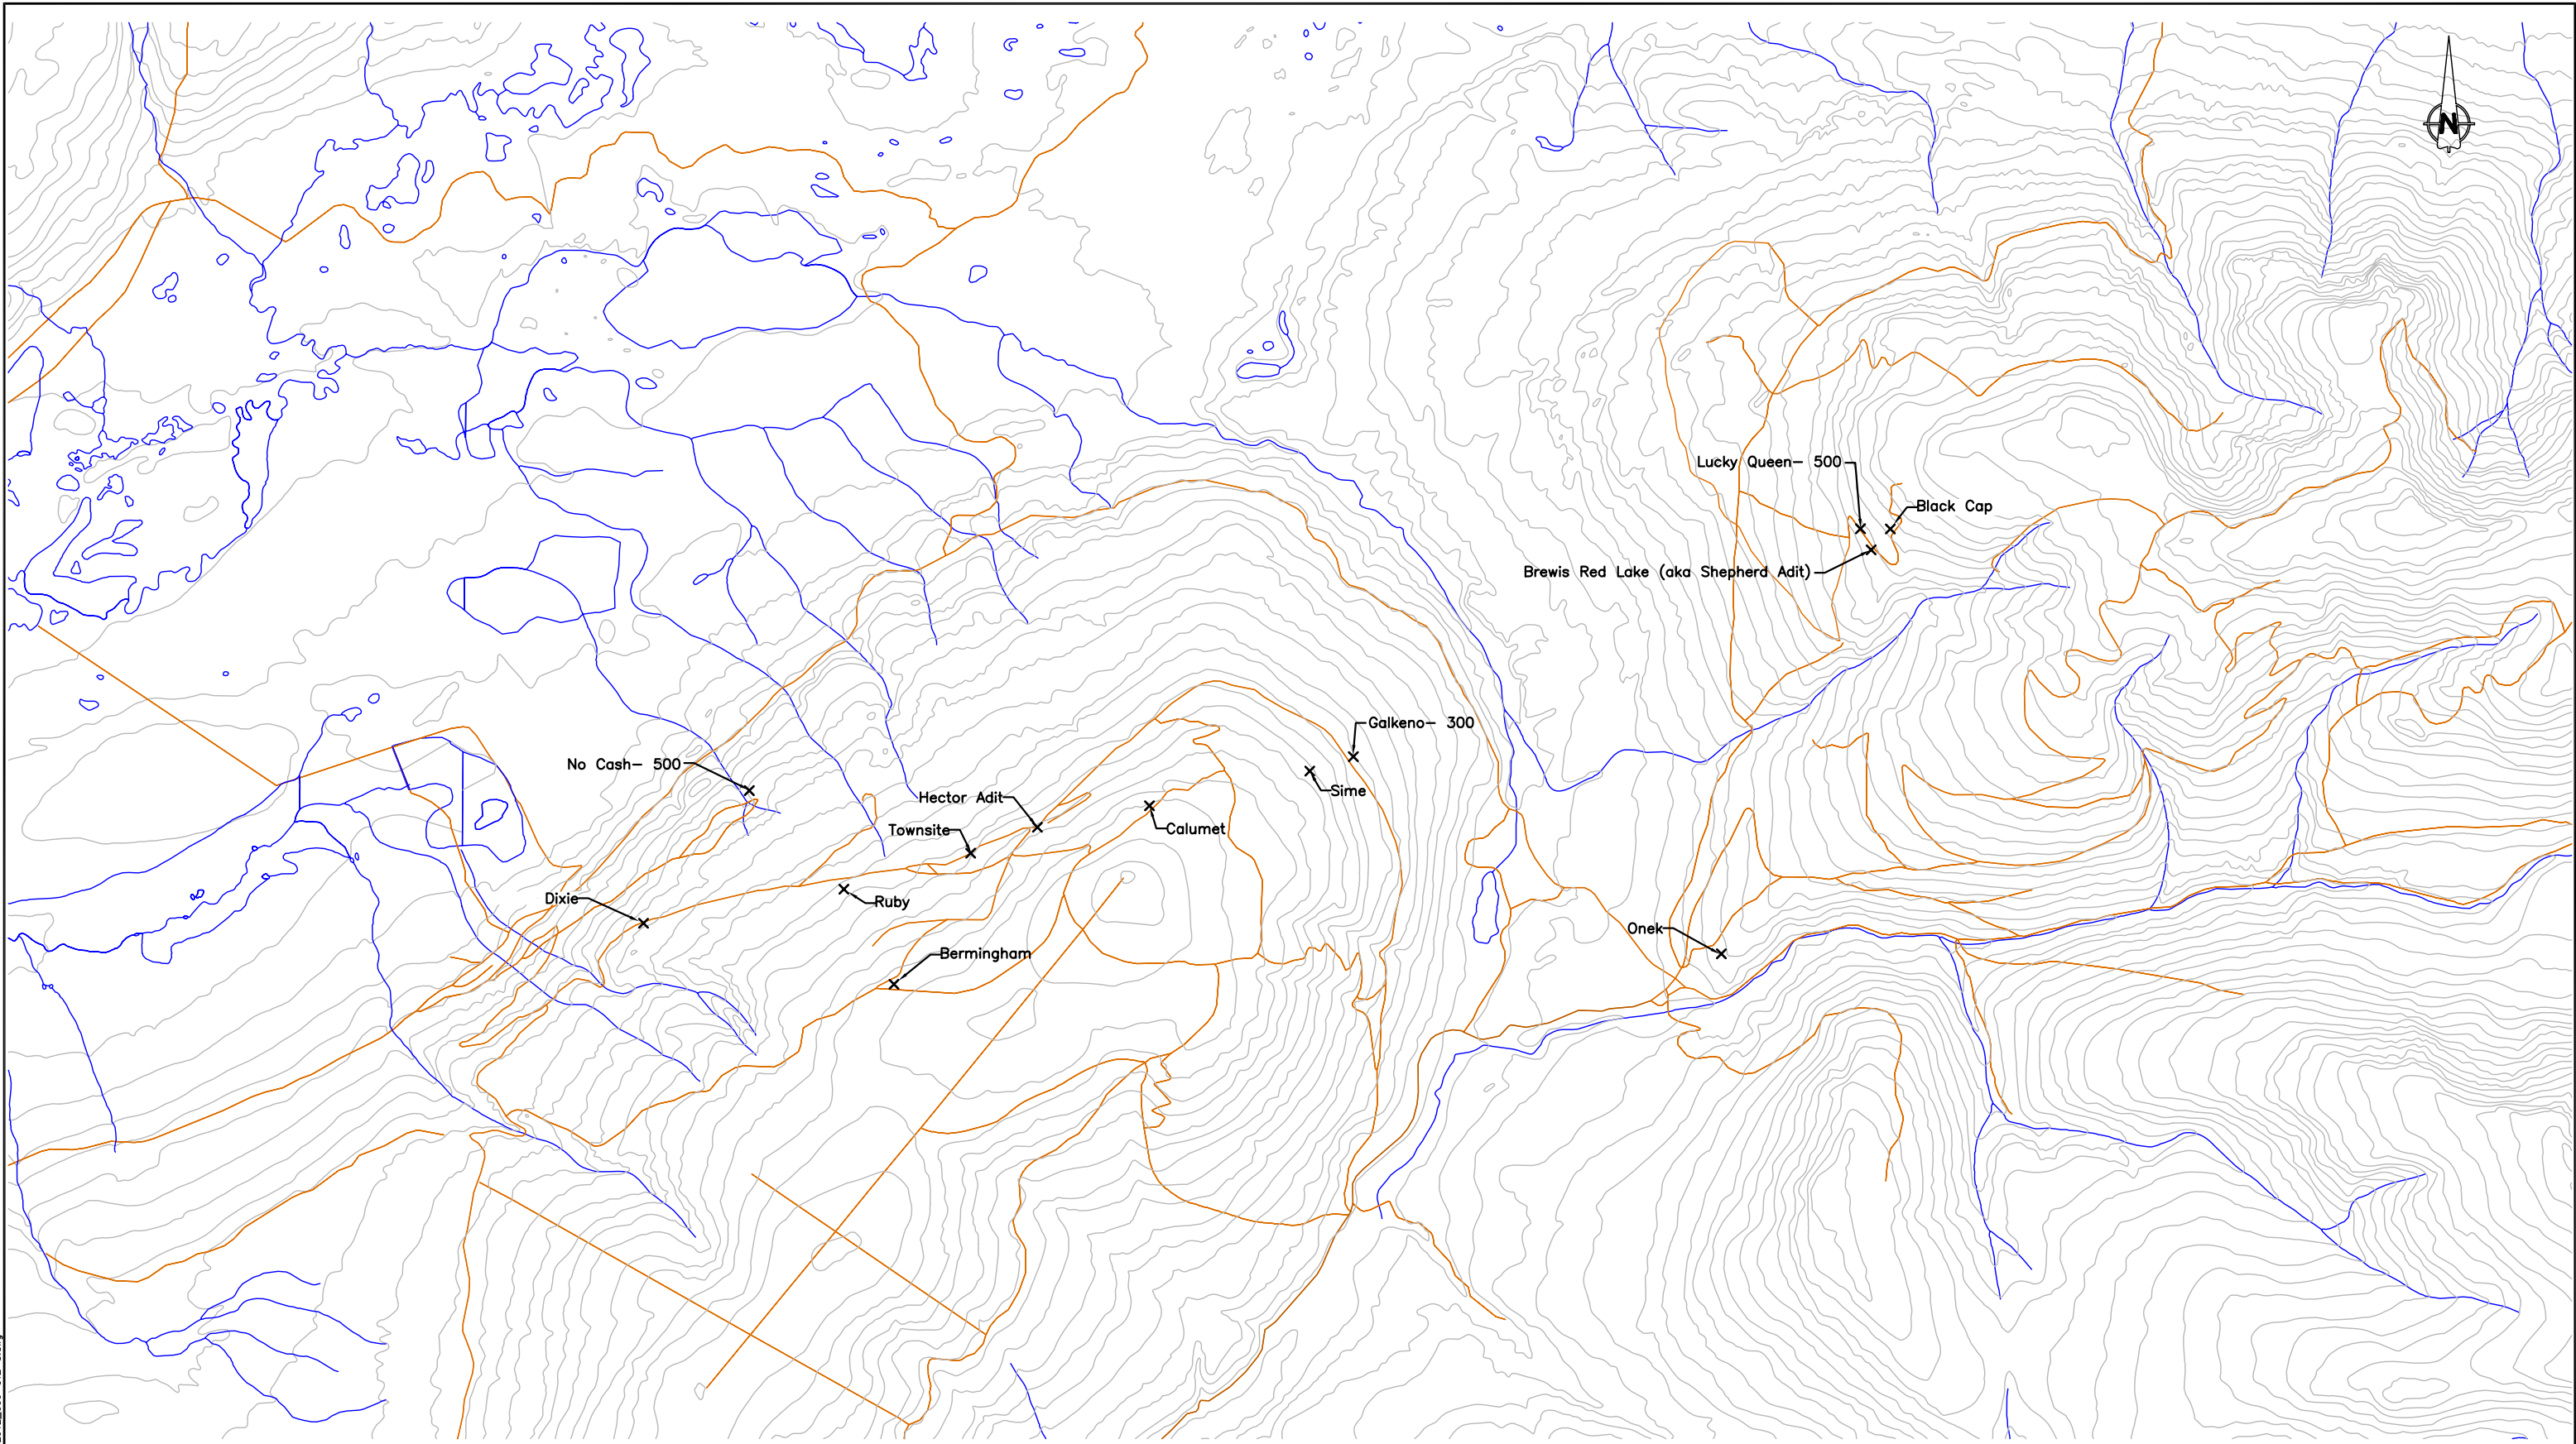
DATE: Feb. 2008	APPROVED: LW	FIGURE: 1
--------------------	-----------------	--------------

Six boreholes were completed along the crests of Dam #1, Dam #2 and Dam #3. Soil stratigraphy, depth to bedrock, geotechnical conditions and permafrost extent and characteristics were logged and samples were collected for laboratory testing. Monitoring wells and 5-bead thermistor cables were installed in the completed boreholes (Figure 1) to provide data on the respective groundwater flow and temperature regimes.

Borehole GT7 was drilled to refusal at a depth of 17.46 m on the upstream crest of Dam #1 (Figure 1). Sample recovery from GT7 was generally good over the borehole except in the wet till below the peat. Recovered soils did not contain permafrost and the hole was dry at the bottom at the time of drilling, with refusal in bedrock. A monitoring well and a thermistor cable were installed at this location.

Borehole GT8 was drilled to refusal at a depth of 17.27 m on the downstream crest of Dam #2 as shown on Figure 1. Sample recovery from GT8 was generally 100% over the entire length of hole, except for a one meter interval at the contact zone between the base of the dam fill and the native till. It is assumed that this very soft interval contained peat. Recovered material was unfrozen and refusal was in bedrock. A monitoring well and a thermistor cable were installed at this location.

Borehole GT9 was drilled to refusal at 13.17 m on the upstream crest of Dam #2 (Figure 1). Upon completion of the borehole, a monitoring well and a thermistor cable were installed. Sample recovery from GT9 was poor in the dam fill but generally 100% over the remaining length of hole. All recovered material was unfrozen, with refusal in bedrock. The bottom of the borehole was dry at the time of drilling.

Borehole GT10 was drilled to refusal at 10.29 m on the downstream crest of the southeast limb of Dam #3 as shown on Figure 1. A monitoring well and a thermistor string were installed in the borehole. Sample recovery from GT10 was generally 100%. The borehole met refusal in bedrock and was dry at the bottom at the time of drilling. No frozen material was encountered.

Borehole GT12 was drilled to refusal at a depth of 15.48 m on the upstream crest of the northern half of Dam #3 (Figure 1). Sample recovery from GT12 was generally excellent. Recovered overburden was unfrozen and refusal was in bedrock. A monitoring well and a thermistor cable were installed in the completed borehole.

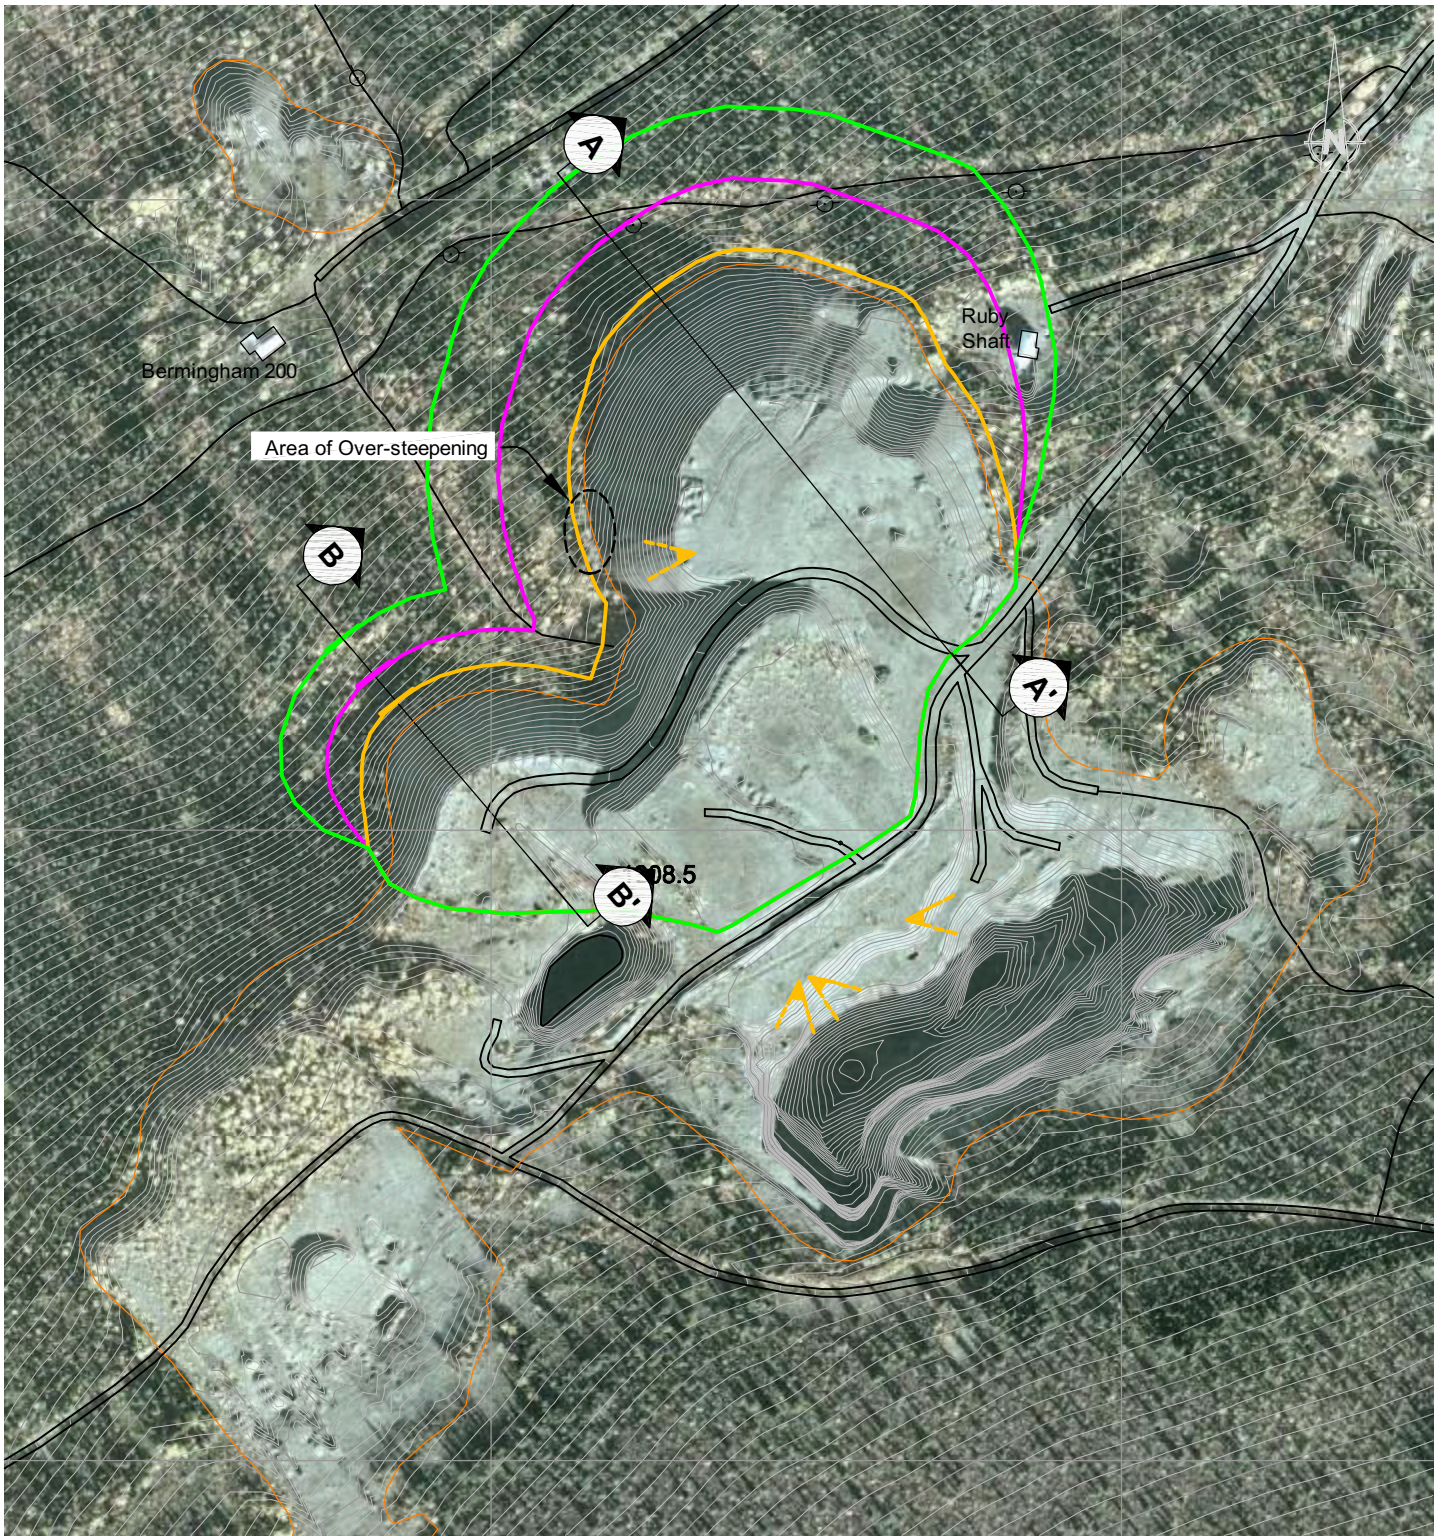
2007 Geotechnical Closure Studies		
Locations of Waste Rock Piles Inspected		
DATE: March 2008	APPROVED: DBM	FIGURE: 2

Snow cover and frozen ground at the time of the 2007 site visit limited the inspection to confirming dump slope angles, looking for signs of oversteepening, and inspecting terrain below dumps to inform the resloping assessment. Figure 2 shows the locations of dumps inspected in 2007.
