KENO HILL PROPERTY

PHYSICAL HAZARD REDUCTION PROGRAM

2007

February 2008

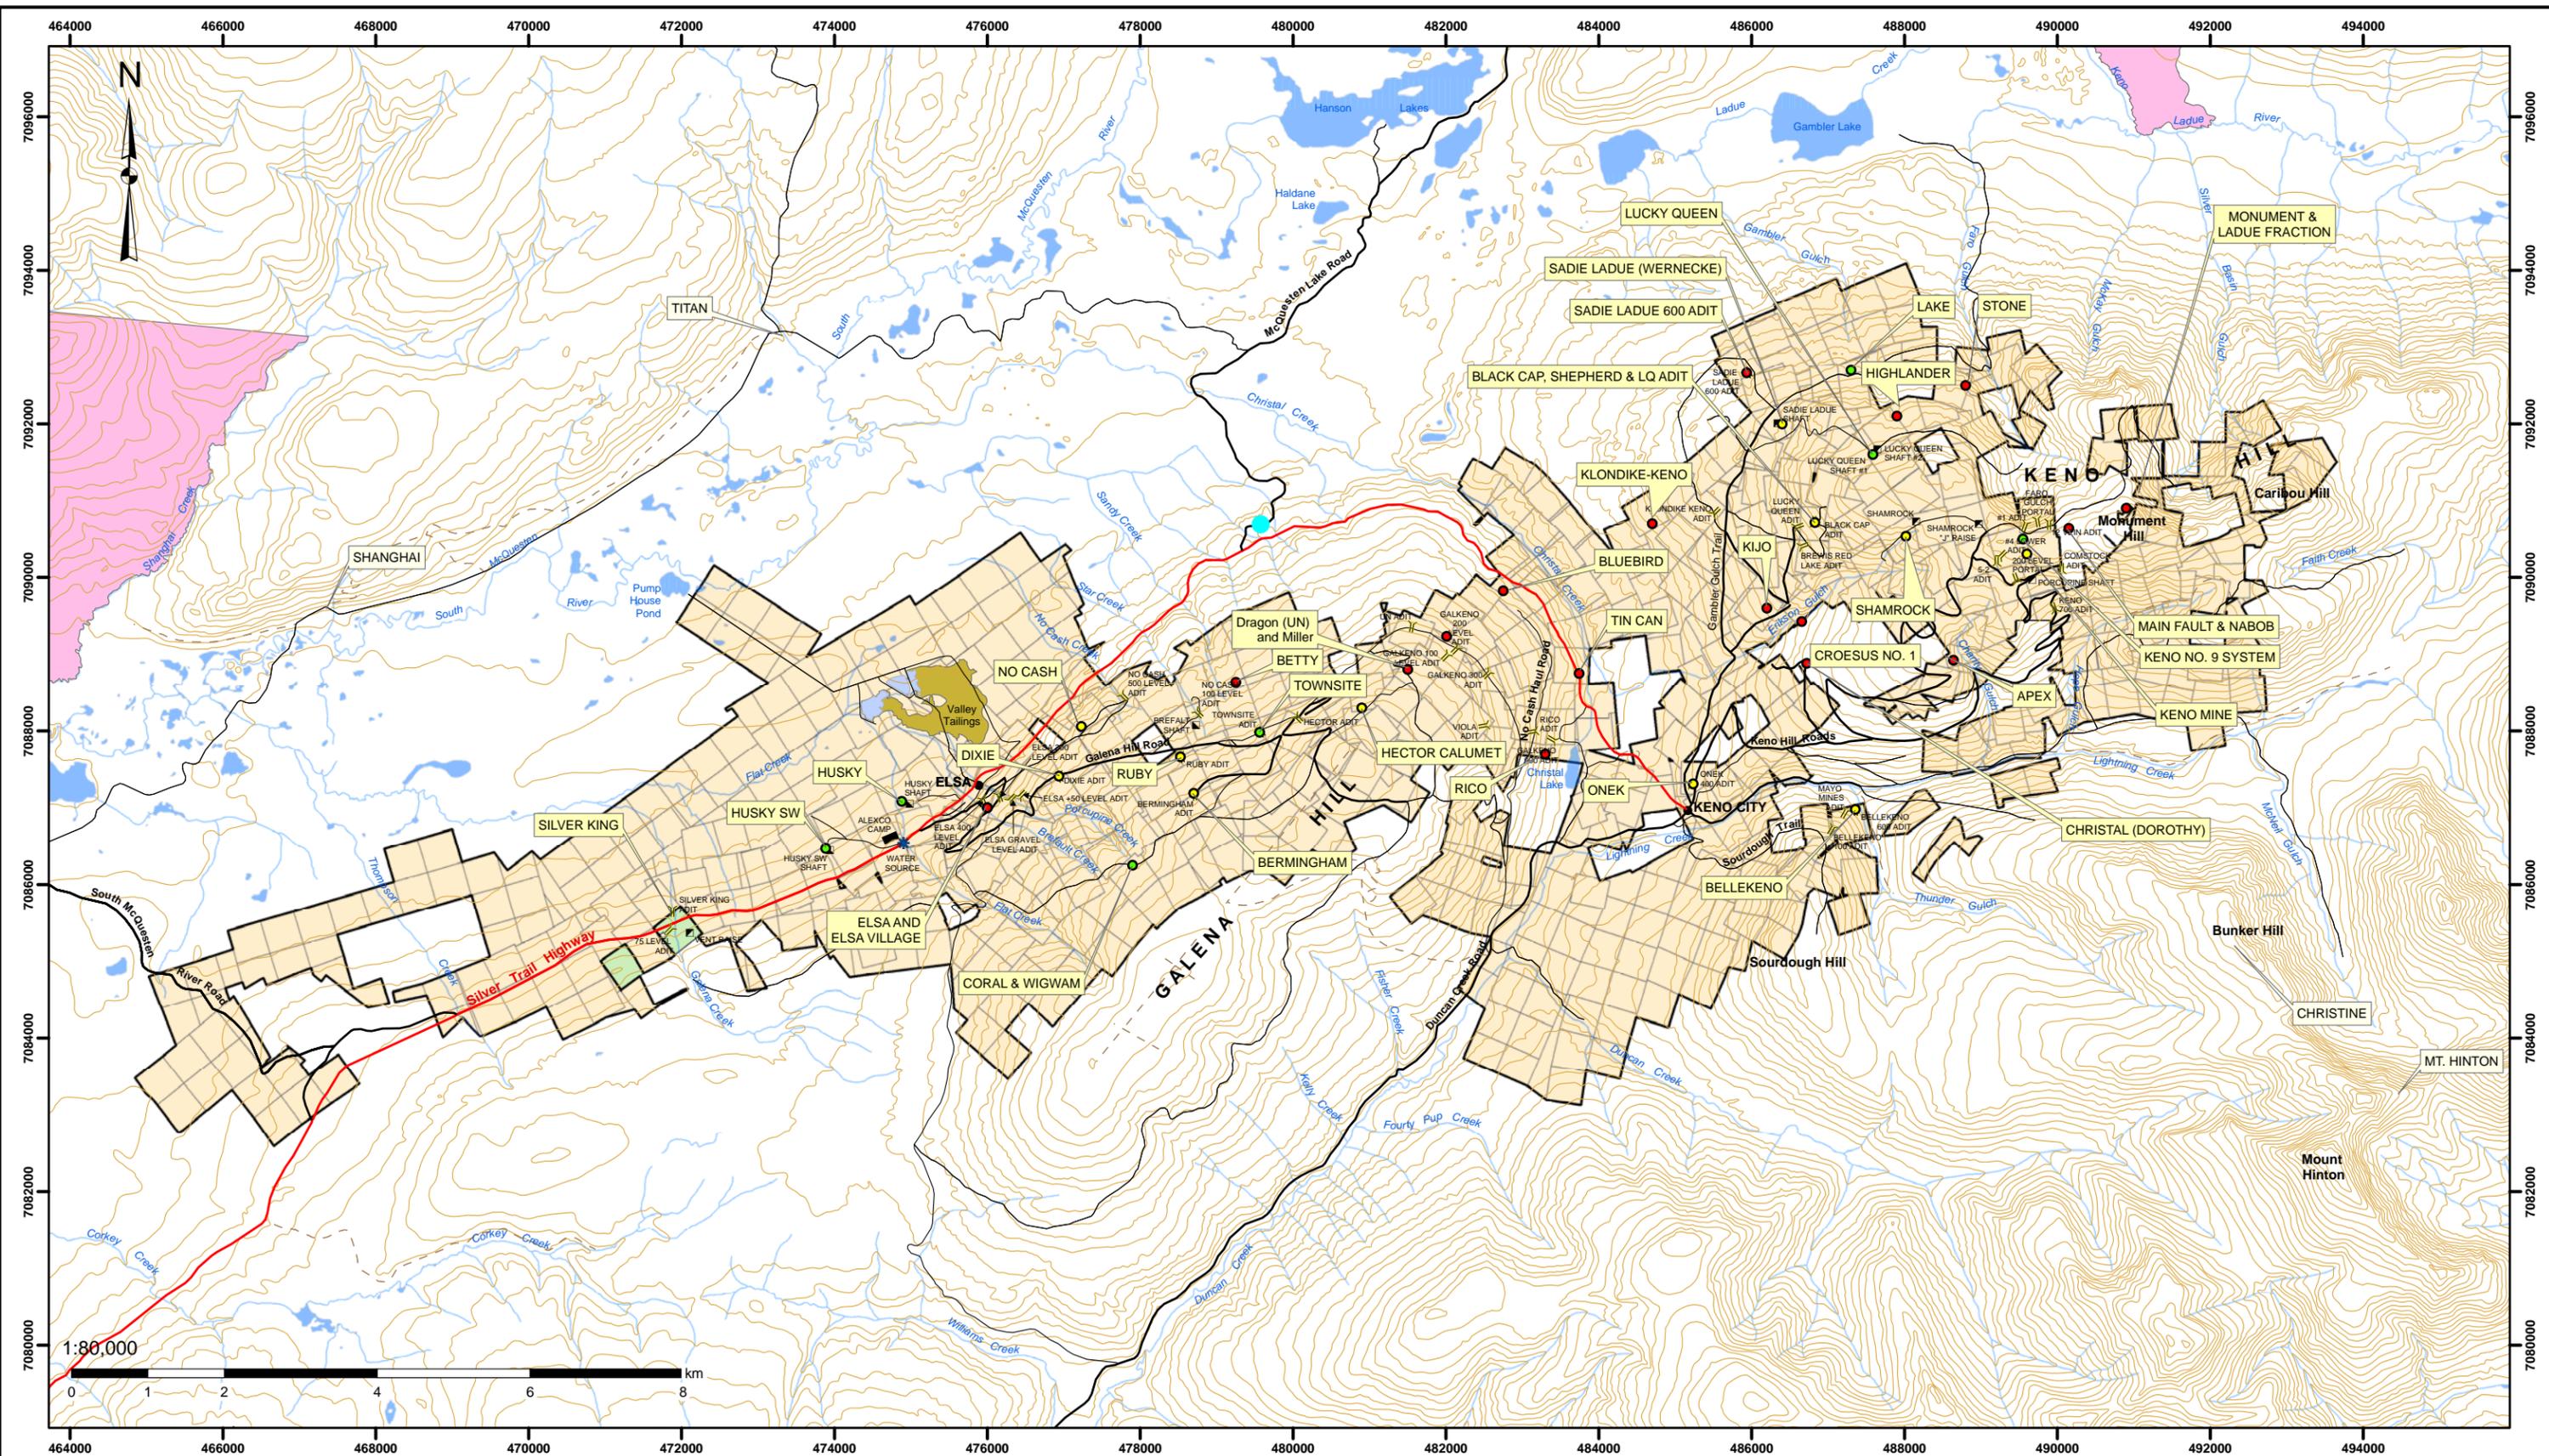
The sites that were visited during the 2007 season were Dixie, Coral and Wigwam, Bermingham and Ruby, No Cash, Hector Calumet, Onek Adit, Blackcap Shepard and Lucky Queen Adit's, Lucky Queen Shaft House, Lake Shaft House, Highlander Adit, Keno 200 Adit, Keno #9 system, and Sadie Ladue 600 Adit. The results of site assessments and remedial work completed are outlined in Section 4.0. A diagram showing all the sites inspected and their remedial status from 2005 - 2007 is shown in Figure 1.
