**REFERENCE No.** 1410944-011-TM-Rev0-2016

**TO** Ms. Carrie Gillis  
Faro Mine Remediation Project

**FARO MINE REMEDIATION PROJECT - SEPTEMBER 2016 SITE VISIT**

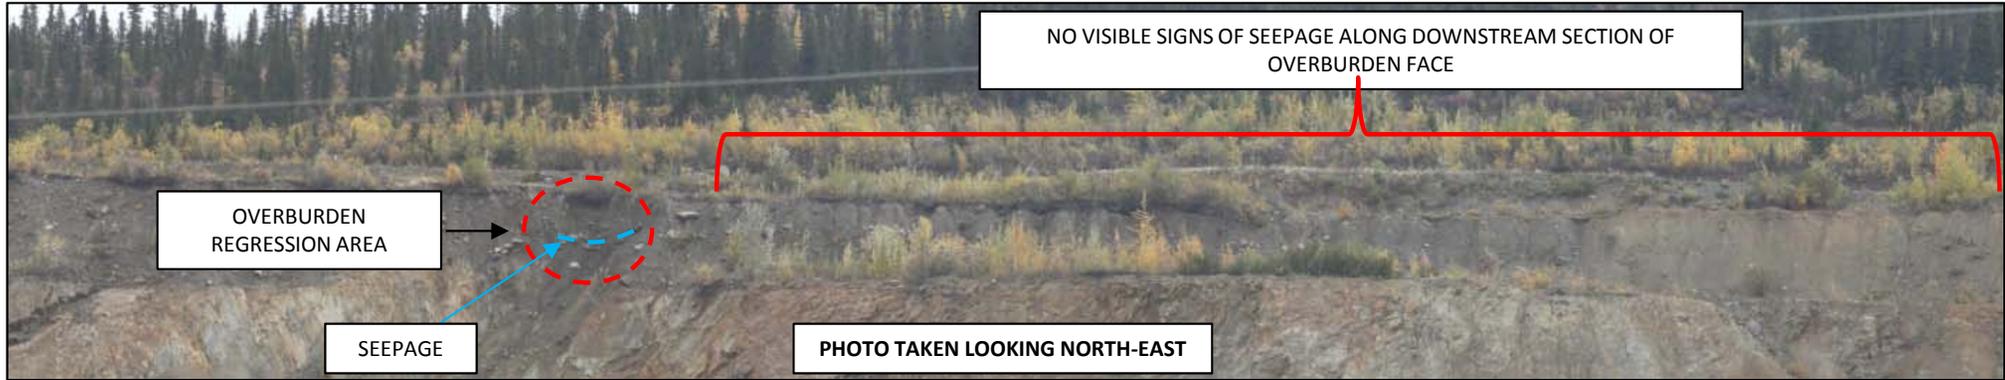
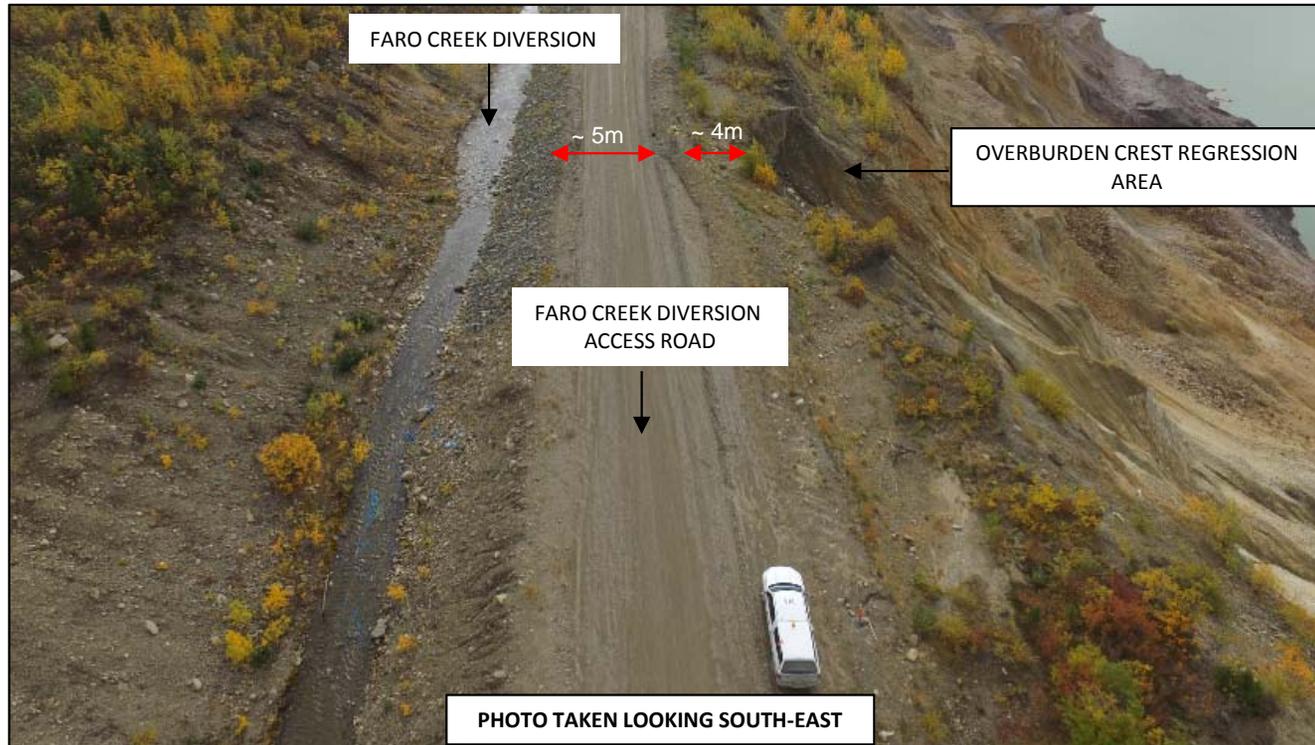
# Overburden Crest Regression Area – Site Visit Photographs

NO VISIBLE SIGNS OF INSTABILITY ON SURFACE OF NARROWEST SECTION  
BETWEEN PIT AND FCD – NO CRACKS

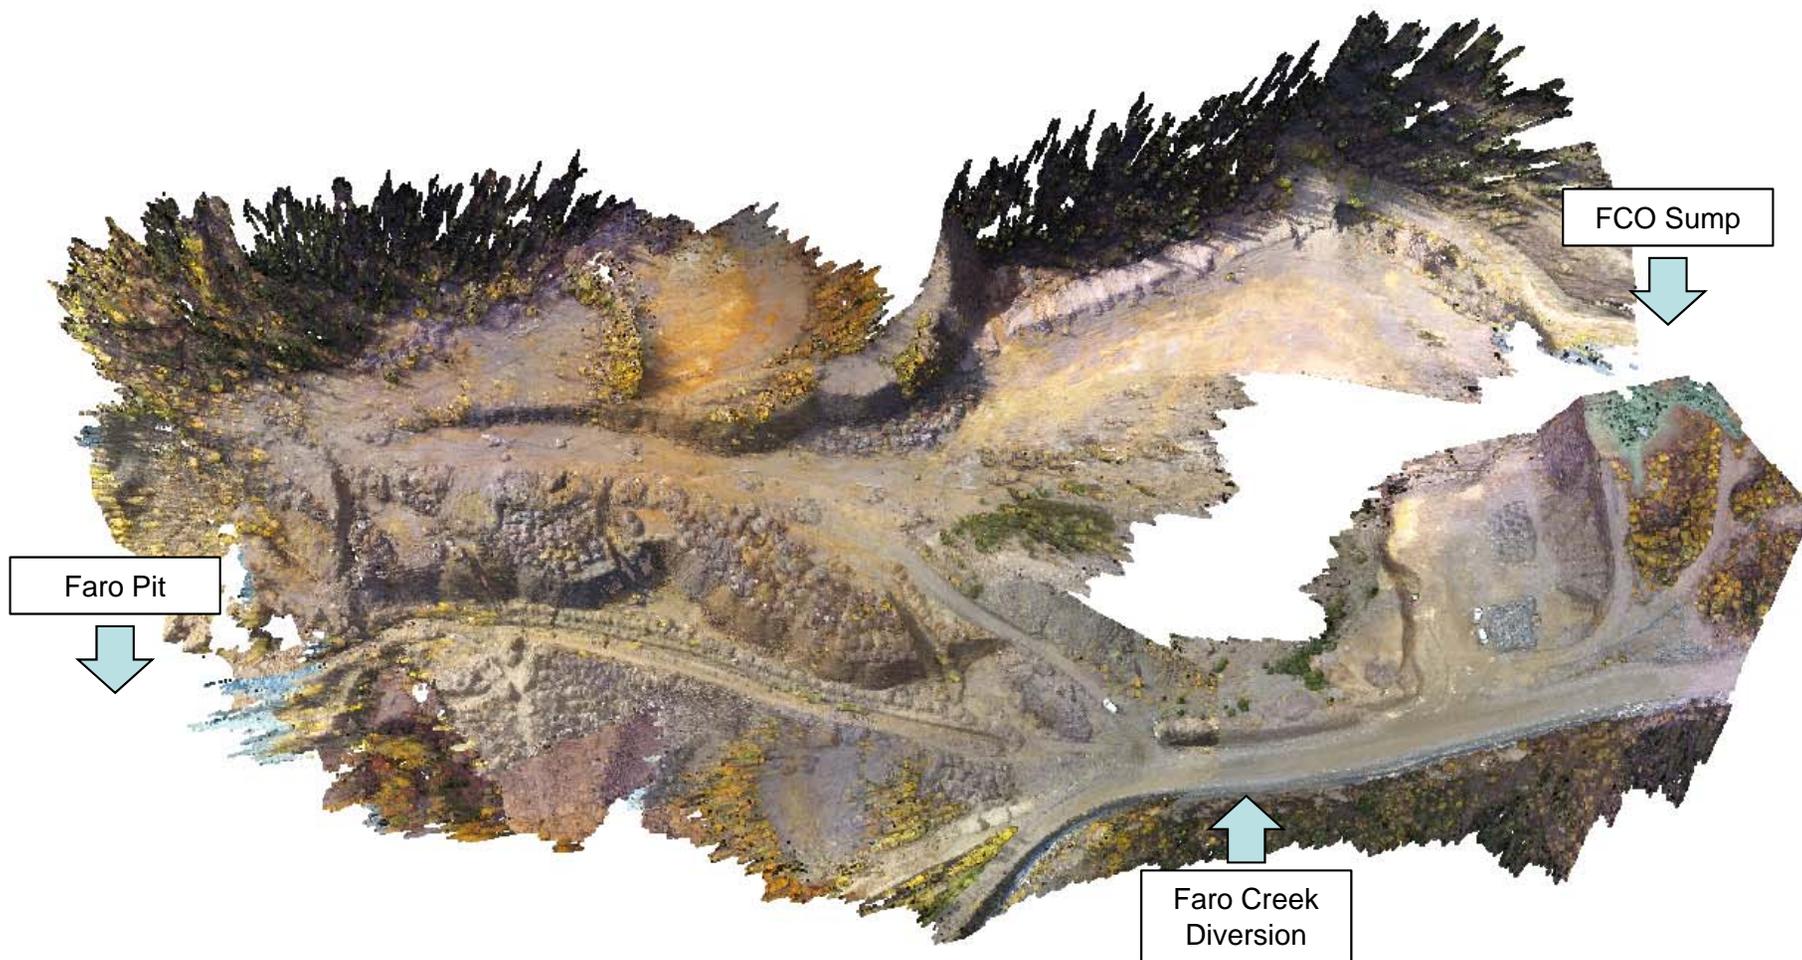
# FCO Sump Erosion Flow Path – Plan View

The FCO sump and potential overflow paths were visually assessed from the ground on 9 September 2016. The potential flow paths were walked, and material types and size distributions were noted. Photographs of the FCO sump potential overflow paths is included in Attachment 3. These findings together with a remedial options review are discussed in a separate report (Golder 2016b).
