Glaciation Assessment and Remediation

Of The Dome Creek Diversion Channel

At the Mount Nansen Site

December 12, 2011

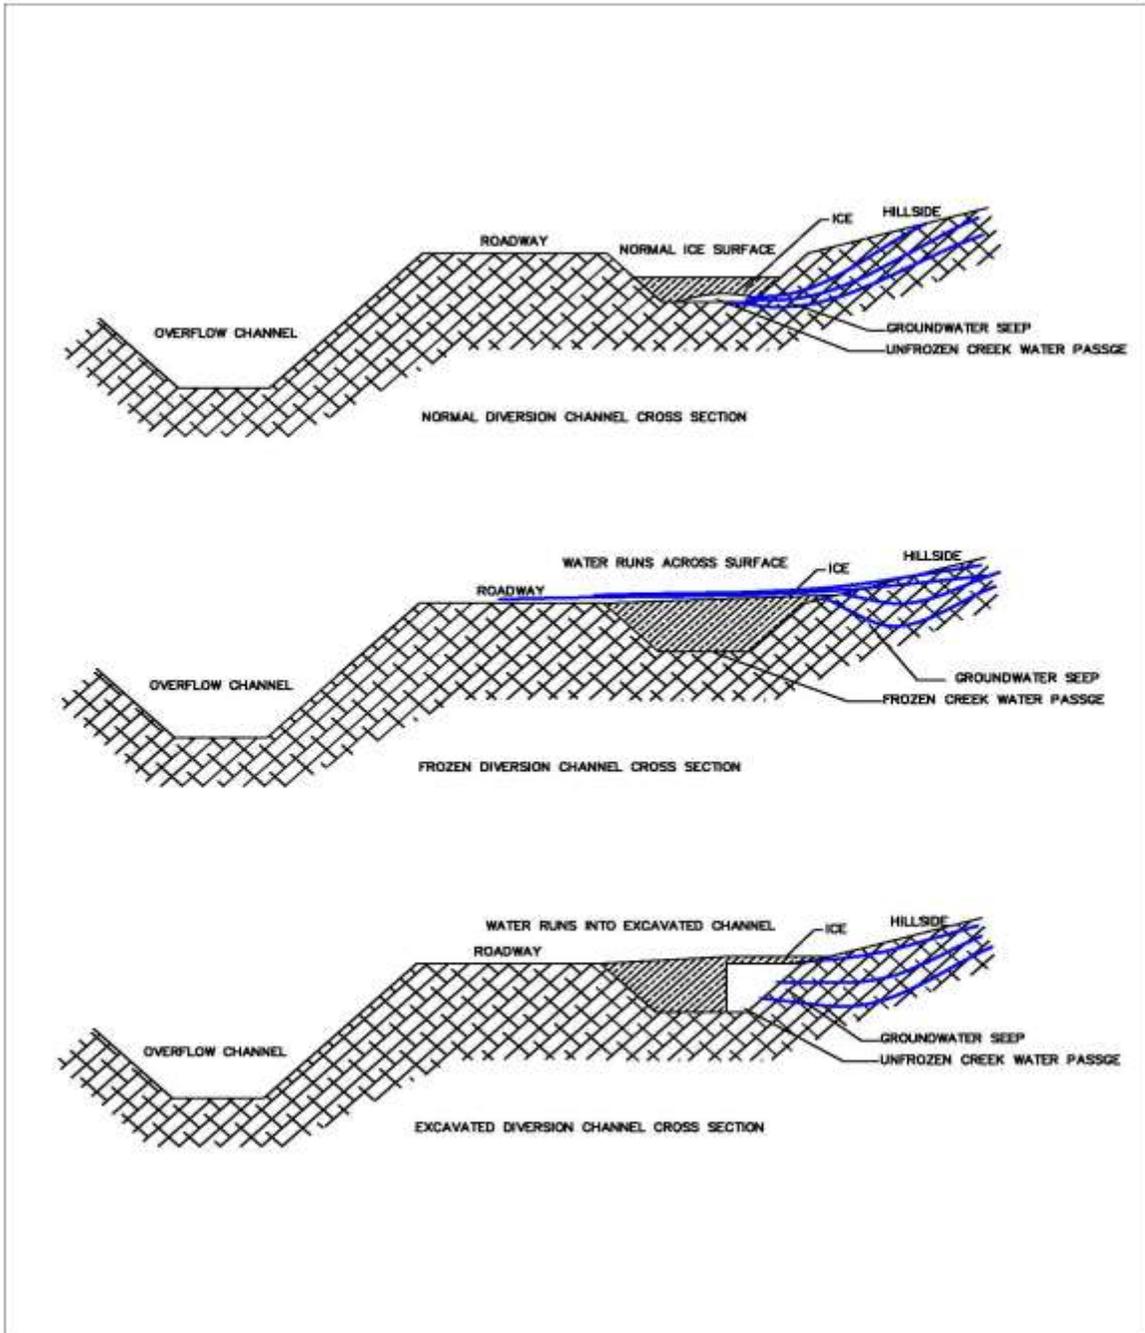
Excavation was completed in about 8 hours of work and resulted in a trench with a smallest depth of water of approximately 50 cm. At the end of the day an ice crust approximately 2.5 cm thick had formed in those areas which had been excavated first, and water was flowing continuously.

The first excavation was carried out downstream of the bridge to allow the water to escape while creating a channel under the bridge. In order to cut a channel under the bridge, several methods were considered including steam, cold water flow, drilling, heat trace, removal and replacement of bridge, and hand excavation using picks, shovels and a chainsaw. The hand excavation method was chosen which although labour intensive and uncomfortable due to water and cold temperatures, worked fairly well and was necessary due to lack of other available equipment. A 320 CAT size excavator as well as a D7G crawler operated by the Care and Maintenance Contractor excavated the narrow trench elsewhere in the diversion channel.
