YUKON GOVERNMENT

GRUM SULPHIDE CELL COVER, FARO MINE

2014 REVIEW

PROJECT NO.: 0533-006
DATE: March 11, 2015

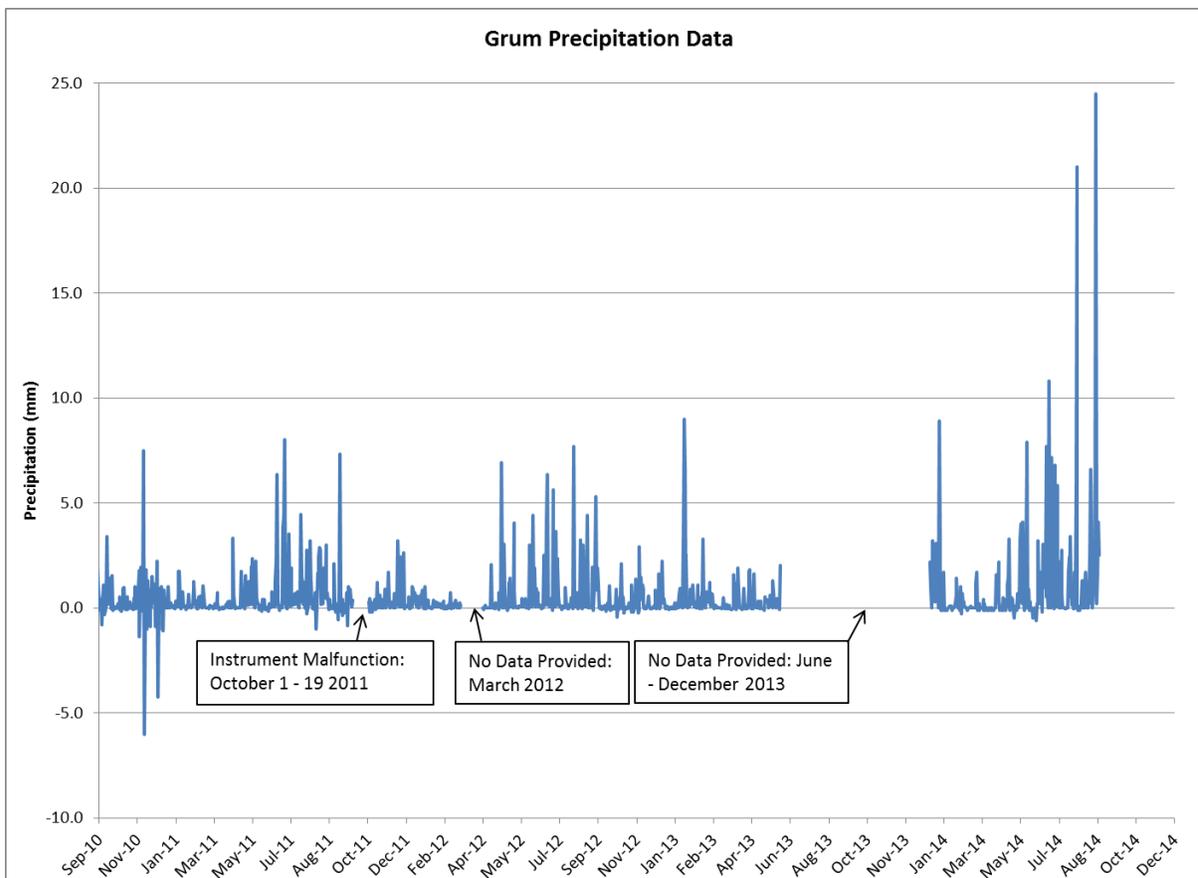
Figure 3-2. Grum Station Daily Precipitation Values¹

Temperature ranges recorded in 2014 were generally in agreement with previous years, although summer 2014 appeared cooler than summer 2012 (incomplete data for summer 2013). Precipitation values in 2014 were similar to ranges from previous years with two specific comments; rainfall fell in January 2014 (also occurred in January 2013) and two significant rainfalls occurred in summer 2014. Unfortunately, specific snow pack depth and density measurements are not available for the cover for the various years. This data would be useful to understand the water equivalent quantity trapped in the late winter snowpack, but this data was not provided to BGC. The snowpack data would provide context for the quantity of run-off while the temperature data review provides context on its intensity.
