GRUM SULPHIDE CELL COVER, FARO MINE COMPLEX

2016 REVIEW

FINAL REPORT

PROJECT NO.: 0533-017
DATE: March 31, 2017

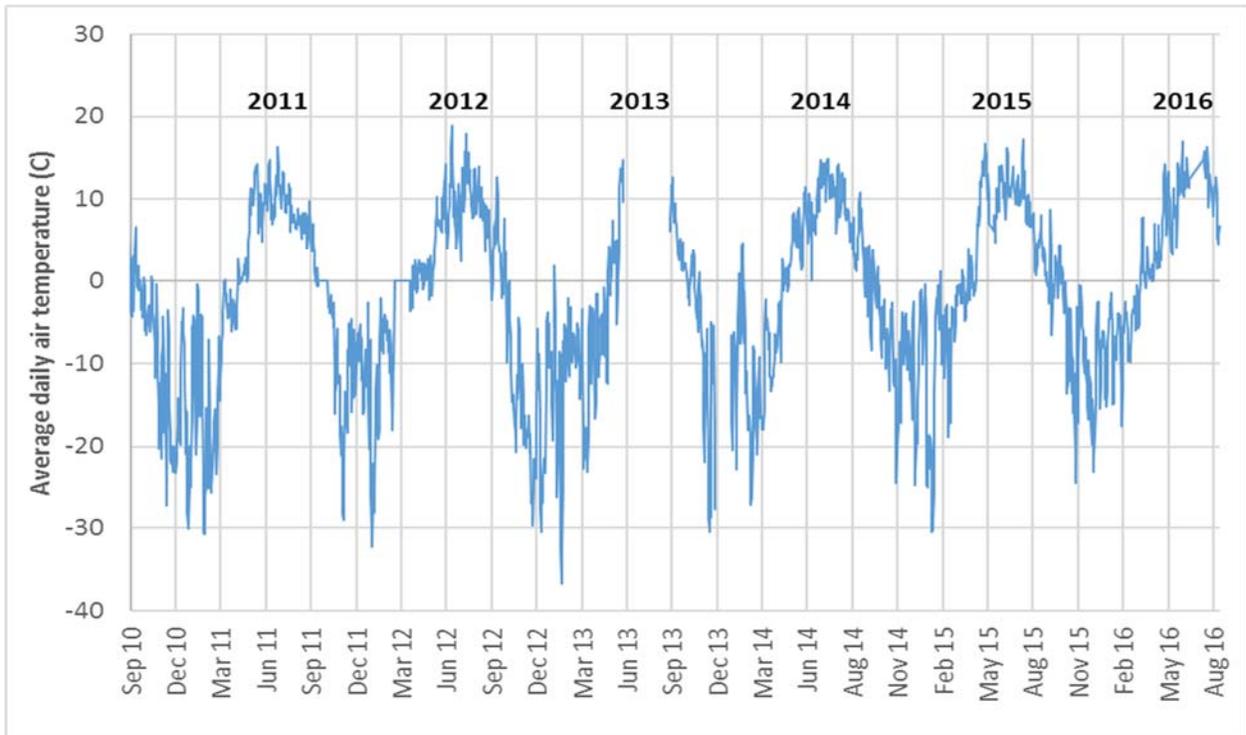
Figure 2-1. Grum Climate Station air temperature data since 2010.

The 2015/2016 winter was slightly warmer than previous years (Figure 2-1). The snowmelt freshet usually occurs in mid-April to early May. The 2016 snowmelt freshet at the GSC occurred somewhat slowly over a period of weeks: there was a week of above-zero mean daily temperatures during the last week of March (Figure 2-2). Mean daily temperatures do not normally exceed zero until into April. Pumping of the GSC Ponds (see Section 2.5) started on April 1 and continued sporadically throughout April. Plates B-1 and B-2 from April 5 indicate much of the snow on the GSC cover was lost, but much was still present on the benches. Mean daily temperature remained above zero after April 9th.

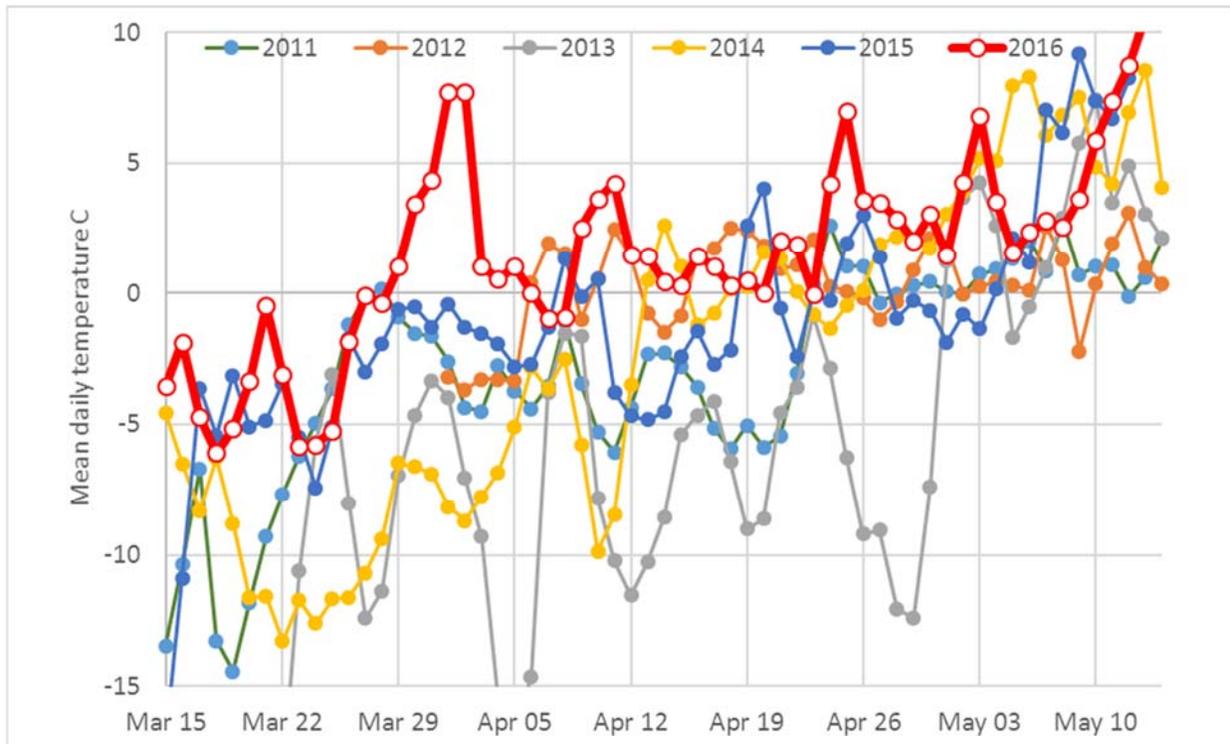
Figure 2-2. Grum Station mean daily air temperatures during spring freshet 2010-2016. Note warm 2016 temperatures in last days of March and first week in April with a rapid rise from March 25 to April 2.

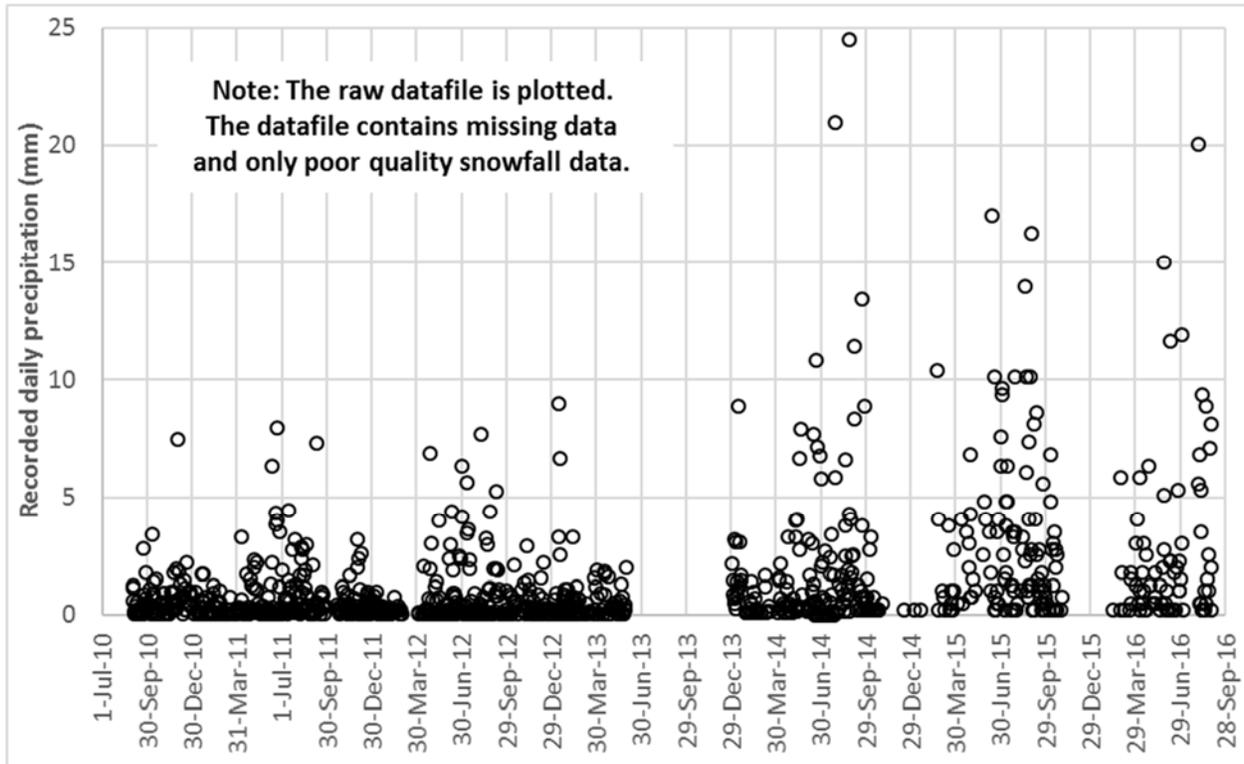
Figure 2-3. Grum Climate Station precipitation data 2010-2016.

Figure 2-3 shows the daily precipitation measured at the Grum Climate Station from 2010 to 2016. Figure 2-4 shows the same data but only for 2015 / 2016. The data file has not been assessed for data quality. There are numerous days with missing data and the snowfall data appears unreliable and is not plotted.

The data indicate a few modest rainfall events during the past year and frequent small rainfall events, superficially similar to past years with no years that are especially dry or wet.

Future assessments would benefit from a reconciliation of the raw Grum Climate precipitation data and production of a continuous record based on interpolation of missing values and extrapolation of data from other climate stations on site and in the region.

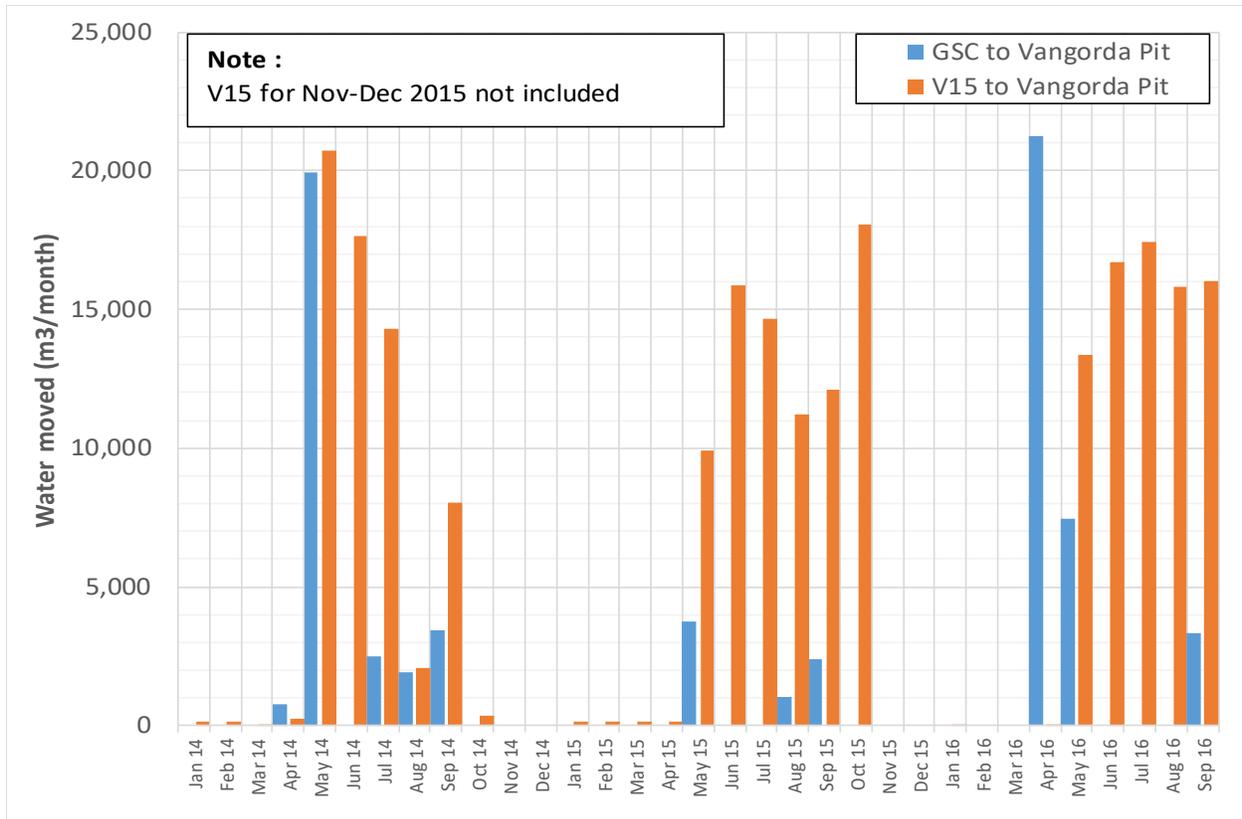
Figure 2-5. Monthly pumping at GSC Lined Pond and Pumping Station V15 (2014-2016).

Figures 2-5 and 2-6 presents the recorded quantities of water pumped from the GSC Ponds and from the Pumping Station V15.

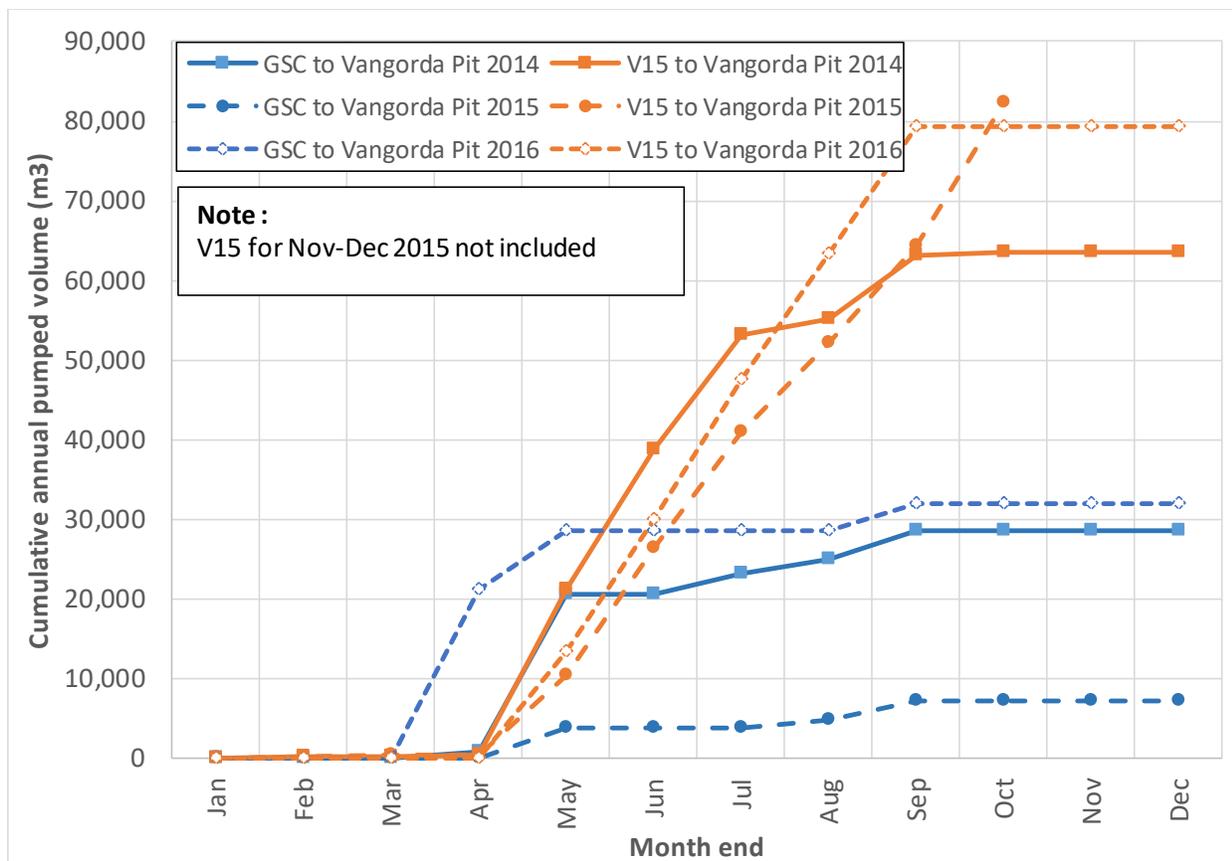
Figure 2-6. Cumulative pumping at GSC Lined Pond and Pumping Station V15 (2014-2016)

As noted in Section 2.4.2, the pumping from the GSC Ponds started April 1 (earlier than in past years). The total flows pumped in the spring of 2016 are similar to that of 2014 but much greater than 2015 (Figure 2-6). The flow quantity equivalent reporting to the GSC Ponds from the nominal 28 ha surface watershed is about 100 mm for 2014 and 2016 but only about 25 mm in 2015.

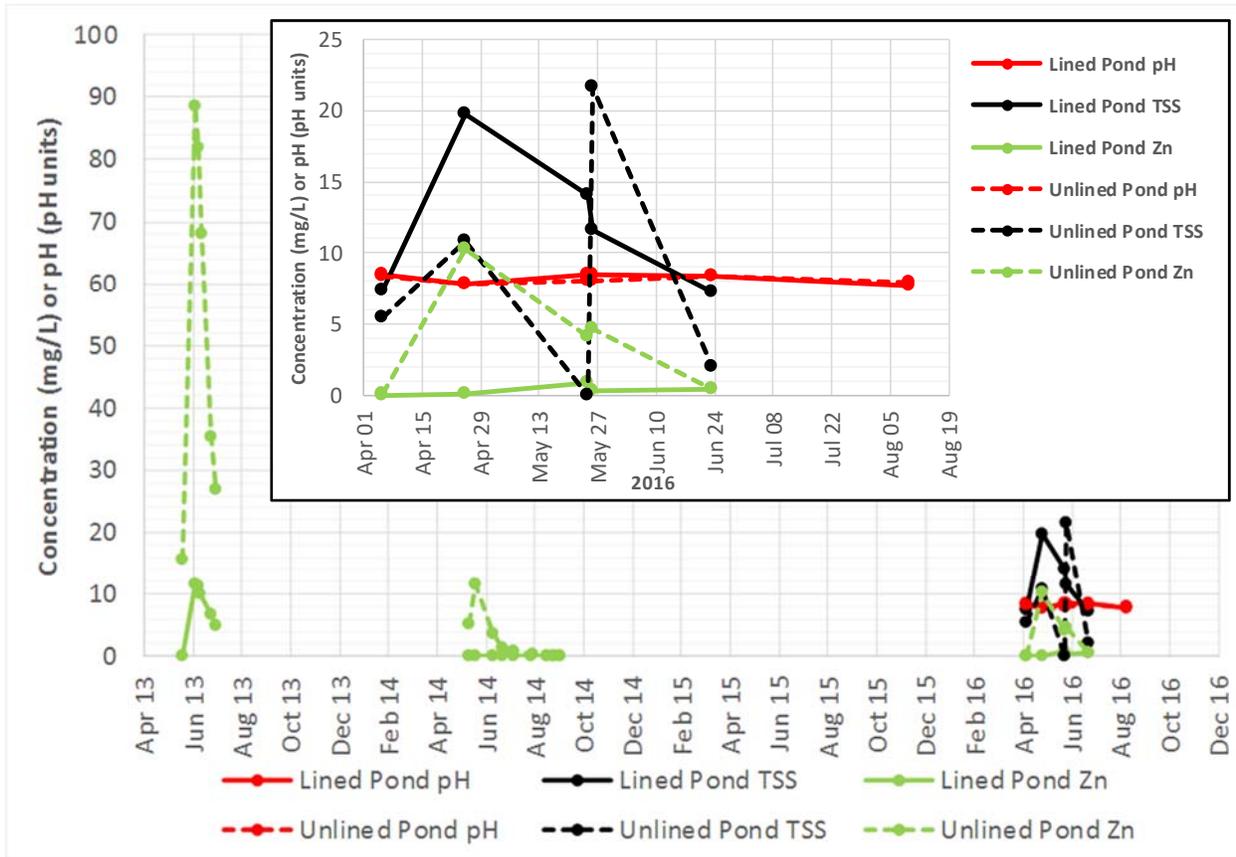
Figure 2-7. Water quality data for GSC Lined and Unlined Ponds.

waters were tested for pH, sulphate and TSS and some samples were tested for a broader suite of metals. Figure 2-7 and 2-8 present the data graphically. Note, no GSC Pond water quality data was collected in 2015.

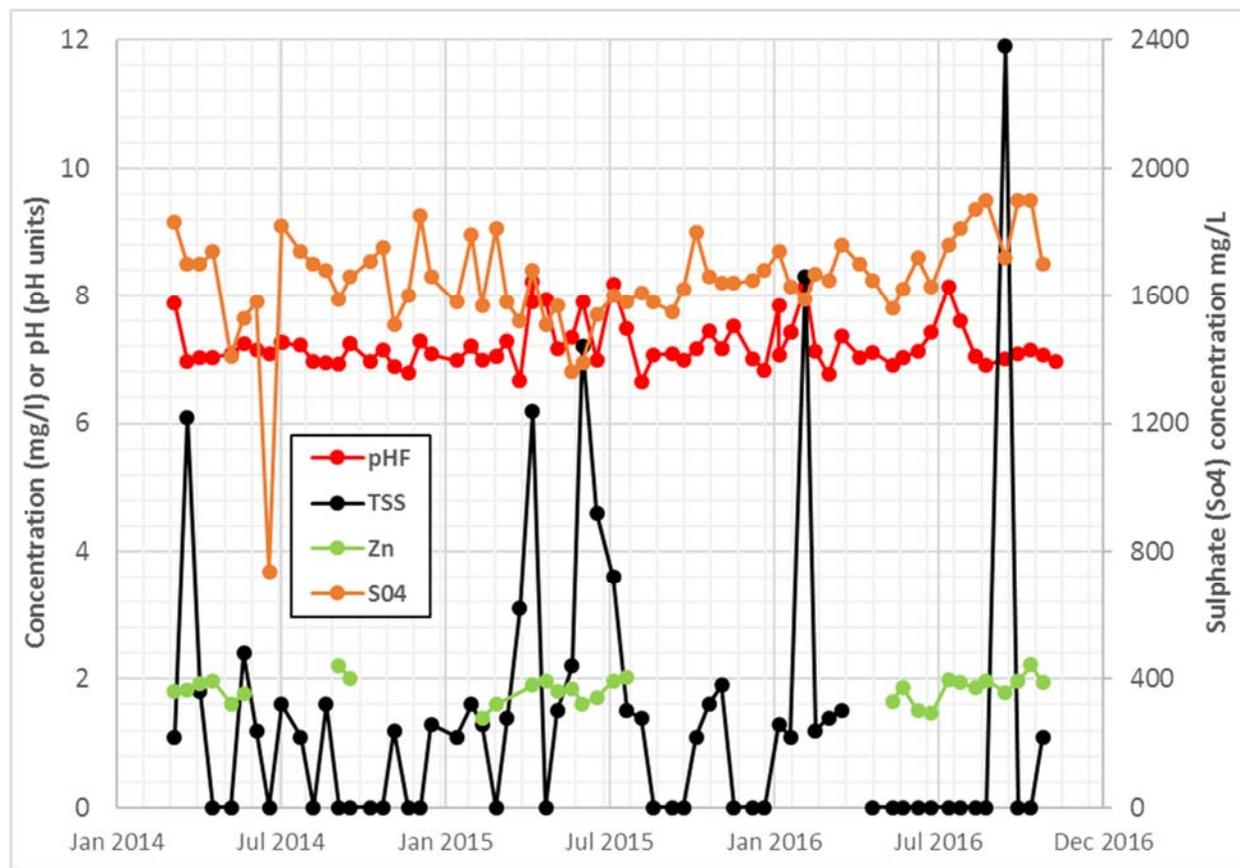
Figure 2-8. Select water quality data for Pumping Station V15 (zero for TSS indicates below 1 ppm detection limit)
