## ***Landslide Dams and Creek Stabilization at the Former Clinton Creek Asbestos Mine***

Gil Robinson, P.Eng., Ken Skafffeld, P.Eng., Rolf Aslund, P.Eng.,

UMA Engineering, Winnipeg, Manitoba

### **1.0 Abstract**

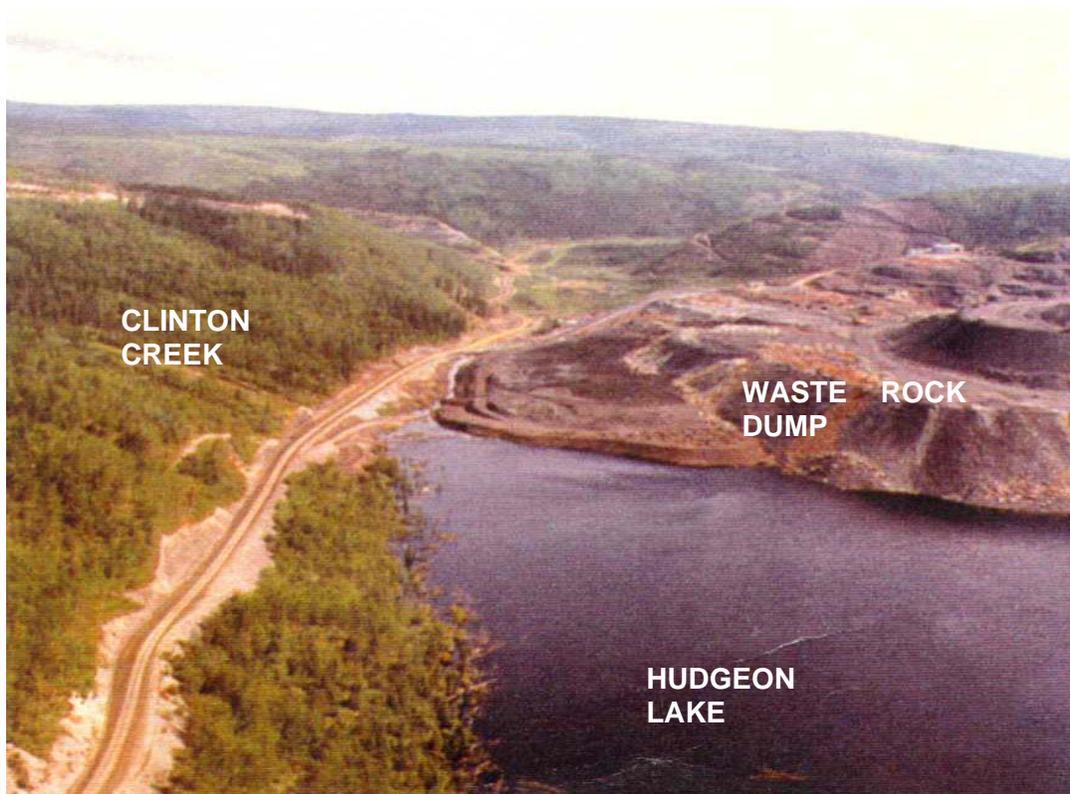
**Figure 04**  
**Waste Rock**  
**Dump In 1974**  
**(View**  
**Downstream)**

A significant slope failure of the waste rock dump into the Clinton Creek valley occurred in 1974 (Figure 03). The resulting landslide dam blocked natural drainage through the valley creating a 74 ha lake (Hudgeon Lake) as shown in Figures 02 and 04. Figure 02 also shows the valley before the landslide. Stability analysis indicates a weak foundation material is contributing to the continued horizontal displacements following the initial failure of the waste rock dump. The loss of strength may be related to a number of geological conditions unique to the site including ice content, soil type and the relationship between the rate of thawing and dissipation of excess pore-water pressures. It is likely that disturbance to the thermal regime, in particular thawing of permafrost beneath the dump, has resulted from filling of the upstream reservoir (Hudgeon Lake).

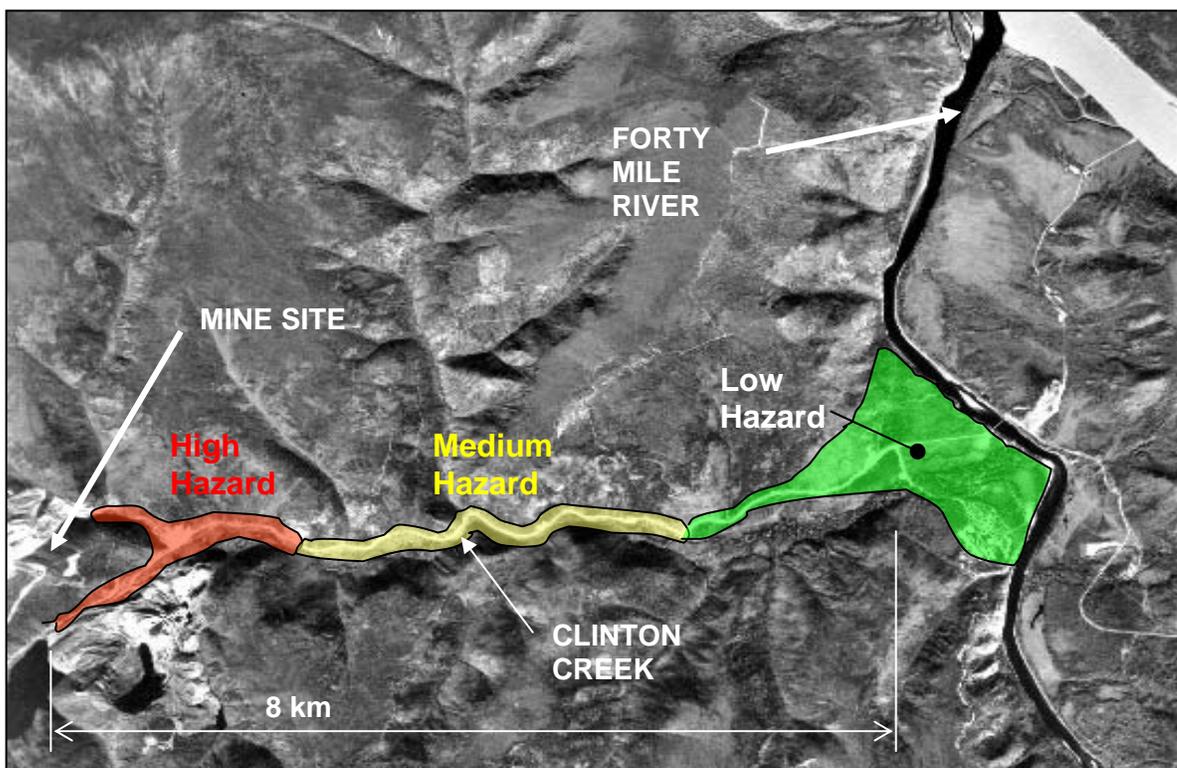
**Figure 10**  
**Downstream Hazard Mapping**

In terms of public safety, the level of risk downstream of the mine site was categorized as high, medium or low based on the severity of flooding in each zone (Figure 10). The inherent risk to humans and the potential for loss-of-life is dependent upon the likelihood of exposure (occupancy) within these zones. The potential for loss-of-life is greatest immediately downstream of the mine site in the area potentially inundated by a breach of the Hudgeon Lake outlet. Farther downstream along Clinton Creek, the risks are reduced, as the high water levels will be confined to the creek valley below the road where human exposure is less likely. The risk is considered low at the next most likely downstream area of occupancy in the vicinity of the former Clinton Creek Town-site where the valley widens considerably.
