**MOUNT NANSEN RISK ASSESSMENT,
CONCEPTUAL CLOSURE PLAN AND COST
ESTIMATION**

Prepared for the Government of Yukon

Prepared by EBA Engineering Consultants Ltd.

Project # 1200081

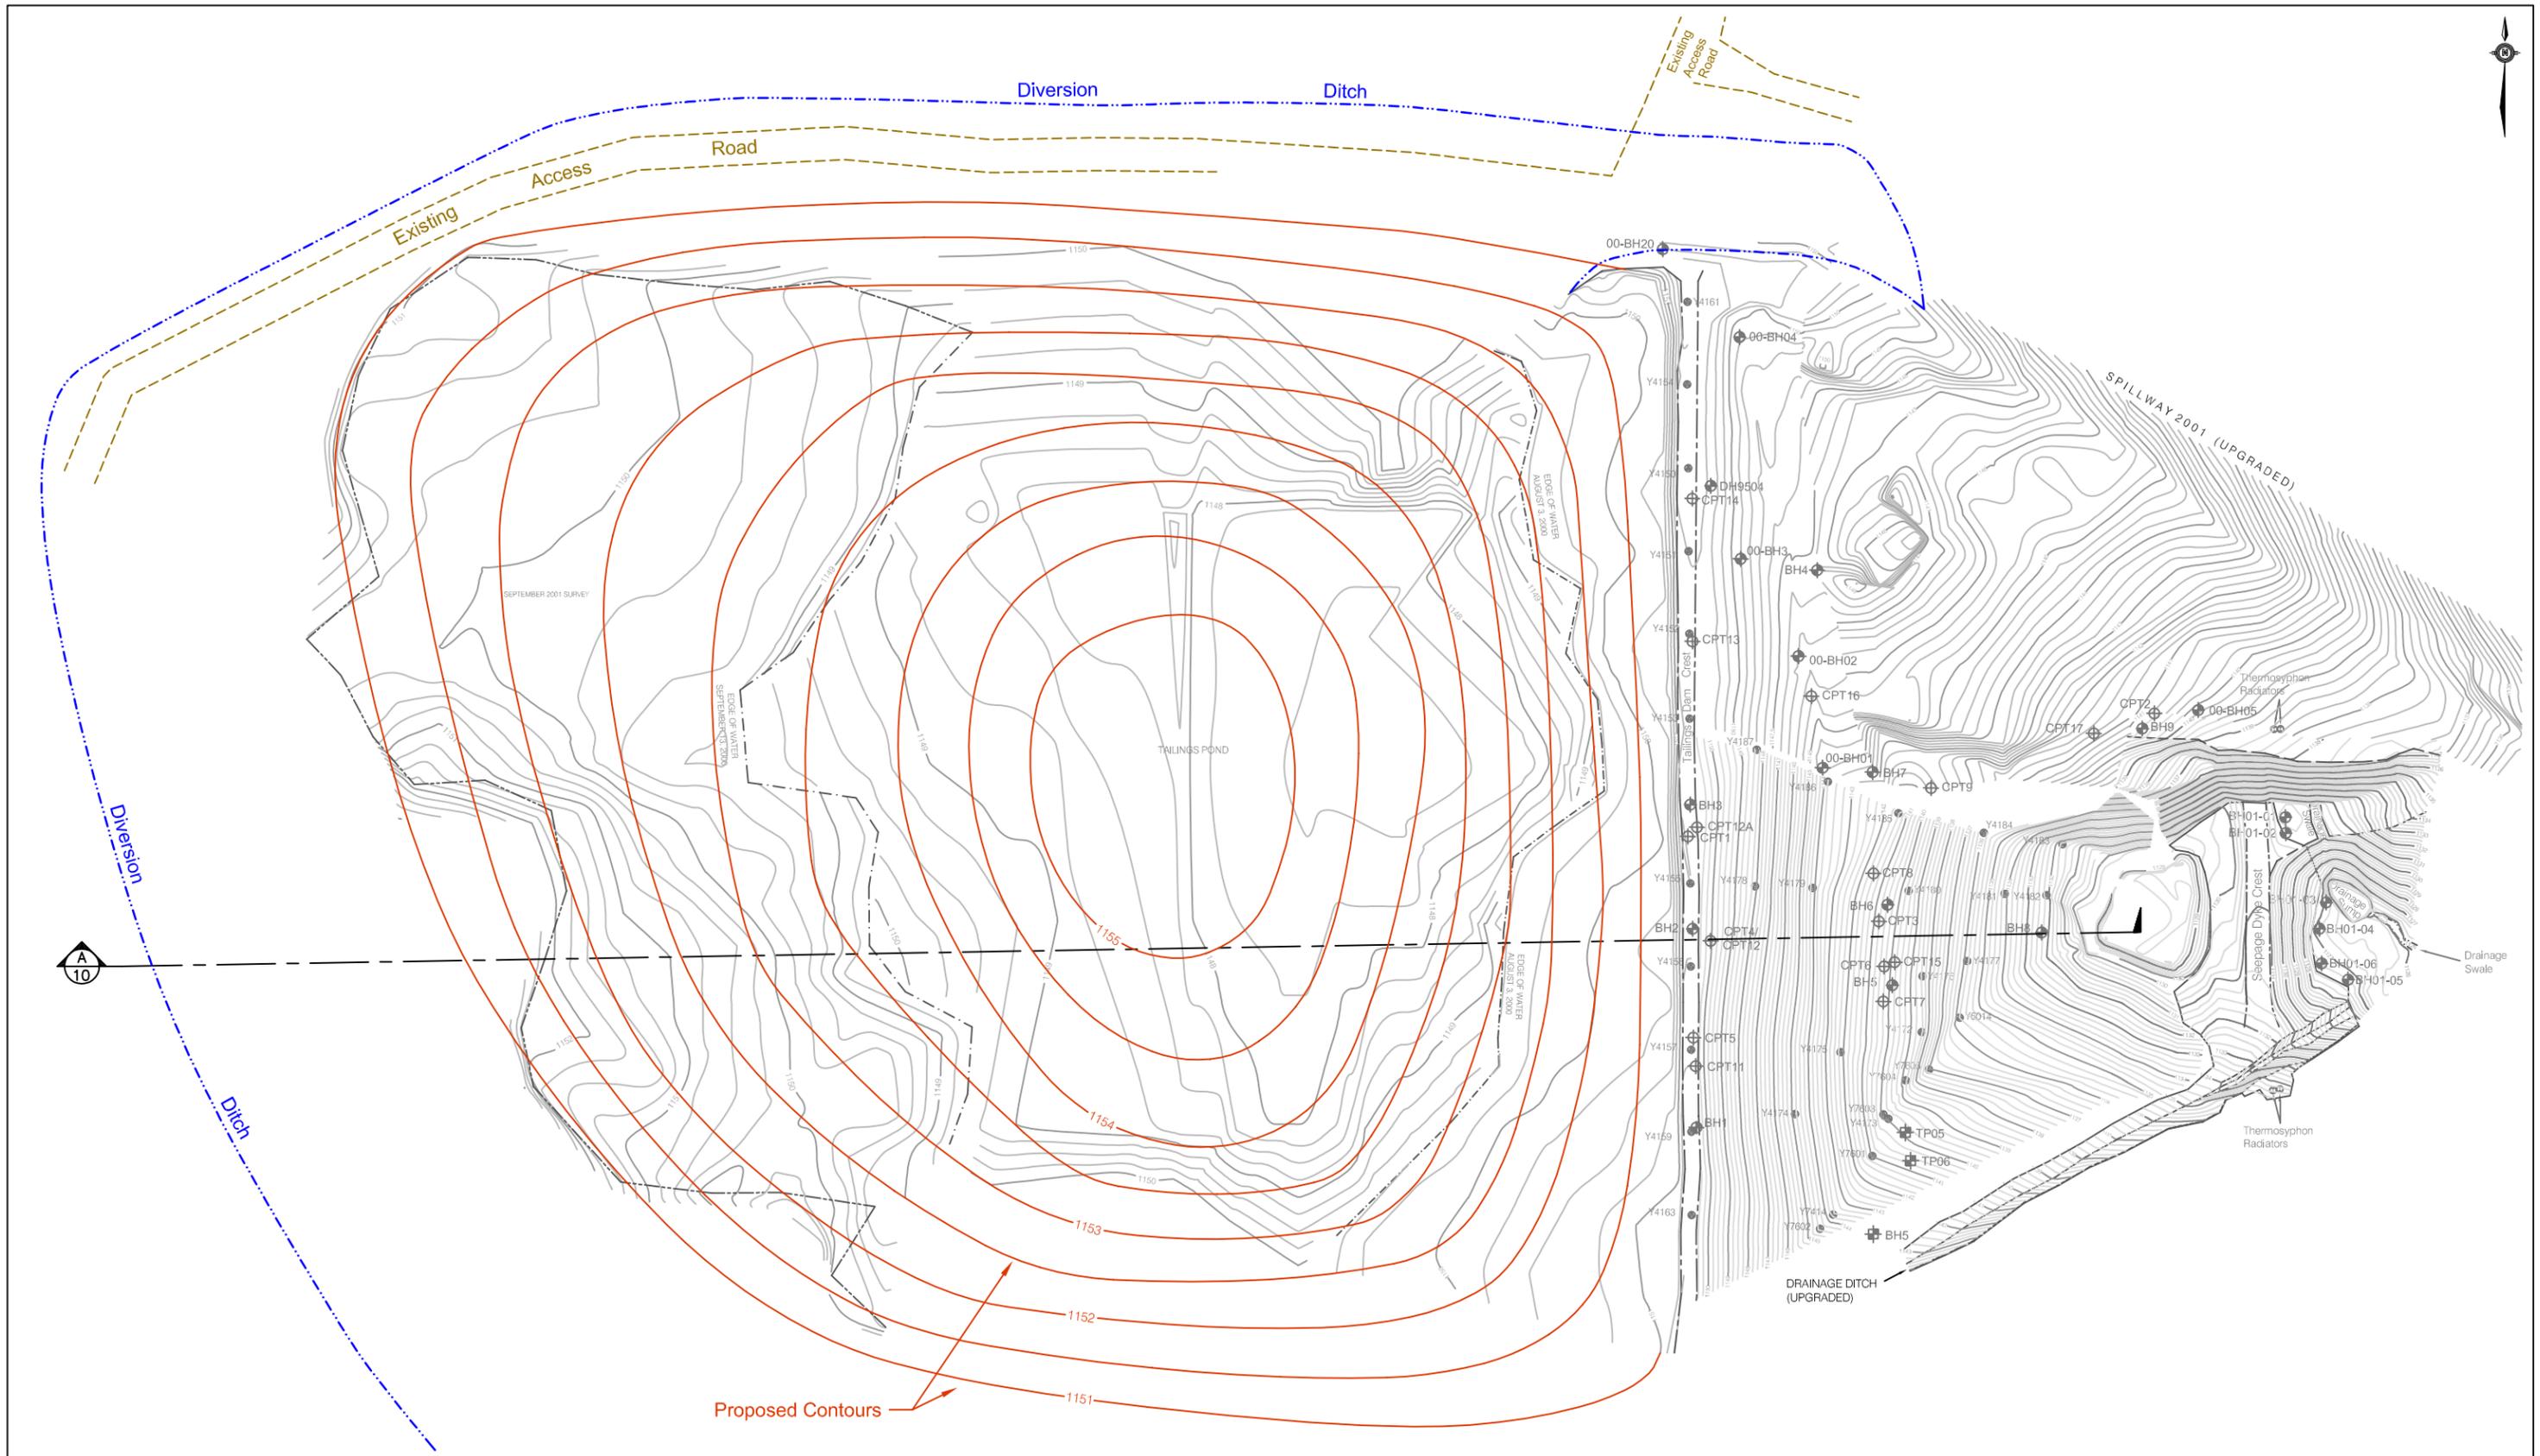
EBA Engineering Consultants Ltd.			PROJECT: MOUNT NANSEN DAM SAFETY ASSESSMENT		
CLIENT: GOVERNMENT OF YUKON ENERGY, MINES & RESOURCES			TITLE: TAILINGS IMPOUNDMENT FACILITY		
DATE: May, 2004	DWN: JSB	CHKD: CRH	FILE NO.: 1200081	DWNG: FIGURE 1	REVISION:

As shown in Figure 1, the Mount Nansen tailings facility currently consists of a tailings impoundment with a water reclaim/pump causeway, a tailings dam, diversion channels, a reclaim pond formed by a cross valley seepage control dyke located below the main dam, and an emergency spillway. The impoundment area is roughly 7 ha in area with rough dimensions of 250 m (north-south) by 280 m (east-west). The volume of tailings within the impoundment is estimated to be in the order of 283 500 m³ including both
