**Government of Yukon
Water Resources Branch
United Keno Hill Mine, YT
2007 Geotechnical Inspections**

Prepared by:
UMA Engineering Ltd.
1479 Buffalo Place
Winnipeg, Manitoba, R3T 1L7

UMA Project No.: 6029 010 00 (4.10.4)

February 2008

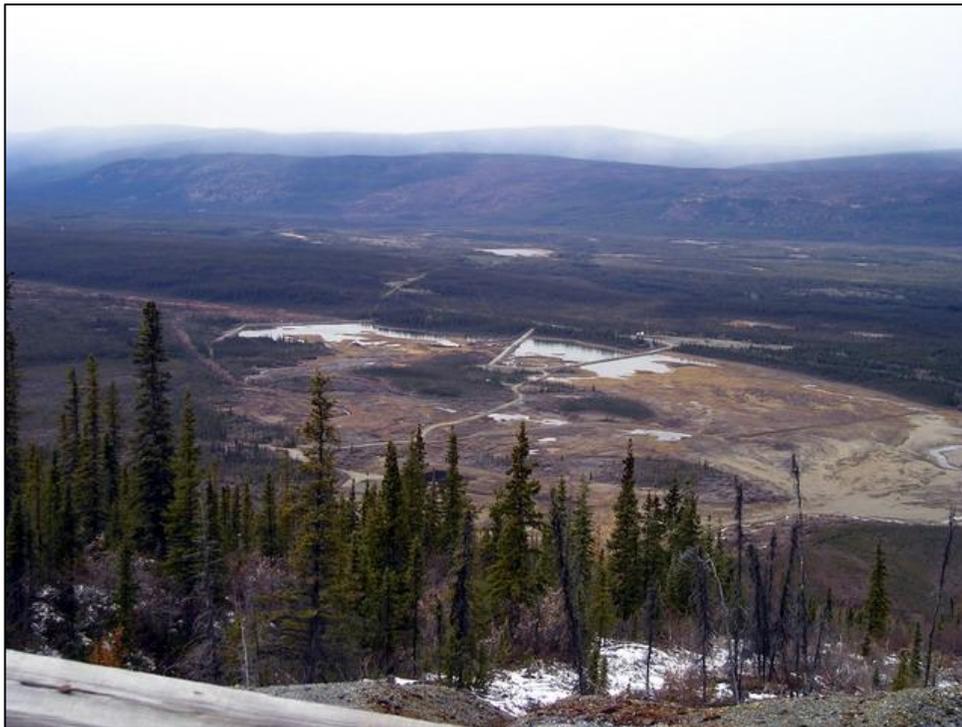
Figure 02 Overall Tailings Management Area

The Elsa Tailings Management Area is located in the Flat Creek valley below the Elsa mill. It consists of three Dams, (Dam 1, Dam 2 and Dam 3) as shown on Figure 02, 03 and Drawing 01. Dam 1 provides the majority of tailings impoundment while Dams 2 and 3 provide retention areas for water treatment and the deposition of lime sludge. Pond 2 and Pond 3 are situated on the east side of each respective dam. The Porcupine Creek diversion channel diverts water around the TMA. A seepage collection ditch along the edge of the tailings area directs tailings seepage water into Pond 3.

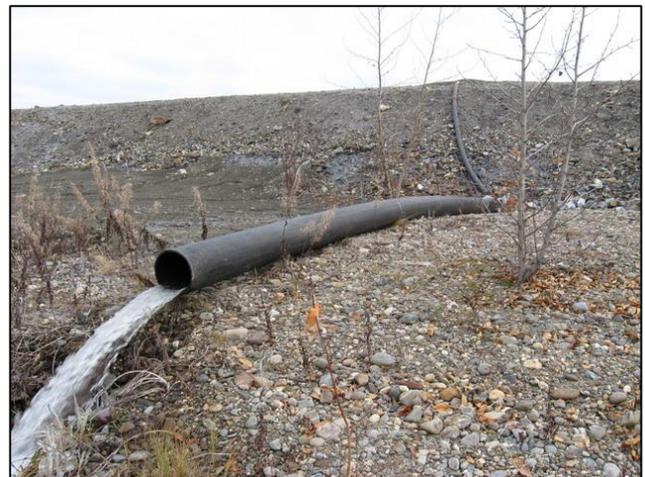
Figure 07 Siphon Discharge into Pond 2

Water from Pond 1 was being siphoned over Dam 1 at the time of our inspection through a 150 mm diameter pipe (Figure 06). A larger pipe on the toe berm conveyed water into Pond 2 (Figure 07). A decant weir consisting of a steel box with stop-log gates located near the south abutment is in good condition although not in use at the time of our inspection (Figure 08). There are three openings in the structure fitted with stop log guides. A 900 mm diameter corrugated metal pipe (CMP) discharges water from the decant weir through the dyke to a lime addition plant on the downstream side (Figure 09). Two steel pipes inside of the CMP are likely for heating. The water level in Pond 1 was well below the base of the decant weir although corrosion on the lower half of the structure provides an indication of previous pond elevations.

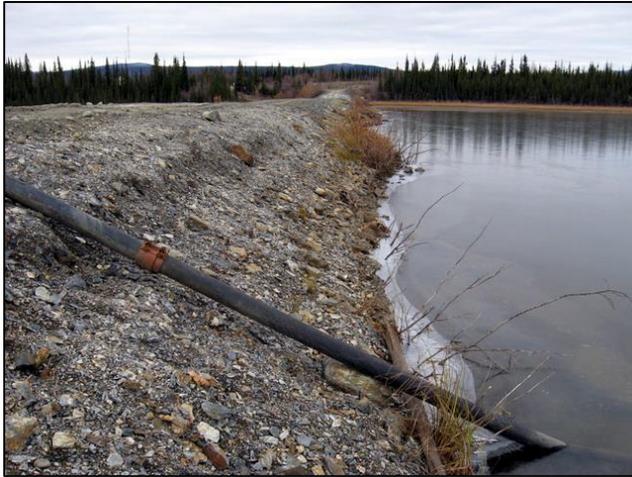
Figure 12 Upstream Slope at Siphon

A 900 mm diameter corrugated metal pipe connects the decant weir to a lime addition plant consisting of an insulated slurry tank, mixer and discharge chute (Figure 10). The plant is in some disrepair and it appears that the inlet culvert through the dyke has settled relative to the inlet to the lime plant (Figure 11). Armouring on the upstream side of the dam is sparse for the first 30 m north of the south abutment and was limited to coarser dyke fill material up to 250 mm diameter exposed from wave action (Figure 12). Between the siphon and middle of the dam, the armouring consists of riprap with an estimated maximum size of 250 mm and a D_{50} of 150 mm. The armouring along this stretch is in good condition (Figure 13) with the high water mark (evidenced by iron staining) visible about 1 m below the crest. The upstream slopes in this stretch are in the order of 1.5H:1V to 2H:1V. A staff gauge in Pond 1 read 0.81 m.

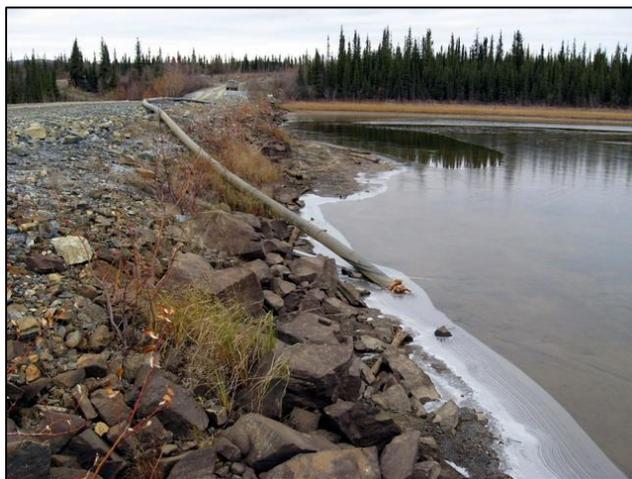
Figure 14 Upstream Armouring Along N Half

The upstream slope of the northern half of the dam are at about somewhat flatter at about 3H:1V with heavier armouring material up to 750 mm in diameter (Figure 14). The downslope side is at about 2H:1V with saplings up to 3 m high becoming established (Figure 15). A 150 mm diameter polyethylene line shown in Figure 14 is used to pump water back from Pond 3 into Pond 1. No water was being pumped during the site inspection.

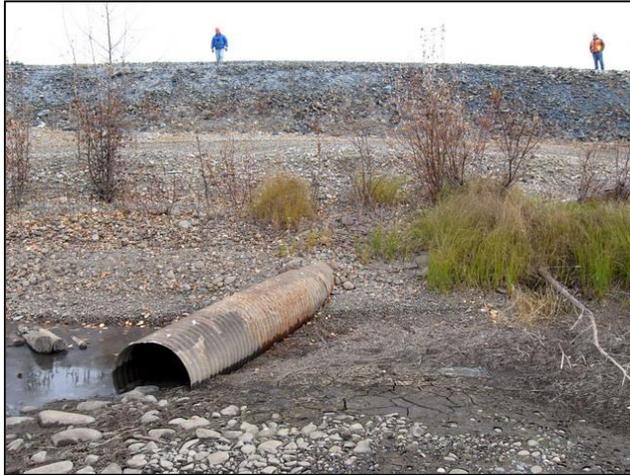
Figure 16 Abandoned Culvert

The discharge end of an abandoned culvert is visible on the downstream side of Dam 1 (Figure 16). Gravel washed into Pond 2 and crest settlement are evident immediately south of the culvert where it

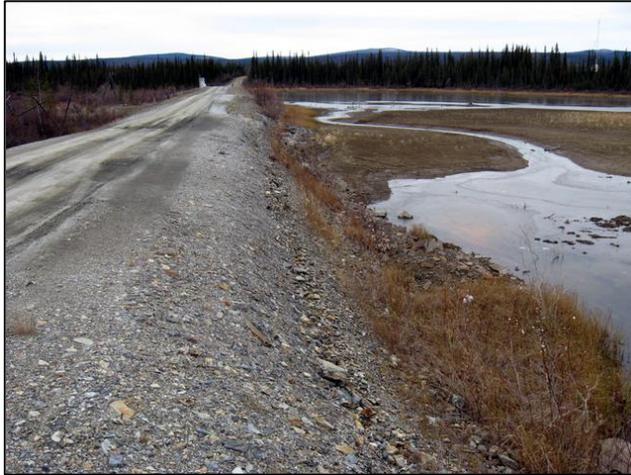
Figure 20 View N Along Dam 2 and Pond 2

Dam 2 is about 3 m high and about 420 m long. Design drawing F-128-A indicates the dam was to be constructed using local esker material with a waste rock drainage blanket and cover on the downstream slope. The freeboard at the time of the inspection was estimated to be in the order of 3 m. Upstream and downstream slopes are steep, ranging from about 1H:1V to 1.5H:1V (Figure 20). Slopes below the water level in Pond 2 were estimated to be in the order of 6H:1V or flatter. Rilling (erosion gullies) of the downstream slope is occurring about 30 m north of the south abutment (Figure 21). Riprap armouring on the upstream slope from the toe to the high water line has a maximum size of about 900 mm with a D_{50} of

400 mm. There is also ponding of water at the downstream toe in this proximity. Minor erosion of the upstream slope was noted for a distance of about 90 m south of the decant weir.

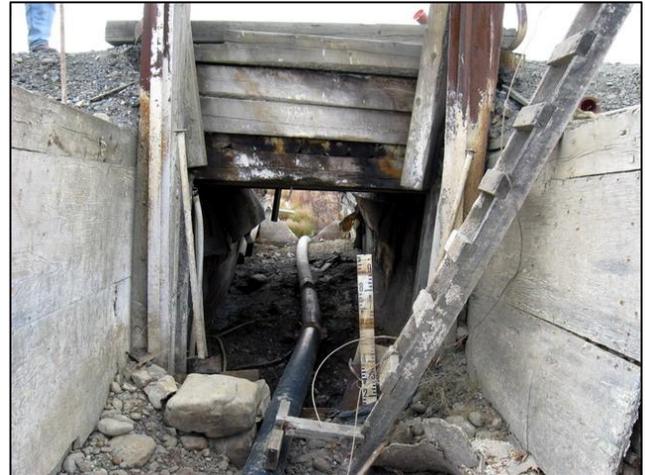
Figure 25 Upstream Side of Decant Weir

A decant outlet (weir) and lime addition system are located near the middle of the dam (Figure 24). The timber decant outlet is in very poor condition and on the verge of collapse (Figure 25). A 150 mm diameter polyethylene line siphons water from pond 2 into Pond 3 at this location, although it was not in

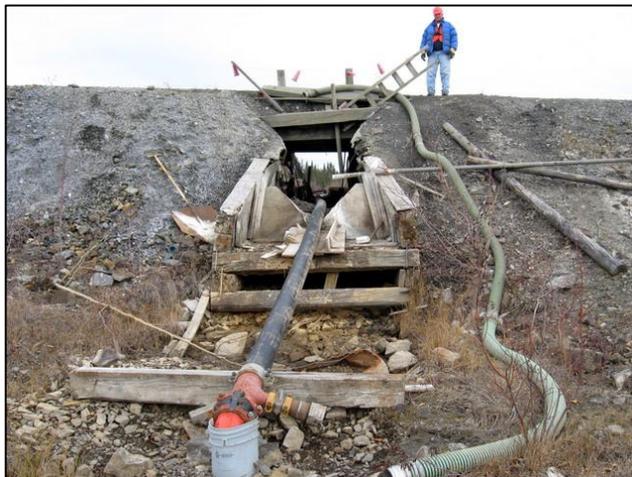
Figure 26 D/S Side of Weir Showing Siphon

operation at the time of our inspection (Figure 26). There are stop log guides on the upstream side of the structure but it does not appear that they have been used in the recent past. During higher water levels in Pond 2, it appears seepage flow occurs beneath the structure as evidenced by staining and a void beneath the downstream discharge apron. A small channel has been excavated at the discharge point into Pond 3 (Figure 27).

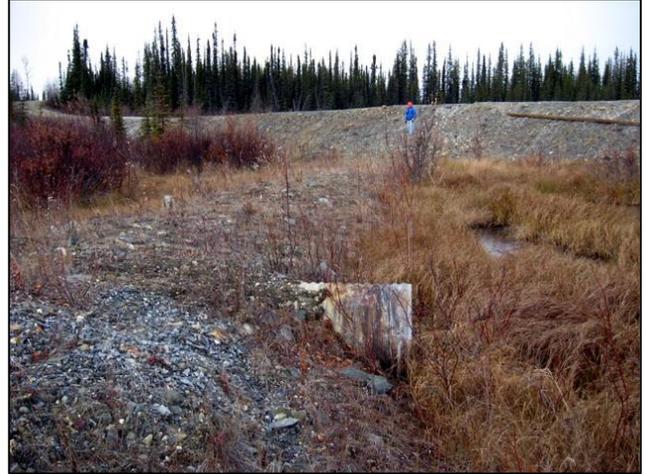
Figure 29 Culvert Through Secondary Dyke

A secondary containment dyke is visible on the downstream side of Dam 2 at the weir (Figure 28). It is believed that it was an emergency dyke built sometime before the construction of Dam 3 (SRK, 2005). The dyke is about 1 m high with a 900 mm diameter culvert installed near the north end (Figure 29). The toe of Dam 2 was noticeably soft and wet at the junction of the secondary containment dyke.

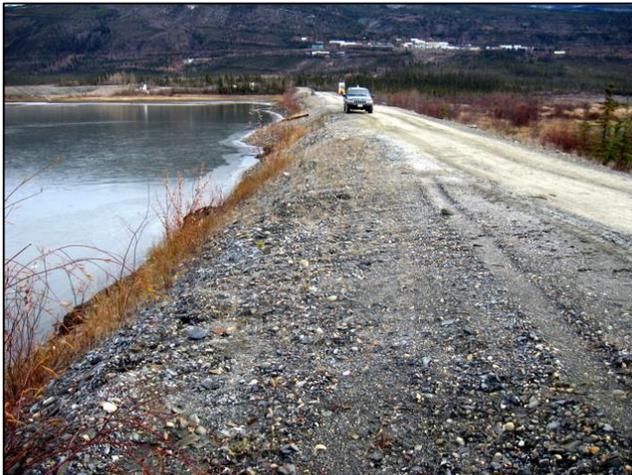
Figure 30 U/S Side N of Weir (view S)

The armouring along the upstream edge extends for about 15 m north of the weir beyond which, there is no upstream erosion protection until about 15 m from the north abutment (Figure 30). Erosion of the unprotected dam slope in this stretch is minor. The maximum rock size visible is in the order of 100 mm. Downstream slopes are steep at about 1H:1V (Figure 31).

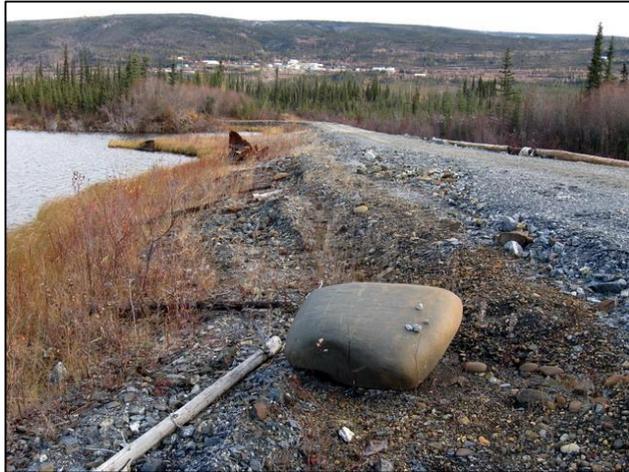
Figure 32 Widened Section of Dam 3

Dam 3 consists of two segments separated by naturally high ground. The total length including the high ground is in the order of 425 m. An abandoned culvert crosses the south segment of Dam 3 where the dam has also been considerably widened (Figure 32). The upstream end of the culvert has collapsed and the downstream side is not visible (Figure 33). Significant settlement of the crest over a 40 m stretch

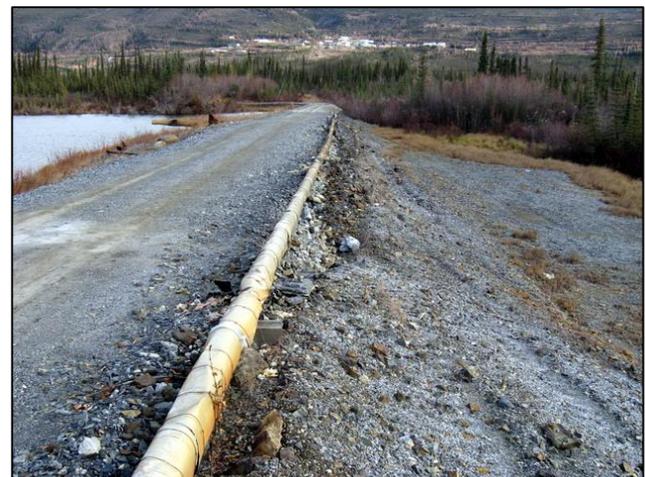
Figure 35 Granular Blanket on D/S Side of Dam 3

is evident just north of the culvert crossing where up to 1.2 m of fill has been added (Figure 34). A granular pad has been placed on the downstream side of the dam at this location although the function of the pad is unclear (Figure 35). Iron staining on the granular pad indicates active seepage at this location. The upstream shoreline is grassy with little to no active erosion.

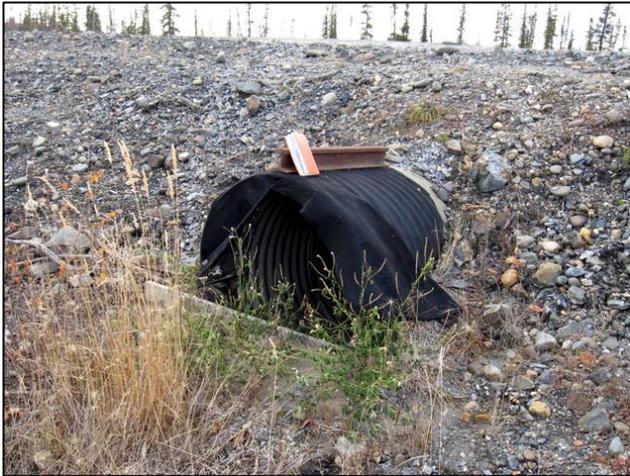
Figure 36 Culvert Inlet

A 900 CMP culvert is located near the south end of the north segment of Dam 3 (Figure 36). The culvert looks relatively new with no deformation or deflections visible throughout its length. The bottom of the inlet is partially blocked with timbers, likely to regulate upstream water levels. A non-woven geotextile cover has been cut open. The purpose of the geotextile is unclear but it may be for sediment control. Erosion of the downstream slope has occurred where the end of the culvert is recessed (Figure 37). The culvert is believed to be an emergency spillway for Dam 3 (SRK, 2005).

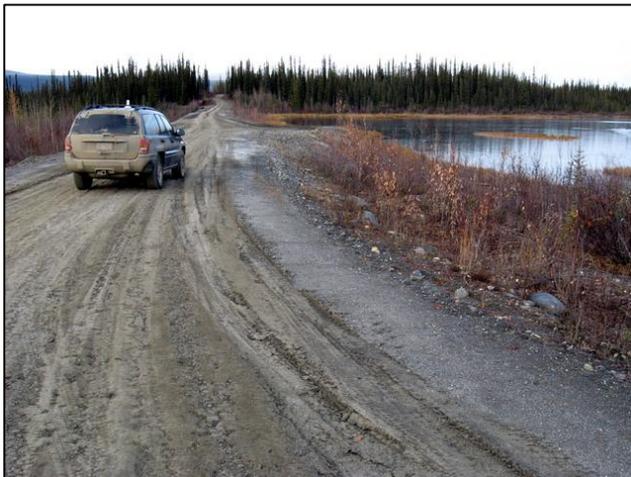
Figure 38 View N at Decant Structure Location

The main control structure for Dam 3 is located at about mid-point along the north dam segment where the upstream slope has been widened to about 18 m (Figure 38). The structure consists of a steel decant box with stop-log guides on the inlet end (Figure 39). The wooden gate (not in use at the time of our inspection) fits into the stop-log guides. A 750 mm diameter steel pipe fastened to the box runs through the dam exiting about 1.5 m above the toe (Figure 40). A flow rate of 0.2 litres per second was measured using a 5 gallon pail. A scour hole has developed at the unprotected toe of the dam (Figure 41).

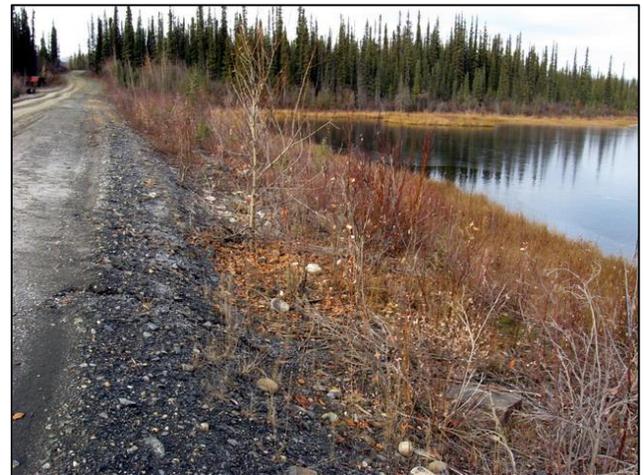
Figure 43 Upstream Shoreline (view N)

A gravel pad has been placed on the downstream side of the dam for about 25 m north of the decant structure, possibly in an area of seepage (Figure 42). Iron staining on the downstream slope just above the toe in this vicinity suggests that seepage through the dam occurs but probably only visibly during higher water levels in Pond 3. The upstream shoreline is grassy and stable (Figure 43).

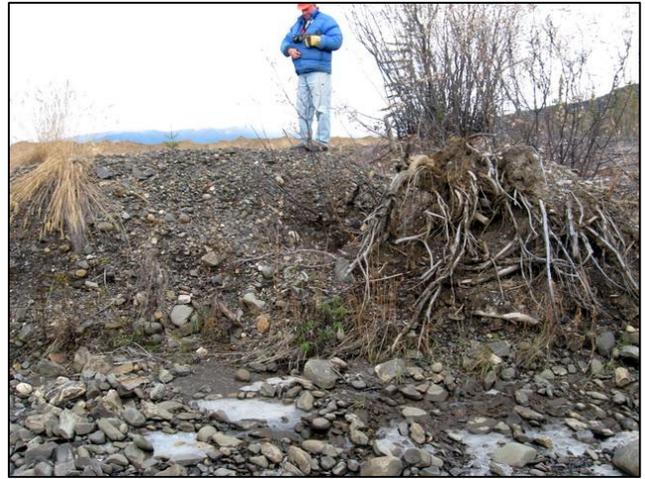
Figure 45 Creek Channel Bank

Overall the creek channel between the road and the diversion ditch is functional although the banks are over-steepened in some cases and the channel width varies considerably. Vegetation is becoming well established along the creek channel. The channel bed appears to be well armoured with cobble sized material. The gravel dyke at the entrance to the diversion channel is in good condition although over-steepened and because of the fine grained material used to construct the dyke, it is susceptible to erosion.

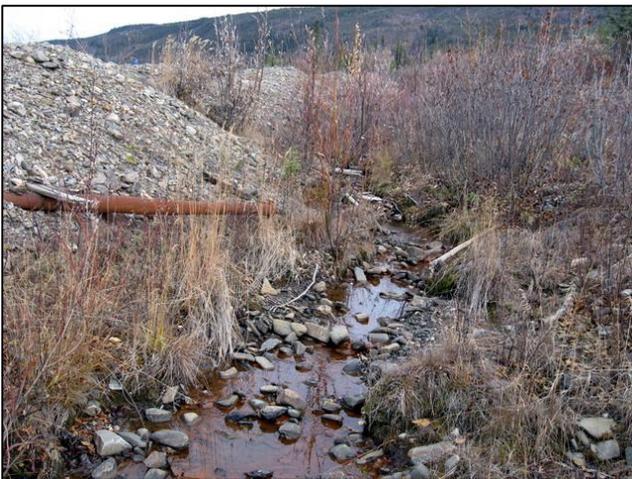
Figure 46 Gravel Dyke

The Porcupine Creek Diversion diverts water around the TMA. The headwater for the diversion is along the natural creek channel between the mill and tailings impoundment referred to as Brefalt Creek on the Plant Site Drawing. A gravel berm or dyke diverts water into the diversion channel, preventing it from entering Pond 3. The author did not inspect the diversion channel itself but observations provided by Mr. Glenn Ford indicated it was flowing with no visible channel blockages. Previous inspections indicated that the channel is cut through natural ground, comprised of stratified silts and sands covered with muskeg. These deposits are apparently ice-rich and thawing continues resulting in sloughing of the bank (Geo-Engineering, 1996). The channel upstream of the diversion is cut through what appears to be natural material. Water first appears in the channel as ice (Figure 44) where the diversion channel banks are about 2 m high (Figure 45). From this point, the creek channel runs westerly until joining the diversion at the gravel dyke (Figures 46-48). Iron staining is visible at numerous locations along the diversion (Figure 49).

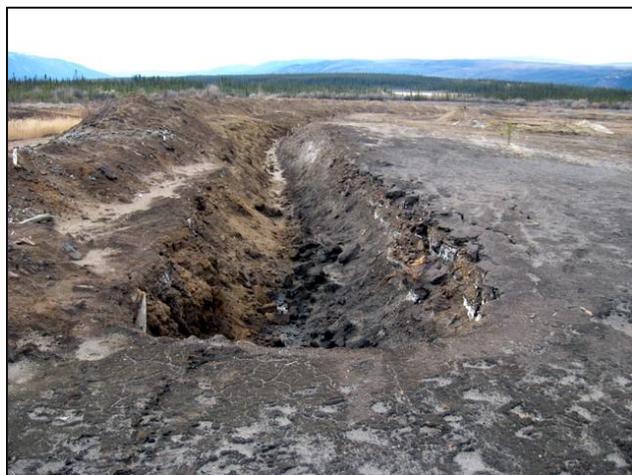
Figure 50 U/S End of Seepage Collection Ditch

A seepage collection ditch has recently been excavated through the tailings north of the Porcupine Creek Diversion. It appears to have been constructed to intercept tailings seepage water before it enters the adjacent creek channel. The ditch starts in the tailings close to the road as shown on Figure 50 and Drawing 01, ending on the flood plain at the edge of the tailings in Pond 3. Water first enters the ditch as groundwater seepage at the location shown on Drawing 01, with flow gradually increasing towards the tailings ponds. The ditch in the upper reaches is V shaped with steep sideslopes. Farther downstream the banks are still very steep but the channel bottom is wider. Instabilities and slumping of the ditch banks are evident throughout its length (Figure 51). The ditch enters a grassy channel before entering the flood plain at the edge of Pond 3 (Figure 52 and 53).
