Phase I & II Environmental **Site Assessment**

Former Military Site Snag - Enger Lakes Mile Post 1189 Alaska Highway (DIAND Site 36)

Prepared for:

November 1996

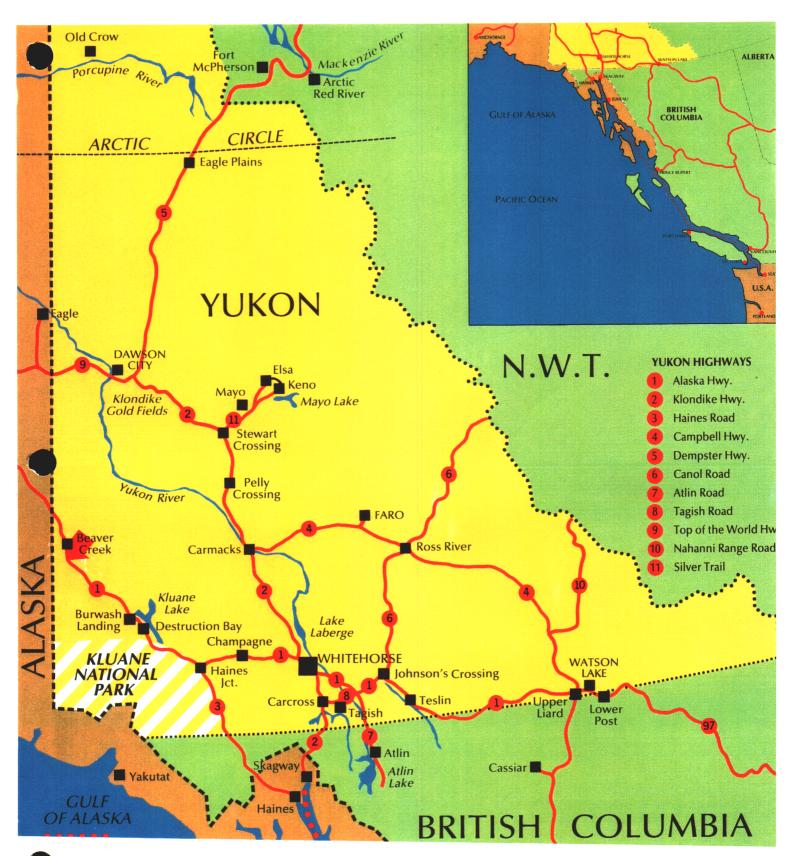
Figure 1. Site Location.

Hycal Environmental Sciences Ltd. (Hycal) was retained by Action on Waste, Arctic Environmental Strategy, Indian and Northern Development, Canada to carry out environmental assessment of four separate sites. This report outlines the investigation of one of these sites, known as "Site 36". Site 36, also known as Snag - Enger Lakes is located in the western Yukon Territory, at Mile Post 1189 of the Alaska Highway (Figure 1).

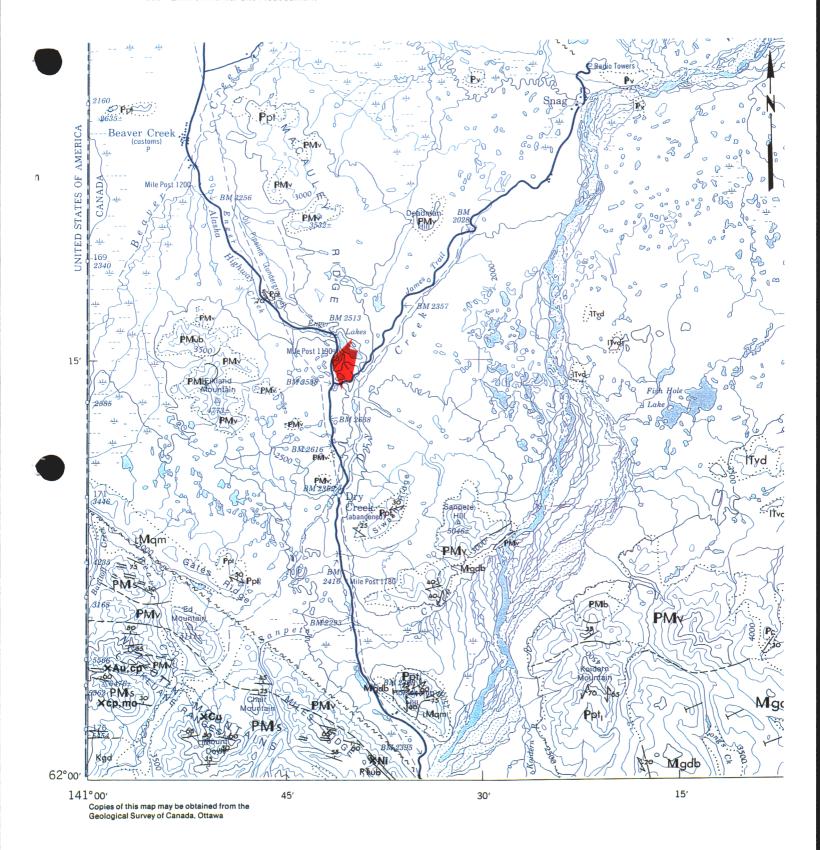
Figure 2. Detailed Site Location.

Mile Post 1189 of the Alaska Highway is located north of the junction of the Alaska Highway and the James Trail, which runs to the old townsite of Snag (Figure 2). The location is approximately 13 miles south of the town of Beaver Creek.

The area around the clearing was visually inspected and no indications of previous occupation were discovered. The area was found to east of a small lake. Groundwater flow from the site would be anticipated to be towards the lake.
