**1997 Environmental Investigations along the
Canol Road**

Prepared For:
Ross River Dena Council

Prepared By:
Gartner Lee Limited

May, 1998

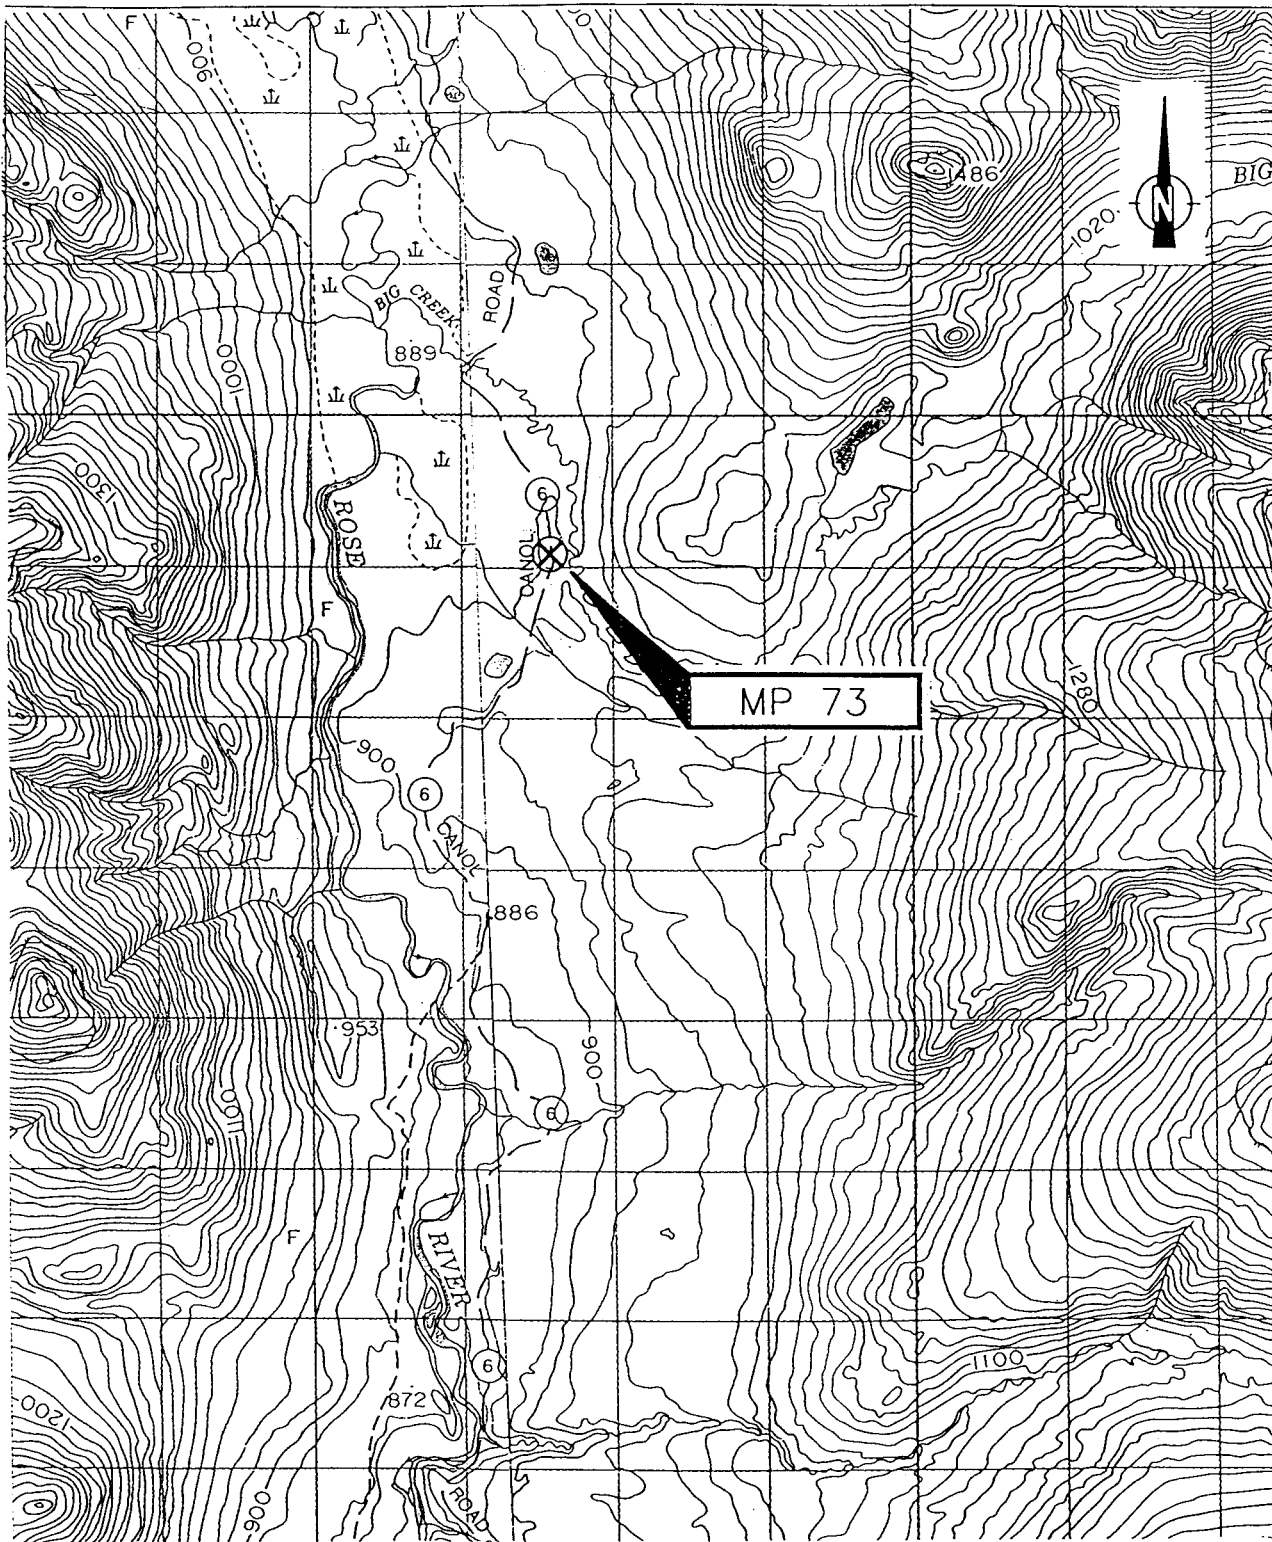
1. soils in excess of 2 m in depth around the POL tank site (Area A in Figure 4) have been impacted by petroleum hydrocarbons at concentrations which exceed the Parkland and Industrial criteria;
2. an Underground Storage Tank (UST) is located adjacent to the pump station foundation (Area B in Figure 4) and the soils beneath the tank have been impacted by petroleum hydrocarbons at concentrations which exceed Special Waste criteria;

3. buried refuse, including full cans of oil and crease, are located on the west side of the road in (Area C in Figure 4) and the underlying soils have been impacted with petroleum hydrocarbons at concentrations which exceed the Parkland criteria.

A program of test pitting was conducted around the dump site located west of Canol Road. A series of five test pits were dug in the dump site area (TP 97-3 to TP 97-7) on August 12th. Based upon the pits dug, the dump site was delineated as shown on Figure 4—an area of approximately 350 m² with a depth of material around 1.5 m. This area is much smaller than originally thought, and seems to be centered around TP 96-6 from the 1996 investigation.

Hydrocarbon contamination was found in the dump site (Area C). Two groundwater monitor wells were installed down-gradient of the dump site. There is wetland area west of the dump site that is a potential receptor of contaminants. The locations of the two wells (MW-1 and MW-2) are shown on Figure 4. Wells were installed by excavating a pit, installing Waterra environmental grade PVC monitoring wells, and backfilling the pit.

The dump site area has been defined as shown in Figure 4 with an extent of approximately 25 x 20 m.
Debris has been encountered in test pitting up to 1.5 m below the surface. The dumps site was found to
contain drums of grease and motor oil (Phillip sample ID 97031496). These drums represent potential
sources of contamination since they contain free hydrocarbon product. Soil samples from the dump site

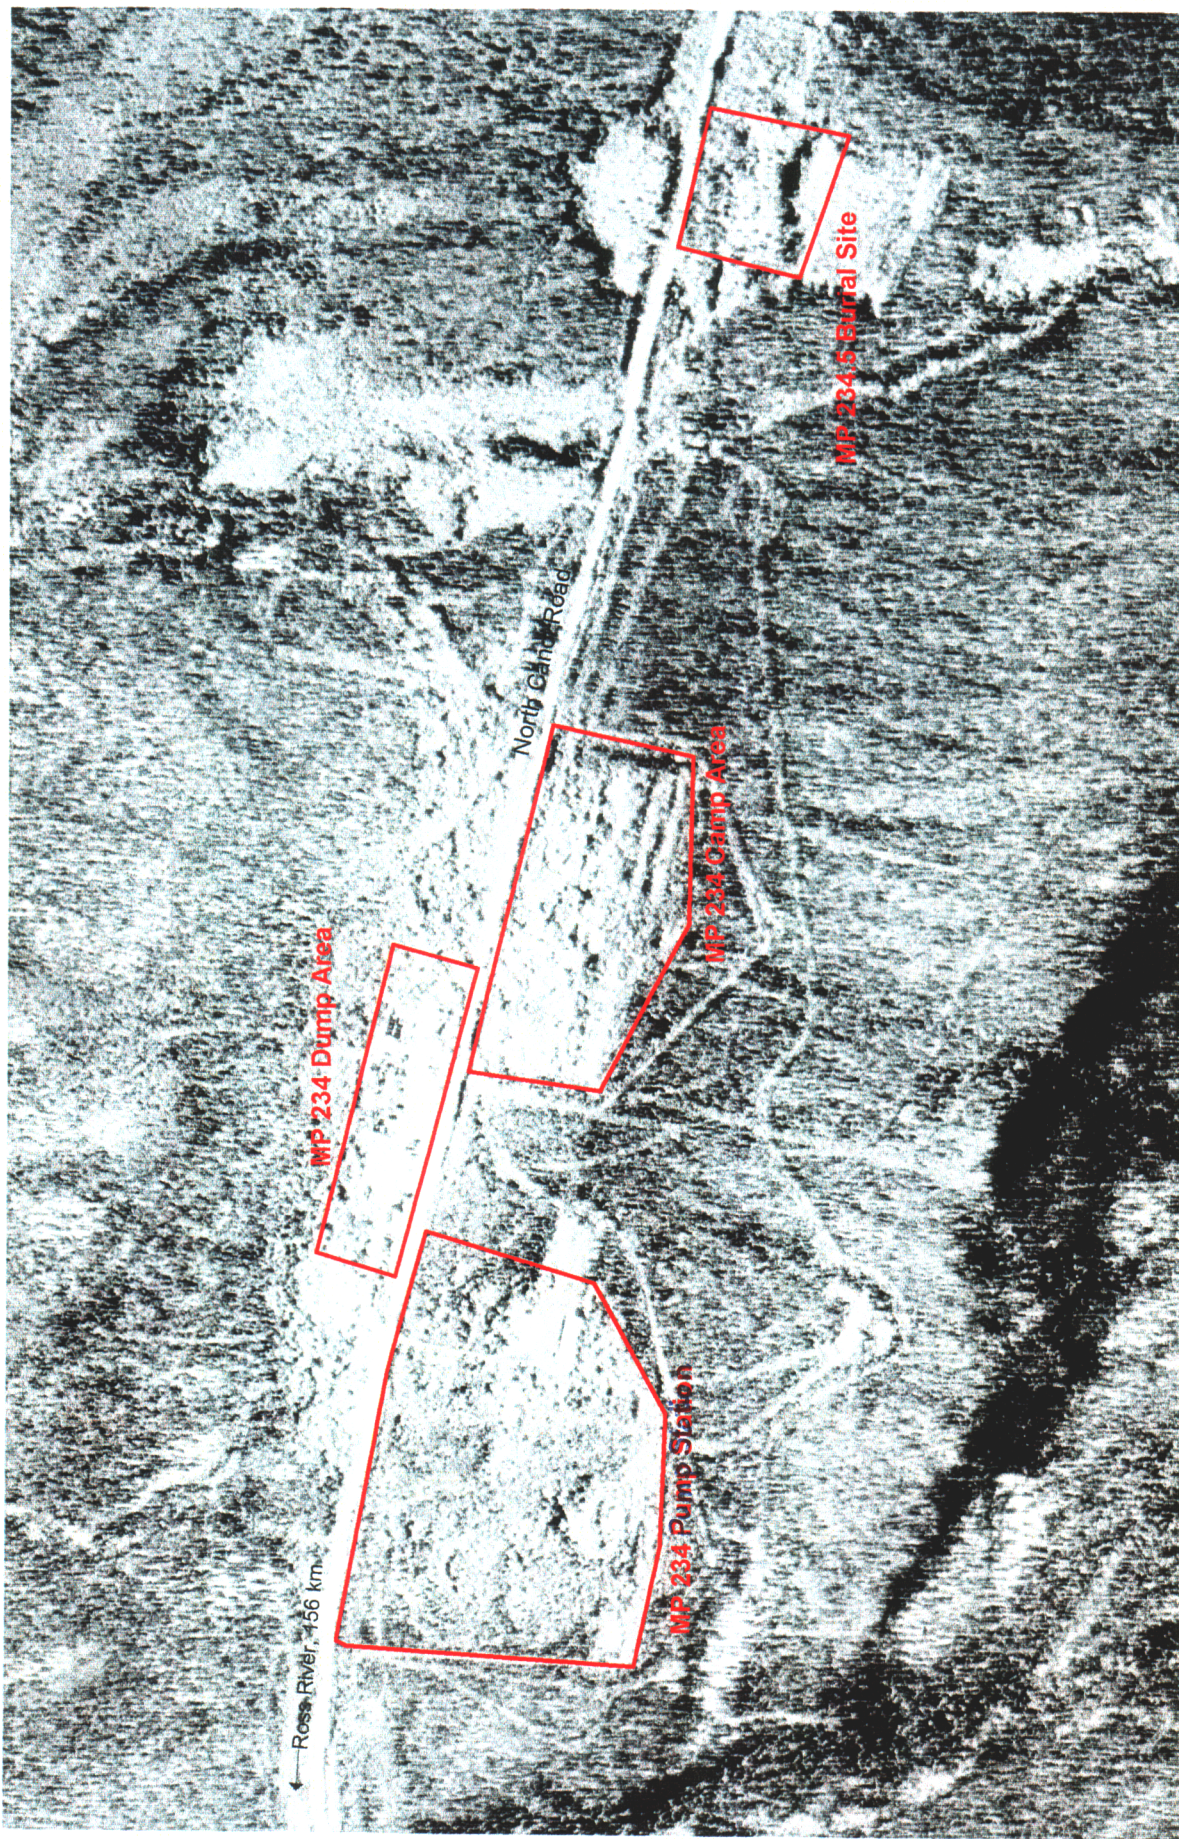
1997 field work revealed that the camp site consists of four distinct areas (see Figure 12). These include:

3. The main camp area at this site is south of the Canol Road and east of the pump station. The camp area is heavily overgrown by willows and alders. Photographs from 1975 show that there were over 20 building ruins in this area. In 1997 only a few overgrown remains of these camp buildings could be found. No issues related to contamination, and minimal unsightly waste was found in the main camp area. No further work was conducted in this area.

4. Less than one kilometre east of the main burial site, a second debris burial site was located south of the North Canol Road. This site has been called MP 234.5 and is described as a new site in Section 7.3. The site was located by Ross River residents and consists of a clearing approximately 30 south of the road. Pieces of culvert are piled on the northeast side of the clearing, and dried grease, desiccated oil and crushed drums are found sporadically over the area.

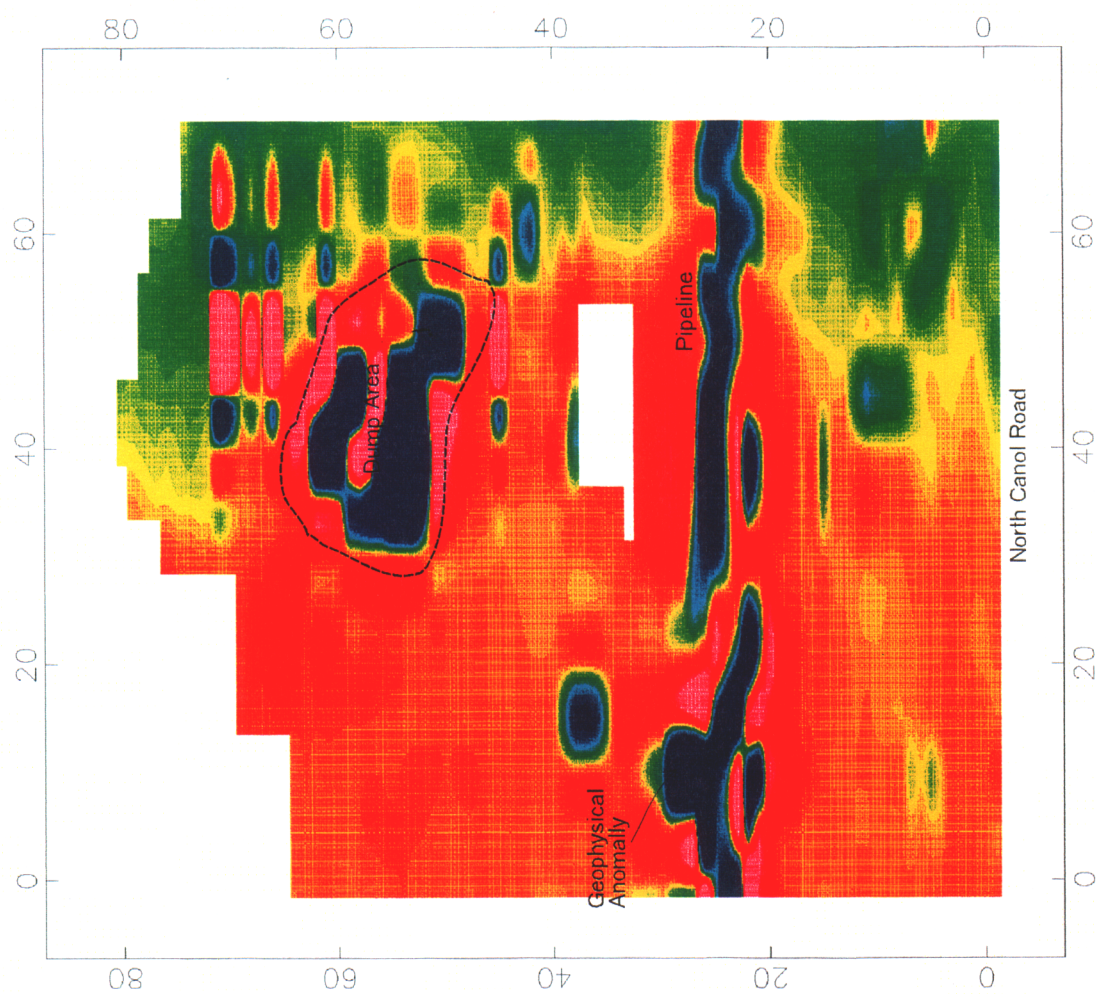
Terrain Conductivity
(mS/m)

Prior to the geophysical survey, a temporary baseline was established along the North Canol road. The baseline consisted of flagging tape spaced 5 m apart and affixed to vegetation. The geophysical survey was conducted along lines run perpendicular to the baseline at 5 m intervals. The lines were run south from the Canol Road baseline. Grid coordinates are shown on Figures 21 and 22.

Following the completion of the surveys, the data are plotted and interpreted from the profile lines of the geophysical data and notes collected in the field. Final presentation of the data is in the form of colour contour maps on Figures 21 and 22.
