**PHASE II ENVIRONMENTAL SITE  
ASSESSMENTS  
Sites HJ035, HJ036 & HJ041  
Kluane Lake Area, YT**

0201-97-12447.1

Submitted to:  
Indian and Northern Affairs Canada

March, 1998

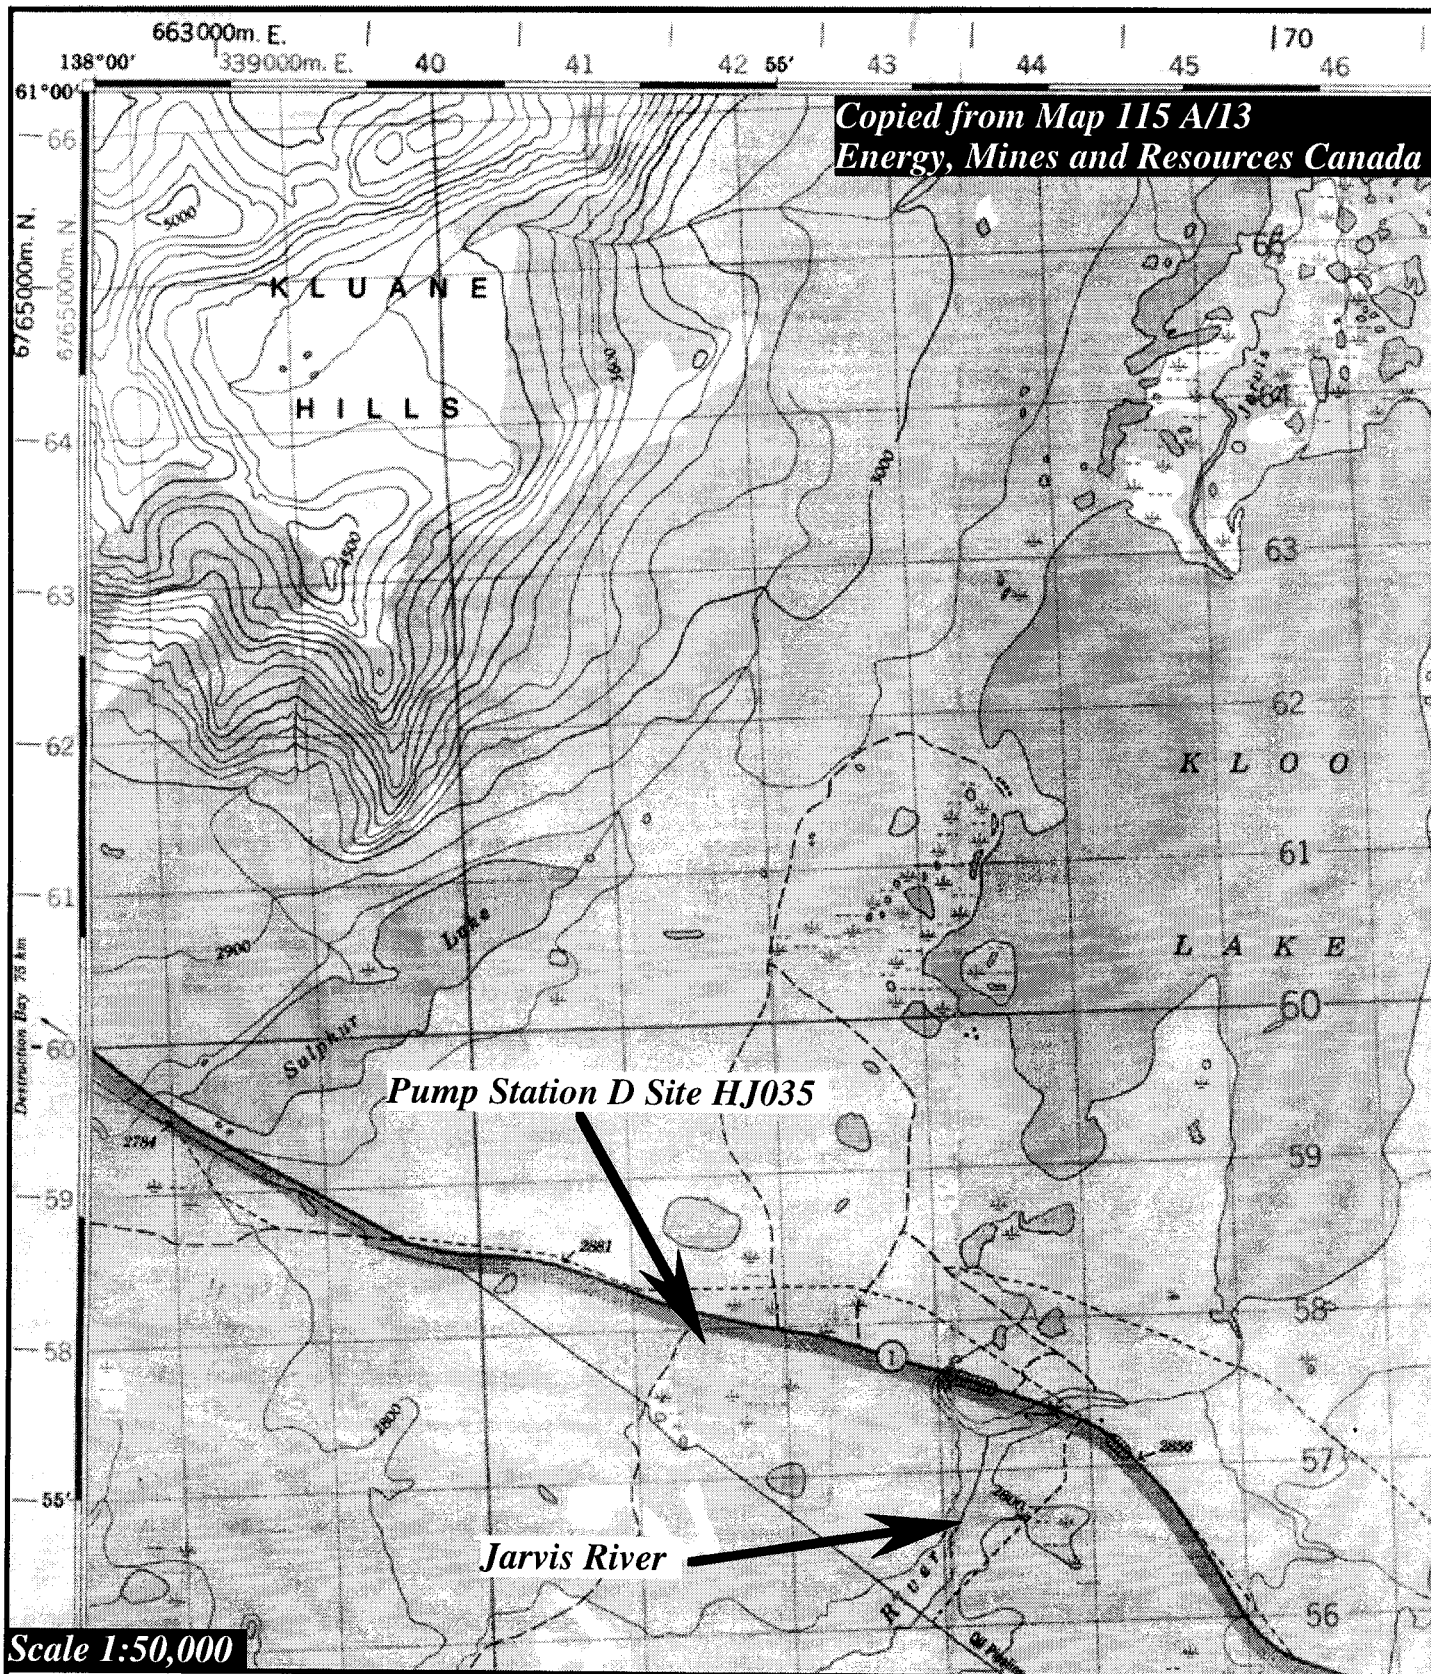
The physical boundaries of the site seen in the 1944 airphoto (Figure 3) are still visible due to the slow revegetation process. Revegetation is occurring throughout the site and stressed vegetation was not encountered.

There were no observed areas of staining or anomalies that might indicate the presence of contaminants. There were small amounts of building debris and remnants of wooden structures scattered throughout the site. These were not considered to be posing any environmental hazard.

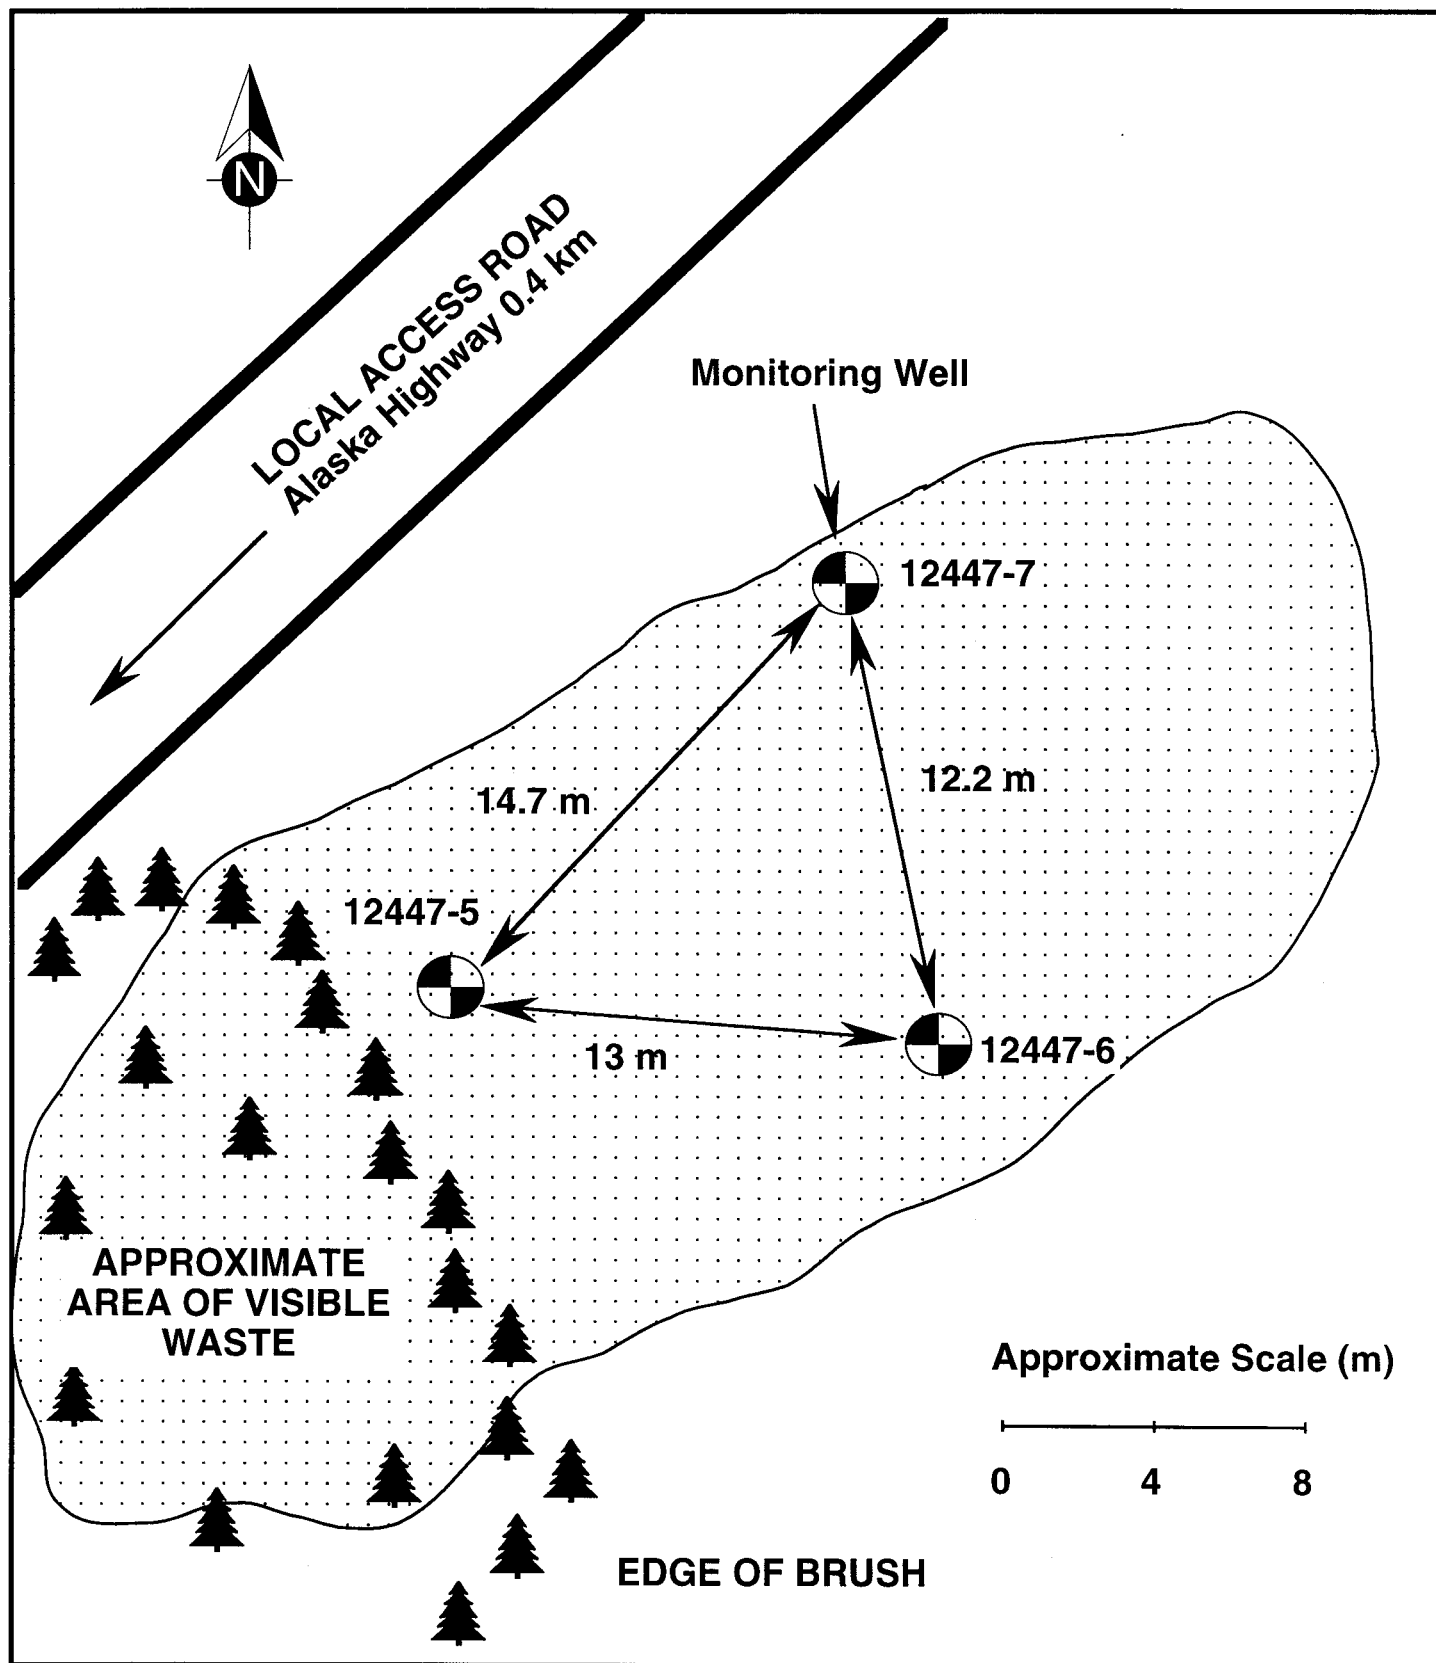
Location 41-1 was the area where wastes including cans of food had been reportedly buried about the time the camp was closed. There was evidence of wastes on the ground surface, and partially buried (Figure 9). A drilling program was designed for the site to investigate the subsurface soils and if ground water was encountered to install a monitoring well.
