**A Preliminary Environmental Investigation
of Site HJ034 - Canyon Creek**

D. B. Craig, Consulting Engineer
and
W. J. Klassen and Associates Ltd.

February, 1998

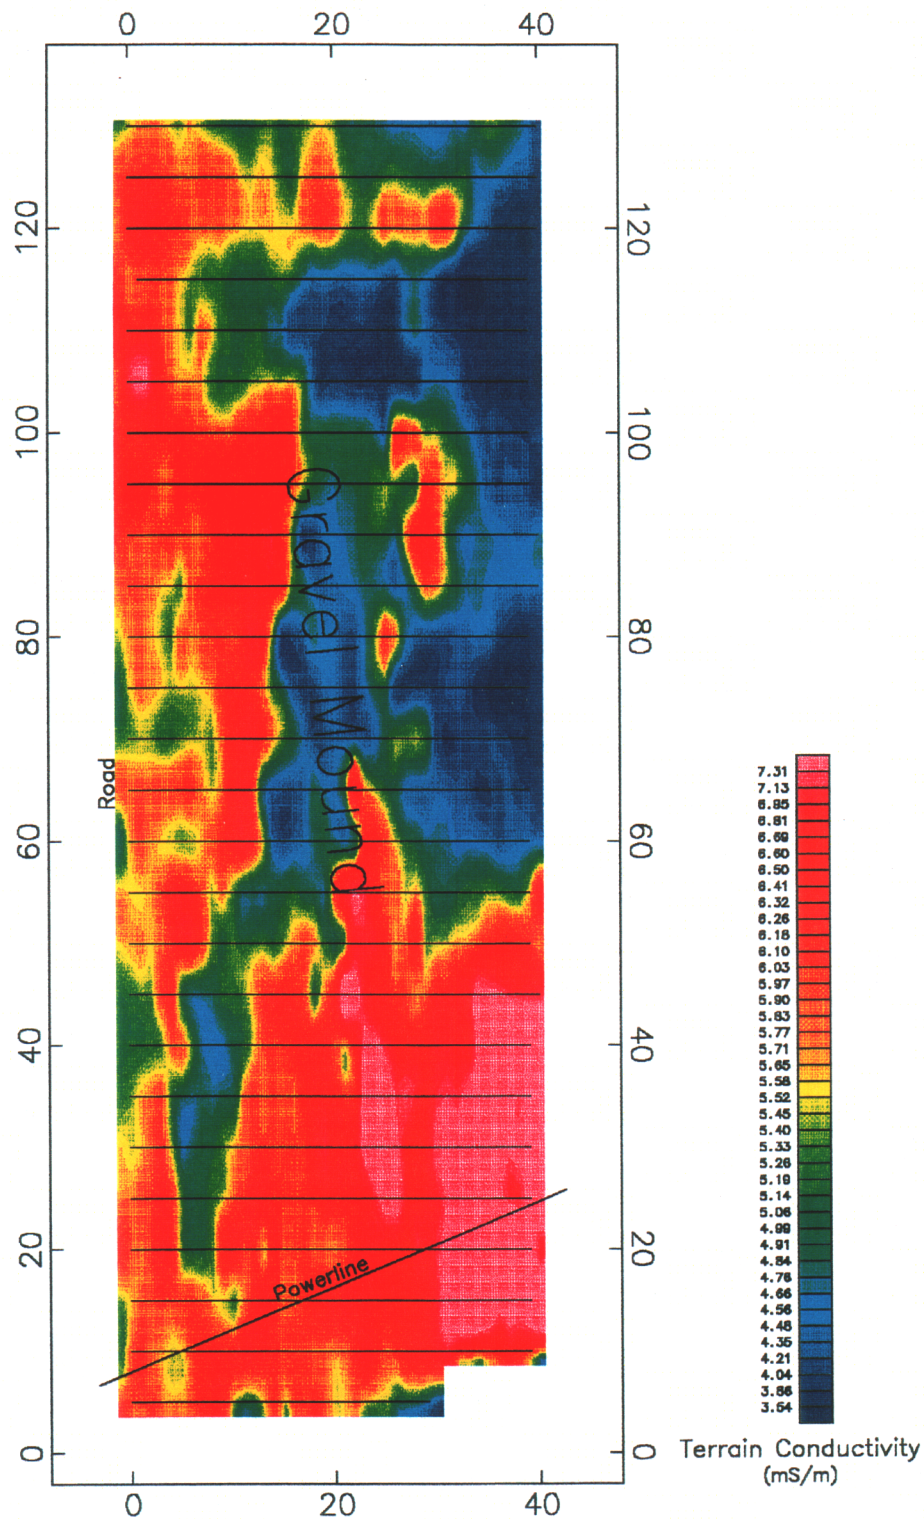
Figure 1b: Canyon Site MDA-1A
In-phase Component

Figure 1b represents the inphase component of the electromagnetic field measured over the site. As stated earlier, this is considered the "metal detecting" mode of the EM31. Similar to Figure 1a, a linear feature which is correlative to the mound is seen in the data, yet no major

anomalies are present. For comparison, the major metal anomaly found at Canyon Site 1A is shown in Figure 4b; note the scale on the right hand side of the Figures.

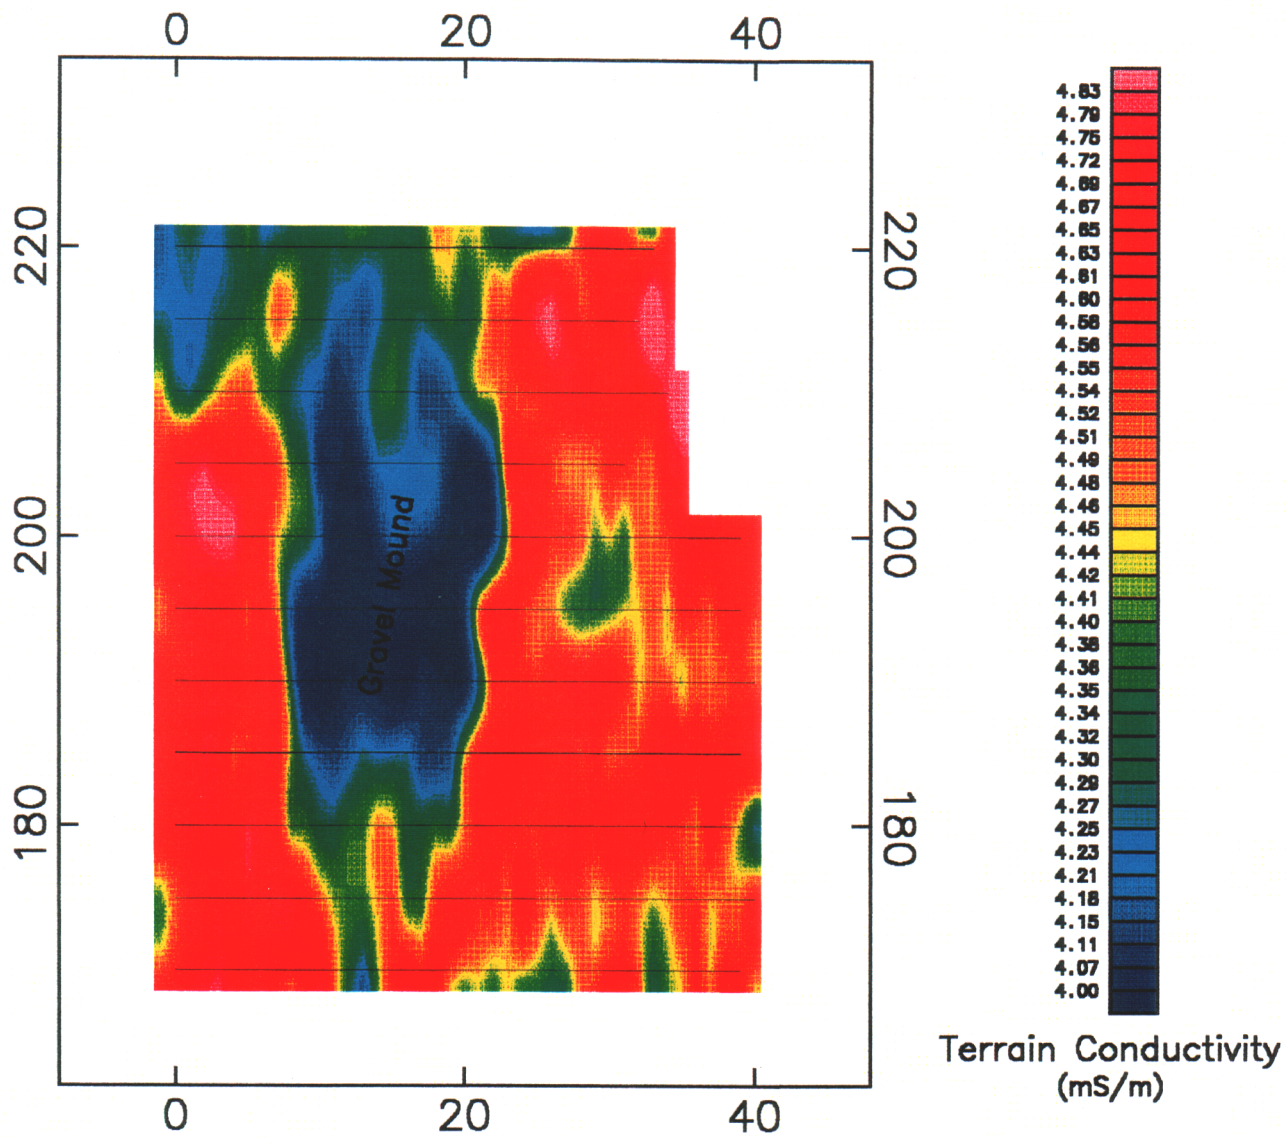
Figure 2a: Canyon Site MDA-1B
Terrain Conductivity

The terrain conductivity of Site MDA – 1B is shown in Figure 2a. In this Figure, the gravel mound which was the target of the survey is clearly visible. The mound shows as a low conductivity feature, with conductivities in the low 4 mS/m range, versus the surrounding alluvial silts and sands in the 4 to 5 mS/m range. This is a very subtle variation in terrain conductivity, and no metallic anomalies were interpreted at this site.

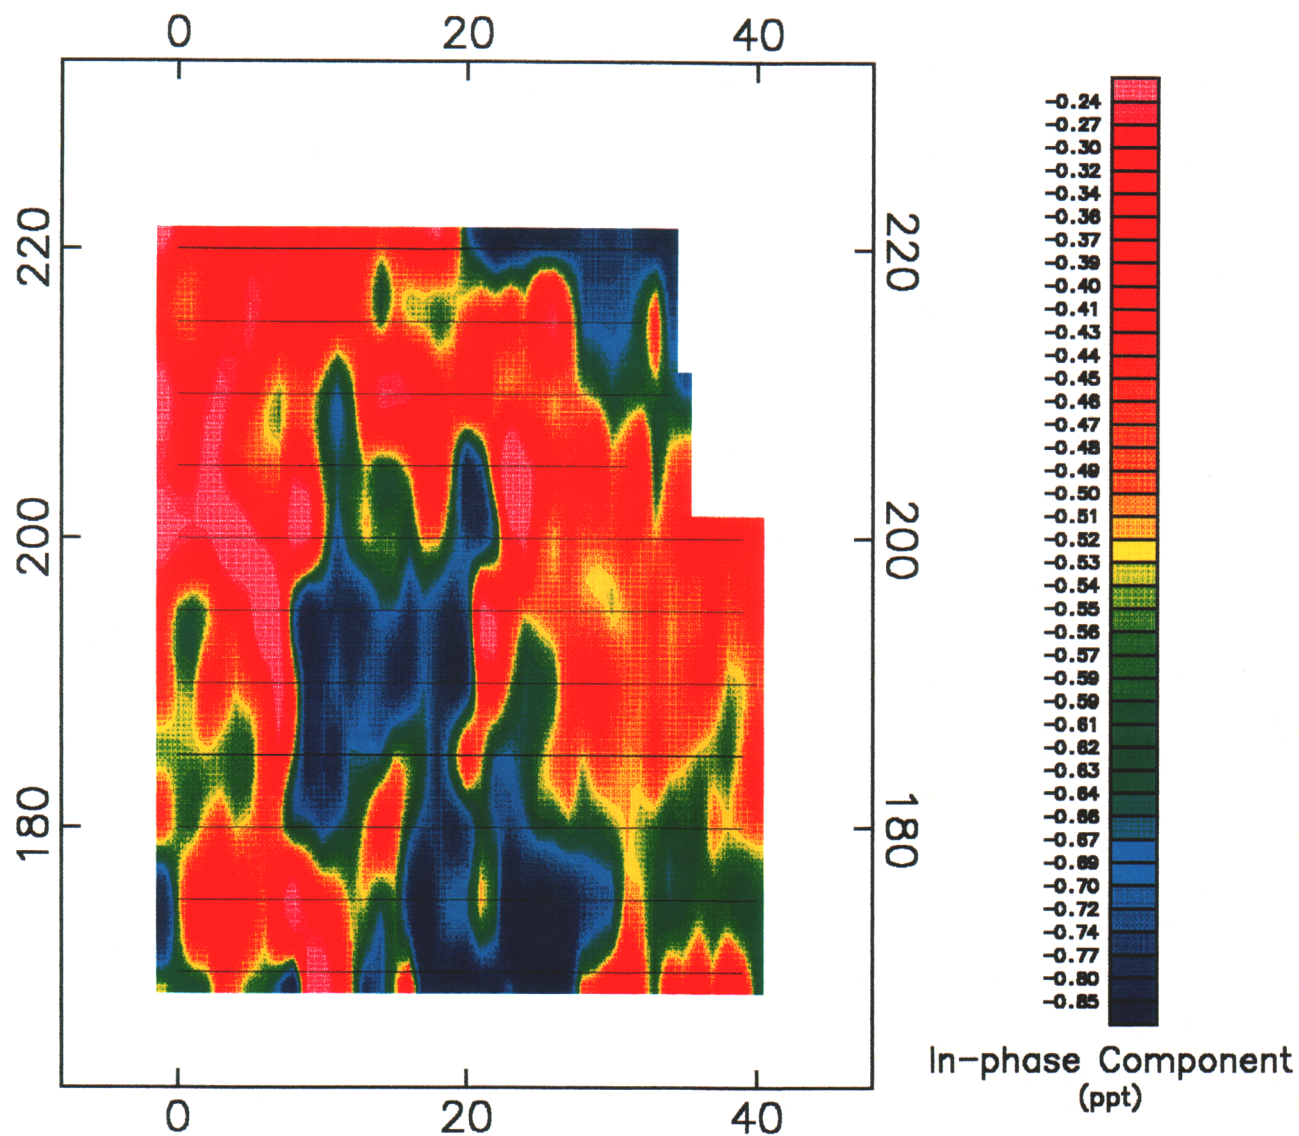
Figure 2b: Canyon Site MDA-1B
In-phase Component

The inphase component for this site is shown in Figure 2b. The data is variable, and shows no major trends, nor significant anomalies that would indicate the presence of buried metal.

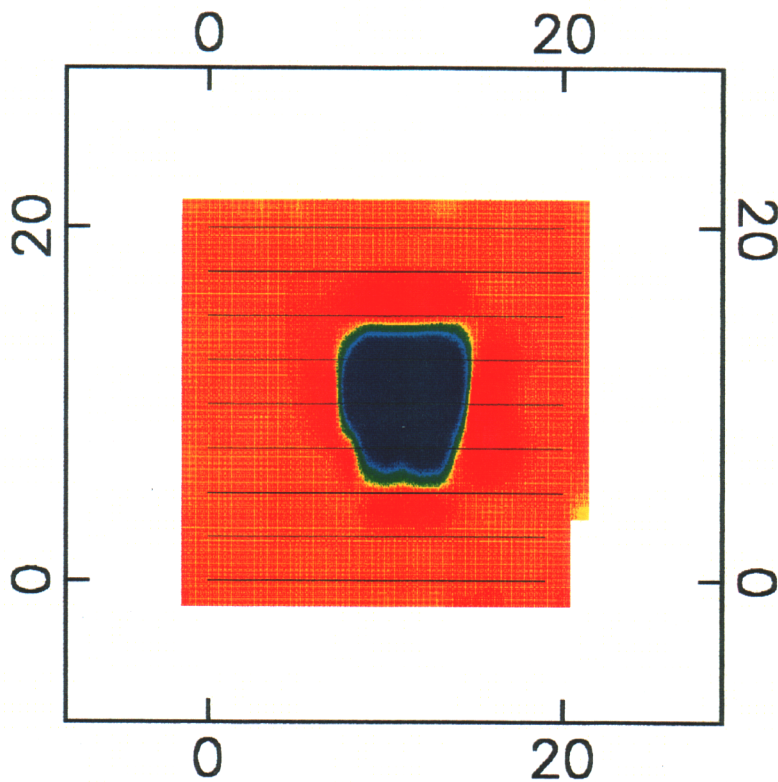
Figure 4a: Canyon Site 1A
Terrain Conductivity

The results of the small terrain conductivity survey conducted at Site 1A are shown in Figure 4a. The obvious negative conductivity in the centre of the survey represents a significant geophysical anomaly. Background values in the 2.5 mS/m range, which is low due to the very dry, well sorted sands, but still clearly distinguishable from the anomaly. The anomaly is characterized by high conductivity “shoulders” on the edges, and a negative conductivity centre. The high shoulder – negative centre type anomaly is typical of that created by a laterally small metallic object. The negative conductivity core is an effect due to the geometry and design of the EM31 Terrain Conductivity Meter.
