**ABANDONED CLINTON CREEK ASBESTOS MINE
ENVIRONMENTAL LIABILITY REPORT**

DRAFT
Prepared for:
Indian and Northern Affairs Canada

Prepared by:
UMA Engineering Ltd.
1479 Buffalo Place
Winnipeg, Manitoba, R3T 1L7

May 2002

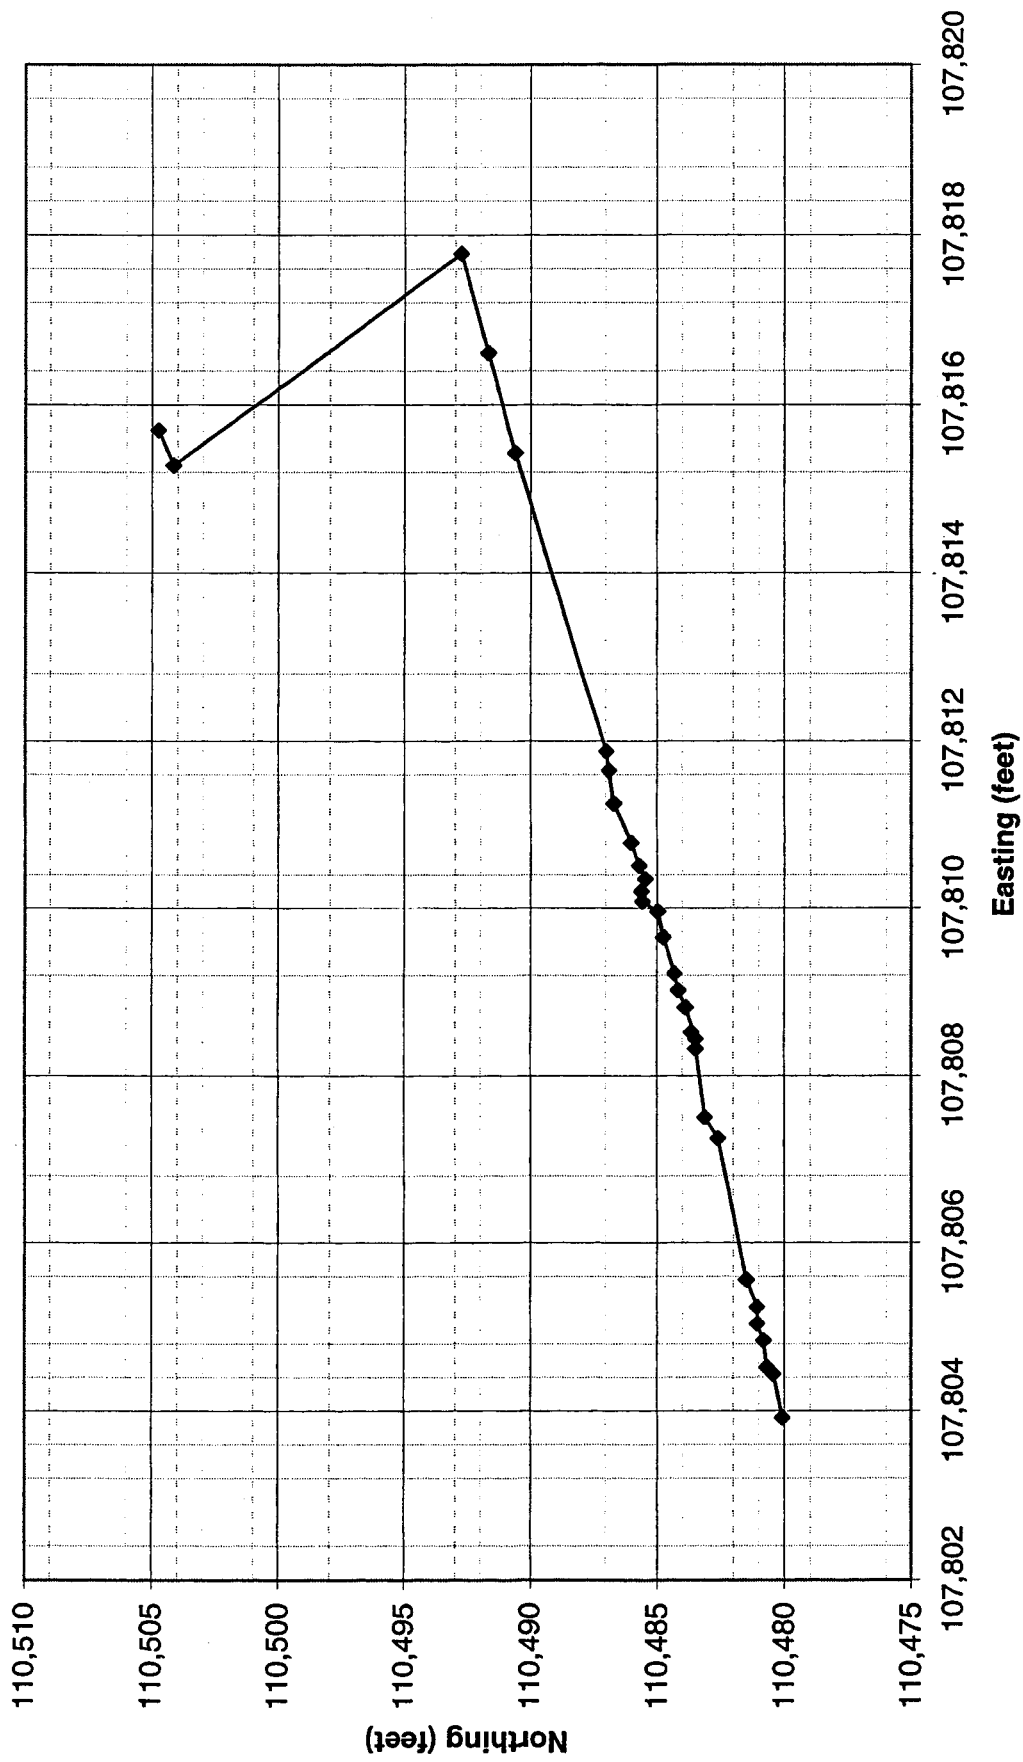
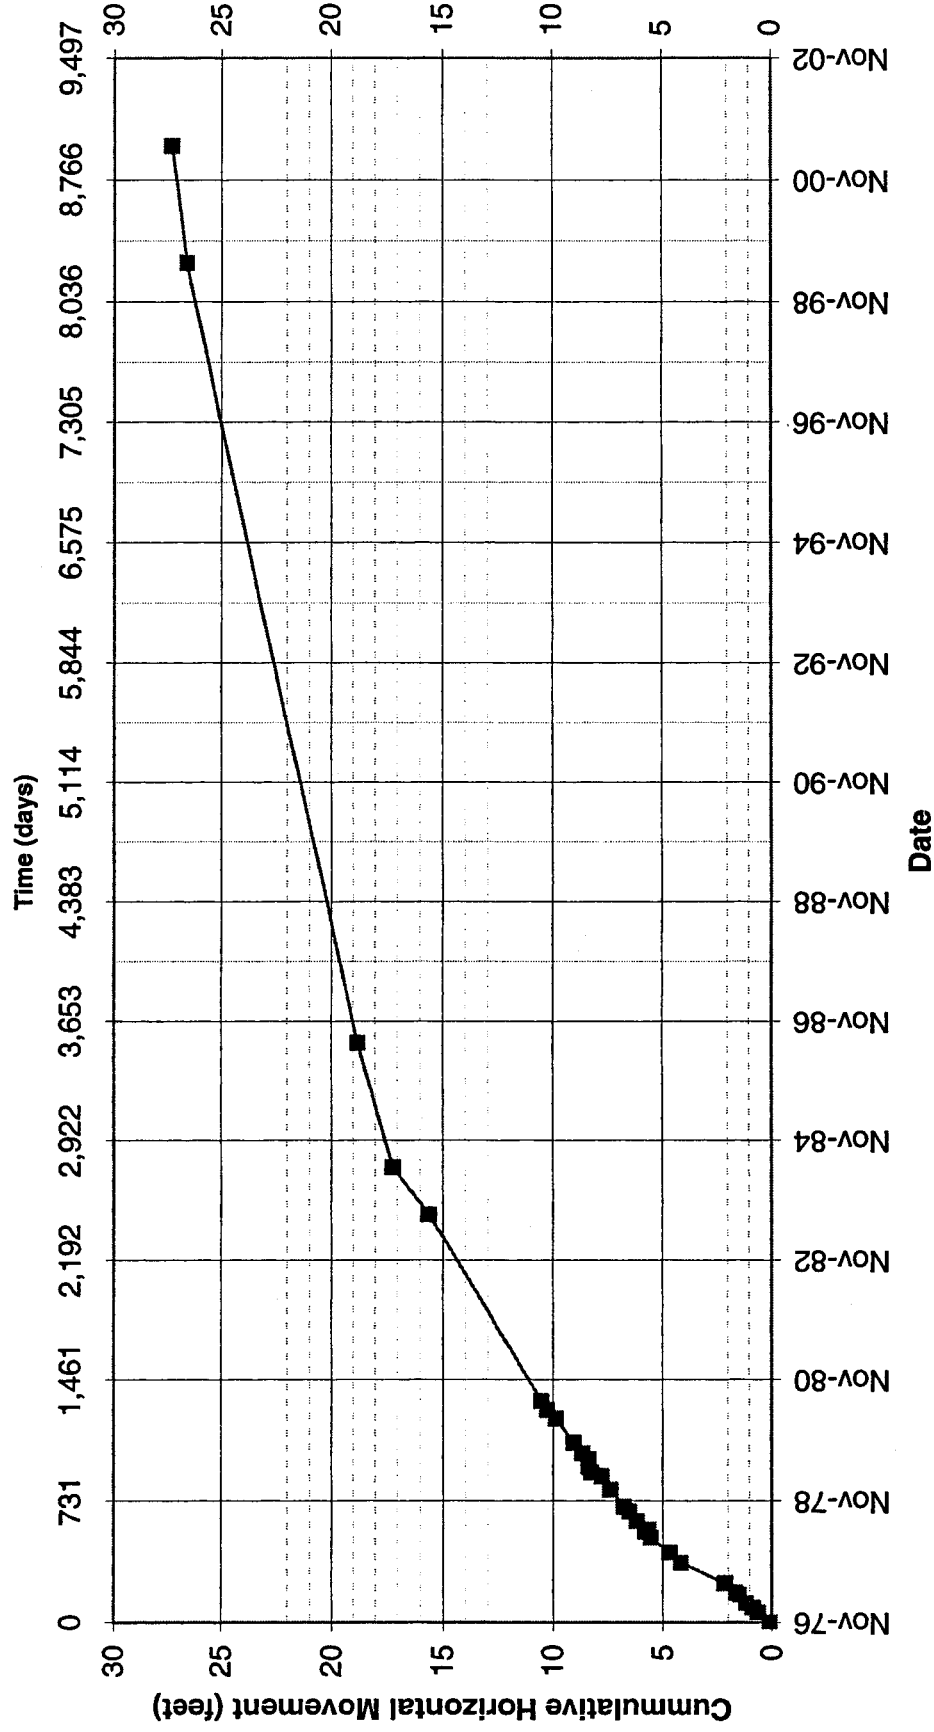
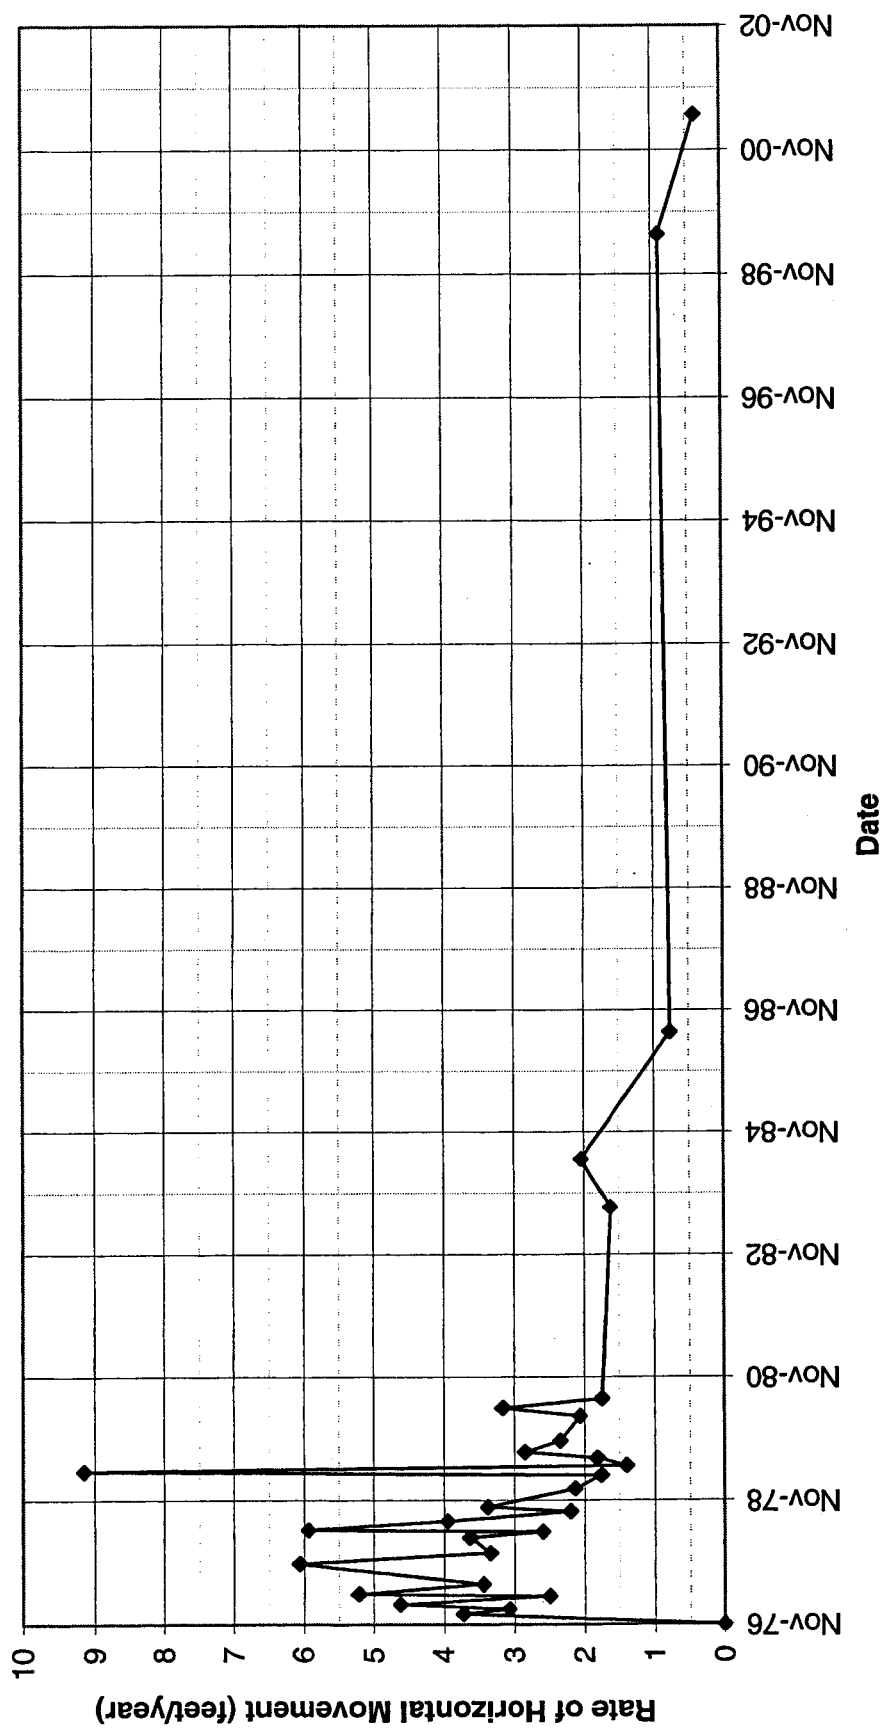
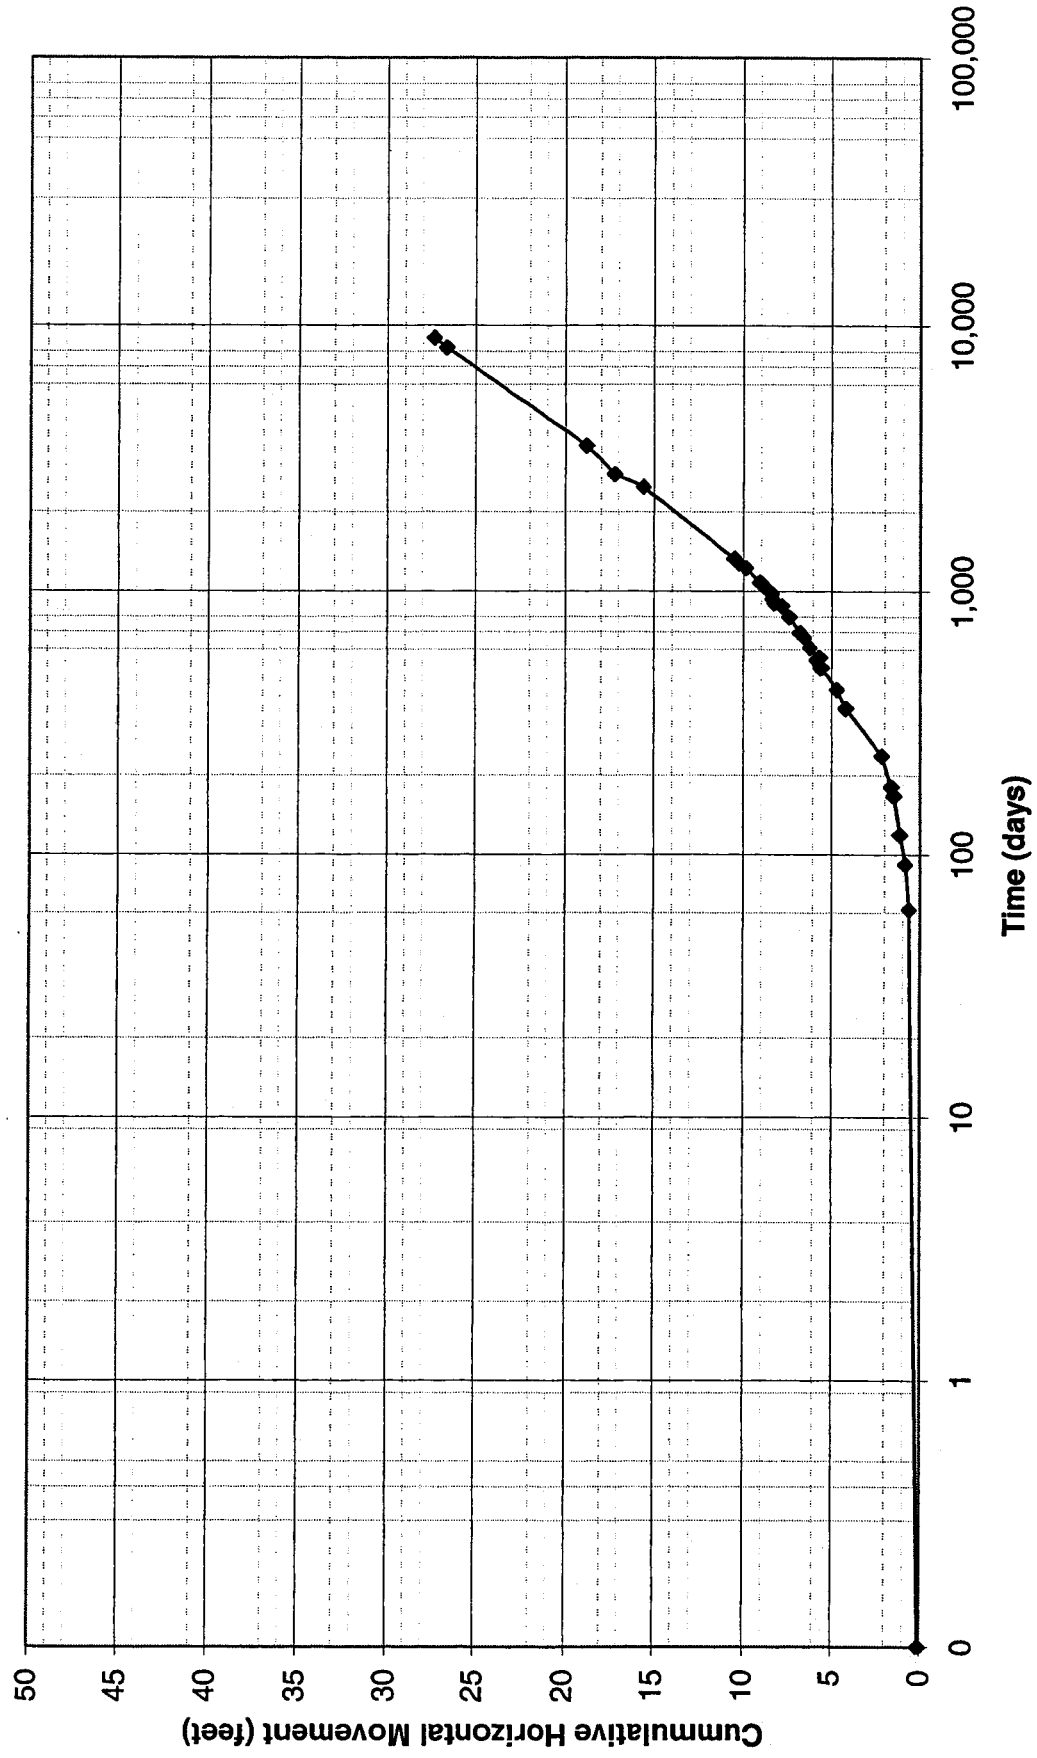
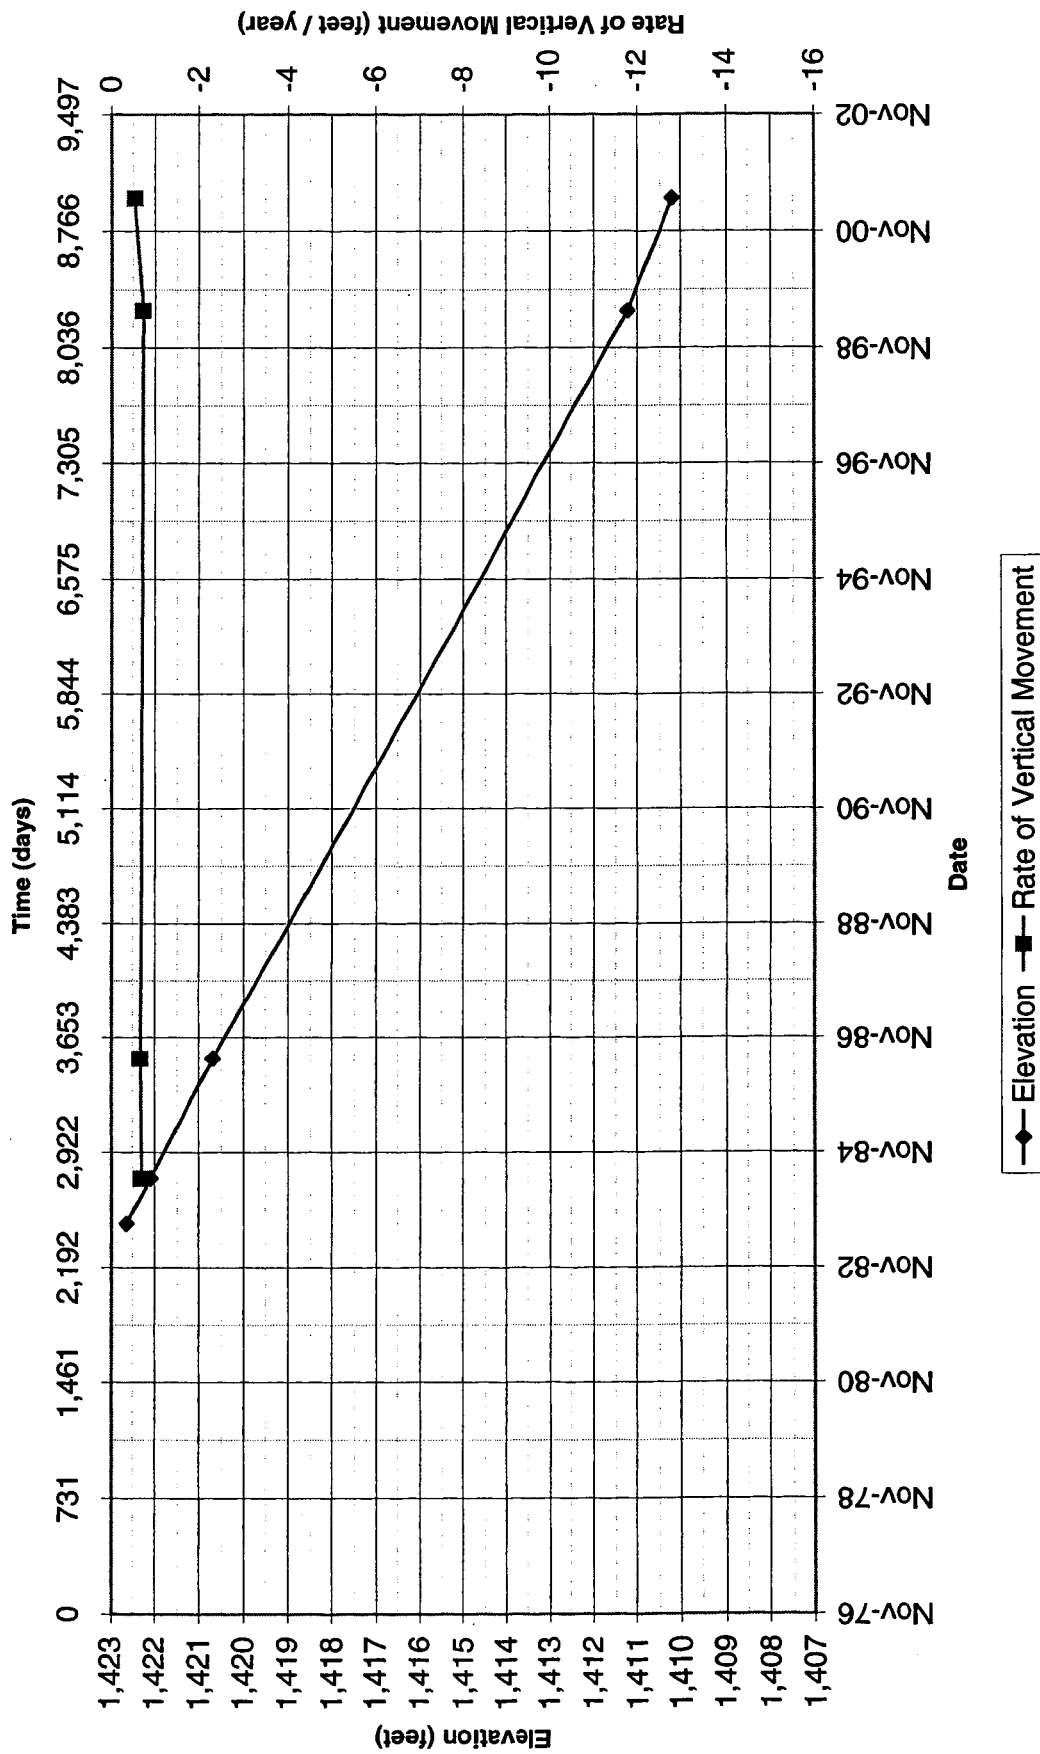
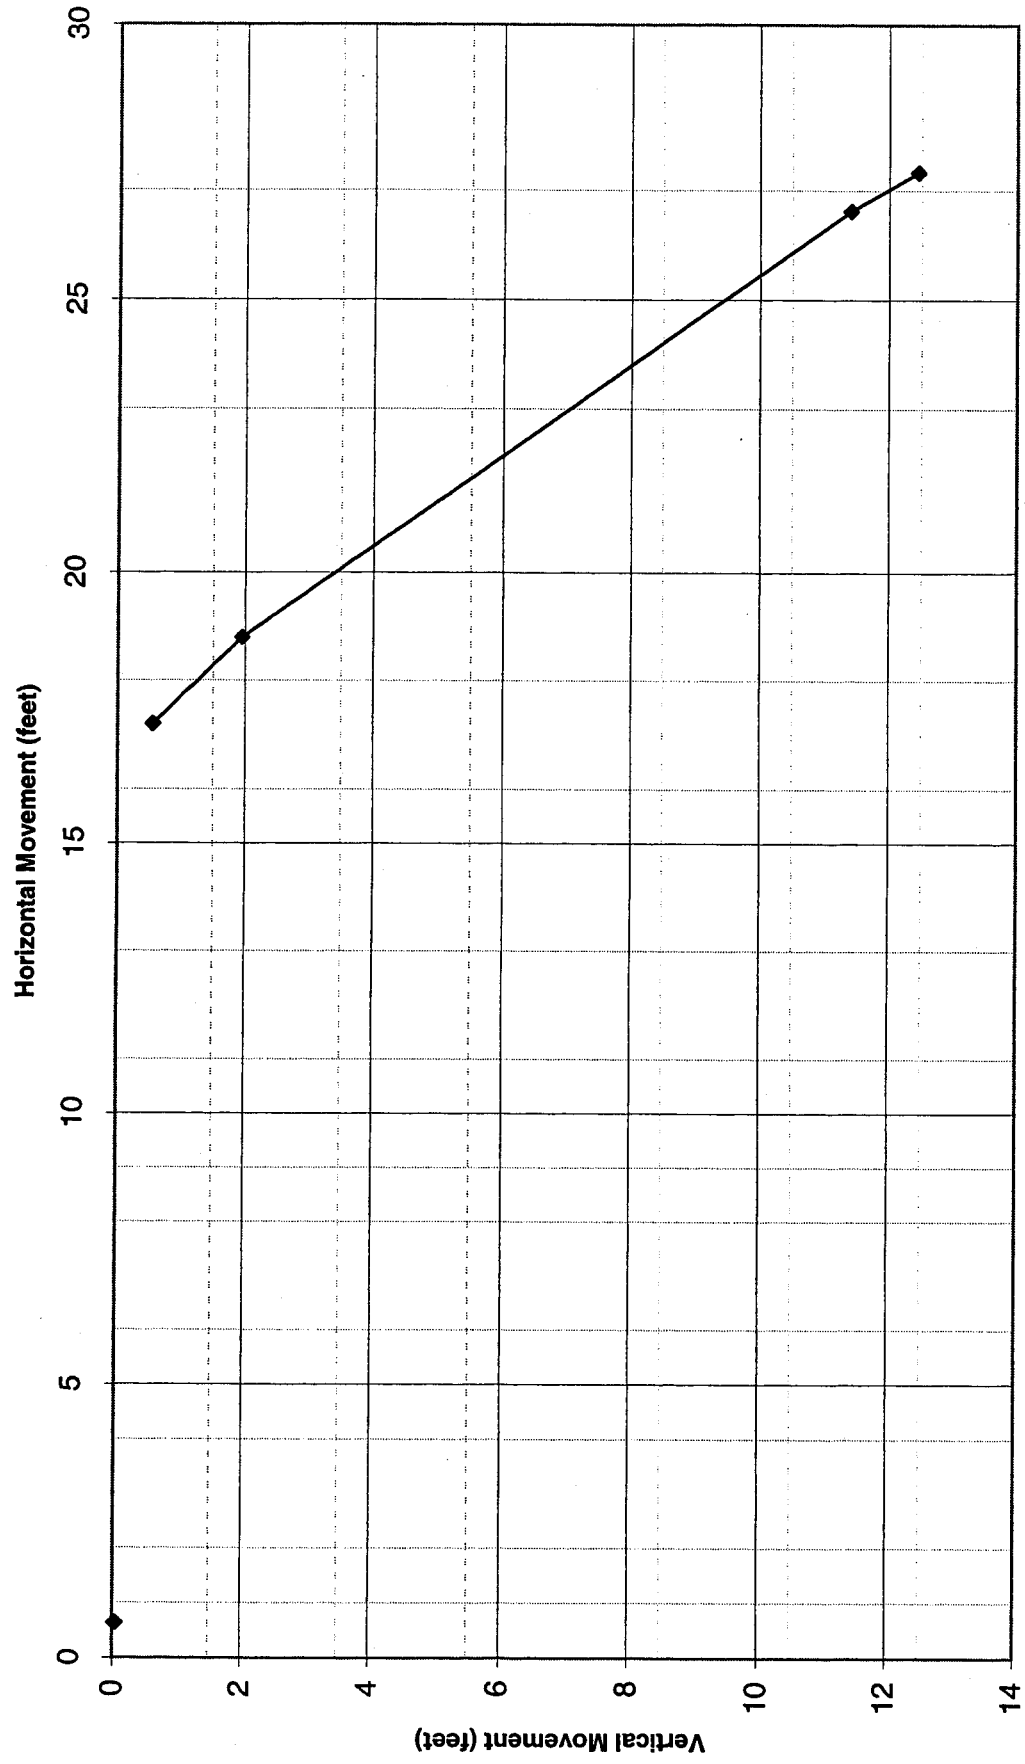
DIAND: Clinton Creek Asbestos Mine Waste Rock Monitoring Monument #19

Waste Dump Stability - Monitoring Point #19
 Notes: Assume all elevations represent top of monitoring point, not ground surface.
 June 2001 survey) monitor point elevation = ground elev + monitor rod ht.

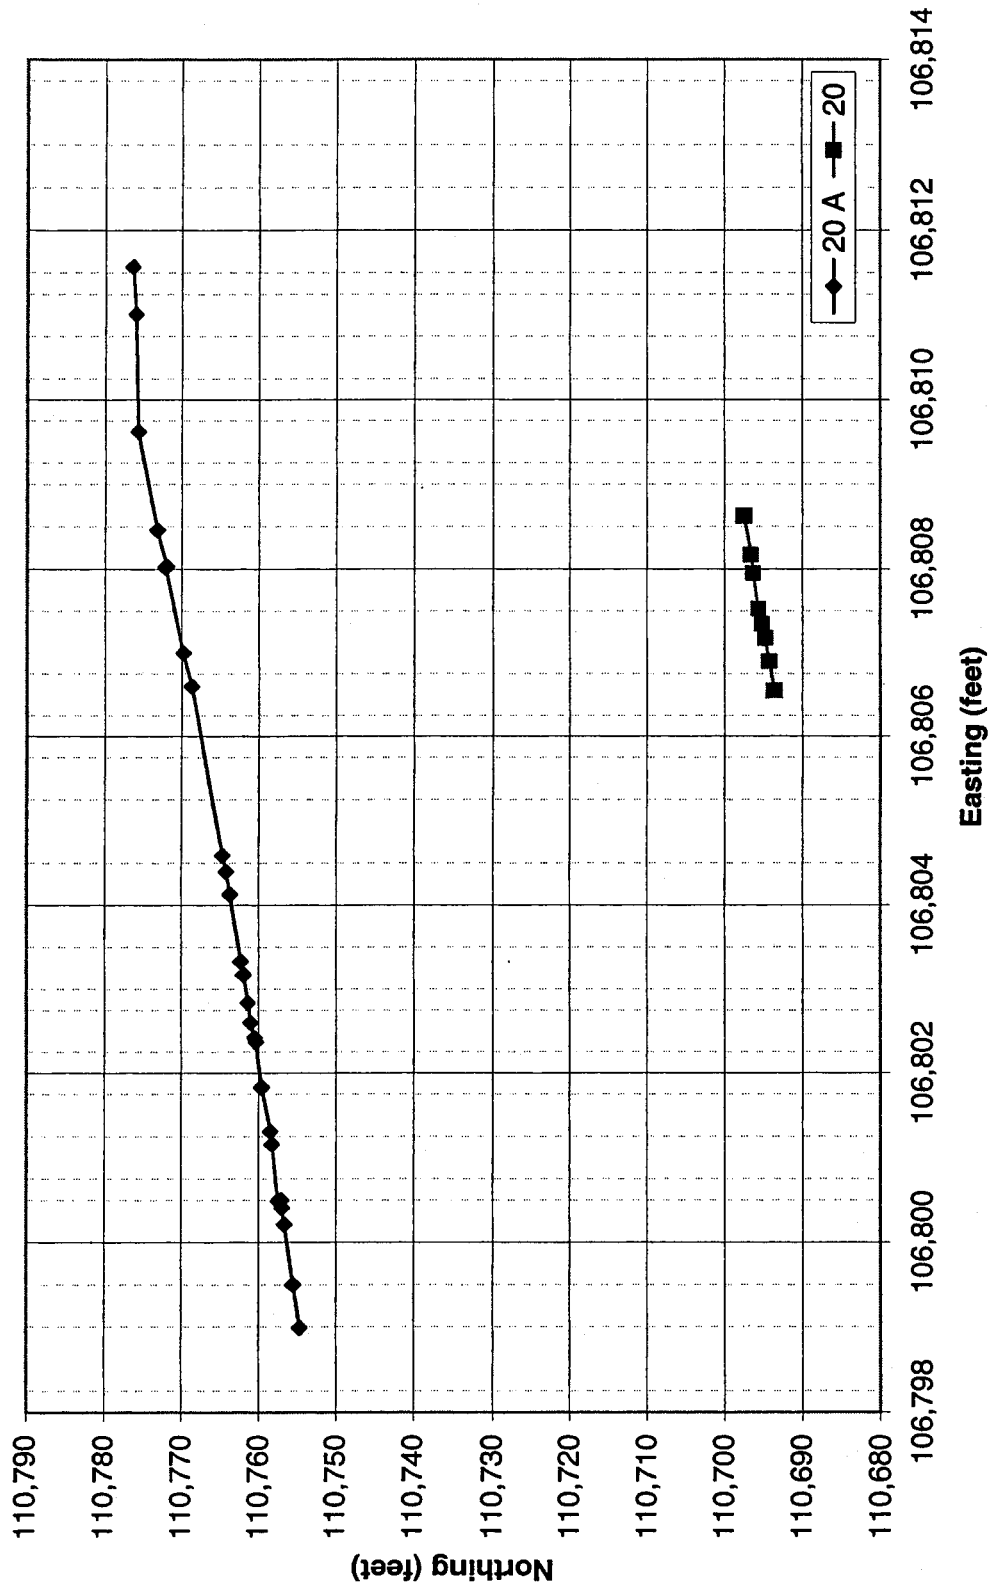
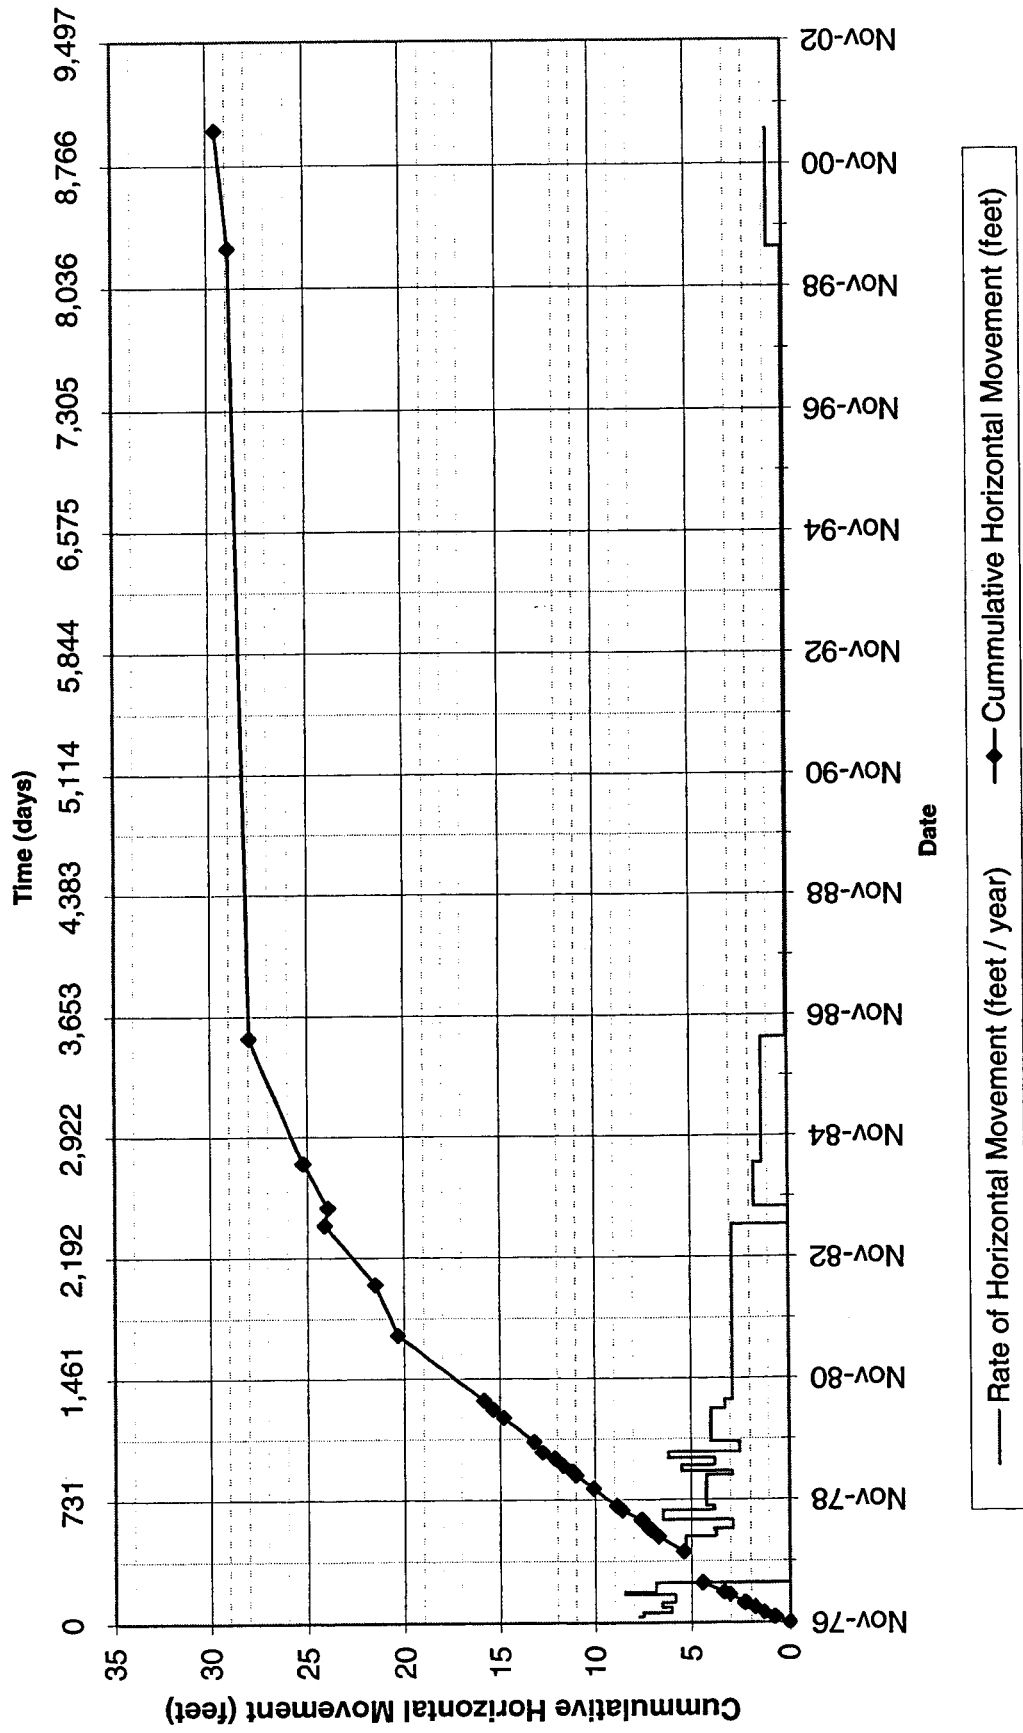
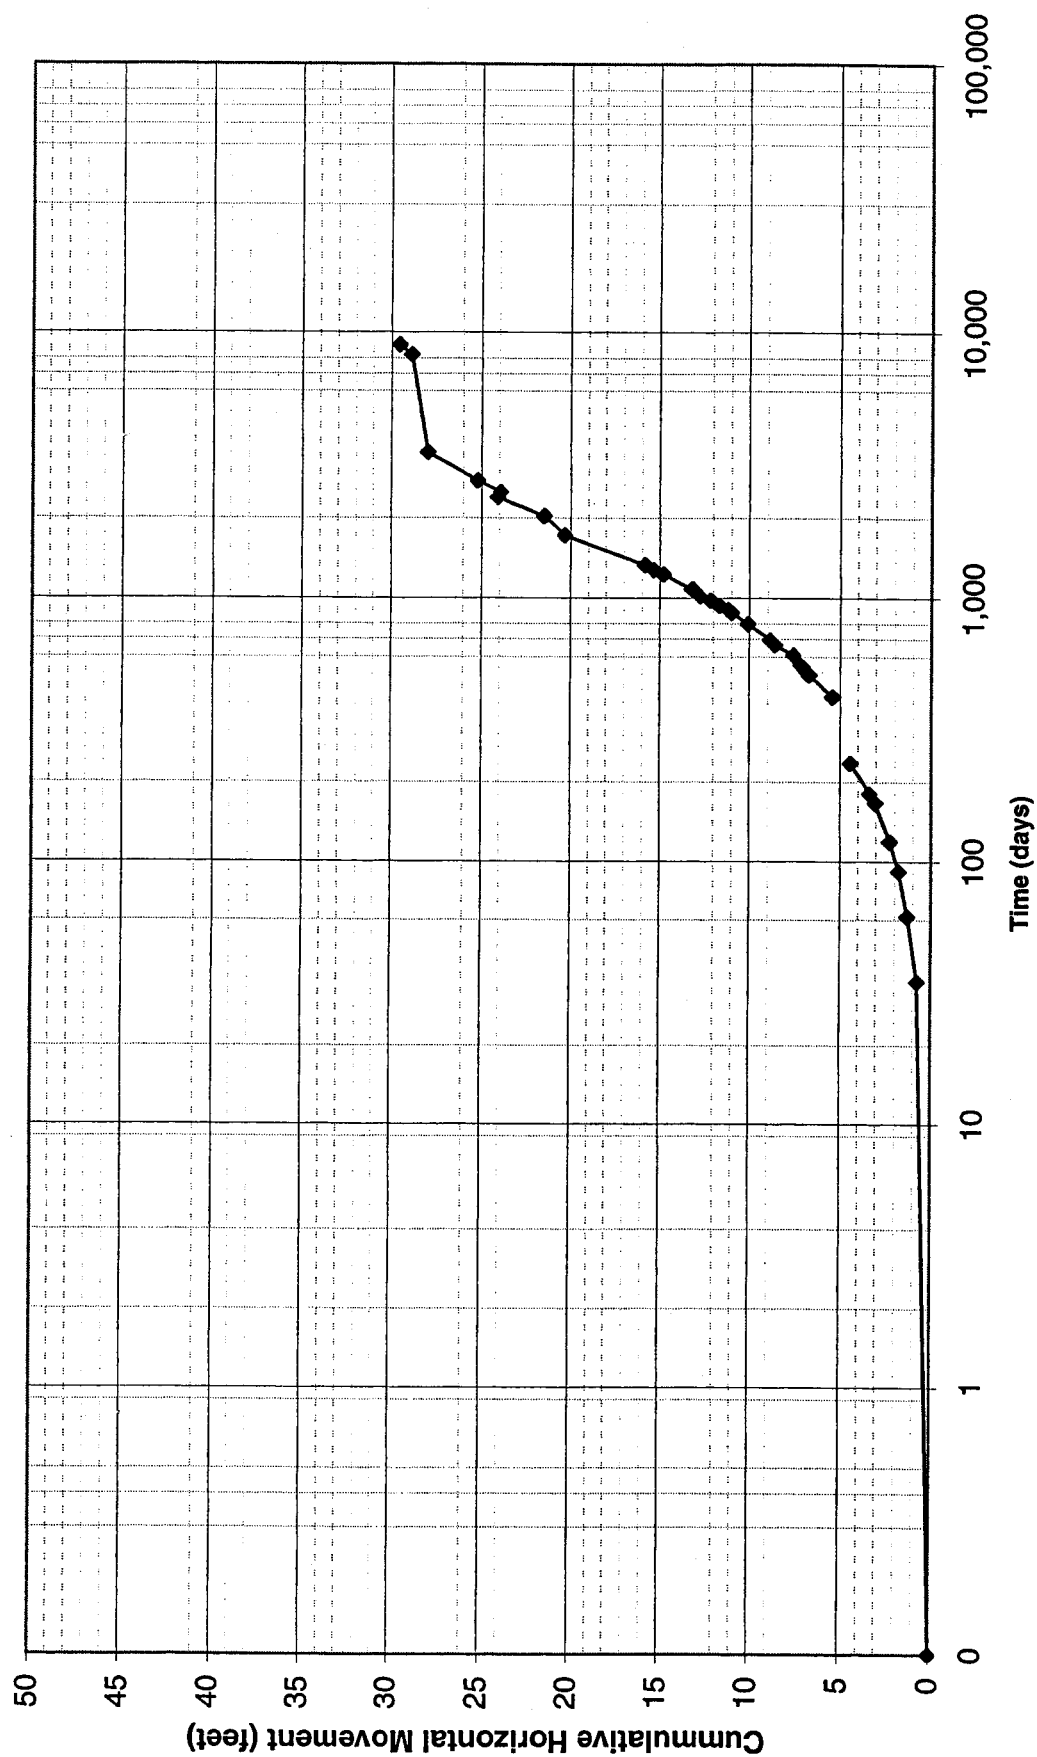
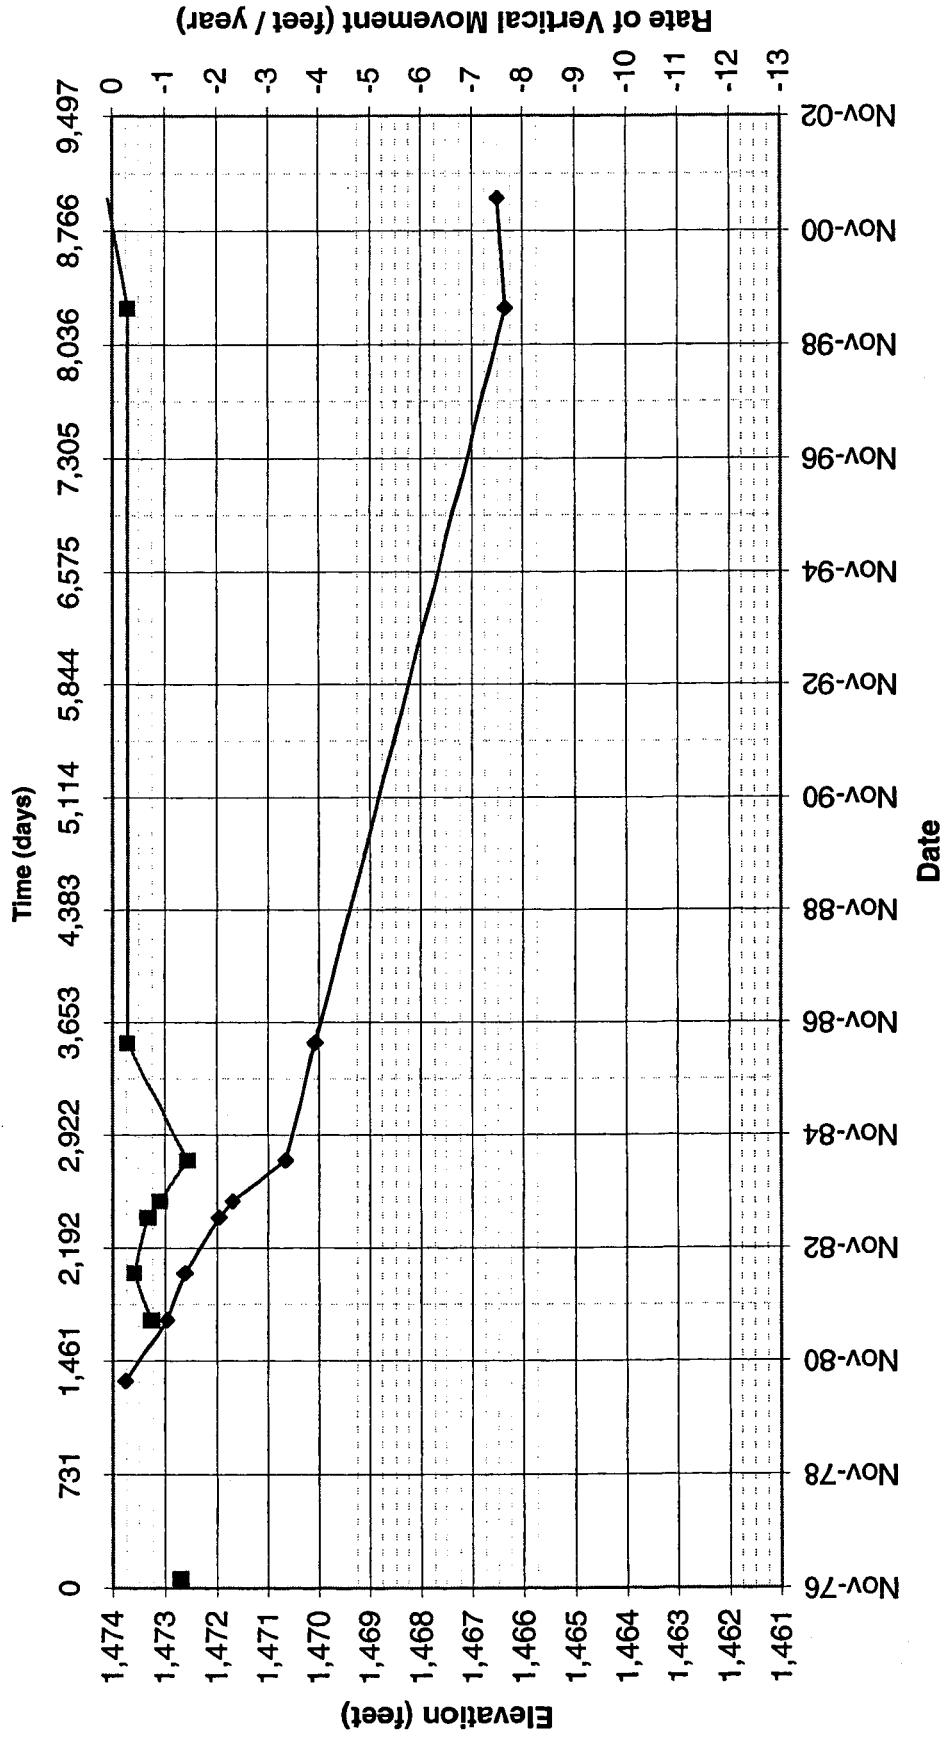
DIAND: Clinton Creek Asbestos Mine
Waste Rock Monitoring Monument #20 & 20A

Waste Dump Stability - Monitoring Point #20A
