**ABANDONED CLINTON CREEK ASBESTOS MINE
ENVIRONMENTAL LIABILITY REPORT**

DRAFT
Prepared for:
Indian and Northern Affairs Canada

Prepared by:
UMA Engineering Ltd.
1479 Buffalo Place
Winnipeg, Manitoba, R3T 1L7

May 2002

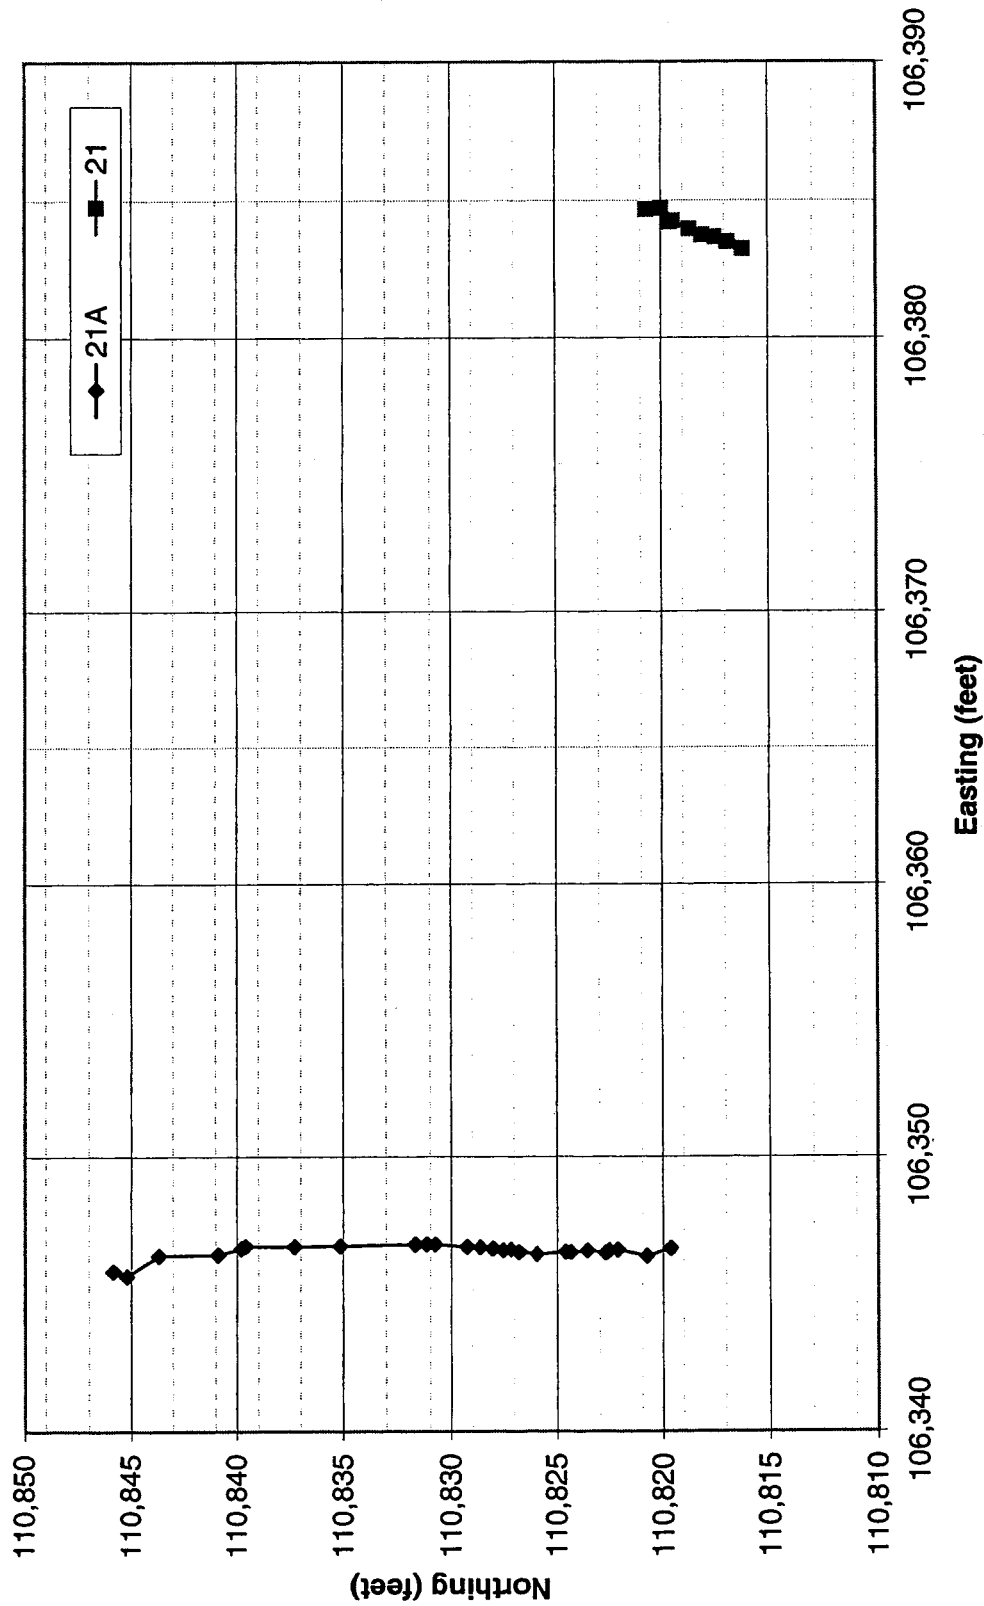
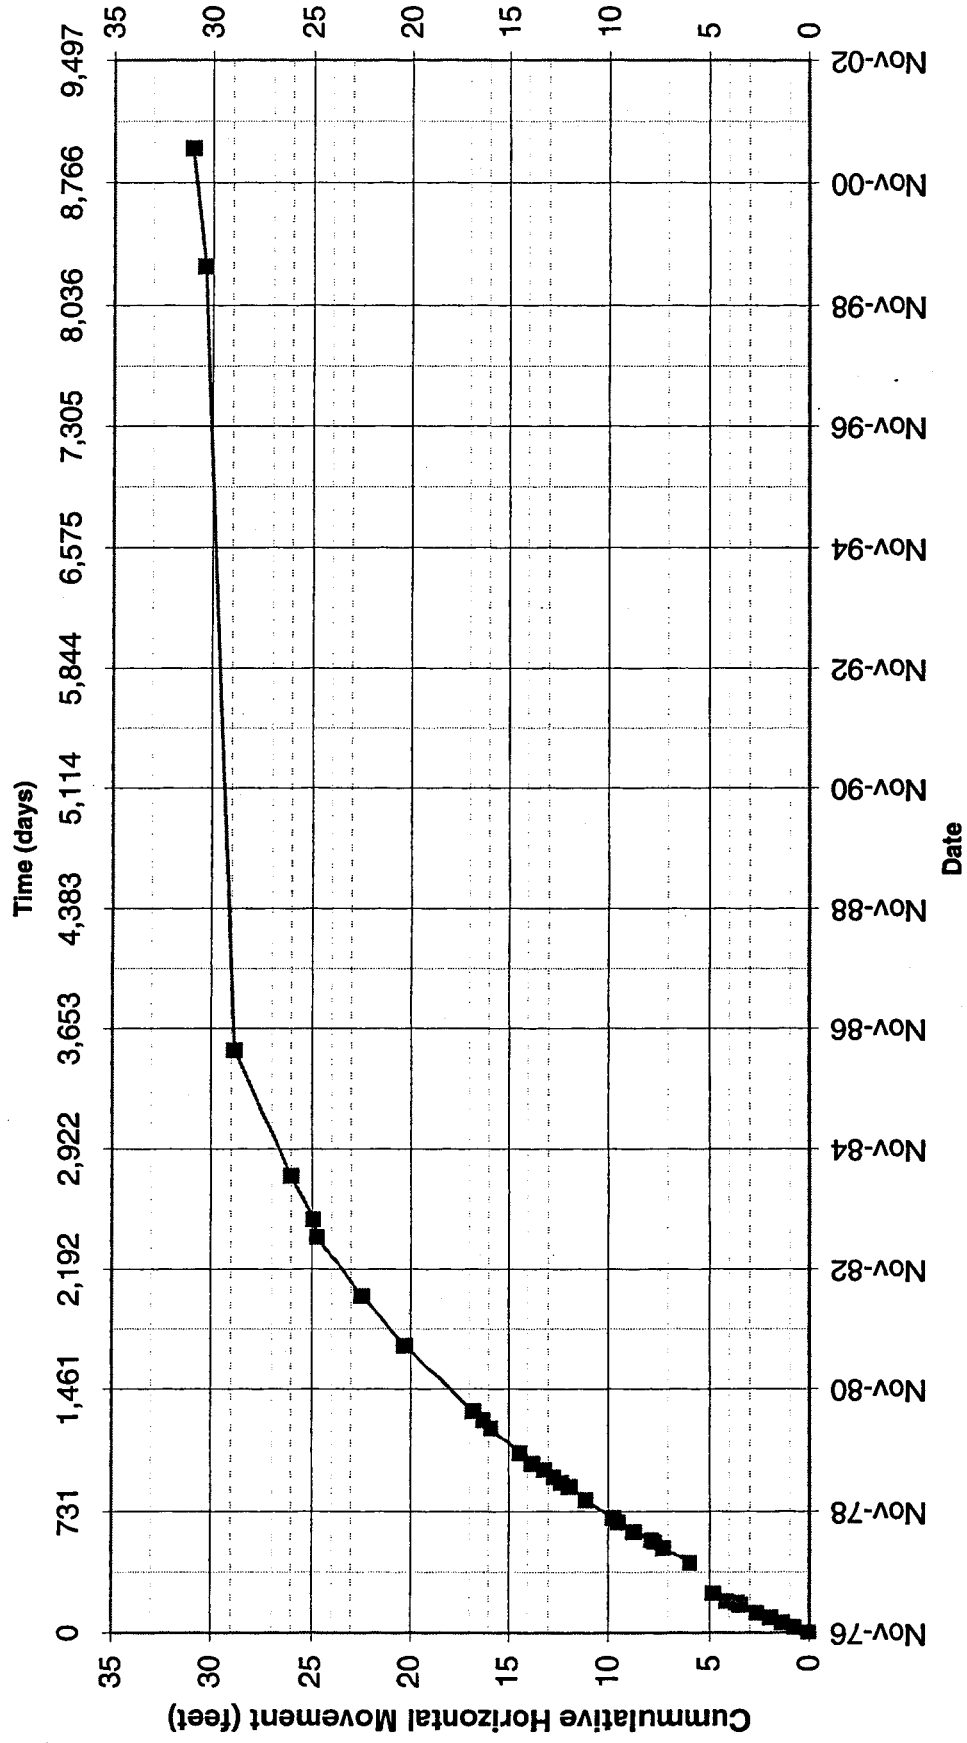
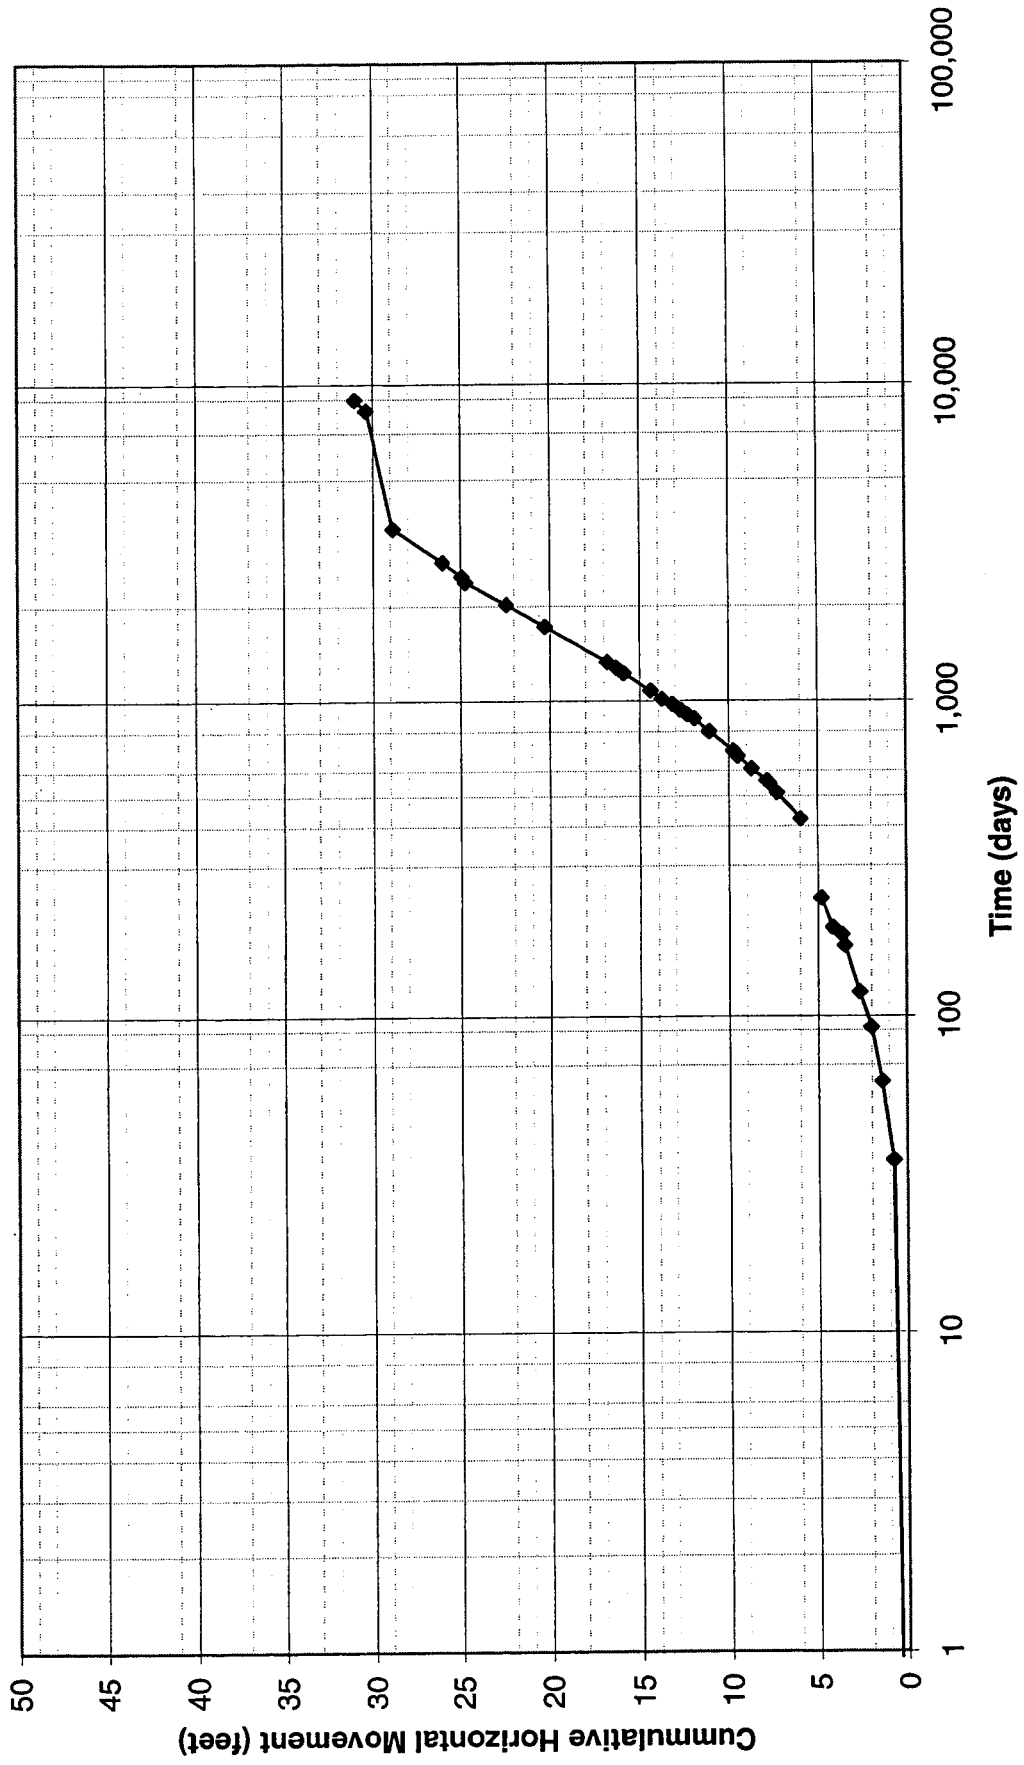
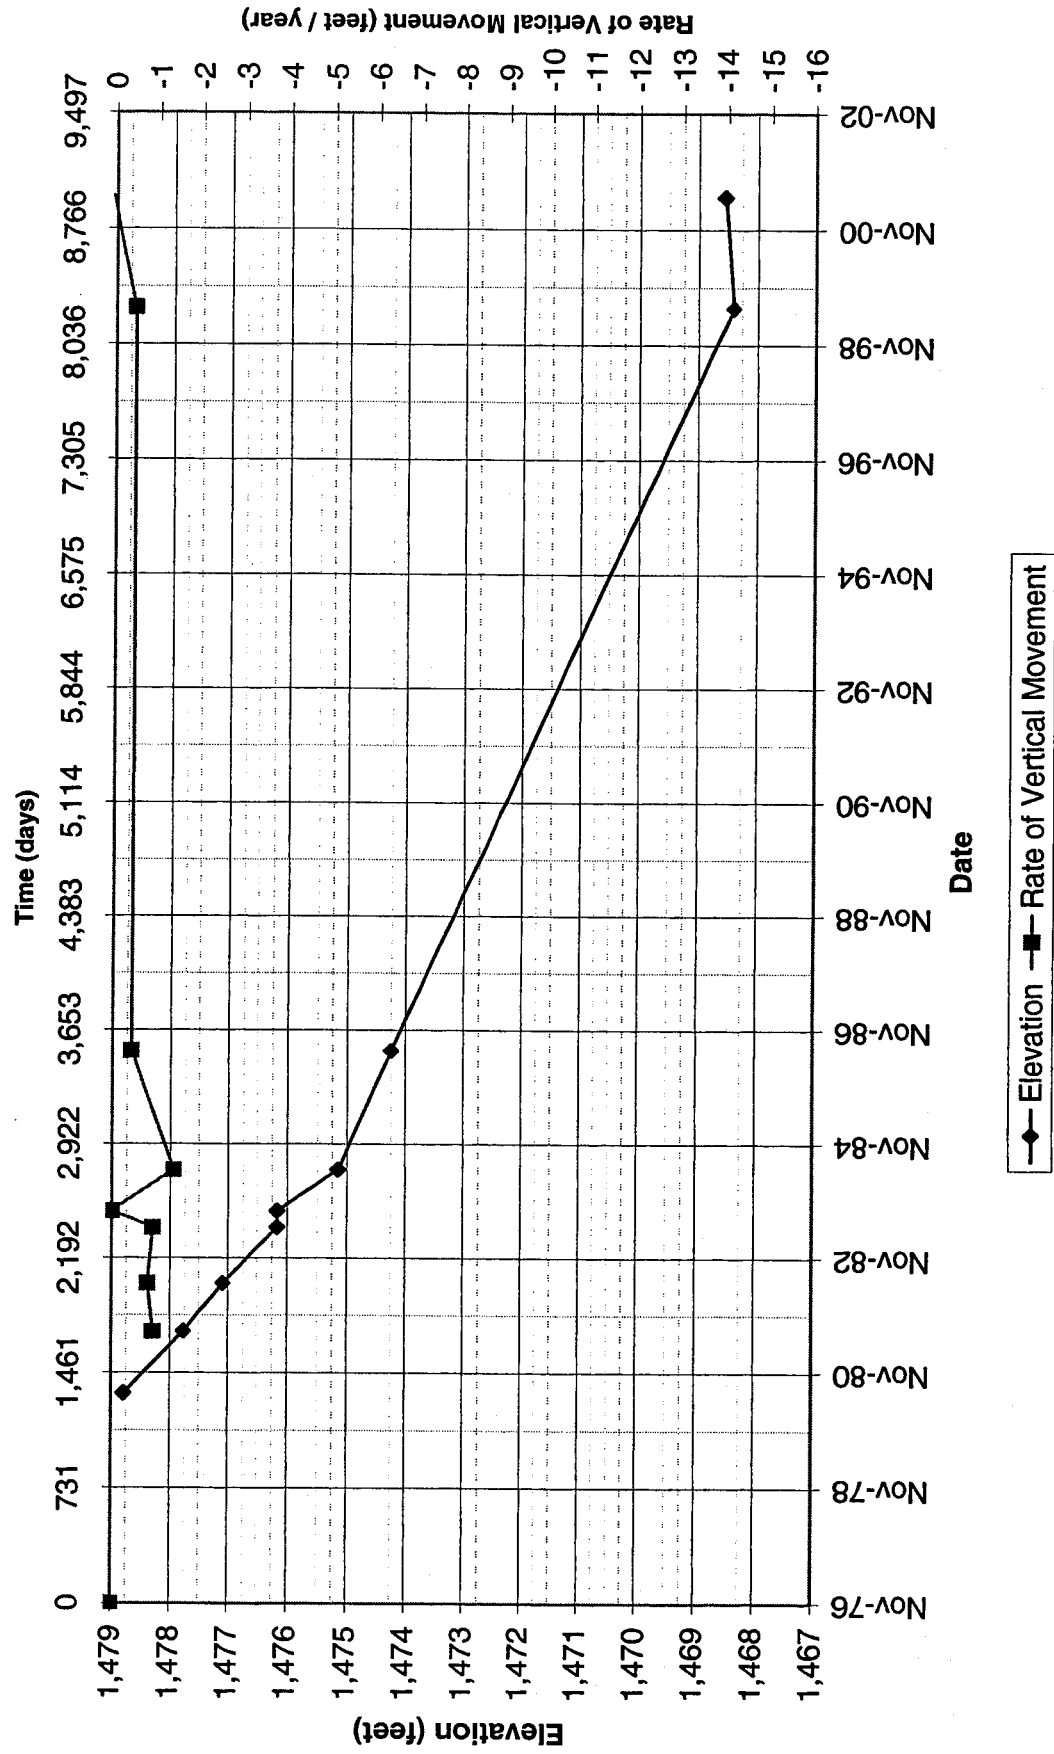
DIAND: Clinton Creek Asbestos Mine Waste Rock Monitoring Monuments #21 & 21A

Waste Dump Stability - Monitoring Points #21 & 21A

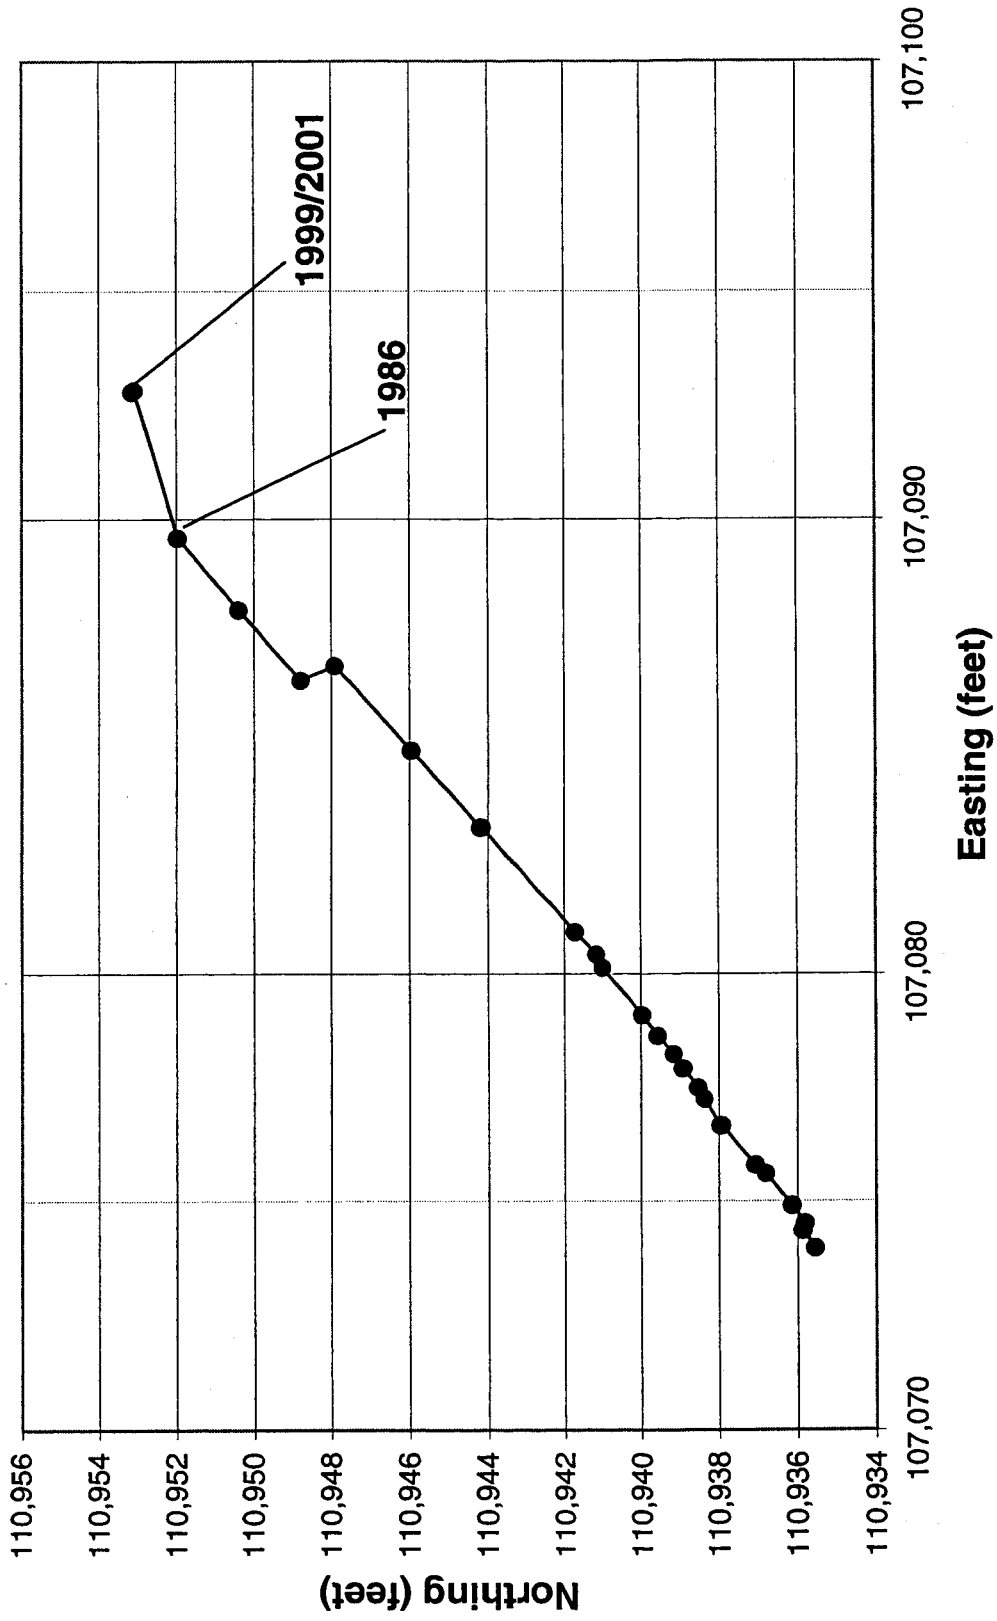
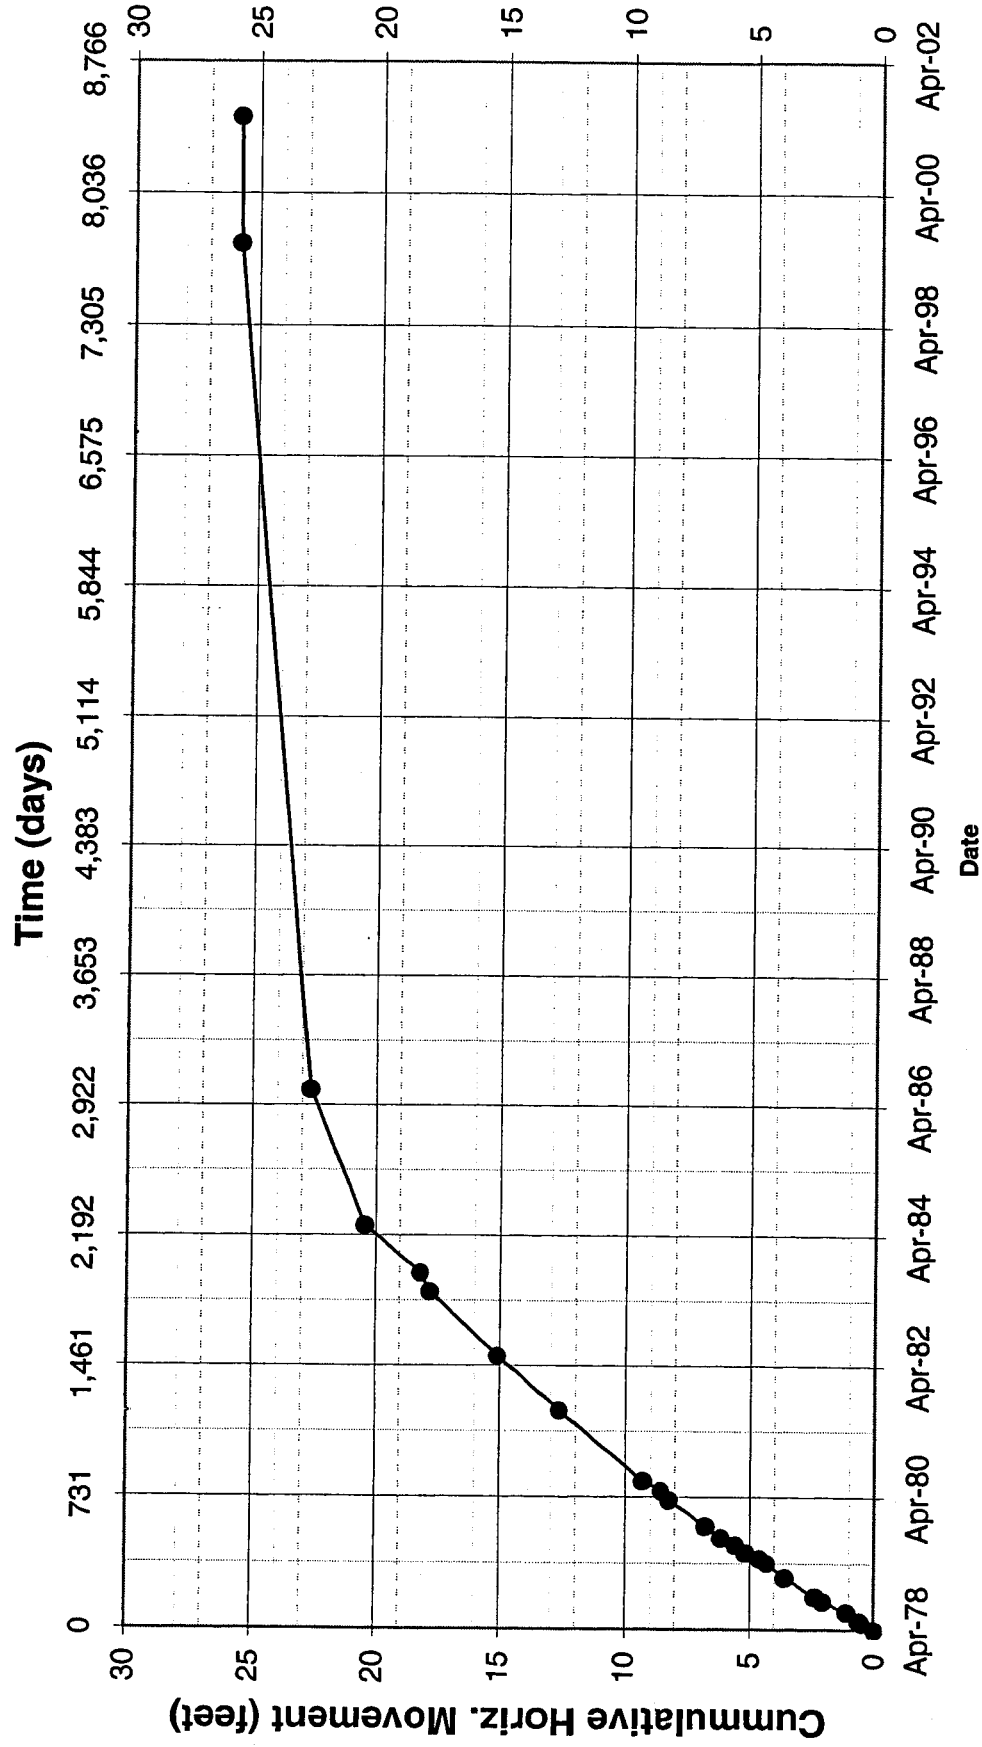
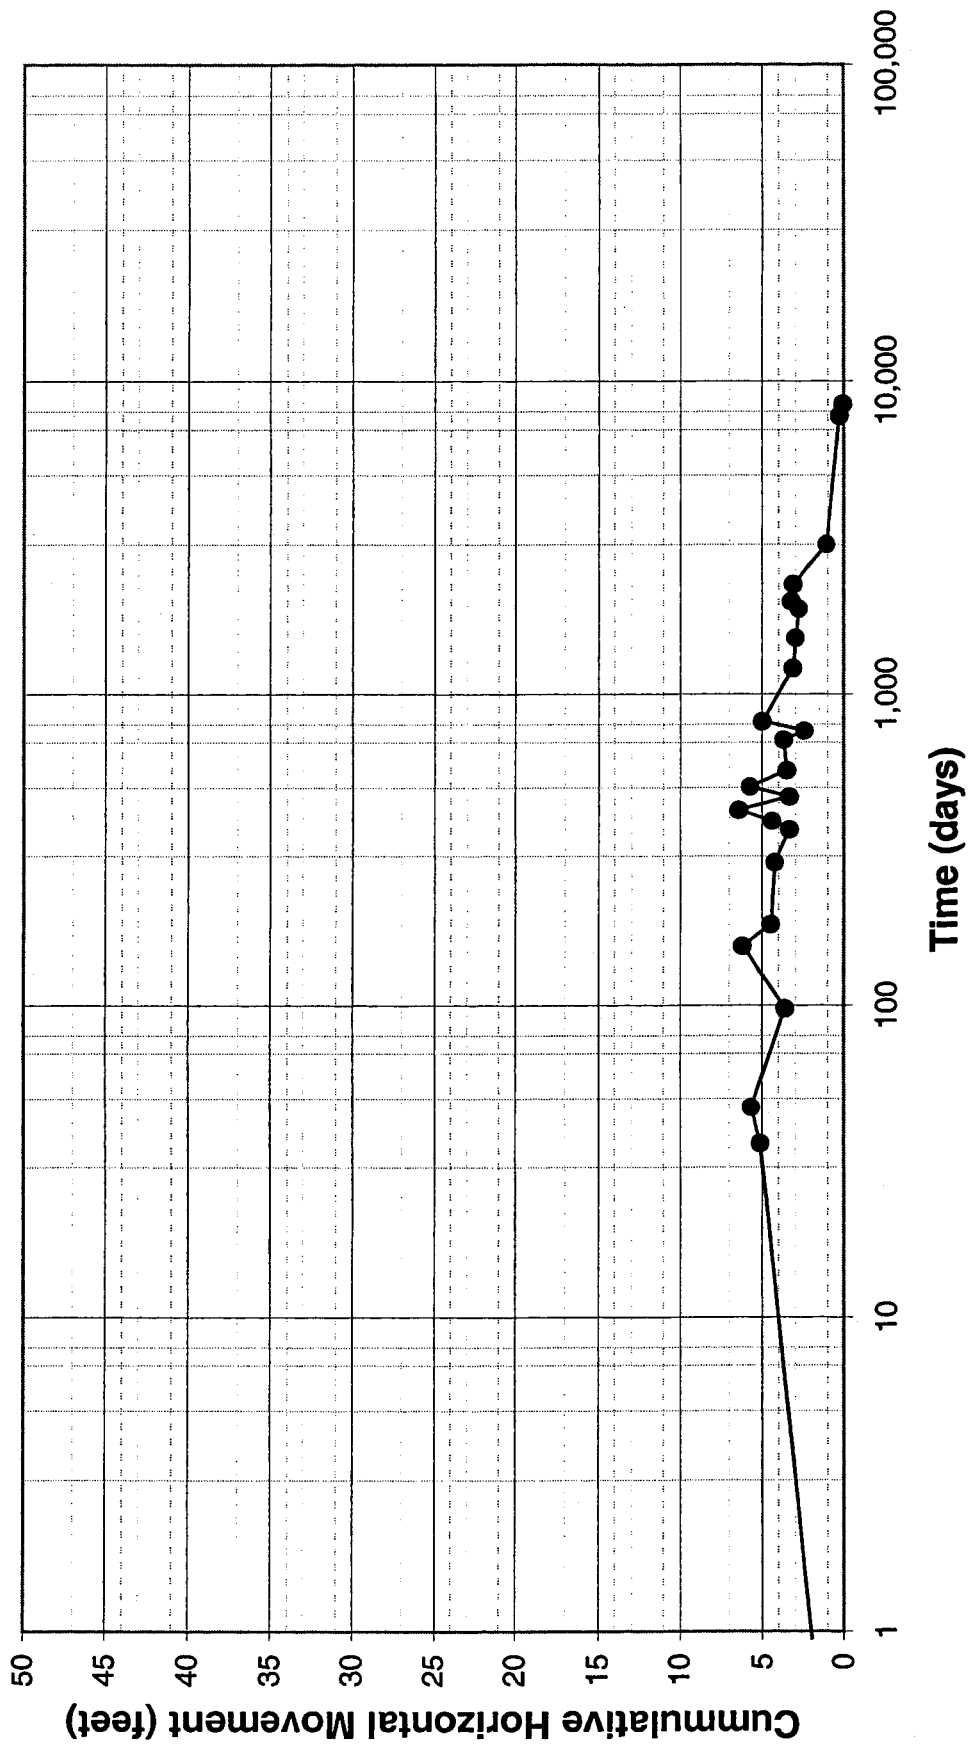
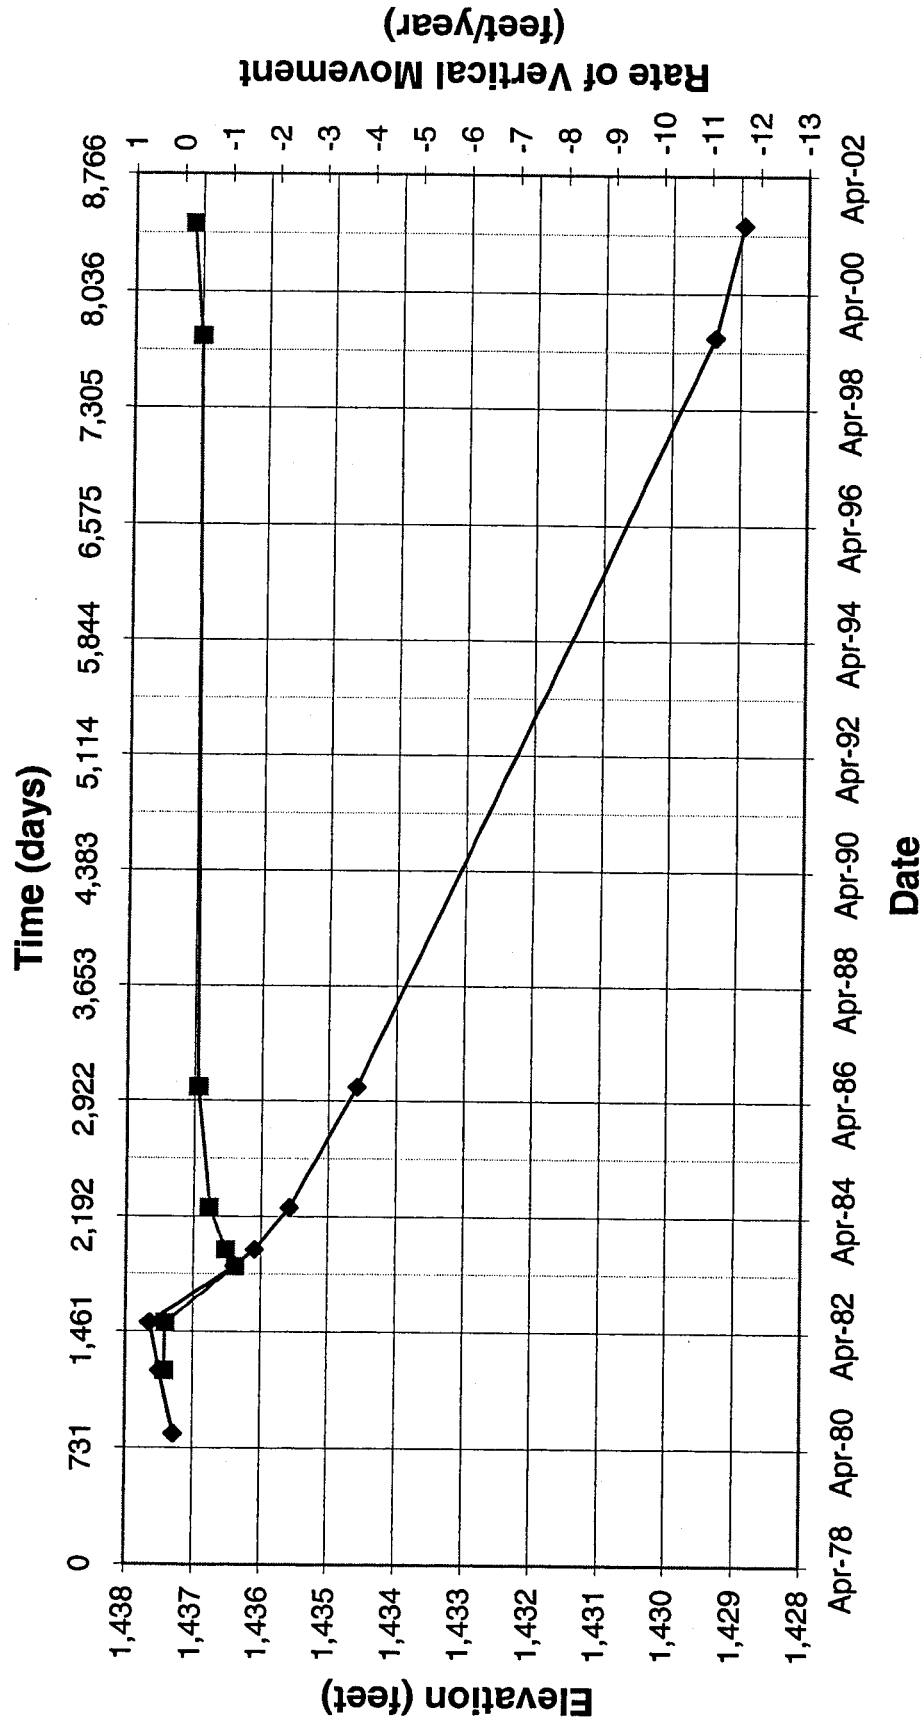
DIAND: Clinton Creek Asbestos Mine
Waste Rock Monitoring Monument #68

Waste Dump Stability - Monitoring Point #68

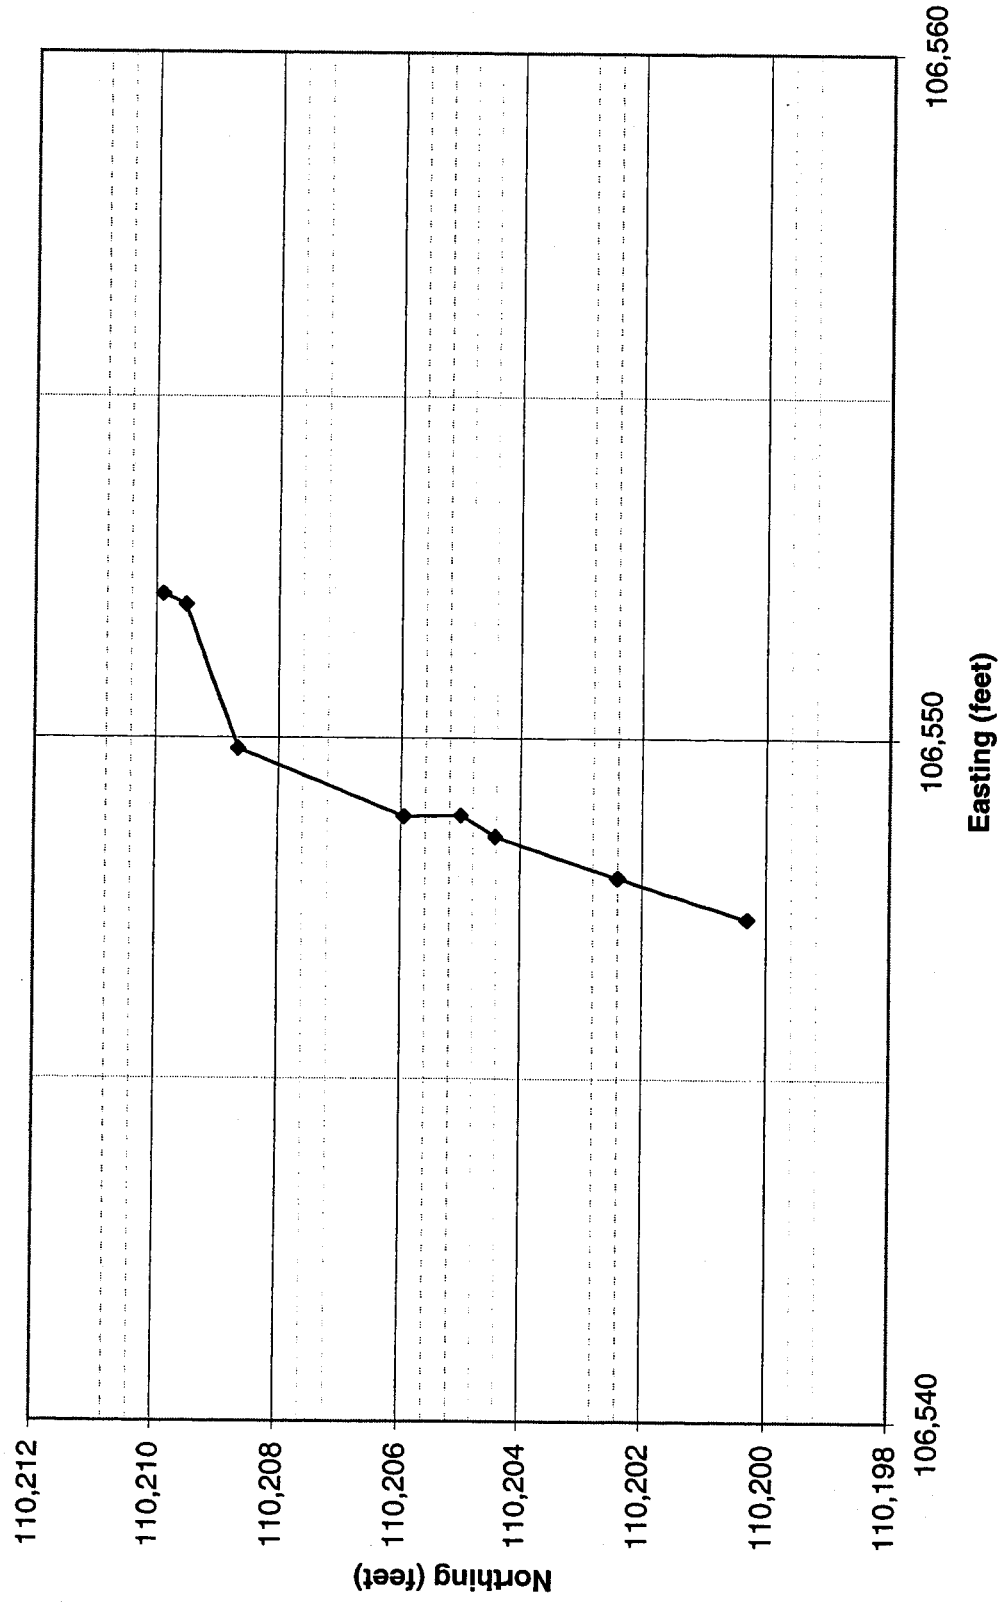
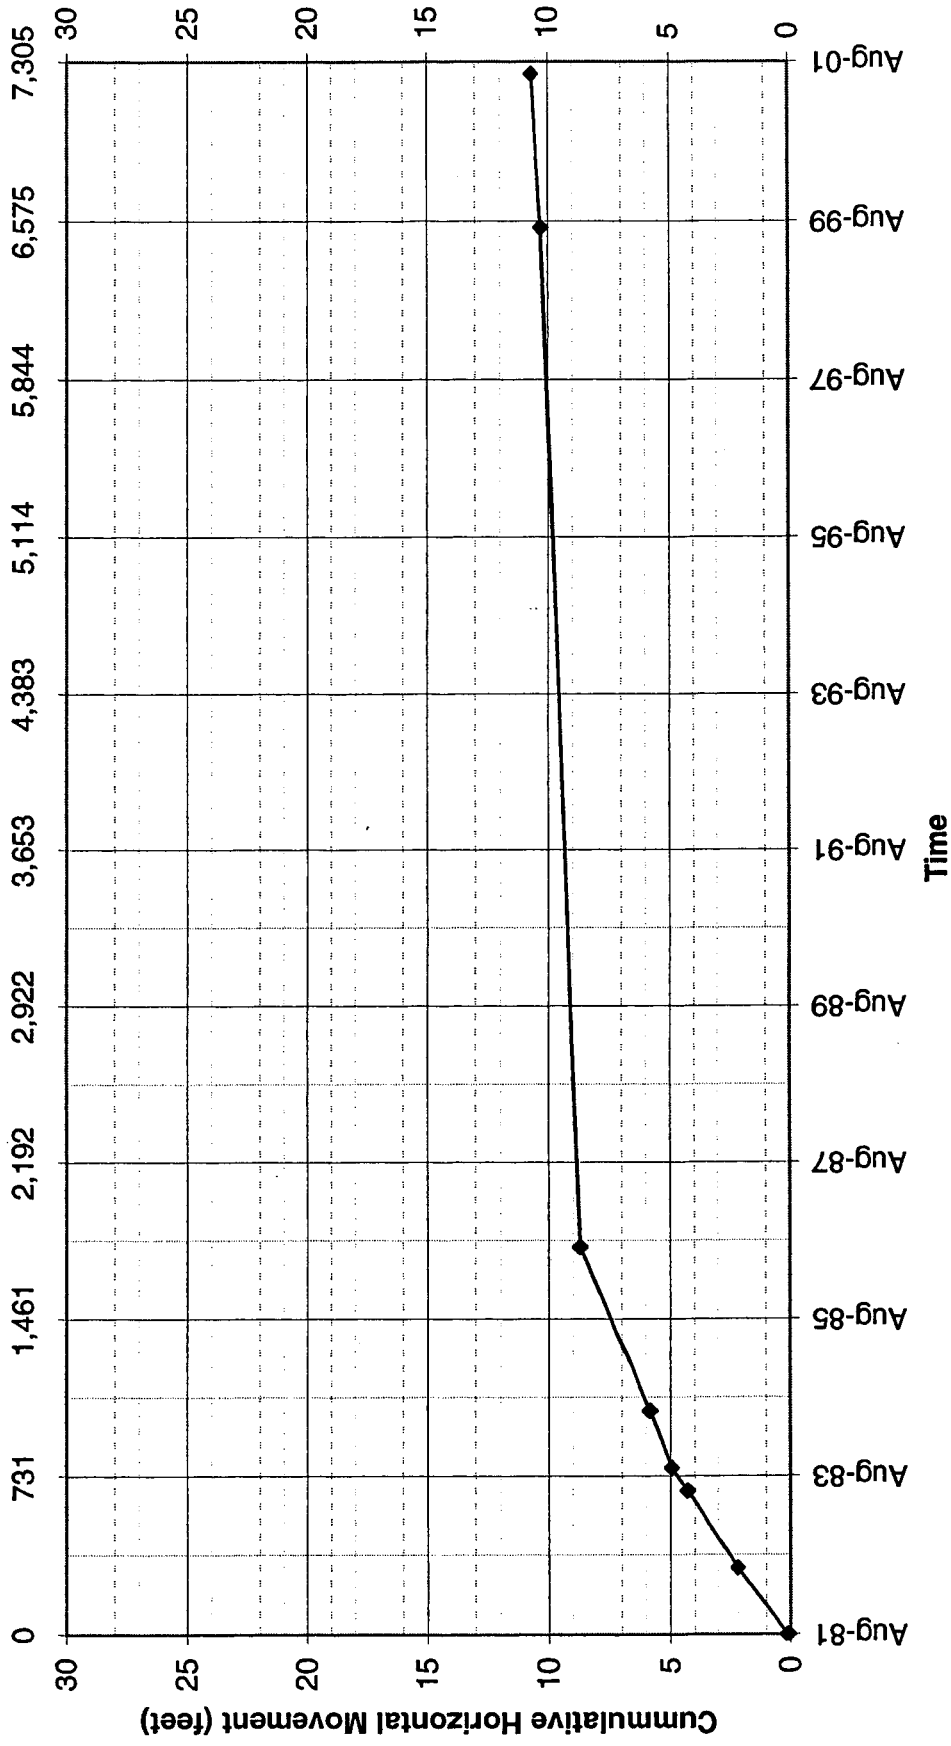
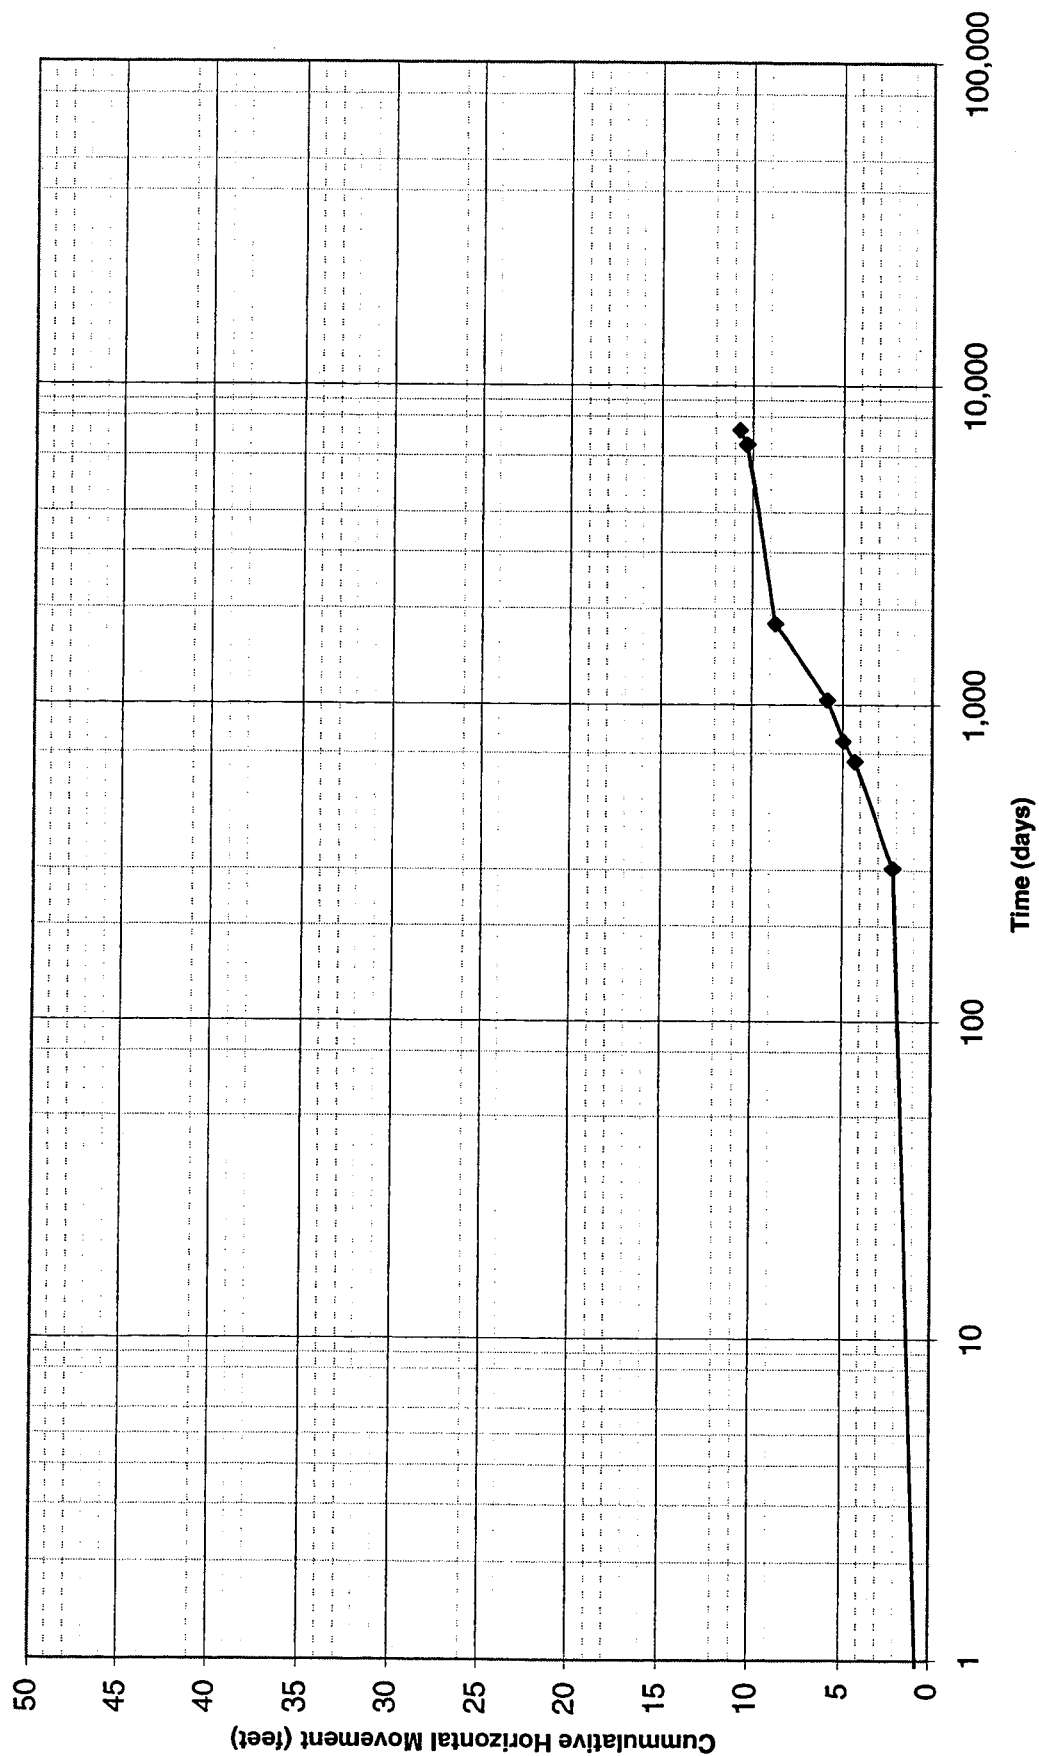
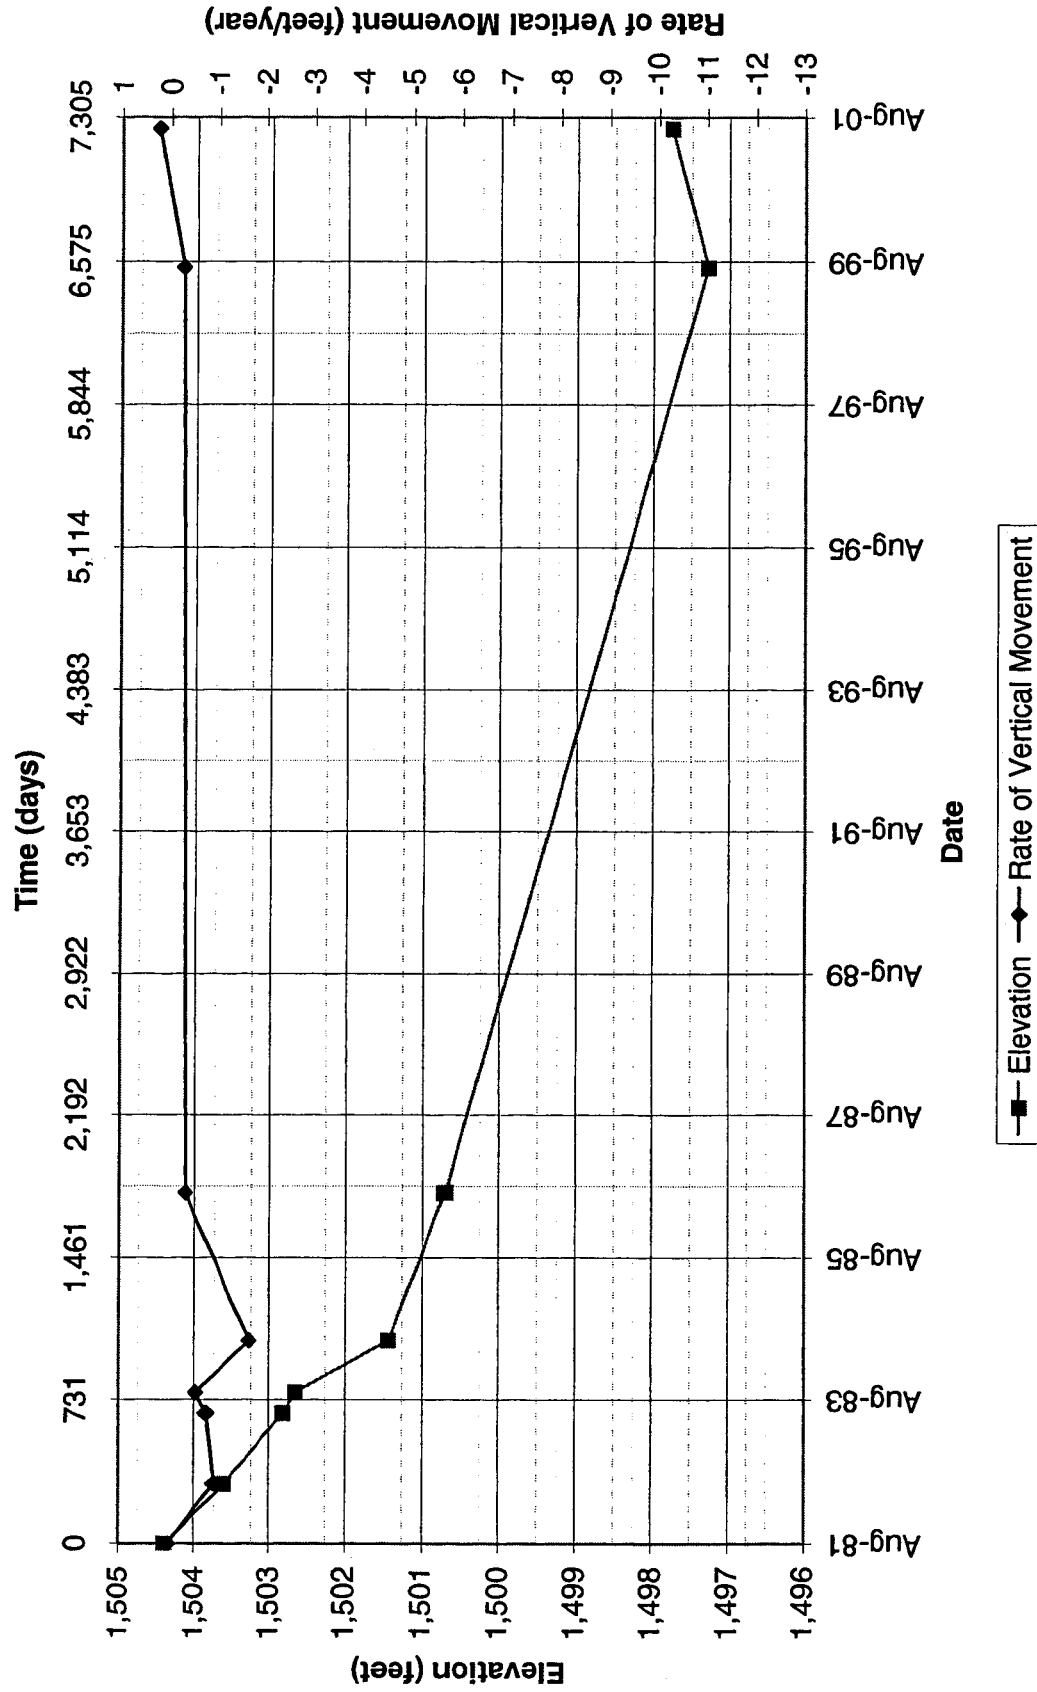
**DIAND: Clinton Creek Asbestos Mine
Waste Rock Monitoring Monument #81-1**

Waste Dump Stability - Monitoring Point #81-1
