**FINAL REPORT
ASSESSMENT OF REMEDIAL MEASURES FOR
ARCTIC GOLD & SILVER TAILINGS SITE**

THE ARTIC GOLD & SILVER WORKING GROUP

STEFFEN ROBERTSON AND KIRSTEN (CANADA) INC.
Suite 800, 580 Hornby Street
Vancouver, B.C. V6C 3B6
Tel: (604) 681-4196 • Fax: (604) 687-5532
E-mail: vancouver@srk.com Web site: www.srk.com

FEBRUARY, 1999

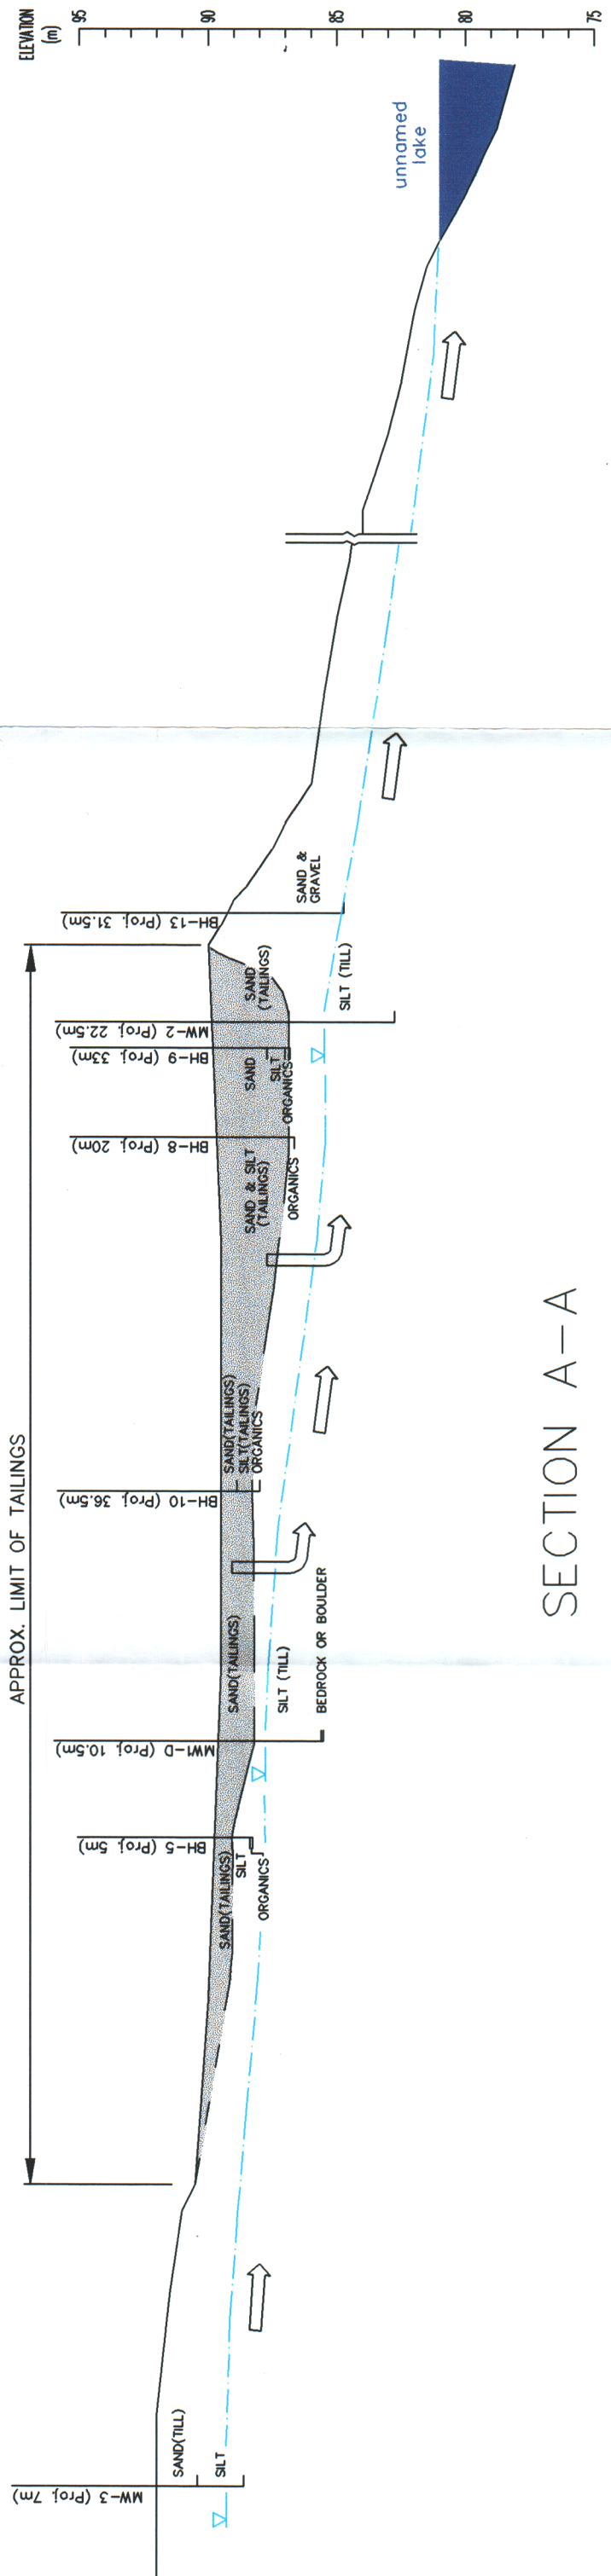
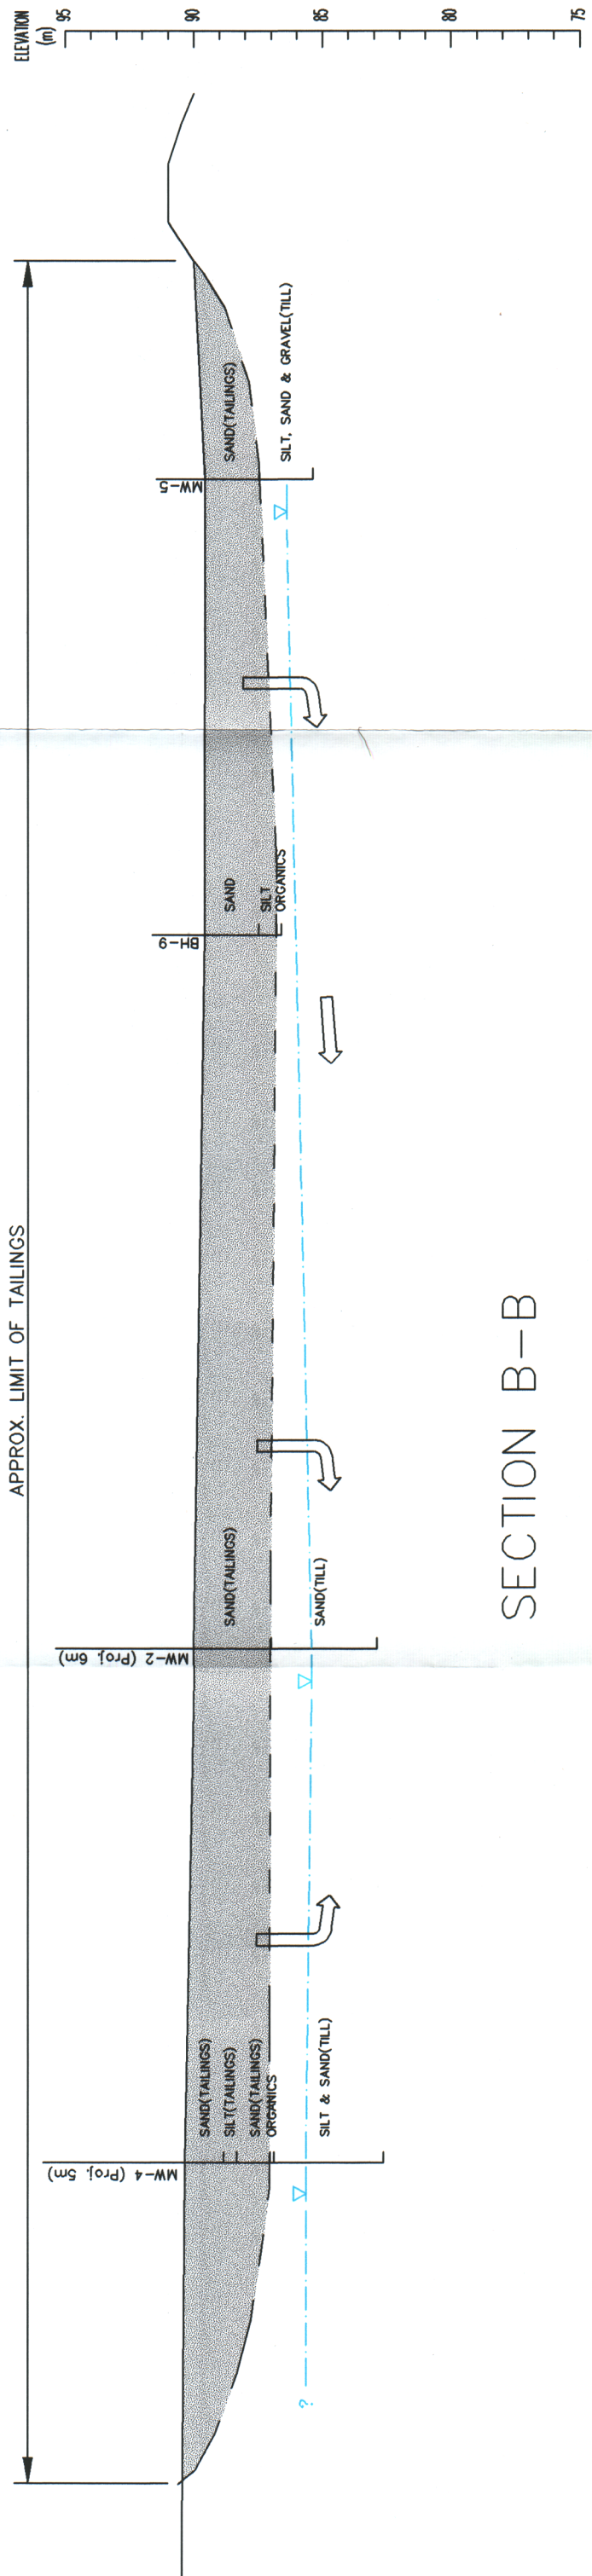
STEFFEN ROBERTSON AND KIRSTEN <i>Consulting Engineers</i>	ARCTIC GOLD AND SILVER			
	SECTION A-A AND B-B			
	PROJECT NO. 1CP001.07.01	DATE DEC. 1998	APPROVED	FIGURE 2.3
PUBLIC WORKS AND GOVERNMENT SERVICES CANADA

The borehole logs and the EBA report describing the geotechnical investigation are presented in Appendix A. Isopachs of tailings thickness interpreted from the borehole and survey data are presented in Figure 2.2. Two sections through the tailings are illustrated in Figure 2.3.

The groundwater table was below the tailings at all points measured (Figure 2.3). Currently, therefore, there is no evidence of groundwater passing through the tailings from the upgradient side. Hence there is no need for additional groundwater or surface water diversions. The water table may rise in spring, but due to the low permeabilities of the tailings and foundation soils, it is unlikely that significant horizontal flow through the tailings would result.

Groundwater monitoring wells were not installed down-gradient of the impoundment. As a result, the direction and rate of flow of the contaminated groundwater seepage cannot be determined. However, it is reasonable to assume that the contaminated groundwater flows towards the unnamed lake and/or Tank Creek (Figure 2.3) and therefore represents a potential source of surface water contamination.

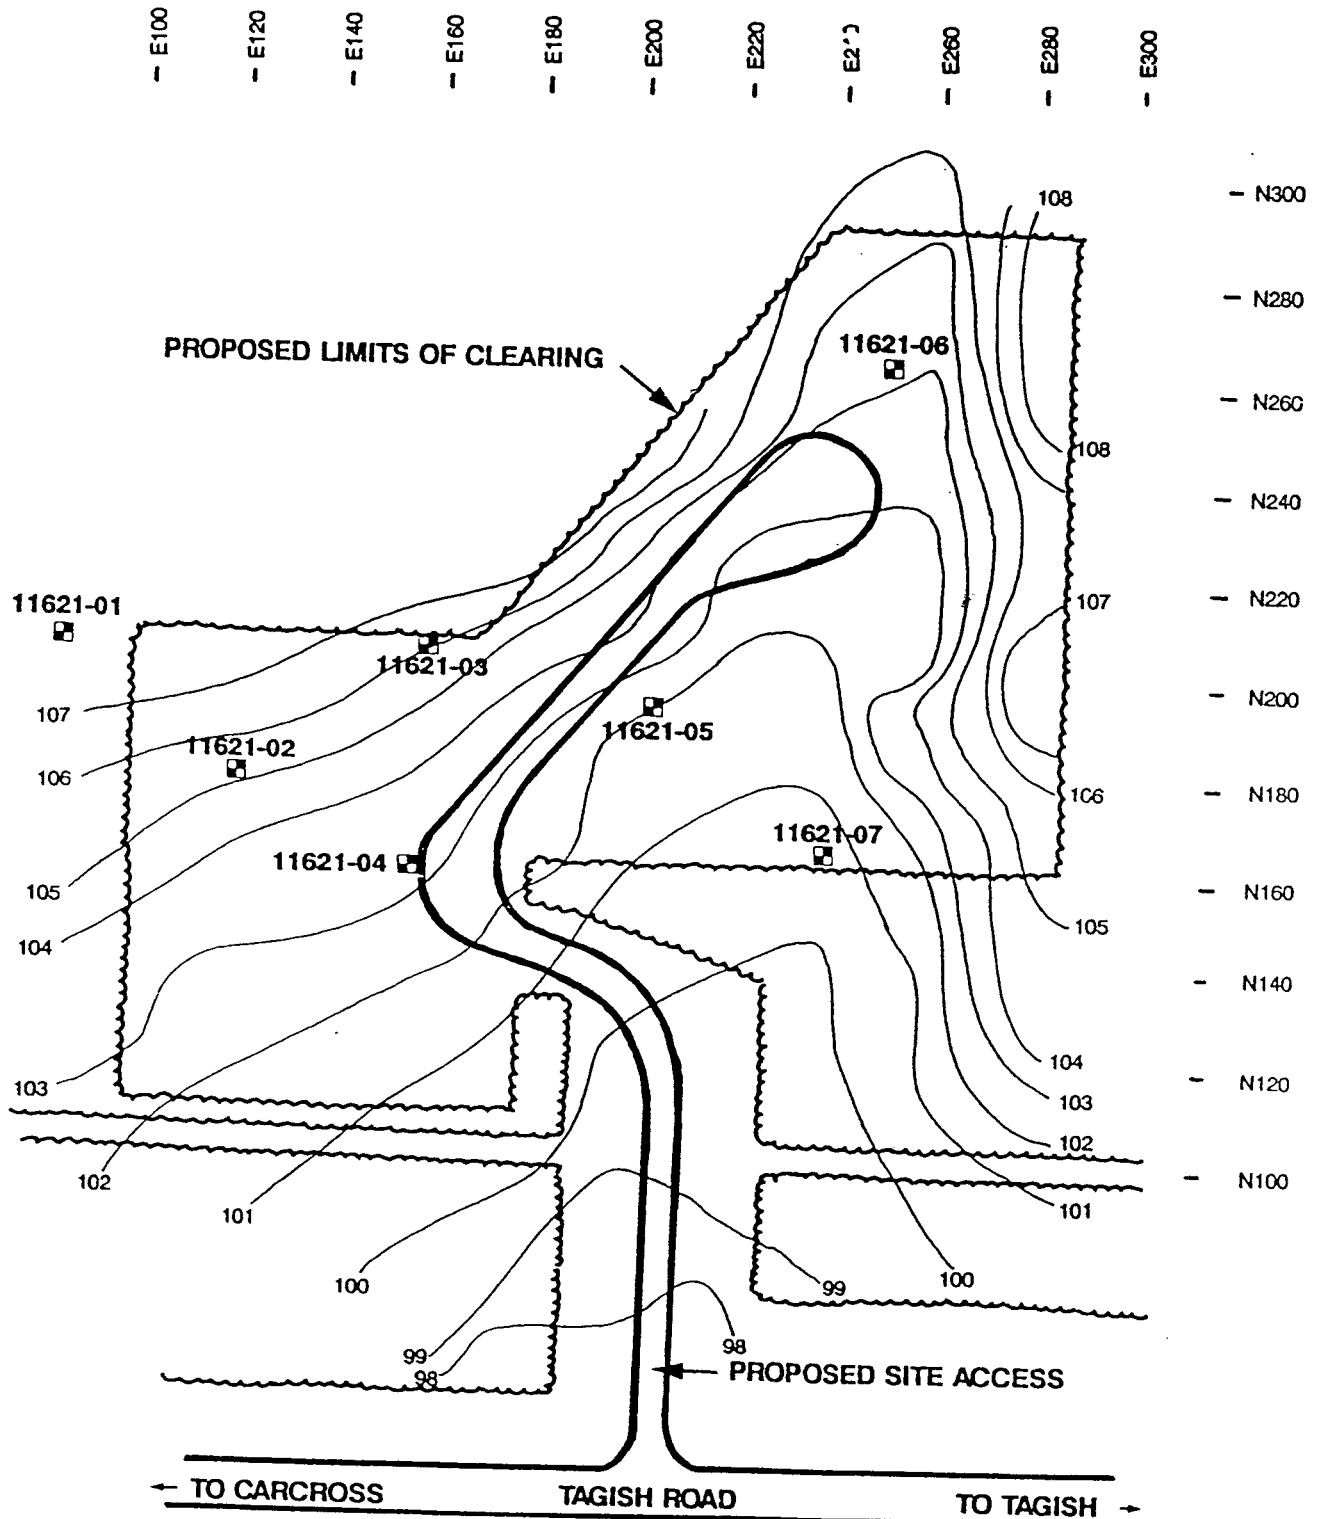
EBA Engineering Consultants Ltd.				PROJECT PROPOSED DUMP SITE km 50.7 - TAGISH ROAD	
CLIENT GOVERNMENT OF YUKON ENGINEERING AND DEVELOPMENT				TITLE SITE PLAN SHOWING TESTPIT LOCATION	
DATE	95-10-23	DWN	MCP	CHKD	
				DWG NO.	FIGURE 1
				0201-11621

AND OPERATION: The location at km 50.7 appears to have good potential for a landfill. The landfill operations should be kept north of the power line with a buffer between the power line and the landfill site. Test holes to date have concentrated on the west portion of the site and indicate good sub-surface conditions in a limited band for a landfill operation.
