HUSKY #2
(MINFILE#105M 001bb)

HUSKY SOUTHWEST #2
(MINFILE # 105M 001bb)

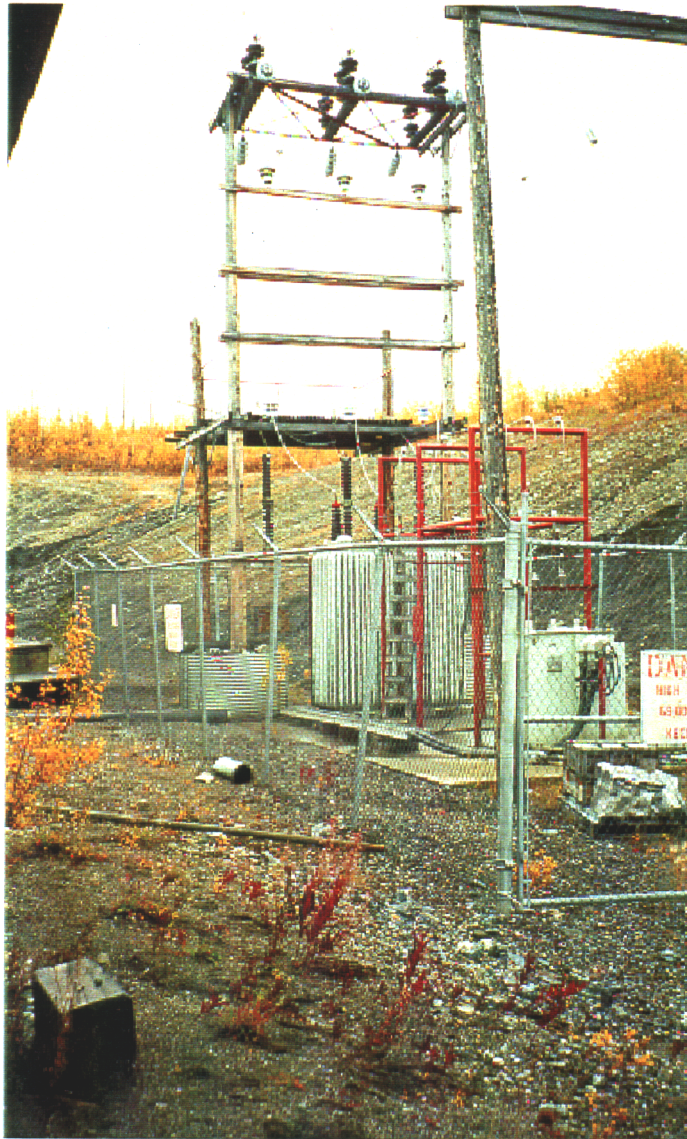
There was a transformer station at the site that was fenced and padlocked (photo 2-12). The transformers were situated on a concrete pad. They were still in service at the time of the site inspection, however, admittance to the transformers was restricted by padlock and no identification of the equipment was attempted. No samples were taken. These transformers were older and may contain PCB's.

Photo 2-12: Power compound generating station.

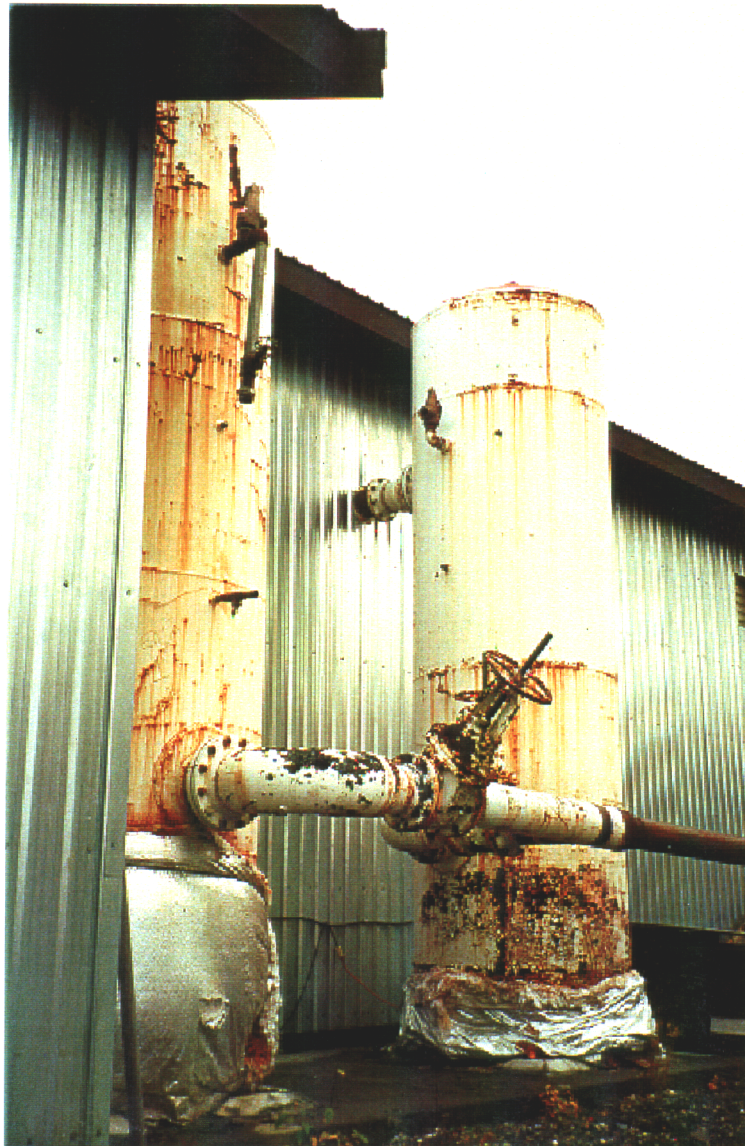
Note: The area to the west of the building has scattered debris. Approximately 300 bags of powder concrete are stacked. Approximately half of the bags have been exposed and are no longer useful. There is various metal debris scattered, one empty AST was noted, and a fuel drum that was labeled as motor oil Chevron 200L was $\frac{3}{4}$ full. There is some staining surrounding the fuel drum indicating that it is or has been leaking. Area impacted is approximately 4m x 2m. Two air compressor tanks are located on the south wall of the hoist house (photo 2-16). The tanks are situated on a concrete pad and are piped into the utilidor that enters the hoist house at this point. Both tanks measure 6m in height and 3m in diameter.

Photo 2-16: Air compressor tanks, south wall.

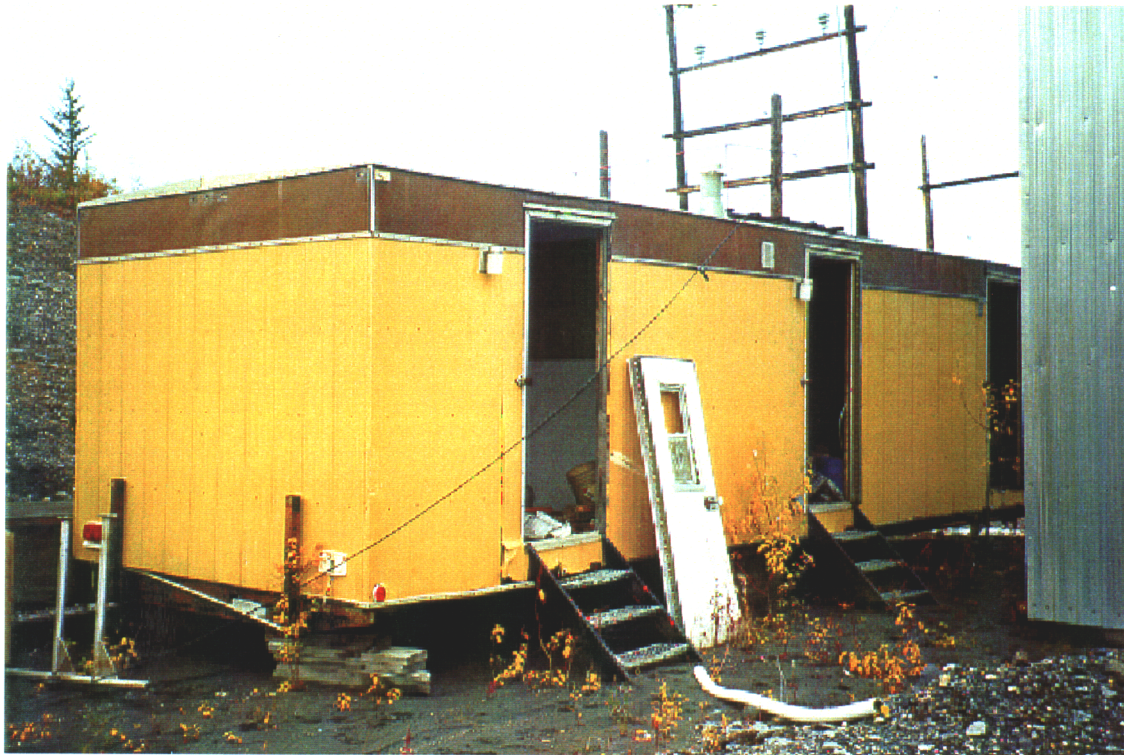
Photo 2-17: Atco trailer.

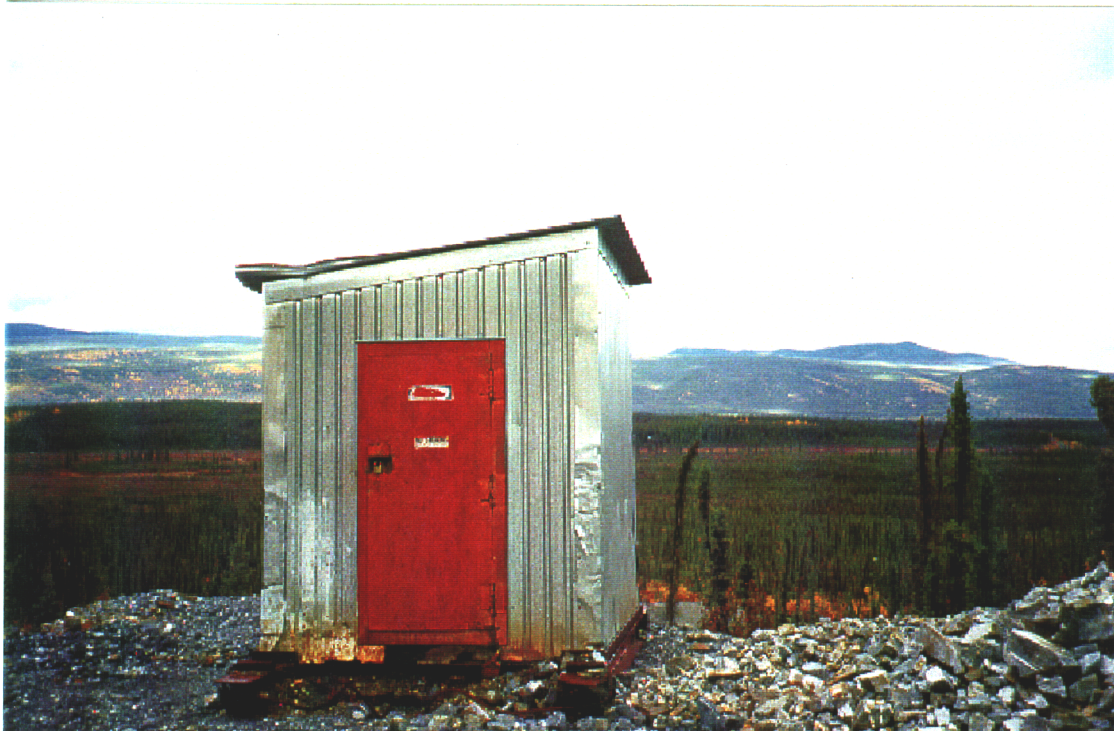
Photo 2-18: Ammunitions magazine

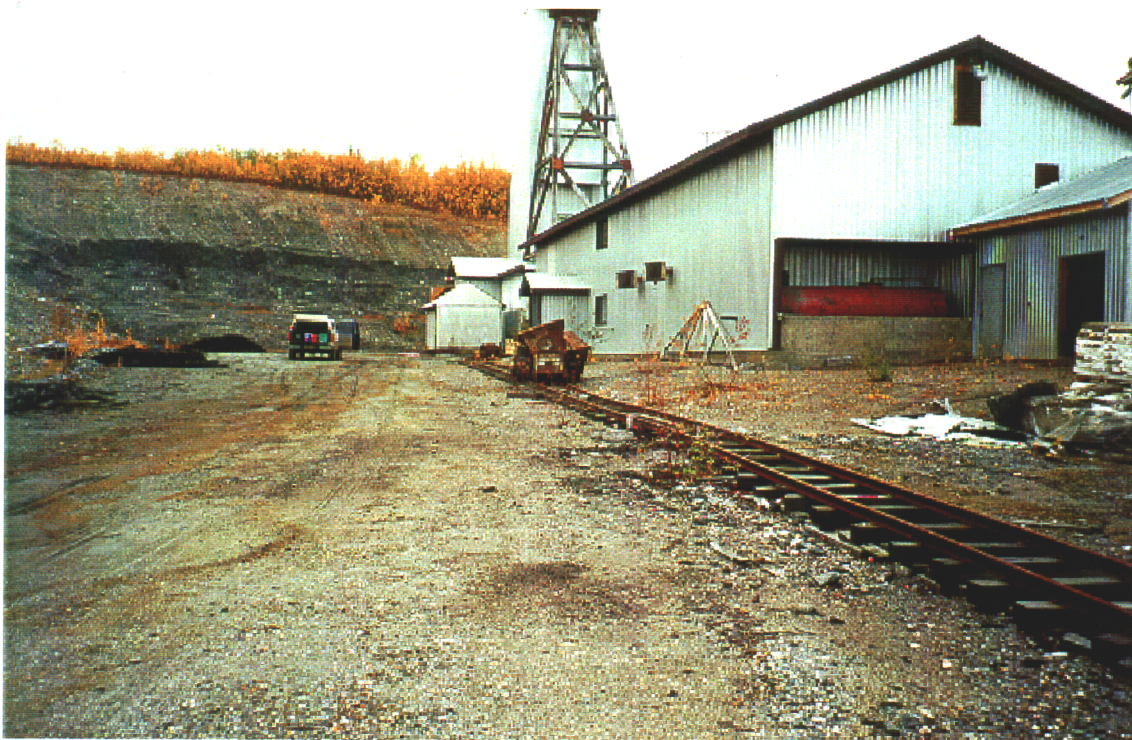
Photo 2-20: Tracks & Cars.

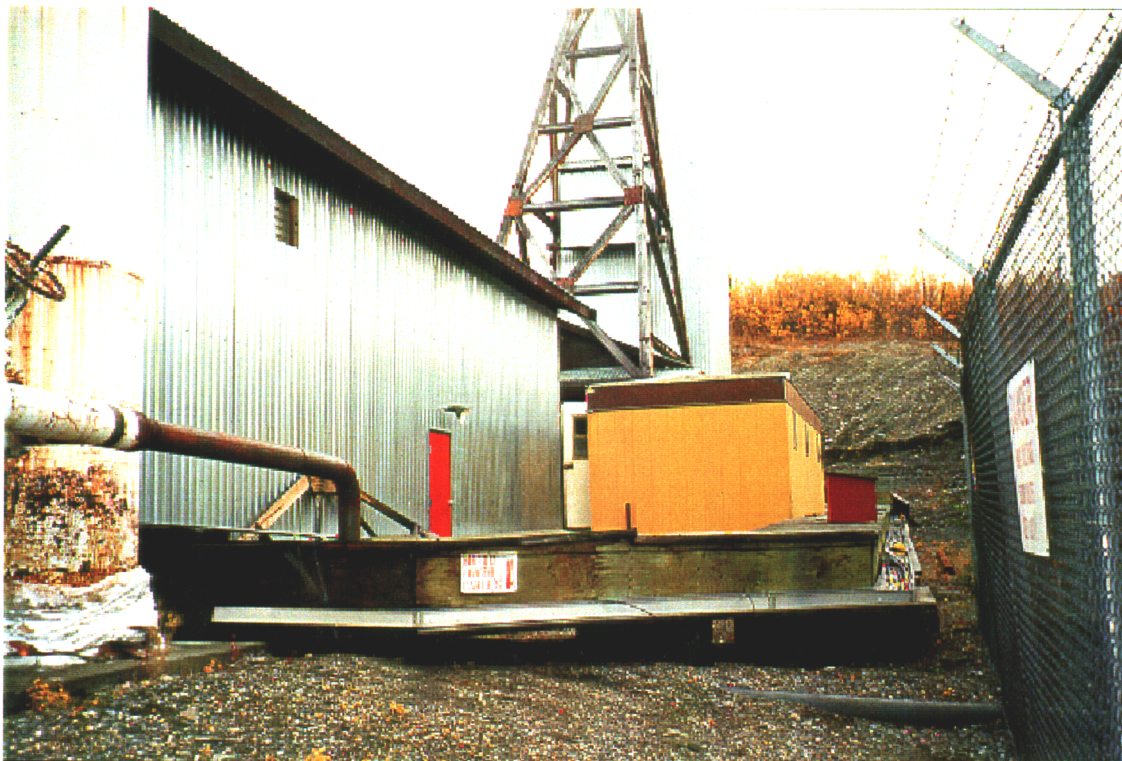
Photo 2-21:

A utilidor extends from the shaft headframe building on the south wall to the hoist house and is protected by a fibreglass insulated 1m x.5m boxed plywood receptacle with power cables running alongside (photo 2-21).
