## **MACKENO (#81)**

### **(NO MINFILE)**

Public Works and Government Services Canada Architectural & Engineering Services Western Region	Travaux publics et Services gouvernementaux Canada Architecture et Services d'ingénierie Région de l'ouest	Designed by: conçu par: drawn by: dessiné par: approved by: approuvé par: révisé par:	C.S.I.B. Nov. 1999
Drawing title:	Makino Site # 81 Site Assessment Yukon Territory			Project no. no. du projet:
				125-12.01
				1 of 1

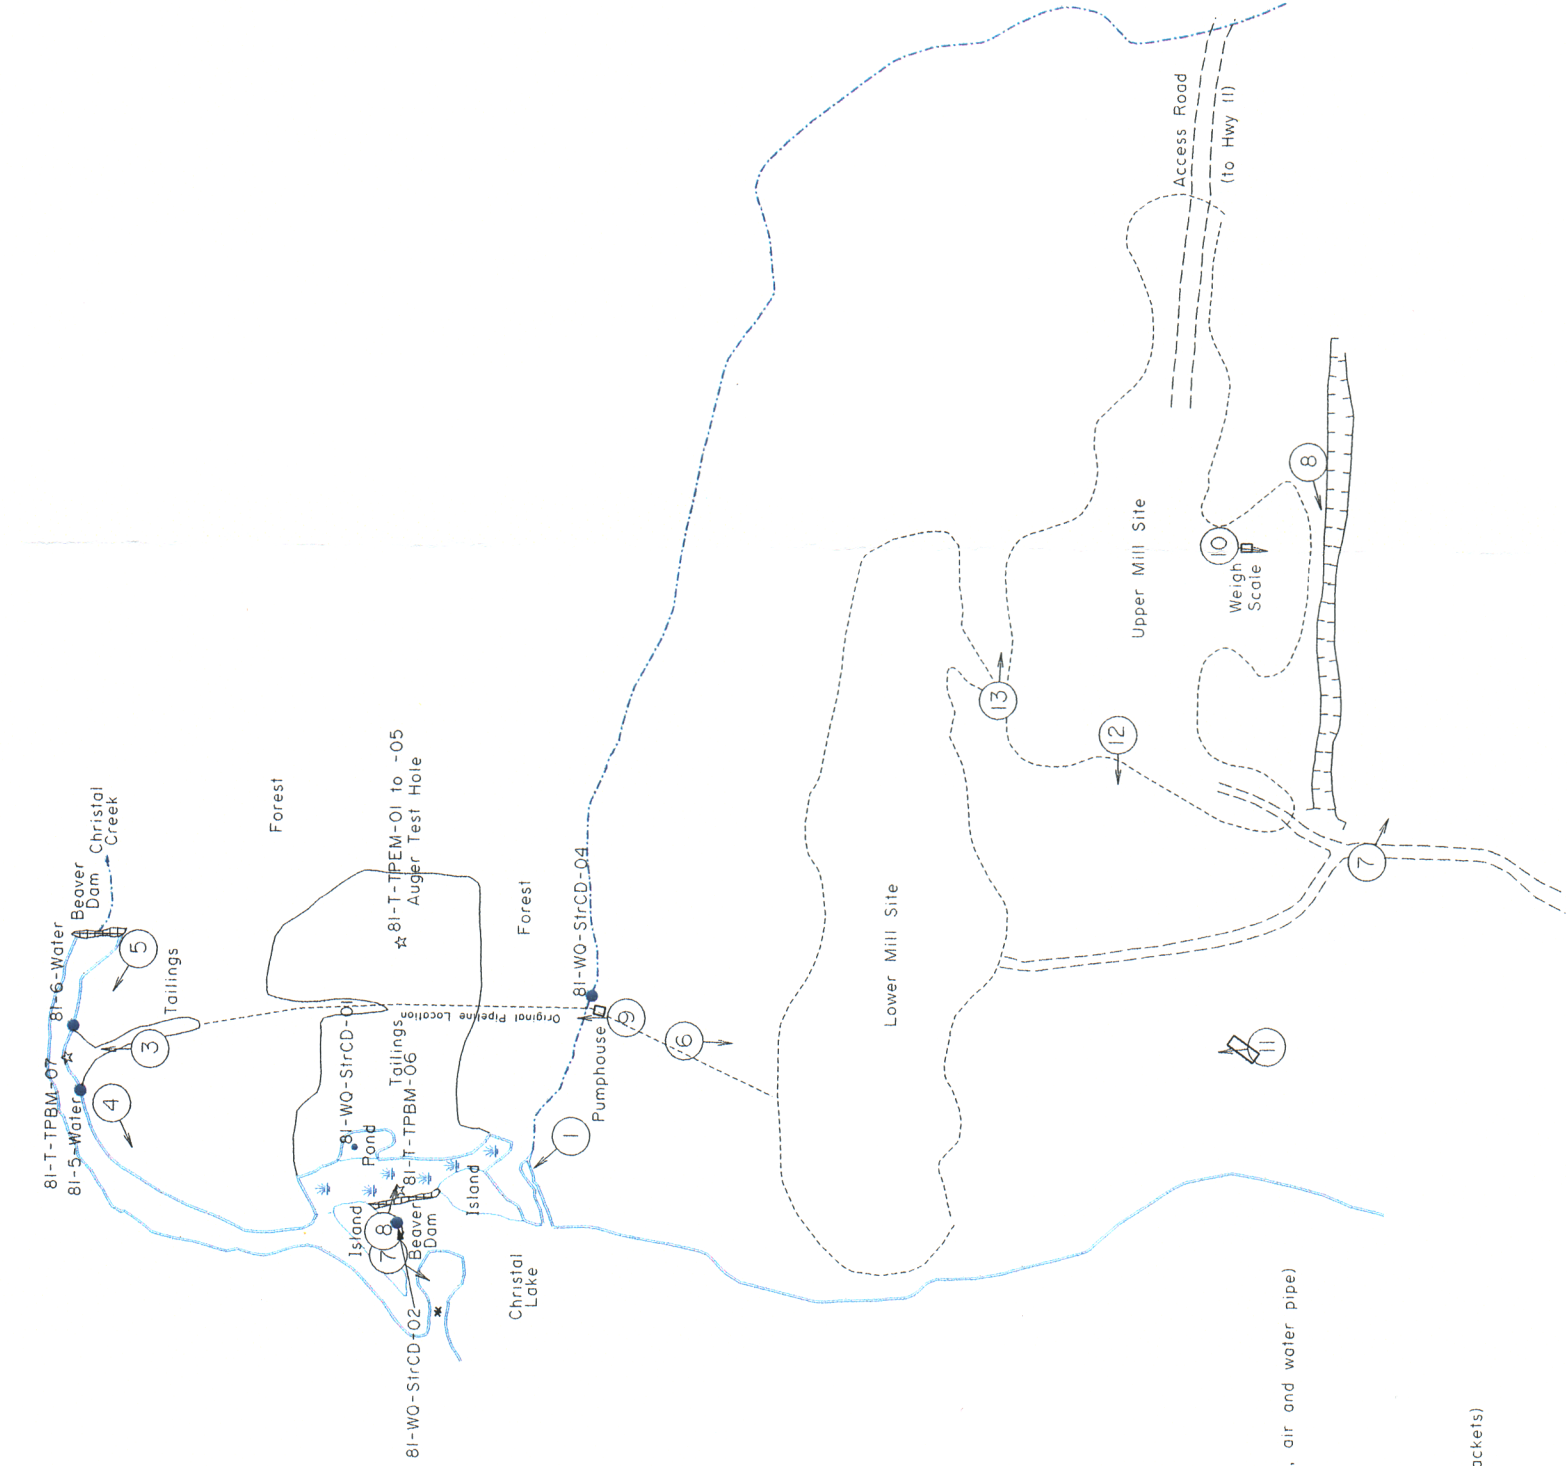
CAD FILE: SITE81.DGN

The site is accessible along a gravel road stemming off of the main highway approximately 2 km north west of Keno City. The gravel road enters the south portion of the millsite (Figure 1) from the east and the north portion is accessible via one of two access points from the south portion of the site. The tailings area is not accessible by vehicle but can be visited through the primary forest from the millsite or by walking east along the lakeshore from the Galkeno mine site (Figure 2). Mackeno is at 63°54'57"N and 135°19'28"W and an approximate elevation of 870 m above sea level. UTM co ordinates are 7087675.770m N 484083.054m E.
