AN ENVIRONMENTAL STUDY OF THE WHITE
PASS & YUKON ROUTE PIPELINE FROM THE
B.C. - ALASKA BORDER TO WHITEHORSE, Y.T.

by: D. MUNRO
K. WEAGLE

ENVIRONMENTAL PROTECTION SERVICE
WHITEHORSE, YUKON - SEPT. 1976

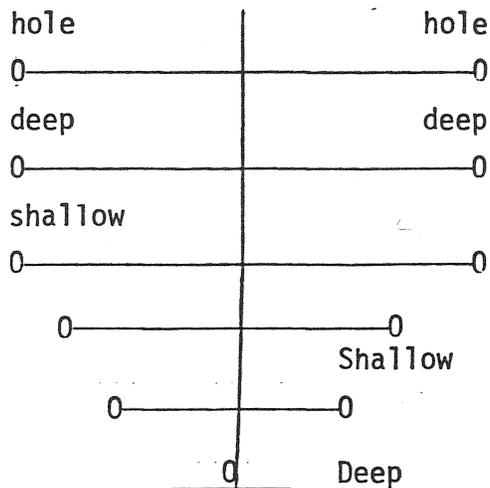
- 1) dig several holes right through the ice to allow oil under the ice to rise, then put vermiculite in the hole;
- 2) dig several shallower holes that released oil trapped within the ice, put vermiculite in the hole;
- 3) cut or dig a series of trenches between all the holes as outlined in the diagram, and spread vermiculite in the trenches.

- 4) Wait until vermiculite has a chance to soak up the oil (5 to 10 minutes).
- 5) Light the fire.

We found the length of burning and intensity increased as with the number of holes and trenches, but the amount of oil in any area is probably the most important factor.
