# Colomac Remediation Project

## Major Civil Works

Lowell Wade, M.Sc., E.I.T. & Cam Scott, M. Eng., P.Eng.

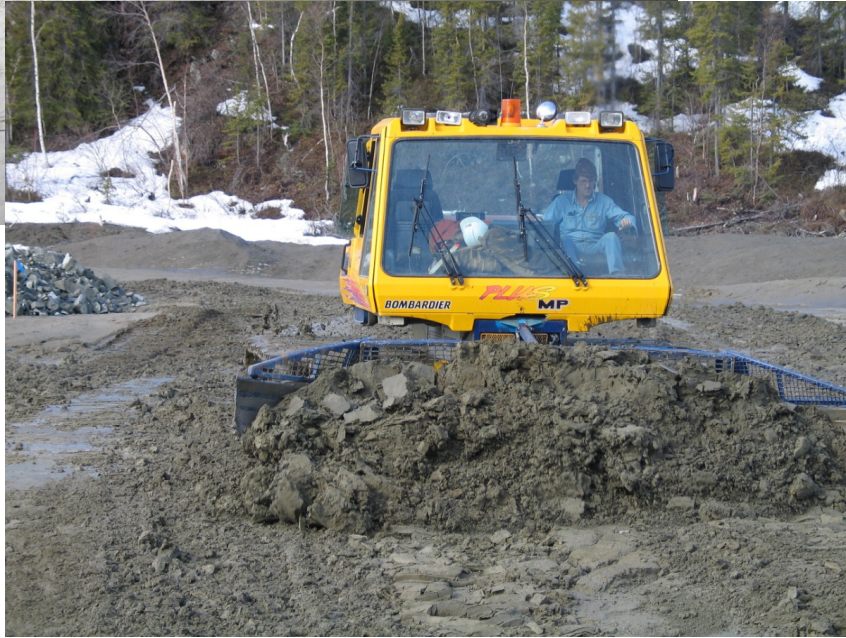
Tailings surface was hummocky in some areas and irregular in others mainly due to the thawing of ice lenses and subsequent water erosion. This made placement of cover and travel by heavy equipment difficult

Surface re-grading was performed using a snow cat

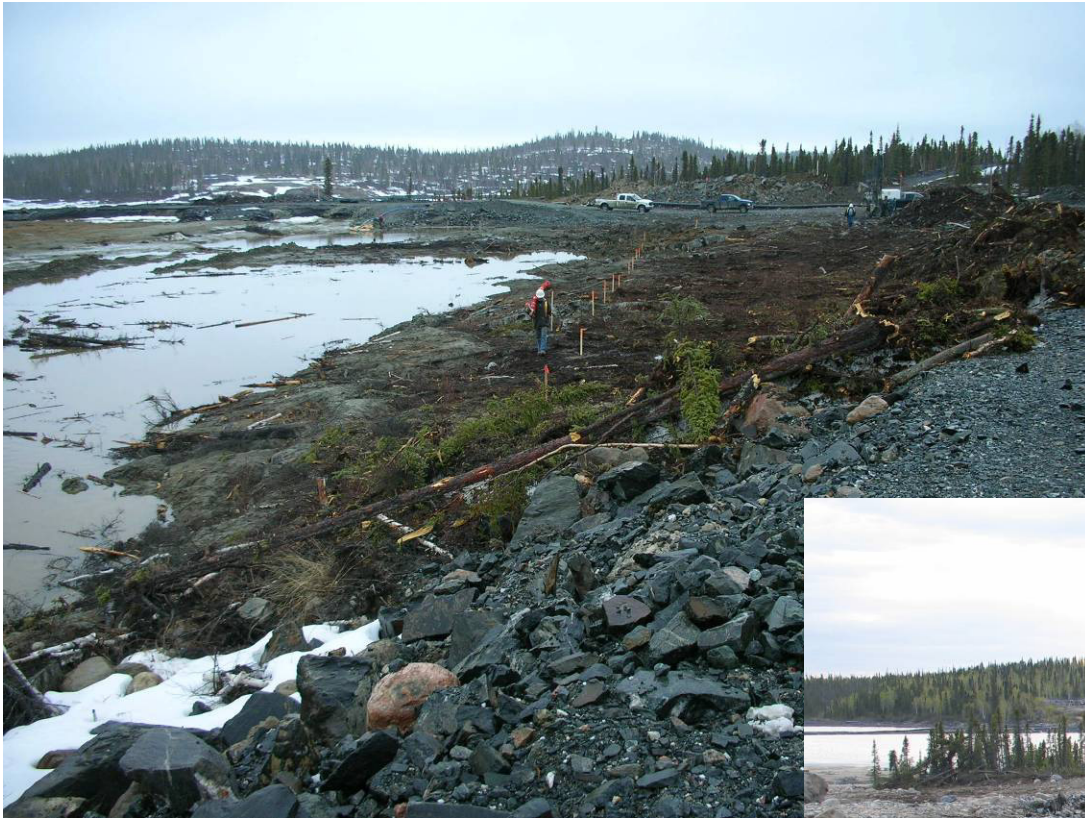
Start of Dyke 7 Spillway excavation with excavation and blasting of bedrock

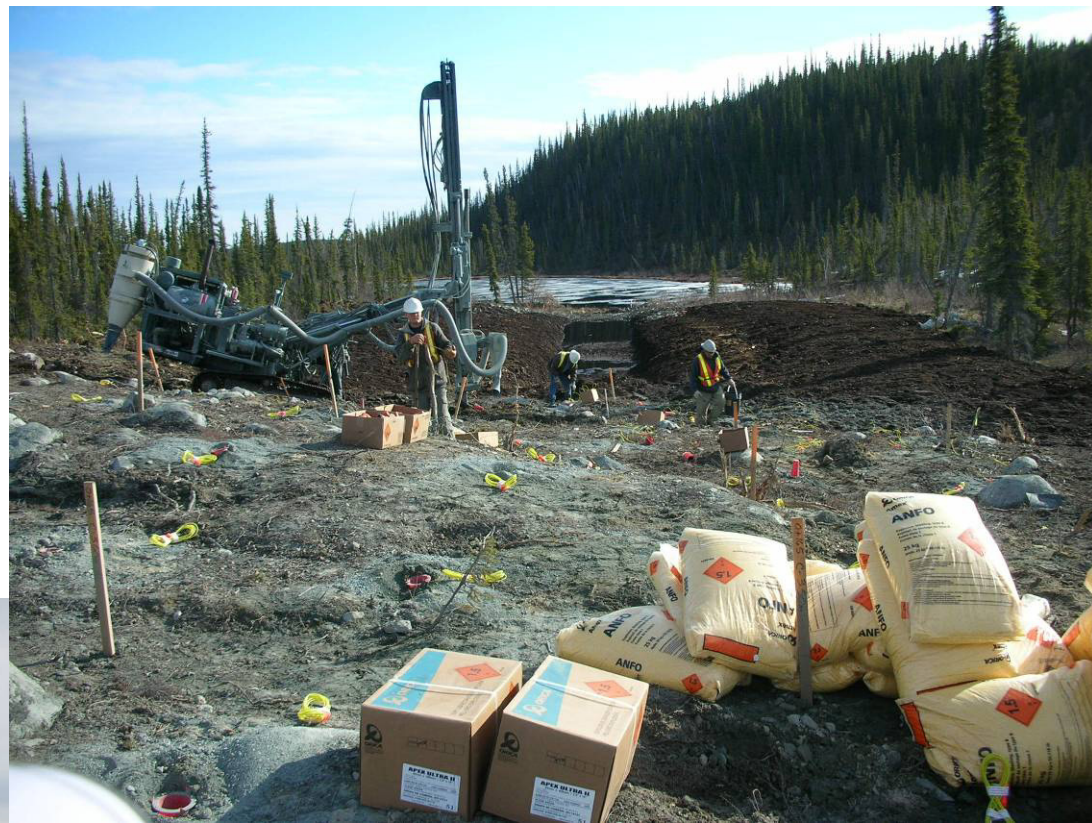
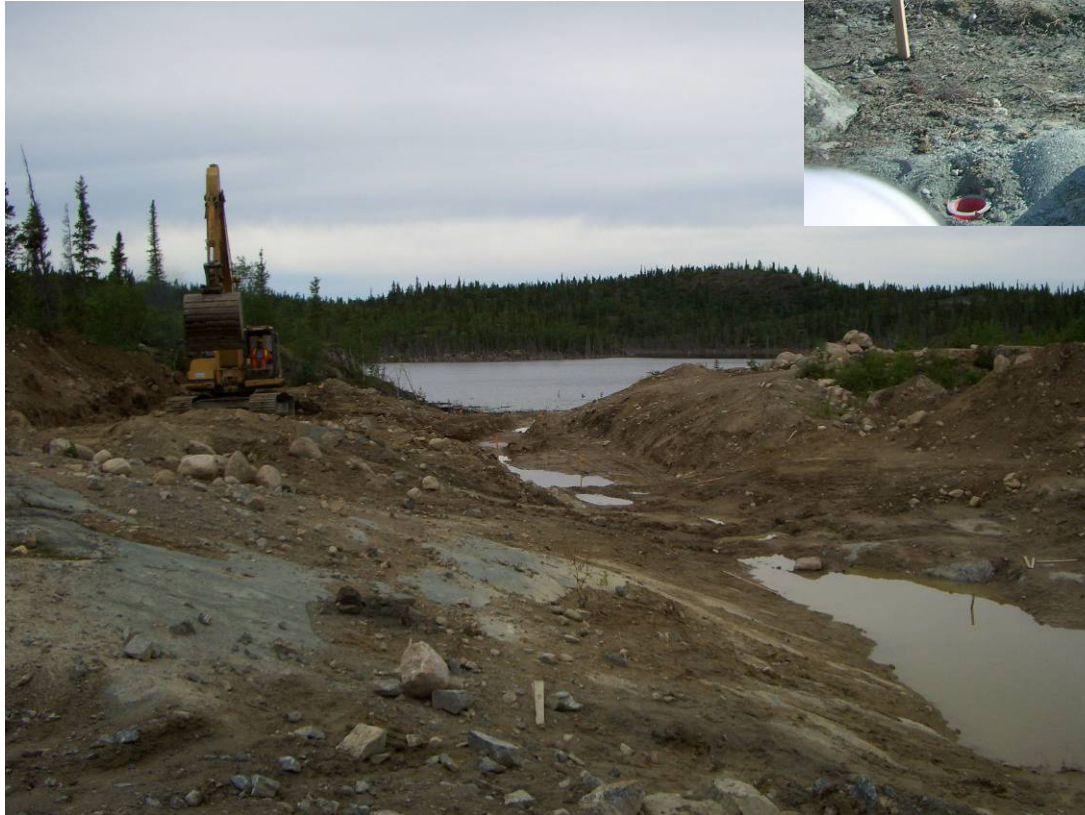
Excavation of peat and blasting of bedrock along the downstream reach of the Discharge Channel

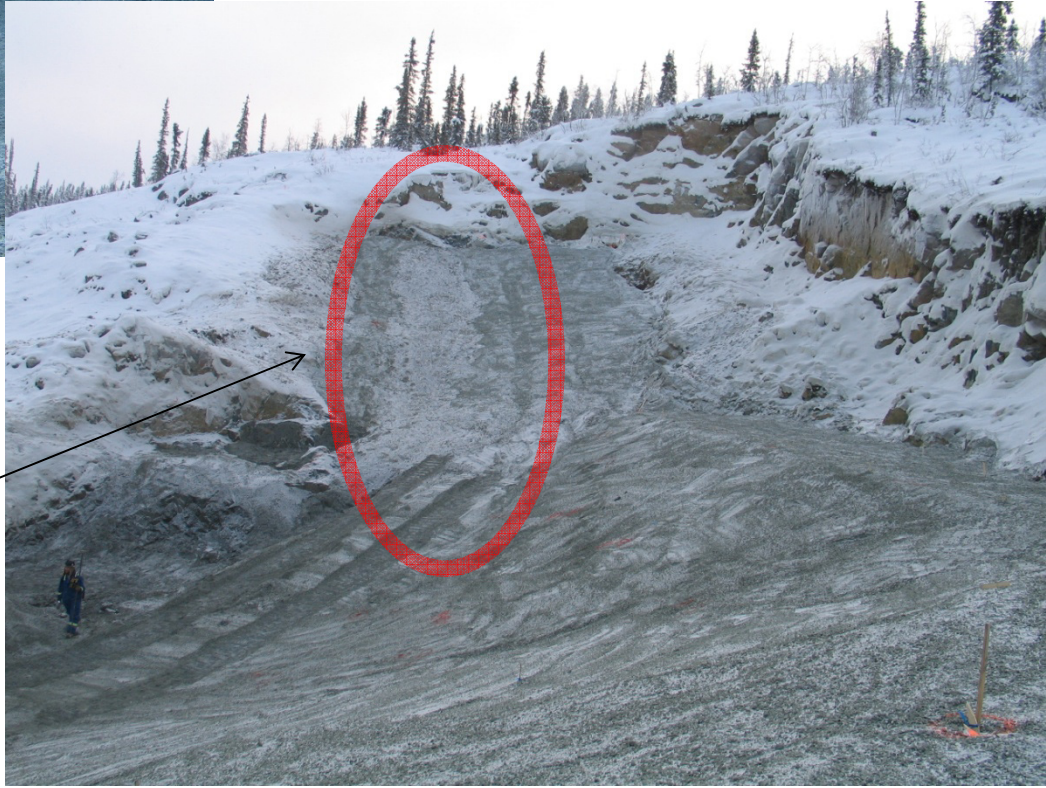
A zone of tailings mixed with bentonite was used to create a low permeability zone between the liner system and the bedrock surface
