# Performance of Low-permeability Tailings Cover, Arctic Gold and Silver Mine, Yukon

EBA, A Tetra Tech Company

Northern Latitudes Mine Reclamation Workshop, Fairbanks, AK, May 11-12, 2011

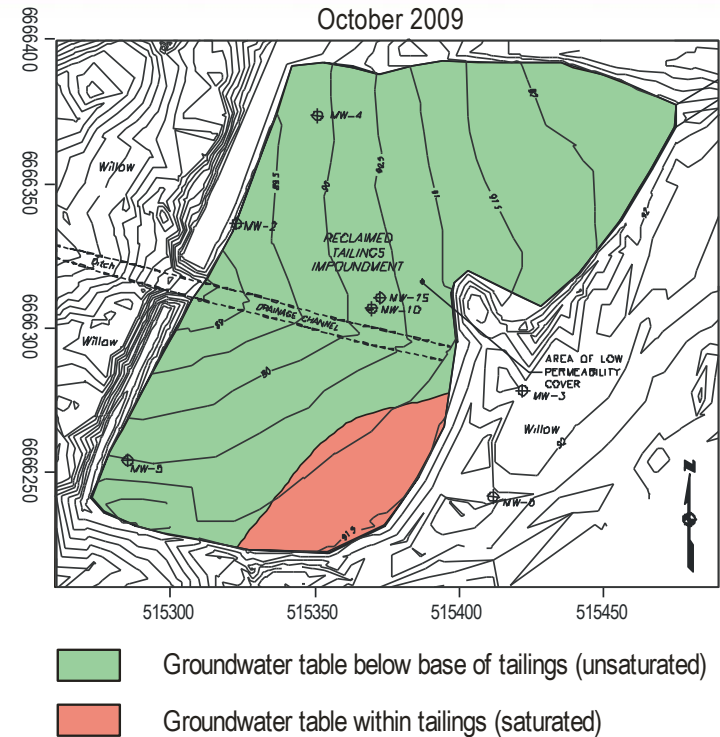
- Measured and interpolated groundwater elevations suggest that some of the tailings might be below the groundwater table – at least seasonally.
- Infiltration through tailings cover along preferential flow path (e.g., surface cracks in silt layer, plant roots).
- Slow groundwater flow velocity (metres to tens of metres per year), i.e., affected groundwater beneath tailings may not have been replaced yet.

Surface cracks in tailings cover

- Collected field data are inconclusive with respect to performance of tailings cover.
- Soil moisture and ground temperature profiles suggest that cover acts as infiltration barrier and limits ARD processes.
- Oxygen profiles and persistent groundwater contamination suggests ongoing ARD processes and impact from tailings on groundwater quality.
- Integrated approach is necessary to assess cover performance (no single parameter is able to provide this information).
- Continued monitoring is recommended to assess long-term performance of tailings cover.
