Forty Mile Cultural Resource Management Plan 2014

VOLUME II

9. UPDATED BUILDING CONDITION SURVEYS

Building 1 – Fish House, FMEB – 1, YHSI ID: 116C/07/003

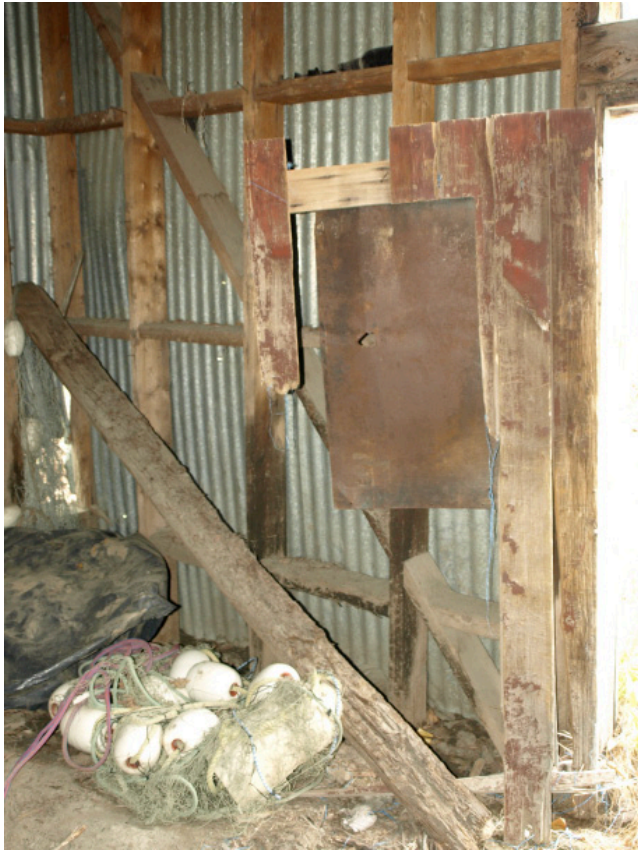
16. Interior Photo:
Front Door remnants

- i. replace the cross ties with similar rough sawn material
- ii. excavate the sill plates to confirm condition, undertake a repair/replacement program as required
- iii. rebuild the existing front door

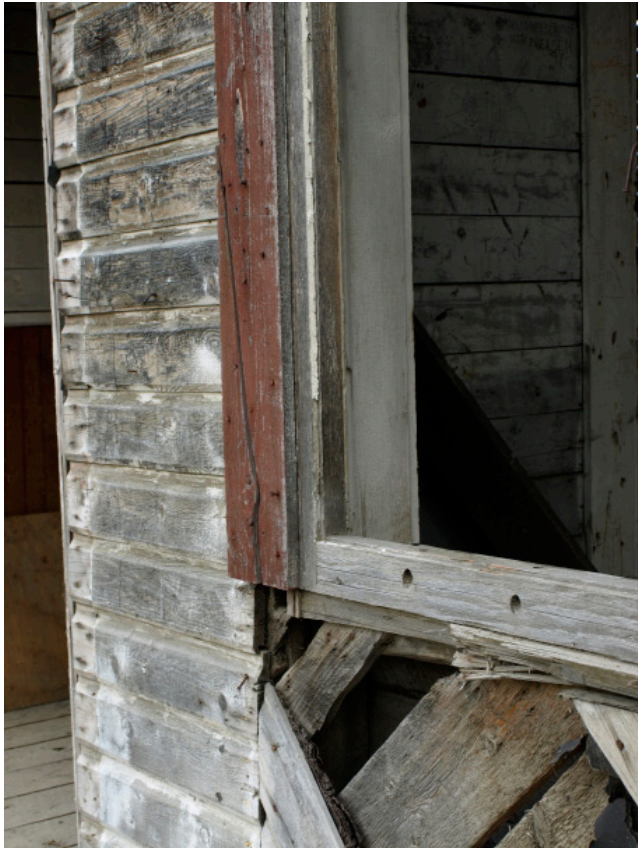
15. Exterior Window: Double pane window with venting holes.

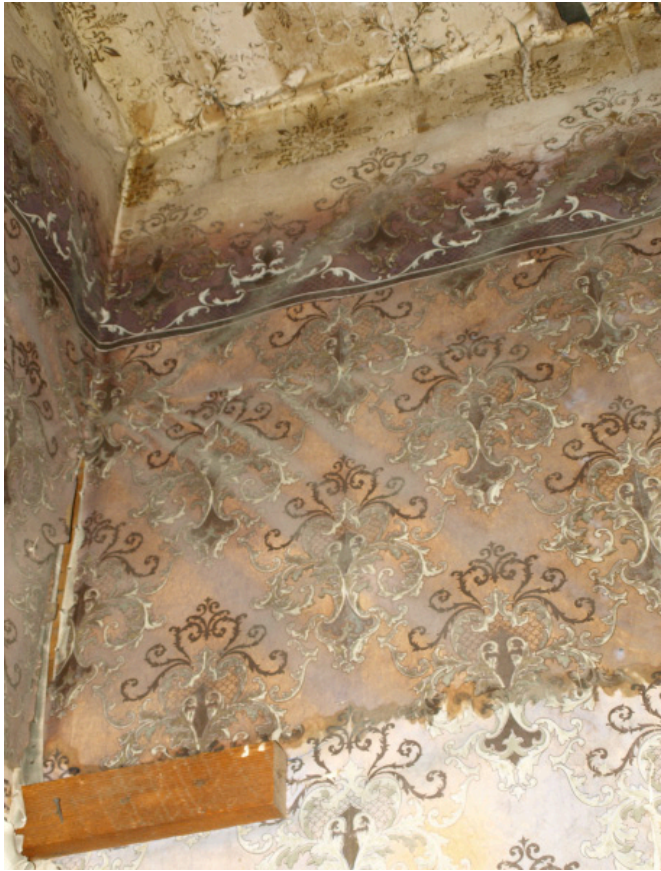
19. Interior Photo: Remaining Wallpaper

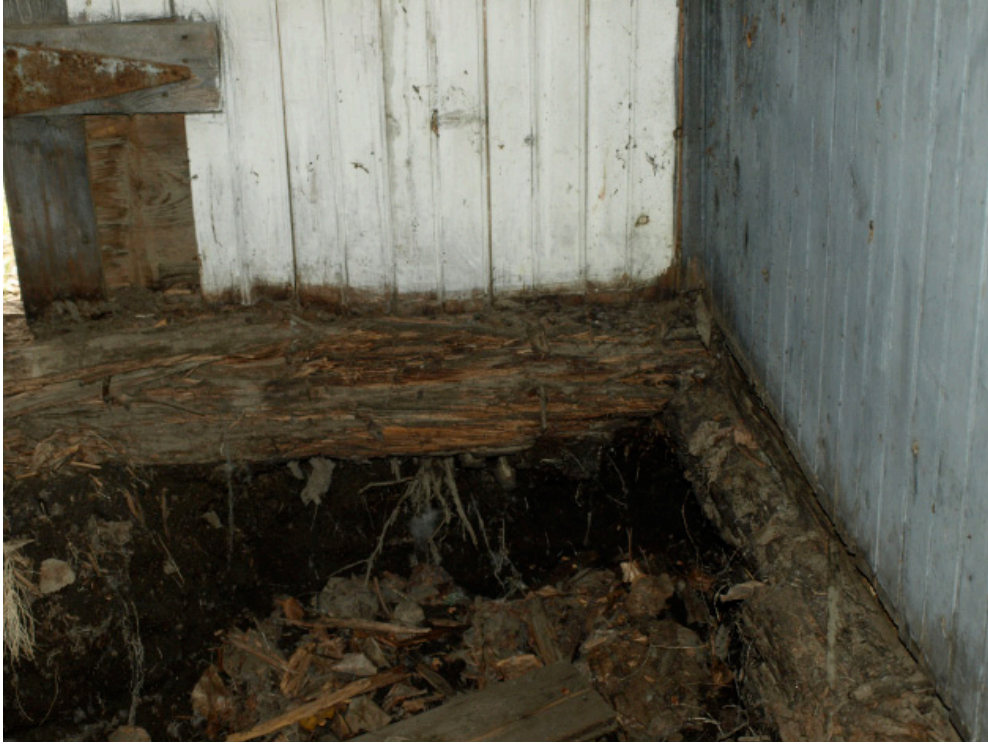
35. Interior Photo: rear shed

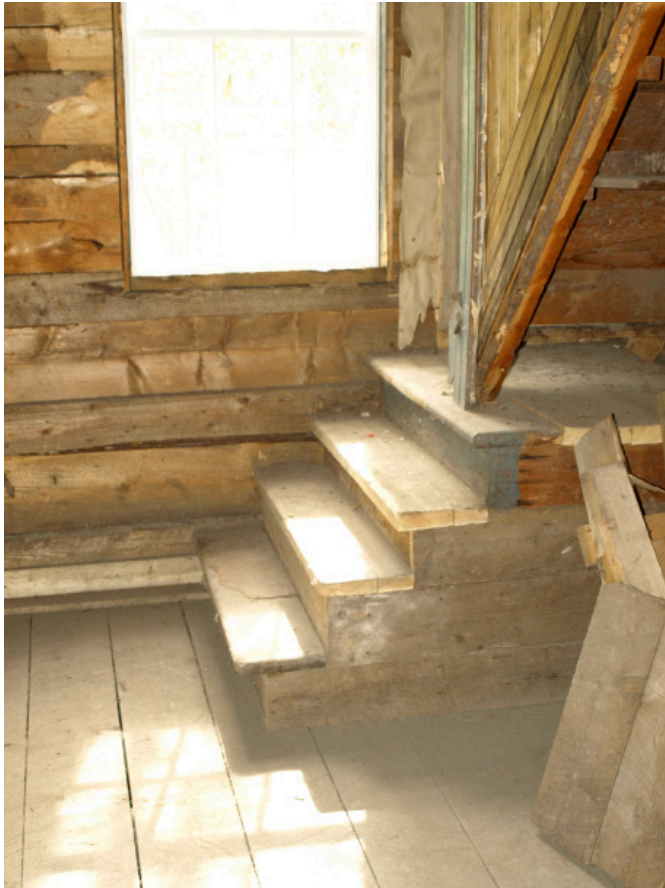
46. Interior Photo: Stair

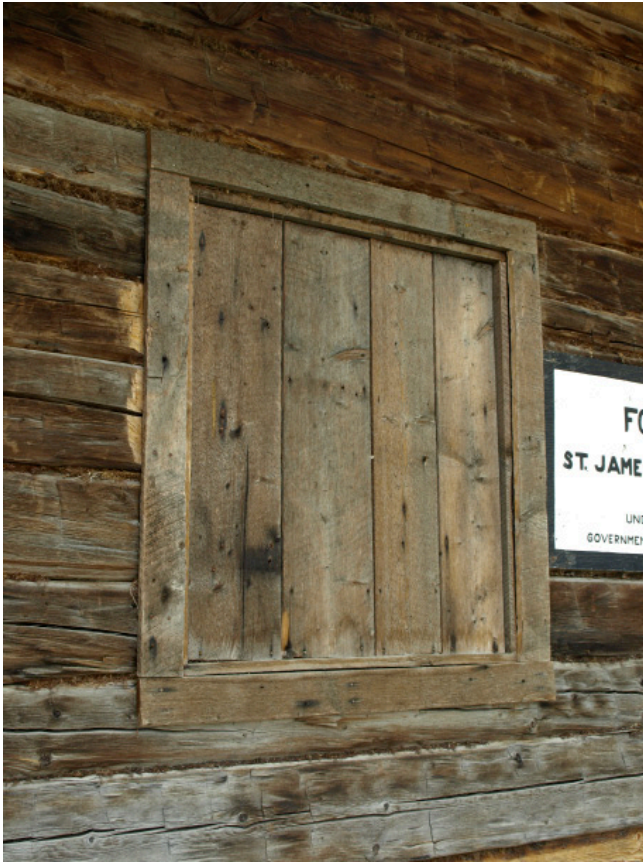
15. Exterior Photo: Window

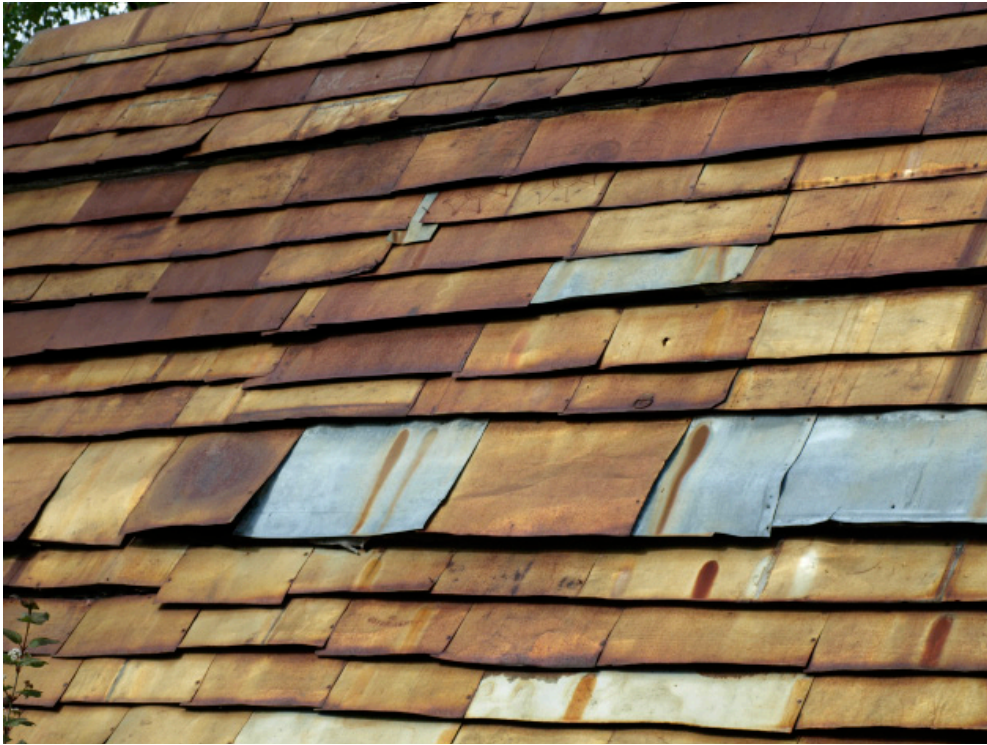
20. Exterior Photo: Roof Detail

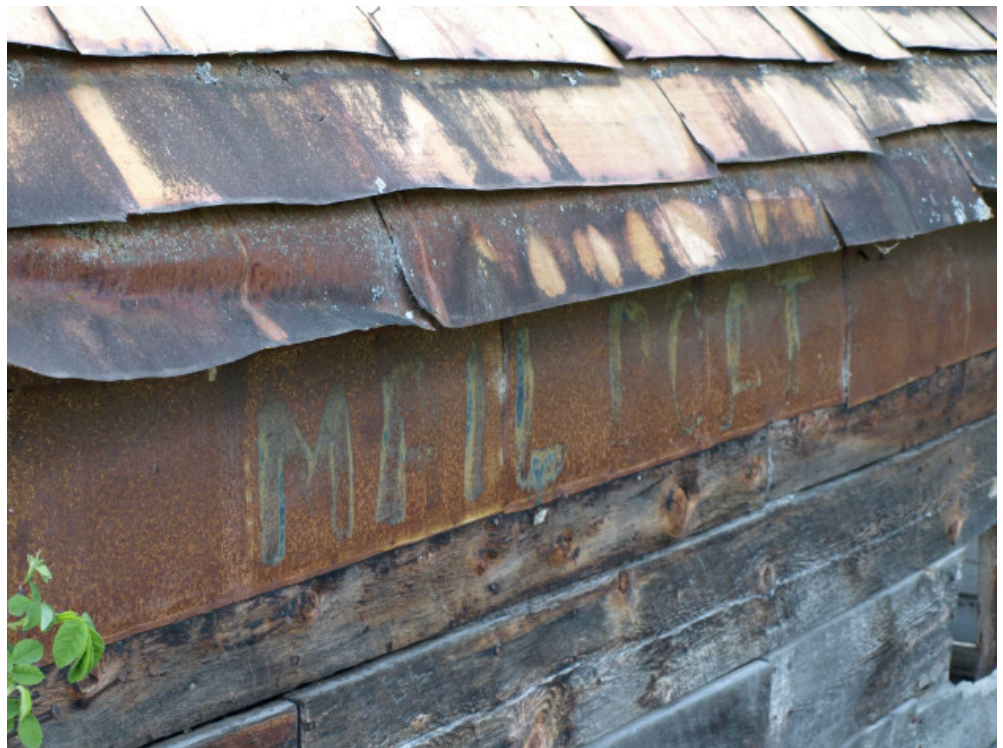
21. Exterior Photo: Roof Detail
