**REPORT ON  
THE CULTURAL RESOURCES AT  
COAL CREEK**

Bob Mitchell  
CAPHC

# REPORT ON THE CULTURAL RESOURCES AT COAL CREEK

AS FOUND IN AUGUST OF 1992

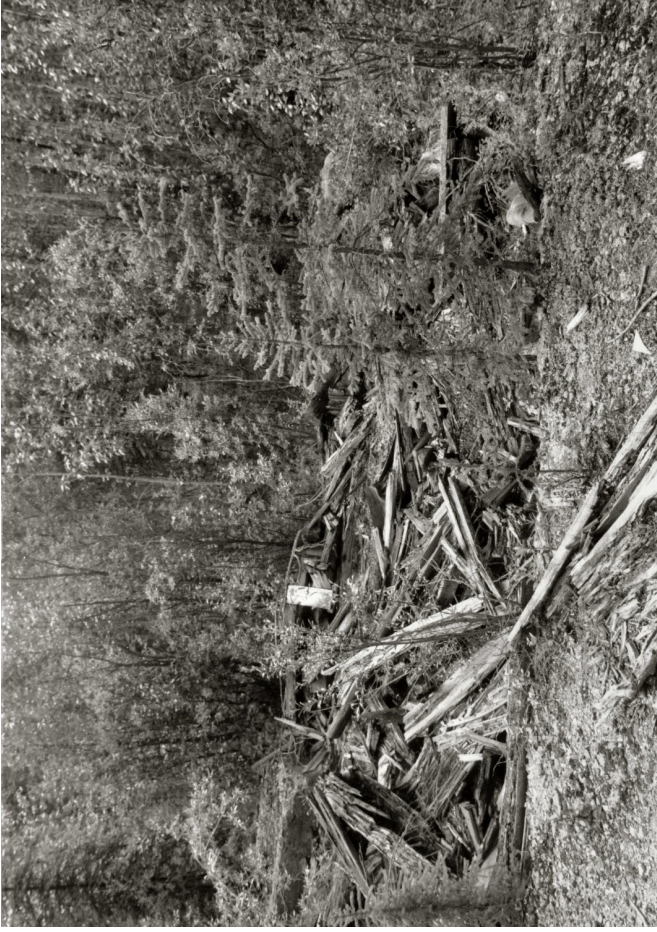
- A10 South-west corner of foundation - note absence of concrete floor
- A11 Debris near south-west corner of foundation
- B 1 Looking south along debris at south-west corner - note concrete piers
- B 2 Looking west along debris at south-west corner - note bag casts

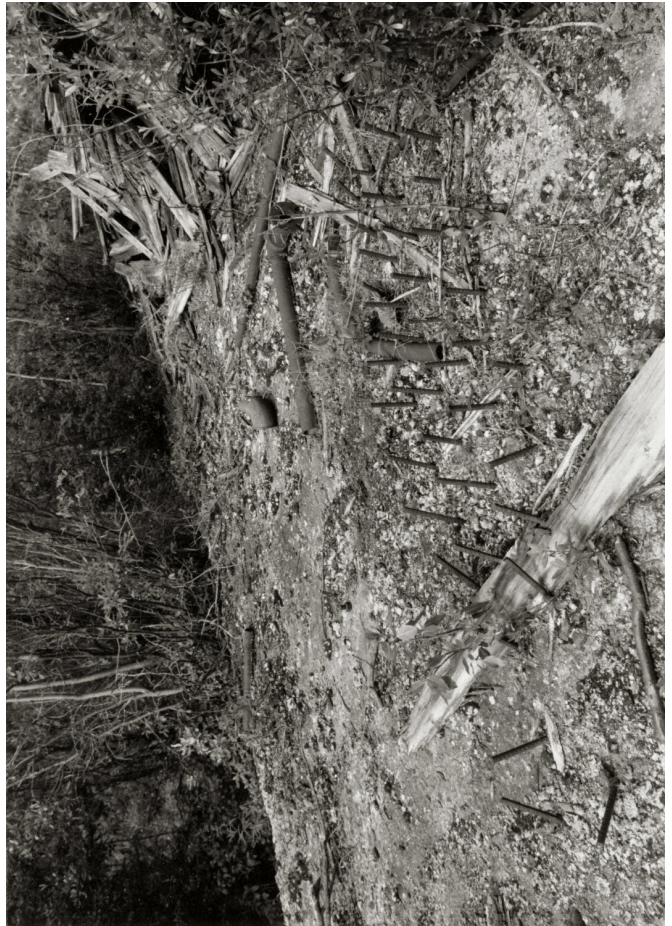
A24

- (A 6) Debris near south-west corner of foundation
- (A 7) Looking west along foundation from south end of Bay 6
- (A 9) Bolts embedded in concrete in Bay 8 for mounting machinery
- (A24) Close-up of debris near south-west corner showing bag shaped casts

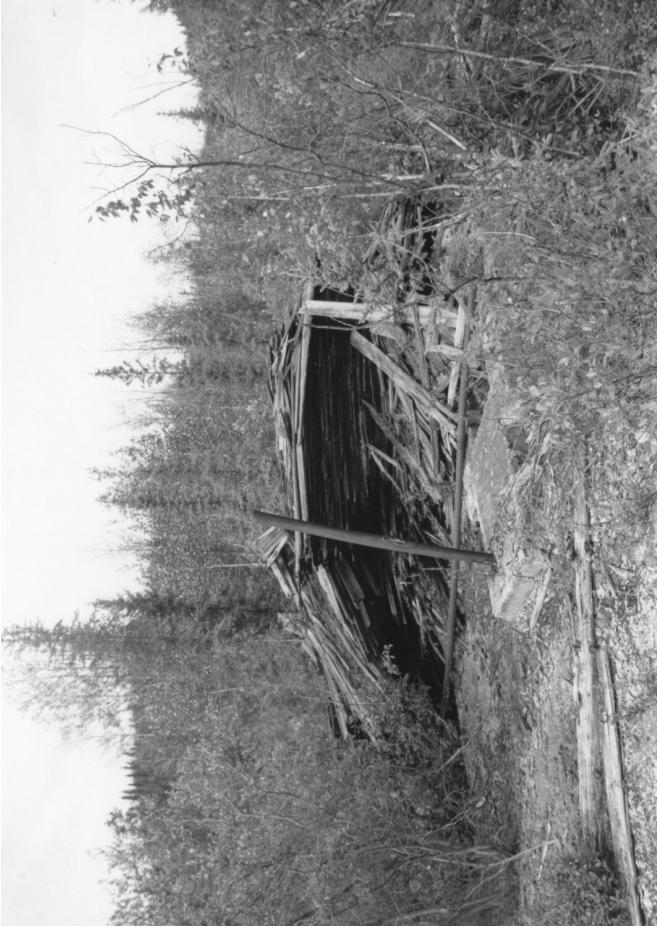
A08

- (A 8) Lumber stacked at north-west corner of foundation
- (A12) South end of lumber stack at north-west corner of foundation in Bay 8
- (A14) Low concrete platform near north-west corner in Bay 7
- (A19) East end of lumber stack

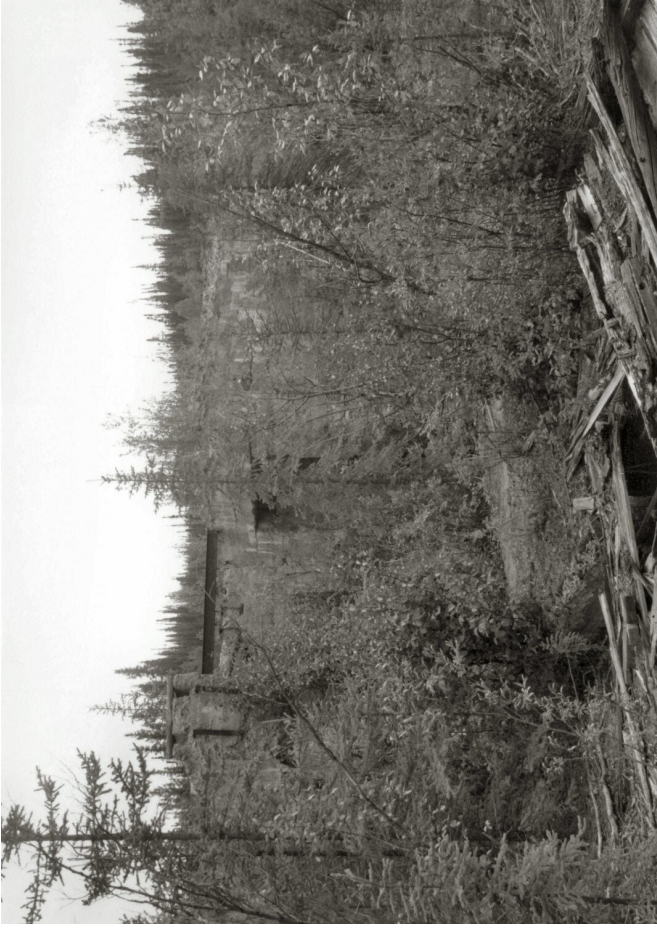
- A15 Looking east from low concrete platform
- A16 Gutter in Bay 8
- A20 Doors in lumber stack
- A21 Looking east from lumber stack - note gutter in foreground

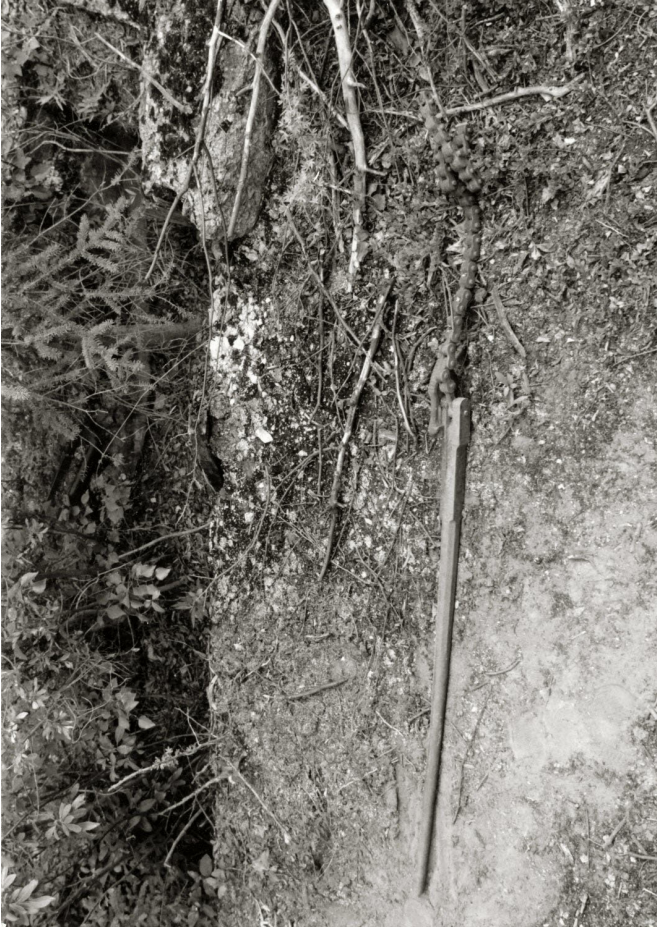
- A13 Cable protectors
- A17 Large chain wrench
- A18 Large chain wrench
- A25 Barrel hoop at south-west corner of Bay 8

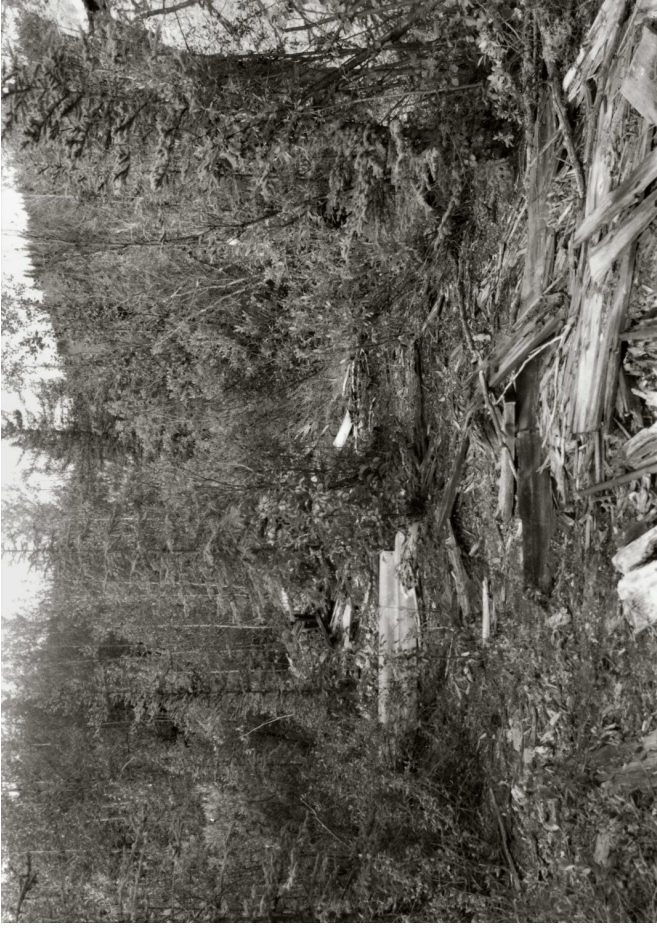
B03

- (A 2) South side of Bay 6
- (A 5) South side of Bay 6
- (B 3) Looking west along south side of foundation
- (B 4) Looking north-west from south side of foundation towards Bay 7

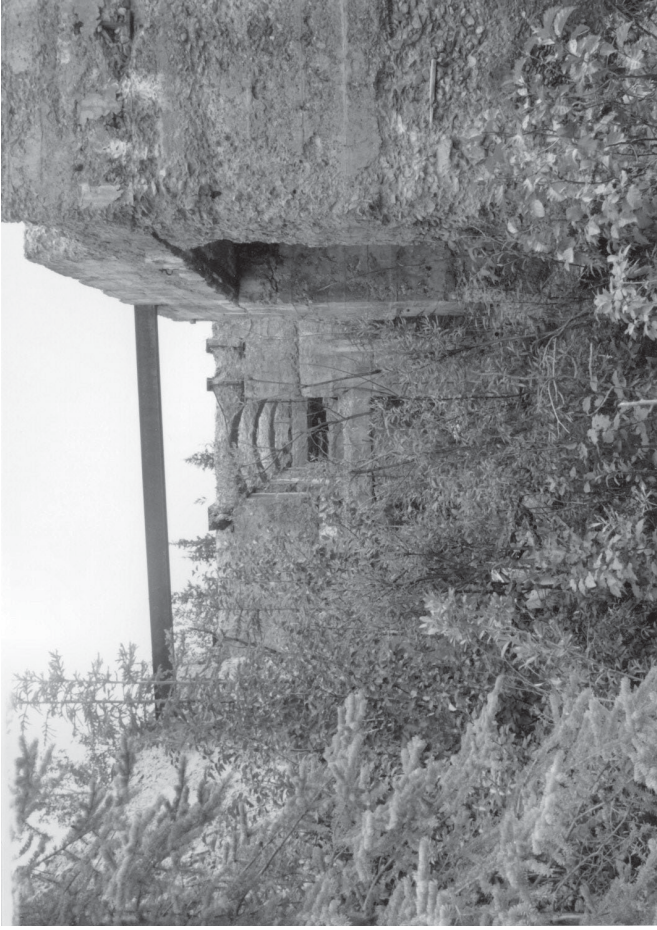
A22

- A 22 East wall of Bay 6
- A 23 East side of Bay 7
- A 26 South wall of Bay 6
- G 31 East wall of Bay 6

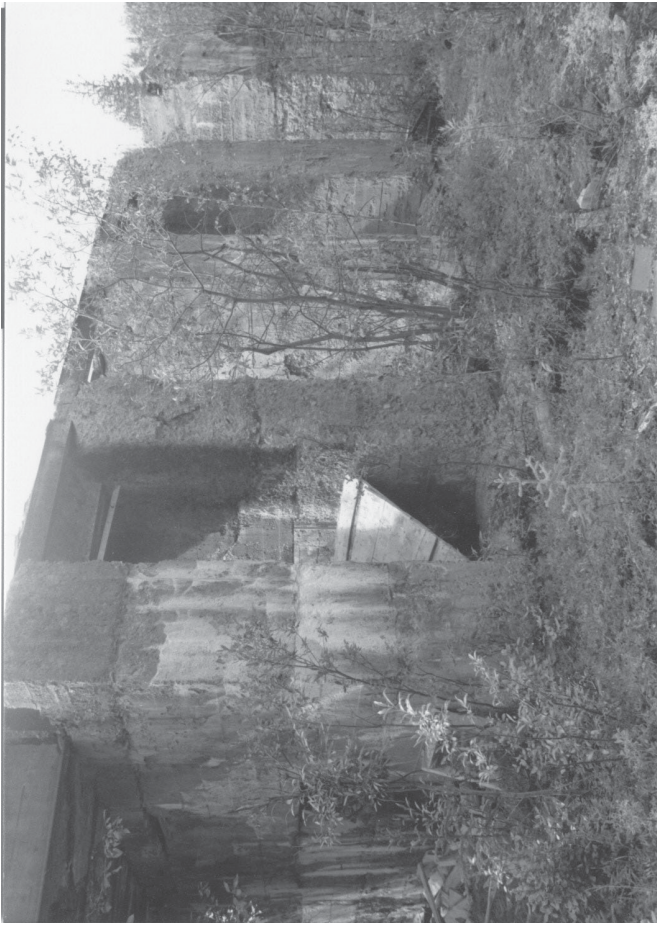
A29

- A 1 Looking north up Bay 2, note stack of lumber
- A 29 Looking south-west along north end of Bays 2, 3, and 4
- A 30 Looking south down Bay 2
- A 32 Looking south down Bay 4

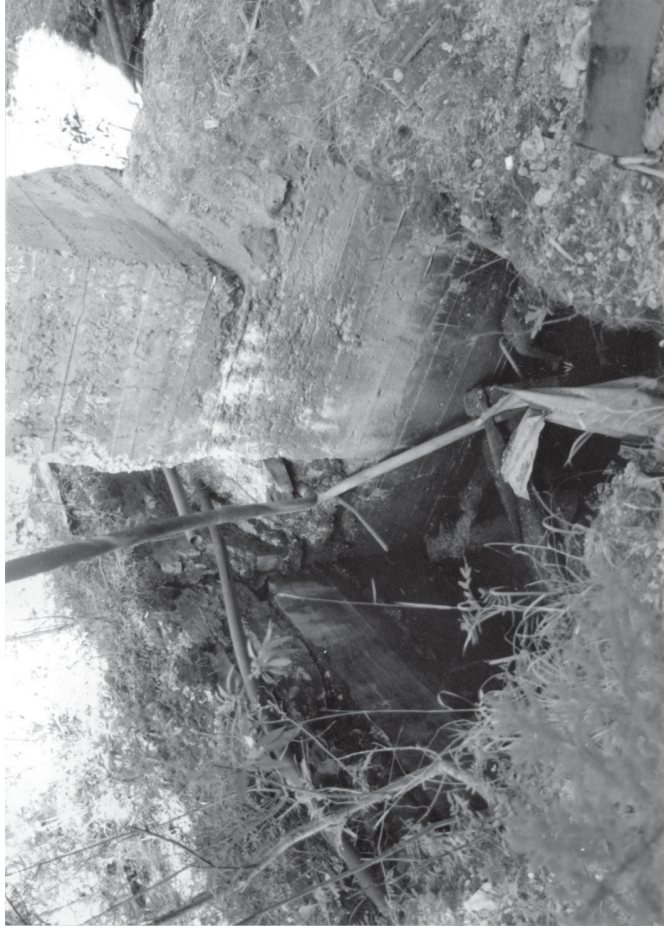
C03

- (B 27) Looking west to the south of the sump
- (C 0) Sump in Bay 4
- (C 2) Sump in Bay 3
- (C 3) Looking up at ceiling in Bay 2

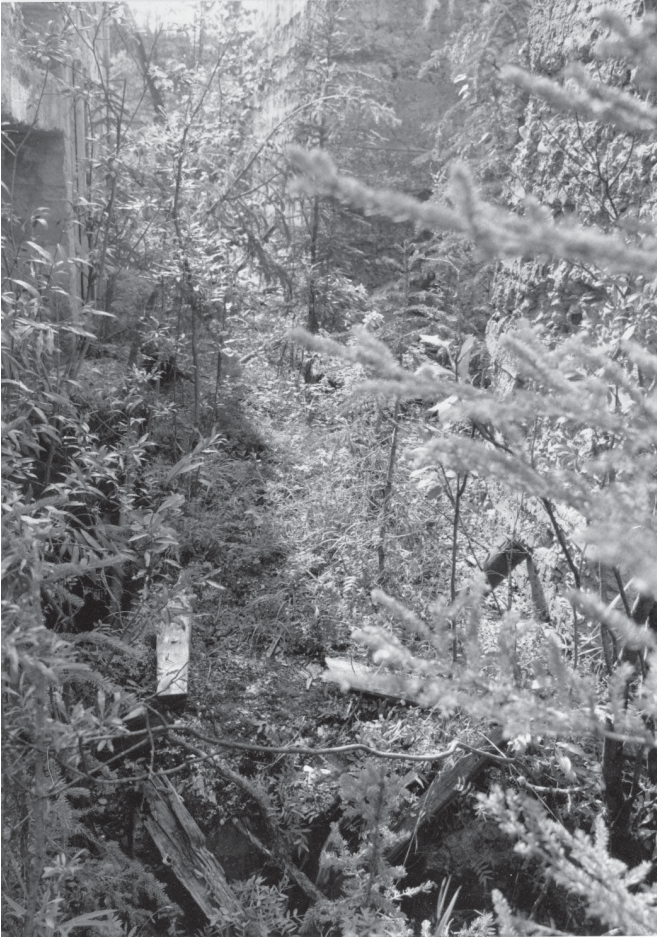
A33

- A 31 Looking south through Bay 3
- A 33 Looking south through Bay 5
- C 1 Artifacts in Bay 3

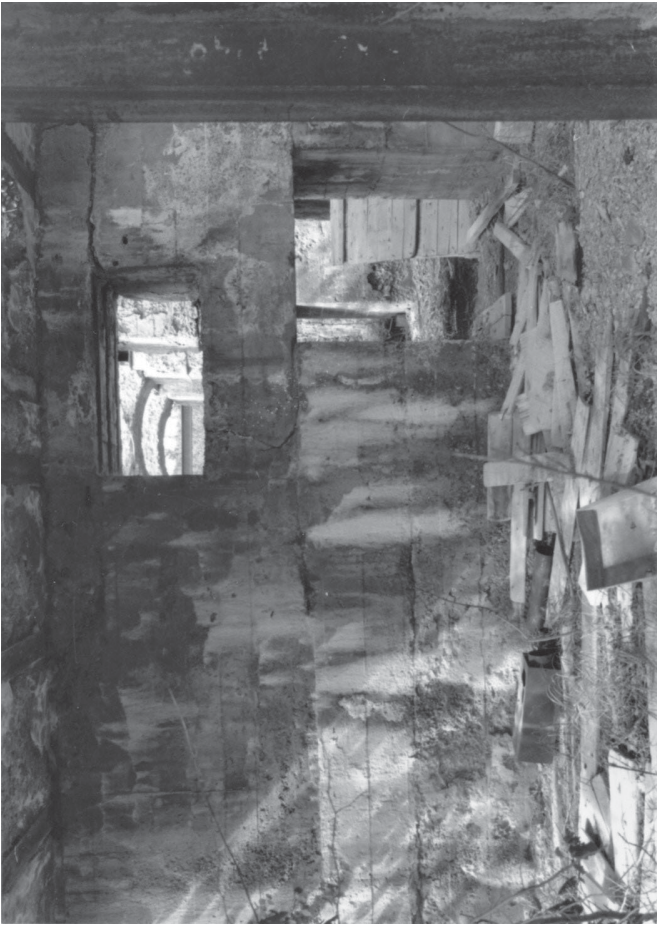
B35

- B 28 Looking south-west into Bay 1
- B 29 North elevation of Bay 1
- B 34 East elevation of Bay 1
- B 35 Close up of east wall of Bay 1

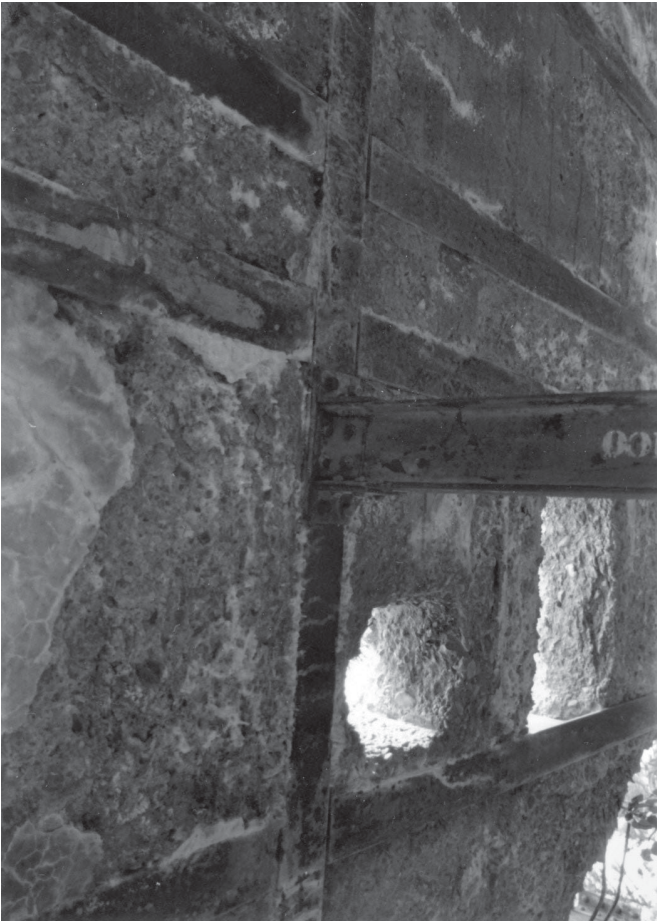
C05

- (B 36) Looking north at ceiling in Bay 1
- (C 4) Close up of stencilling on girder in Bay 1 "Skagway via Puerto Mexico"
- (C 5) Looking up at ceiling showing bolted girder/beam connection
- (J 3) Detail of concrete, looking north-west from east end (Bay 1)

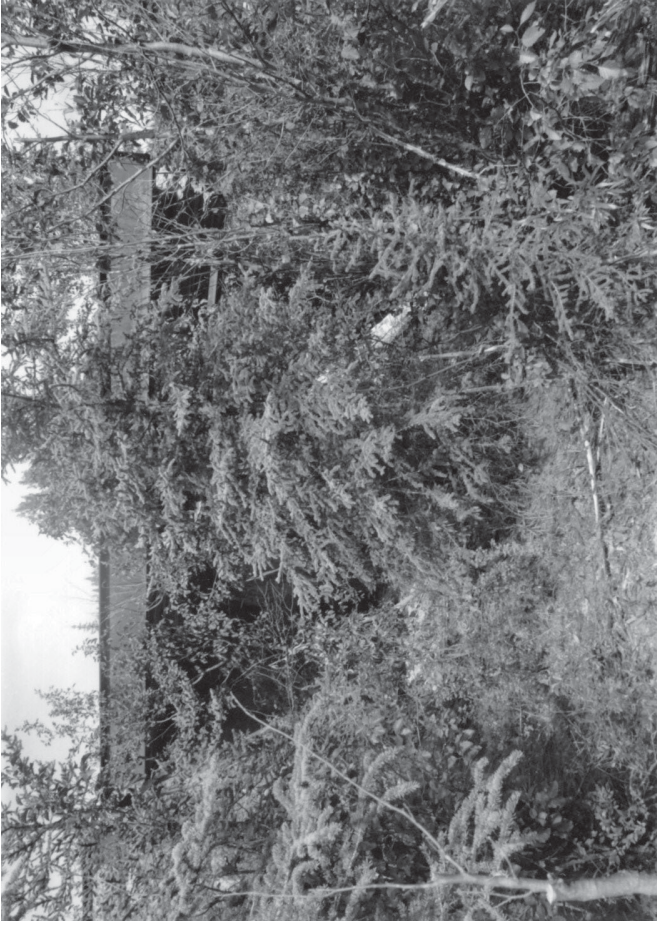
B07

- (B 7) South elevation of Bay 1
- (B 8) Looking north-east into Bay 1
- (B 31) Tool box in Bay 1
- (B 37) Debris on floor of Bay 1

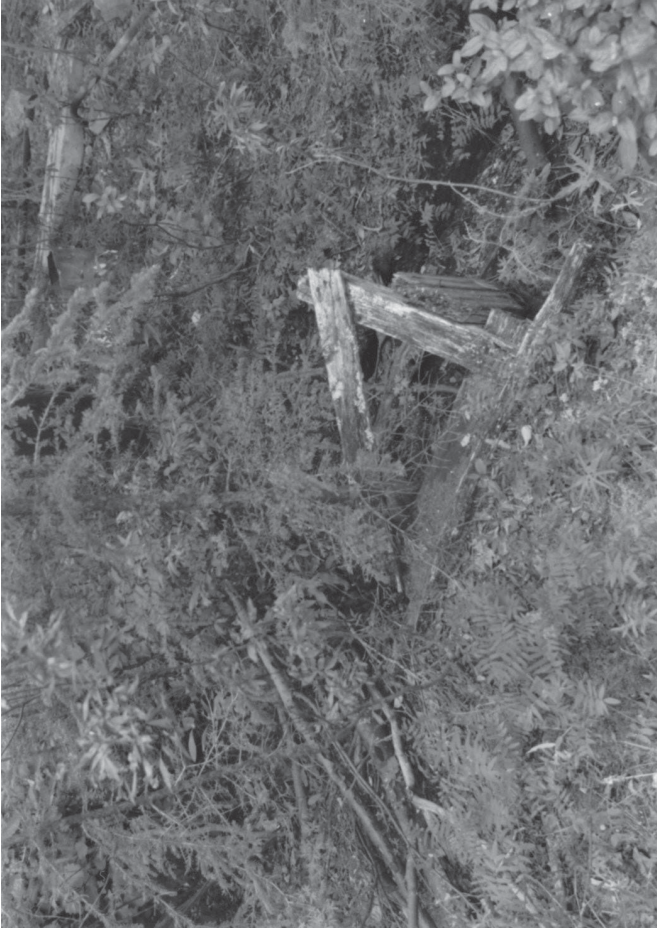
B30

- A 35 Large pipe elbow
- B 30 Wood remains in Bay 1 - possibly a shelf support
- B 32 Sheet metal remains in Bay 1
- B 33 Large metal funnel in Bay 1

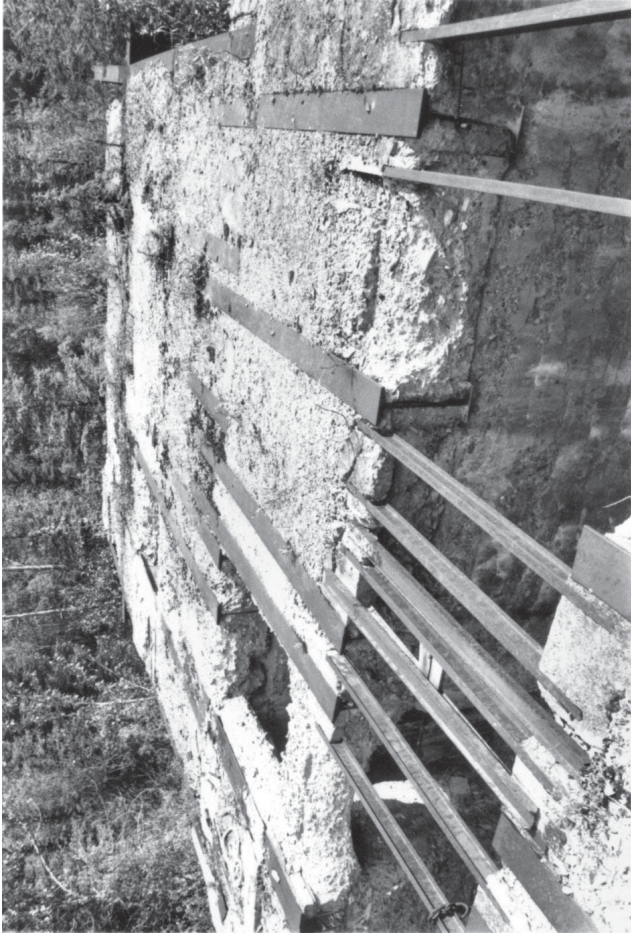
I17

- 116 Engine house, looking west from top of structure
- 117 Engine house, looking east from top of structure
- 118 Engine house, looking north from top of structure

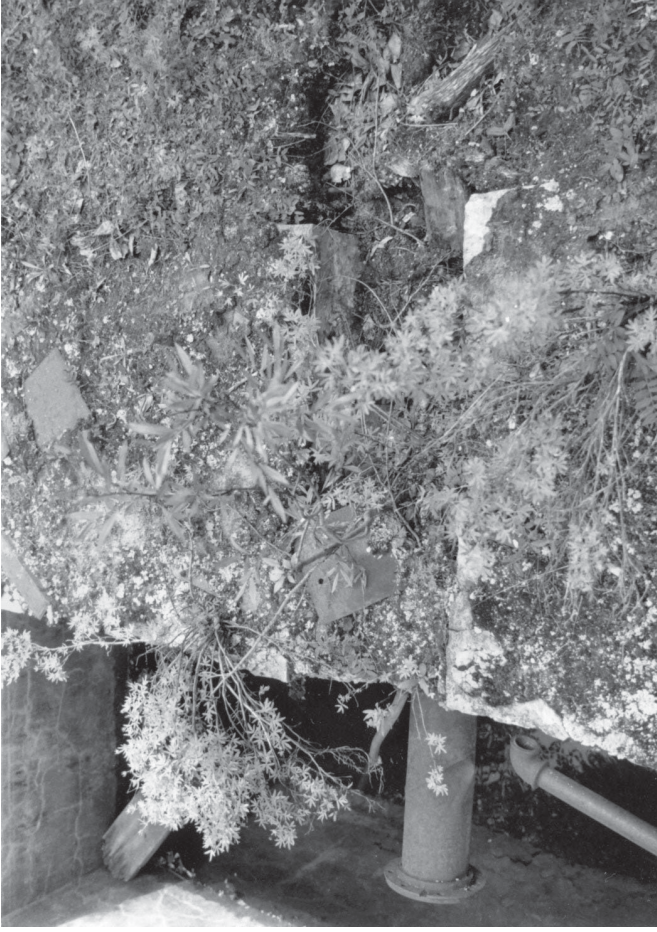
A28

- A 28 Gutter and pipe leading to sump north of Bay 2
- B 14 Looking back at Bay 1 from north-east corner of concrete tank
- B 24 Looking south along concrete tank
- B 26 Looking west along sump

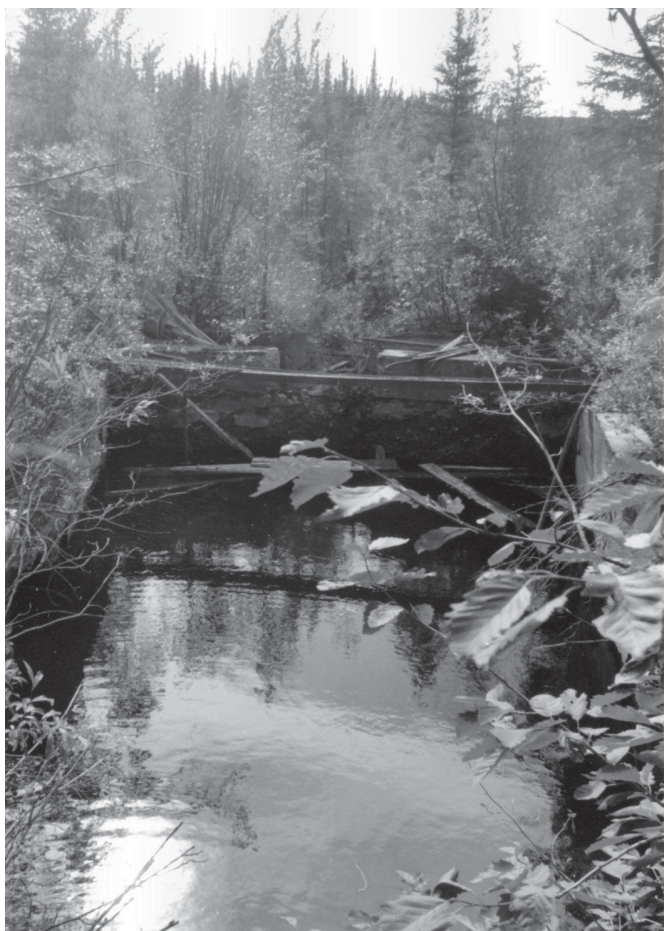
B24

There is a large concrete tank at the north-east corner of the power house foundation, that was used to store cooling water for the various machines used in the installation. It is still partly filled with water, indicating the high level of the ground water. The tank is starting to collapse in on itself.

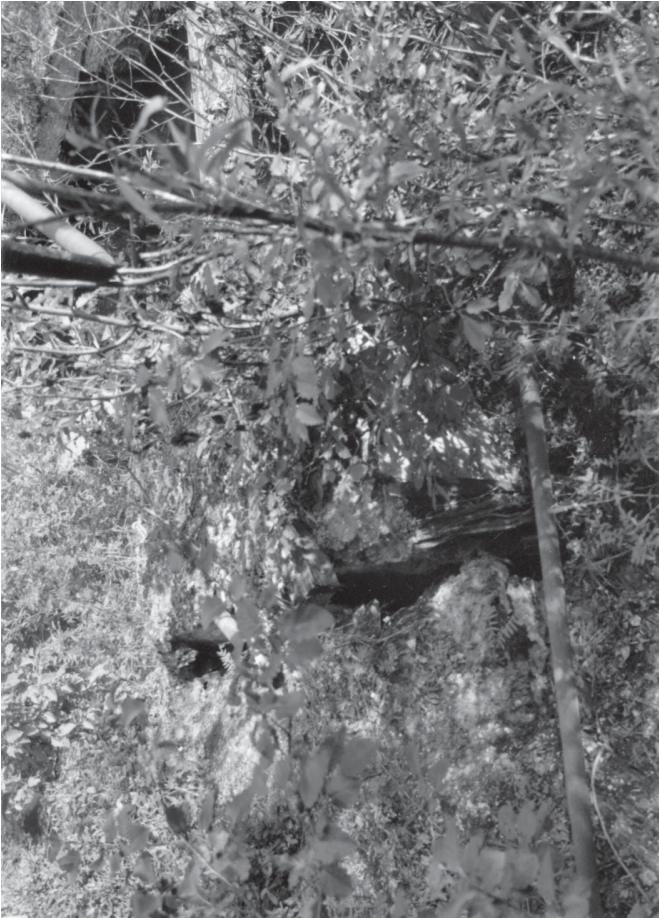
B10

- B 10 Looking north-east into south end of large concrete tank
- B 11 Looking at large gap along west edge of concrete tank
- B 12 Looking south-east into south end of concrete tank
- B 13 Looking north-east into north end of concrete tank

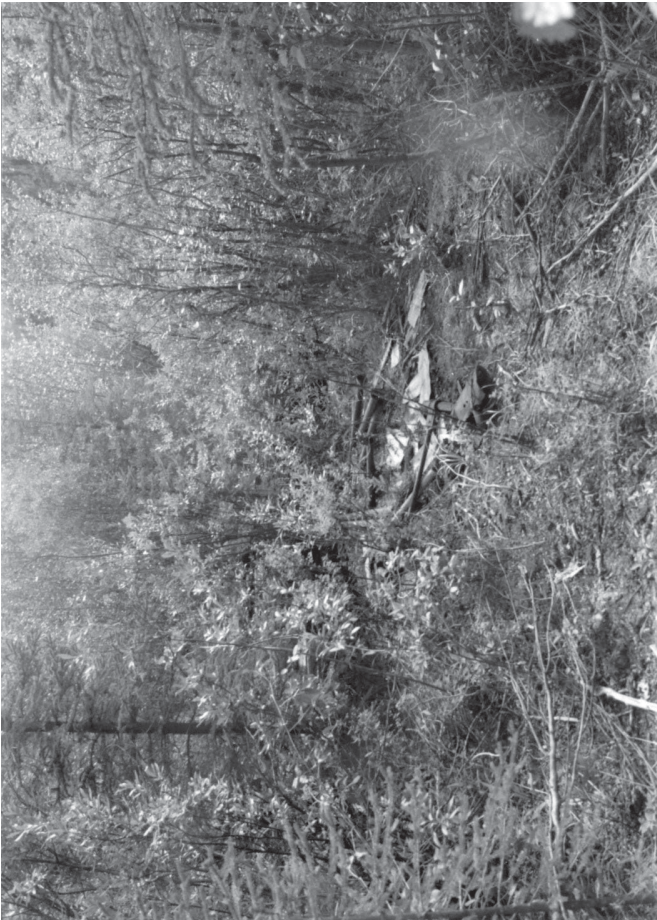
B06

- B 5 Looking east at debris at south-east corner of foundation
- B 6 Close up of debris at south-east corner of foundation

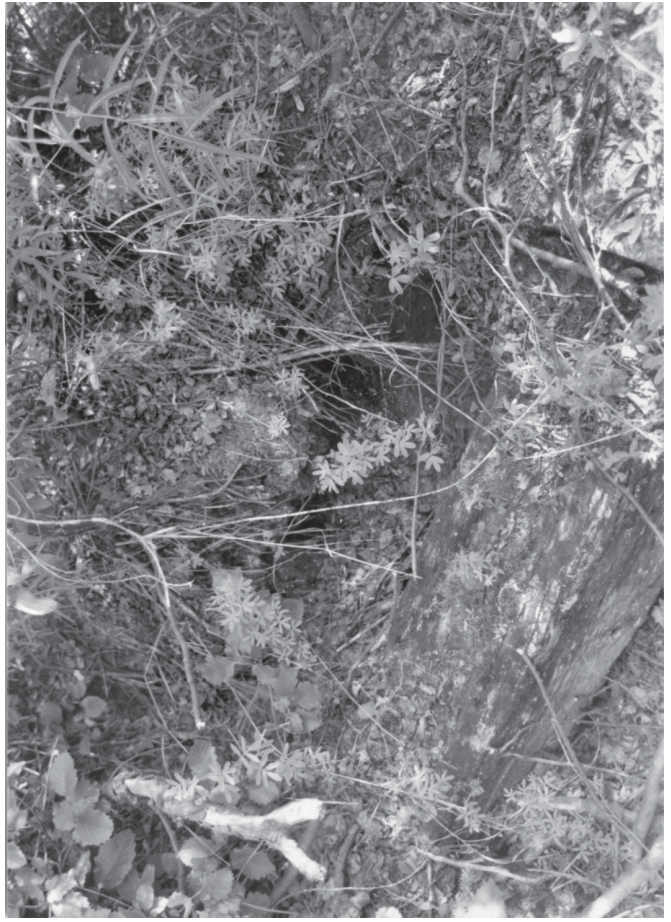
C08

- (B 25) Looking east from base of stack in Boiler House
- (C 8) Looking north from next to stack base towards transverse gutter
- (C 9) Gutter end at west side of Boiler House foundation
- (C 11) Looking into gutter

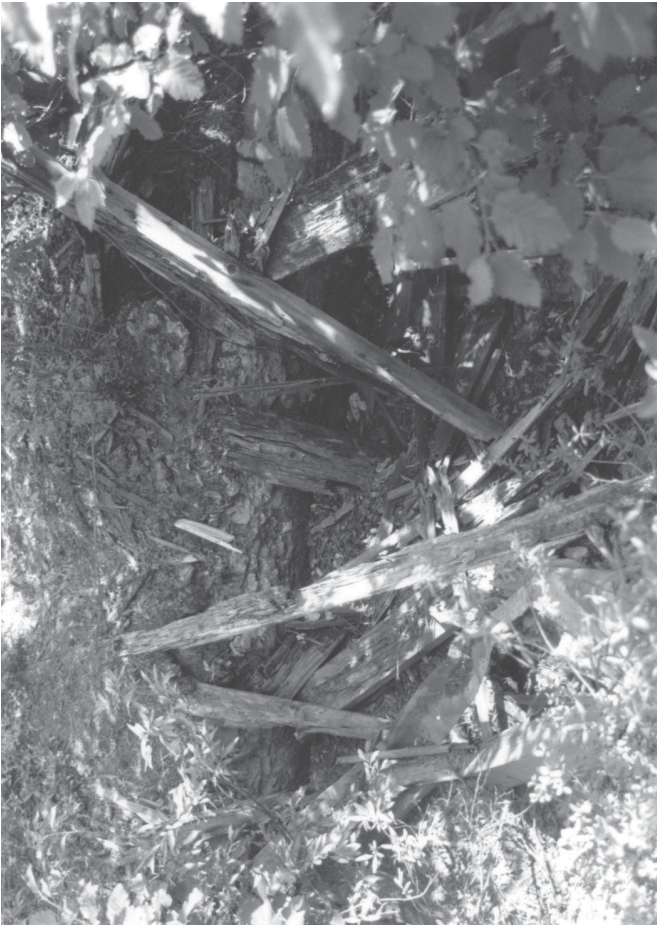
C22

- C 15 Looking south-east at trestle bents
- C 21 Looking north-west at trestle bents
- C 22 Looking at ground at collapsed trestles
- C 23 Trestle bents

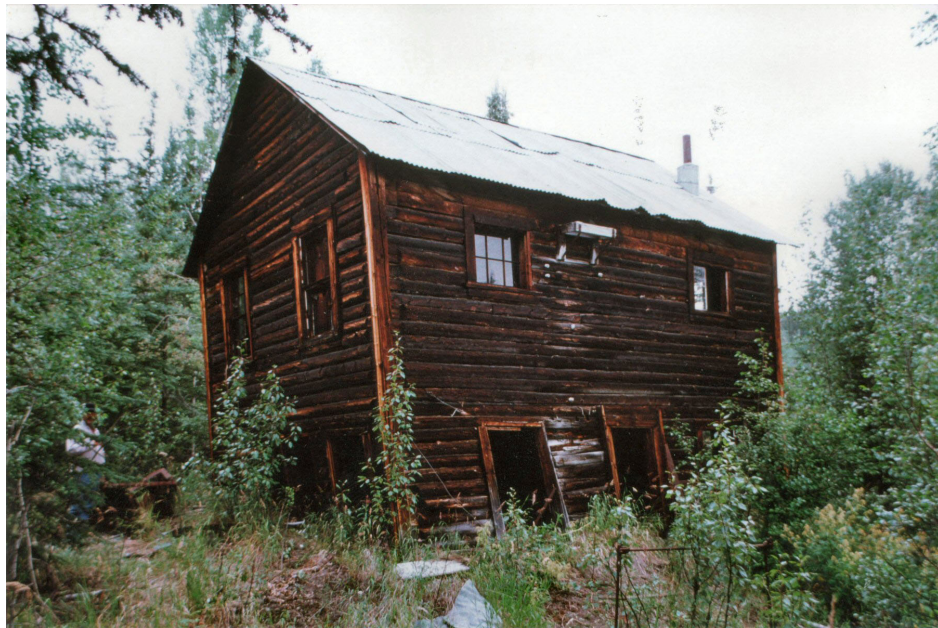
SB38

**T**his 7.63 x 5.81 metre building is identified as the mine office on the historic map on page 11, and appears to have been in use as a residence at some time in the near past (probably by a trapper). The building is in relatively good condition considering its age. It is the sole complete building still standing on the site, probably due to its log construction and its recent occupation. All the other buildings investigated appear to have been of wood frame construction.

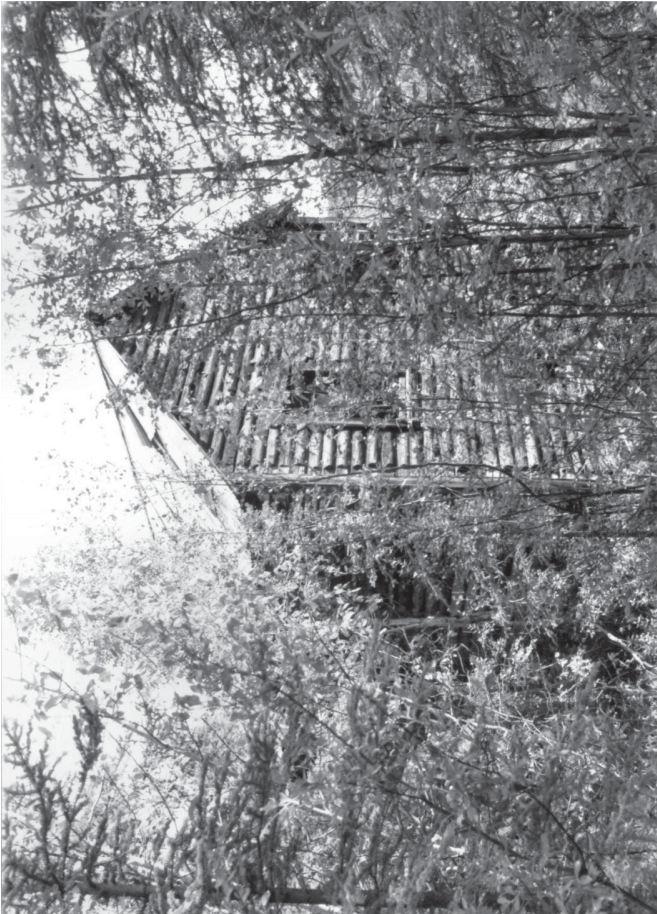
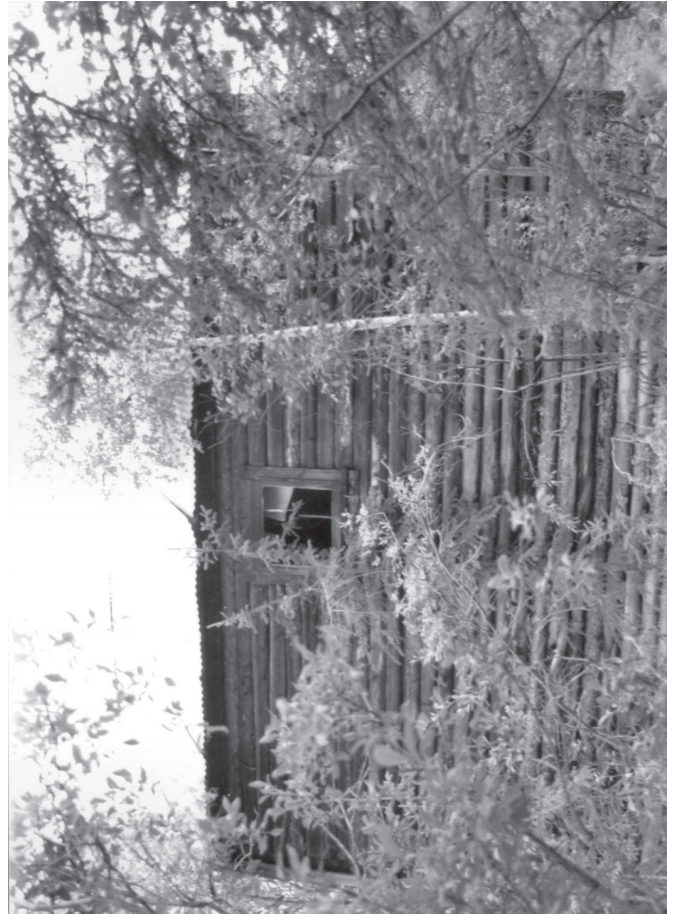
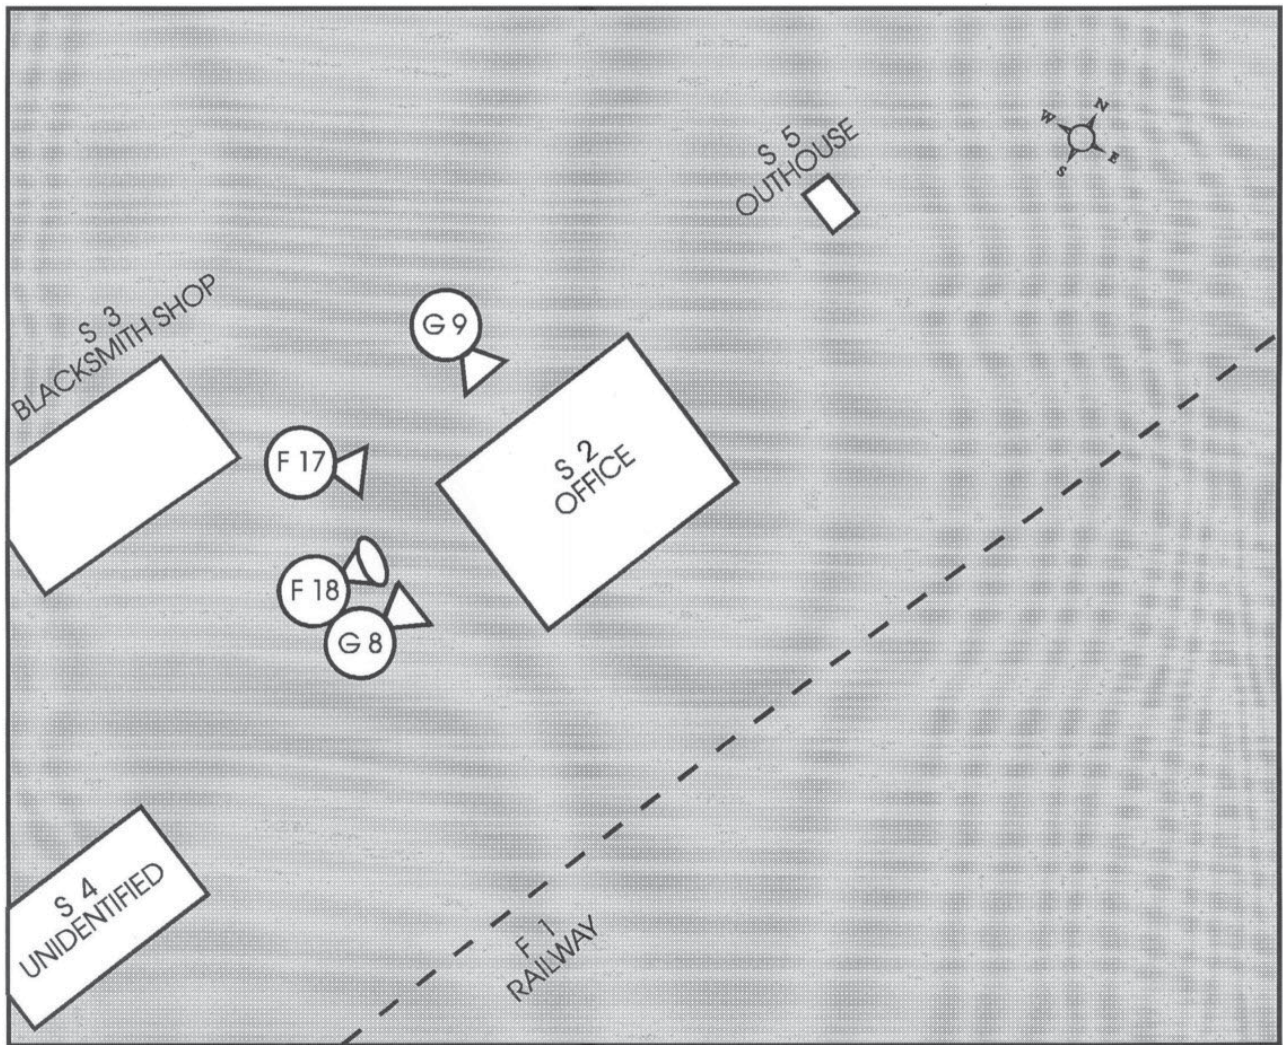
- F 17 3/4 view from south-west
- F 18 Upper portion of south elevation
- G 8 South elevation
- G 9 West elevation

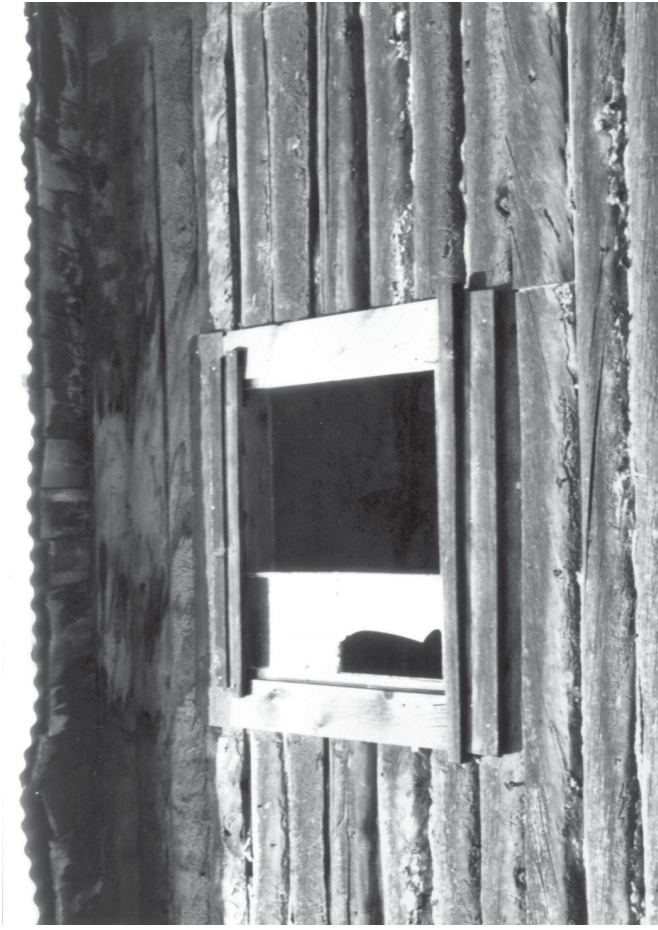
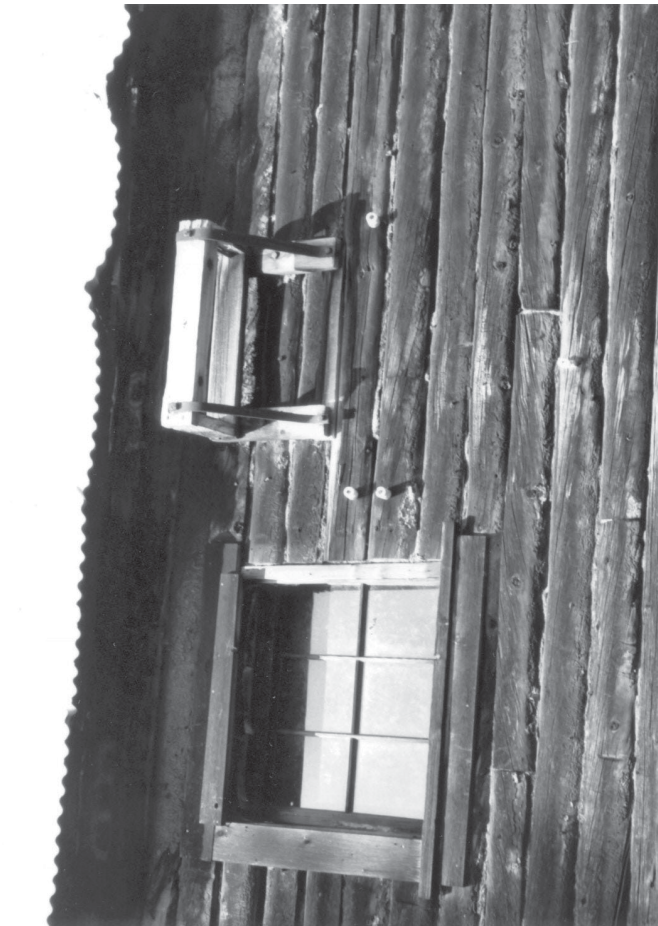
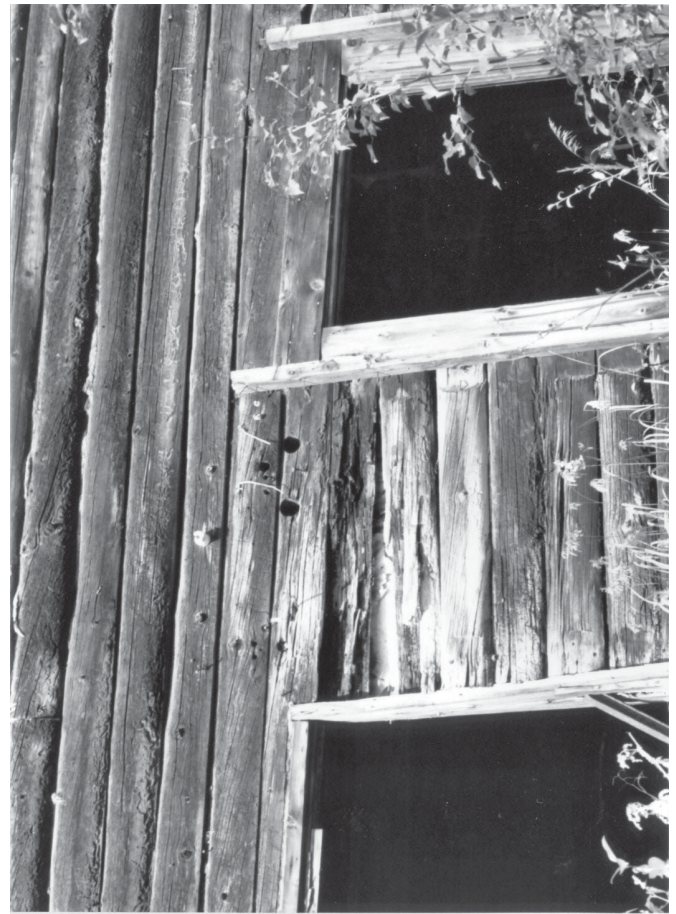
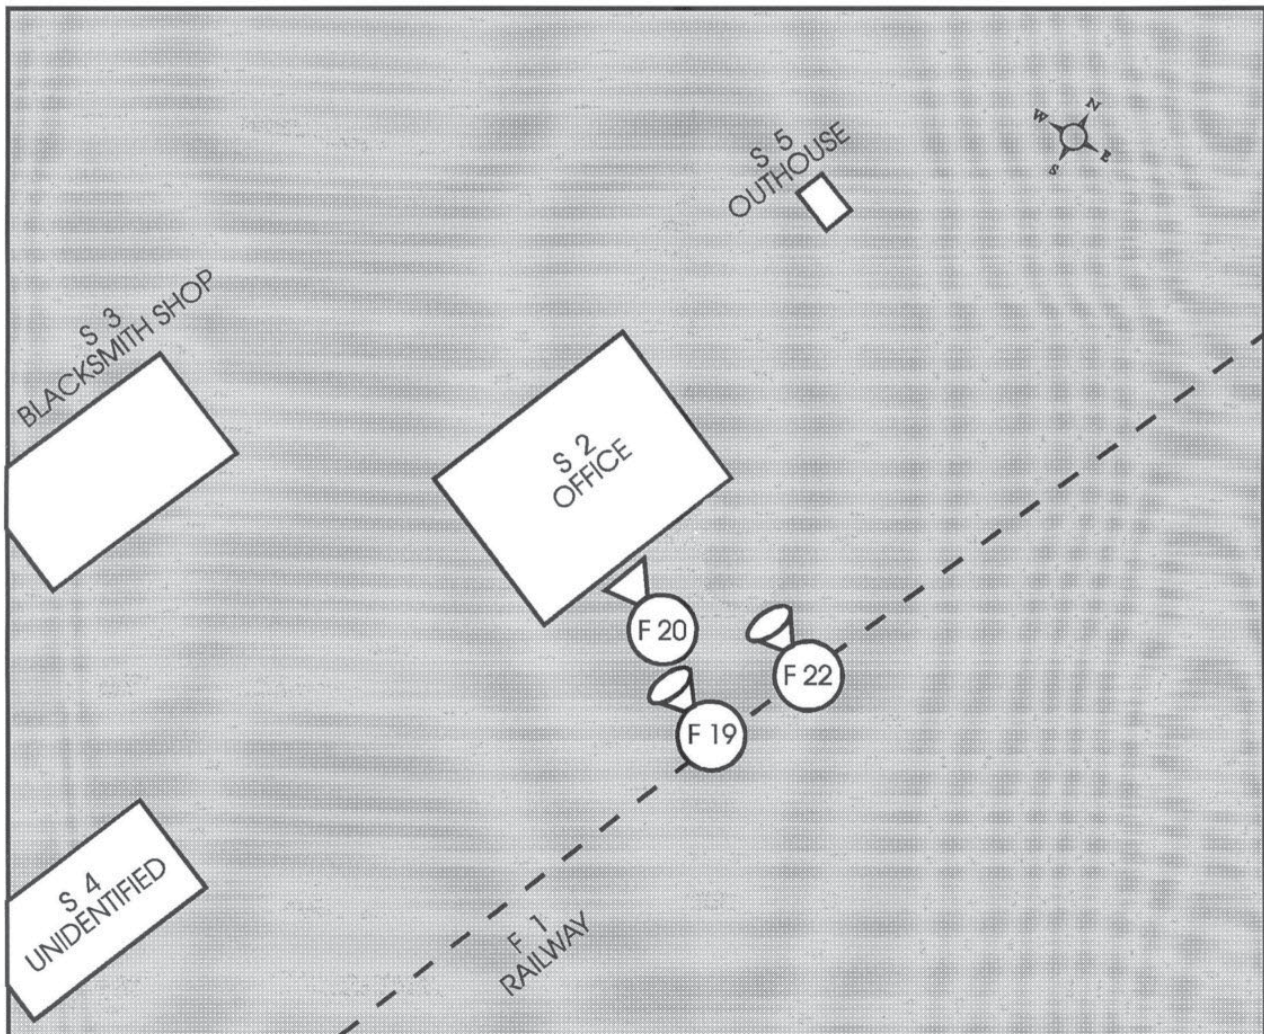
- F 19 Upper left window on east elevation
- F 20 Wall between lower left window and doorway on east elevation
- F 21 Lower right window on east elevation
- F 22 Upper right window on east elevation

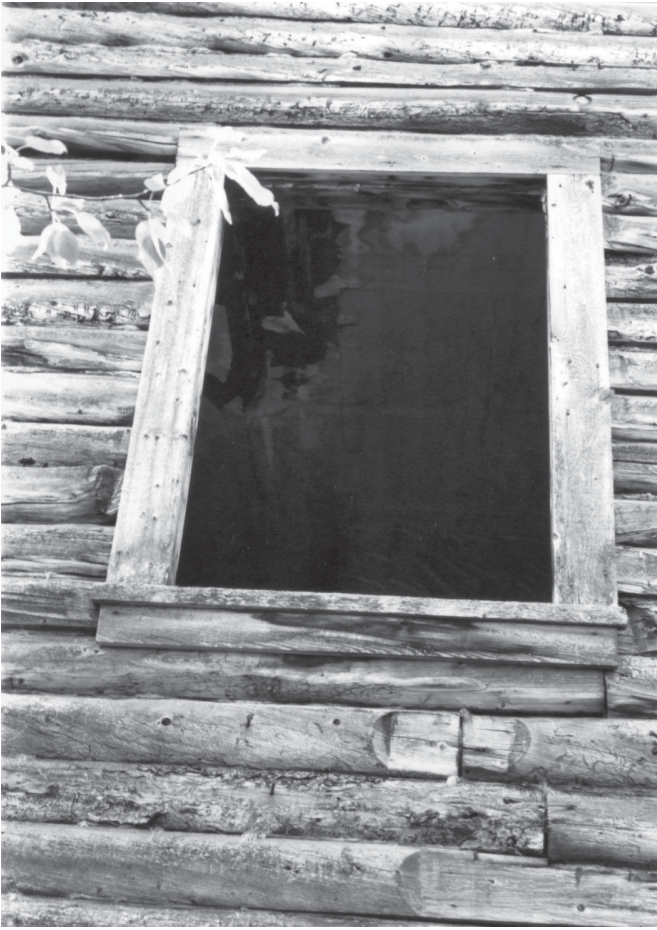
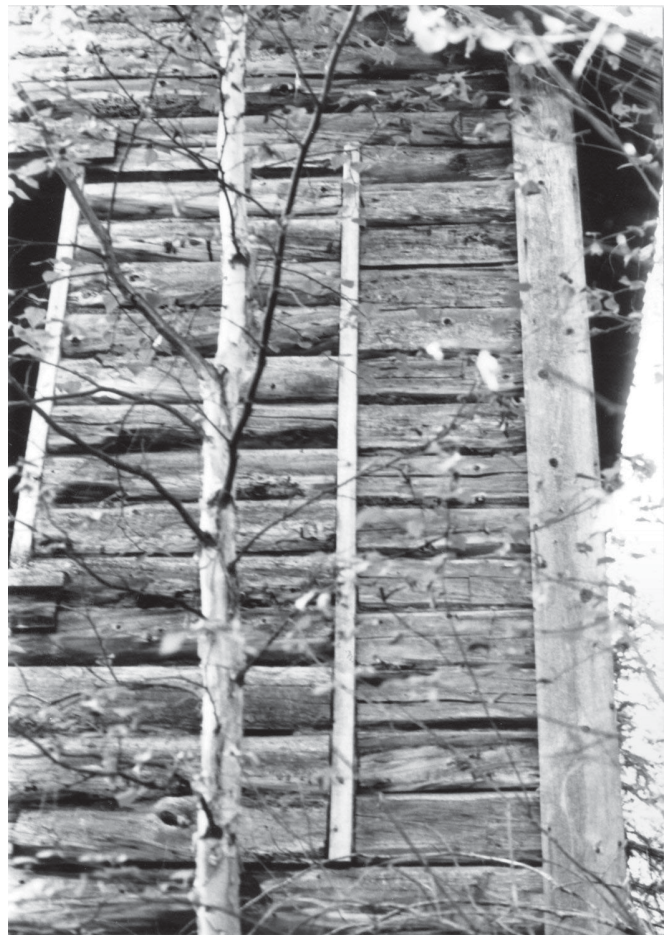
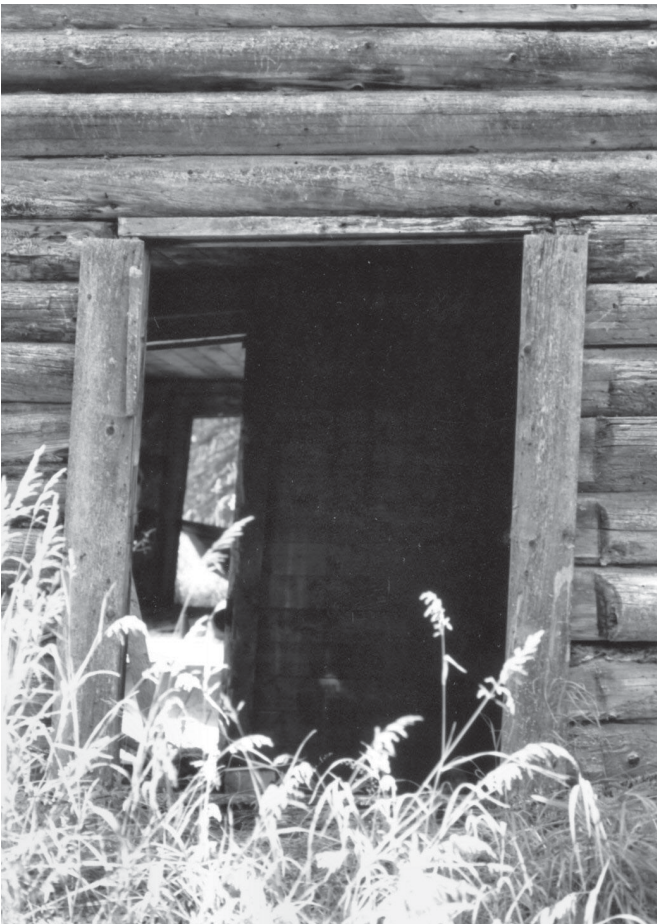
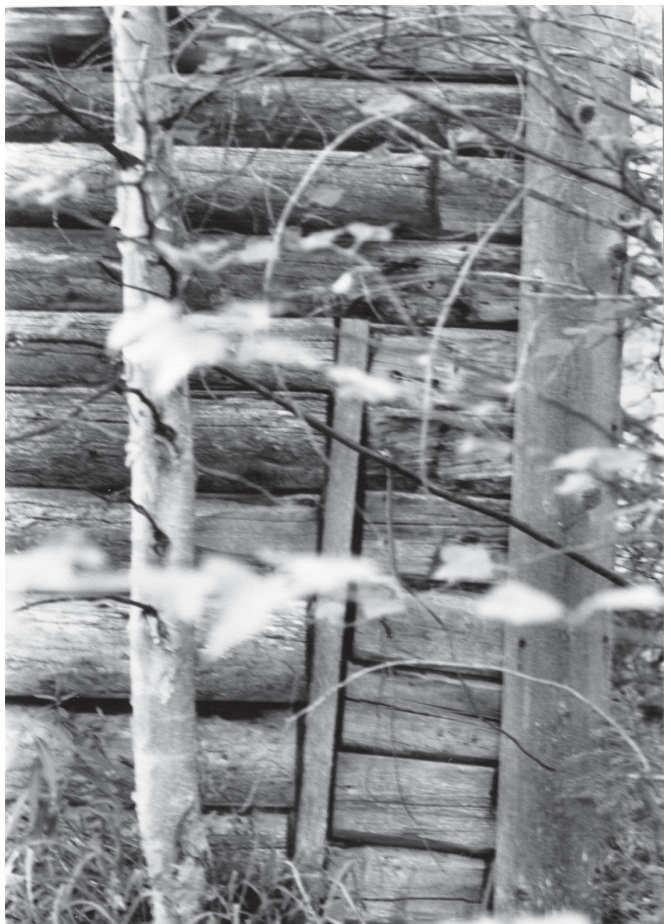
- F 23 Upper window on north elevation
- F 24 Lower window on north elevation
- F 25 Lower portion of north-west corner
- F 26 Upper portion of north-west corner
