**REPORT ON  
THE CULTURAL RESOURCES AT  
COAL CREEK**

Bob Mitchell  
CAPHC

# REPORT ON THE CULTURAL RESOURCES AT COAL CREEK

AS FOUND IN AUGUST OF 1992

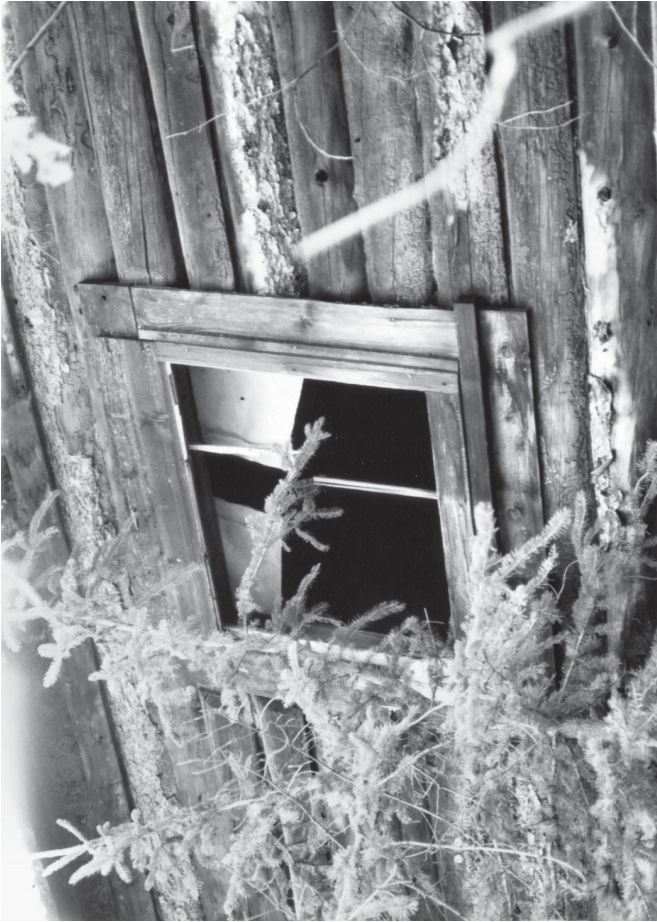
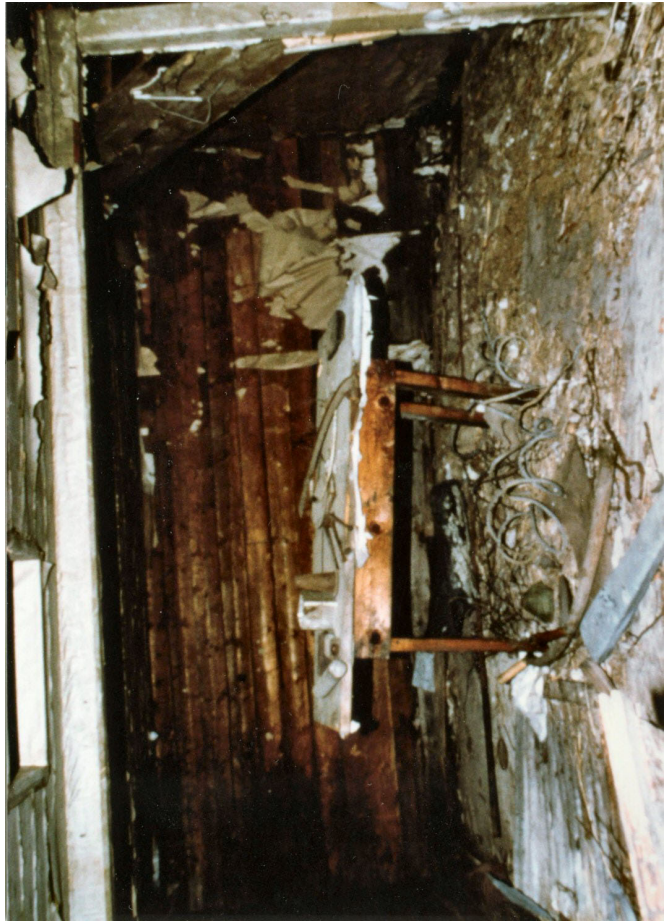
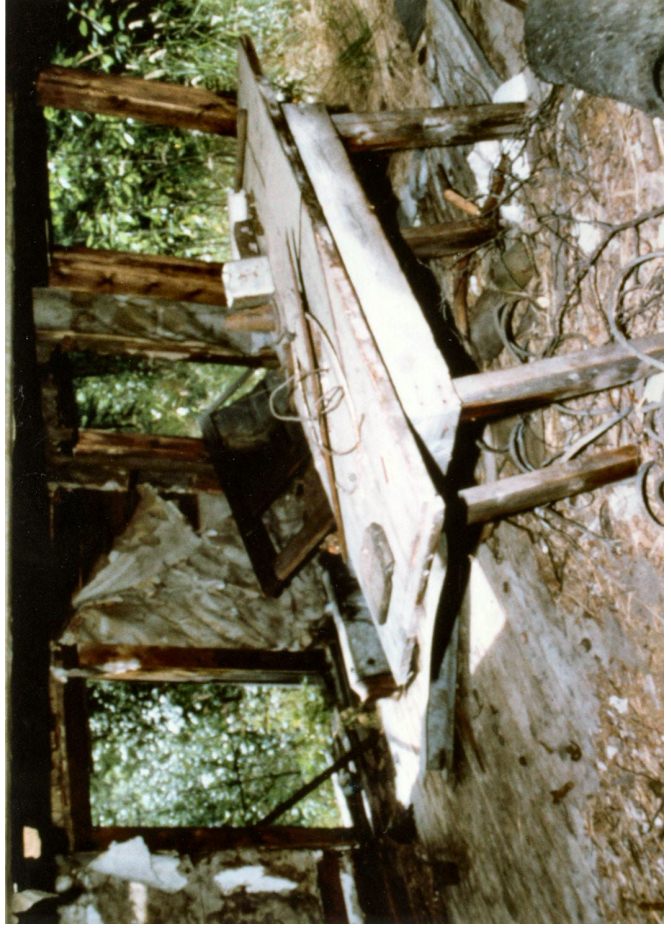
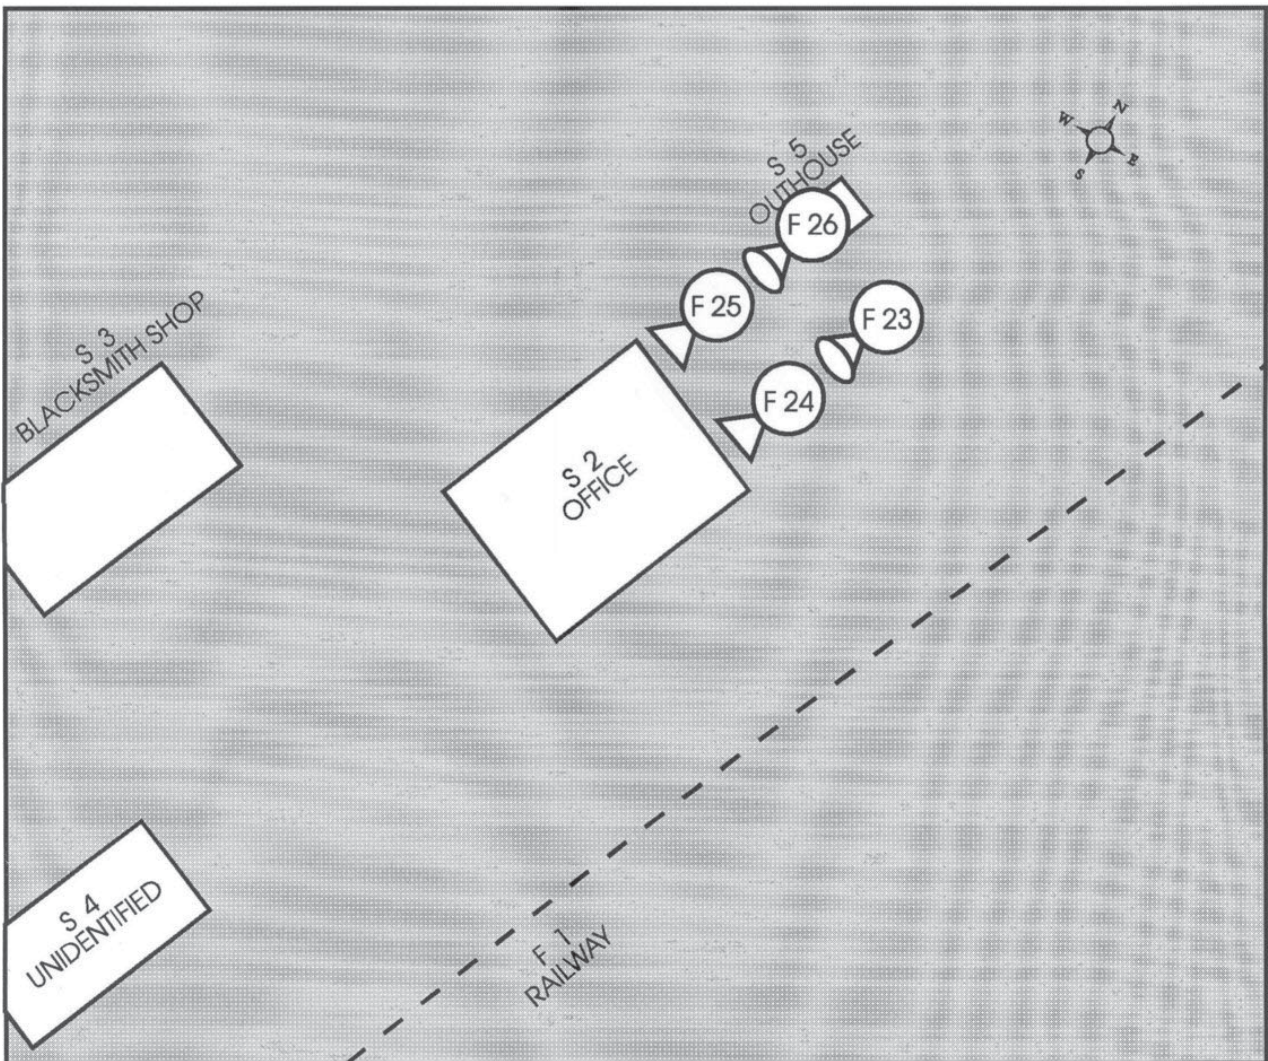
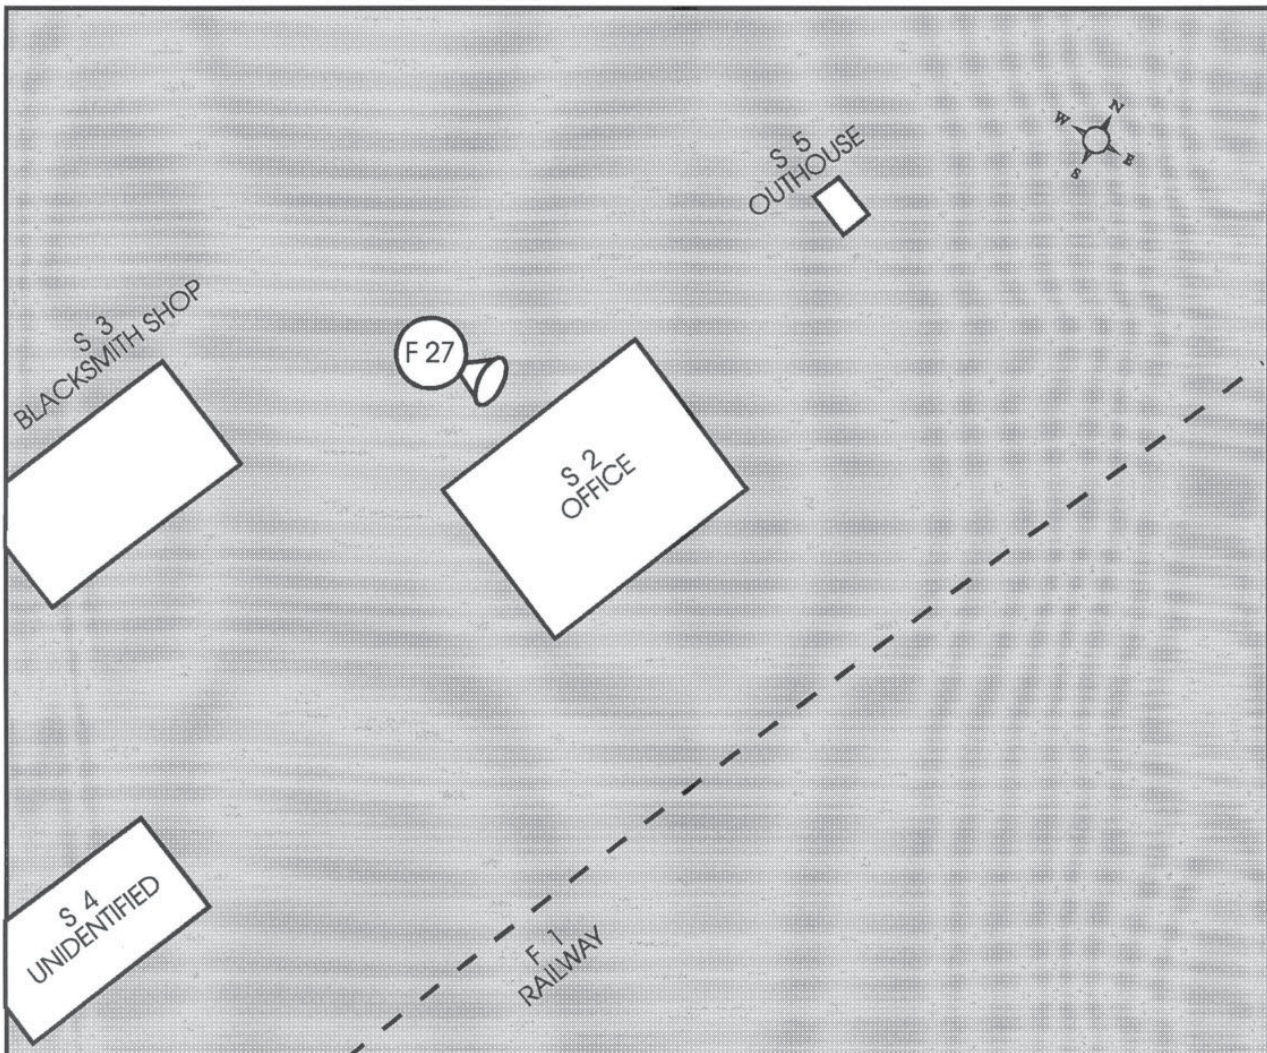
- F 27 Upper window on west elevation
- SH 3 Room 1-01, looking west from doorway
- SH 4 Room 1-01, looking south-east from north-west corner

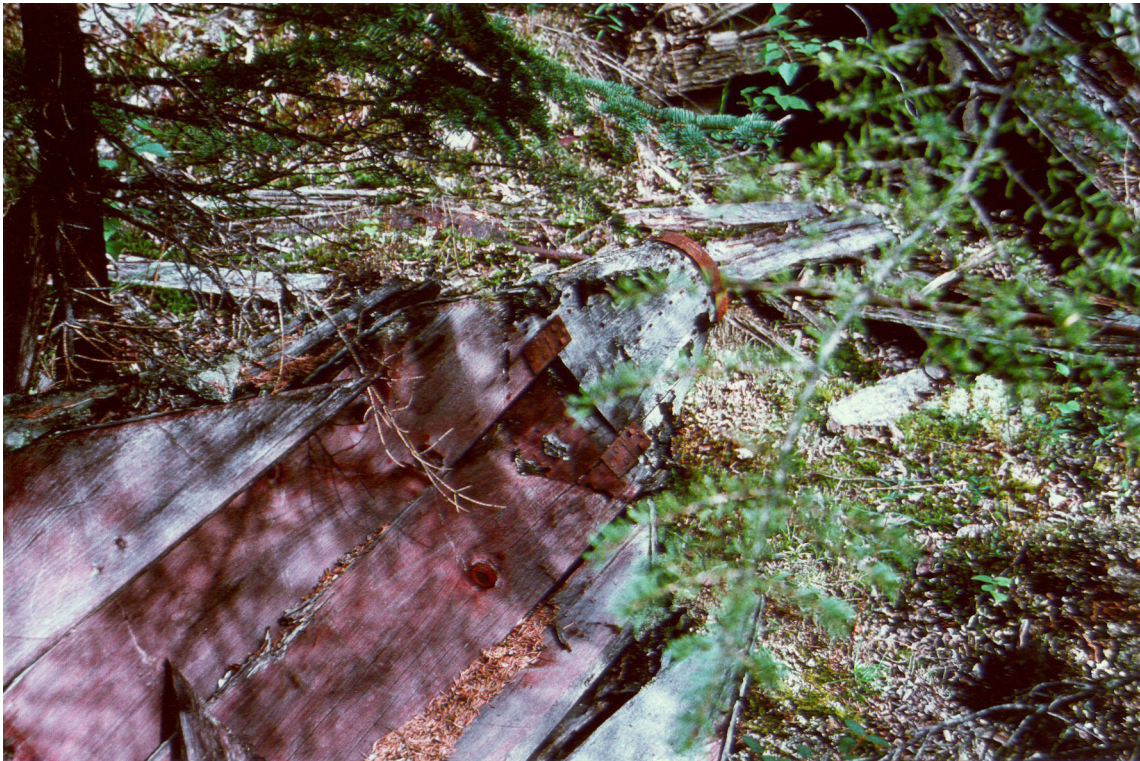
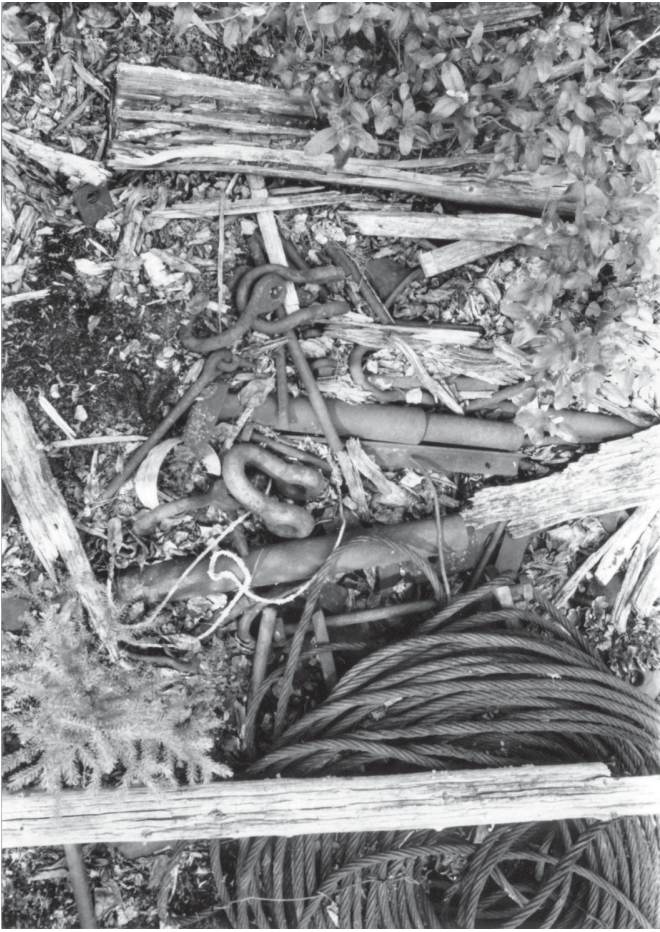
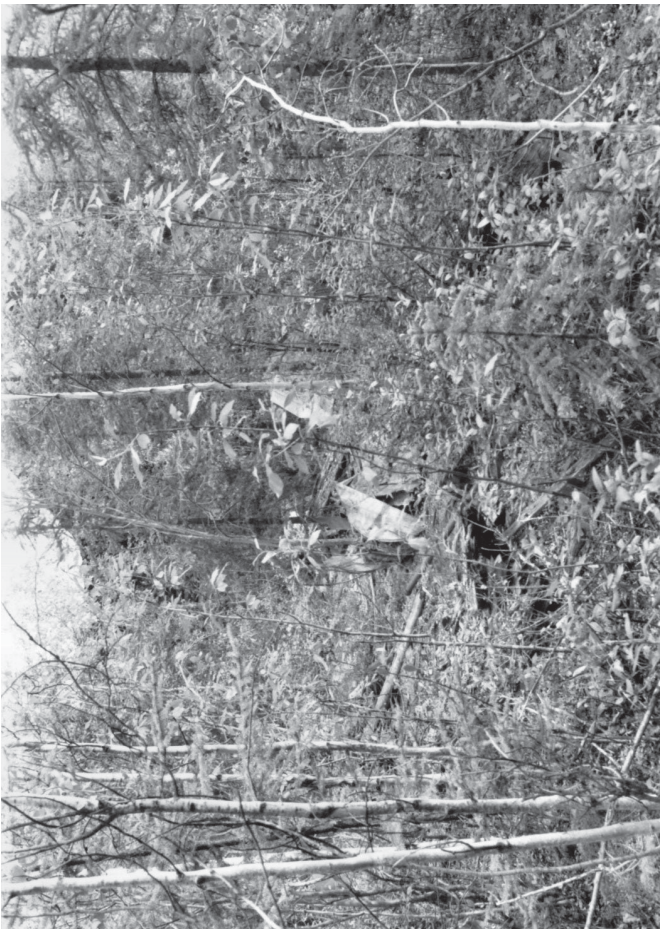
SE34

In historic photographs, it appears to be very rustically constructed, roofed with wood slabs. Today, very little of the structure remains, except for some planks.

- F 33 Remains of bellows
- F 34 Cable, connector, and other metal scraps

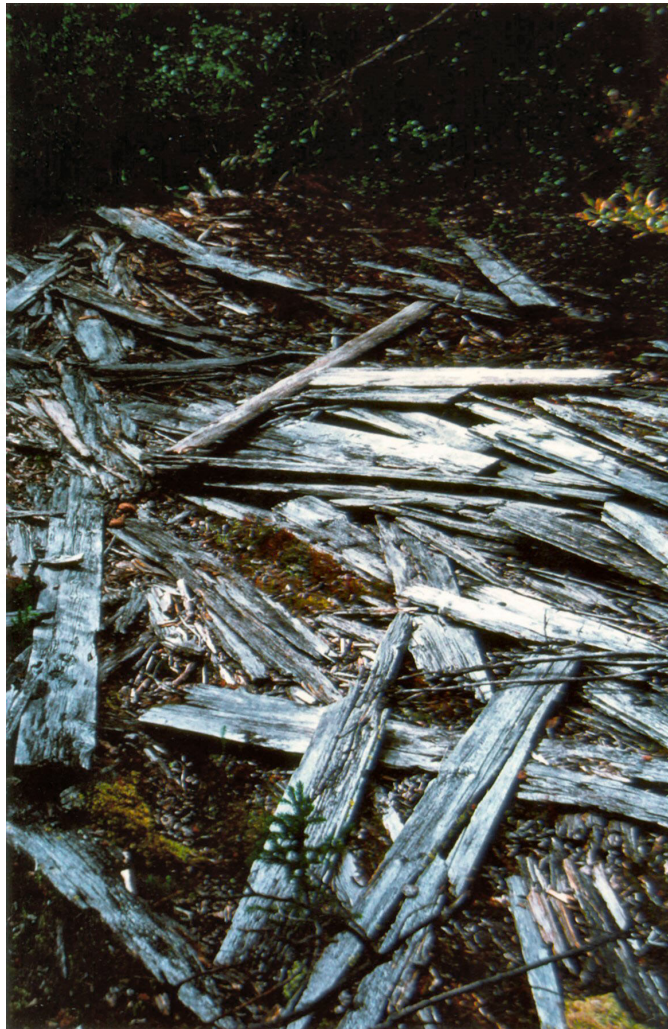
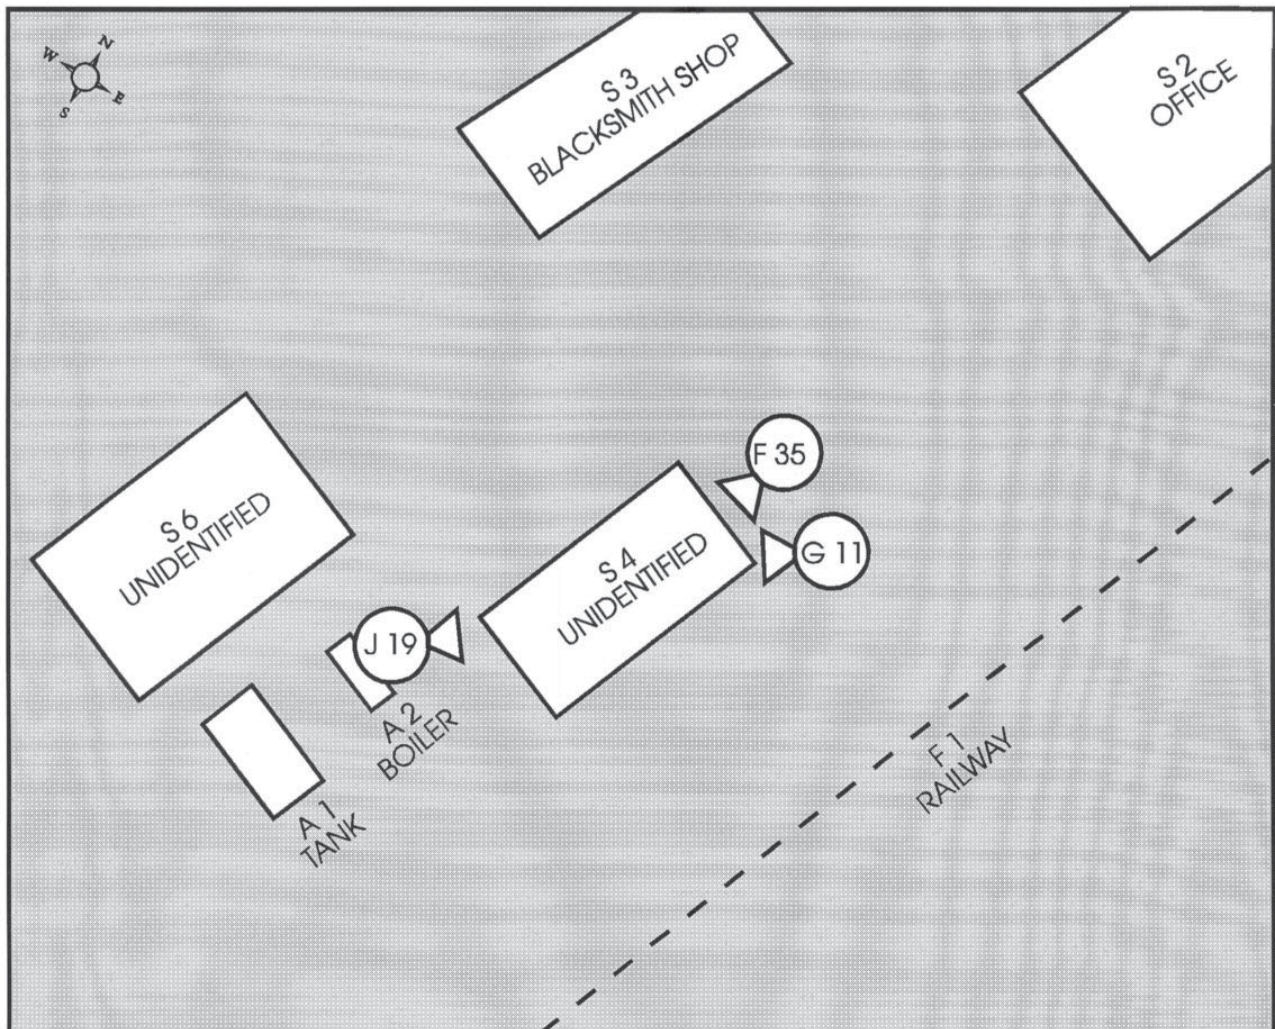
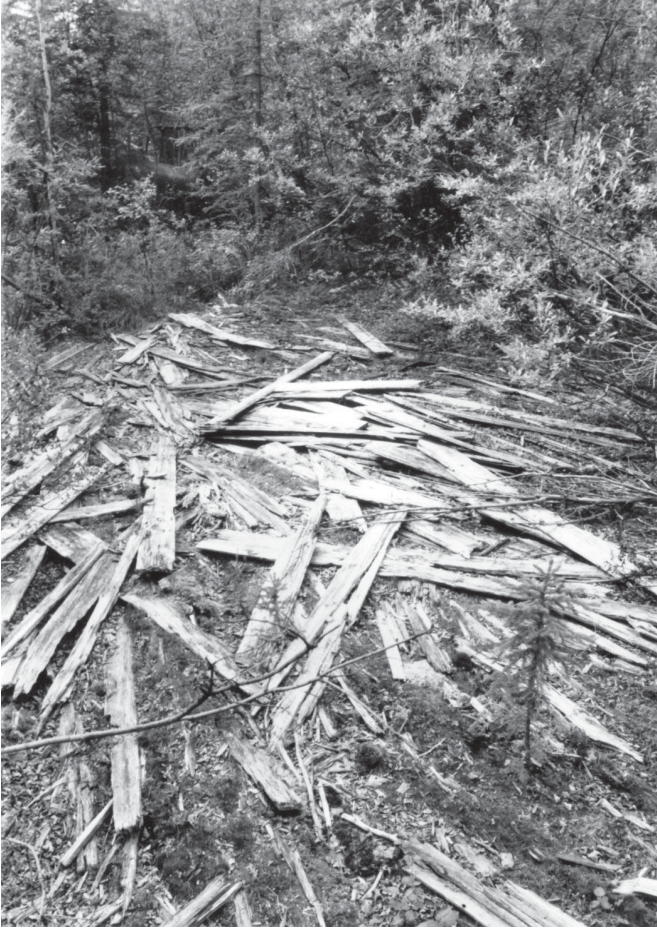
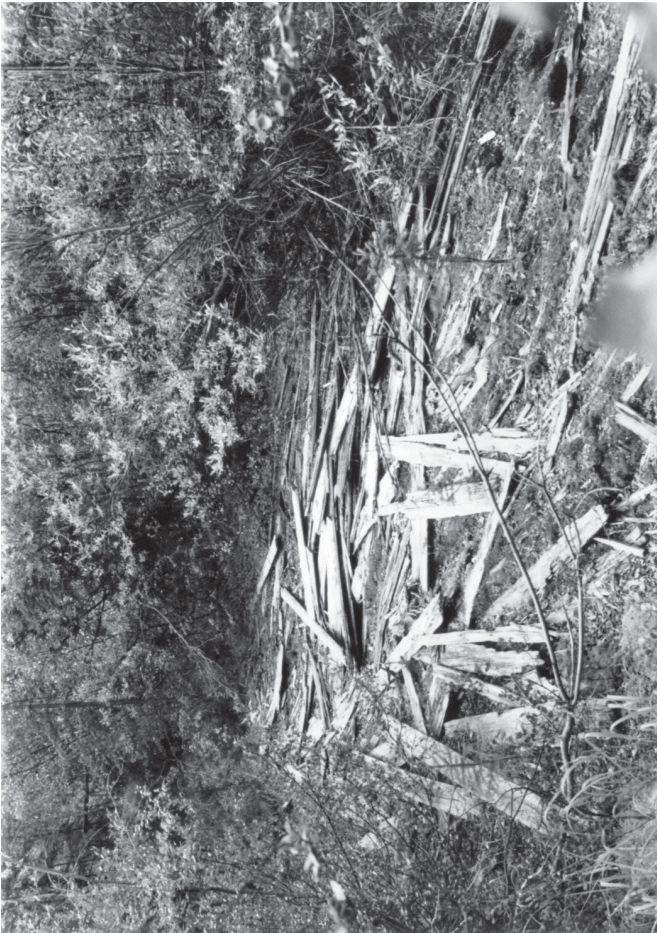
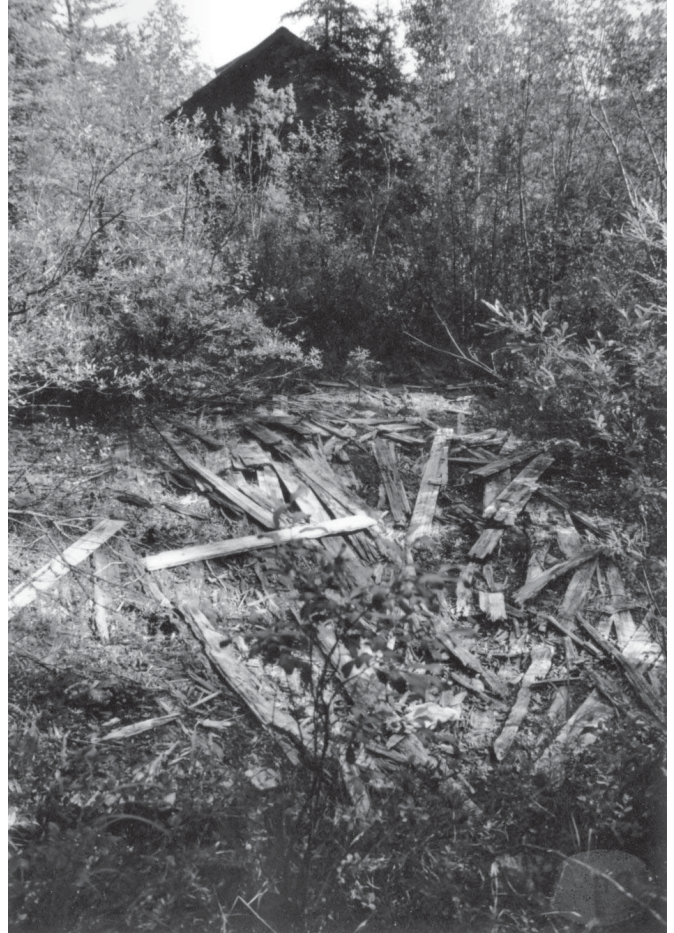
SE36

This unidentified frame building was approximately 7 x 3.5 metres in size, and roofed with corrugated metal. The associated debris, a large round iron bucket full of scrap iron, steel and pipe only hints at industrial usage.

- F 35 Looking south along building remains
- G 11 Looking south along building remains
- J 19 Looking north-east along collapsed structure

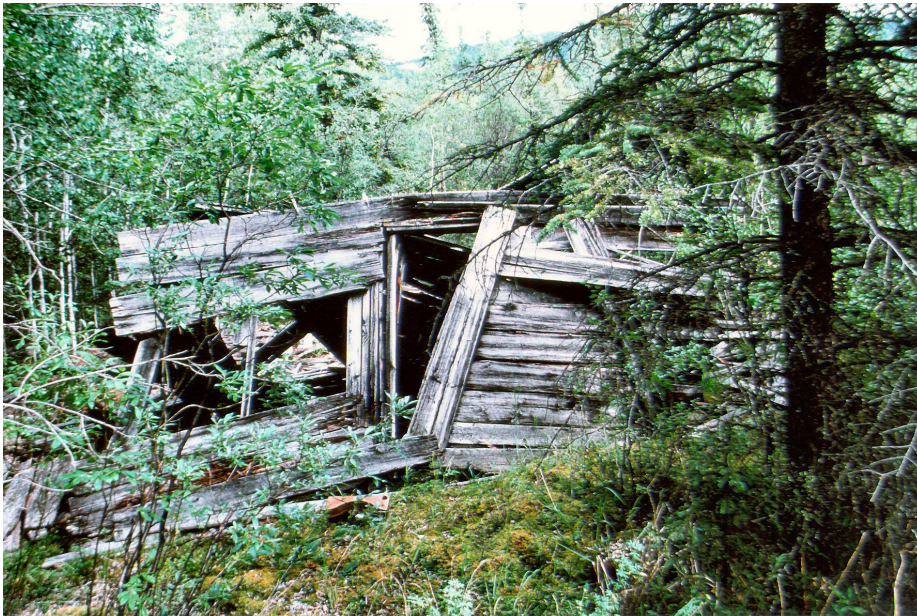
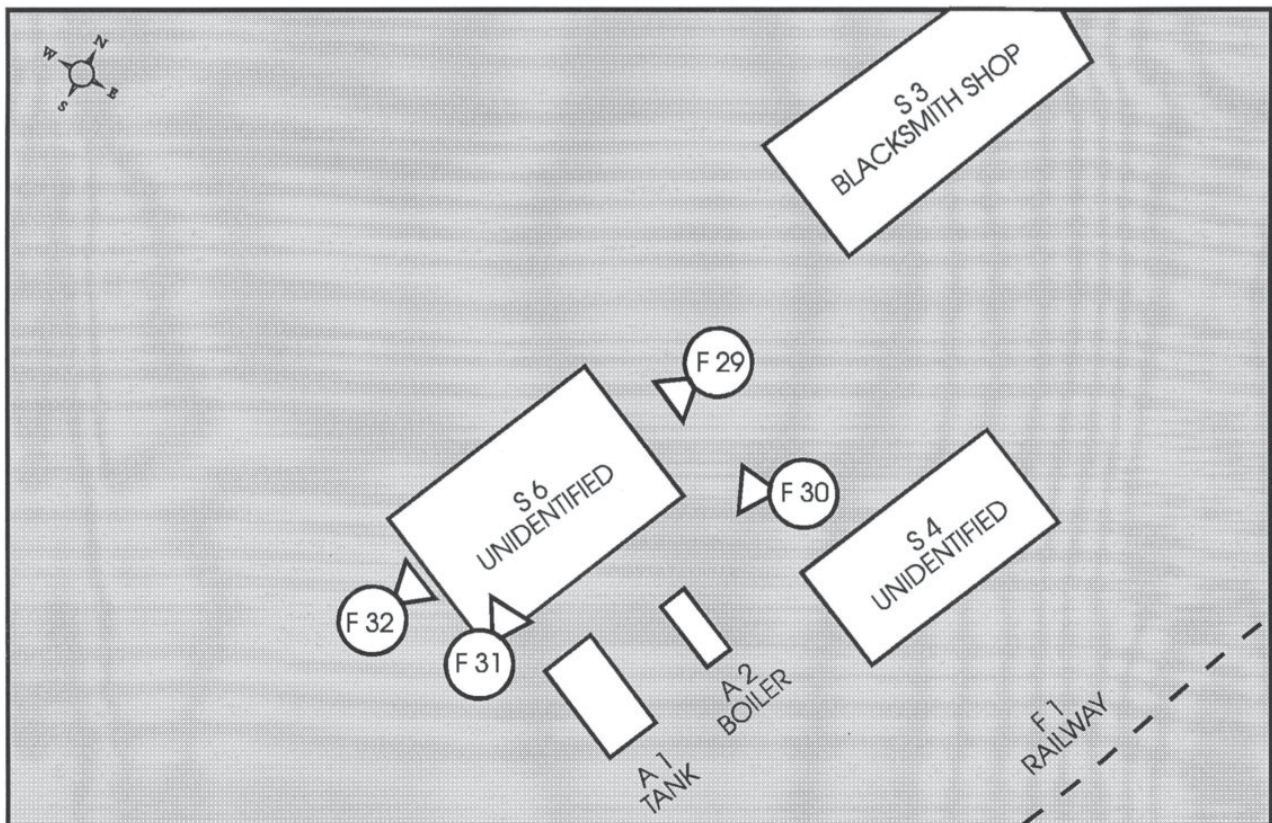
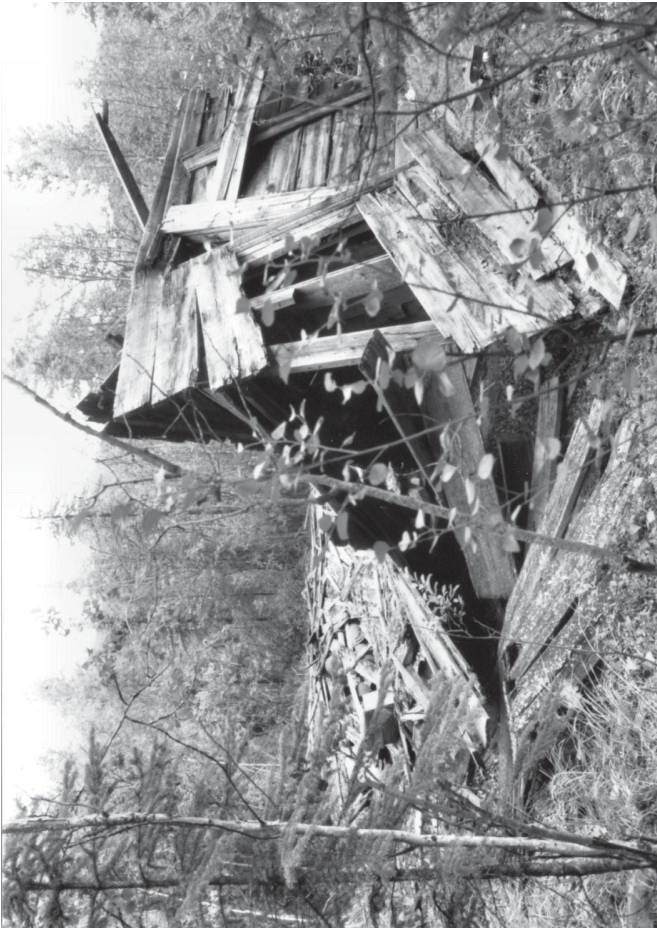
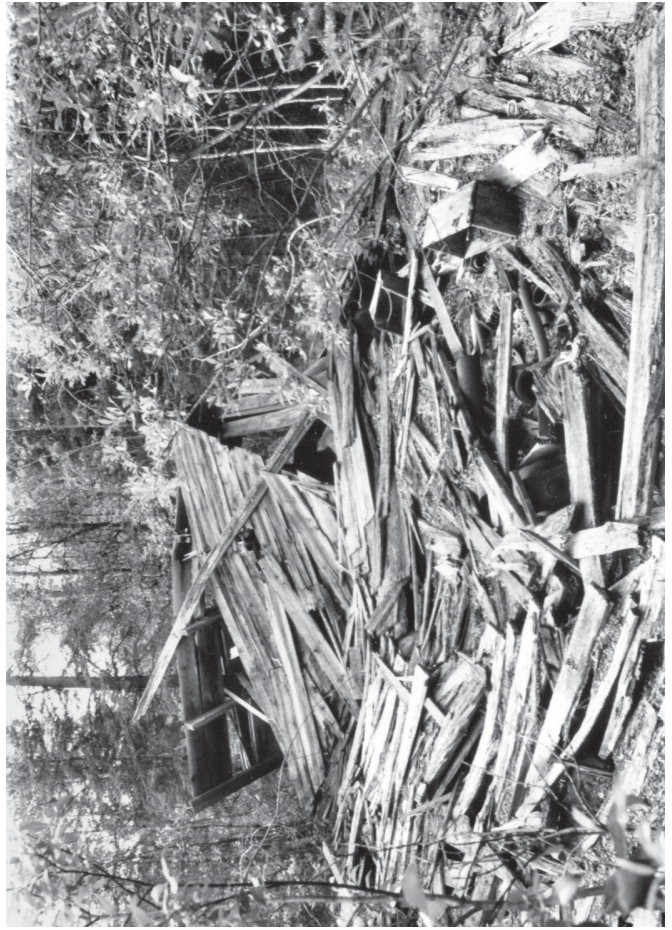
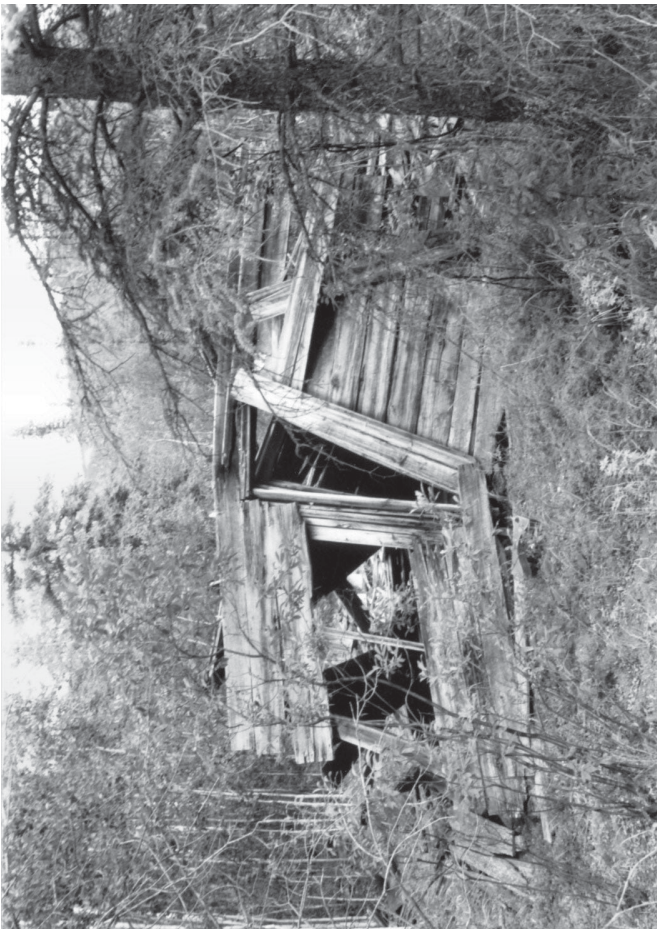
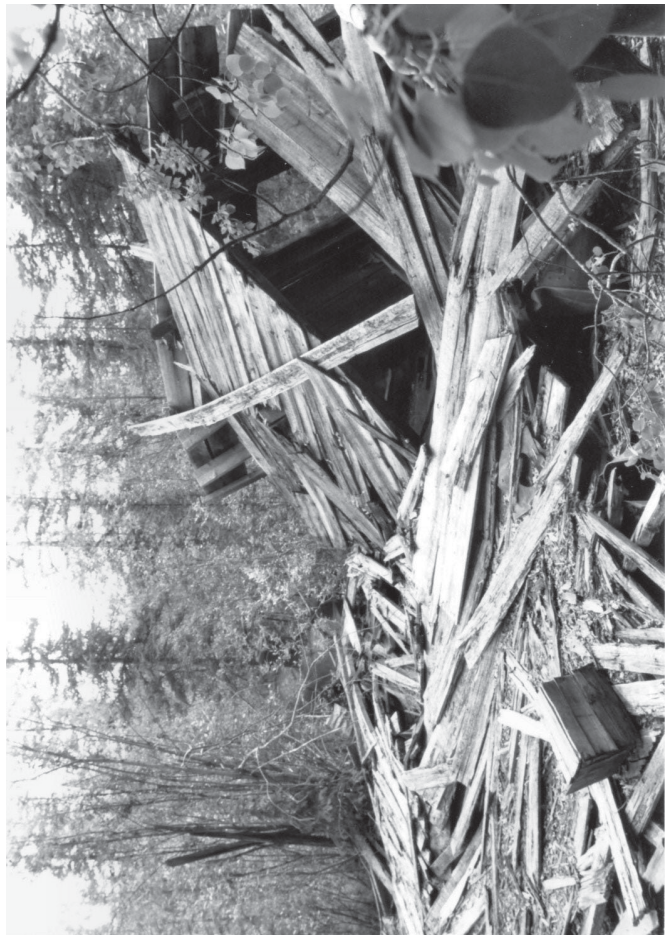
SE27

This unidentified frame building was approximately 7.5 x 4.9 metres in size, and roofed with planks, probably in turn covered with corrugated metal. Near by is a small boiler, a wooden tank, part of a compound pump, and parts of a winch.

- F 29 North elevation
- F 30 3/4 view from north-east
- F 31 3/4 view from south-east
- F 32 Looking north along building remains

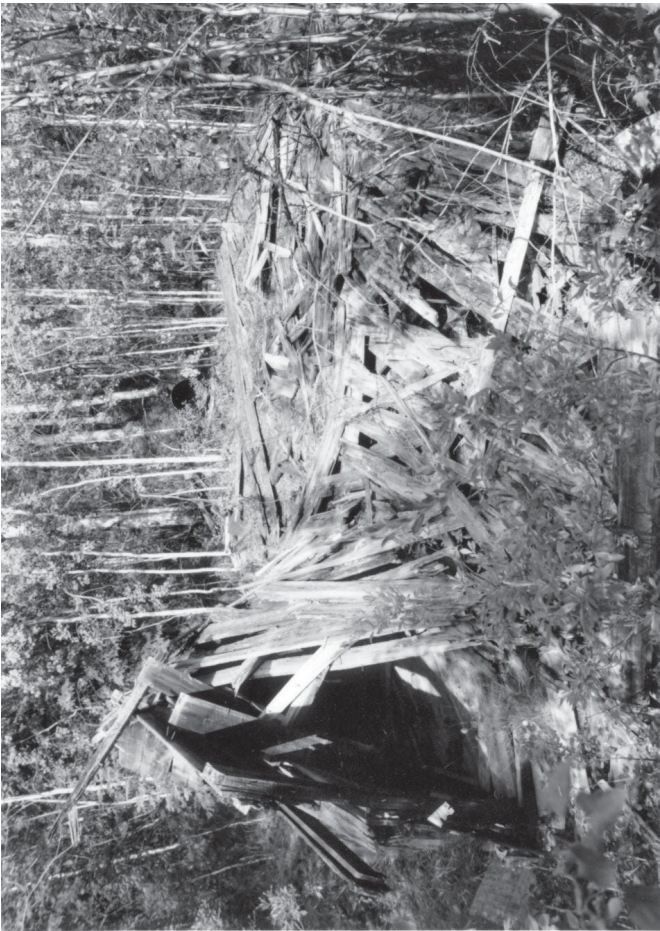
J21

3/4 view from north-west

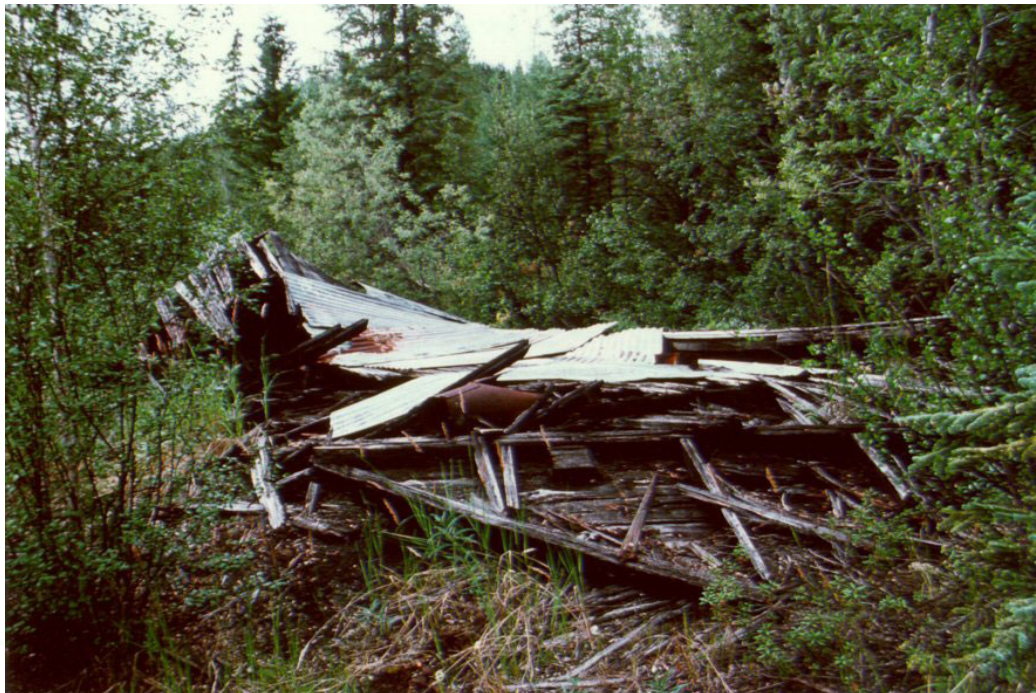
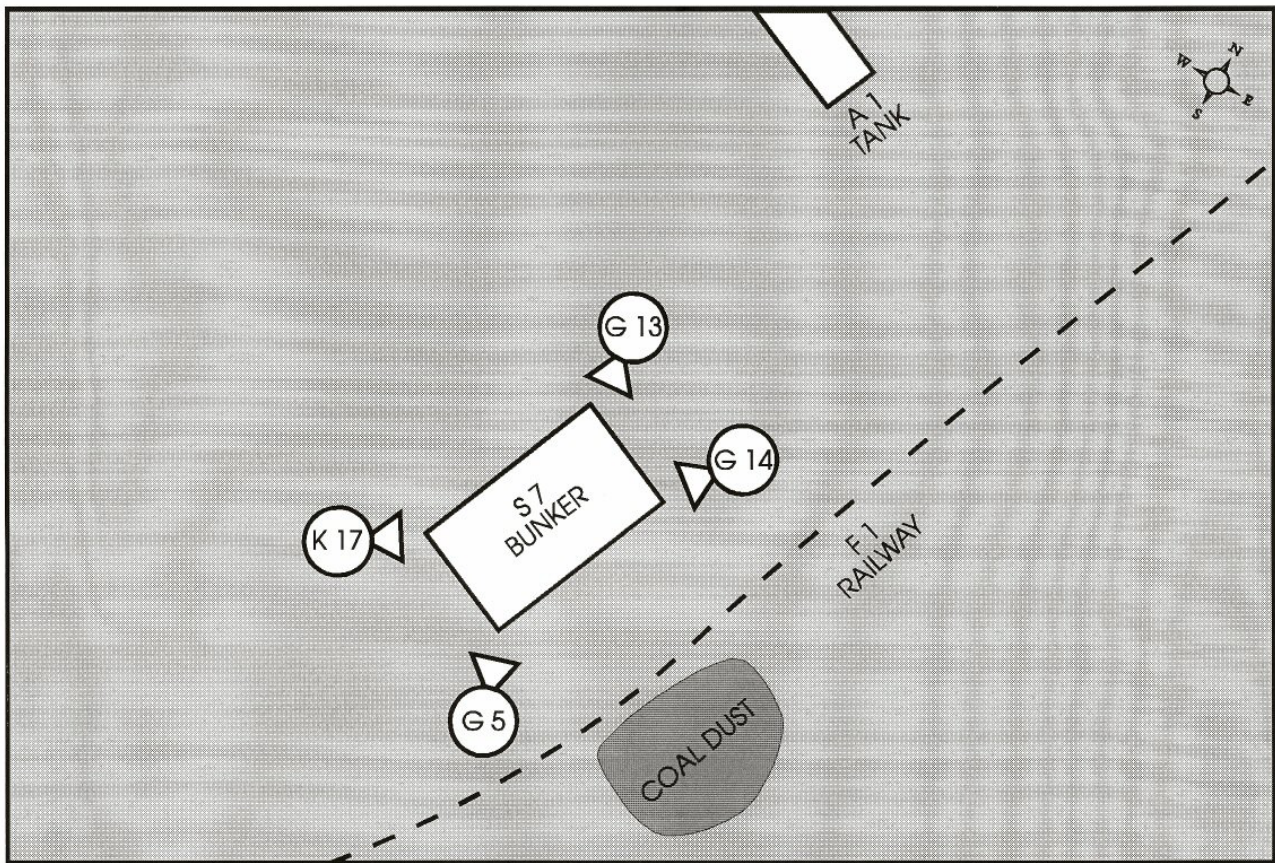
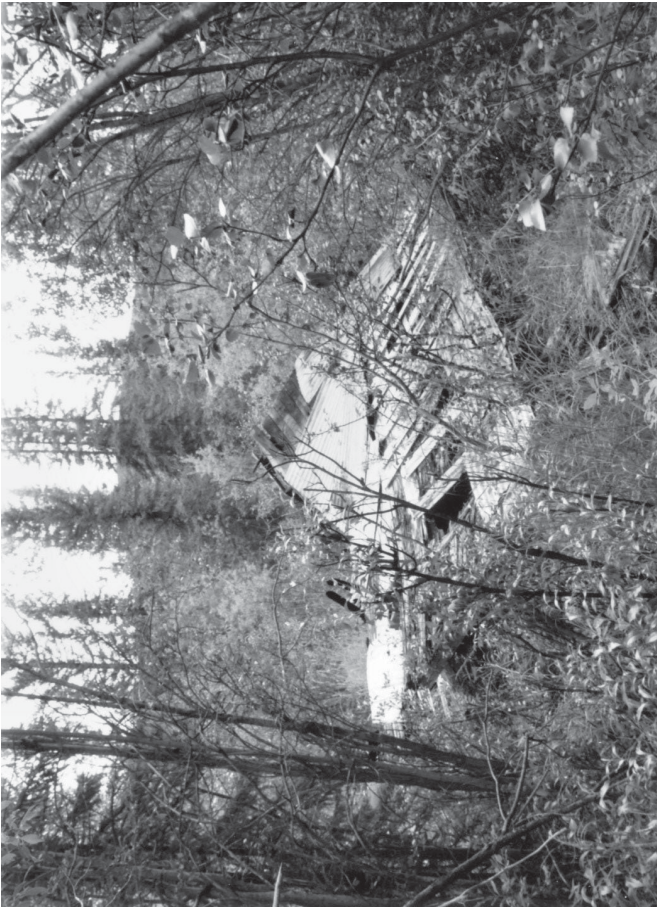
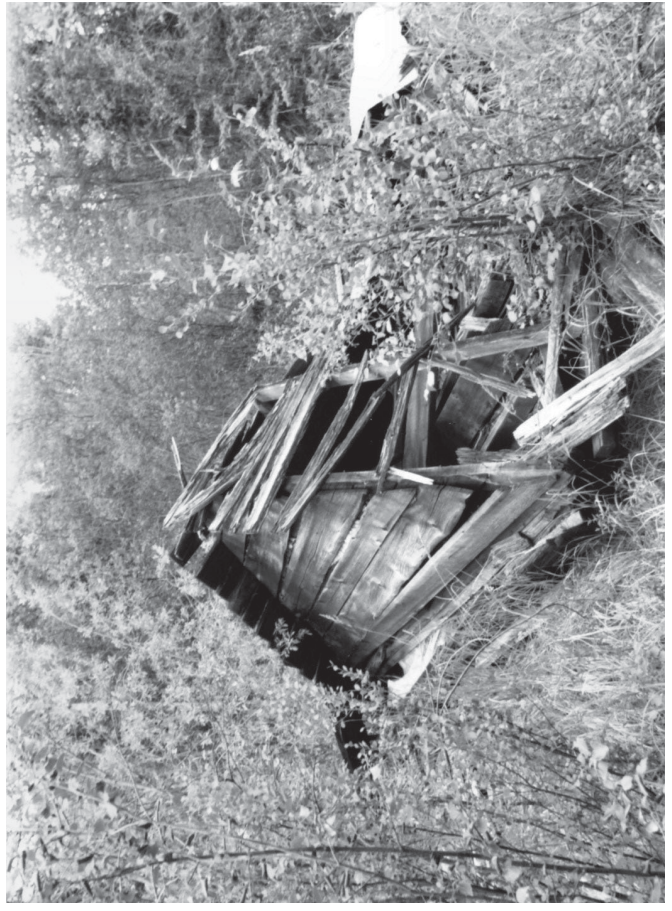
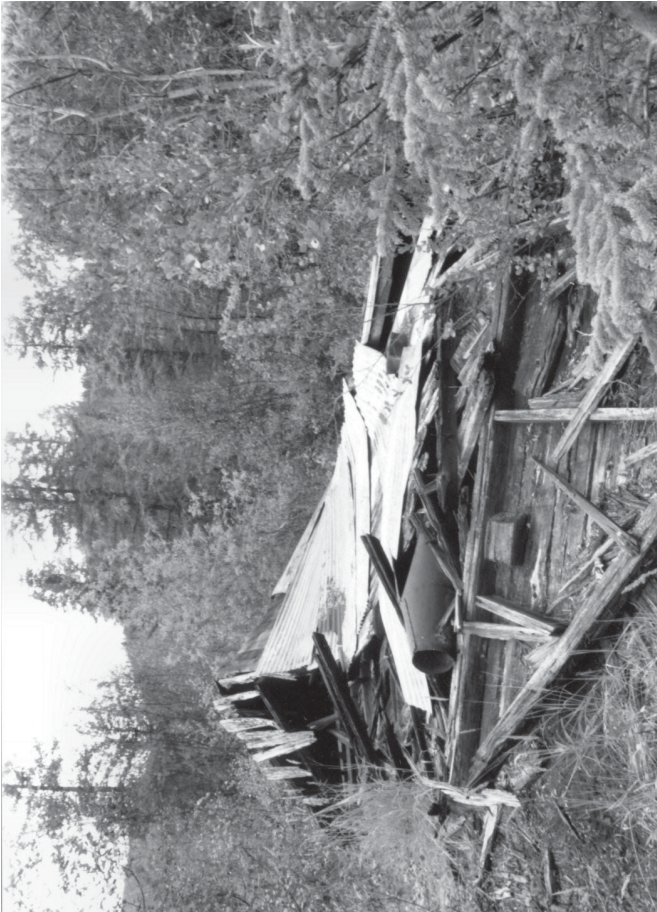
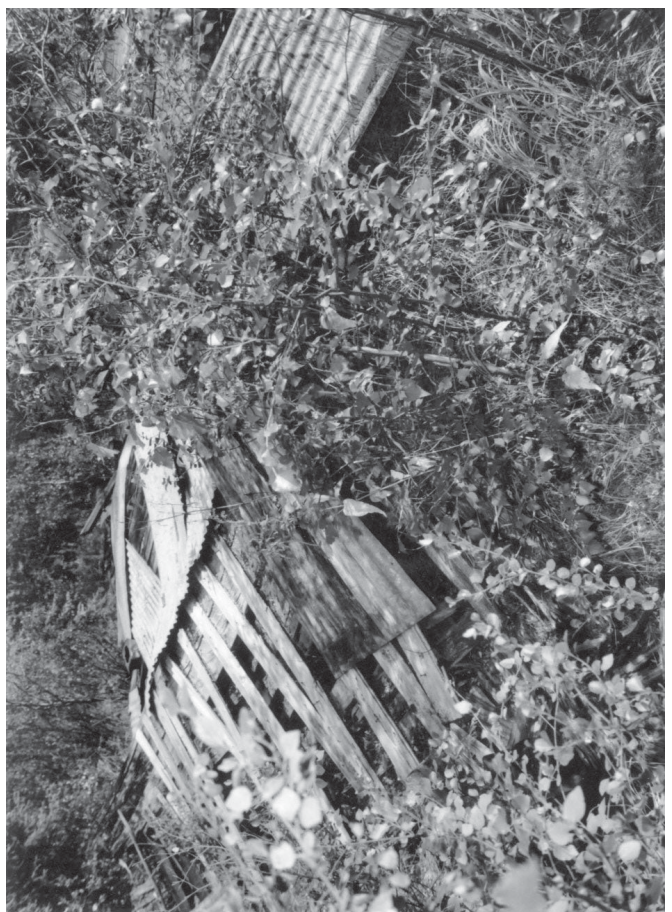
SF05

This structure was 6.3 x 3.66 metres in size, with a corrugated metal roof. There is a large pile of coal dust east of this structure, on the opposite side of the railway line.

- G 5 Looking from south-east
- G 13 Looking from north-west
- G 14 Looking from north-east
- K 17 Looking from south-west

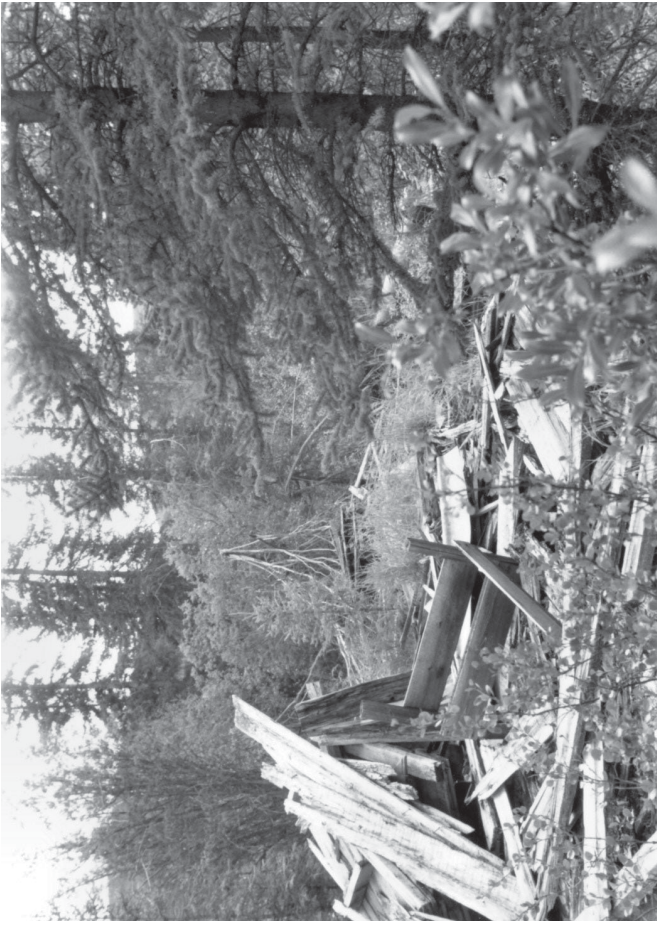
G17

G 17 Looking from south-east

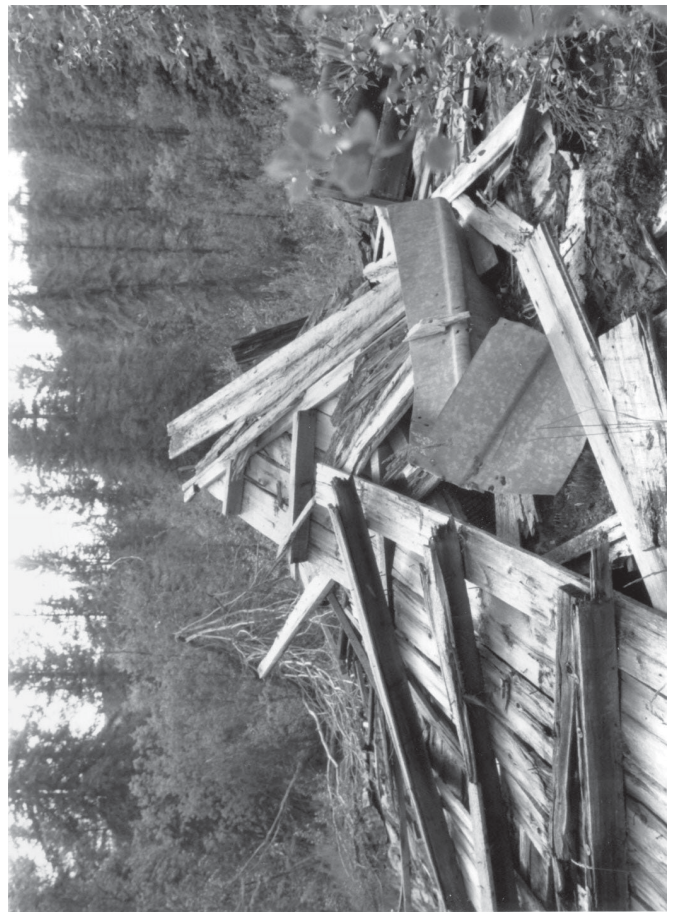
G16

G 16 Looking from south along remains

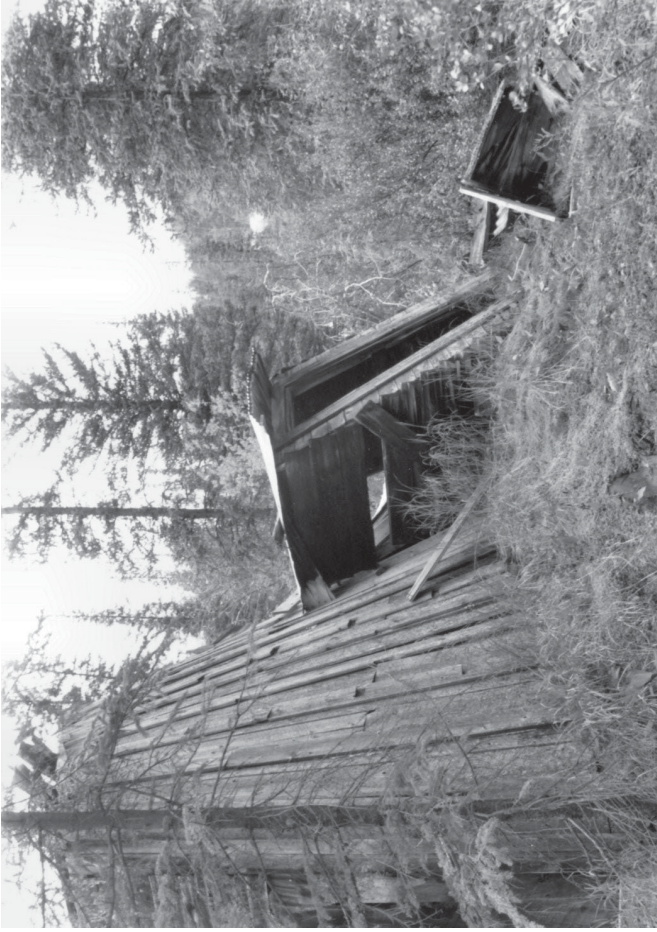
G25

- G 18 Looking south-east towards front part of structure
- G 24 East elevation of north portion of building
- G 25 Looking along north elevation towards "porch"
- G 28 3/4 view of north elevation

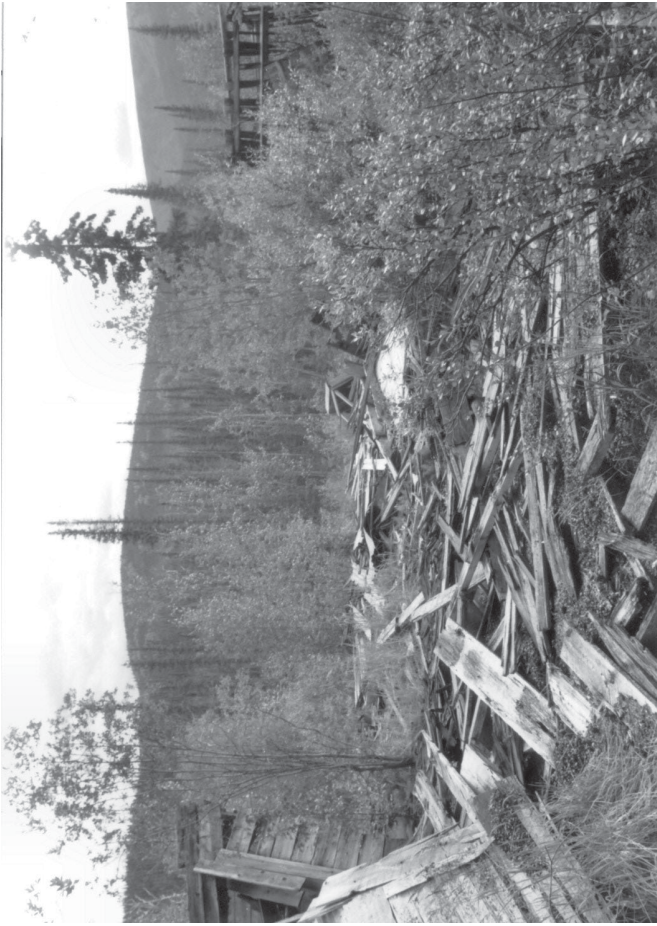
G19

- G 19 Looking south along remains
- G 22 Looking north along building remains
- G 23 Detail of box projecting below a window
- G 27 Heater

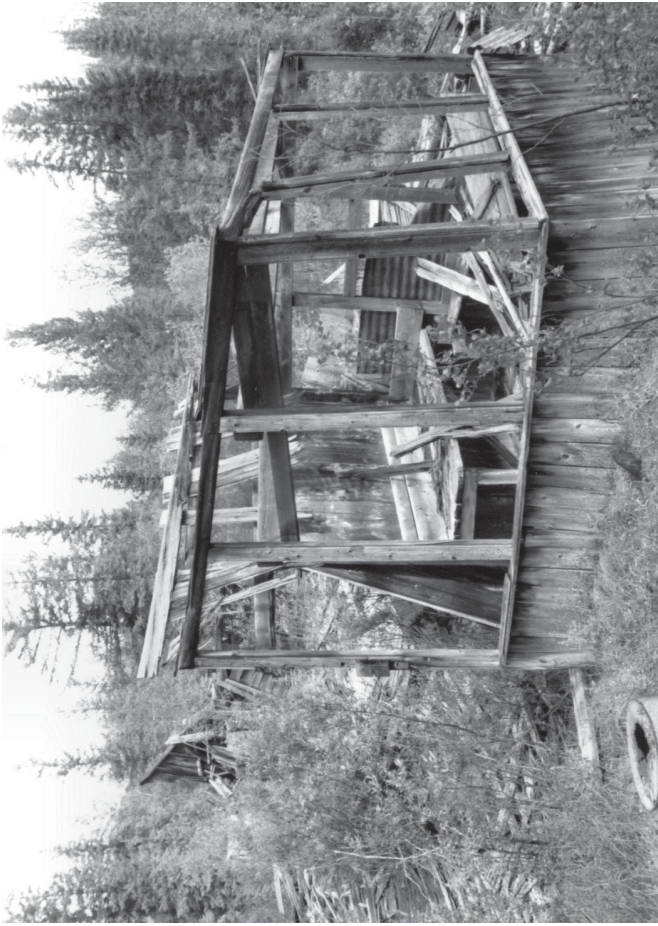
G21

- G 20 Looking south towards building annex (meat cache?)
- G 21 Looking east towards building annex
- G 30 Detail of stove showing cast door with builders name
- K 11 Metal dump with steam powered pump, east of mess hall
