**REPORT ON  
THE CULTURAL RESOURCES AT  
COAL CREEK**

Bob Mitchell  
CAPHC

# REPORT ON THE CULTURAL RESOURCES AT COAL CREEK

AS FOUND IN AUGUST OF 1992

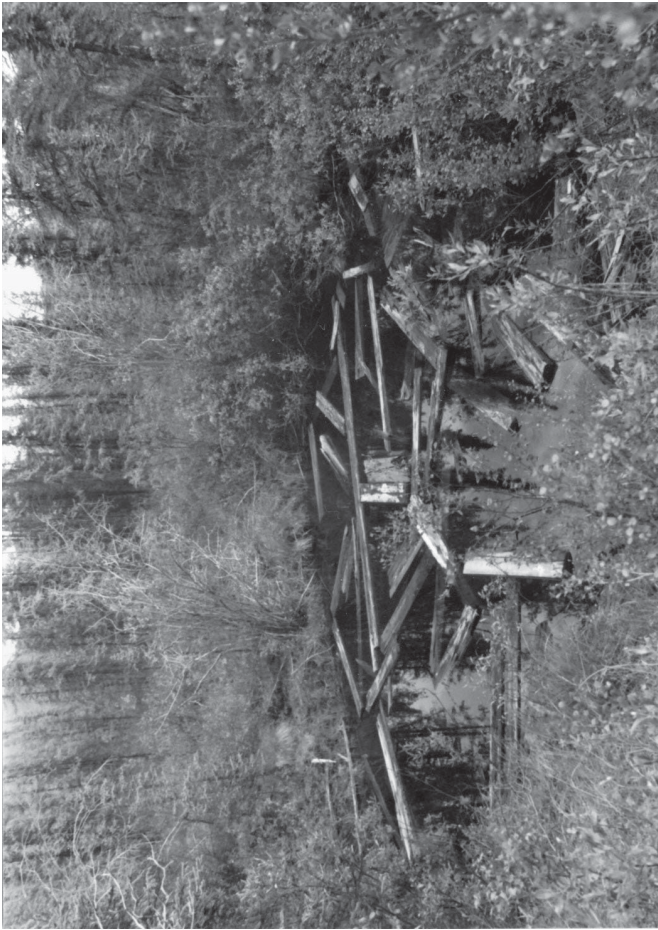
E12

E 12 Looking north from south side of pit

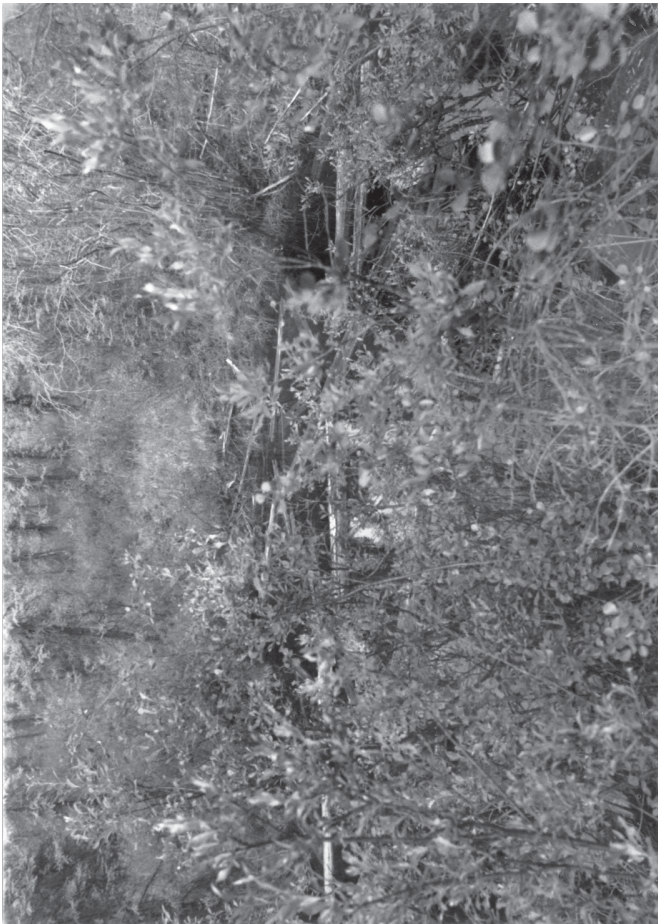
E11

E 11 Looking west from east side of pit

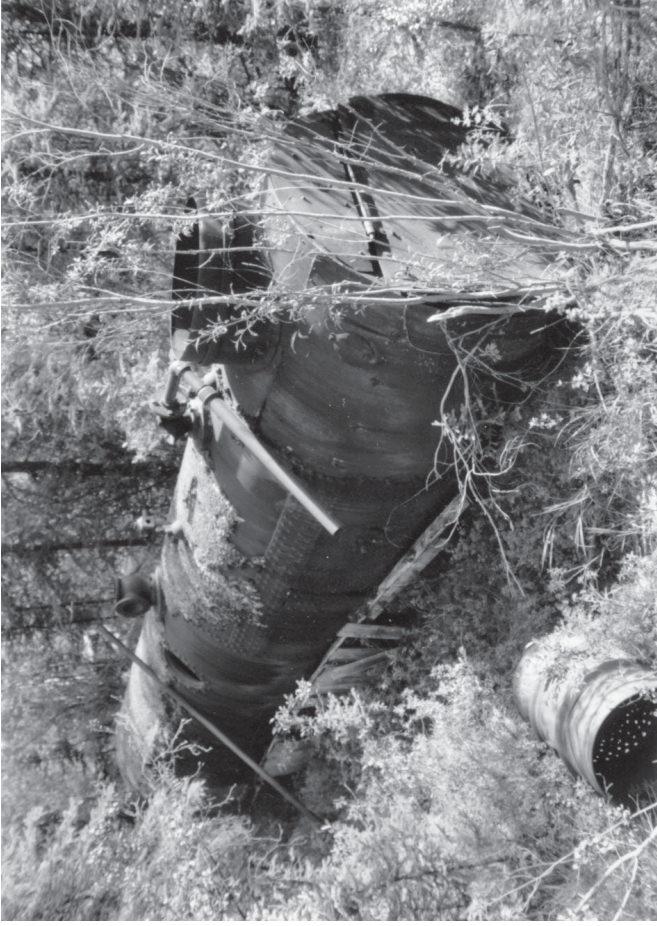
K01

The largest artifact at this site is the boiler (manufactured in Vancouver). It is still partly covered with asbestos held in place with chicken wire. The stack for the boiler is laying beside it on the ground. This boiler was probably used to power the winding engine for the mine shaft, and also possibly to drive the pumps for mine. The building which housed this boiler is quite clearly seen in the foreground of the historic photograph on page 20 (note the stack).

- (J 23) Spoil pile from Mine No. 2
- (K 1) Large boiler, looking south-west
- (K 2) Stack for large boiler, looking south
- (K 5) Concrete pad near large boiler, looking north

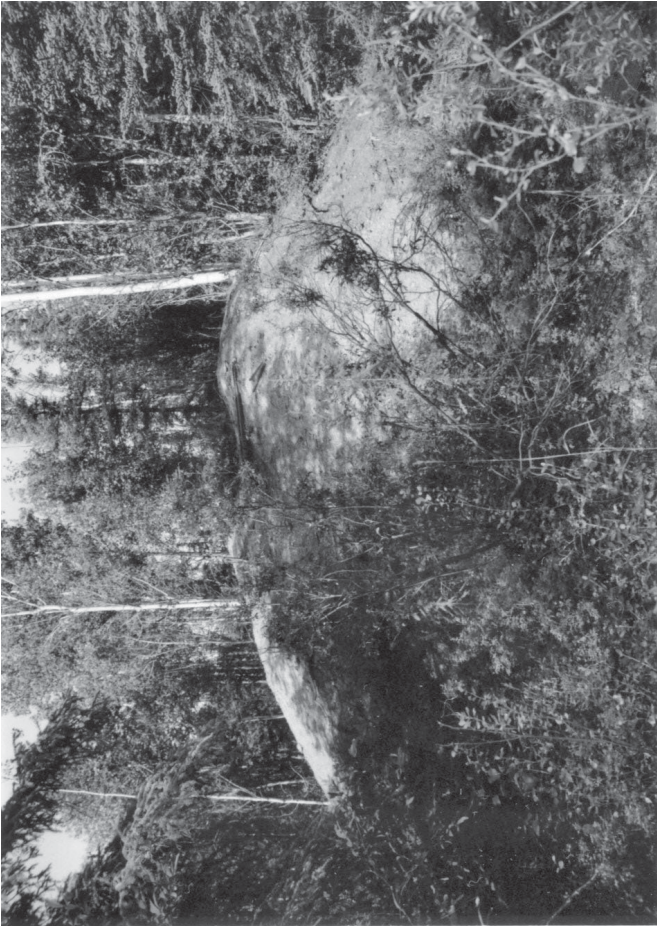
J23

The spoil pile does not seem to be as long as that on the photograph, probably due to weathering. The mine carts located on top of this pile have all been turned up side down, probably in order to remove their wheels and axels. There were also a few pieces of rail from the tramway scattered about, including part of one of the turnouts (a frog).

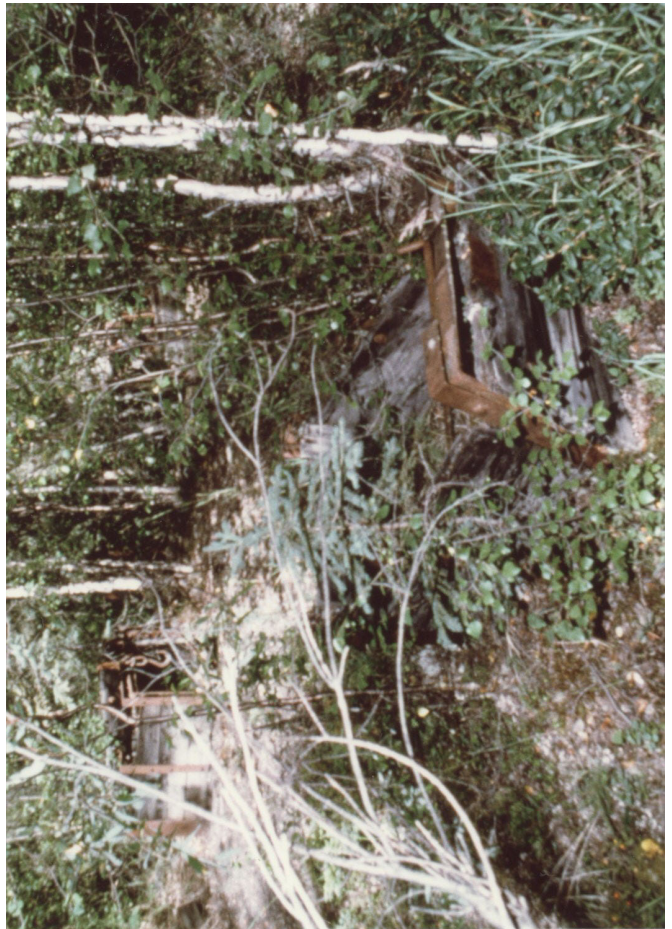
SF20

- (K 3) I.D. plate for large boiler
- (SF 20) Mine cart remains at Mine No. 2
- (SF 21) Mine cart remains at Mine No. 2

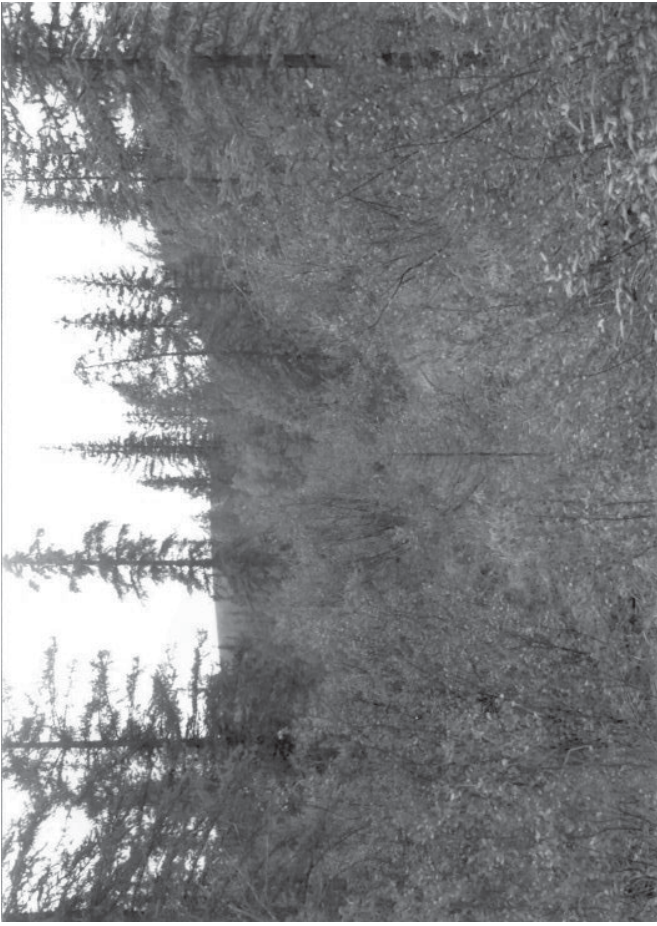
E10

- (D 28) Looking north along right-of-way from north end of feature F 3
- (D 29) Looking south from south end of F 4
- (D 37) Looking south down right-of-way from north end of feature F 3
- (E 10) Looking north along rail right-of-way from north end of F 3

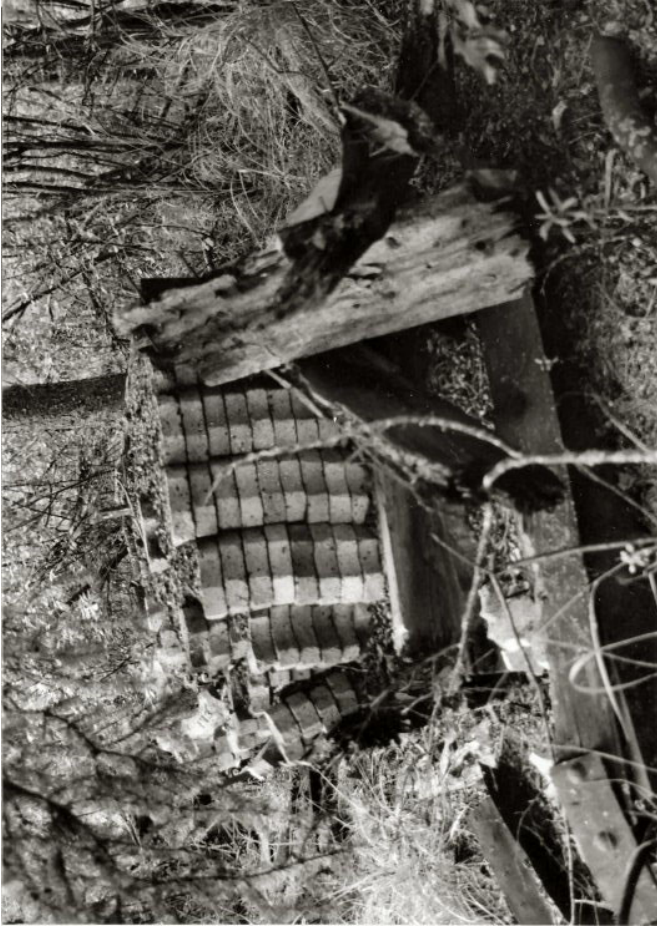
E22

- (E 21) Cart loaded with fire brick, viewed from north
- (E 22) Cart loaded with fire brick, viewed from north-east
- (E 23) Cart loaded with fire brick, viewed from east

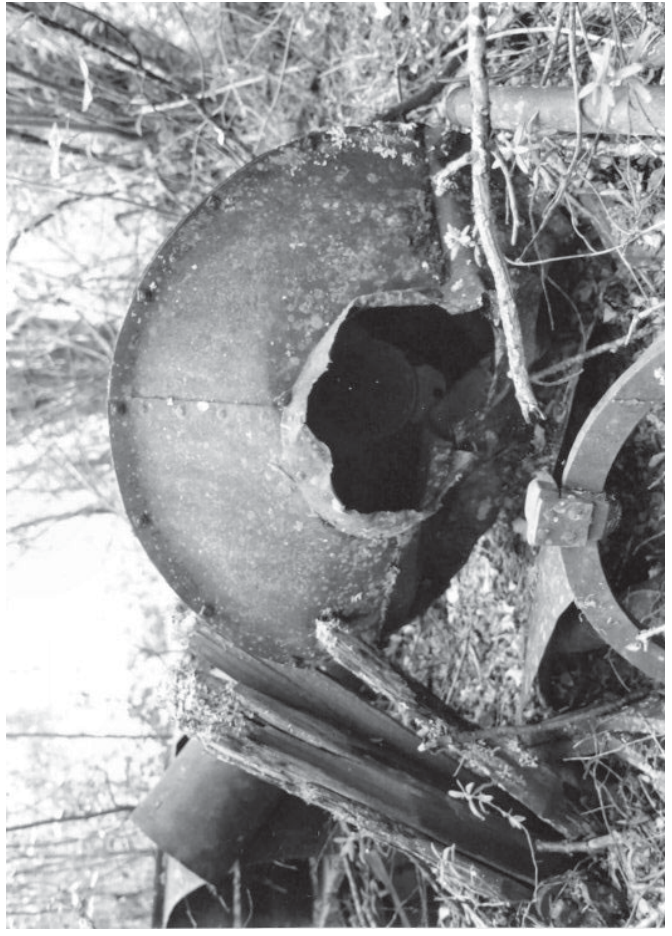
E27

- E 24 Looking south from cart loaded with fire brick
- E 25 Looking south along artifacts
- E 26 Close-up of firebox door
- E 27 Close-up of stack from north

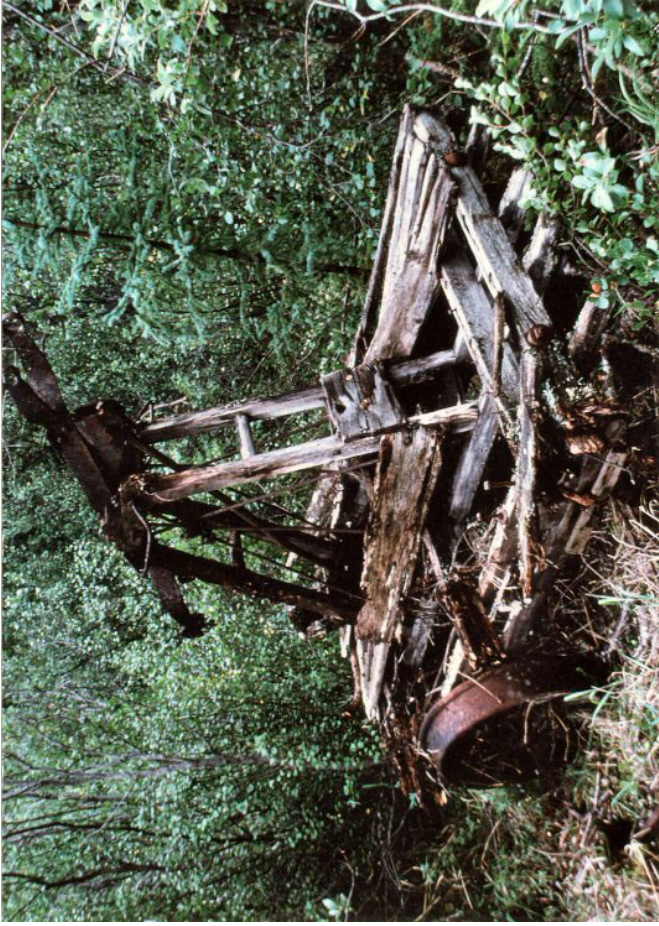
SC05

SC 5 Railway hand cart

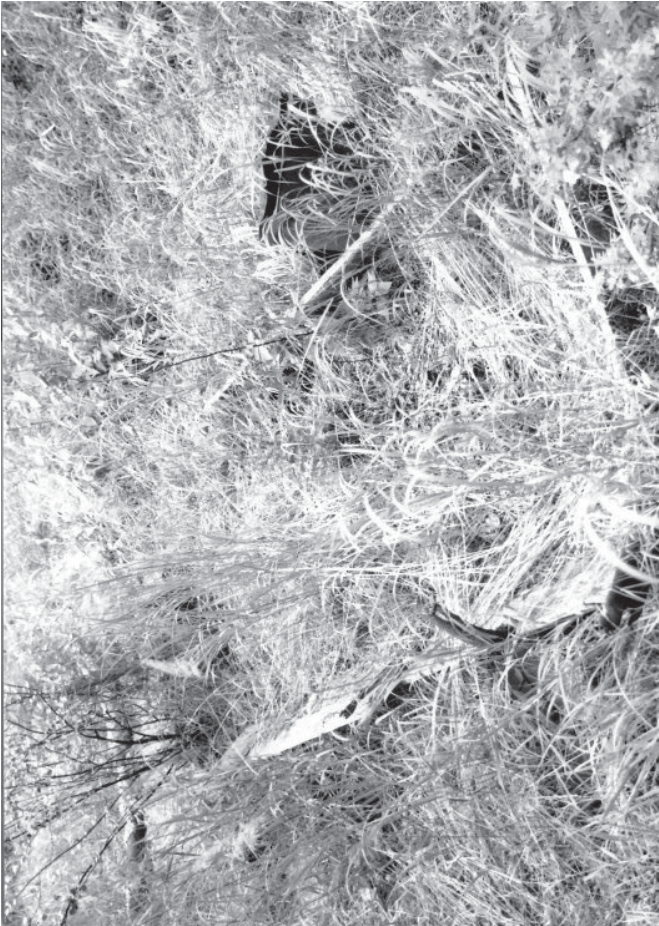
E36

E 36 Looking south along remains of railway car

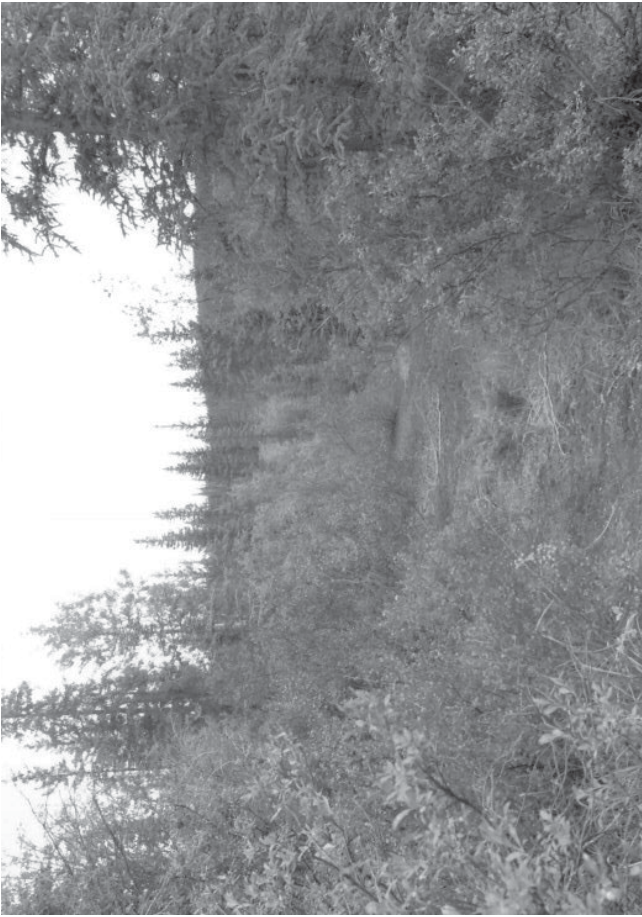
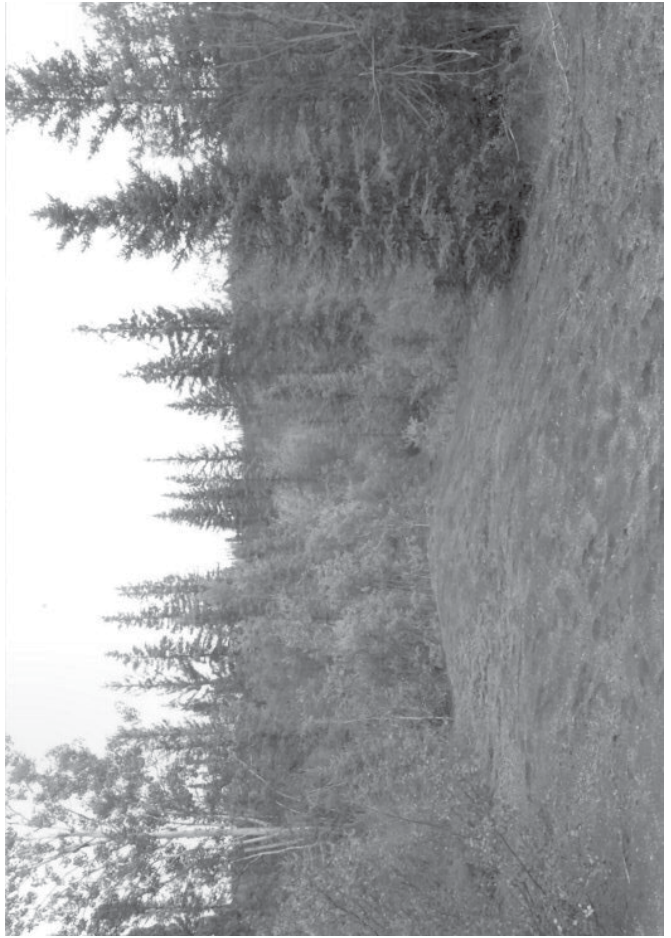
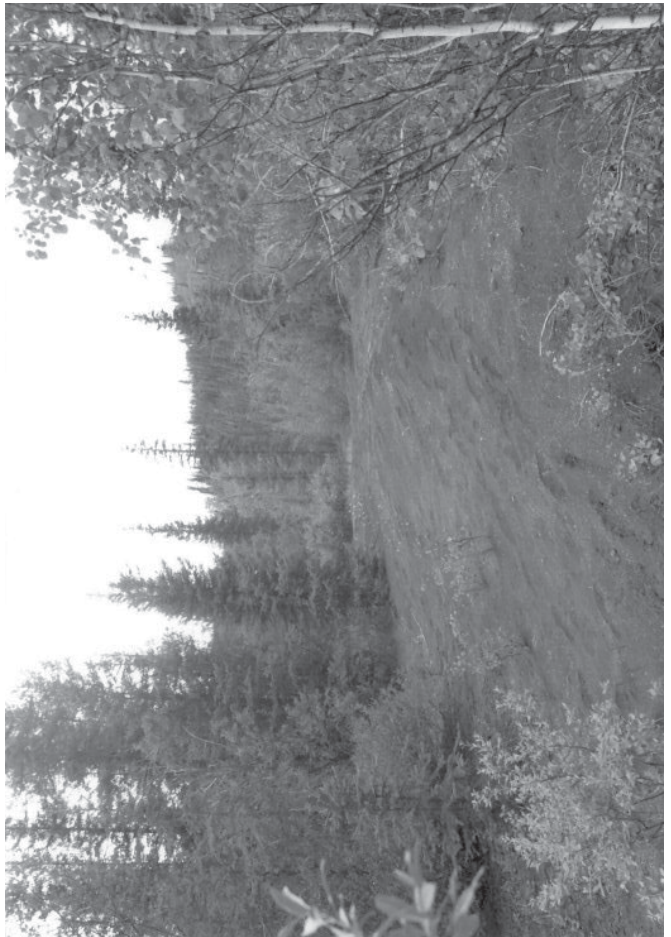
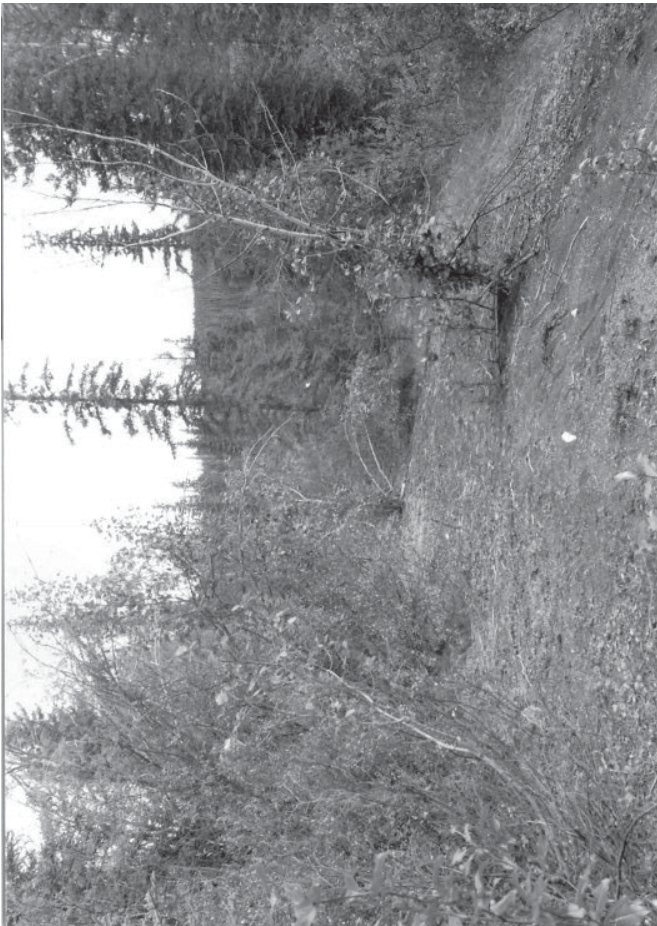
This may just be fill to stabilize the railway road bed, or it may be a dump for waste material from the mines.

- D 30 Looking north along feature
- D 31 Looking north from near north end of feature
- D 33 Looking south down feature from north end
- D 35 Looking north down feature from south end

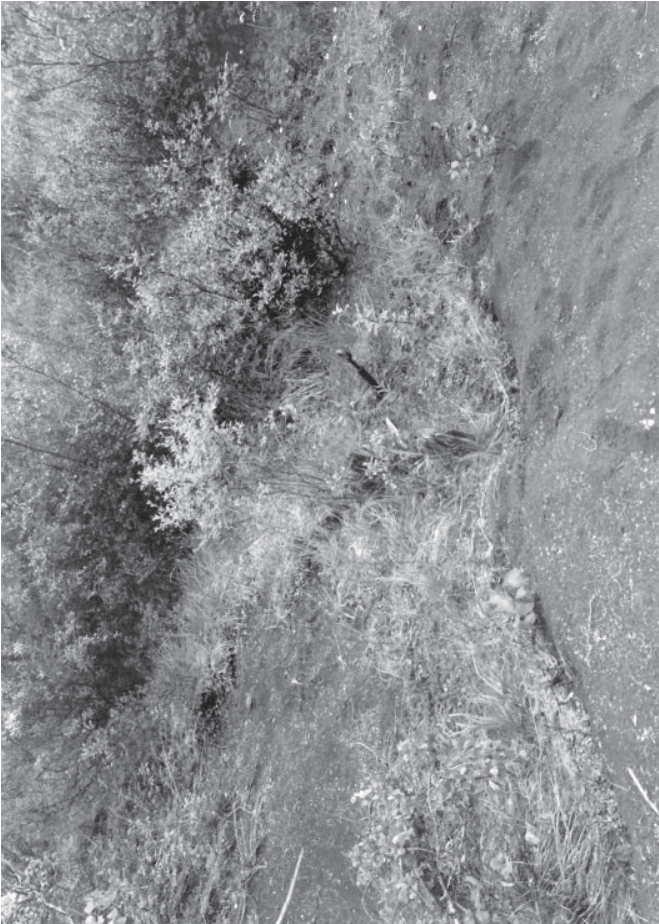
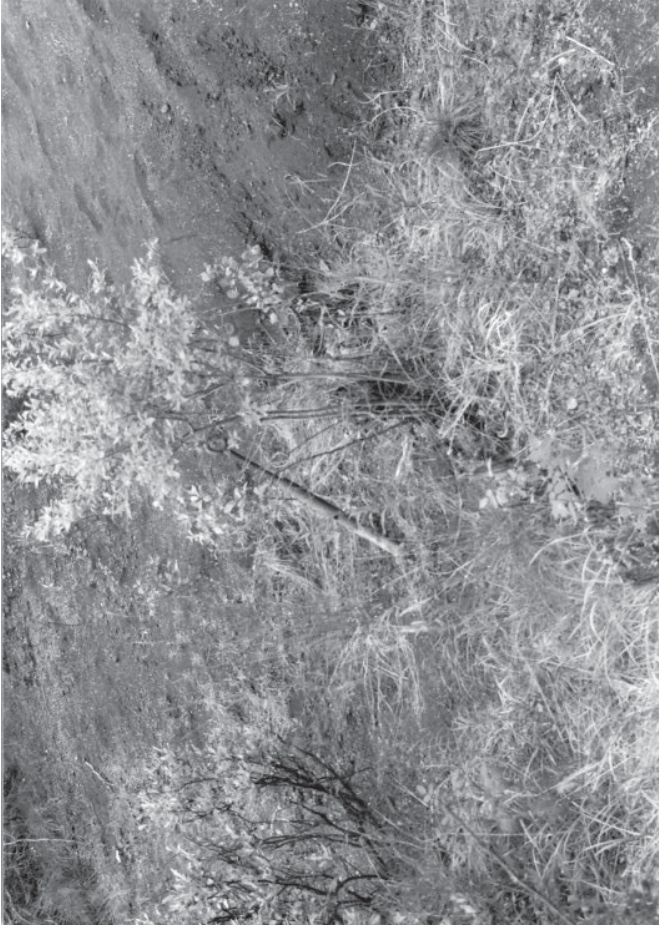
D 32 Looking down at turnbuckle at north end of feature

D 34 Detail of turnbuckle

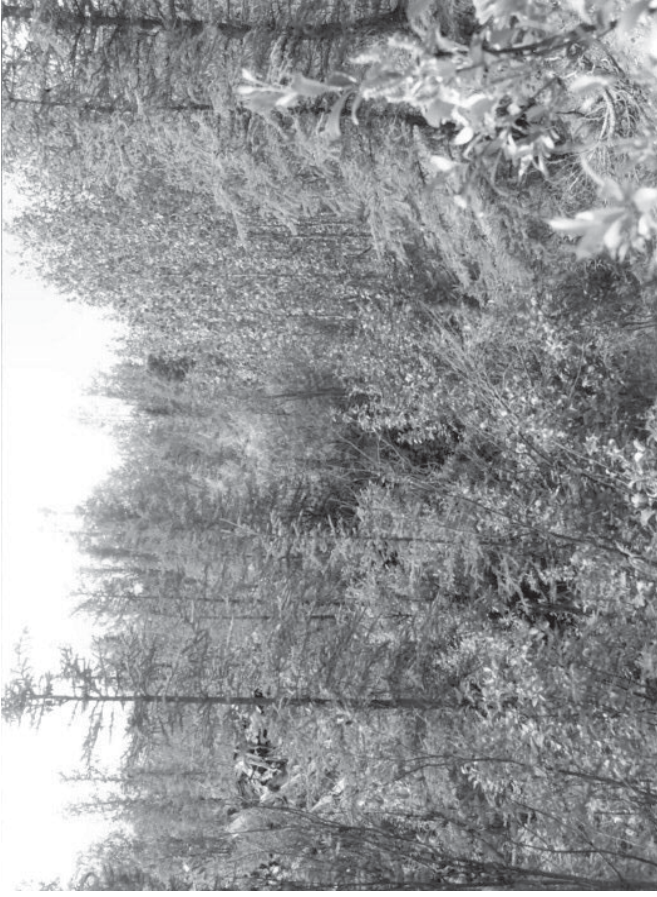
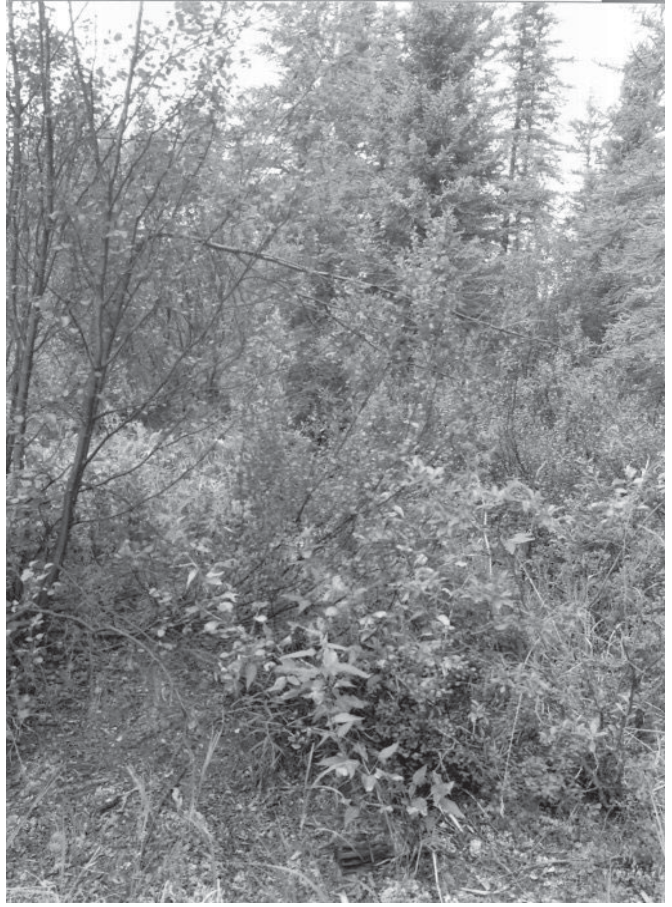
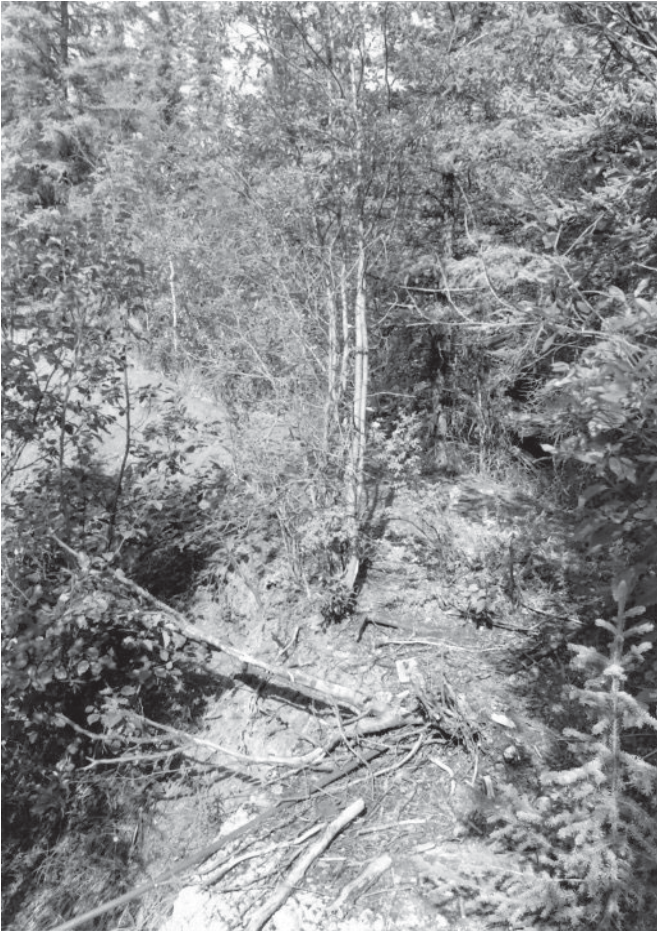
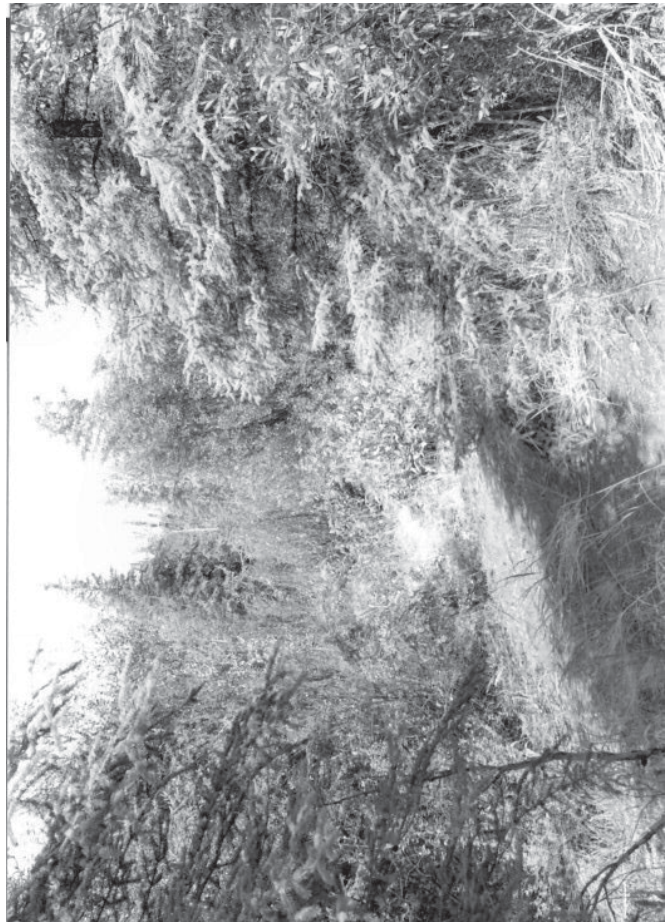
This feature is fairly obvious, and seems to be longer than in the photographs. It was typical railway practice to fill in trestle work to make the railway more stable, and this is probably what happened here.

- C 10 Looking north-west from gutter along steep bank
- C 12 Looking south-west from steep bank toward lumber stack
- C 14 Looking north-west along embankment
- D 24 Looking west along feature

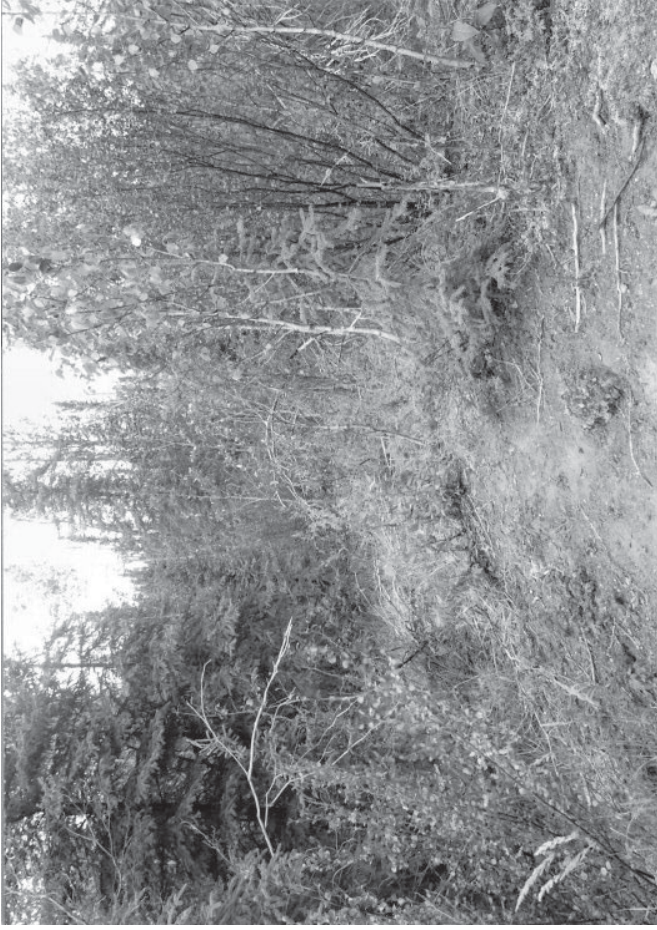
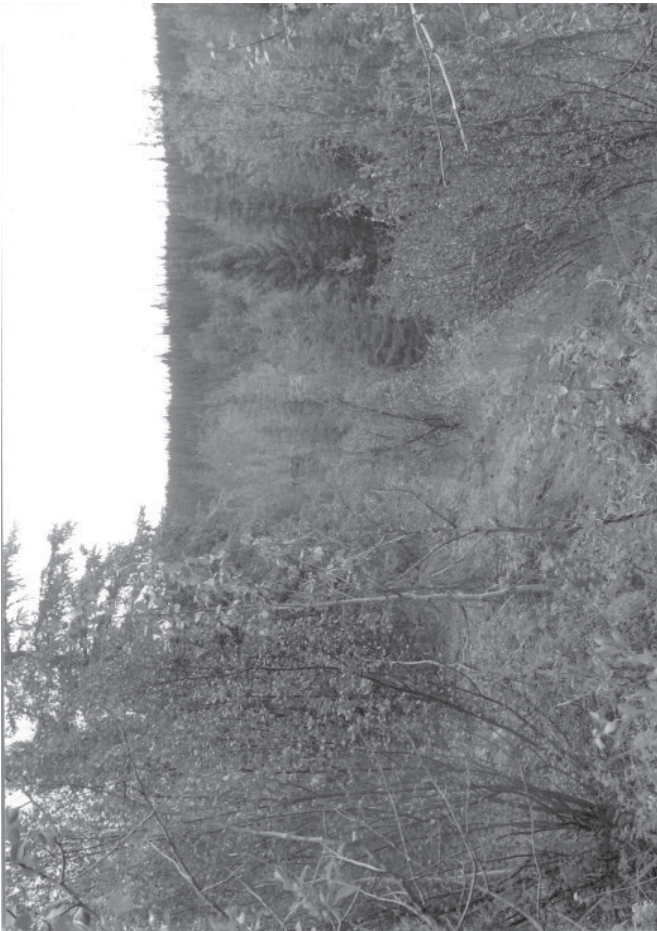
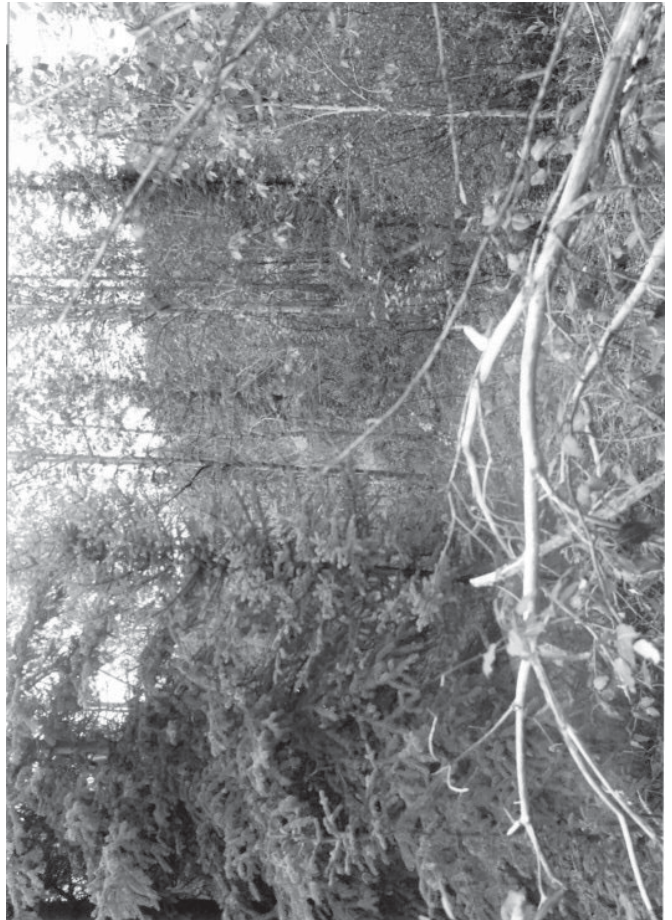
- D 25 Looking west along feature from about the mid point
- D 26 Looking east along feature from about the mid point
- D 27 Looking west from west end of F 3 towards the embankment (F 5)

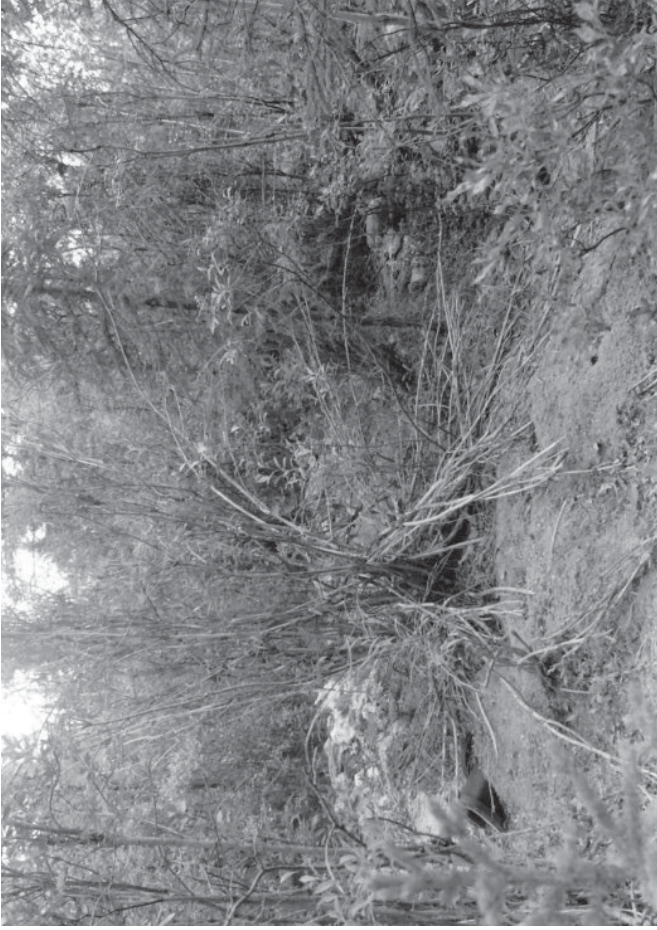
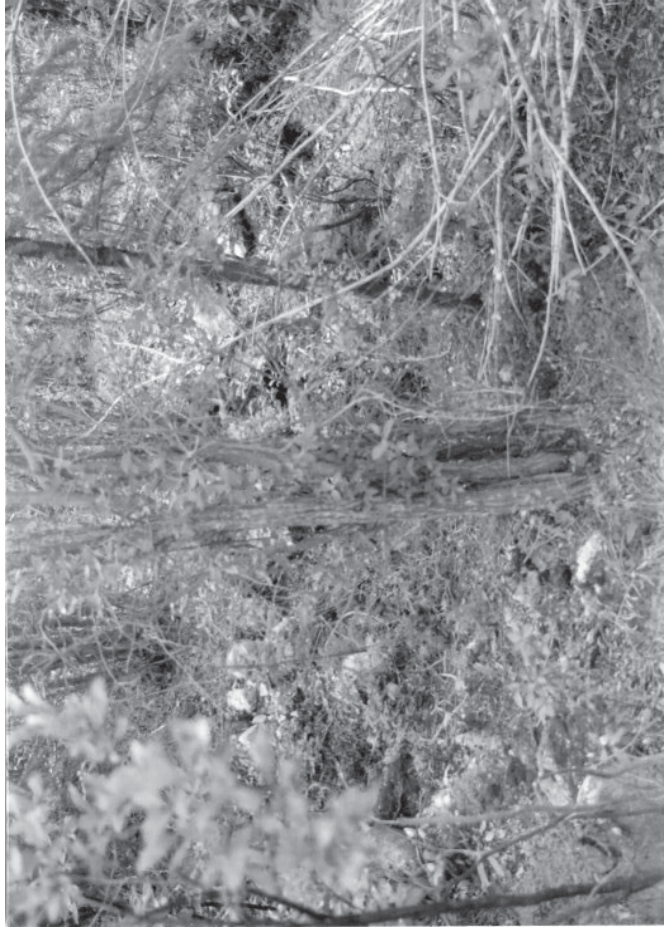
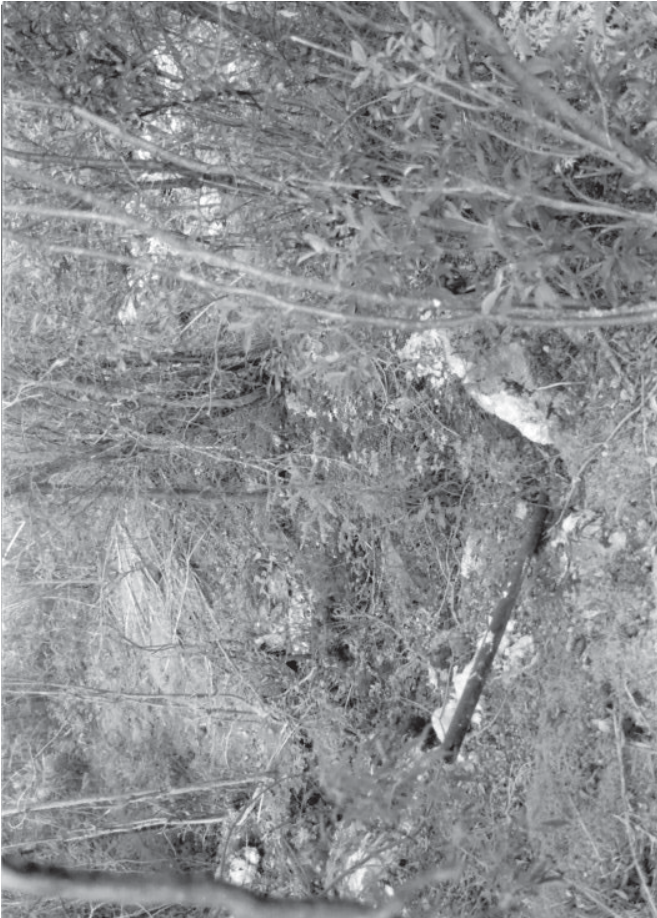
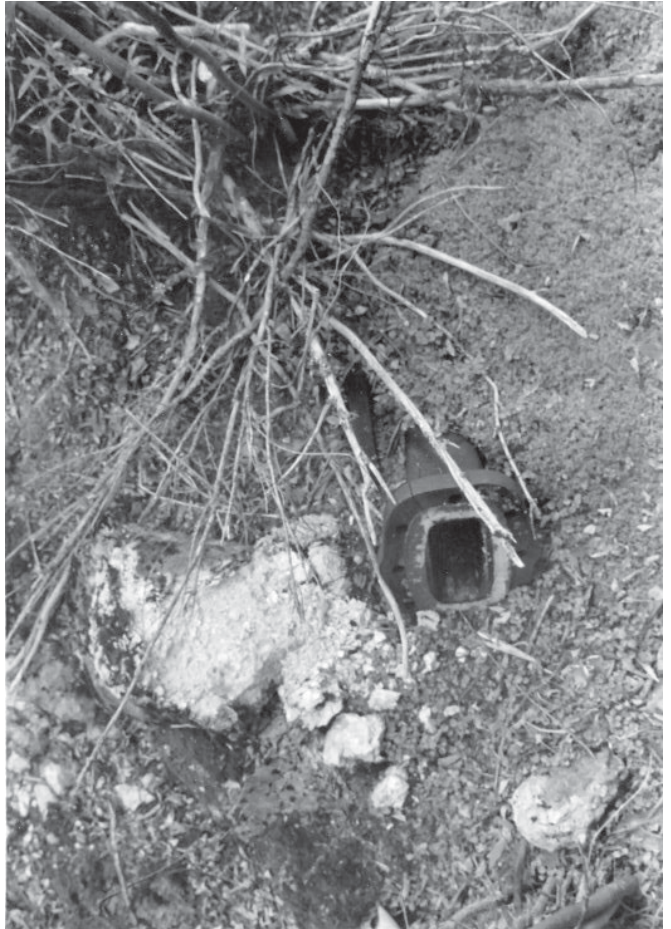
The purpose of this feature is unknown. It may be the remains of a stockpile of materials that were to be used to complete the power house.

- B 16 Looking north at ring of bag casts to the east of power house
- B 17 Looking at earth bank on south side of ring of bag casts
- B 18 Close-up of pipe fitting protruding from earth bank
- B 19 Ring of bag casts from the east

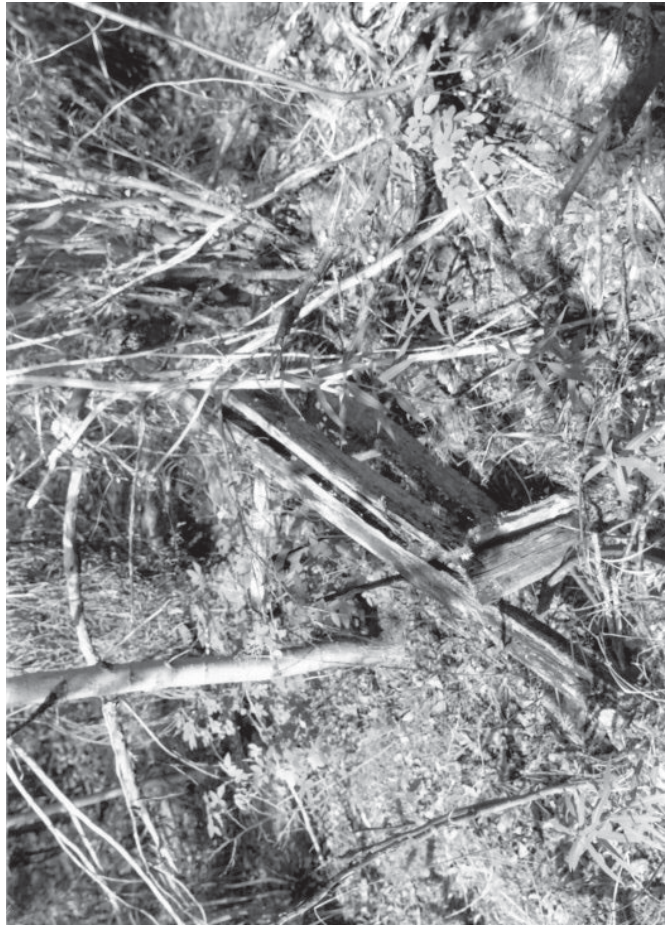
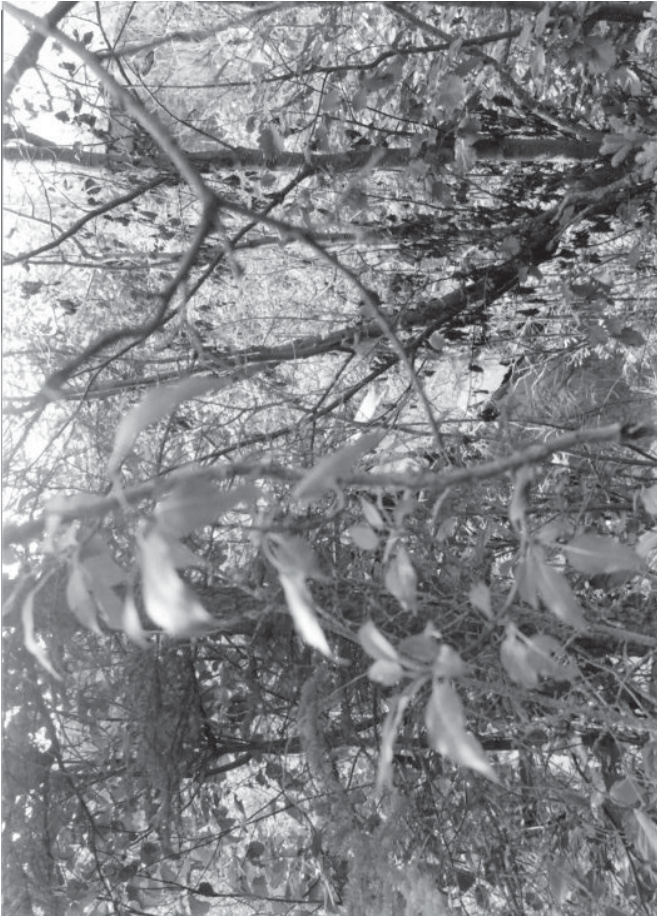
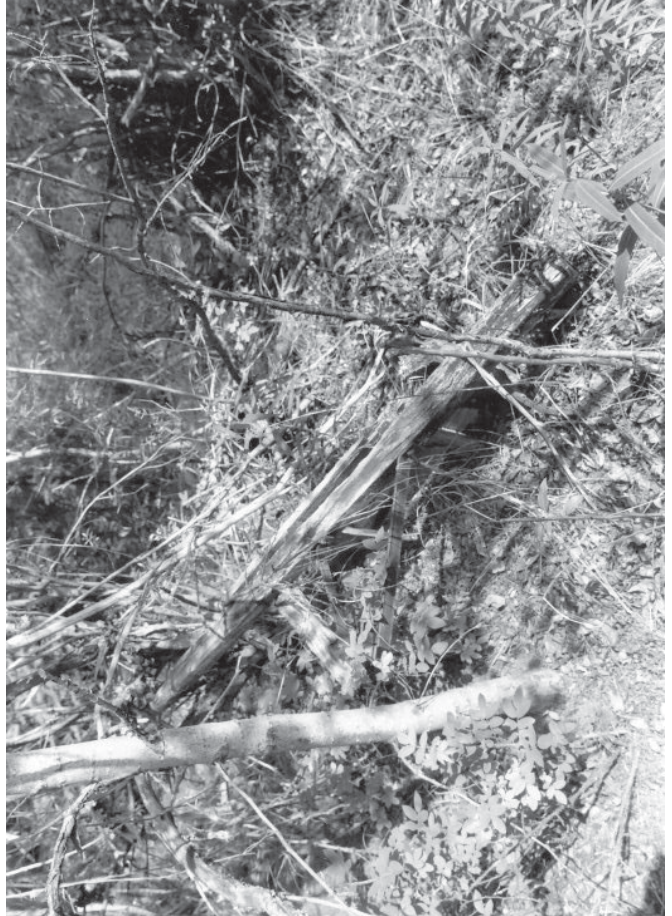
- (B 21) Looking east from east of ring of bag casts
- (B 23) Looking south from south end of probable water channel (F 7)
- (C 31) Wheelbarrow frame at edge of long depression east of foundation
- (C 32) Wheelbarrow frame at edge of long depression east of foundation

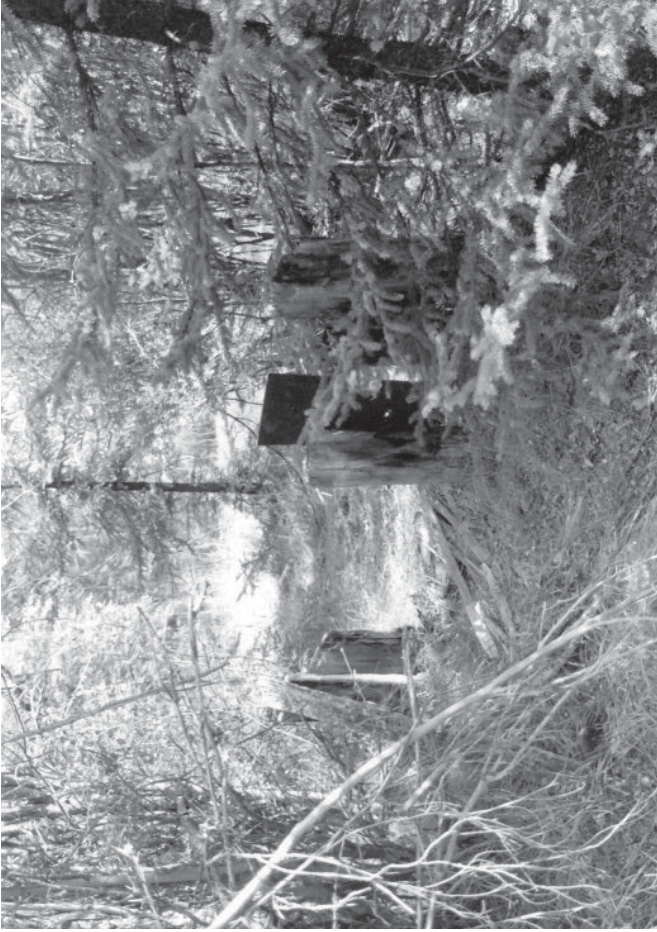
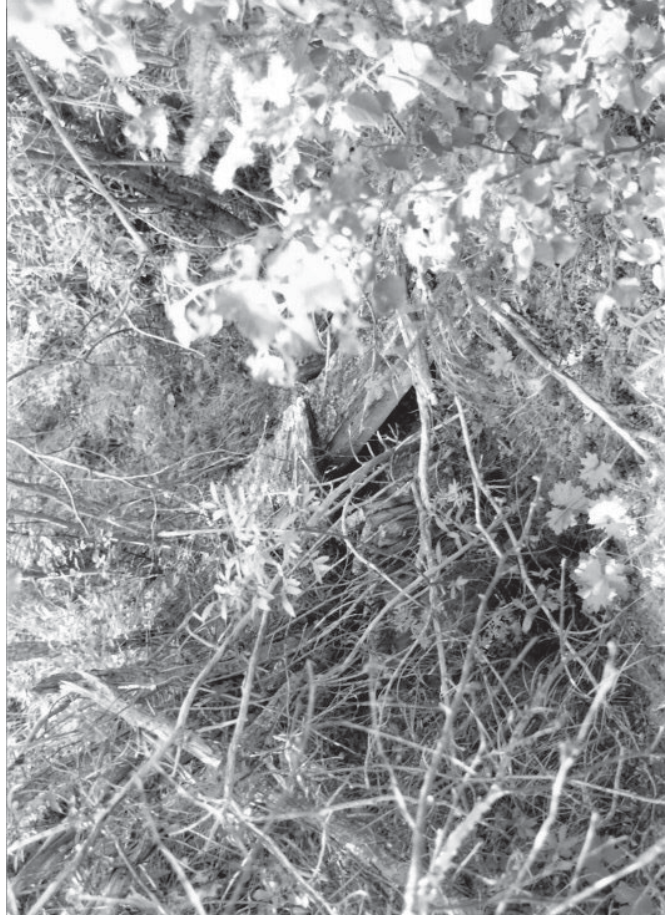
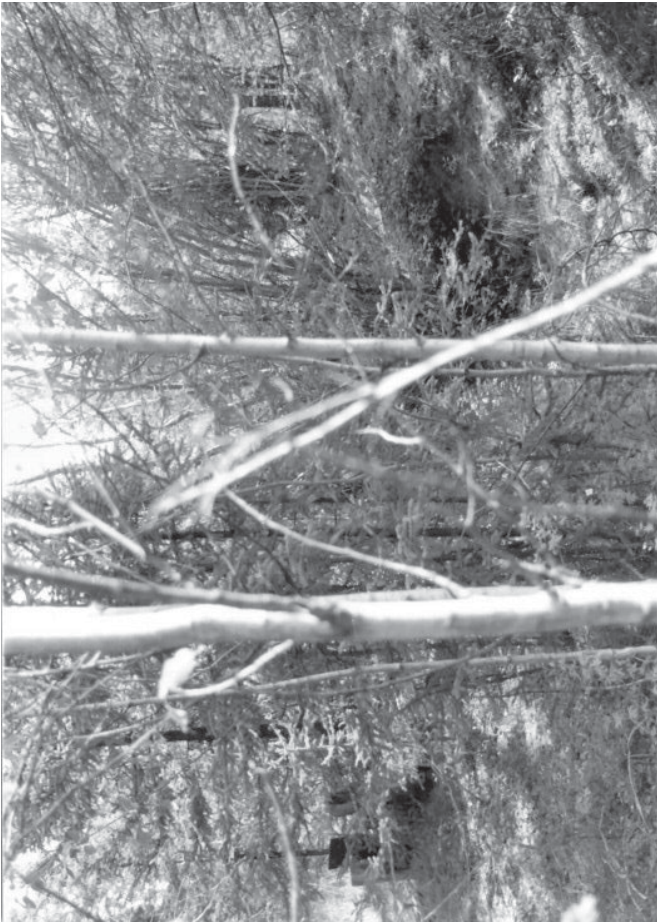
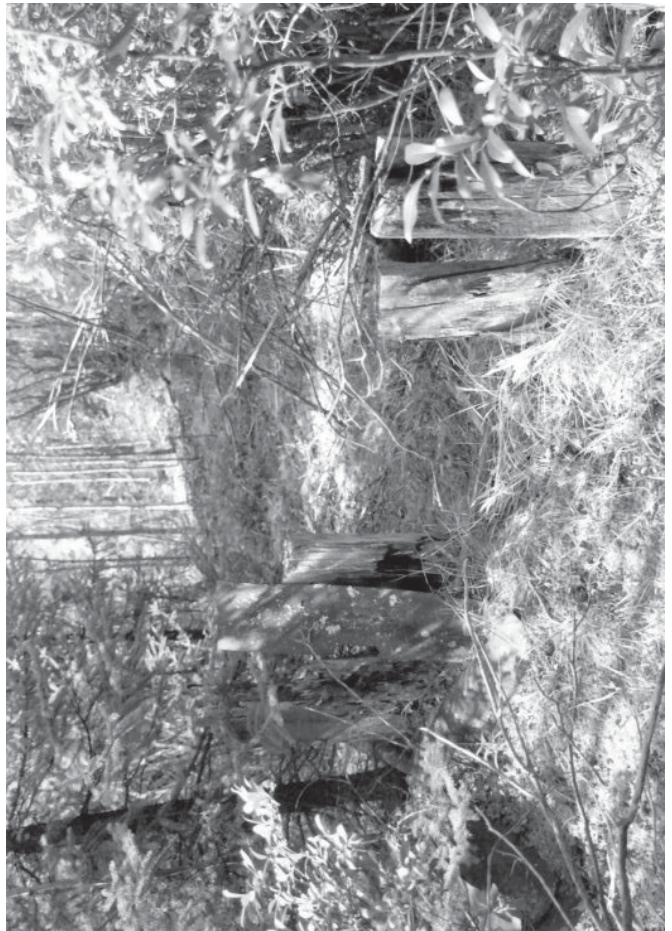
- C 33 Looking north-east from wheelbarrow frame towards plank wall
- C 34 Plank wall projecting up from bank
- C 35 Plank wall projecting up from bank
- D 2 Wooden beam lying across depression

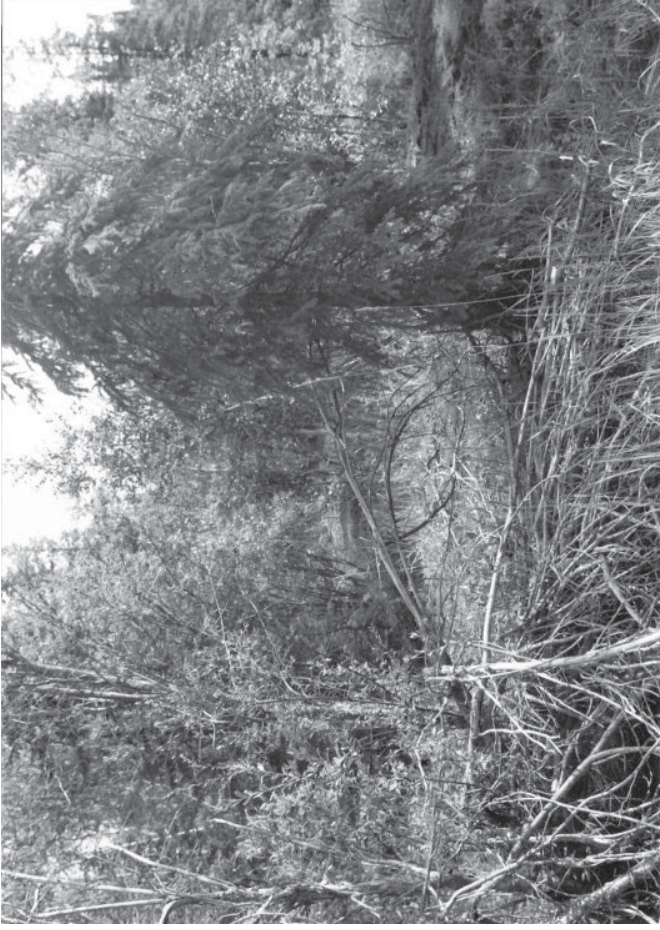
D04

- D 3 Looking north-east along wide ditch
- D 4 Looking north-east along bank of wide ditch
- D 22 Looking north into wide ditch, plough in foreground
