**REPORT ON  
THE CULTURAL RESOURCES AT  
COAL CREEK**

Bob Mitchell  
CAPHC

# REPORT ON THE CULTURAL RESOURCES AT COAL CREEK

AS FOUND IN AUGUST OF 1992

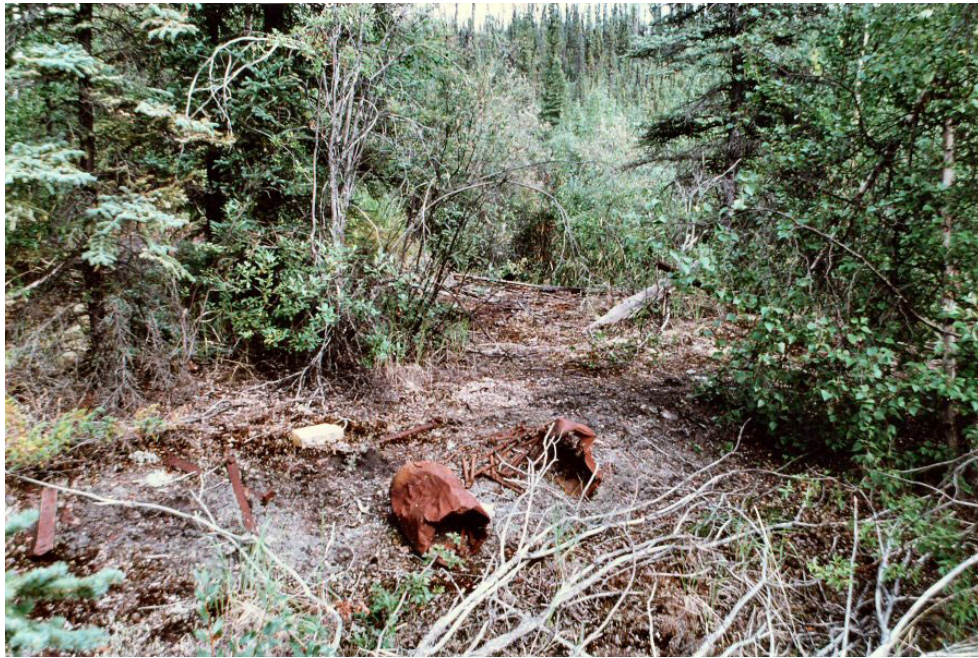
SB22

**T**his site composed of a series of four parallel, linear features of coal dust. These features delineate the location of the bunker, and of the two railway tracks either side of the bunker. No structural components of the bunker remain, though there are some wood remains on the bank of the creek.

The bunker itself was 27 feet wide by 100 feet long according to the historic map on page 11 and as can be seen from the historic photographs on pages 19, 20, and 23, was fairly basic in construction. The one interesting feature was the inclined tramway leading from the mine site to above the bunker.

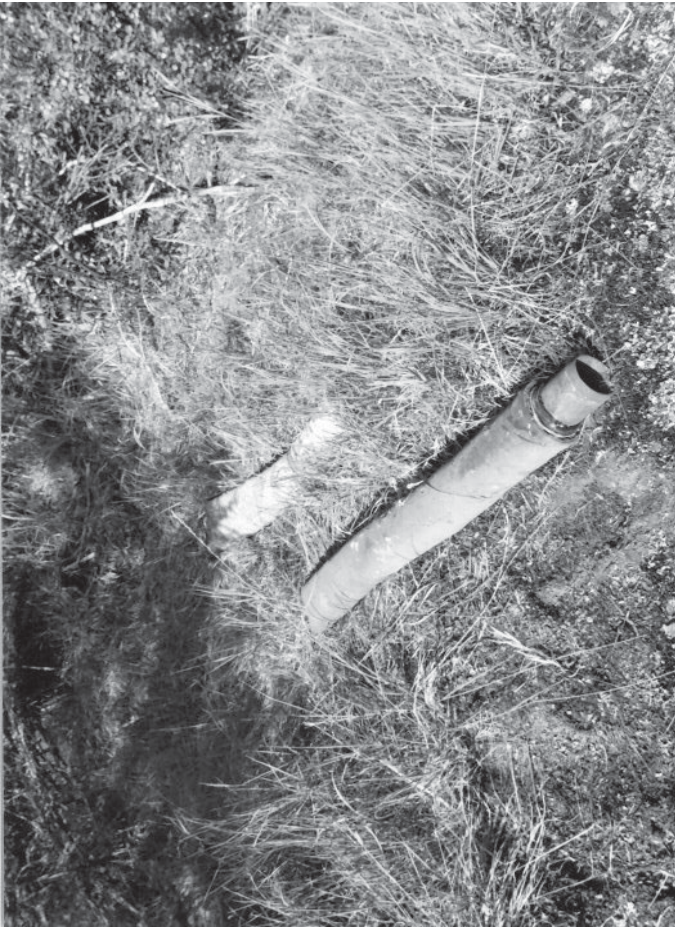
D00

- C 36 Pieces of suction hose north-east of plank wall
- C 37 Looking south-east from suction hose
- D 0 Pieces of suction hose at north-west end of feature
- D 1 Pipe and long handled hoe approximately 2500 mm long

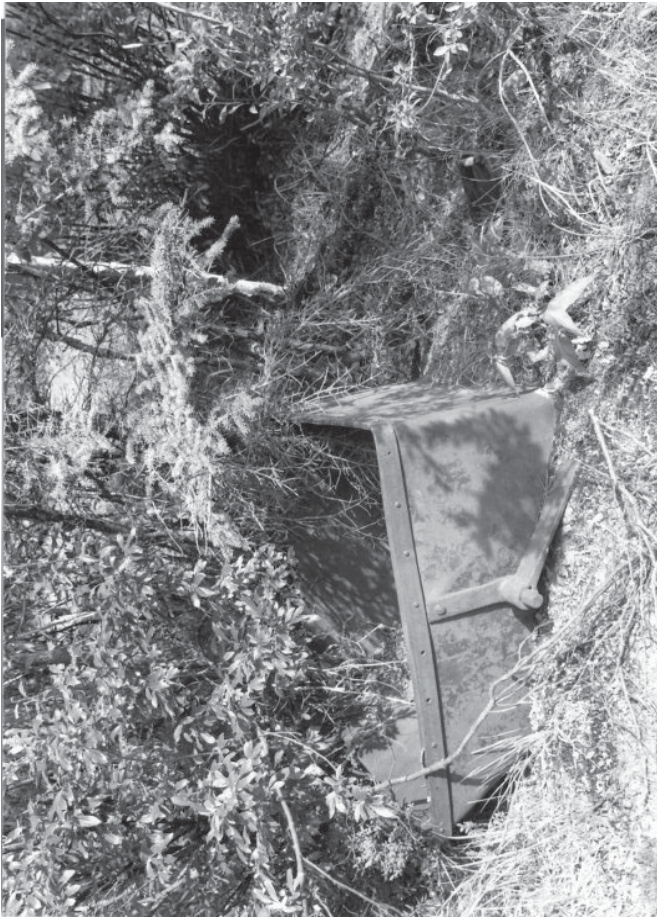
D07

- D 6 Pulley frame for self-dumper
- D 7 Bucket for self-dumper
- D 8 Looking east into feature
- D 9 Bucket of bolts near south-east end of feature

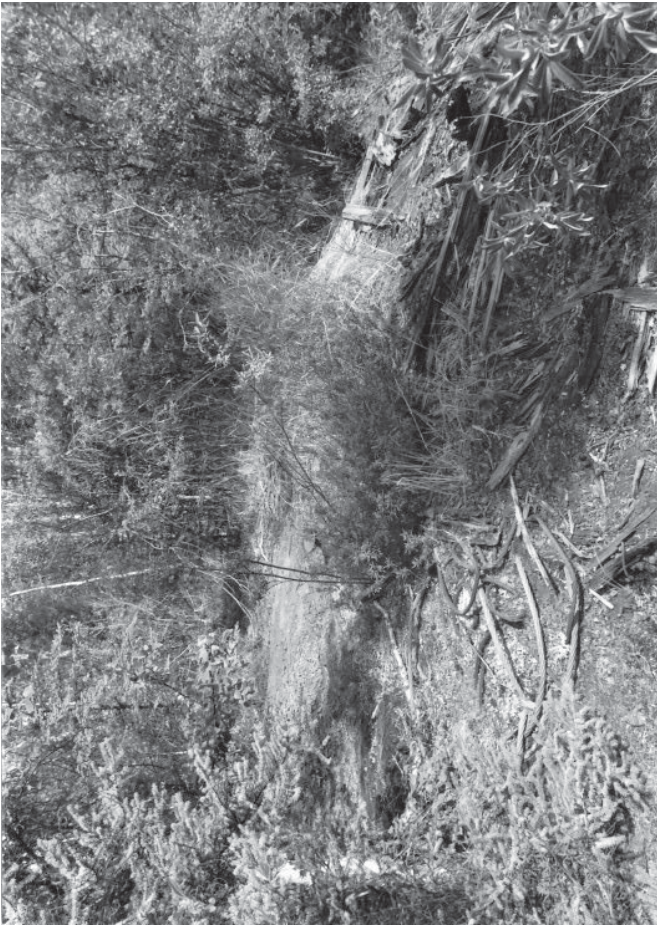
D11

- D 10 Rail at east end of feature
- D 11 Looking north-east along creek bank
- D 12 Wood debris on creek bank
- D 13 Looking south-east across creek towards probable site of Mine No. 1

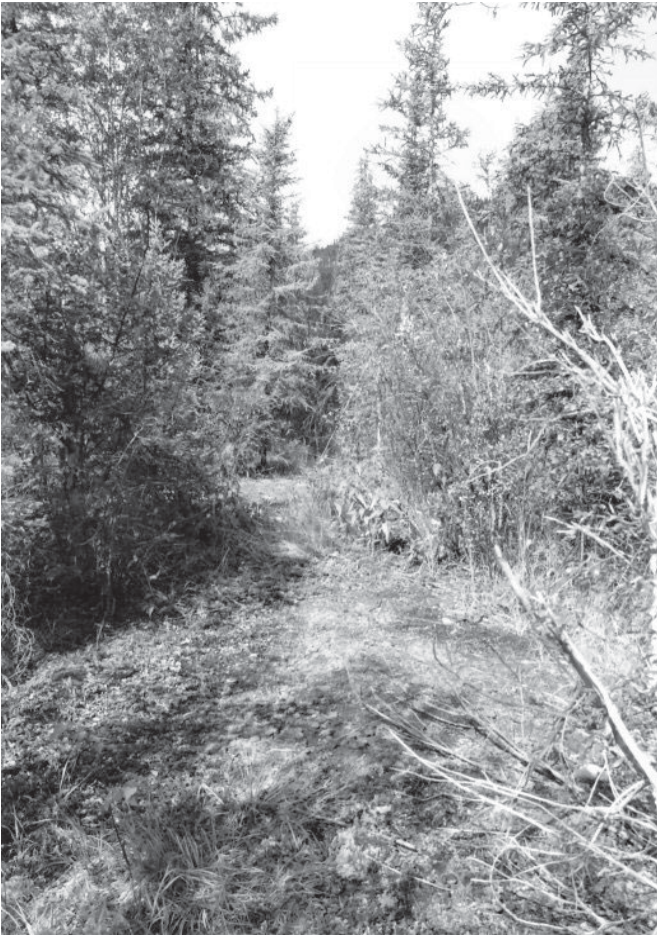
D15

- (D 5) Looking south-east from along bank of wide ditch, north-west end of coal bunker sit3 is visible
- (D 14) Looking north-west along feature
- (D 15) Looking north-west along feature
- (D 17) Looking down into depression in middle of feature

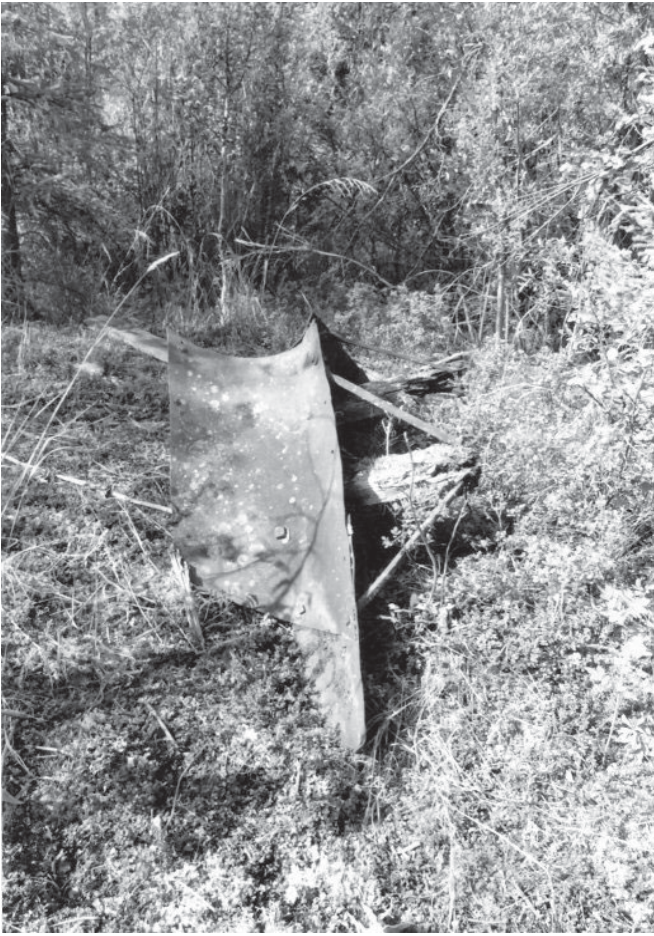
D18

- D 16 Gear cover
- D 18 Plough at north-east end of feature
- D 19 Plough at north-east end of feature
- D 21 Plough at north-east end of feature

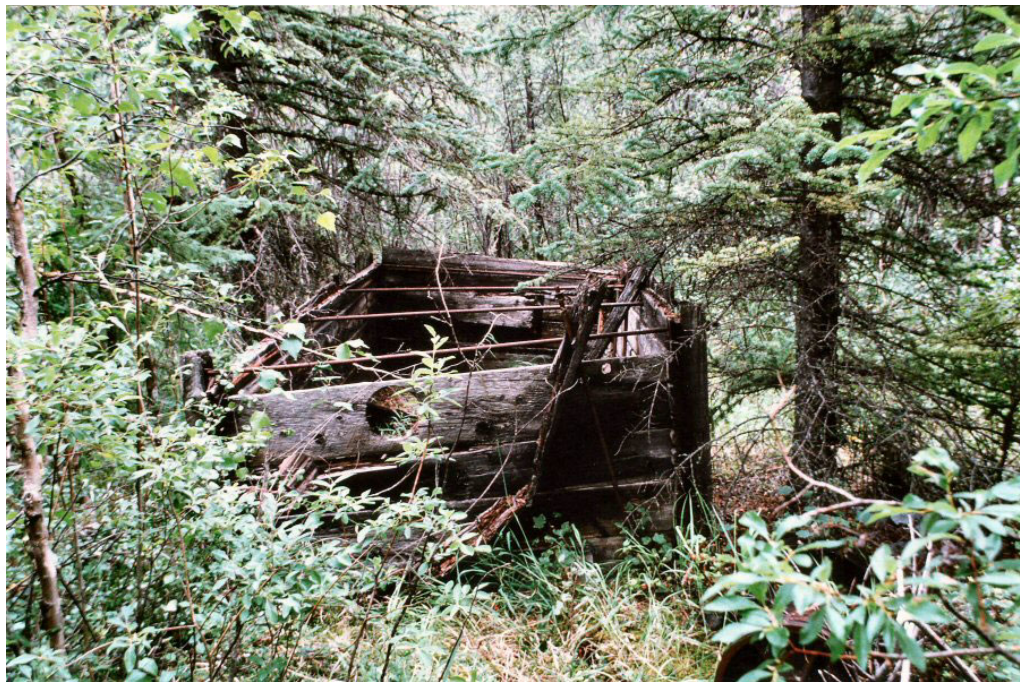
SE39

This artifact is a rectangular wooden box, that was probably a holding tank for water, and this water was more than likely used to supply the boilers at Mine No. 2.

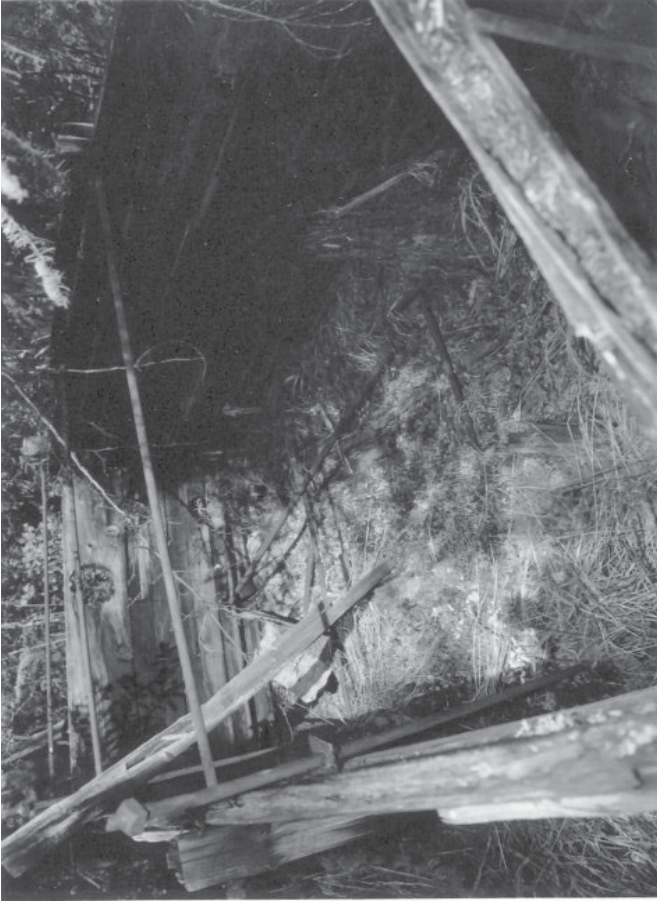
J24

- G 12 Looking north at tank
- J 24 Tank interior, looking north-west

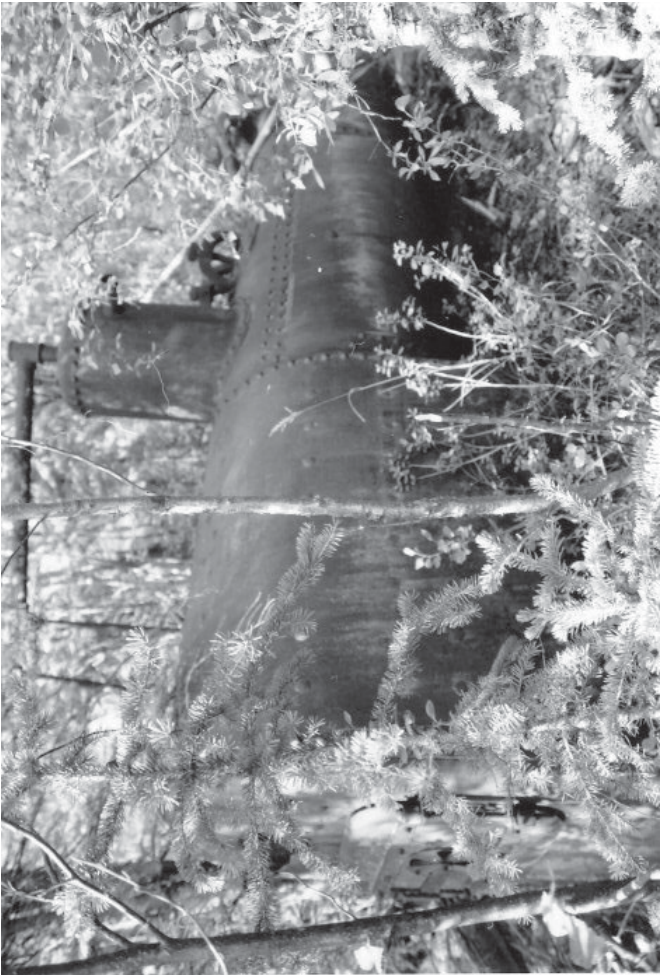
J20

J 20 Boiler near office, looking west

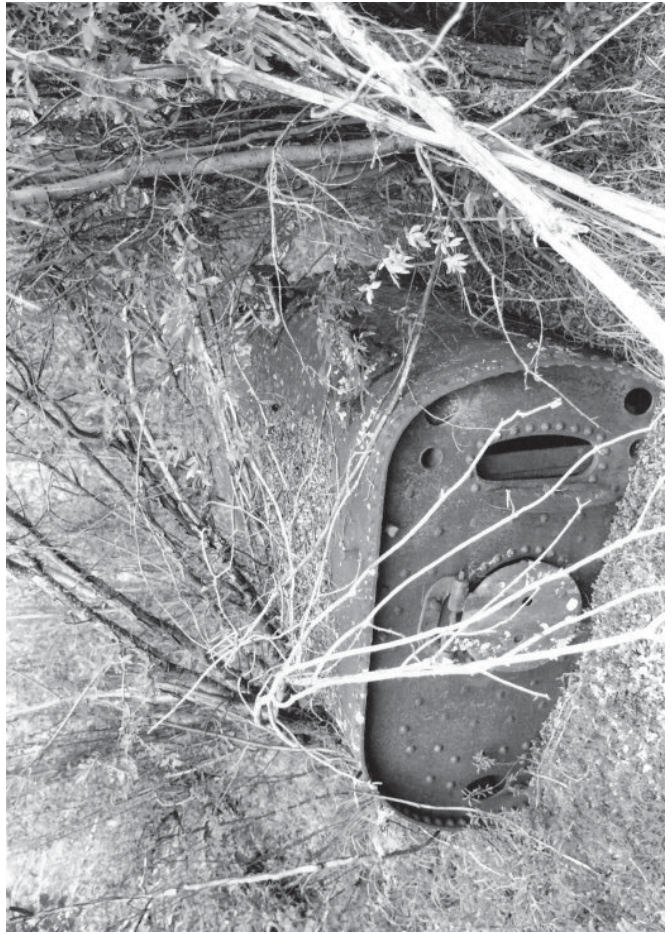
E19

E 19 3/4 view of firing end of boiler

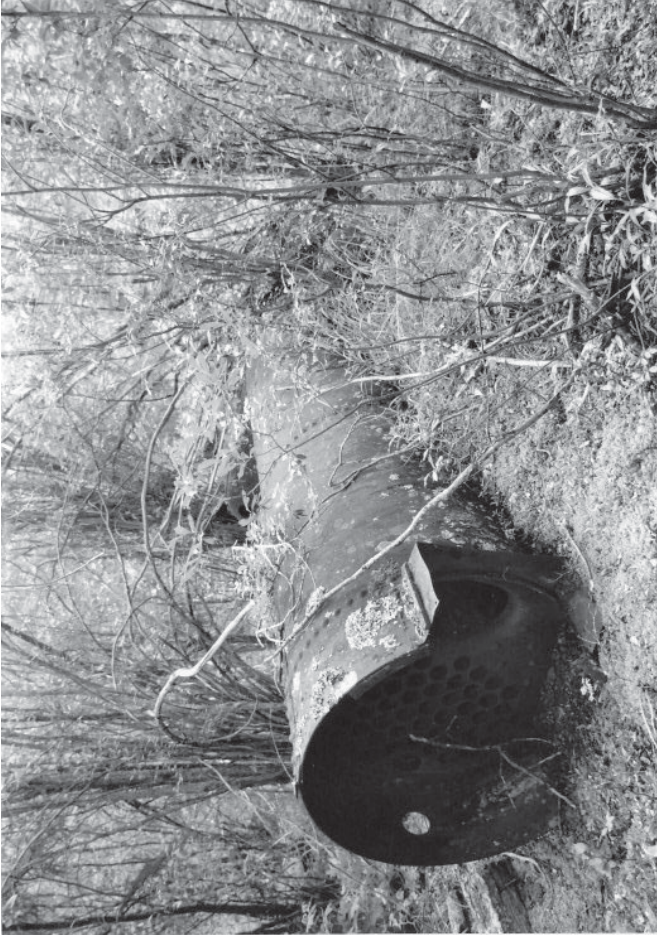
E13

- E 13 Smokebox end of boiler
- E 14 View of underside of smokebox showing brace
- E 15 View of upper side of smokebox showing stack base

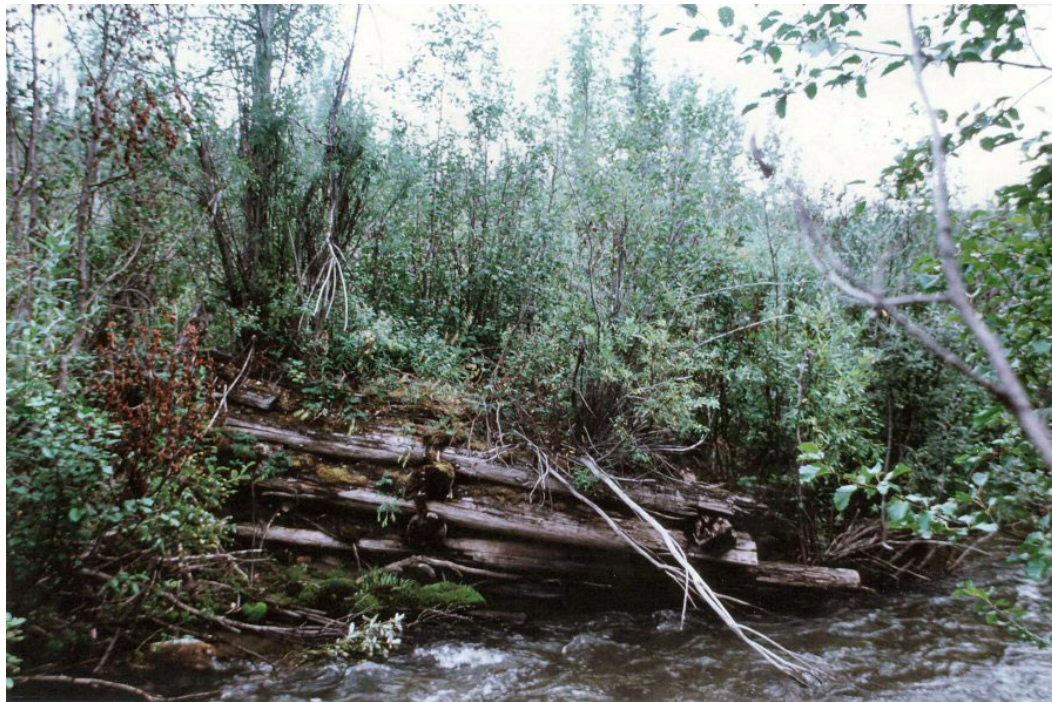
SC04

**PROBABLE DAM ABUTMENT**

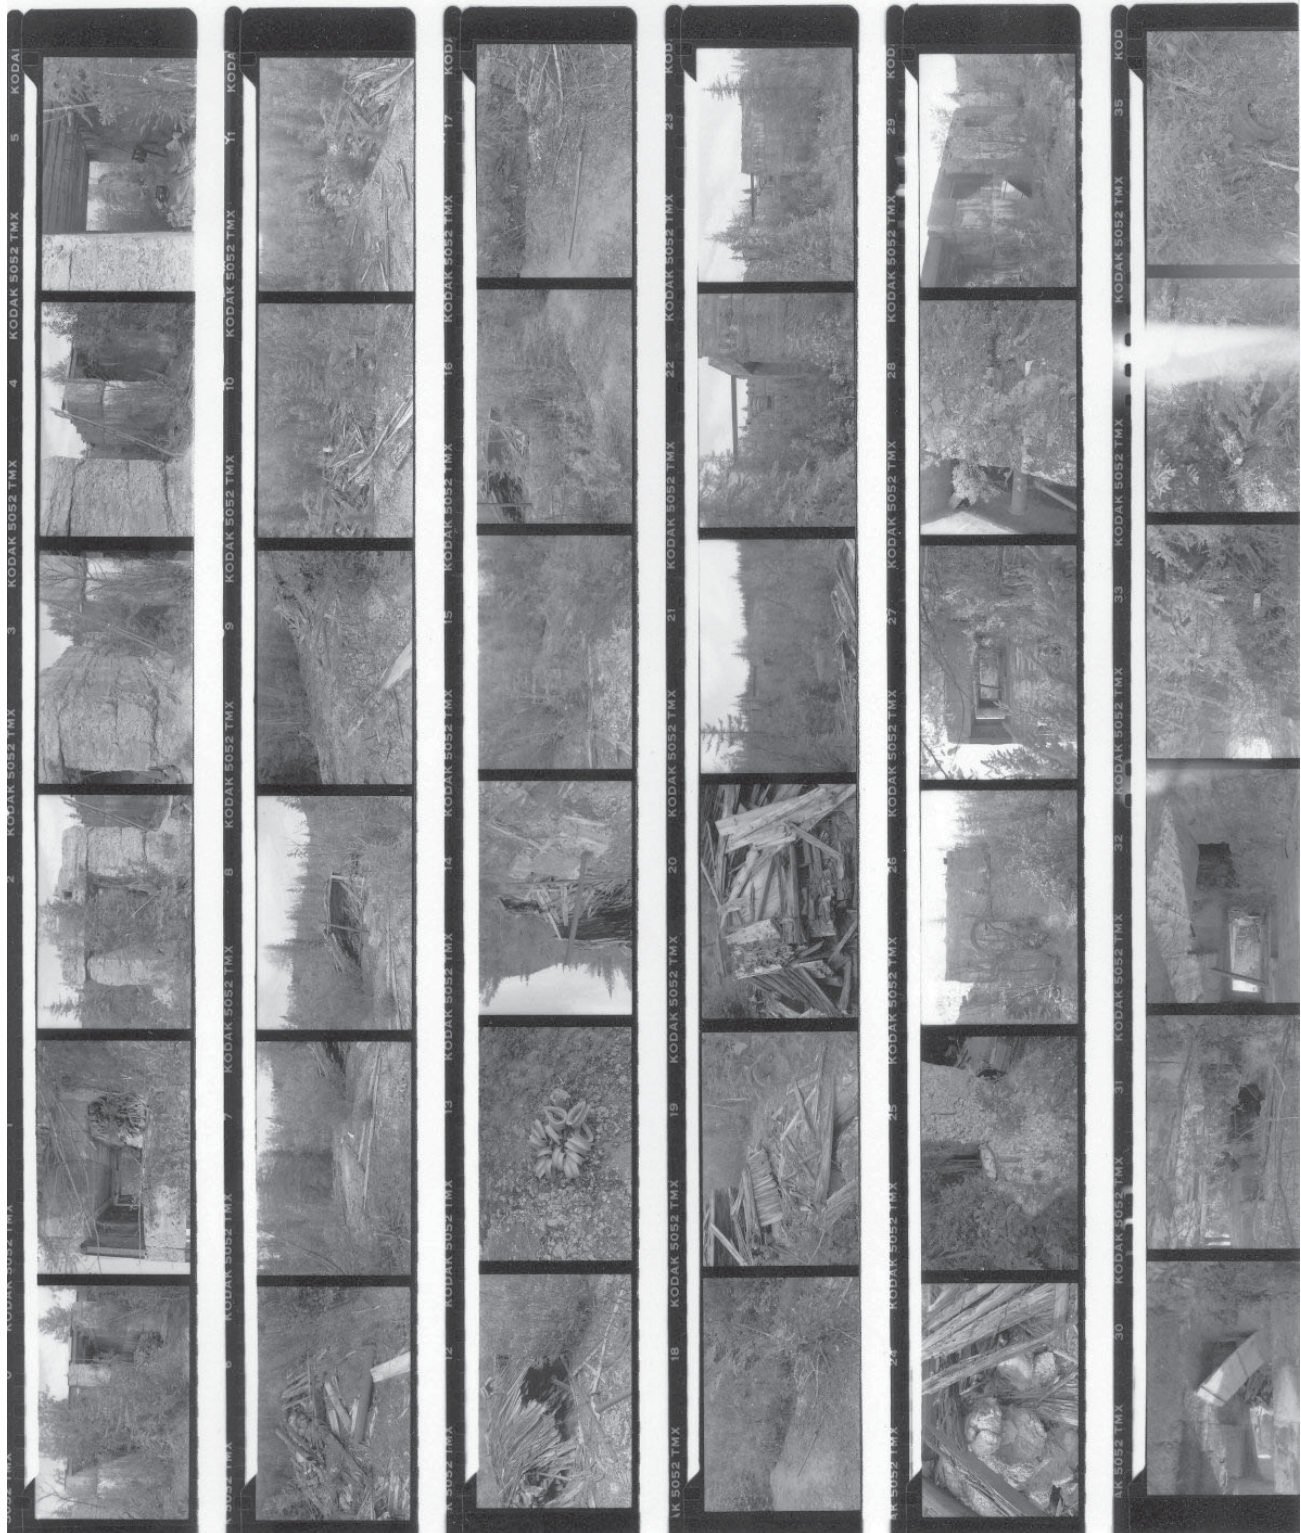
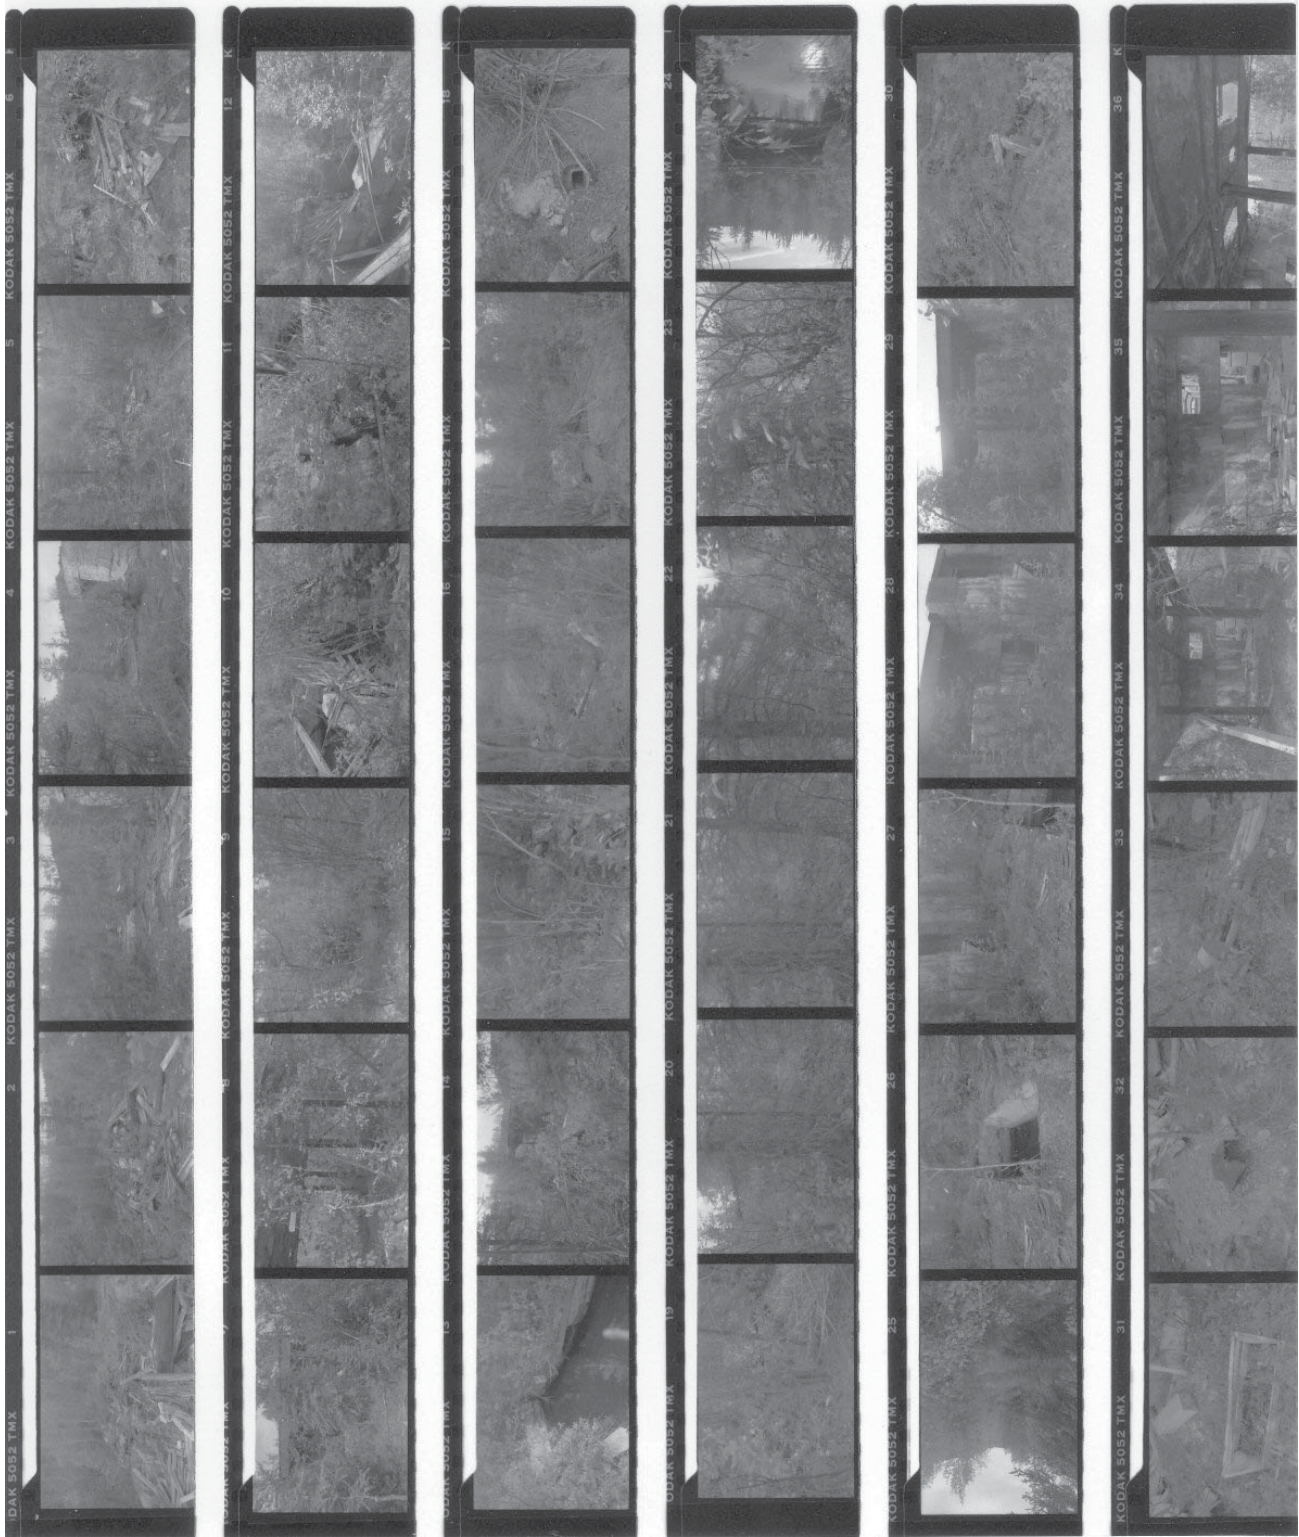
TECHNICAL DATA ROLL A

Neg. No.	Notes
1	Looking west along debris at south-west corner - note concrete piers
2	Looking east along debris at south-west corner - note bag casts
3	Looking west along south side of foundation
4	Looking north-west from south side of foundation towards Bay 7
5	Looking east at debris at south-east corner of foundation
6	Close-up of debris at south-east corner of foundation
7	South elevation of Bay 1
8	Looking north-east into Bay 1
9	Looking south from Bay 1
10	Looking north-east into south end of large concrete tank
11	Looking at large gap along west edge of concrete tank
12	Looking south-east into south end of concrete tank
13	Looking north-east into north end of concrete tank
14	Looking back at Bay 1 from north-east corner of concrete tank
15	Looking east from north-east corner of concrete tank
16	Looking north at ring of bag casts to the east of power house
17	Looking at earth bank on south side of ring of bag casts

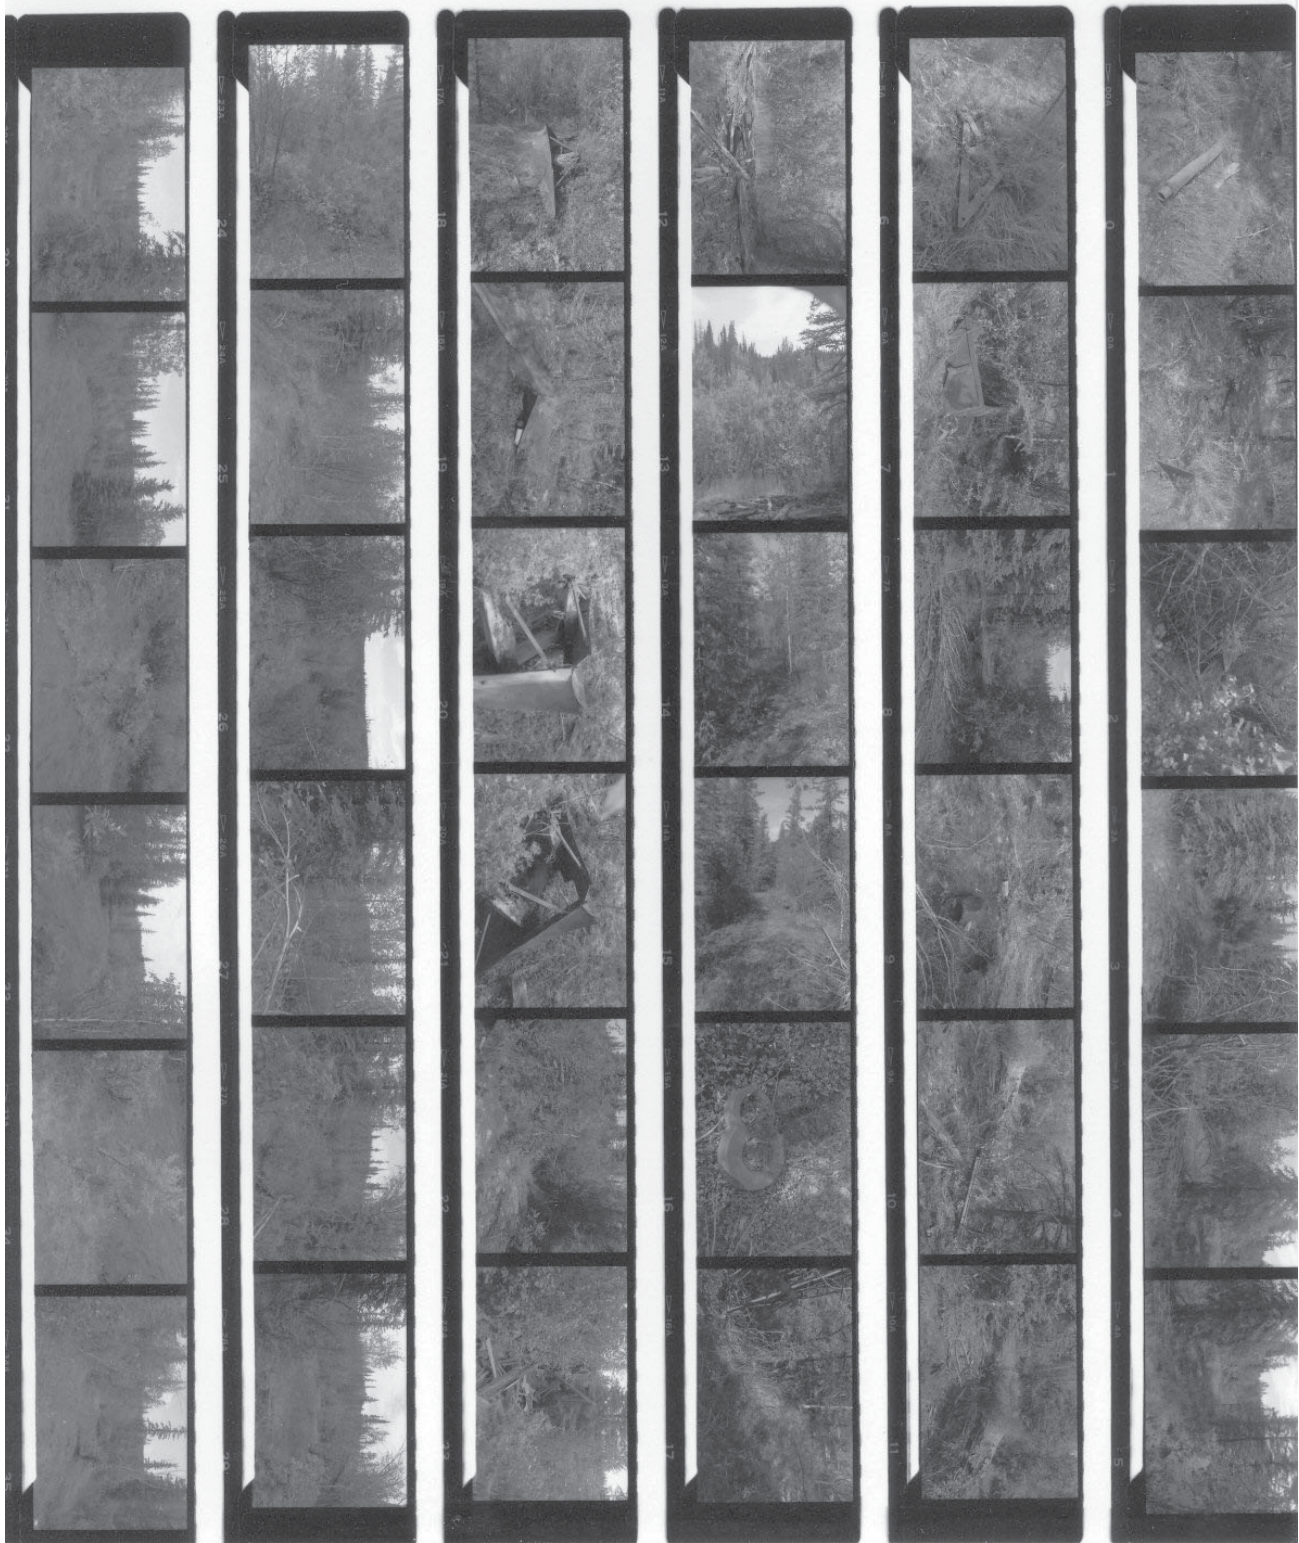
SUBJECT COAL CREEK - BUNKER AREA - AREAS ALONG Rwy LINE DATE AUG 4/92  
TECHNICAL DATA ROLL D

Photo Ref. D Date Aug. 4/92 Photographer Bob Mitchell  
Subject Features F 4, F 5, F 7, F 8 Film Type Kodak TMax 100

Neg. No.	Notes
0	F 8 - Pieces of suction hose at north-west end of feature
1	F 7 - Pipe and long handled hoe approximately 2500 mm long
2	F 7 - Wooden beam lying across ditch
3	F 7 - Looking north-east along wide ditch
4	F 7 - Looking north-east along bank of wide ditch
5	F 7 - Looking south-east from along bank of wide ditch
6	F 8 - Pulley frame for self-dumper
7	F 8 - Bucket for self-dumper
8	F 8 - Looking east into feature
9	F 8 - Bucket of bolts at east end of feature
10	F 8 - Rail at east end of feature
11	F 8 - Looking north-east along creek bank
12	F 8 - Wood debris on creek bank
13	F 8 - Looking south-east across creek towards M 1
14	F 8 - Looking north-west along feature
15	F 8 - Looking north-west along feature
16	F 8 - Gear cover
17	F 8 - Looking down into depression in middle of feature
18	F 8 - Plow at north-west end of feature
19	F 8 - Plow at north-west end of feature
20	F 8 - Plow at north-west end of feature
