Faro Mine Complex AMP Event #4 Response: 2008 Status Report

*Project Reference Number
SRK 1CD003.110*

**AMP Event #4 Response:
2008 Status Report
FINAL**

2008 GROUNDWATER REVIEW
ANVIL RANGE MINING COMPLEX, YUKON TERRITORY

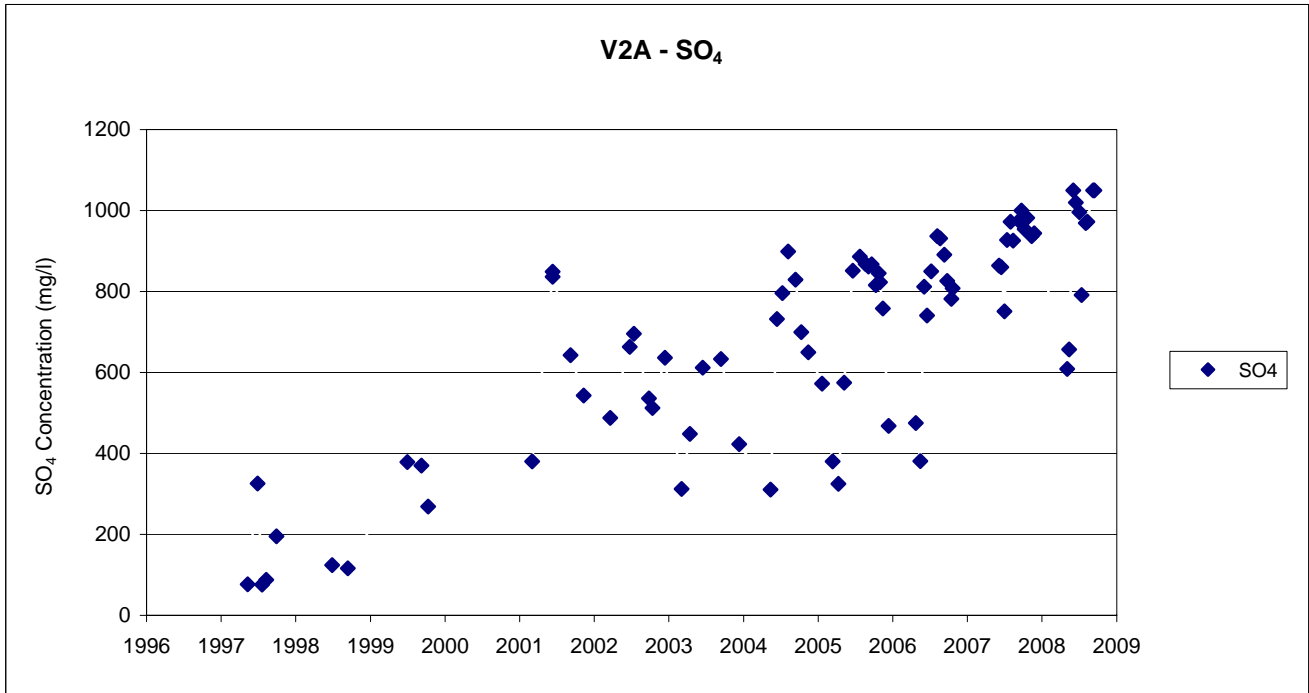
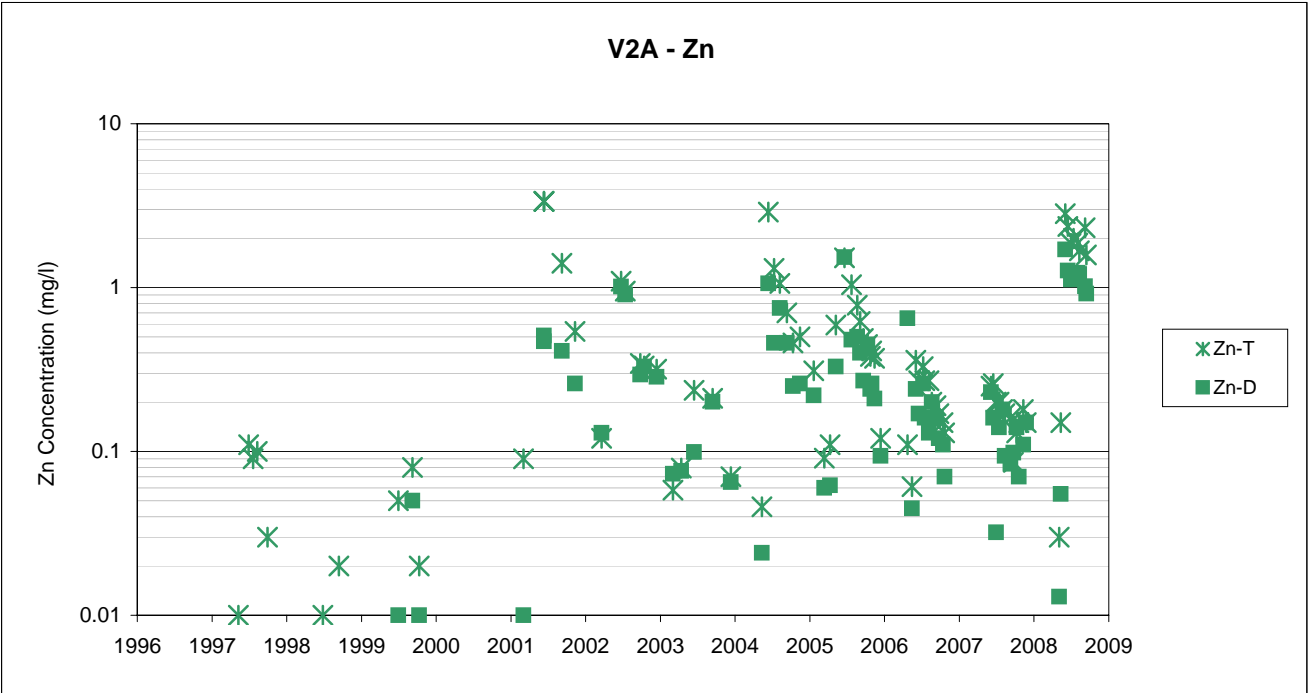
Figure:
4

Zinc and sulphate concentrations at Station V2A are shown in Figure 4.

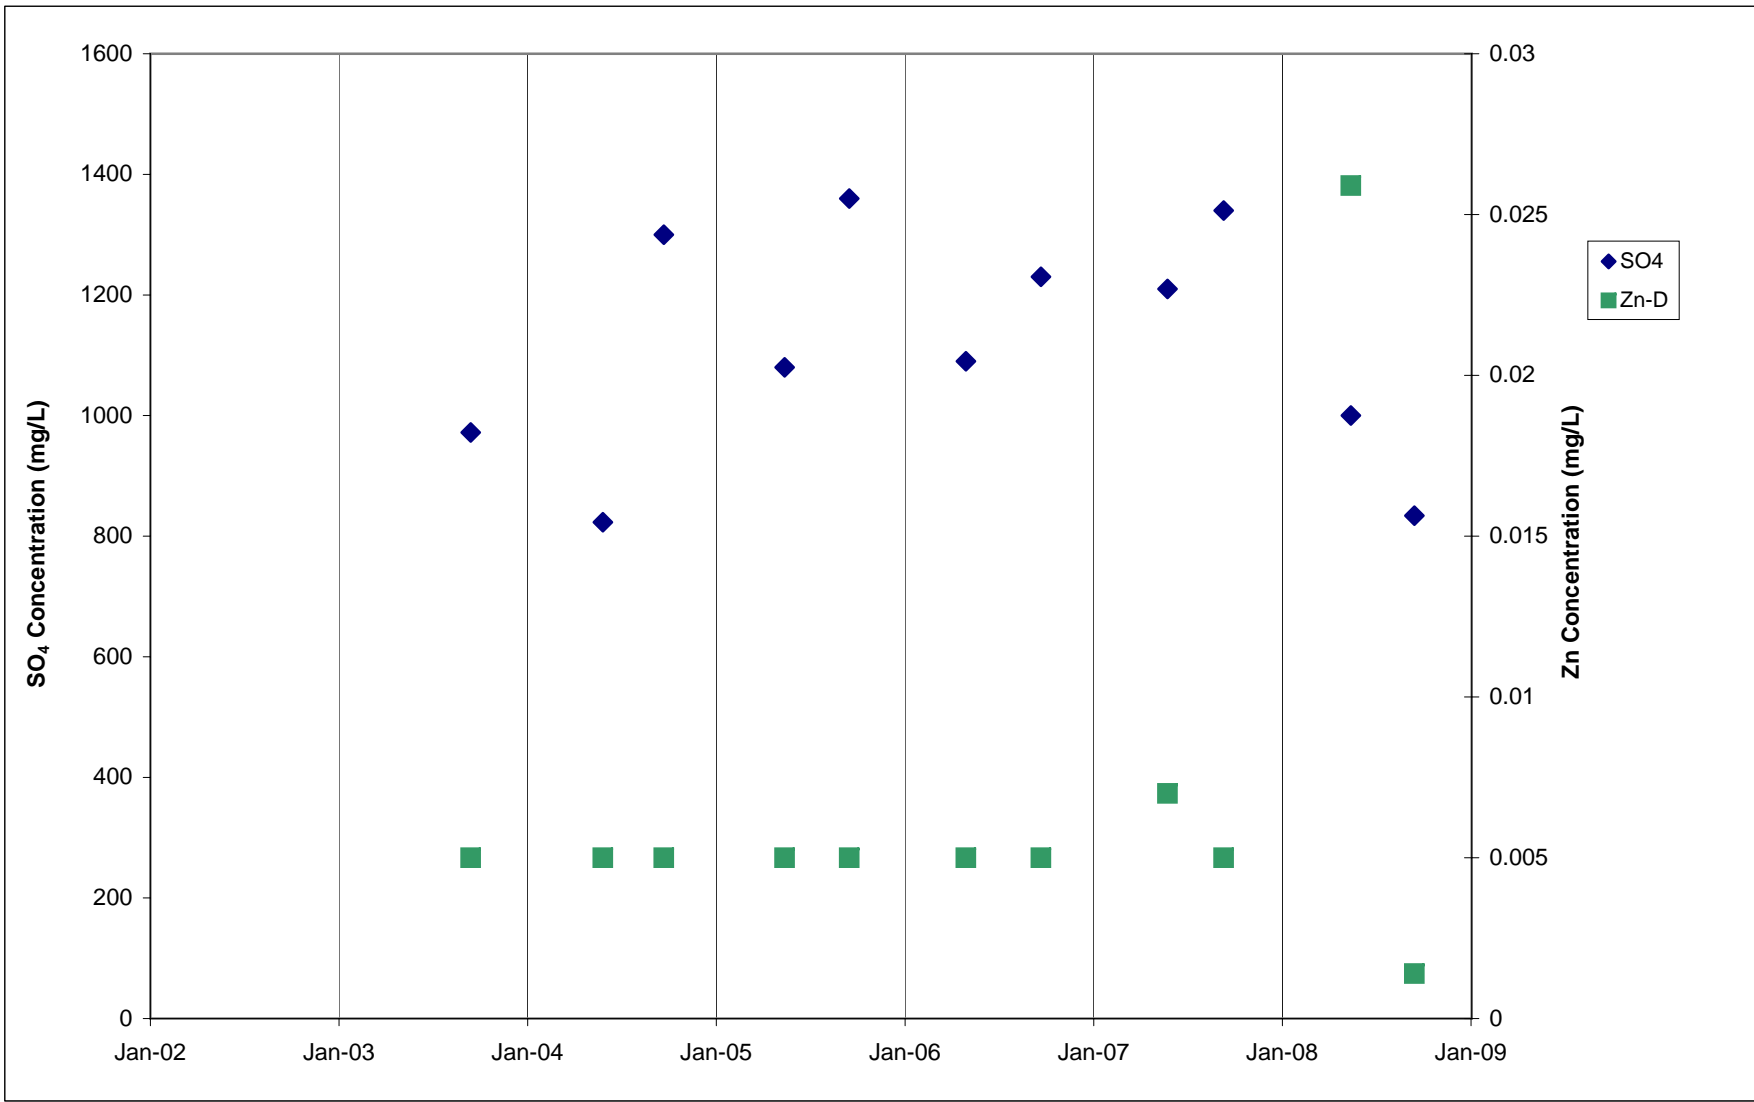
Figure:
10

Station SRK-GD05 is located at the dump toe directly upgradient of the swale shown on Figure 1 as No Fork Creek, and has been monitored on a semi-annual basis since 2002. Sulphate and dissolved zinc data are summarized in Figure 10.
